DEPARTMENT OF MINES SOUTH AUSTRALIA

Rept.Bk.No.71/176 B.M. No.29 D.M. No.1119A/65.

DRILLING & COMPLETION PRACTICES

IN THE GREAT ARTESIAN BASIN.

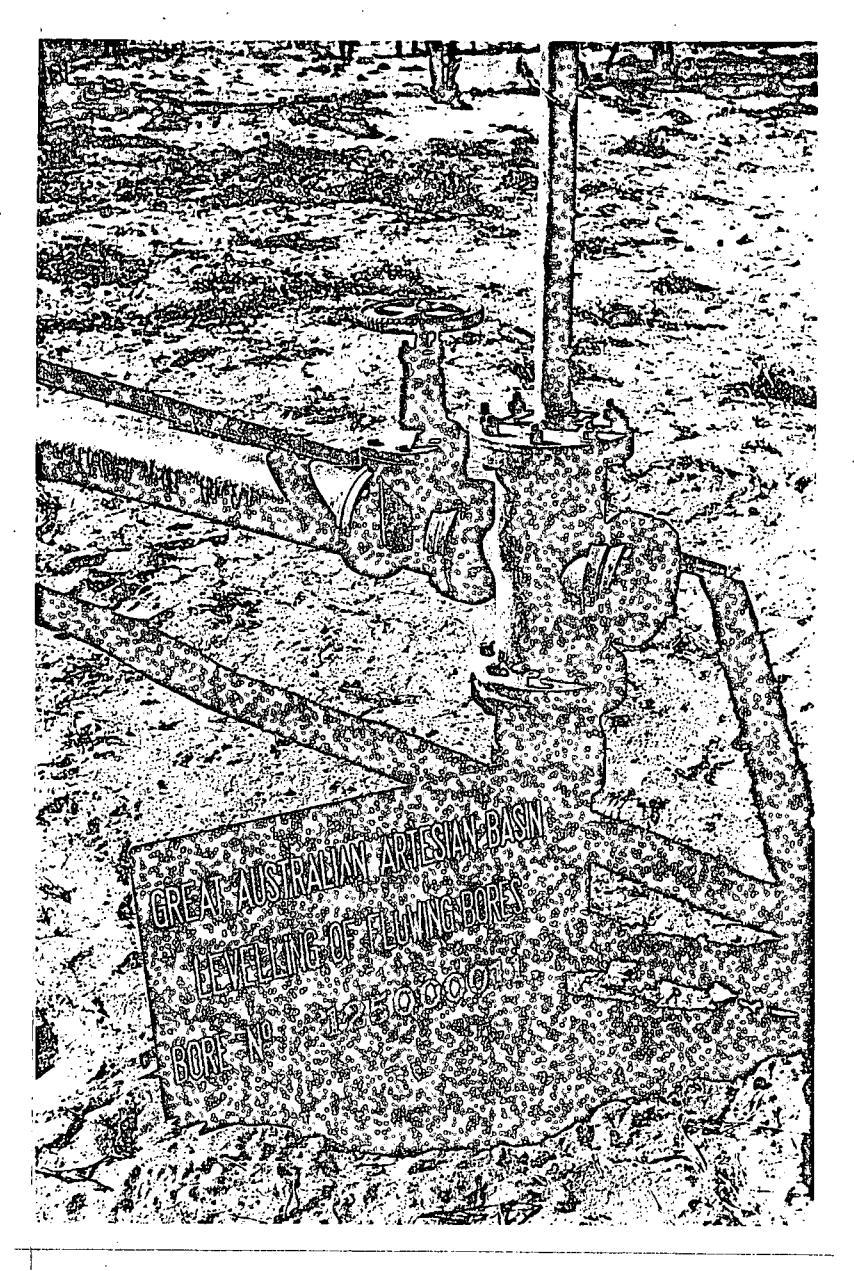
FIG. 6.

An existing artesian bore equipped with control valves, and with a dry area in the vicinity of the well head.

This completion is satisfactory but varies from the recommended artesian well headworks (Hancock, 1971). Production can be "controlled and shut off when the issuing water is not being turned to account" (L. Keith Ward, 1946)

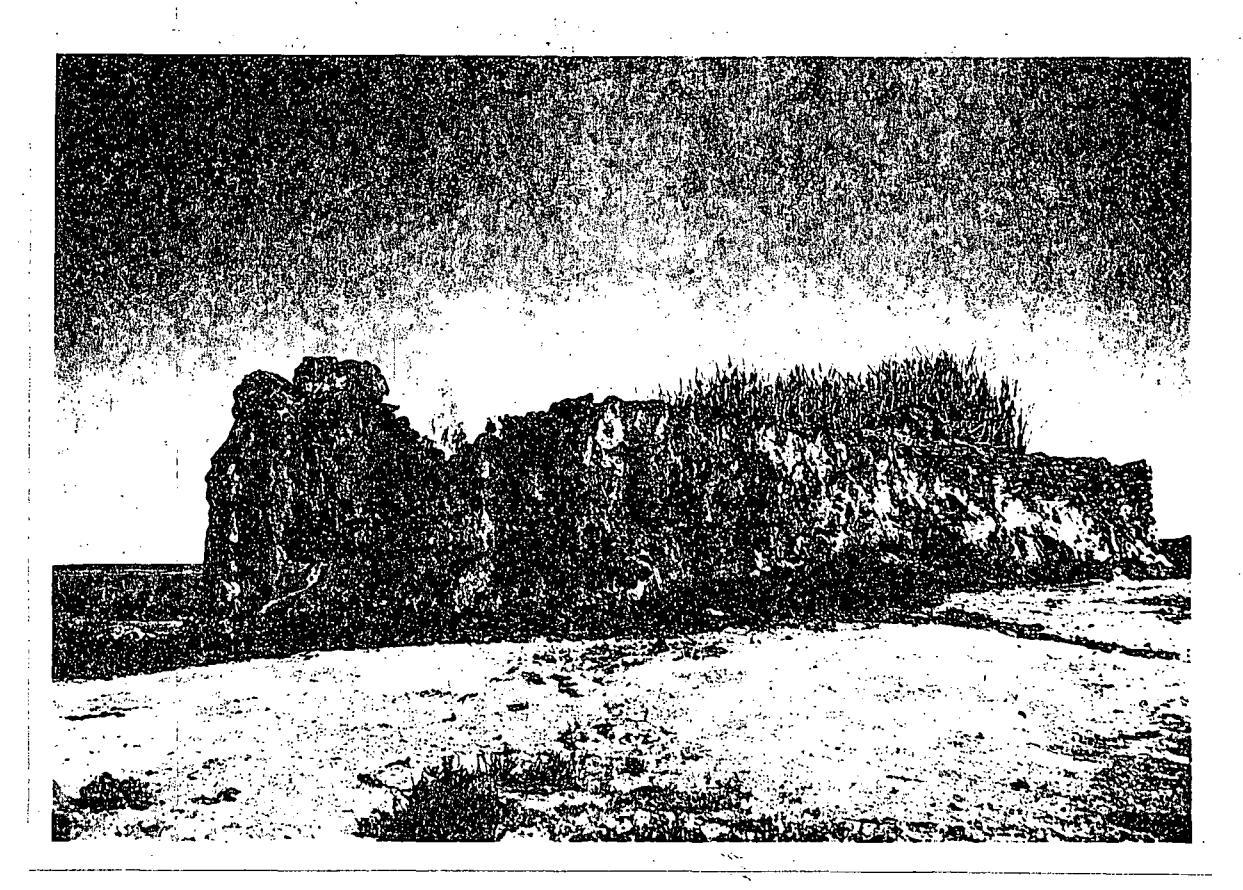
FIG. 7.

Uncontrolled artesian flow of 220,000 gallons per day gushing from a small diameter pipe. A storage tank was built around the original bore. This became filled with solids, resulting in the elevated position of the water discharge.

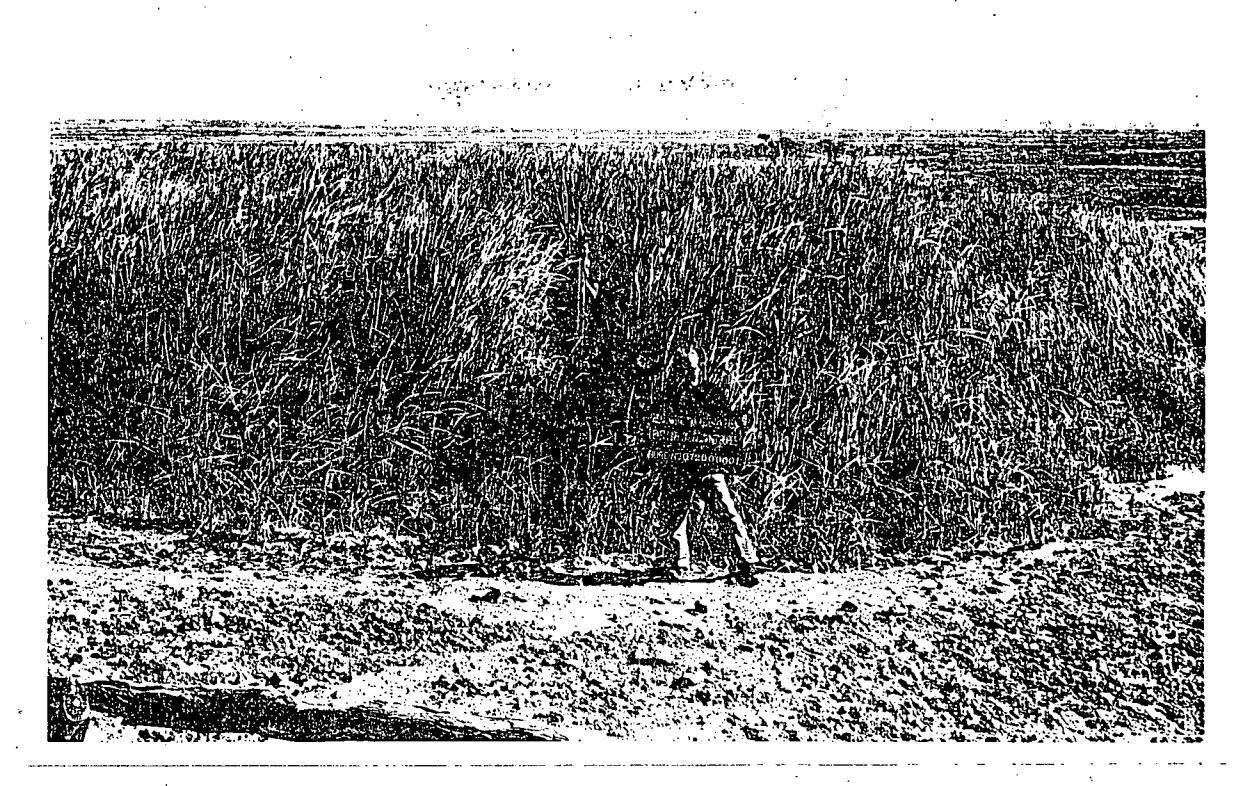
FIG. 8.

HORSESHOE BORE

An Artesian bore located in a swamp overgrown with weeds. The original bore site was selected in a low lying area with no natural drainage.

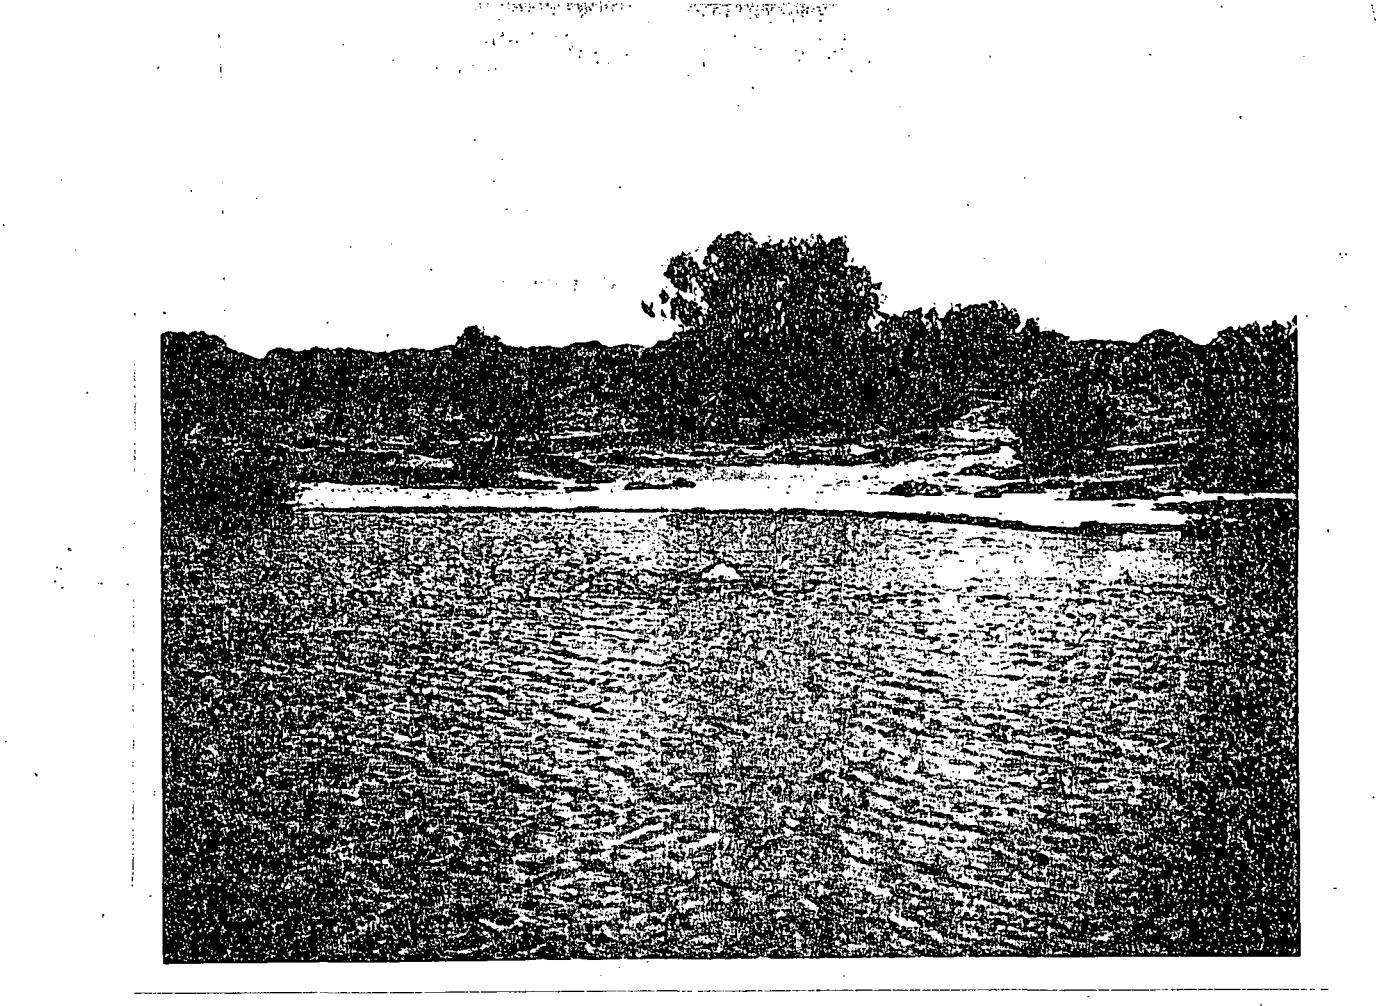
FIG - 9.

SNAKE CREEK BORE 08200001 Neg.... Uncontrolled artesian flow bubbling to the surface from the bottom of a lake 200 feet in diameter. The bore was drilled in a depression between sand dunes, with no natural drainage from the well head. The poor site selection will result in a very expensive re-equipment or abandonment operation.

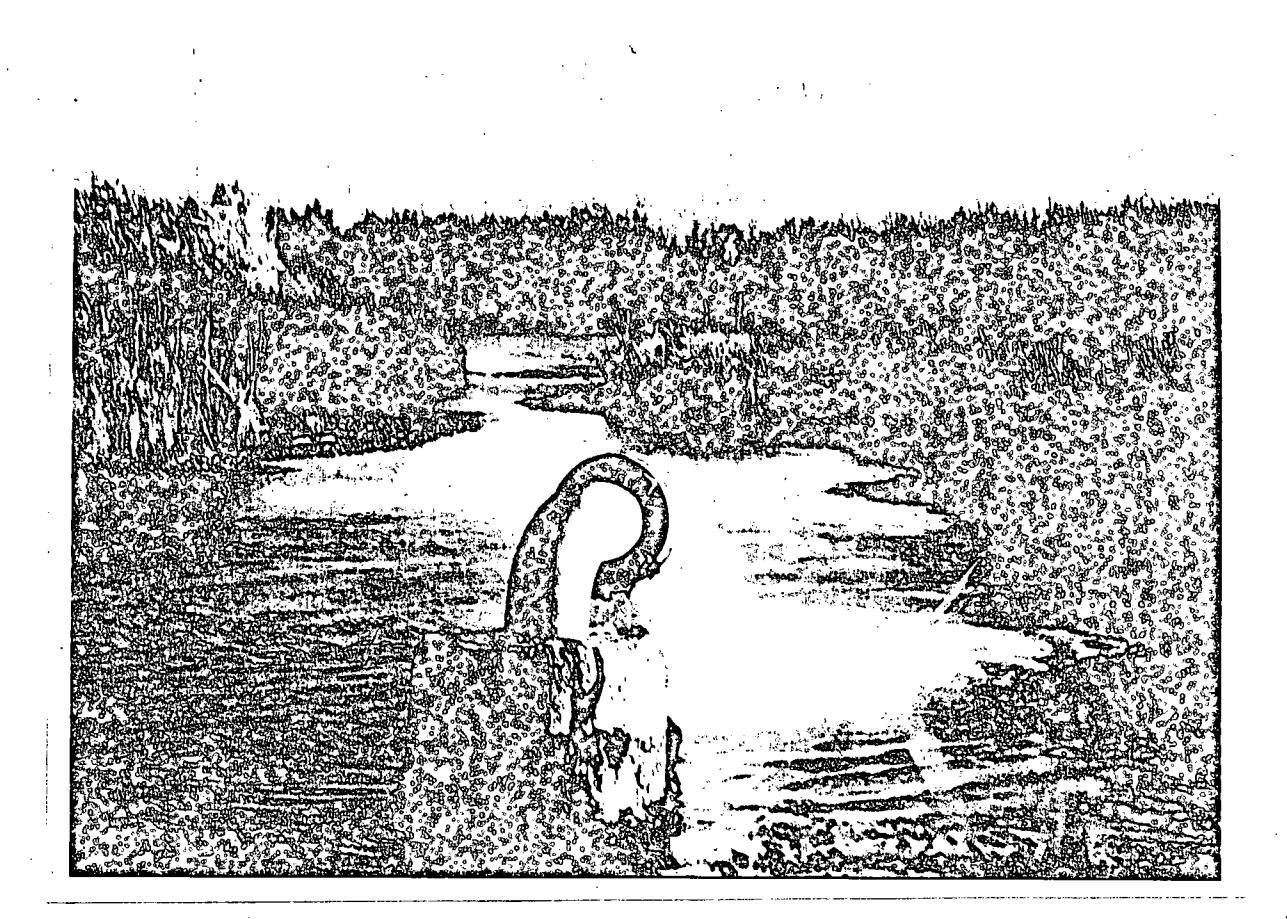
FIG . 10.

Uncontrolled artesian flow of approximately 700,000 gallons per day issuing from pipe bend; also from bottom of deep pond surrounding the well head:
