DEPARTMENT OF MINES SOUTH AUSTRALIA

GROUNDWATER SURVEY County of Sturt, Hundred of Tungkillo, Section 042

13th February, 1974

Rept.Bk.No.74/50 G.S. No. 5368 Hyd. No. 2624 D.D. No.162/74

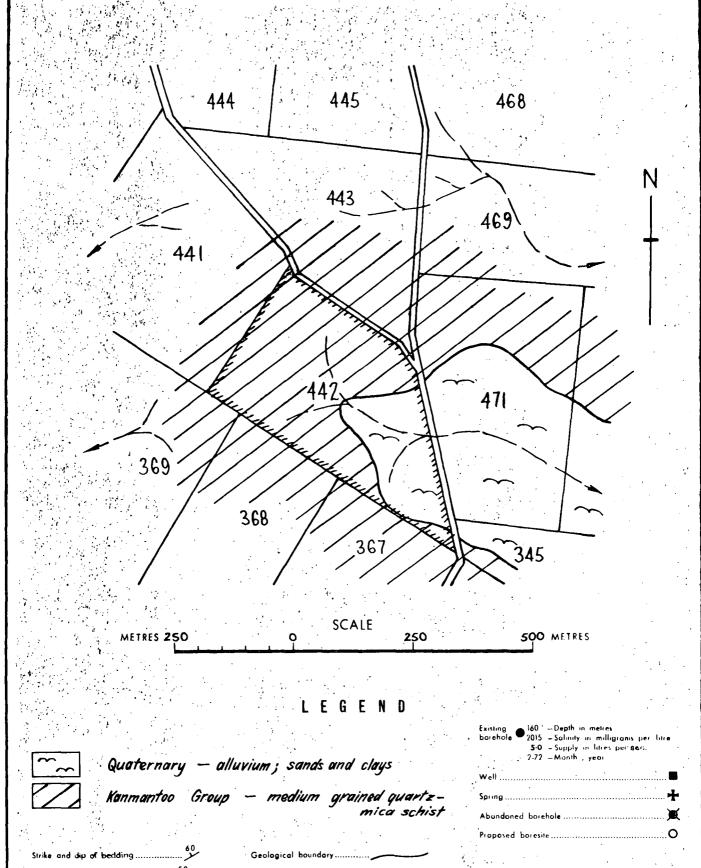
General: Two bores already on the property have salinities of approx. 5000 mg/l and because of the requirement for water of less than 3000 mg/l, further drilling cannot be recommended.

The property was inspected geologically and due to the high salinities already recorded on the property (approx. 5000 mg/l) and the poor recharge prospects, further drilling cannot be recommended. Instead the feasibility of constructing a small dam in the gully to the west of the house should be investigated.
