SEISMIC INVESTIGATION OF DAM SITE
WIRRINA HOLIDAY VILLAGE

Hd. Yankalilla

Rept.Bk.No.74/52
G.S. No. 5371
DM. No. 1303/72

14th February, 1974

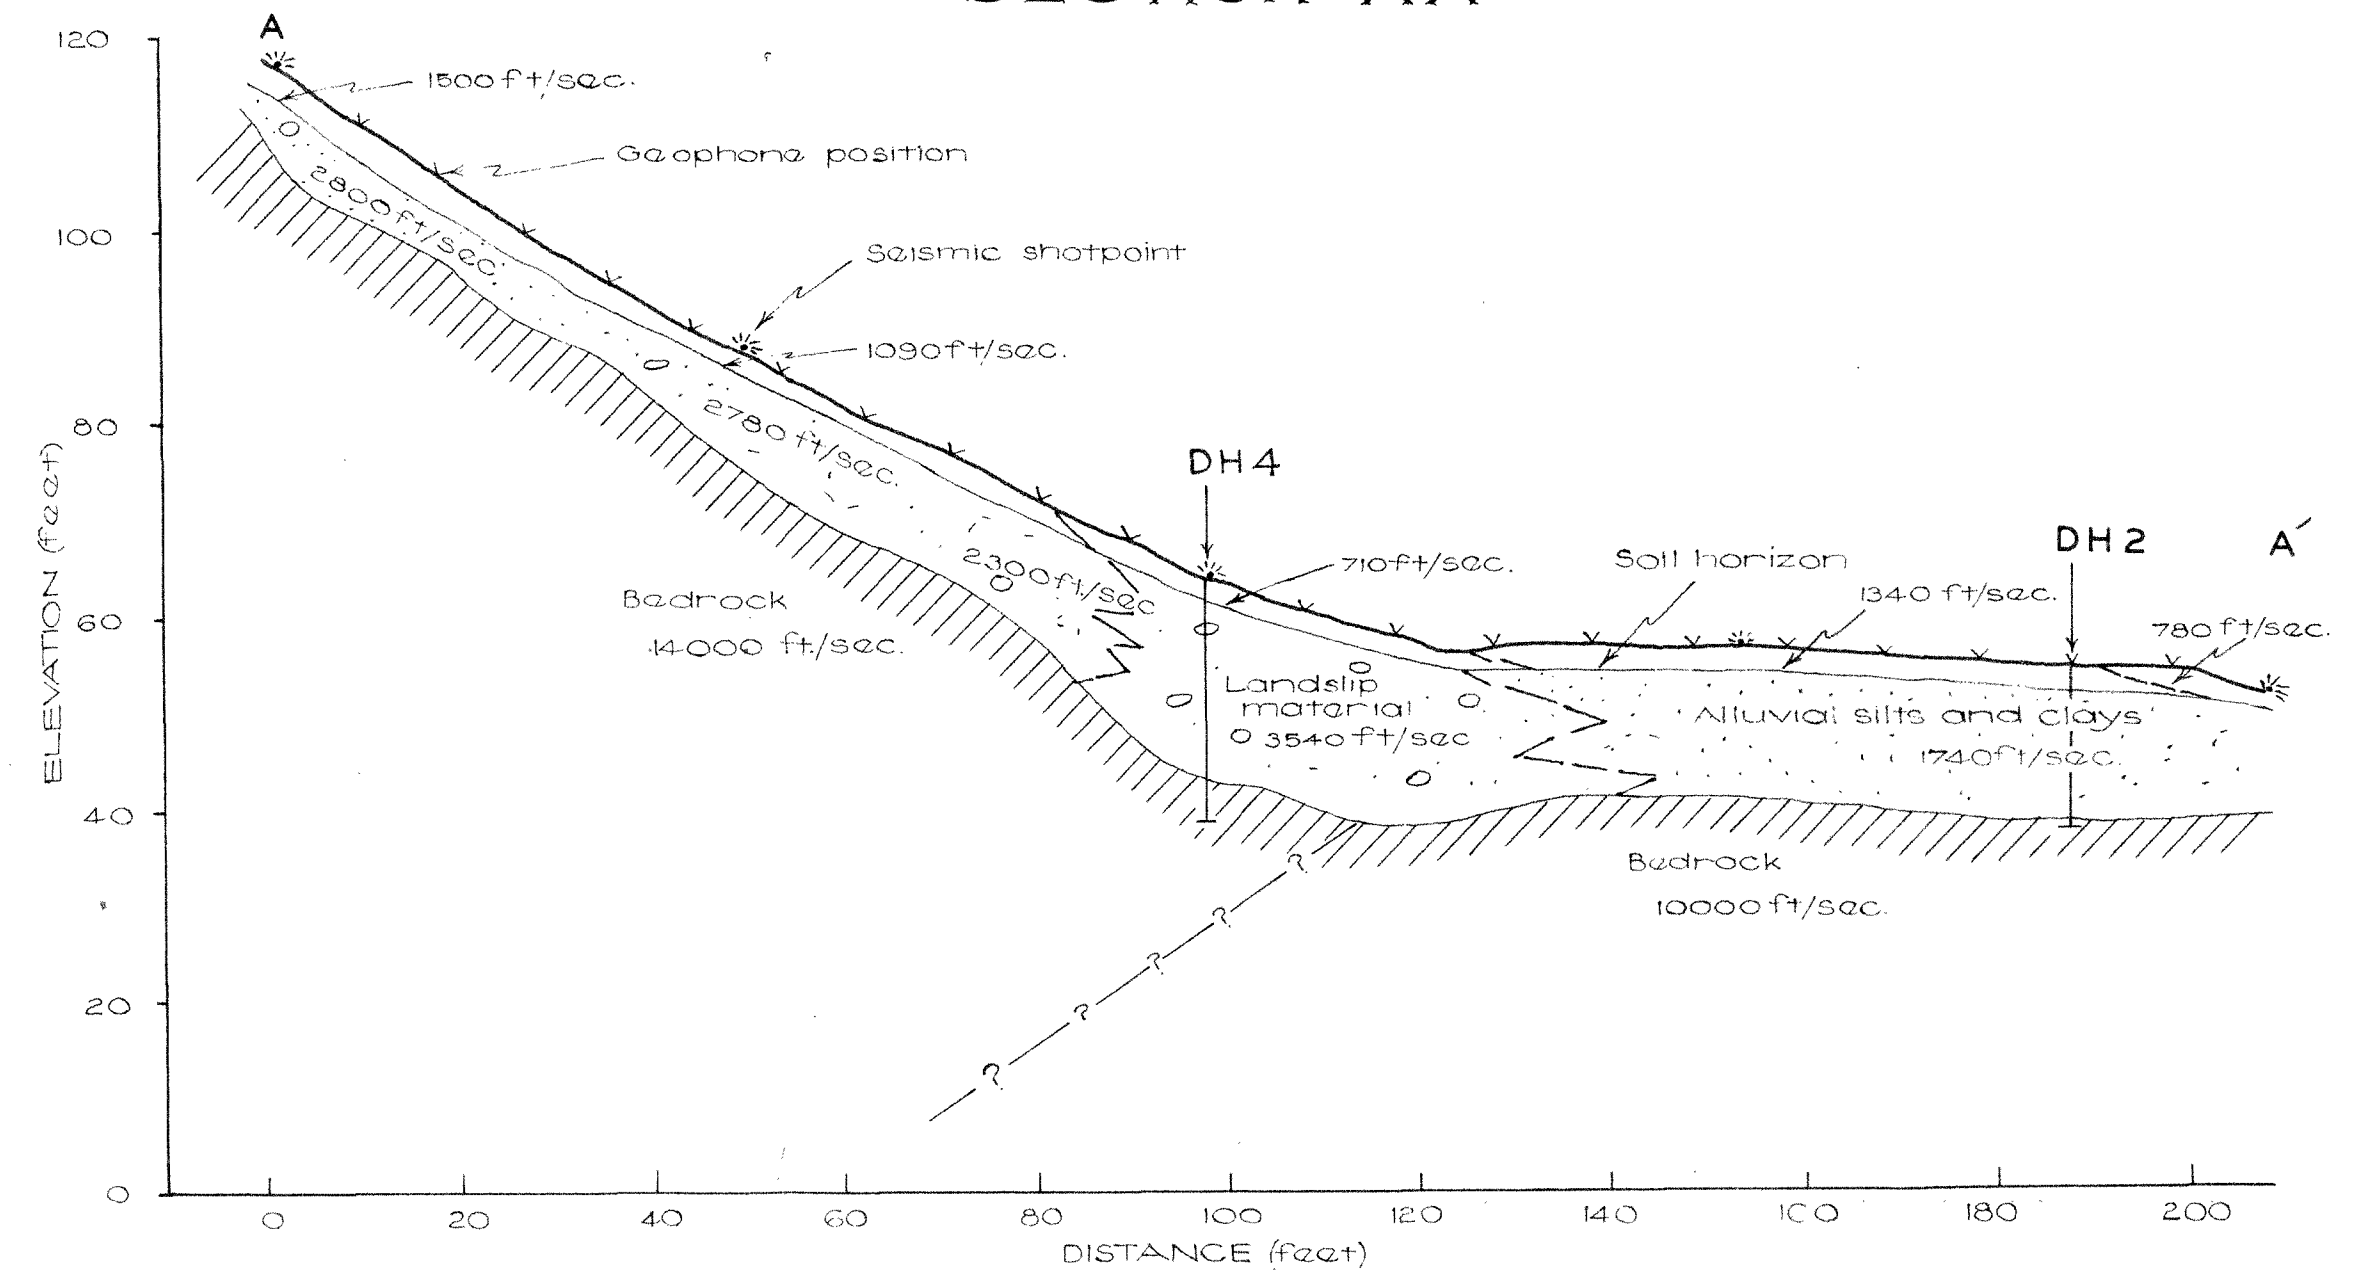
SECTION AA'

Section AA', covering the left abutment line shows that the landslide material (near DH4) has a seismic velocity of about 3 500 ft./sec. compared with a velocity of 1 740 ft./sec. for the alluvial silts and clays near DH2. The position of the contact between the two types of material is uncertain, but probably occurs near the foot of the bank as shown. Bedrock appears to be at its deepest near DH4 where about 20 ft. of unconsolidated landslide material overlies it. A lithological change in bedrock may occur near the foot of the hill where the bedrock velocity changes from 14 000 ft./sec. to 10 000 ft./sec.

On the western bank of the Congeratinga Creek, where the left abutment of the dam is to be built, the seismic survey has shown that the thickness of landslide material should be no greater than 20-25 ft. This agrees with drillhole information in the area. The greatest thickness of unconsolidated material occurs near DH4 at the foot of the hill.

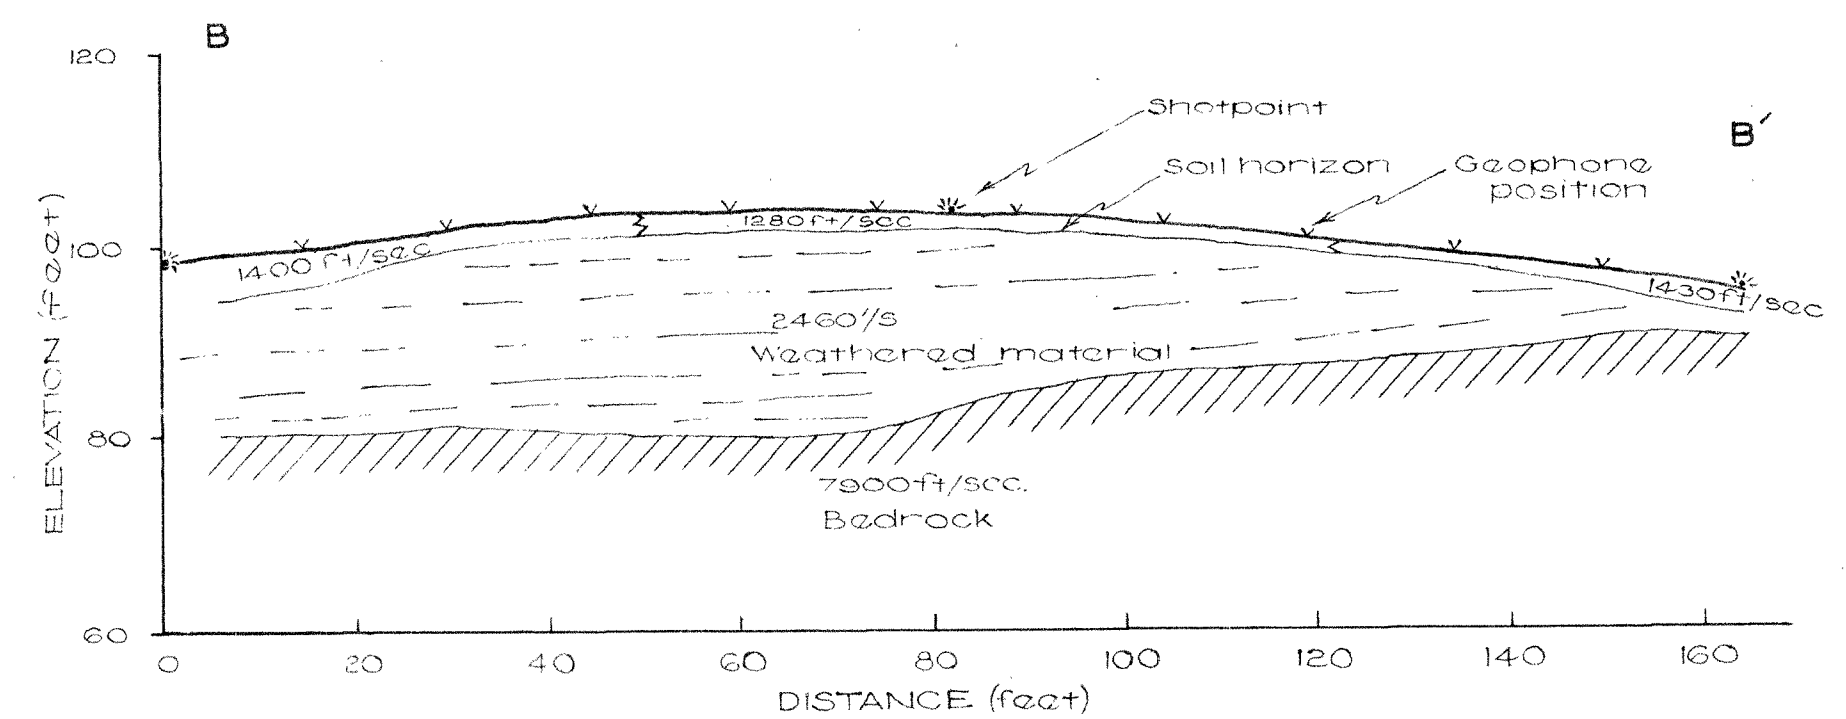
SECTION BB'

Section BB' which runs from Station 5 to Station 6(A) near the top of the right abutment shows that there is a greater thickness of weathered material on the east side of the saddle where the spillway is to be situated than on the west (dam abutment) side. The most deeply weathered section is to a depth of 24-25 ft. about 60 ft. west of Station 5. Unweathered bedrock occurs as sub-outcrop near Station 6(A). Its seismic velocity is 7 900 ft./sec. and it may be rippable with difficulty.

A thickness of 20-25 ft. of weathered material (2 460 ft. sec) covers the saddle where the spillway is to be built. Near the top of the right abutment of the dam this becomes thinner and bedrock appears close to the surface. Bedrock lies between elevations of 80 to 90 feet and has a seismic velocity of 7 900 ft./sec. It should be marginally rippable.
