PROPOSED SUBDIVISION - MAGILL

Pt. Secs. 1055 & 1059 Hd. Adelaide

REPORT ON GEOLOGICAL INVESTIGATION

State Planning Office Docket No. 515/74

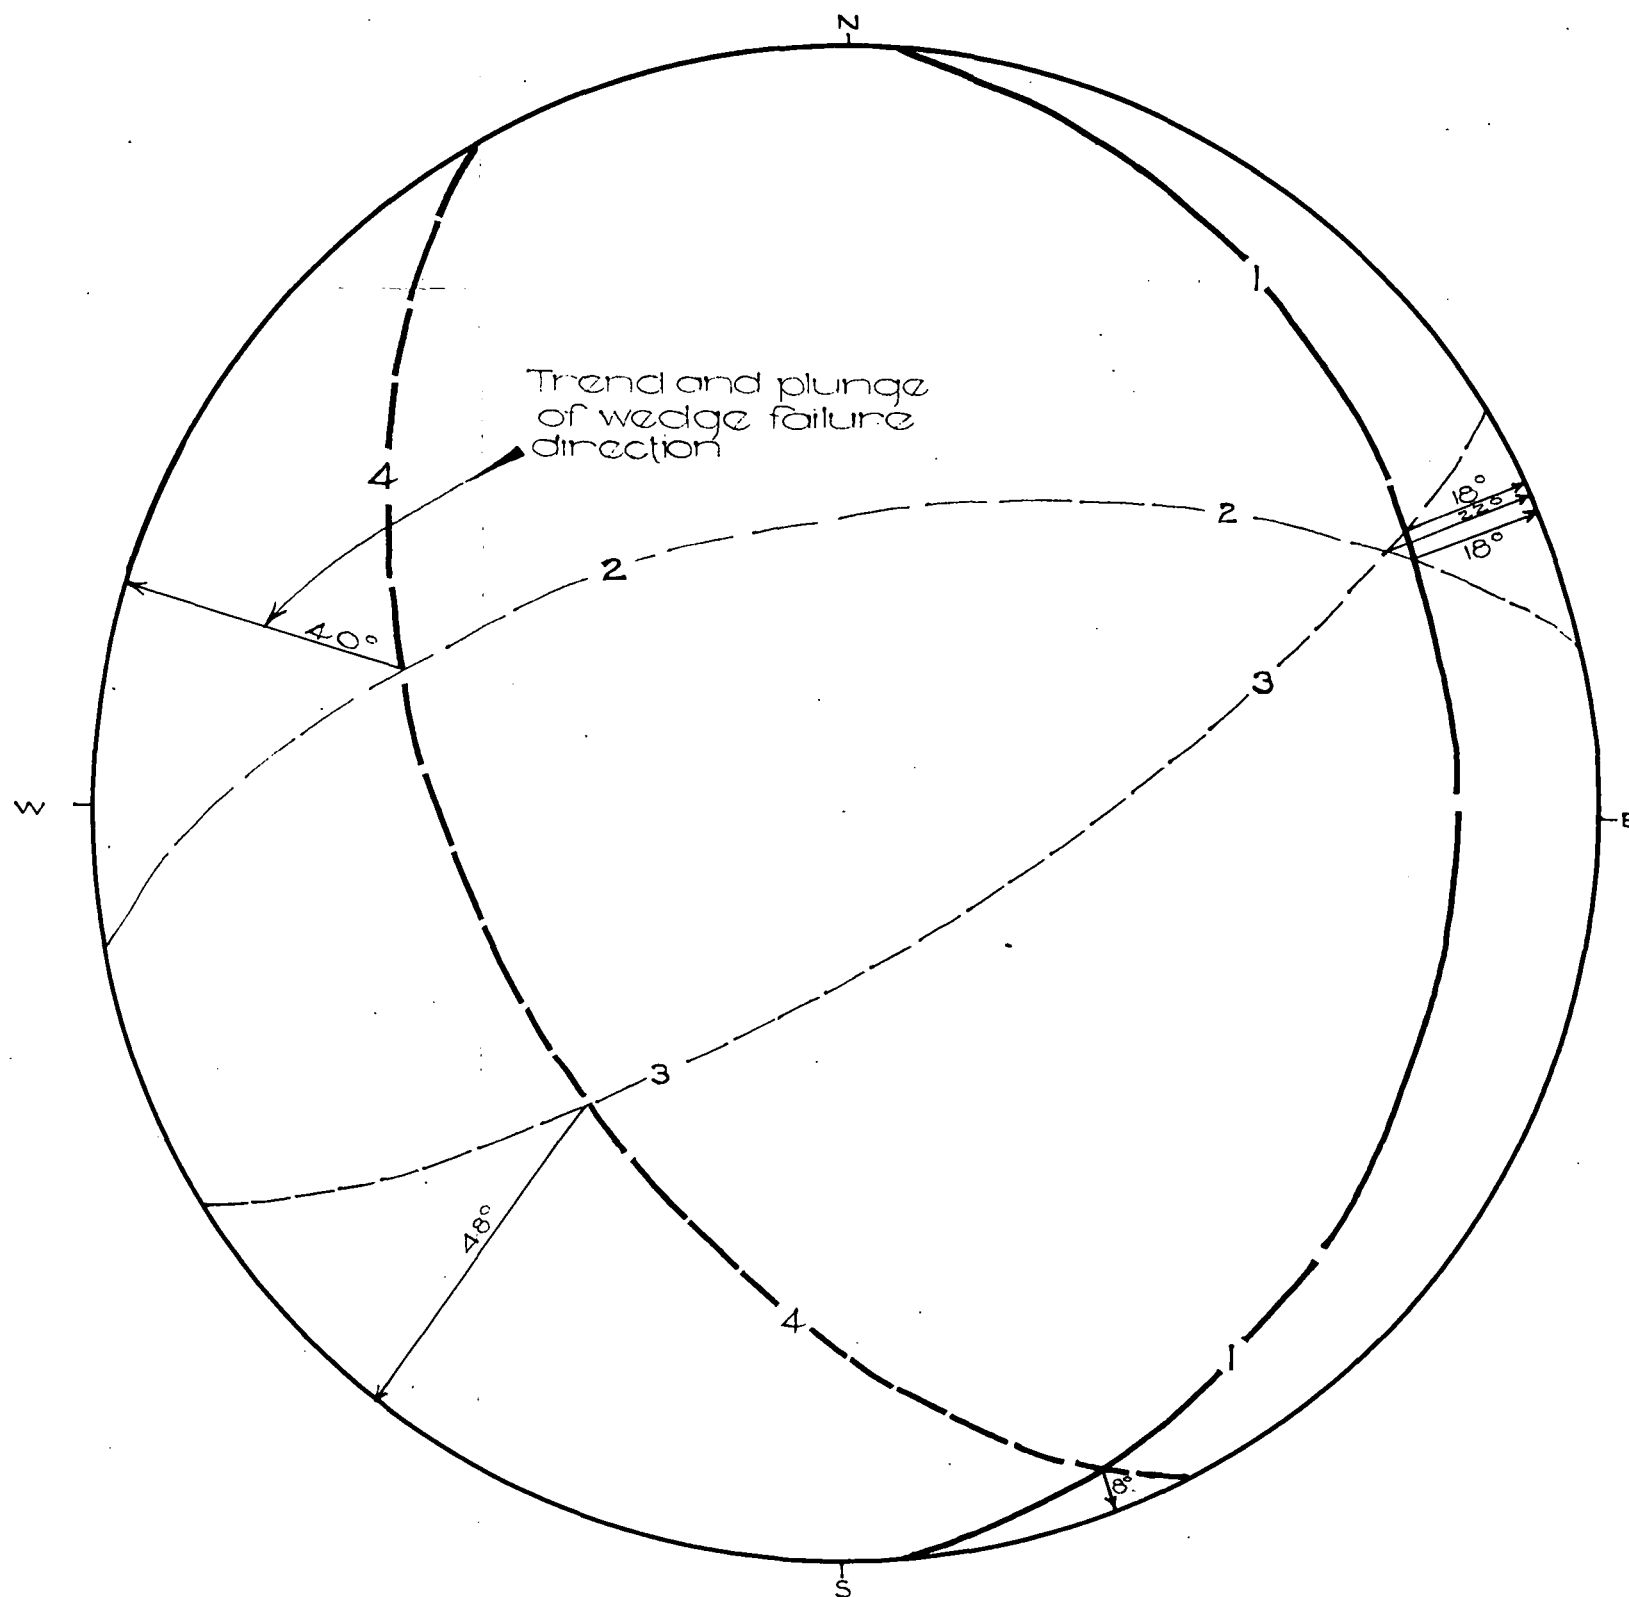
STEREOGRAPHIC PROJECTION OF ROCK DEFECTS

Joints and bedding in the bedrock phyllite, measured in a cut on Palomino road are plotted stereo-

graphically in Fig. I. This shows the trend and plunge of the major wedge failure directions resulting from the intersection of the joint and bedding planes. It serves to indicate the main directions of instability in potential rock cuts on the subdivision. The major directions of instability are:-

East and north east (bedding and 3 wedge failure directions)

West and south west (joint 4 and one wedge failure direction)

North west (one wedge failure direction)

North north west (joint 2)

South east (joint 3)

STRIKE	DIP	TYPE
1	000°	20°E	Bedding
2	075°	60°N	Joint
3	055°	75°SE	Joint
4	150°	50°SW	Joint

In view of these conditions of potential instability within the well jointed and slabby bedrock and the possibility of seismic activity it is recommended that as a safety precaution housing cuts should not be carried deeper than 1 m into bedrock.

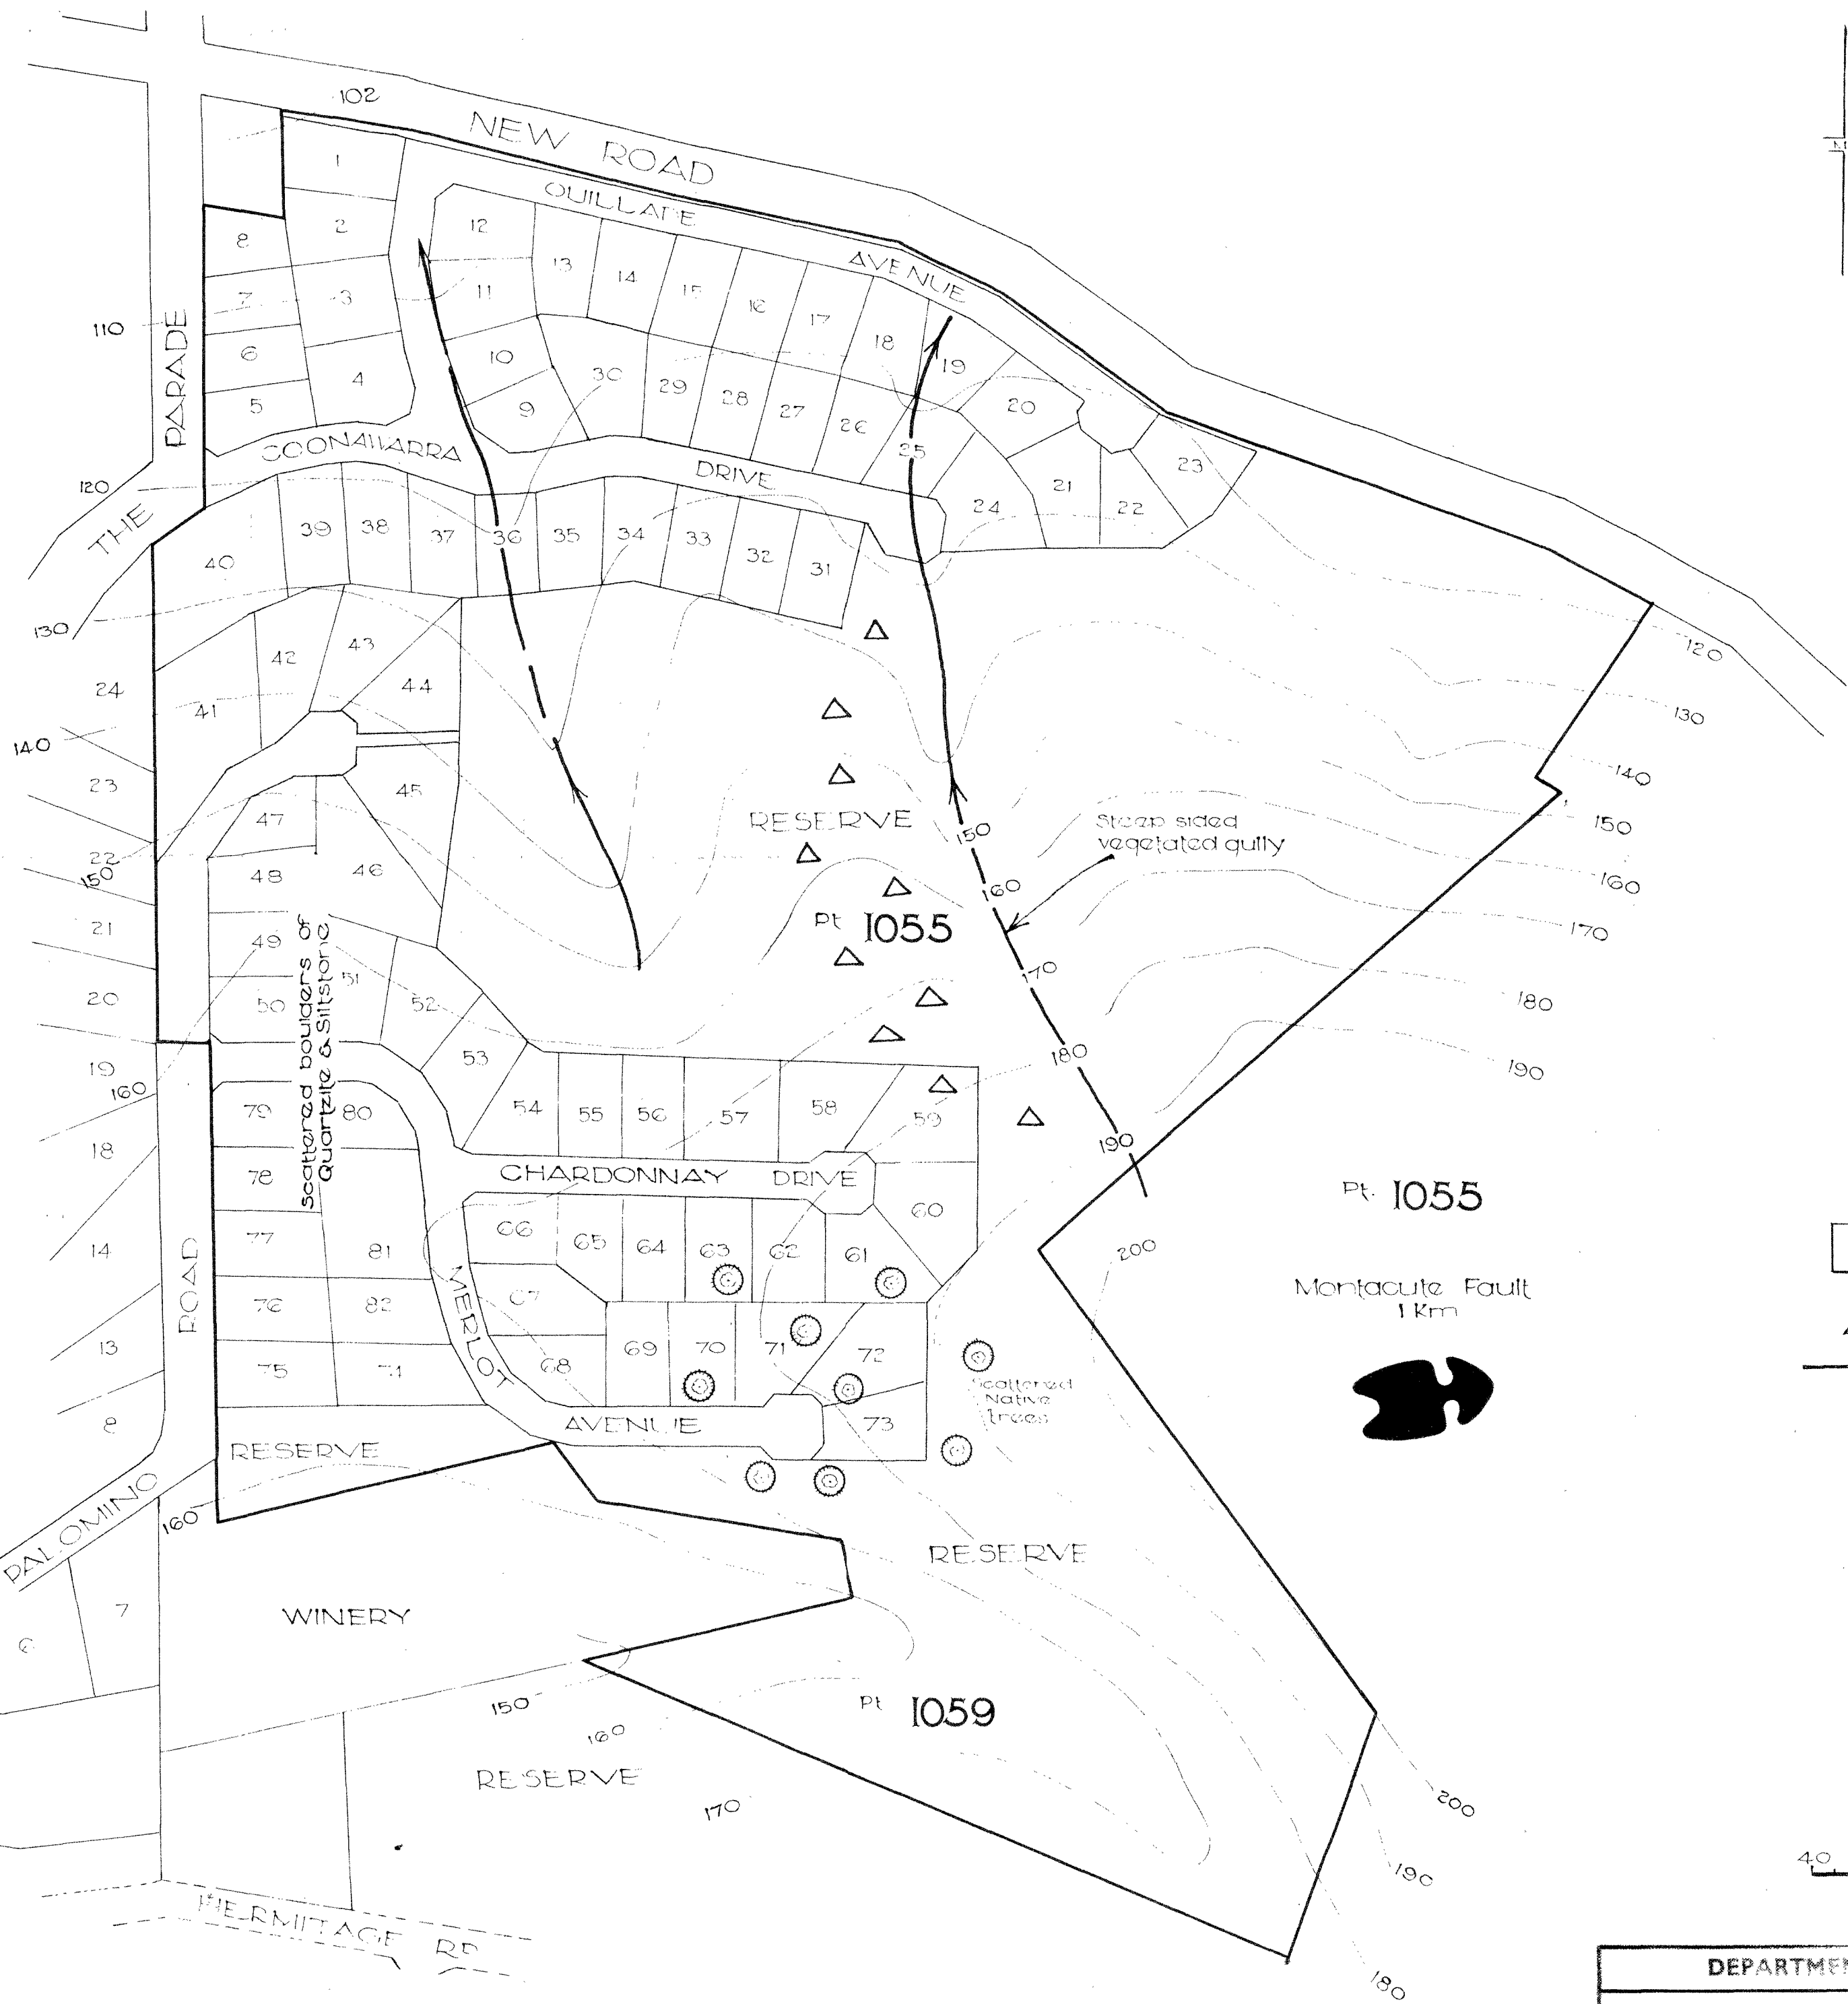
PROPOSED SUBDIVISION - MAGILL
PT. SECS 1055 & 1059 HD. ADELAIDE
GEOLOGICAL PLAN

The subdivision straddles three north running spurs having average slopes of 15° (steeper in the reserves). Two deep gullies separate the spurs. Phyllite and quartzite bedrock probably lie at shallow depth beneath the entire subdivision with a thin cover (less than 1 m) of brown clay soil, low plasticity (CL)* containing gravel fragments.

During wet periods it is expected that considerable runoff will flow down the two gullies. This can be expected to increase as a result of residential development and adequate drainage easements should be left to cope with this. For this reason it is recommended that Lot 36 be excised and Lots 18, 19 and 25, 26 combined.

..... Adequate drainage easements must be left to cope with runoff along the two steep gullies. To allow for this Lot 36 should be excised and Lots 18, 19 and 25, 26 combined.

Protection of the winery in the south from increased runoff can be achieved by suitable drainage along Merlot Avenue.
