DEPARTMENT OF MINES AND ENERGY
SOUTH AUSTRALIA

REPORT BOOK 96/30
**PUREBA/NUNNYAH
REHABILITATION PROJECT**

August 1996

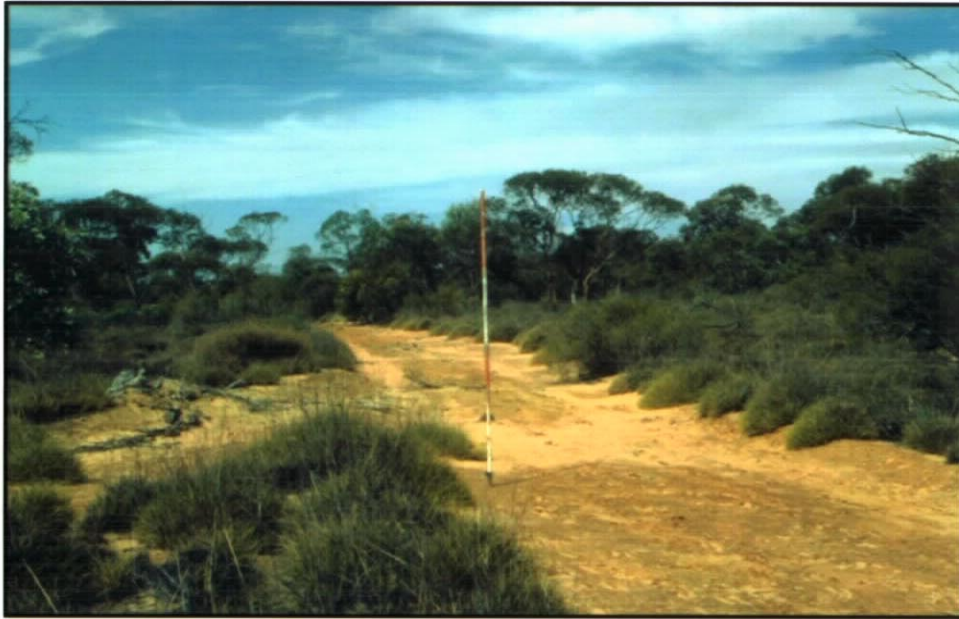
In most cases the rehabilitation of tracks was not satisfactory. The access tracks had been created using a D7 bulldozer. Little effort had been taken to avoid standing vegetation and both the above ground portion as well as the rootstock was removed. Topsoil was displaced to the edges of the track forming windrows (Plate 1).

The reason for the tracks not regenerating sufficiently is due to the severe compaction of the soil on the tracks and the removal of rootstock and topsoil. Compaction was primarily the result of exploration related traffic and to a lesser extent third party vehicle use since the programme.

Plate 1. Abandoned mineral exploration access track. (Photo 43723)

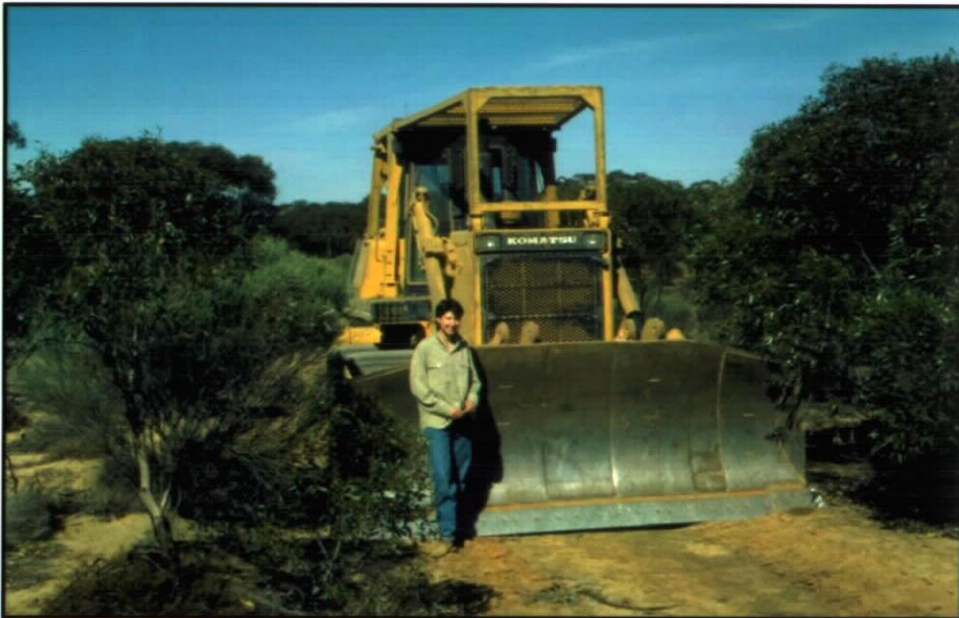
The restrictions imposed by timeframe, terrain and track width (approx four metres) meant that a D85A dozer was the ideal machine in this case (Plates 3 and 4). A wider (greater horsepower) machine, although quicker and more powerful, would have resulted in damage to vegetation on either side of the track. A smaller machine would have been incapable of ripping through the calcrete and would have been comparably slower in other areas and would have had trouble pulling three times at a depth of 600 mm through areas without calcrete.

Plate 3. Komatsu D85A front view. (Photo 43705)

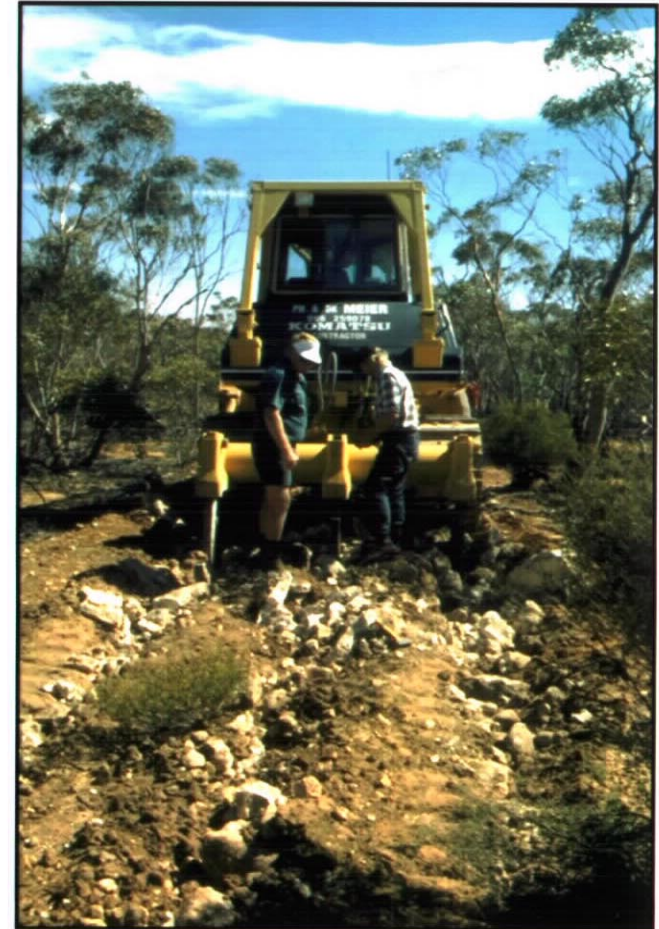
During the trial it was discovered that there was a layer of calcrete approximately 300 mm below the surface of the soil. The grader was not capable of ripping through the calcrete layer and therefore could not reach the required depth of 600 mm. The D85A bulldozer was capable of ripping through the calcrete, in places bringing to the surface large boulders of calcrete (Plate 2). In comparison to the grader, ripping

Plate 2. Result of ripping trial using D85A. (Photo 43715)

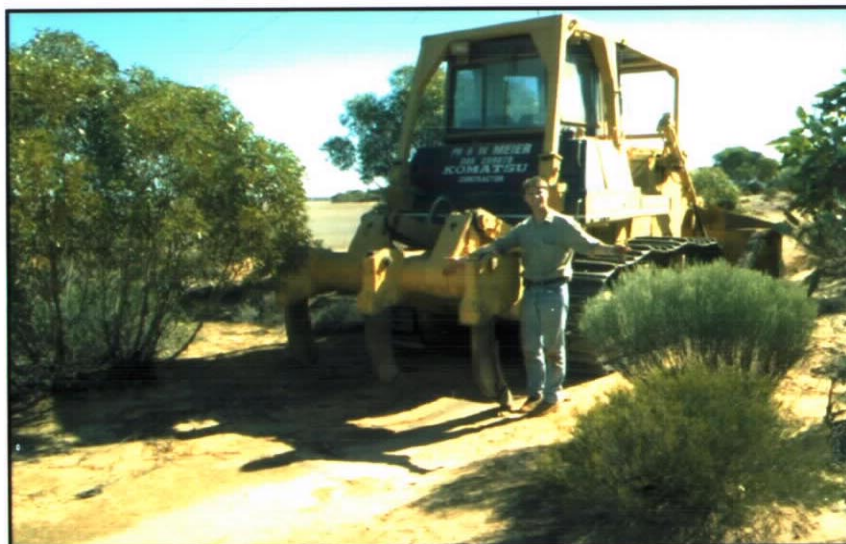
Plate 4. Komatsu D85A rear view. (Photo 43706)

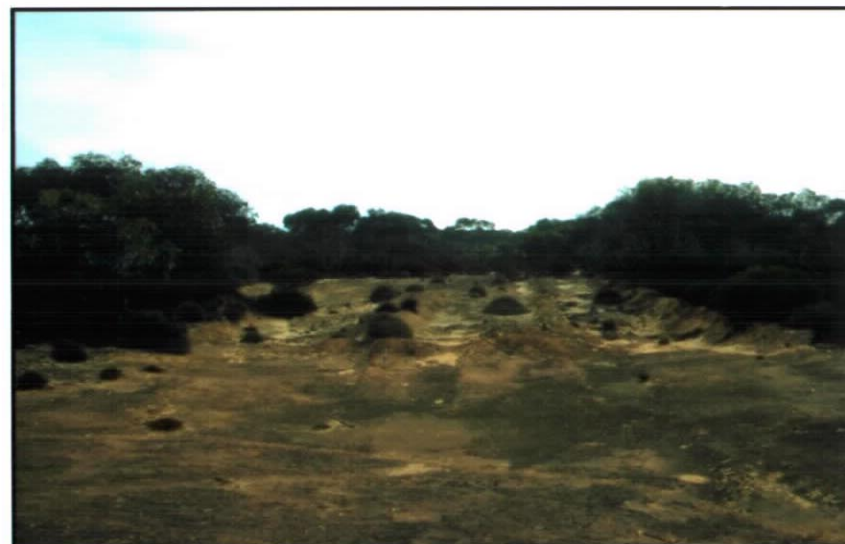
Plate 5. Borrow pit prior to ripping. (Photo 43717)

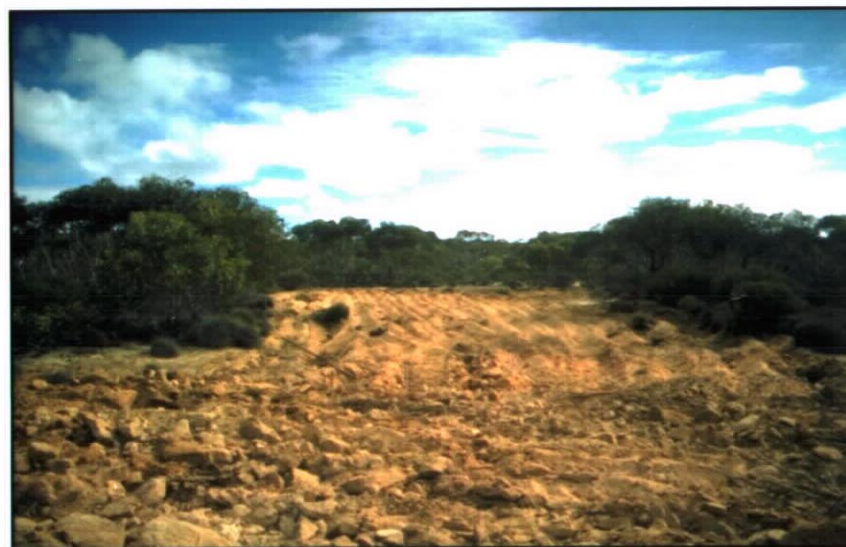
Plate 6. Borrow pit after ripping. (Photo 43718)

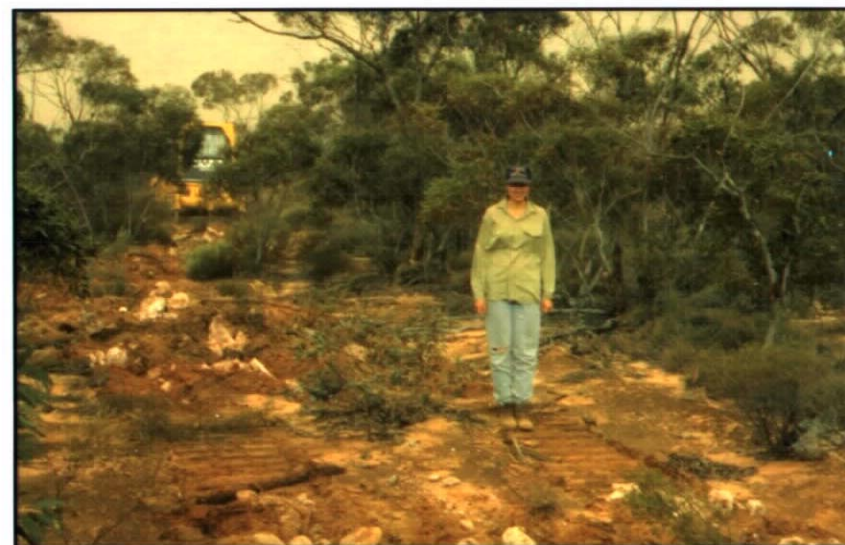
Even on those tracks which required ripping there were places where the existing vegetation was in good condition and did not warrant ripping. In such instances, the dozer was either manoeuvred around the vegetation or walked over it with the rippers and blade raised (Plate 7).

Plate 7. Minimal impact caused by 'walking'. (Photo 43712)

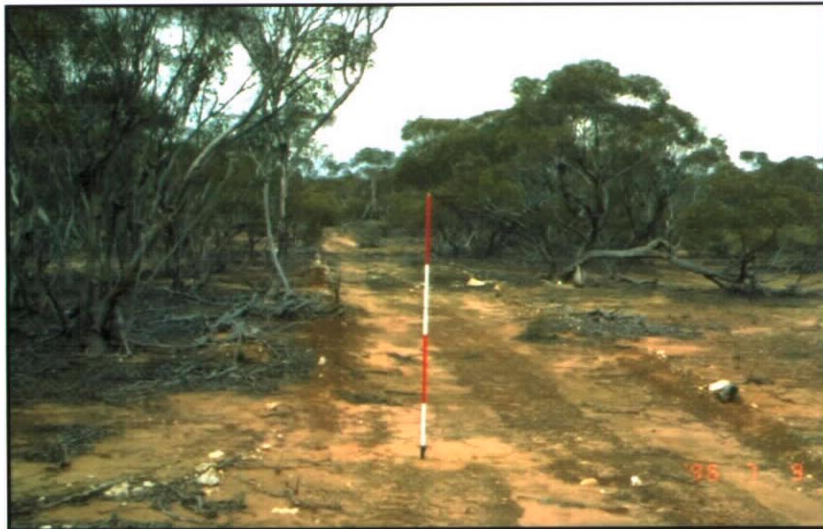
Photopoint 33, 1996. (Photo 43919)

Site No: 33 **Time:** 2.30pm
Line No: 55 **Photo No:** 043919
Direction: East **Status:** unripped
Distance from main track: ~150m
Soil Type: C/S over calcrete
Landform: Interdunal swale
Vegetation Description: Eucalyptus, very open, some melaleuca and scattered triodia.
(Looked like it had a burn through it 2-3 years ago)
