MOUNT SCHANK VOLCANIC CONE
REPORT ON EFFECT OF EXISTING
AND PROPOSED QUARRIES

GEOLOGICAL SURVEY
ENGINEERING DIVISION

Sections 347, 425, Hundred of MacDonnell

Rept. Bk. No. 72/178
G.S. No. 4943
D.M. No. 700/72
Hyd. No. 2433

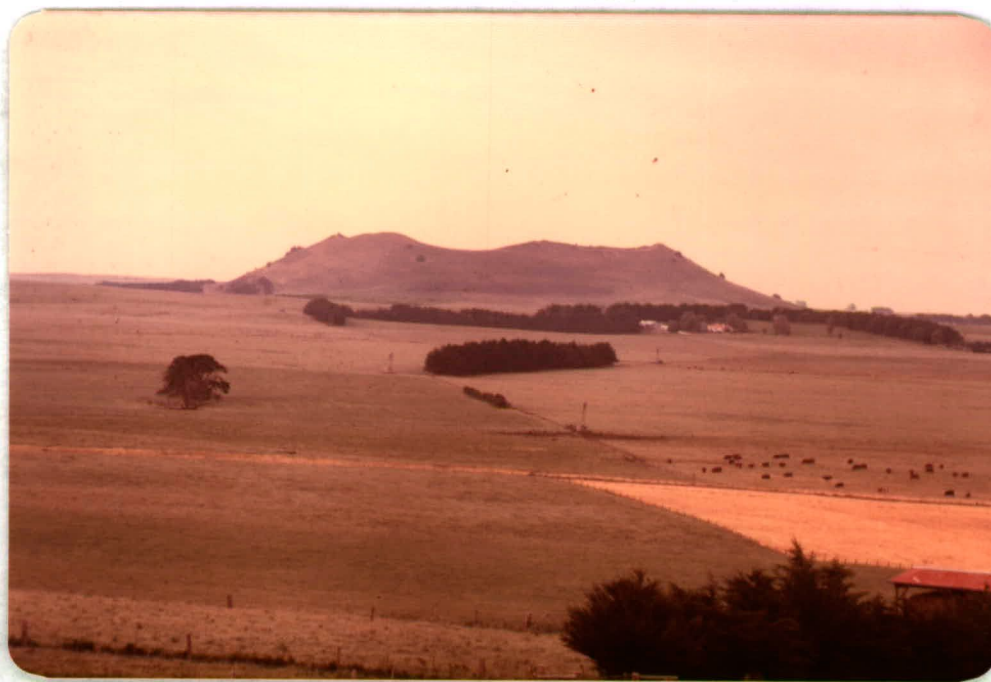
Mount Schank is a small, well preserved volcanic cone about 12 km south of Mount Gambier, near the main Mount Gambier to Port MacDonnell road. Although only 160 m high it is one of the few prominent landmarks in the area. (Plate 1).

PLATE 1 Mt. Schank (viewed from the north)

The sides of the volcanic cone are steep (up to 35° - Plate 1) but in their natural state appear stable. However any slight disturbance of the slope is likely to result in some

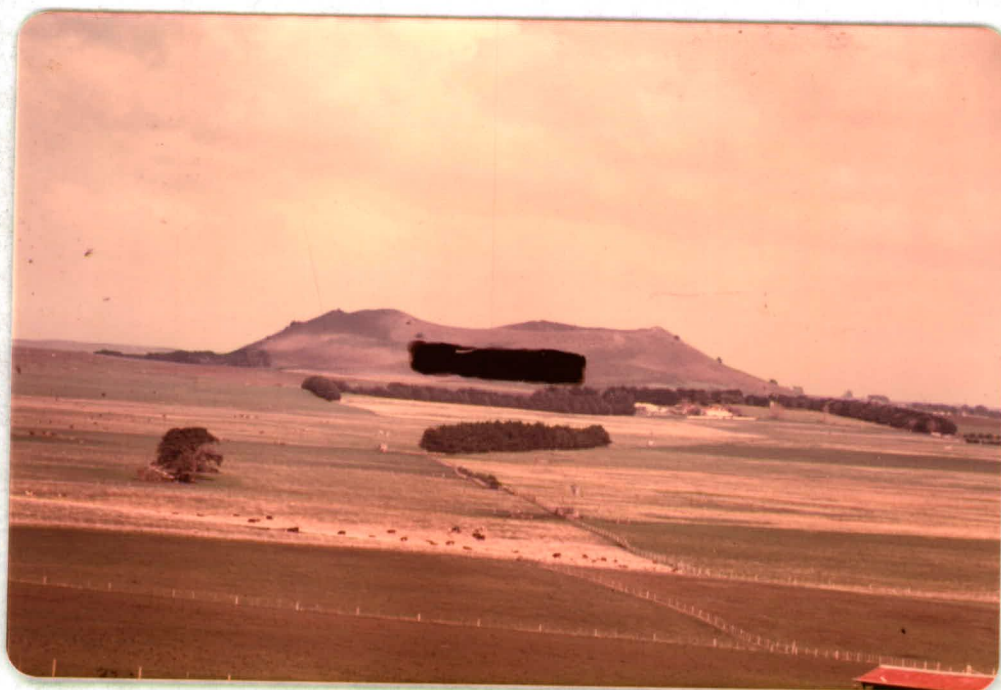
Site A appears to be a slight extension of the quarry in section 347 (Plate 4), whilst site B is an entirely undeveloped site, at present used for pasture, on the northern flank of the cone (Plate 2).

PLATE 2 Showing the area covered by site B

The other site (B) is not recommended for quarrying. It is in full sight of the main road, visible for several miles, and operations there would spoil the symmetrical appearance of the cone.

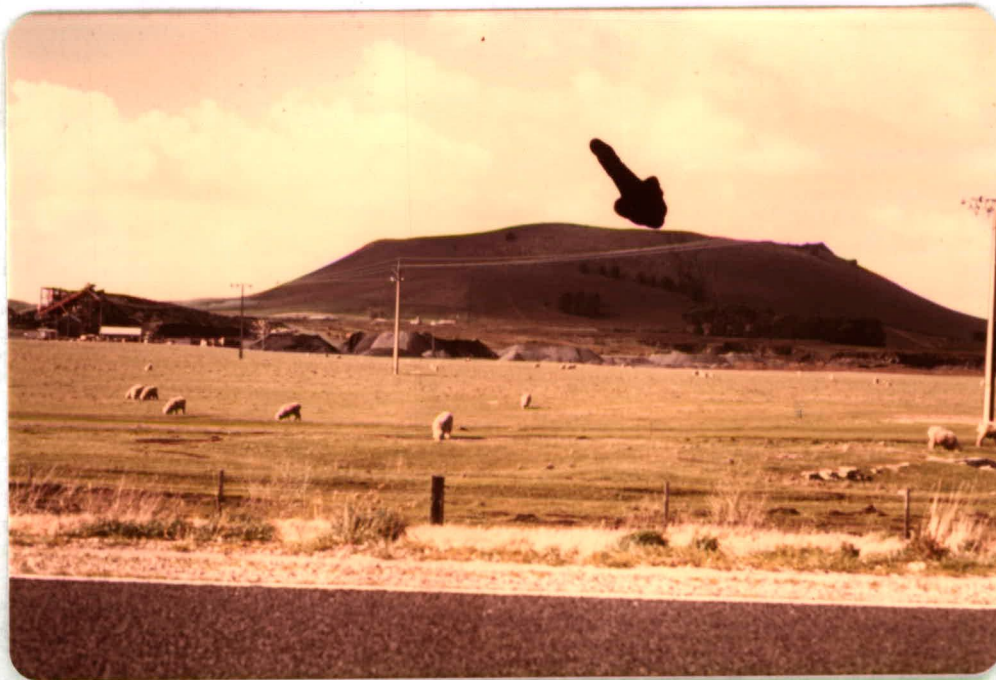
The volcanic ash and cinders are being excavated in a quarry on the eastern flank of the cone itself (Plate 4), while the lava is being excavated in a quarry to the west of the cone (Plate 3).

instability. Erosion gullies (Plate 3) have already formed along a path used by tourists ascending the hill in an area where the slope is much less steep than elsewhere.

PLATE 3 Mt. Schank from the main road to the west,
showing quarrying operations and erosion
gullies (arrowed).

Both sites border a Recreational Reserve, and there is danger of damage by erosion unless any proposed operations are carefully controlled.

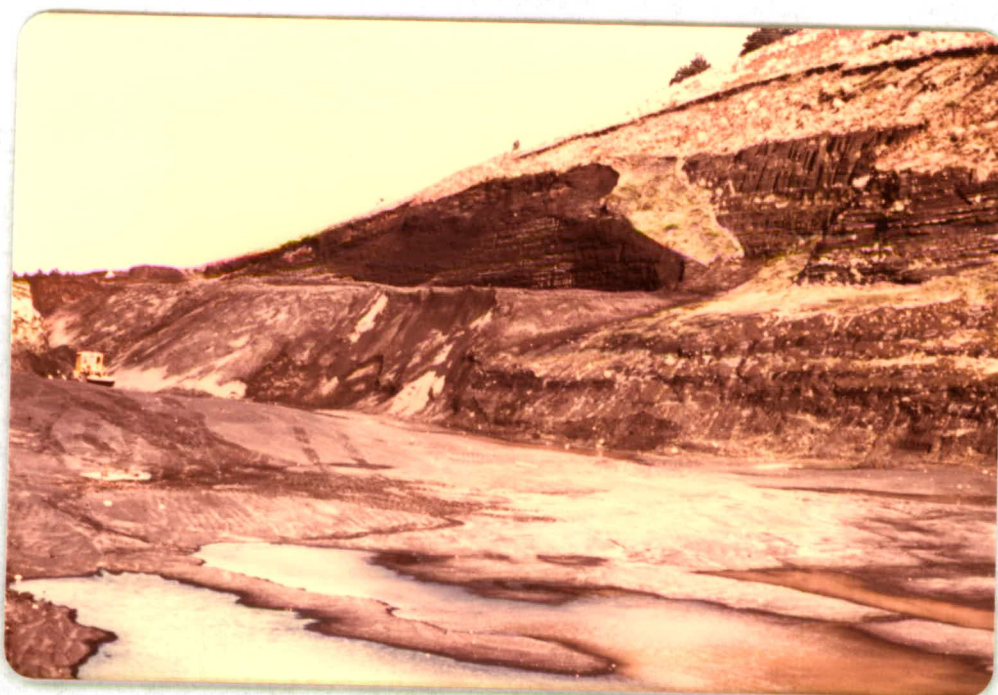
The near vertical quarry faces excavated in unconsolidated volcanic ash appear stable at present, but instability would occur in the long term. Collapse of the vertical face could spread well up the hill slope.

PLATE 4 Quarry at site A

One site (A) is already being quarried, and a slight increase in the area of these operations is unlikely to damage the shape of the cone much, although any further damage is undesirable. This site is well hidden from view except from a minor road adjacent to the quarry itself.
