INSPECTION OF FLOWING EXPLORATION HOLES,  
PEAKE AND DENISON RANGES, SOUTH AUSTRALIA  
NOVEMBER, 1974

GEOLOGICAL SURVEY  
ENGINEERING DIVISION

HYDROGEOLOGY SECTION

Rept.Bk.No. 74/229  
G.S. No. 5540  
Hyd. No. 2671  
D.M. No. 1150/74

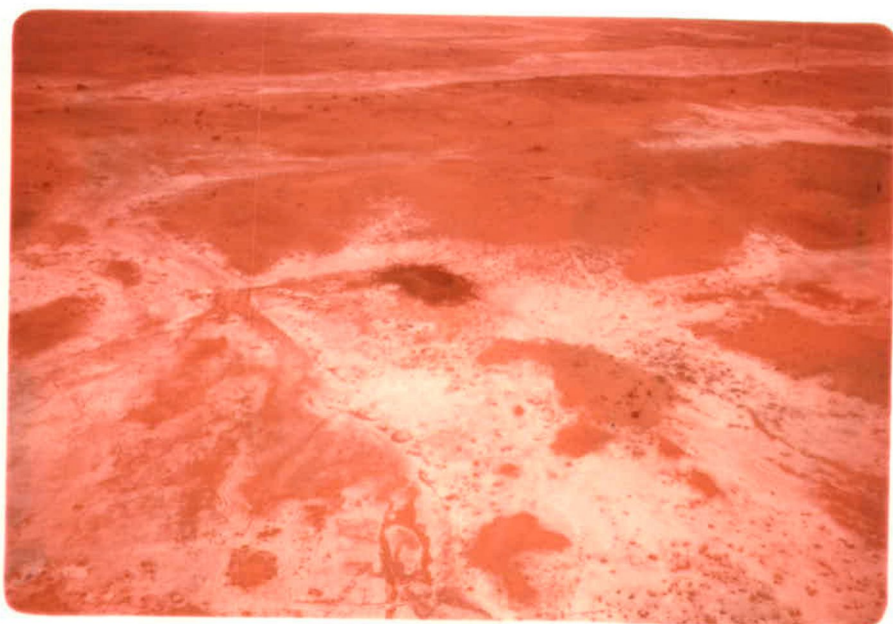
Access to these three holes is difficult because of the boggy nature of creeks along the seismic line. These are permanently wet due to the flowing shotholes on the Pexa PYH line. From the aerial photograph, each hole appears surrounded by reeds and open water so it is unlikely that a heavy vehicle could approach to within more than 5-10 metres of the shothole. TX94 and 97 (18 and 17 on Fig. 2 and plate 1) appear more accessible than TX86 (19 on Fig. 2 and plate 1). An aerial view of TX 97 is presented on Plate 3.

1. Looking west at shothole 17 (S.A.D.M.). Neg. No. 10636 (Slide).

Driller's logs show these holes to be all about 20 m deep (see Appendix II) and to have just penetrated or else just finished above the aquifer. Provided the shothole is still open to say 6-8 m and access is not too restricted, there should be no problem in killing the flows by pumping in cement.

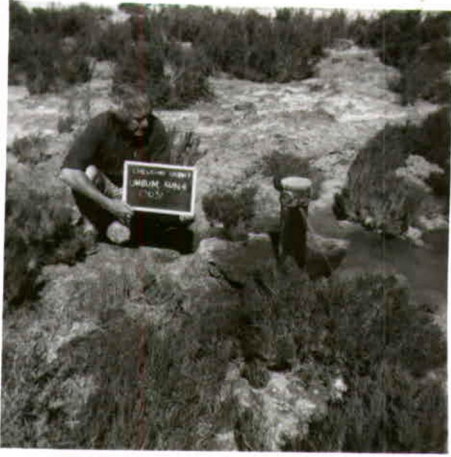
(i) LHDH 3. Neg. No. 25988

(ii) LHDH3 (Plate 3, photo (i))

This bore was drilled in an area of mound springs. Ground is therefore treacherous and heavy vehicles may have trouble approaching the hole. At the time of inspection, the bore was shut off by means of a welded steel cap (not open as reported by Chevron on 9/7/73). A small leak has developed near the top of this casing with a very small flow. The back pressure is estimated as about 6-9 m. Further corrosion will increase the flow from the bore and impede access. In a further twelve to eighteen months, it may be almost impossible to approach the bore - so fast is the corrosion rate.

Flow was estimated as 2.5-3.8 l/sec by the driller.

Backfilling by pumping cement down the hole to completely shut off the flow.

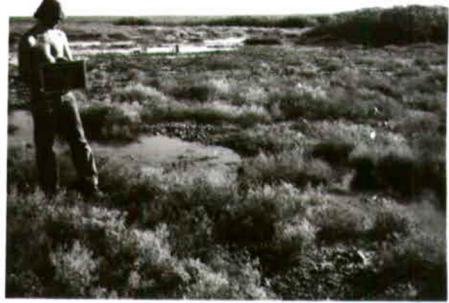
(iv) LHDH5 (Plate 4, photo (ii))

This bore occurs on flat ground which is poorly drained. Access is very bad - a plant or heavy truck could not approach closer than 20-30 m to the hole. The hole is open and water is flowing from the top of 152 mm casing which is sitting in the centre of a pool about 3 m in diameter and over 2 m deep. Flow from the casing was estimated at 0.7 l/sec. However, a strong flow of 5-6 l/sec was recorded by Chevron during drilling of the hole. Thus considerable leakage through the confining beds may be occurring or else the bore has partially collapsed thus reducing flow.

(ii) LHDH 5. Casing in pool in Centre of photo. Neg. No. 25993

This bore may be "killed" by pumping cement down the casing provided a platform can be erected to enable more direct access.

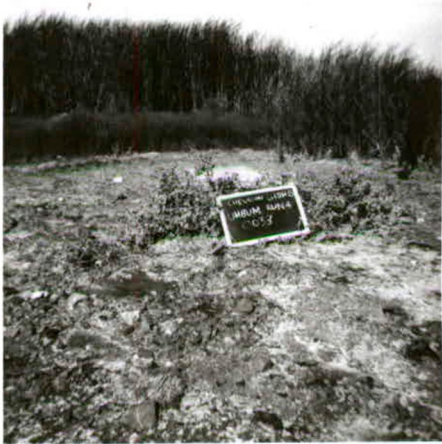
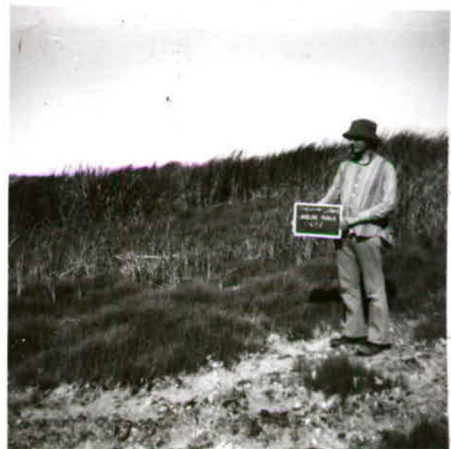
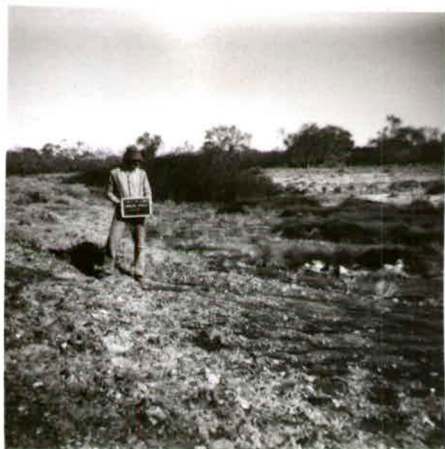
(v) LHDH6 (Plate 4, photo (iii), (iv) and (vi))

This bore has been drilled at the top of a small rise, adjacent to a large creek. The bore is cased and cemented to a depth probably of the order of 5-10 m. No water issues from the bore but a significant amount is leaking via the confining beds into a small gully adjacent to the bore. Also minor seeps occur all round the edge of the rise (see Plate 4, photo (v)). Access is bad - heavy vehicles might approach to within 5-10 m of the bore. The bore water has cut the main track necessitating a detour which involves a probable difficult crossing of a creek channel. Flow was estimated as about  $\frac{1}{3}$  -  $\frac{1}{2}$  that in LHDH7 (a gauged flow) i.e. about 9-14 l/sec. This bore, together with LHDH2, 3 and 3A is the responsibility of Chevron Exploration and none were requested to be left for use as stock bores by Peake Pastoral Company.

(iii) LHDH 6. Note casing behind black board. Neg. No. 25989

(iv) Downstream from (iii) Neg. No. 25990.

(v) LHDH 6. Seeps around edge of rise. Neg. No. 25991.

This might be effectively plugged by either drilling out the cement plug in the bore hole and re-cementing down the whole length or by grouting. A platform would be required here.

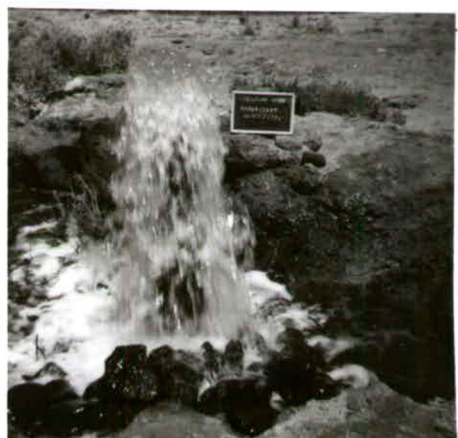
(vi) LHDH 7. Neg. No. 25987

(vi) LHDH7 (Plate 4, photo (vi))

Access to this bore is good - a plant or heavy truck could approach to within 2-3 m of the bore head. All water flow is via the casing. This flow was gauged with a current meter at

about 29 l/sec (23 000 gph). Anna Creek Station is responsible for the maintenance of this bore.

Pressure cementing P.V.C. casing might be possible with this hole if it is open to total depth. The casing collar should be able to be unscrewed and additional equipment attached (e.g. a shut-off valve if necessary).

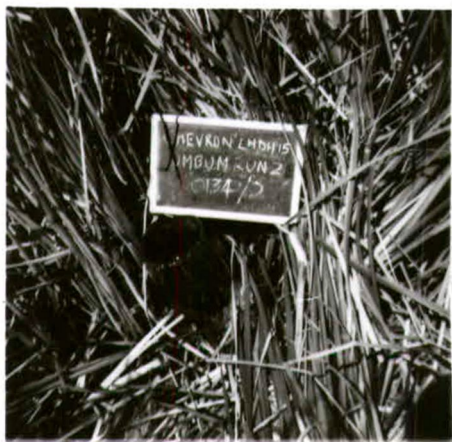
(viii) LHDH16 (Plate 5, photo (ii))

This bore was drilled on flat ground and is consequently poorly drained. A plant or heavy vehicle might approach within 10 m of the borehole. All water is discharging through open casing (152 mm) which is surrounded by a thick growth of reeds. The bore has flooded the track so detouring is necessary. Anna Creek Station is responsible for the maintenance of this bore.

(i) LHDH16. Neg. No. 26001  
(Blackboard incorrect)

Treatment as for LHDH5.

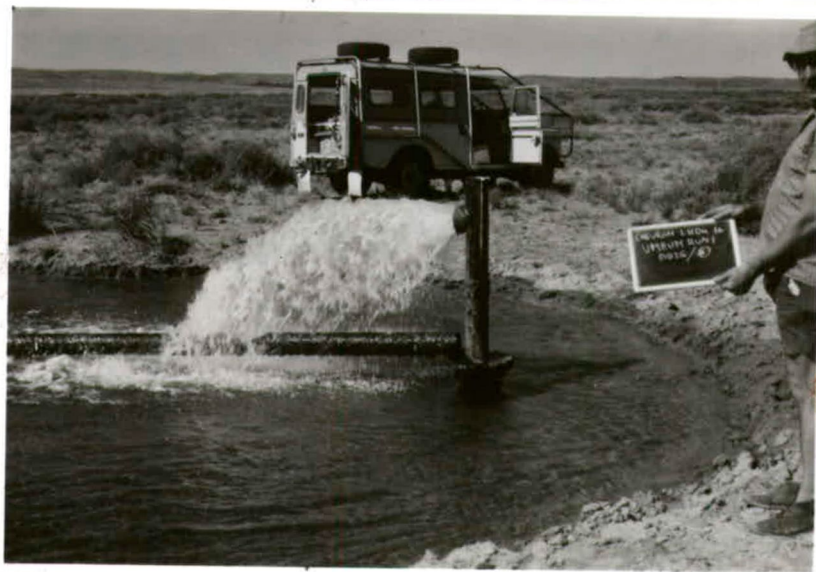
(vii) LHDH15 (Plate 5, photo (i))

Access to this bore is also good. All water is flowing from the casing (152 mm). Peake Pastoral Company have accepted responsibility for the maintenance of this bore.

Flow was gauged by current meter as about 31 l/sec (24 600 gph).

(ii) LHDH15. Correct reference  
WARRINA RUN1/026/6. Neg.  
No. 26002 Slide 10622

Although this bore is easily accessible, its large flow would make it virtually impossible to use pumped cement for control. A similar technique used for LHDH7 might be used here.

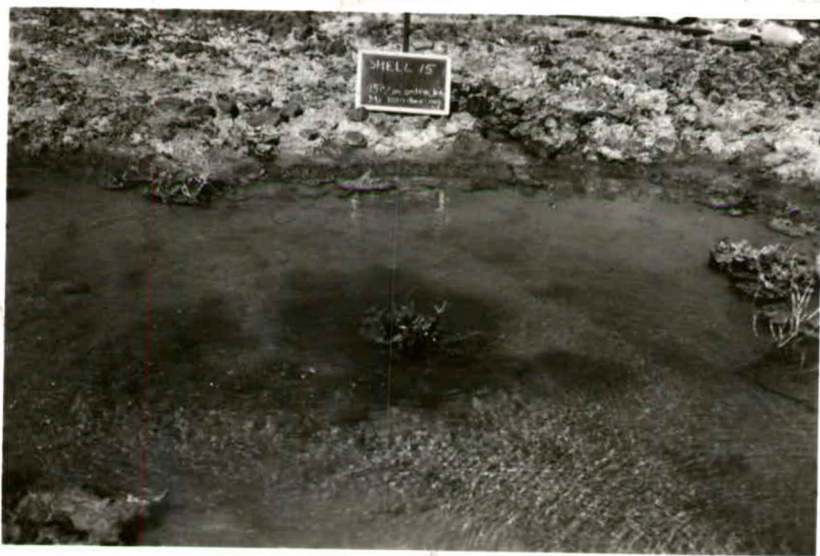
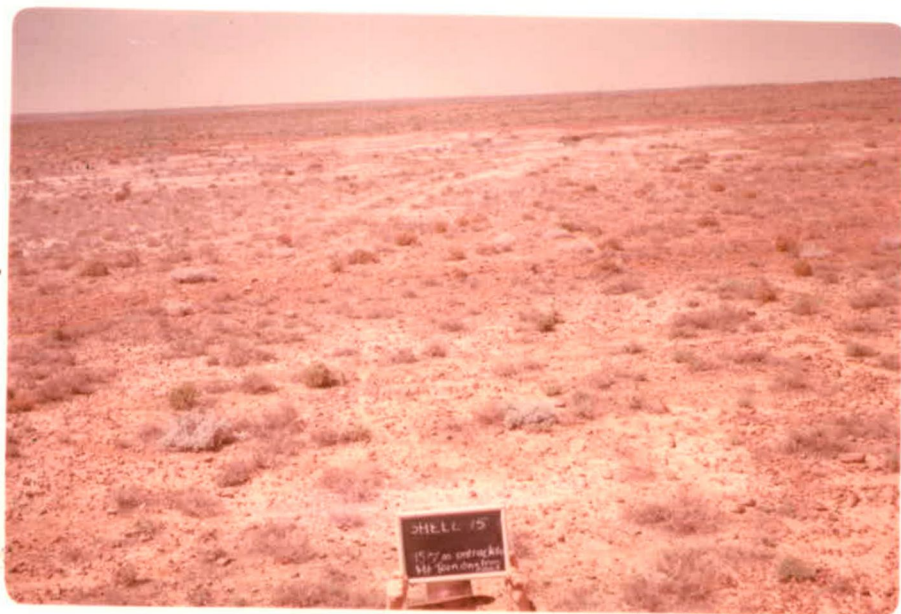
(iii) SDA15 (Plate 5, photo iii and iv).

This bore is about 25 km (15.7 m) west of the Marree - Oodnadatta road along the Mount Toondina seismic track and was drilled on flat, poorly drained gibber plain. Access over the bore is very bad - no vehicle could approach closer than 30-40 m.

Flow was gauged at 8 l/sec (6 300 gph).

(iii) Left. SDA15  
Casing buried  
about 0.1 m below  
centre of pool.  
Neg. No. 26003  
Slide 10623.

(iv) Left. SDA15  
Bore near top  
centre position  
(dark patch).  
Surrounded by  
water and sa-  
turated clay  
soil overlain  
by gibbers.  
Neg. No. 10624  
(Slide).

(ii) SDA15

Although no casing is visible, a 127 or 152 mm diameter length is sitting at a slight angle in the hole about 0.1 - 0.2 m below the surface. This casing is full of sand (from aquifer) and gibbers. It is doubtful that this bore can be cemented off; most water appears to be coming up around the casing which is probably blocked along its whole length (6 m?). Here grouting may be again necessary. It should be noted that action was taken
