Rept.Bk.No. 79/118

CHRYSTOPRASE AND MOSS AGATE DEPOSITS
MOUNT DAVIES, NORTH WEST PROVINCE
REPORT NO. 3 - MINING ACTIVITY,
1975-1978

November, 1979

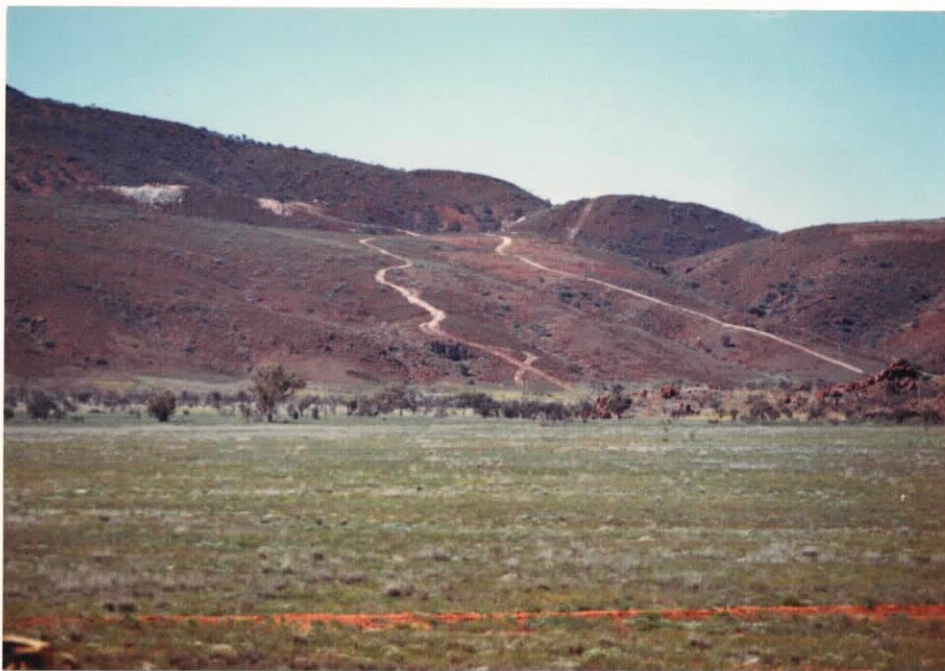
PLATE 1. Kalka massif (Scarface) - August 1978

View northwards from the alluvial plain. The track on the left leads to No. 1 Mine behind the white spoil at upper left. The track on the right leads to No. 2 Mine mainly obscured in valley.

A steep track has been bulldozed up the southern face of the Kalka massif to the visible No. 1 Mine and beyond to No. 2 Mine (Plate 1).

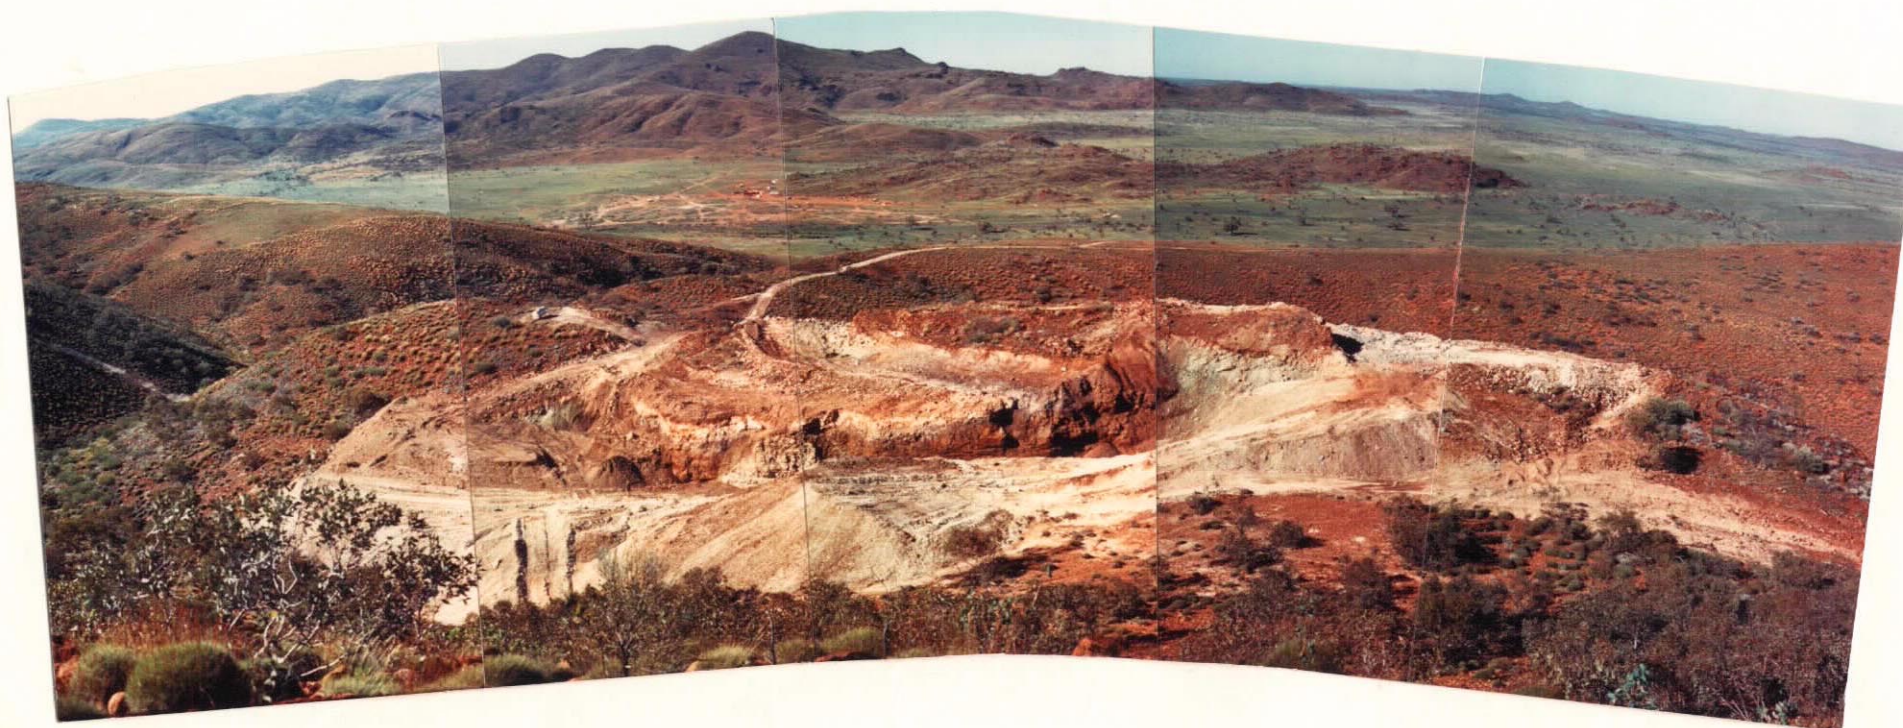
PLATE 2 Mount Davies Chrysoprase, No. 1 Mine - August, 1978

A northerly facing open cut has been bulldozed to a depth of 12 m at the site of the pits recorded in 1975 with a trench, extending southwards (Plate 2). The area of workings and dumps is approximately 200 m long by 50 m wide.

The partial collapse of the trench, 4-5 m wide, is the

View southwards with access track to the settlement of Pipalyatjara on the plains upper left. Partly collapsed open cut, approximately east-west, is 12 m deep. Track on far left to No. 2 Mine.

Note: For scale a man is located on floor of cut at left below settlement.

apparent reason for the halt to mining.

The unsafe condition of the workings was reported to the Chief Inspector of Mines in September 1978.

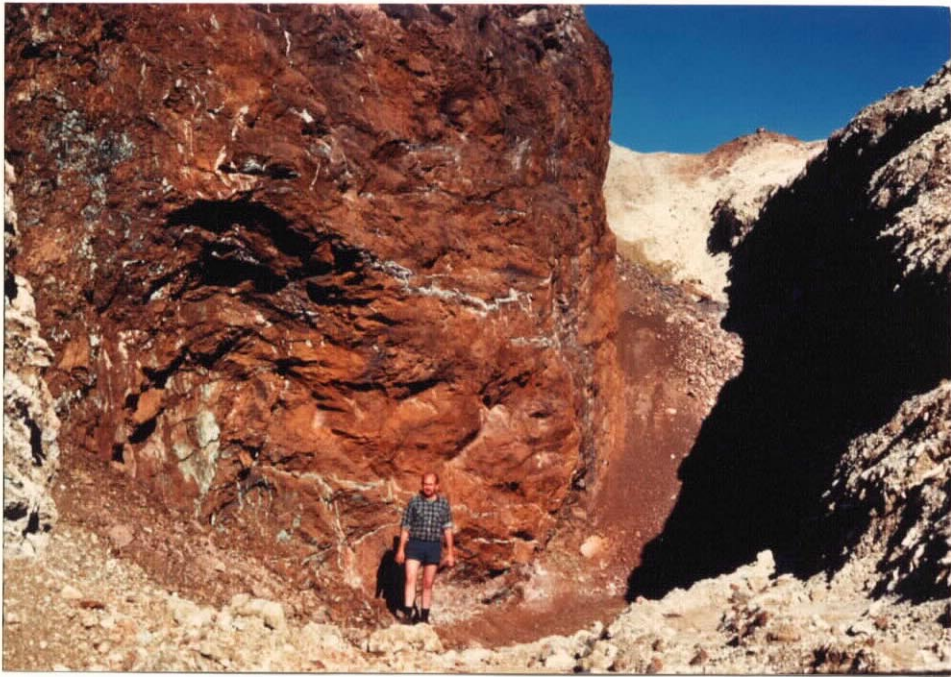
PLATE 3 Mount Davies Chrysoprase, No. 1 Mine - August, 1978

Massive jasper, veined with chrysoprase generally 1-2 cm and rarely up to 5 cm thick, is exposed in the southern wall and ochreous clay in the northern wall of the trench. (Plate 3). The base of the weathered profile was not reached.

Southern wall of jasper with light coloured
chrysoprase - chalcedony veins. Ochreous clay
on northern wall at right.

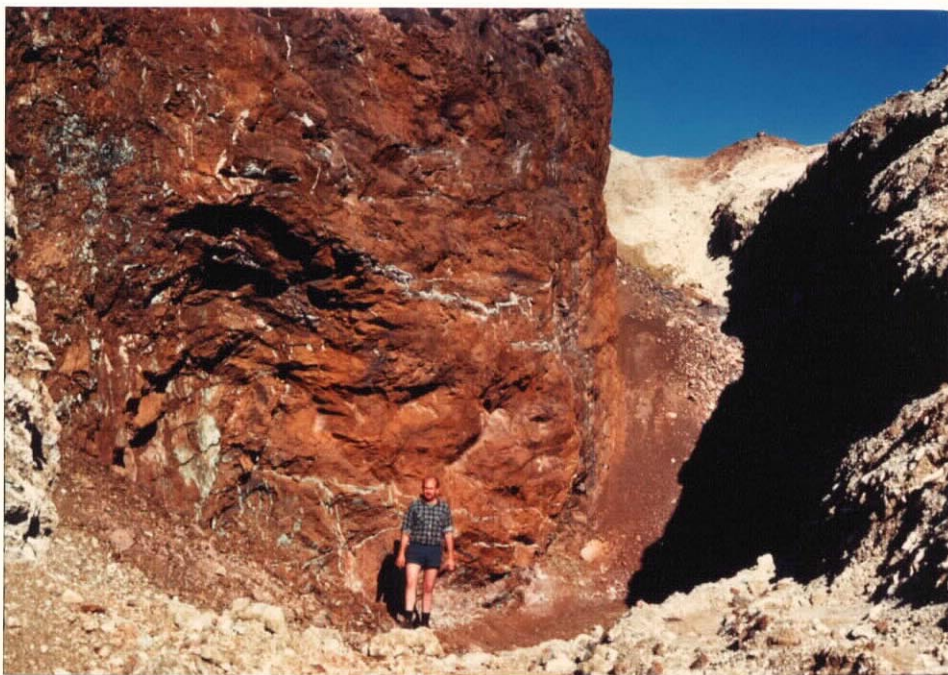
PLATE 3 Mount Davies Chrysoprase, No. 1 Mine - August, 1978

Southern wall of jasper with light coloured
chrysoprase - chalcedony veins. Ochreous clay
on northern wall at right.
