Net community benefits and Seismic Line Remediation – a case study

Petroleum Group of Primary Industries and Resources South Australia (PIRSA) conducted an audit of seismic lines within Petroleum Exploration Licenses (PELs) 5 & 6 in 1999, to assess their condition upon expiry of these licenses.

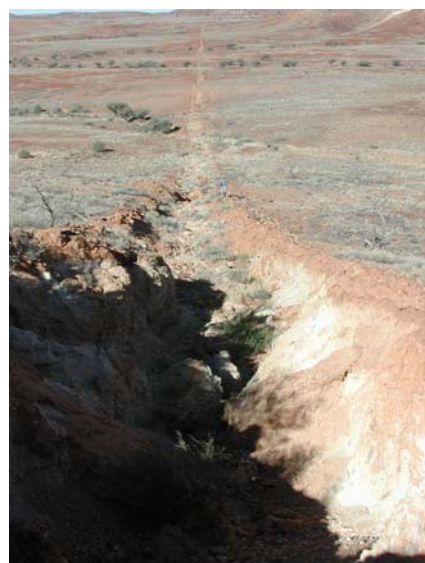
Figure 1. Six metre deep erosion Gully

Seismic lines that traverse the gibber plains and tablelands of the Merninie Ranges, north of Innamincka, were identified as being in much poorer condition. Removal of the protective gibber mantle has resulted extensive areas of gully erosion along many segments of 1975 to 1984 seismic lines (Figures 1 & 2). During this period, seismic lines were deeply 'cut' by bulldozers to make a smooth access track for seismic vehicles. This practice stopped in 1985 when long-term erosional impacts of the practice were identified. The few seismic lines recorded prior to this period had much less impact as there was much less earthmoving and lines were located in more accessible terrains.

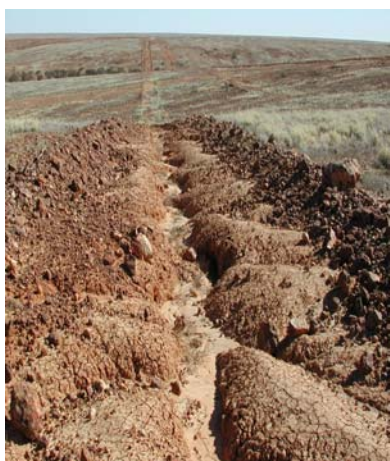
Figure 2. Erosion Gully on 1981 Seismic line

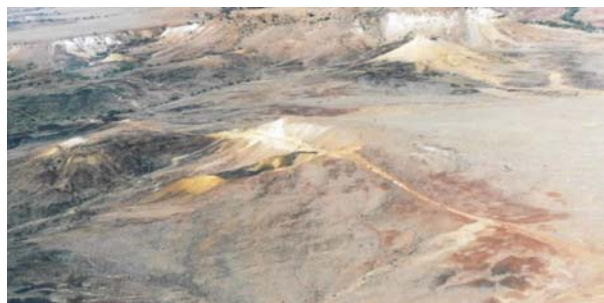
The area is in naturally eroding terrain rarely visited by tourists. The community benefit of funding projects in the Innamincka Regional Reserve area far outweighed costly physical rehabilitation that would be unlikely to achieve substantive long-term benefits (Fig 5).

Figure 5 Seismic line cutting across an Escarpment
