Miscellaneous Purposes Licence Application – Ardrossan Dolomite Quarry Mine Waste Rock Area

10 June 2010

OneSteel Ardrossan

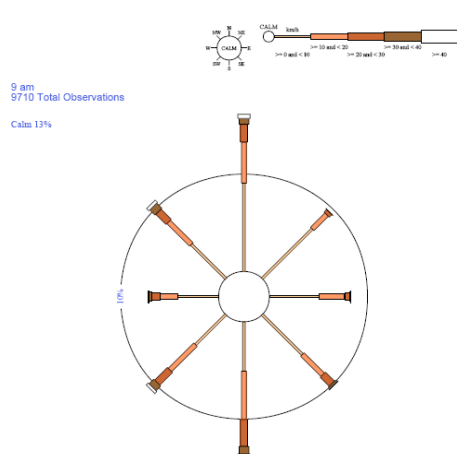
Figure 5.2 Price, Rose of wind direction versus wind speed in km/hr – 5 Jan 1965 – 29 Dec 2006

Price experiences calm condition on average 13% with the prevailing wind direction from the north and south. Prevailing winds at Maitland are from the north and calm conditions are experienced on average 1% of the time.

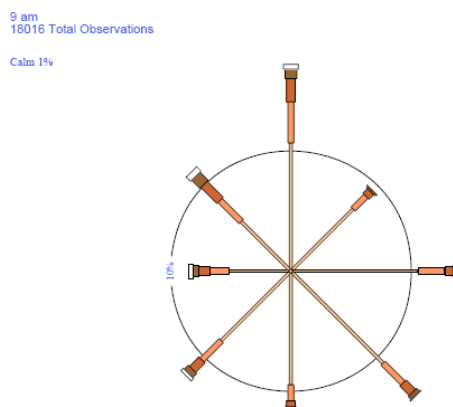
Figure 5.3 Maitland, rose of wind direction versus wind speed in km/hr – 1 Jan 1957 – 31 Dec 2006

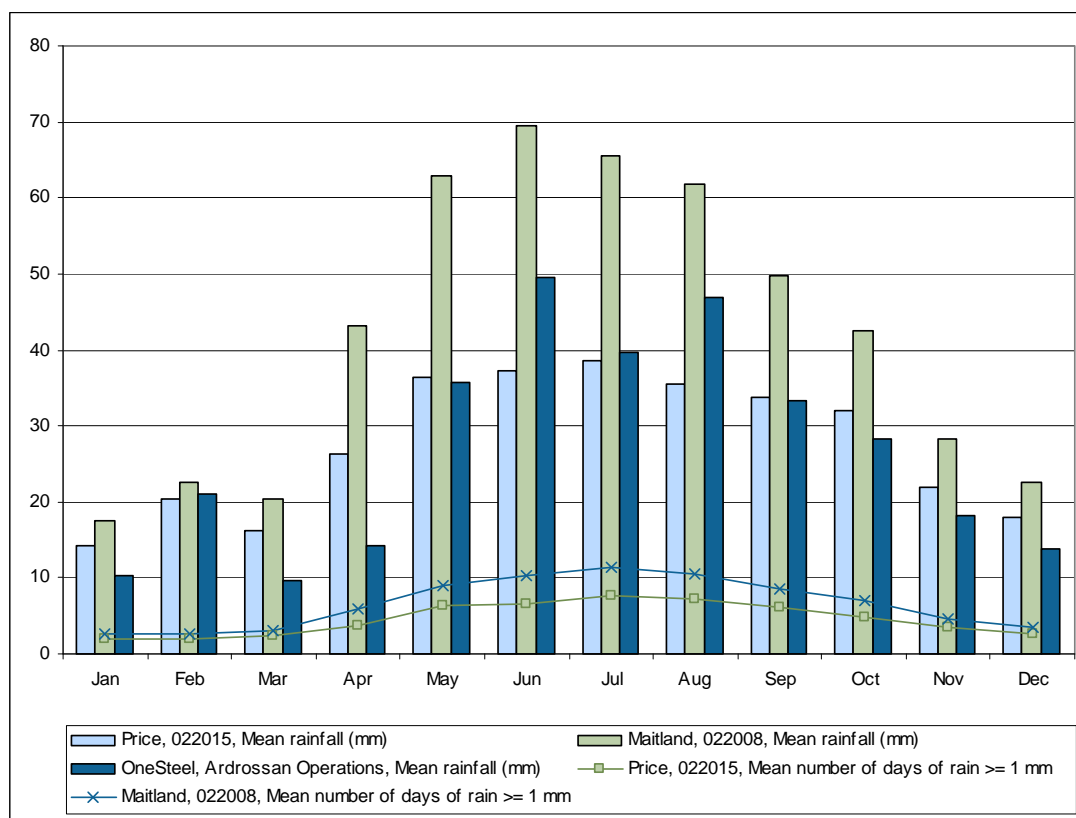
Figure 5.4 Mean monthly rainfall for the Maitland and Price BOM weather stations and OneSteel Ardrossan Operations

Annual rainfall ranges from 330.2–505.7 mm between the two weather stations. The month-to-month rainfall variability at Price and Maitland is shown in Figure 5.4. June and July are the wettest months at both sites. May to October are the months that experience the most number of days greater than 1 mm.

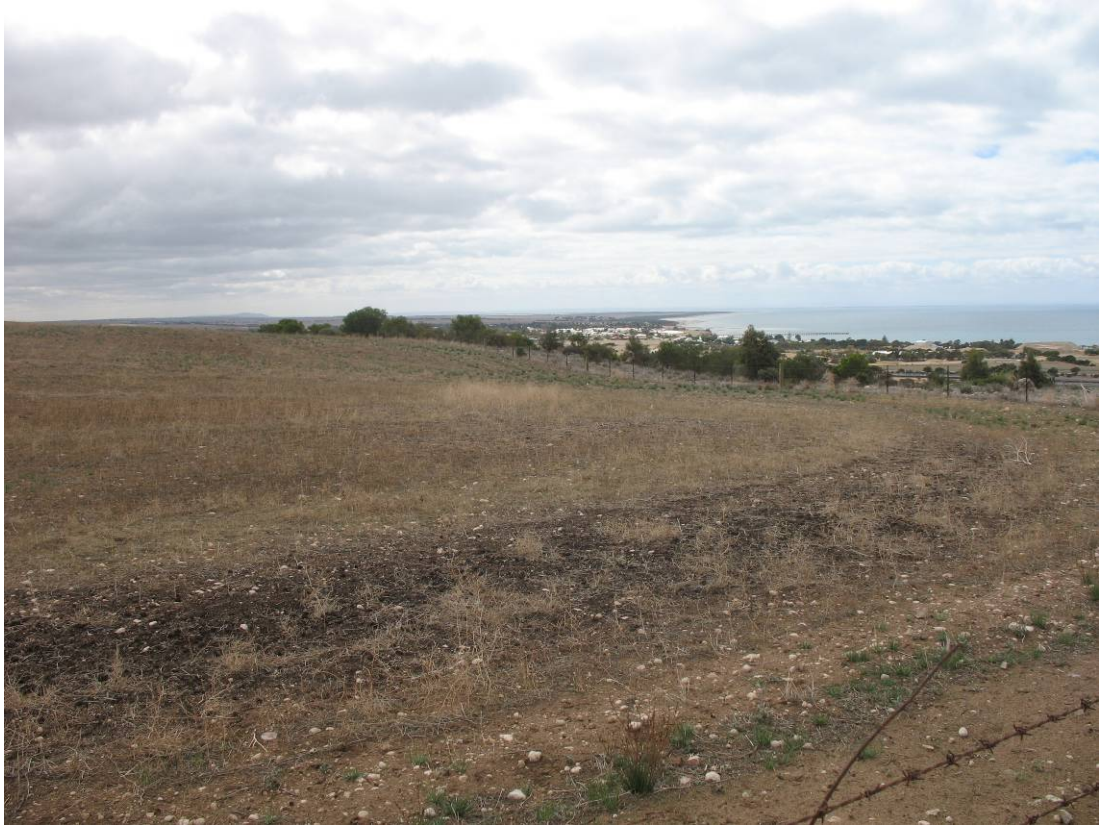
Photo 5.1 View from north of quarry northeast towards Ardrossan township and Gulf St Vincent

The location of the Ardrossan quarry itself is elevated because of the Kulpara Fault and the land falls away to the coast (Photo 5.1).

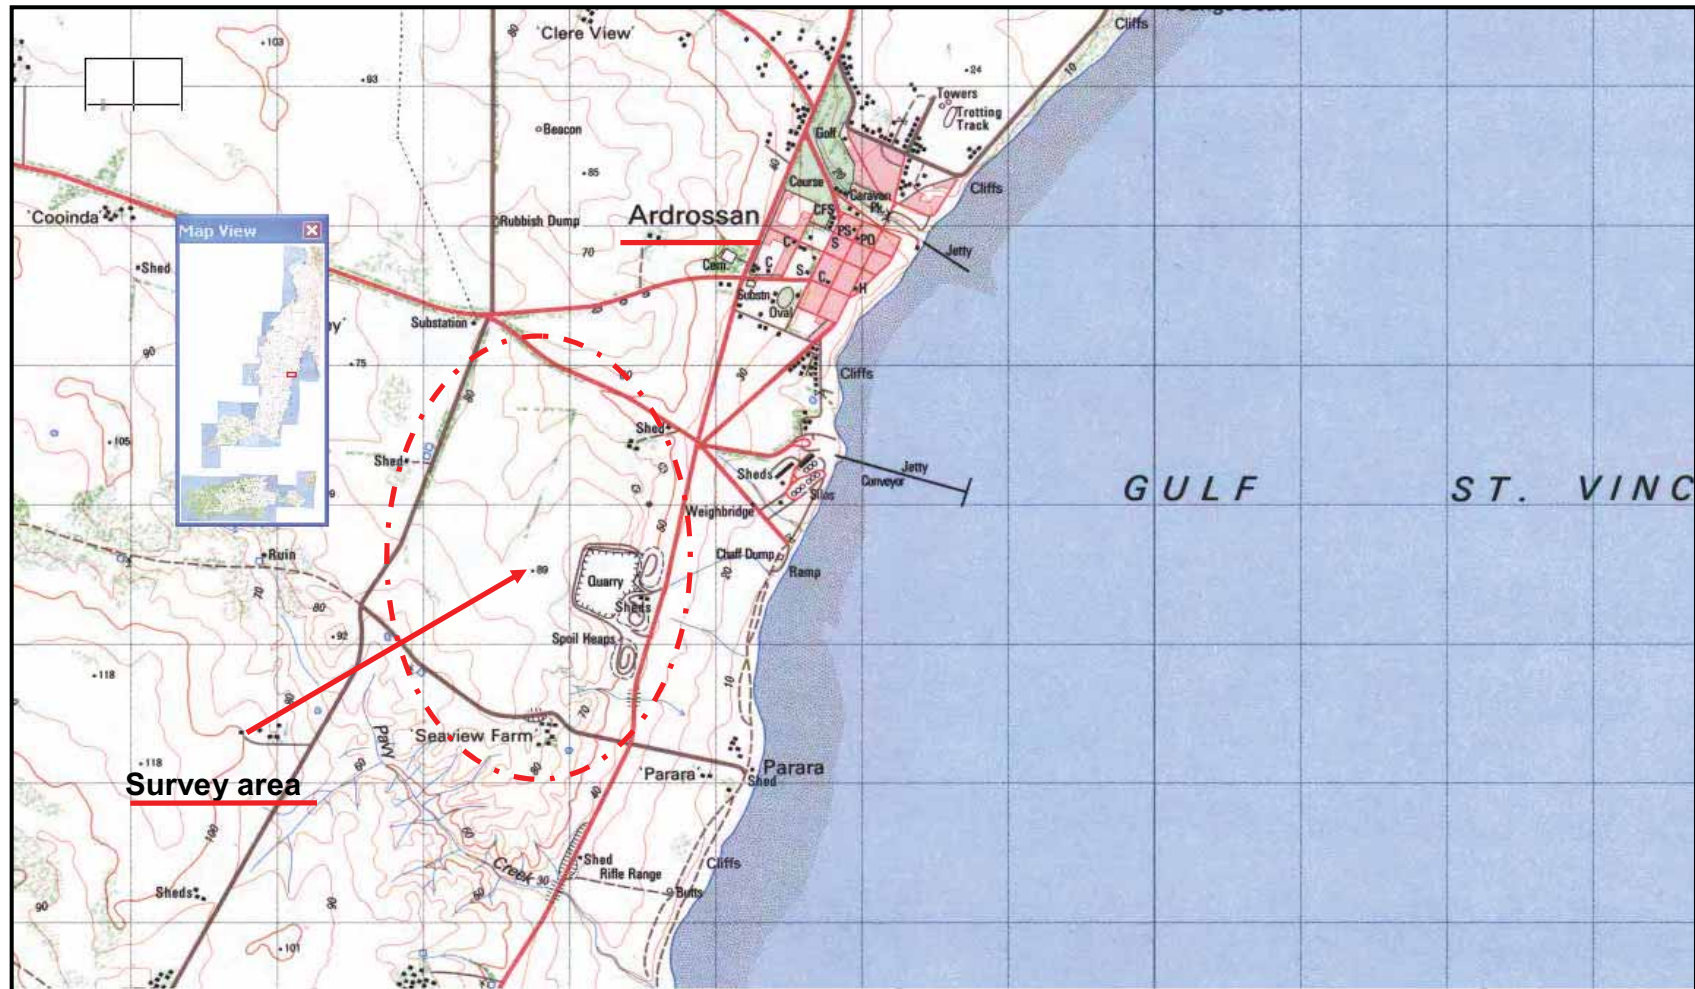
Figure 1. General location of survey area

The survey area (approximately 203ha) directly surrounds the current OneSteel Ardrossan mine site along Main Coast and BHP Road (Figure 1). The area proposed for mine expansion is divided into several paddocks with the majority being used for stock grazing (sheep) or cereal cropping. Another surveyed area connected to the cropped/grazing paddocks contained an old homestead and several old sheds. Small patches of remnant vegetation are located scattered within the survey area, whilst revegetation has been undertaken over parts of the survey area as well.

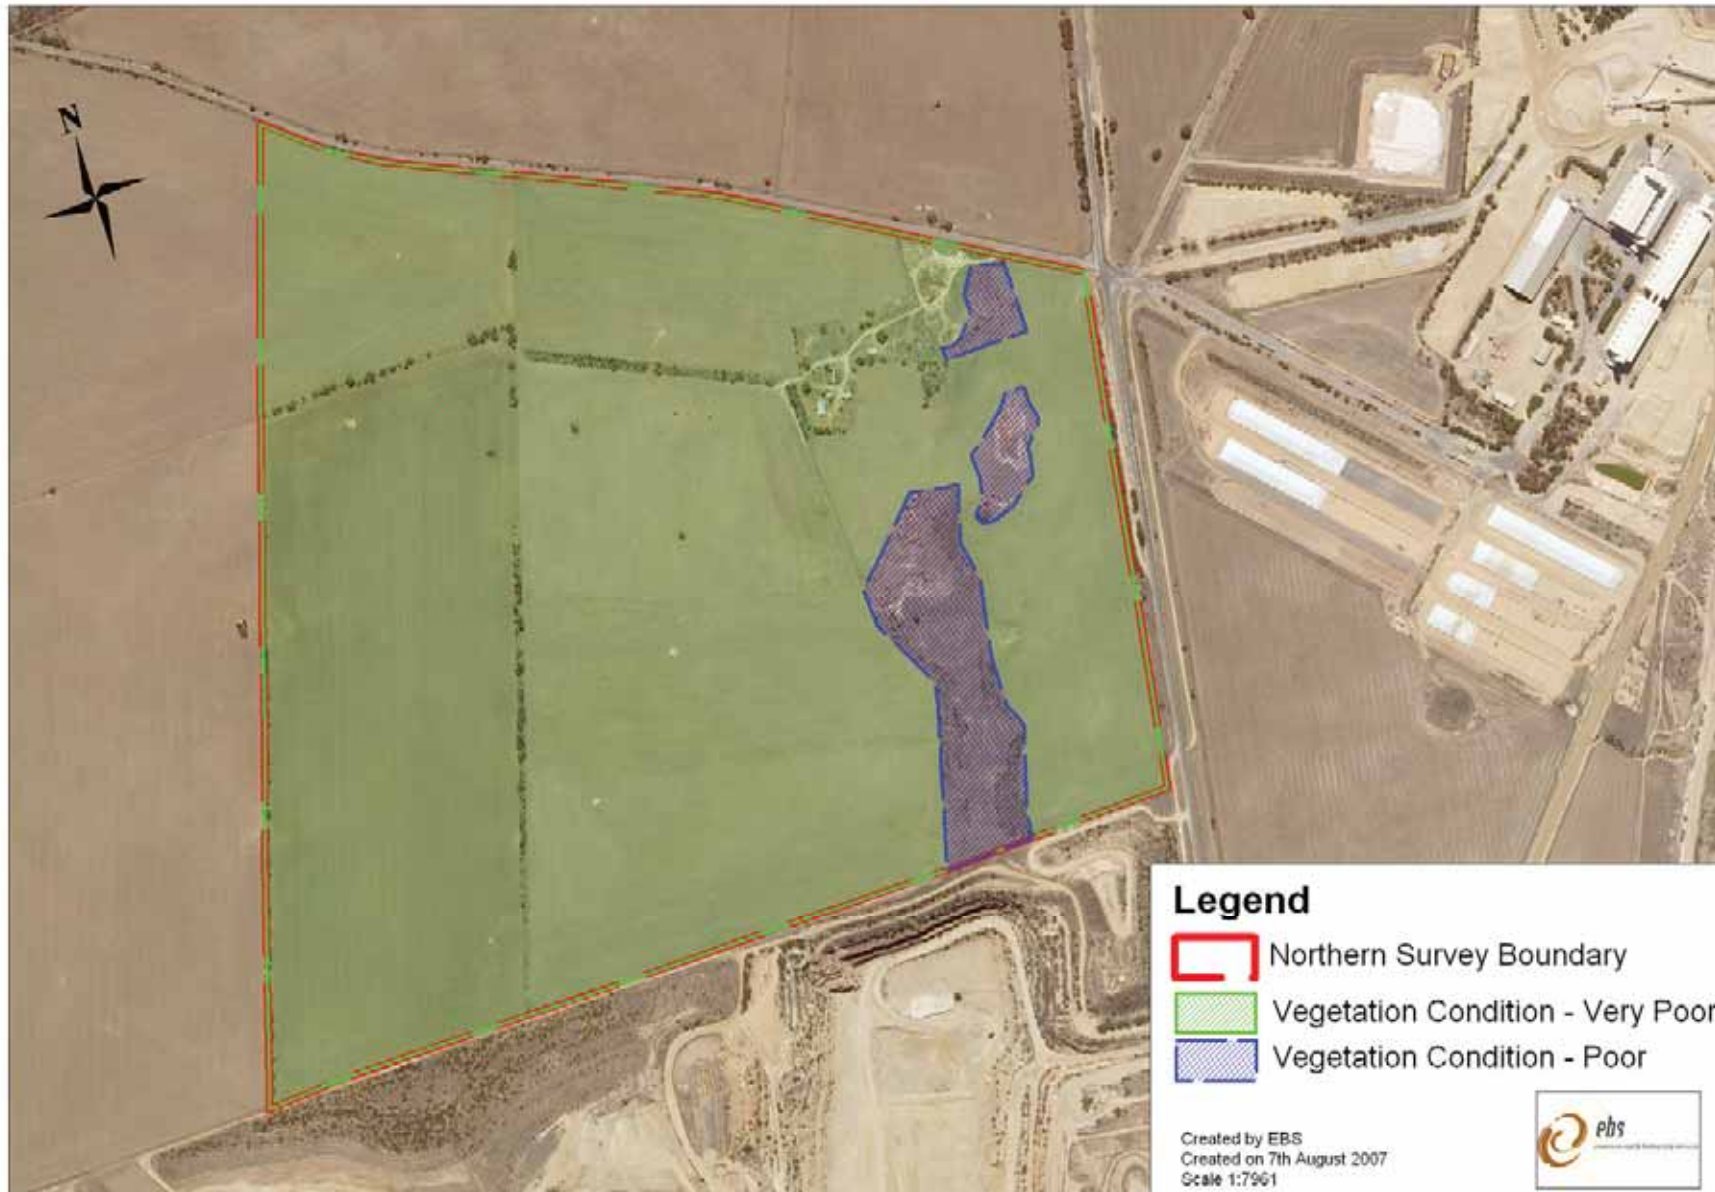
Figure 2a. Location of each different vegetation condition rating within the northern survey area.

Native understorey vegetation occurring within the survey area is considered to be in poor to very poor condition. Figures 2a and 2b illustrate the locations of the vegetation conditions within the survey area. A total of 64 flora species were identified occurring within the survey area with 30 species being native, six of which have been planted, and 34 exotic species, seven of which have been planted around the old homestead (Appendix 1).

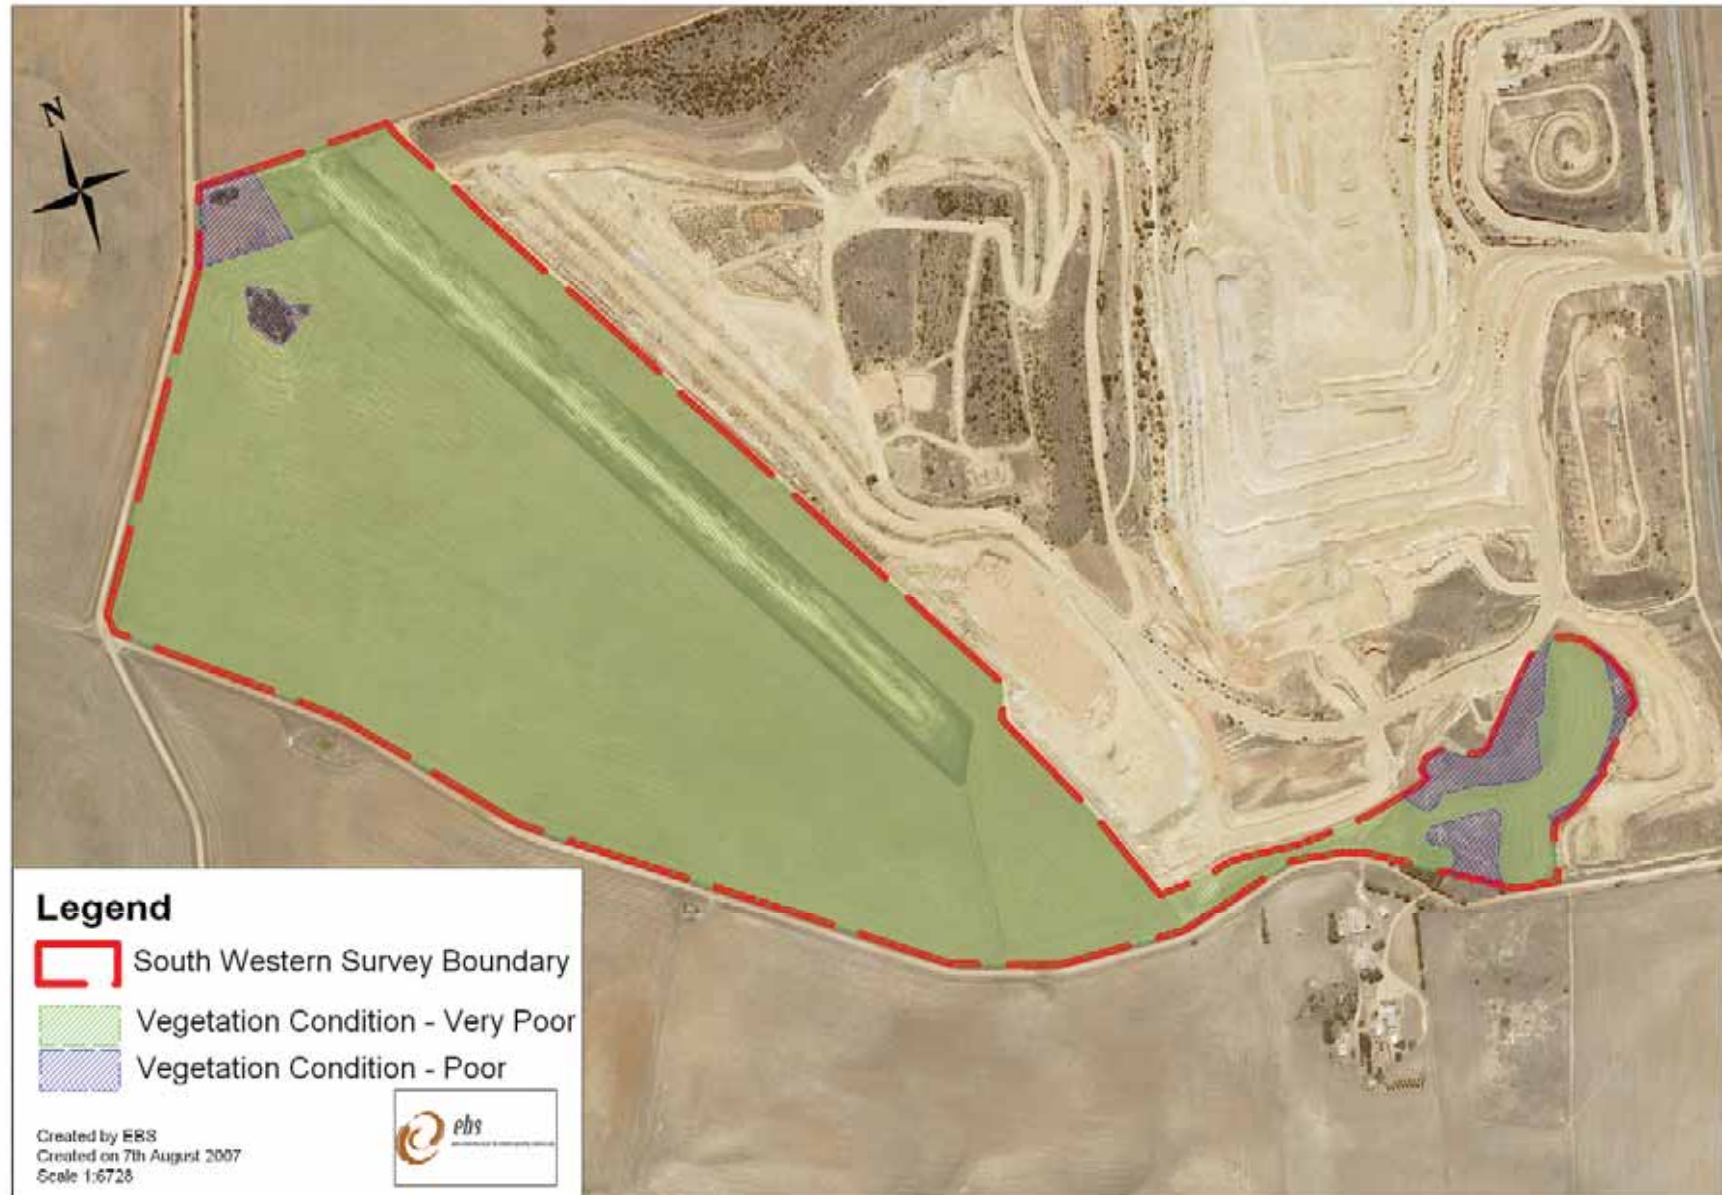
Figure 2b. Location of each different vegetation condition rating within the south western survey area.

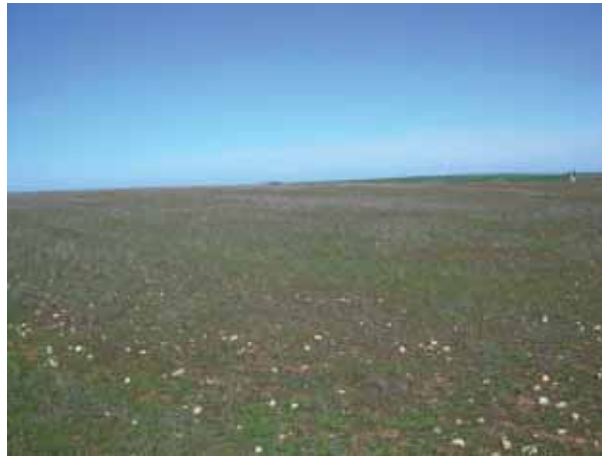
Figure 3a: General photo of a grazed paddock within the survey area.

The survey area is dominated by an Exotic Grassland and cropped paddocks. The cropped paddocks contain *Lupinus sp.* (Lupins) whilst *Triticum aestivum* (Wheat) dominates the non cropped areas (Figure 3a). A number of exotic weeds occur scattered throughout the association such as *Asphodelus fistulosus* (Onion weed), *Asteriscus spinosus* (Golden Pallensis) and *Carrichtera annua* (Ward’s weed), which were recorded generally along fence lines. Paddocks occurring on the northern side of the survey area are lined with planted vegetation such as *Eucalyptus torquata* (Coral Gum), *Casuarina glauca* (Grey She-oak) and other introduced Eucalypt species with the primary function of the vegetation being as a wind break (Figure 3c).

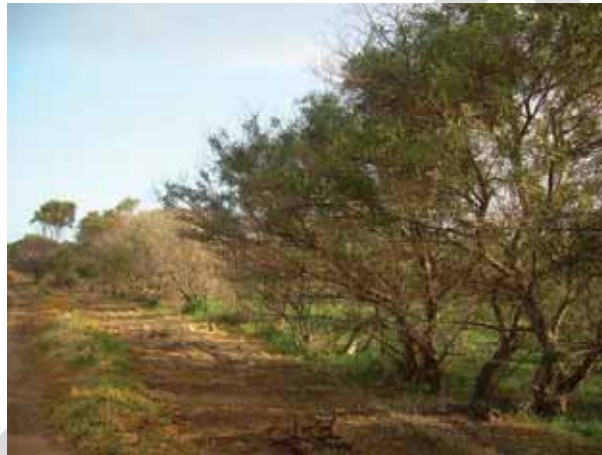
Figure 3b: General photo of the survey area showing a revegetation area.

areas such as *Enchylaena tomentosa* var. *tomentosa* (Ruby Saltbush), *Austrostipa nitida* (Balcarra Spear-grass) and *Lepidosperma viscidum* (Sticky Sword-sedge) (Figure 3b).

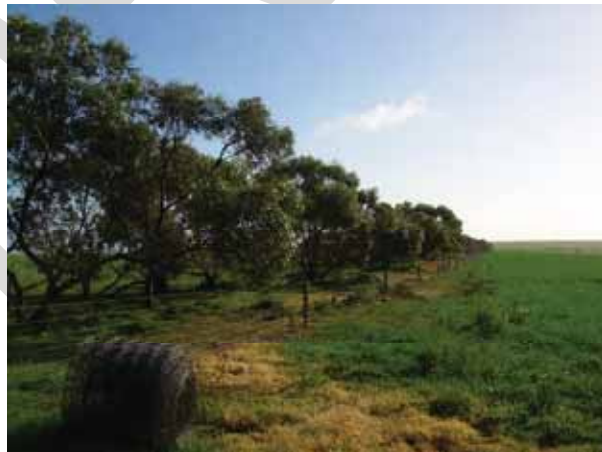
Figure 3c: General photo of the survey area showing a planted windbreak.

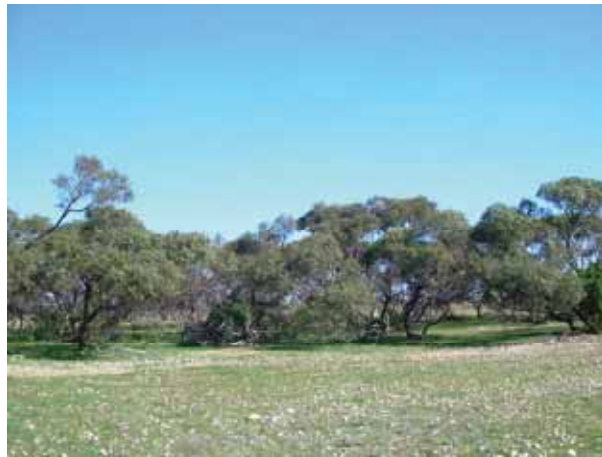
Figure 3d: General photo of the survey area showing a patch of *Eucalyptus porosa* (Mallee Box) occurring within the grazed paddock.

A number of remnant *Eucalyptus porosa* (Mallee Box) scattered within the survey area and are generally located within the paddocks, along fence lines and within wind breaks as single trees or as small groups. The understorey condition of these *Eucalyptus porosa* patches is considered to be in poor to very poor condition with very few native species being recorded (Figure 3d).
