Ammonia Leaching of Oxide Copper Ores by Samin Limited at Burra SA

G J Armstrong

May 2002

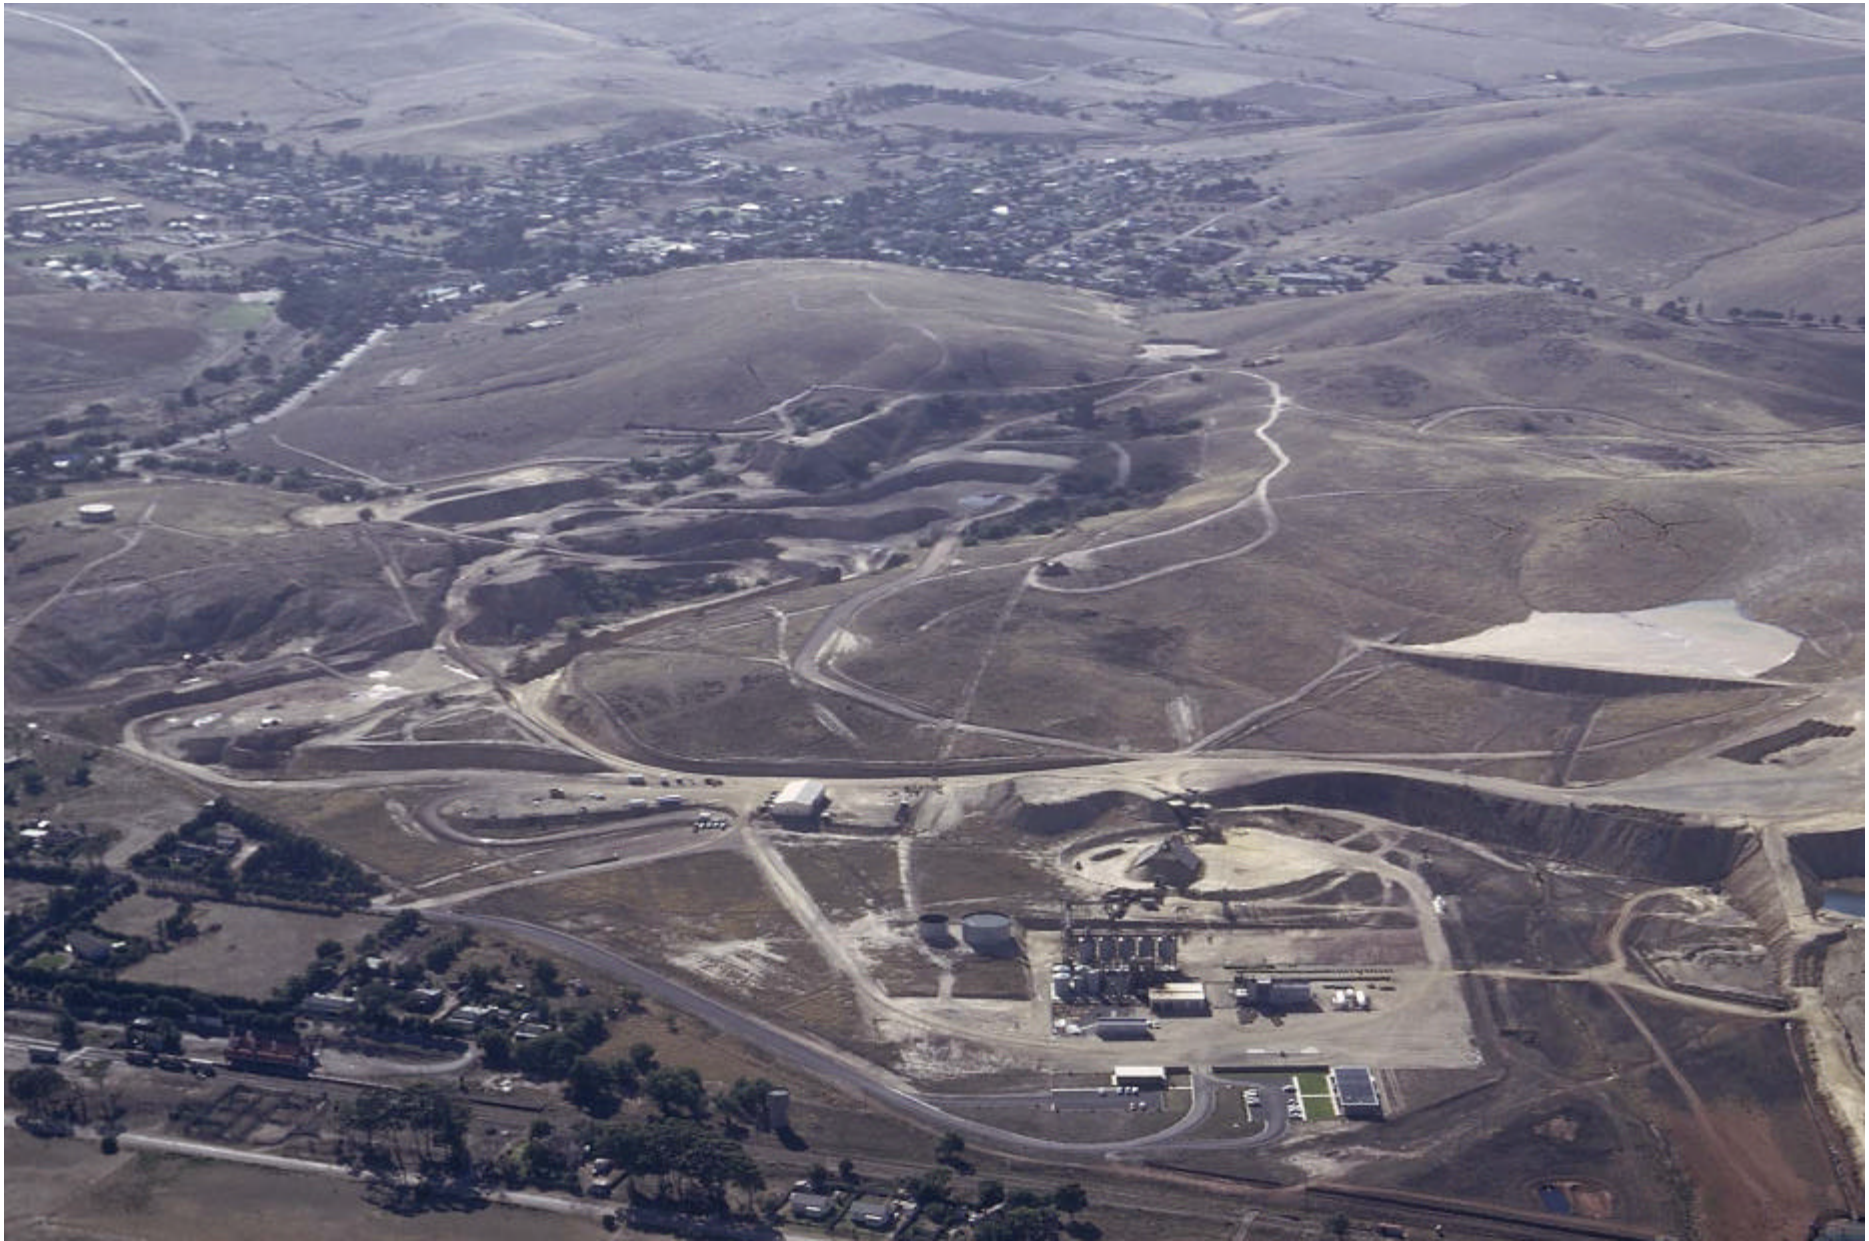
PIRSA Photo T010375

Plate 1 shows the layout of the initial Stage 1 operation and it's relationship to the township of Burra. The main features in the photograph are:

- Central is the early open cut surface development of the Burra Burra mine.
- Below centre is the mine workshop and vehicle holding yard.
- Bottom central and progressing downwards are:
 - Crusher and covered crushed ore storage.
 - Log washer and spiral classifier desliming plant.
 - Murray and Raw water storage tanks.
 - Ore feed conveyers and five low pressure cylindrical leach vessels.
 - Process liquor tank farm and distillation area.
 - Control room, boiler house, store and maintenance workshop.

PLATE 1 Aerial view of Burra Mine and Processing Plant, 1972.

- Copper oxide filtering drying and packaging shed.
- Bunker C fuel oil storage tanks.
- Employee change rooms.
- Administration Office
- Right/middle is the process reject slimes dam.
- Below the slimes dam are waste dumps and wall to the bottom of the photo.
- Below the main waste dump are the leached ore tailings contained by waste walls.
- Above the mine is the township of Burra.
- Left is the township of Burra North.
- The vacant area between the two towns is the site where the smelter used during the 19th century operations was located.

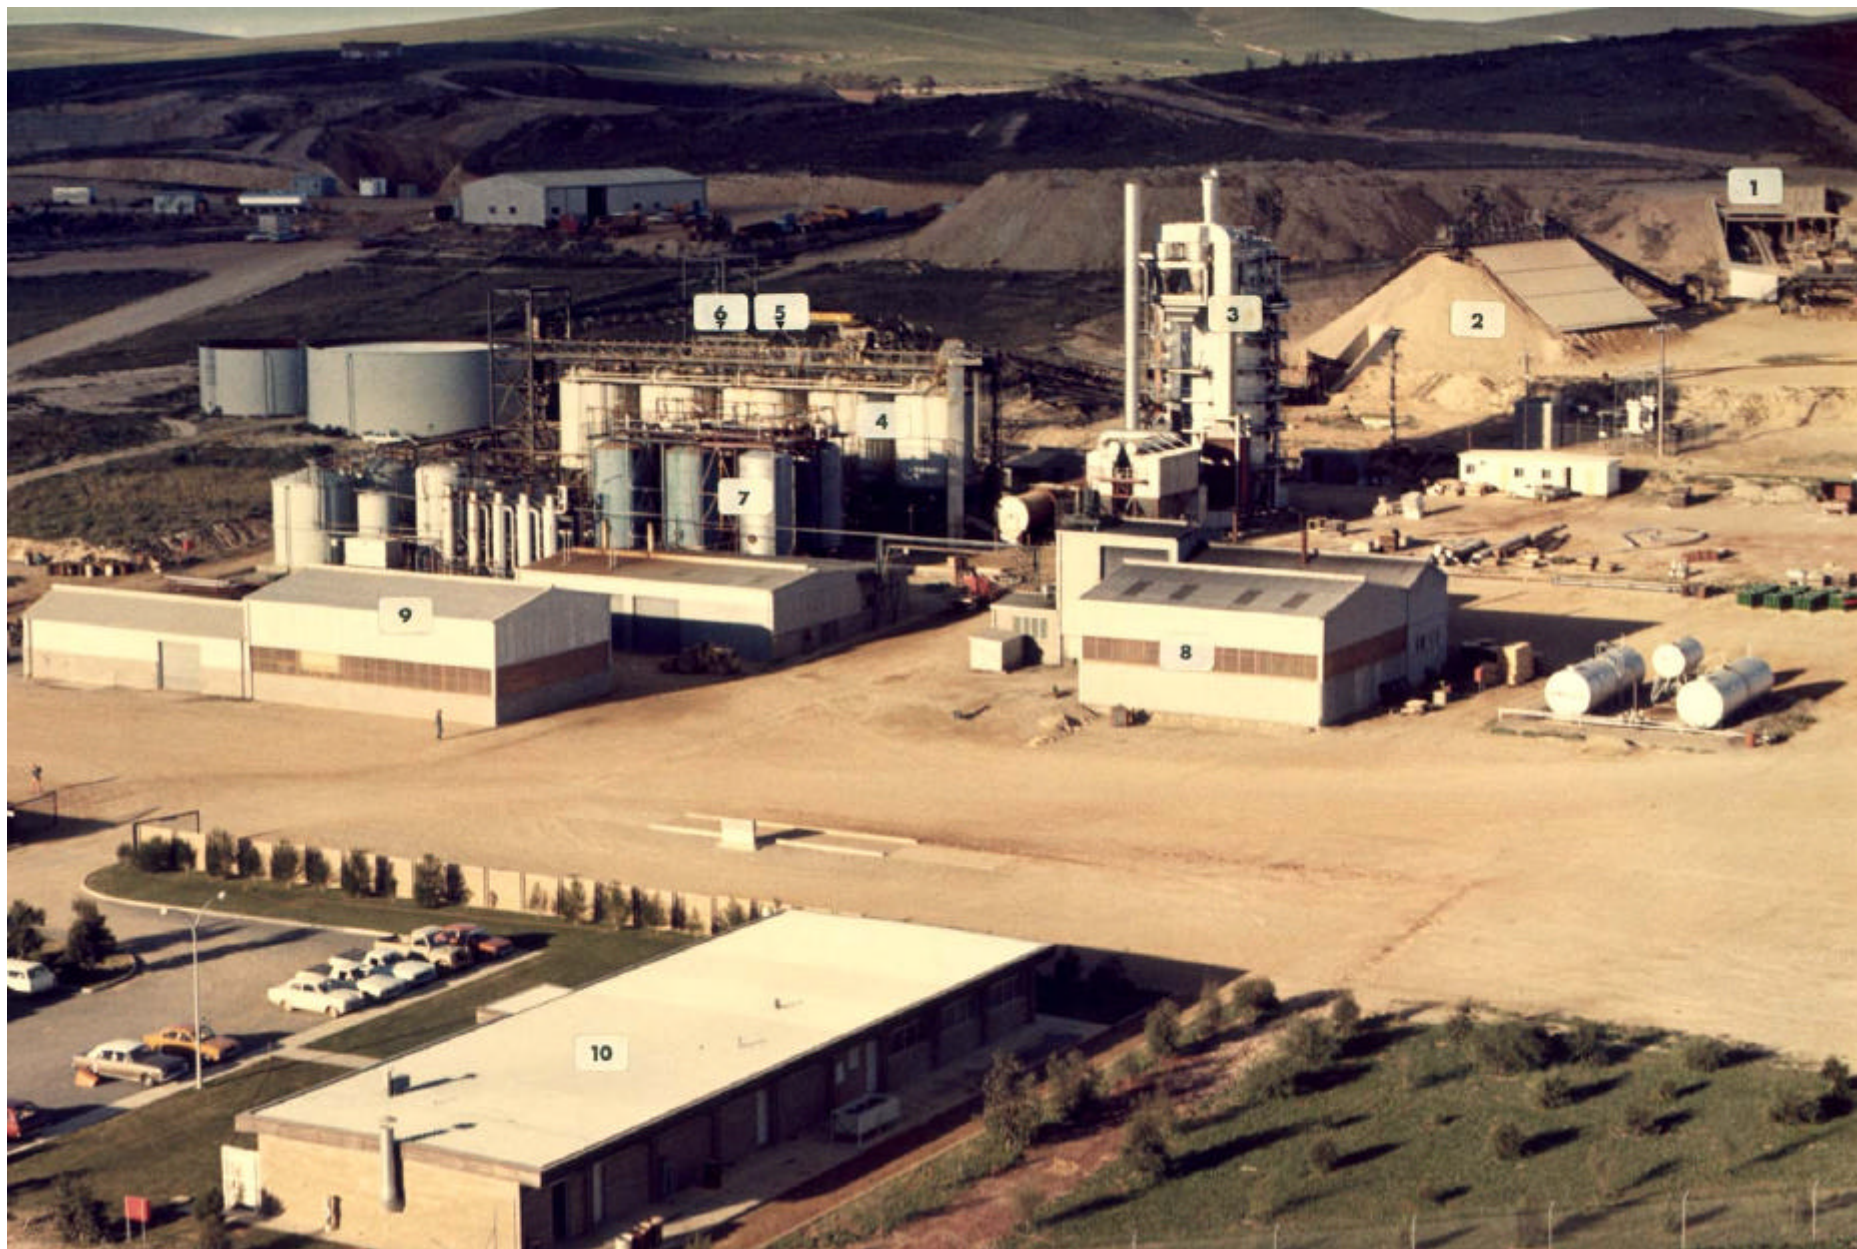
PIRSA Photo 048500

PLATE 2 Burra Processing Plant nearing the end of Stage 2 construction, Oct 1973.

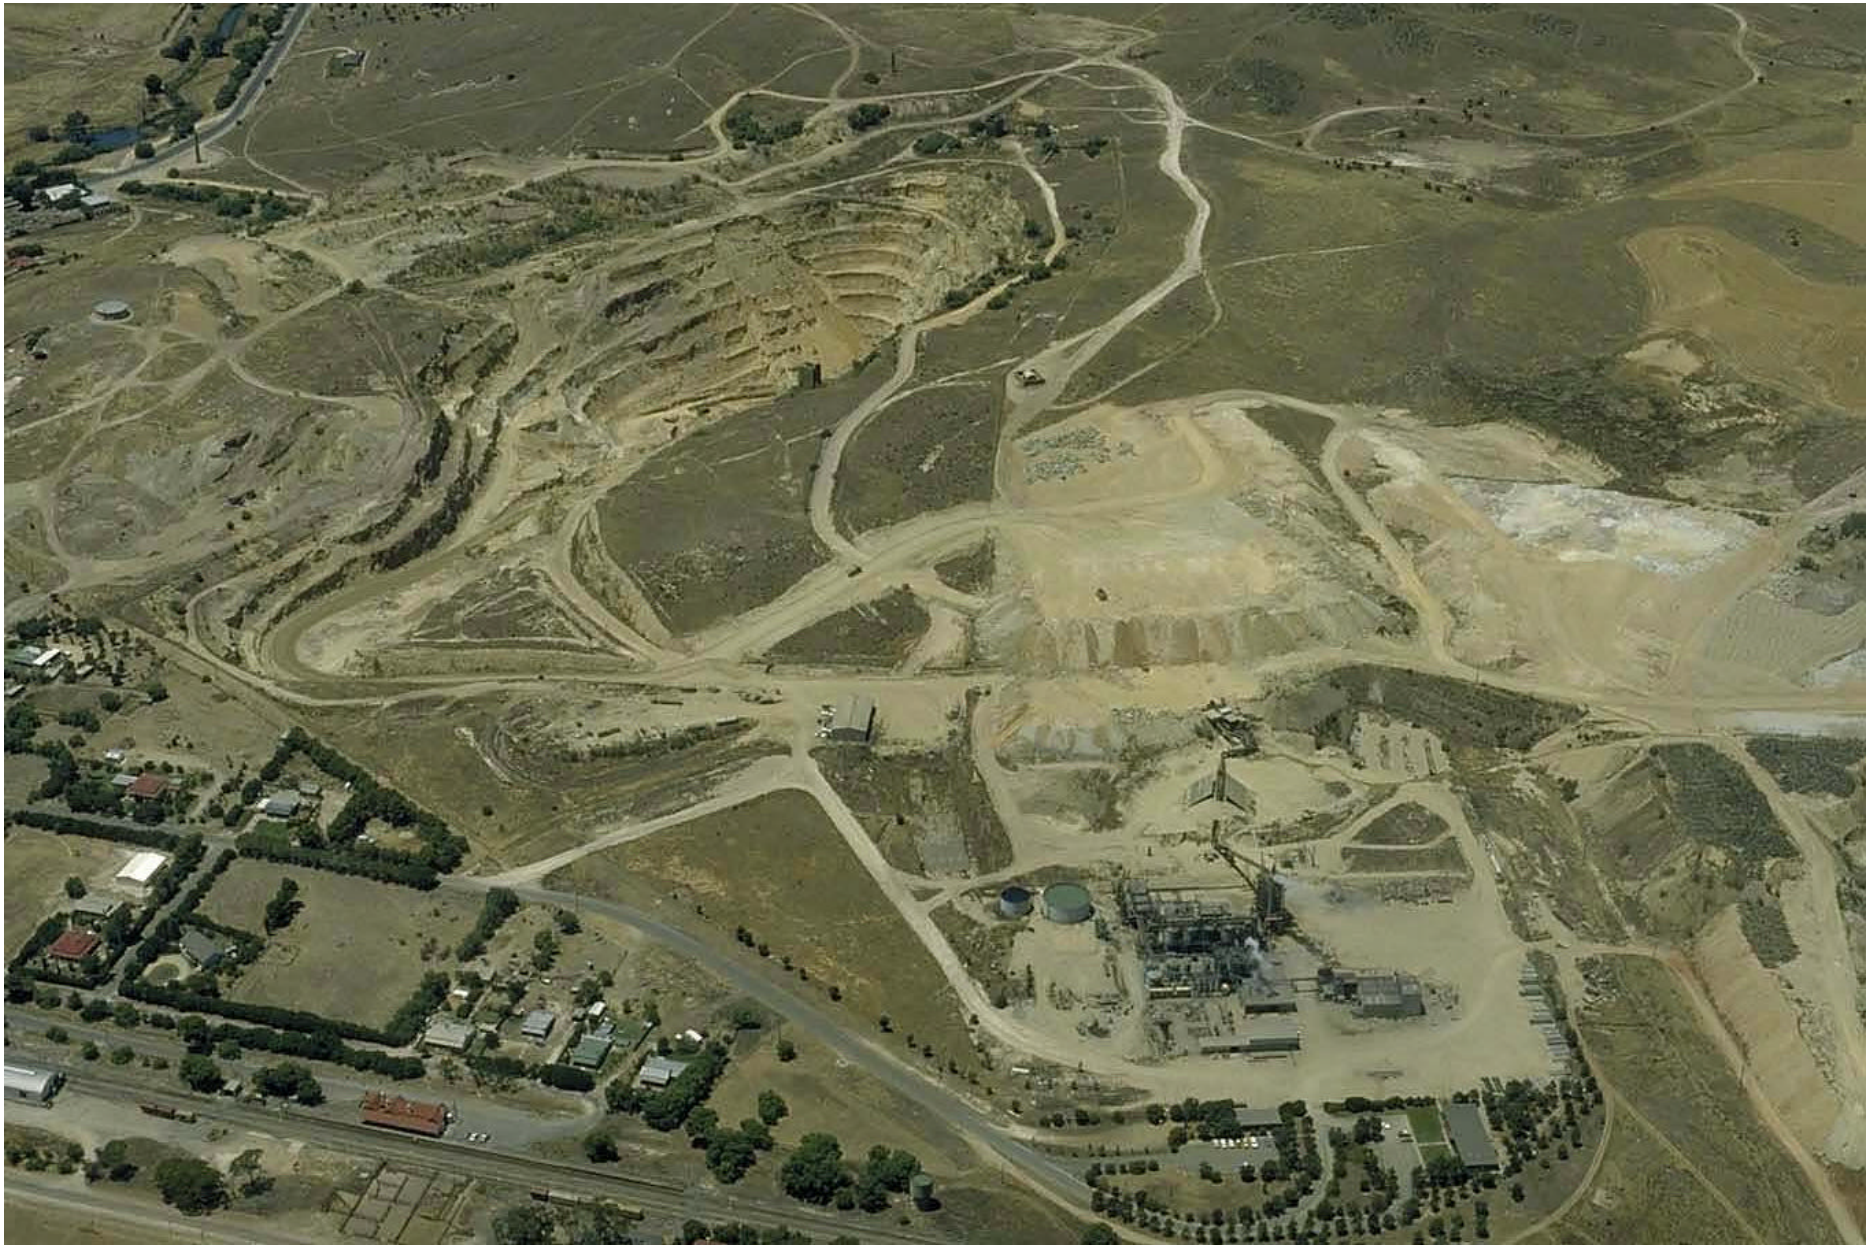
PIRSA Photo 043488

PLATE 3 Aerial view of Burra Mine and Processing Plant, Jan 1981.

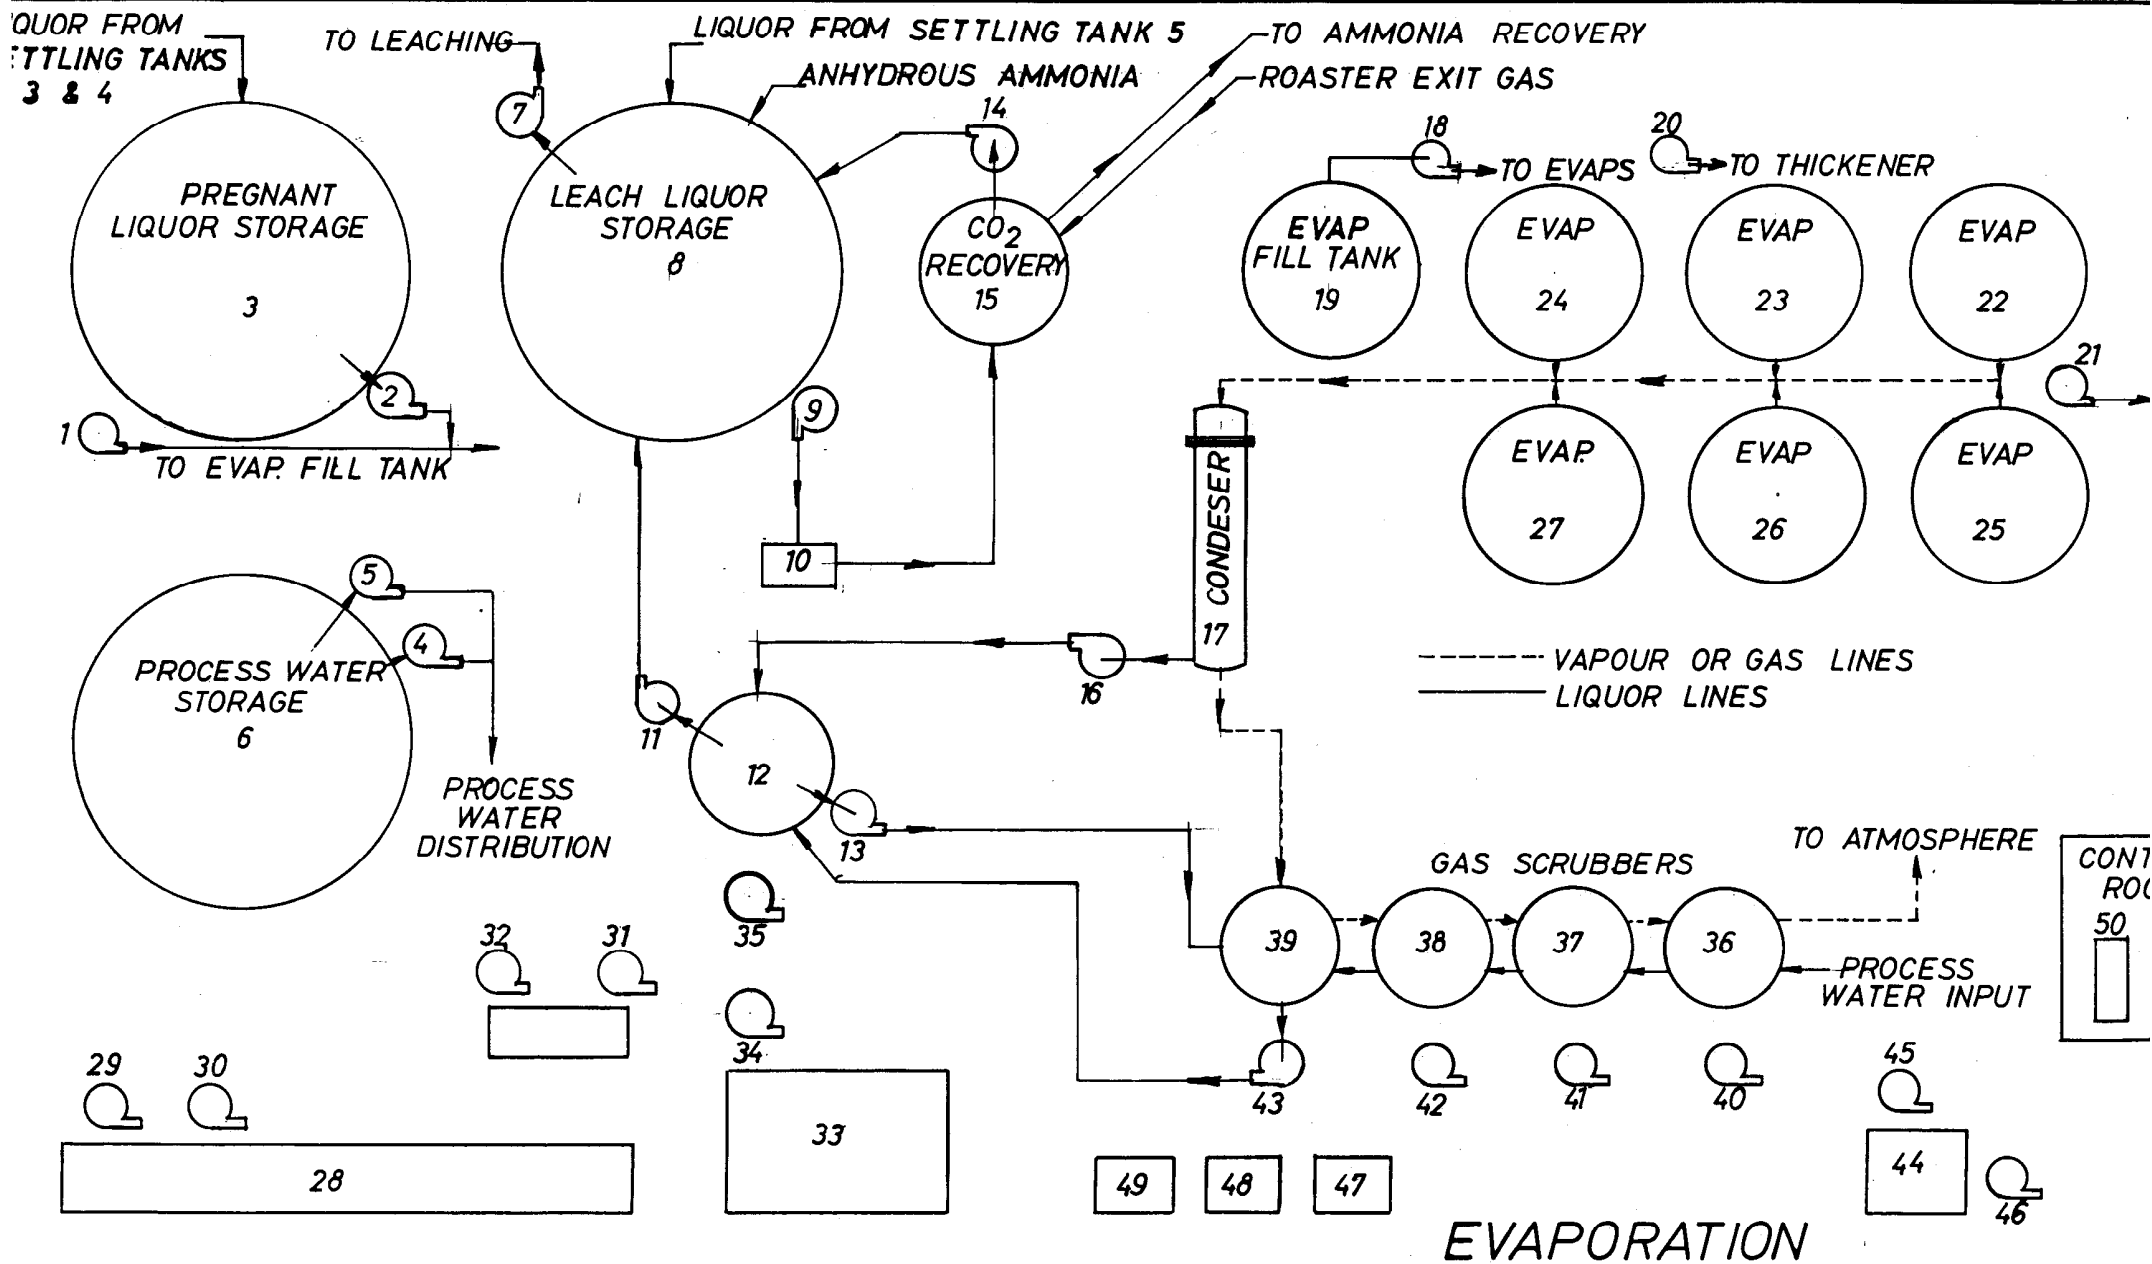
Distillation and Tank Farm

<i>Item No.</i>	<i>Description</i>
1 & 2	Evaporator Fill Tank Pump
3	Pregnant Storage Tank - 40,000 gal
4 & 5	Process (Barrens) Water Distribution
6	Process (Barrens) Water Storage
7	Leach Liquor Pump
8	Leach Liquor Storage - 40,000 gal
9	Leach Liquor Pump to CO2 Recovery
10	Leach Liquor Cooling PHE
11	Condensate ex Evaporator Pump
12	Condensate ex Evaporator Storage Tank
13	Scrubber 4 & 5 Feed Liquor Pump
14	Leach Liquor CO2 Recovery Return Pump
15	CO2 Recovery Scrubber
16	Condenser Condensate Pump
17	Condensers 1 & 2
18	Evaporator Fill Pump
19	Evaporator Fill Measuring Tank
20 & 21	Evaporator Discharge Pumps
22, 23 & 24	Evaporator 1, 2 & 3 - Line 1
27, 26 & 25	Evaporatos 4, 5 & 6 - Line 2
28	Condenser Cooling Tower - CT 1
29 & 30	CT 1 Chemical Dosage Pumps
31 & 32	CT 1 Water Pumps
33	PHE Cooling Tower - CT 2
34	CT 2 Chemical Dosage Pumps
35	CT 2 Water Pump
36, 37 & 38	Scrubbers 1, 2 & 3
39	Scrubbers 4 & 5 in parallel

40, 41 & 42	Scrubbers 1, 2 & 3 Pumps respectively
43	Scrubbers 4 & 5 Pumps
44	PHE Cooling Tower - CT 3
45	CT 3 Chemical Dosage Pumps
46	CT 3 Water Pump
47	PHE for Scrubbers 1, 2 & 3
48	PHE for Scrubber 4
49	PHE for Scrubber 5
50	Distillation Section Control Room
