ILUKA RESOURCES LIMITED

JACINTH-AMBROSIA PROJECT

Mining and Rehabilitation Compliance Report 2010

Date: 30 March 2011

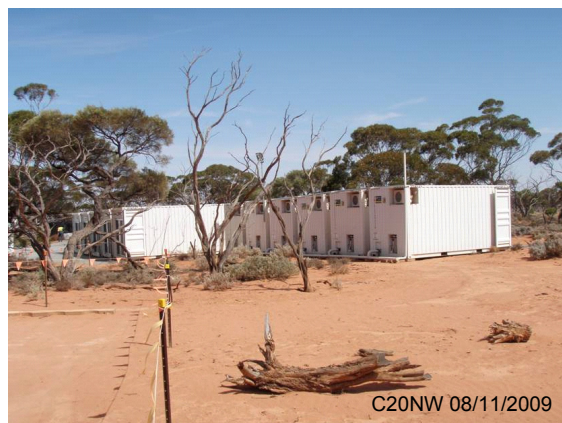
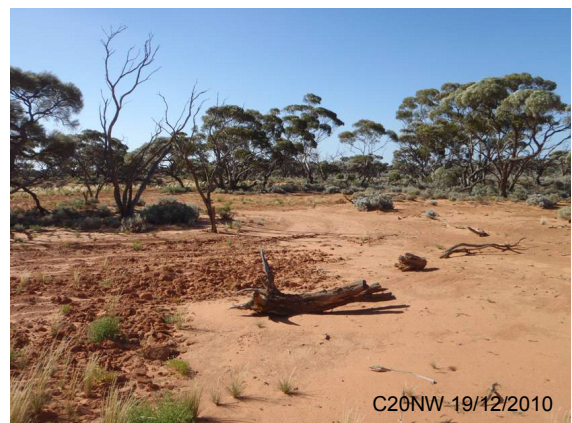
Figure 1: Photo point C20NW, Canberra camp, left: during operation, right: after rehabilitation.

2011 Plans: Septic & pipe to be removed. Continue monitoring & weed control.

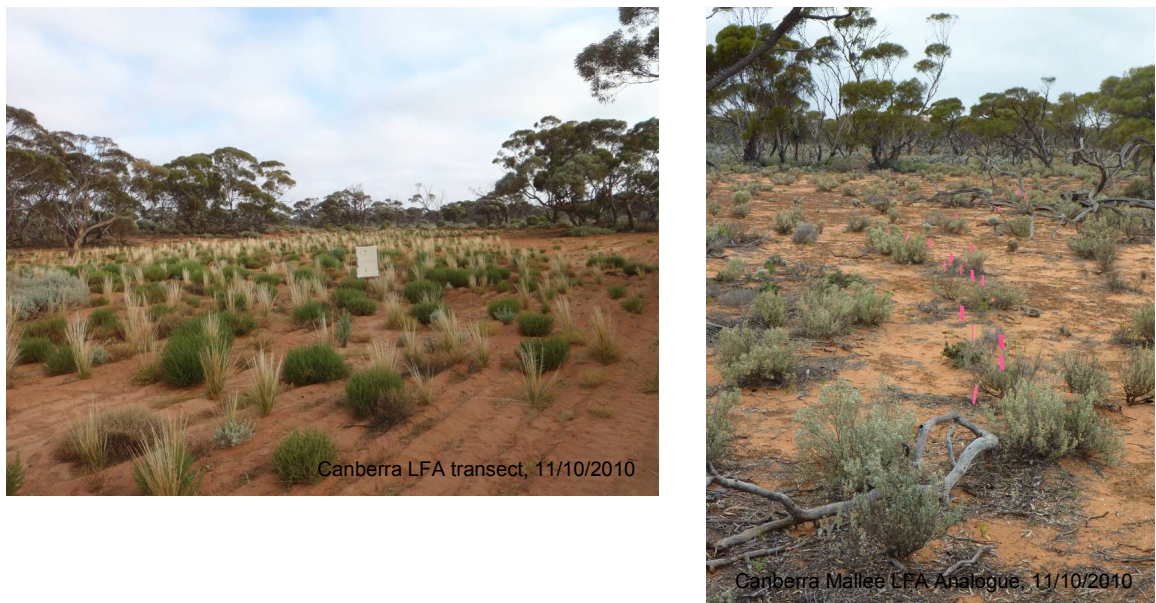
Figure 2: LFA transects, Canberra camp, left: impact site, right: analogue site.

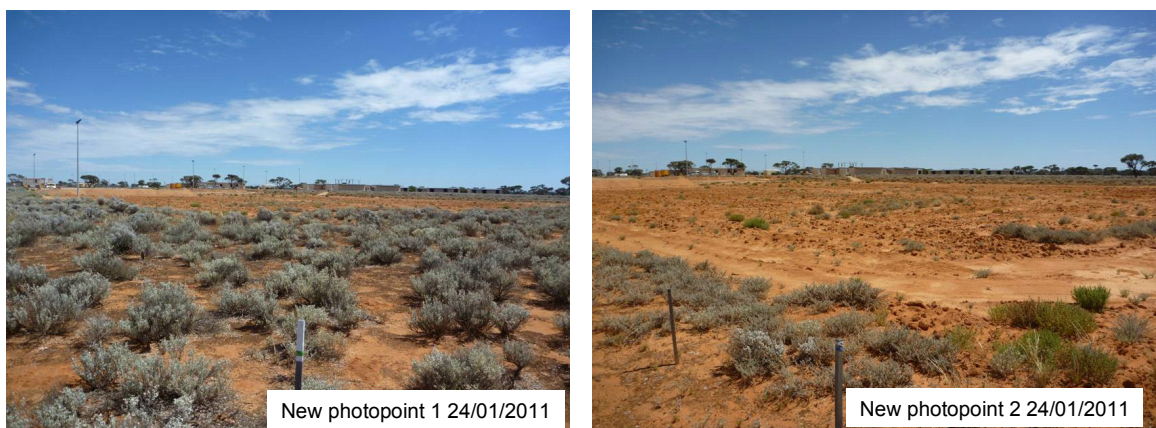
Figure 3: New photopoints at Contractor camp.

2011 Plans: Area to be used in research program for vegetation salt tolerance & tracking salt movement through soil profile.

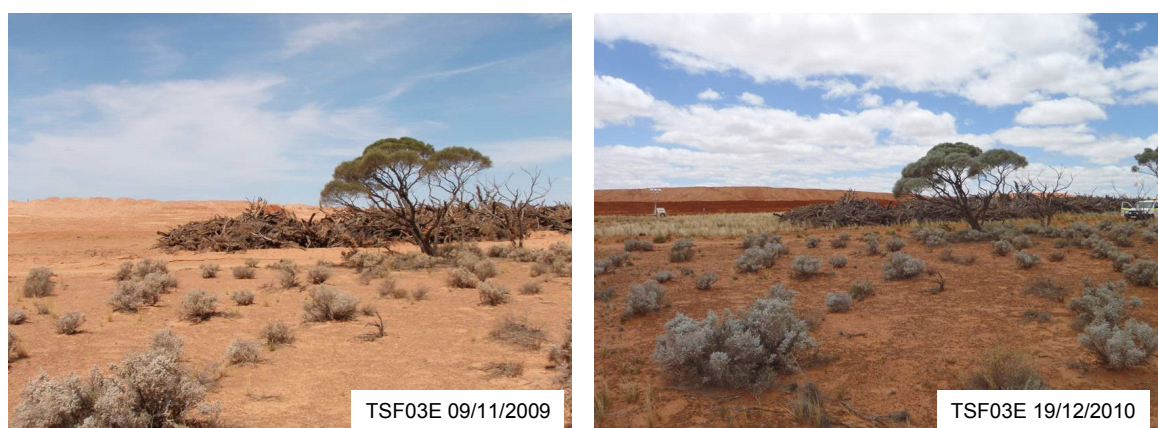
Figure 7: Photo point TSF 03E, tailings storage facility, left: 1 month after construction, right: 14 months after construction.

2011 Plans: Continue monitoring & weed and rabbit control around the perimeter.

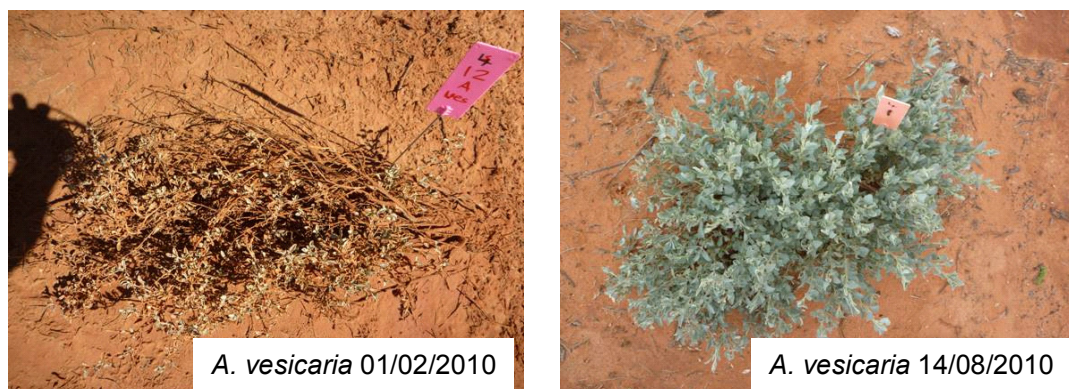
Figure 11: *Atriplex vesicaria* from J-A slime coating trial, left: immediately after slime application, right: 7 months after application.

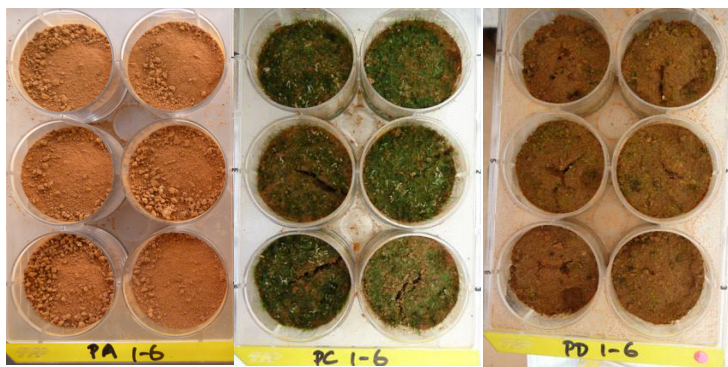
Figure 12: Crushed and watered topsoil showing cyanobacterial filament growth.

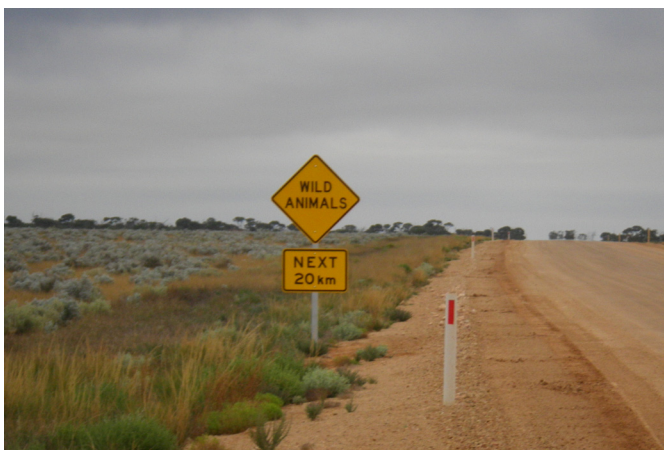
Figure 16: Road sign heading south at 20km along the haul road.

Iluka installed eight animal road signs at 20 km intervals along Ooldea road in an effort to reduce road kill incidents involving fauna (Figure 16).

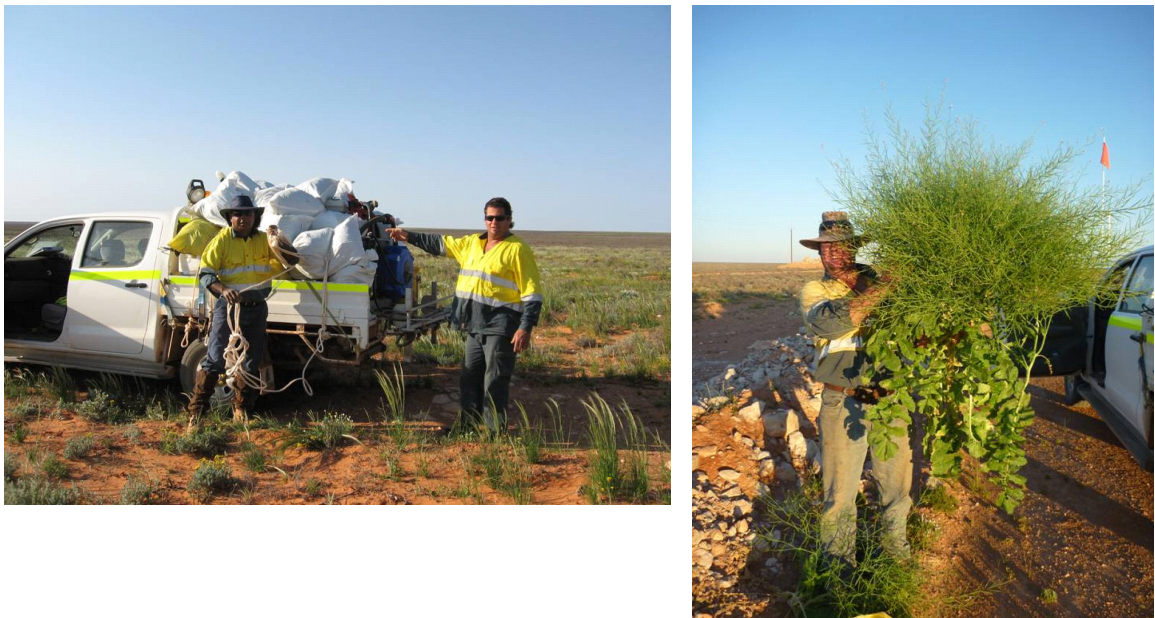
Figure 17: Weed management program 2010, removing mature, seed-loaded turnip.

The weed management response in 2010 was commensurate with the scope of the issue with 85 ha managed, nearly all of which was revisited and re-managed on multiple occasions (Appendix, 13.4). Management techniques included boom spraying large accessible areas, e.g. borrow pits and road sides, and spot spraying and hoeing isolated or inaccessible areas, e.g. stockpiles, creek lines and banks, sand dunes. Despite multiple visits to every known site within the footprint area, there were still many occasions where mature seed bearing individuals or populations needed to be picked and physically removed from site to prevent seed set. The extended nature of the 2010 season meant that efforts were continually focussed on the immediate footprint area with minimal proactive effort extended along other creek lines or towards Ambrosia. The 2010 program was regularly supplemented with supervised local casual labour (Figure 17).

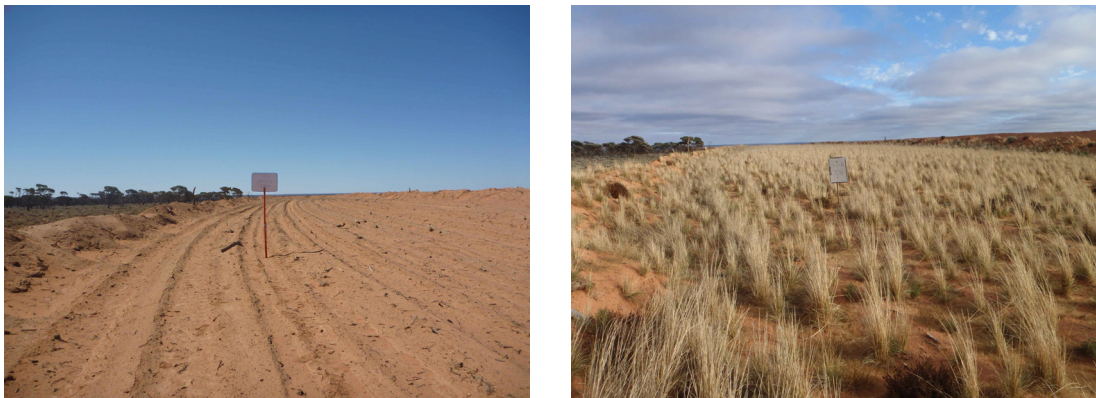
- Clearance of fragile topsoil and subsoils primarily during the period of highest soil moisture, May to September annually.
- Stabilisation of soil stockpiles with non-saline water occurs during and after stockpile construction.
- Once finished, soil stockpiles are bunded and closed to traffic and allowed to regenerate naturally as a result of seasonal rainfall. In the past two seasons stockpiles have been monitored and have achieved a healthy covering of vegetation and are well protected (Figure 19).
- Dust from the pit is managed with water trucks.

Figure 19: Topsoil stockpile TS08, showing development of cover, left: December 2009, right: December 2010 (photos from soil stockpile monitoring program), program details 4.6.2.

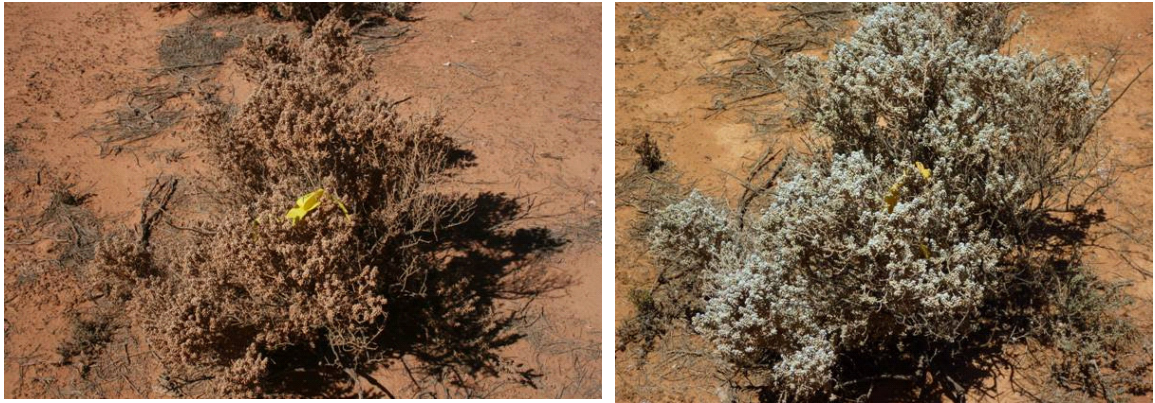
The photo series showed plants completely covered in dust and then washed clean following rainfall (e.g. Figure 20). Given the rapid recovery of the bushes after rainfall, monitoring frequency changed to once per year to pick up longer term trends to plant health. Two more data captures are left, 2011 and 2012, prior to this transect succumbing to the mining path. A new transect to the north of the TSF (out of the mining path) will be established in 2011 to provide LOM data.

Figure 20: *Maireana sedifolia* at photopoint location AR62Ebush, left: 18/08/2009, right: 17/01/2010.

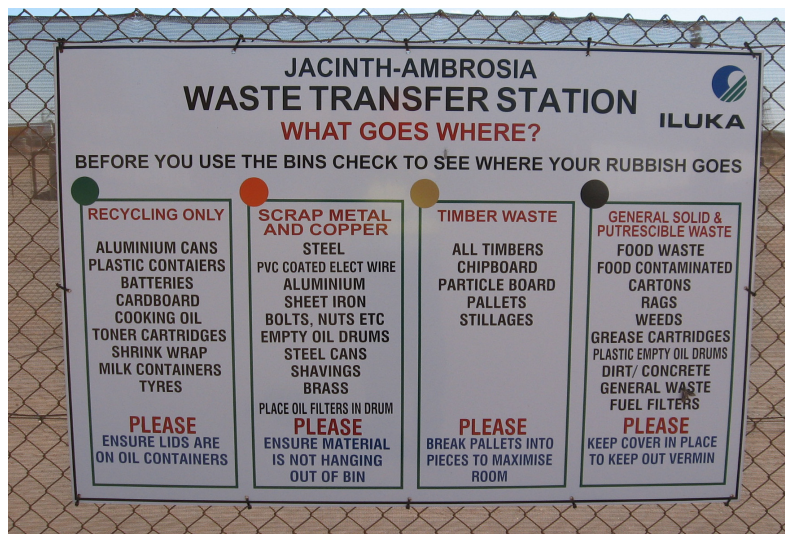
Figure 21: Waste transfer station recycling signage.

Program Implementation: Iluka implemented several improvements in 2010 for managing waste. Iluka now process all oil waste through the Power Station oil recycling unit where contractors then remove the waste from site for resale. Improved signage at the Waste Transfer Station clearly informs personnel about where to place rubbish (Figure 21 and Figure 22).

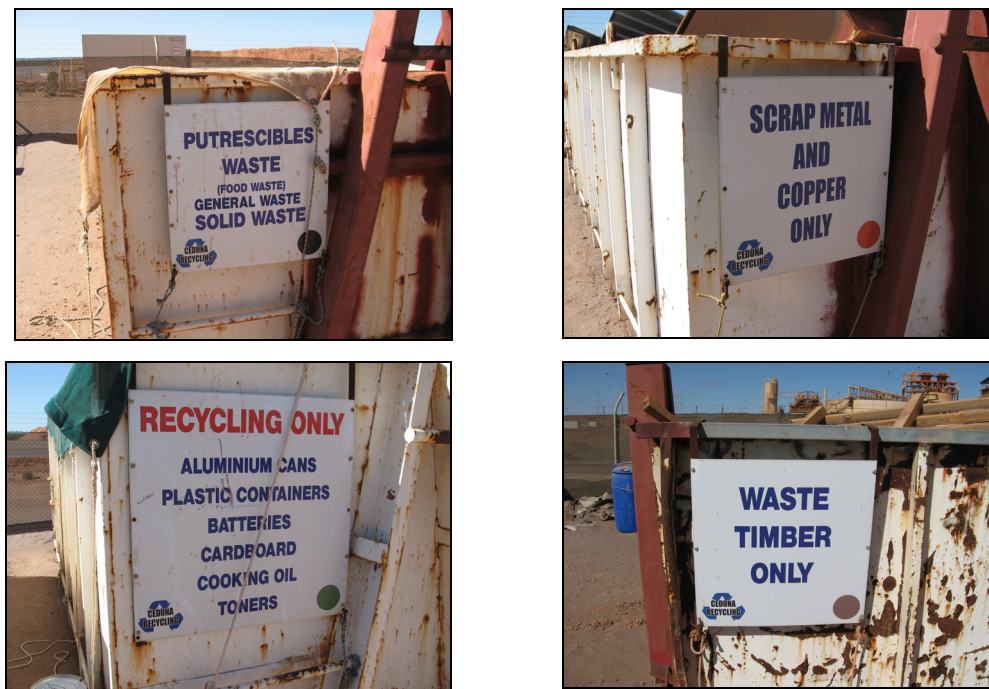
Figure 22: Waste transfer station landfill and recycling bins.

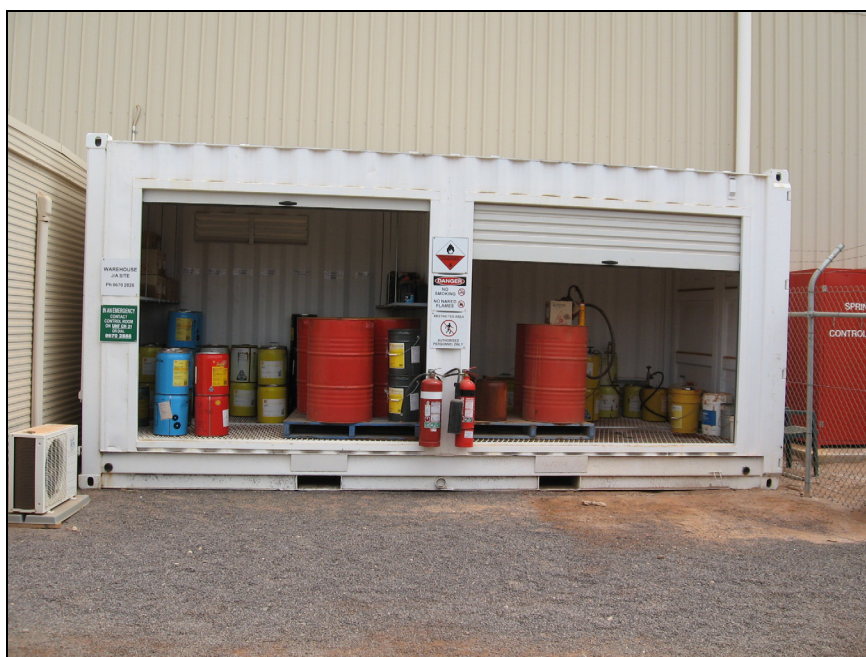
Figure 23: Iluka hydrocarbon storage unit.

Type	Date	Details	Action
Storage	08/08/2010	Tap dripping outside chemical storage bund	<ul style="list-style-type: none"> - Advise contractor of compliance obligations - Position tap inside bund
Storage	21/05/2010	Chemicals stored without bund	<ul style="list-style-type: none"> - Chemicals moved to area with lower risk. - Bunding pallets and hydrocarbon storage unit purchased

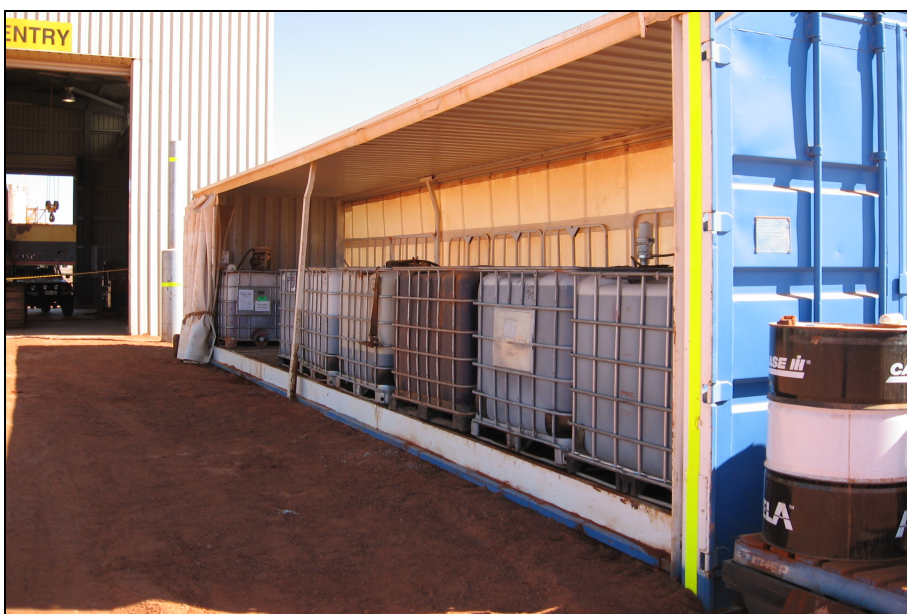
Figure 24: Exact Earthmoving hydrocarbon storage unit.

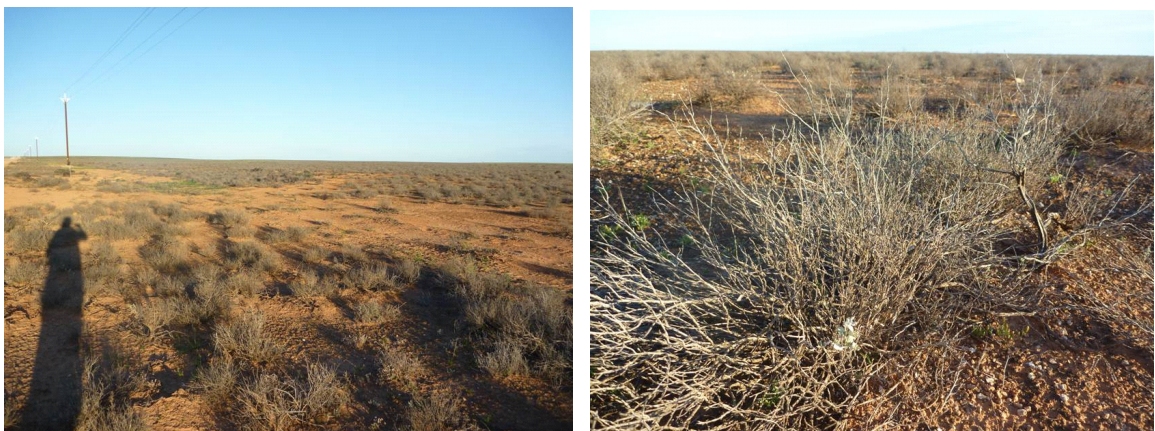
Atriplex vesicaria dieback – a large area of dead/severely impacted vegetation, specifically *Atriplex vesicaria*, was identified extending to the horizon on either side of bore field road 2010 (Figure 25). A brief helicopter survey confirmed the area extended more than 13 km beyond the bore field road. Follow up preliminary investigations showed intensive borer activity in the roots of dead plants and grubs in the roots of barely live plants. The area was reported to the DENR Mining Ranger and the issue was briefly discussed at the 2009 MARCR Review Meeting in January 2011. Both DENR and the University of Adelaide have expressed interest in investigating this issue further. Iluka also needs to understand whether this phenomenon could have potential impact on the success of *Atriplex vesicaria* in future mine rehabilitation.

Figure 25: *Atriplex vesicaria* (left: landscape, right: close up) on the bore field road, 2010.

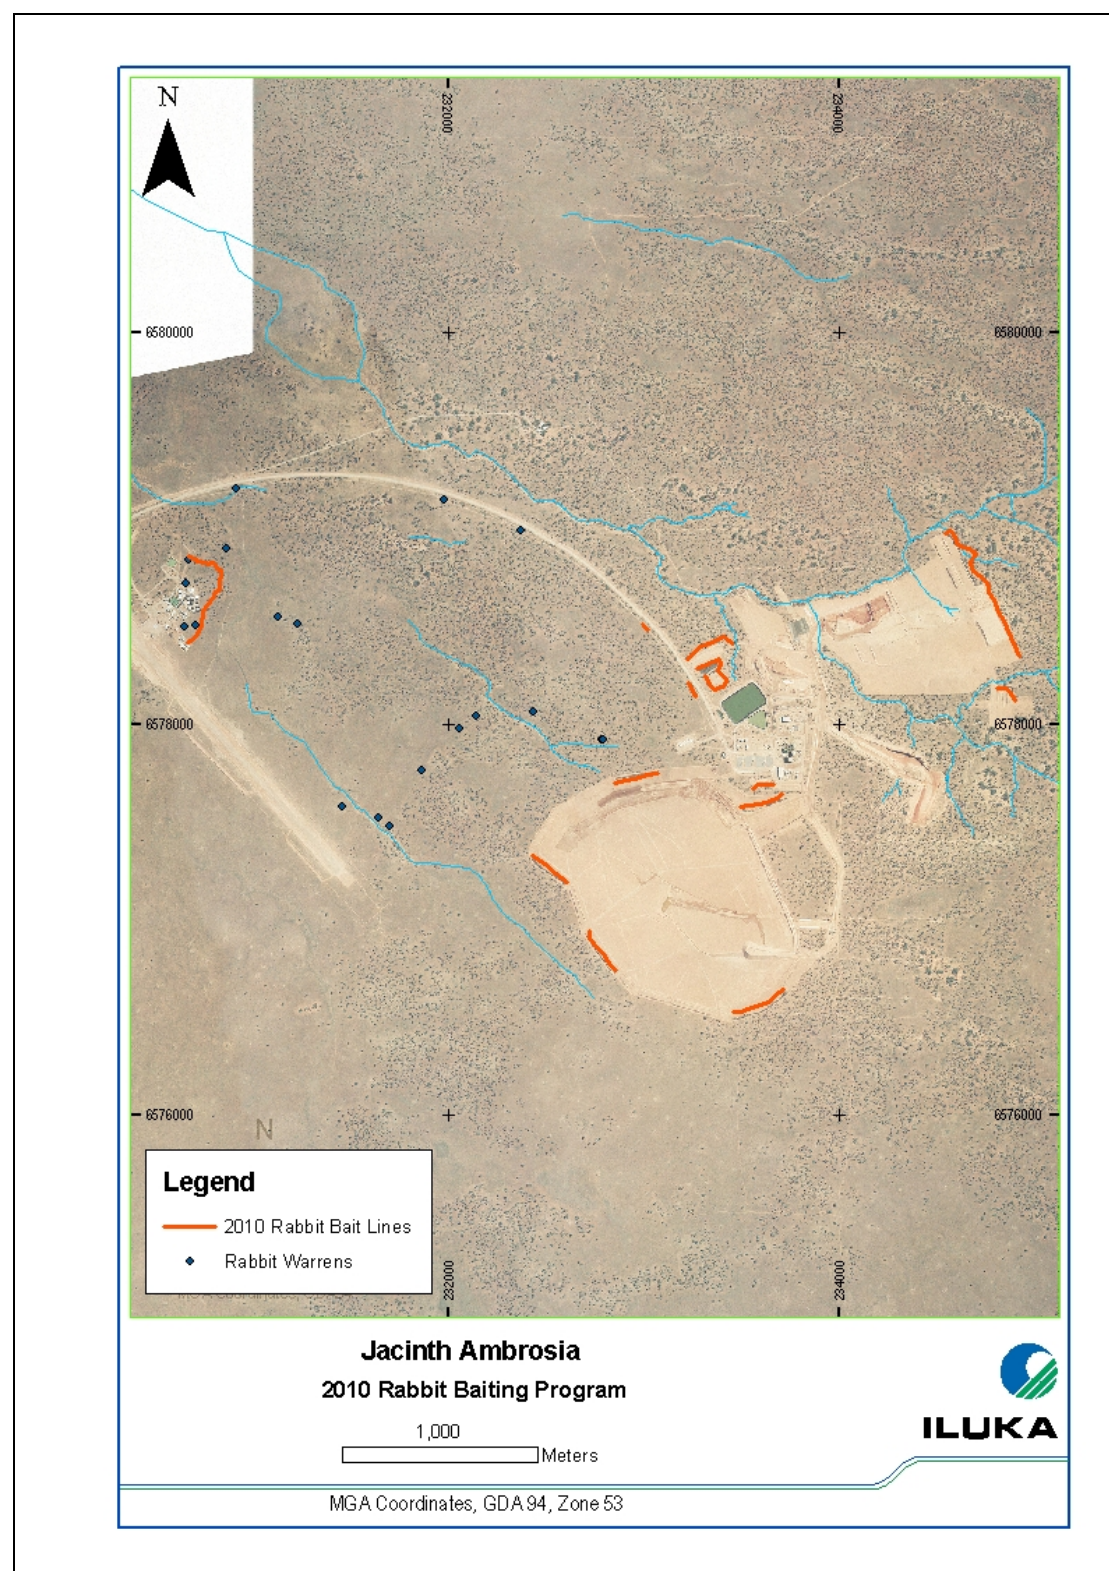
Figure 35: 2010 Rabbit baiting locations.

Baiting locations were selected based on visual rabbit activity; distinct short grazing of native vegetation, rabbit tracks, scratchings and scats. Locations were linked with three landscape features, sand dunes, old wombat holes and adjacent to the vegetation stockpiles created as part of the mining process. A total of 3.7 km of oat trails were laid (Appendix 13.1, Figure 35).

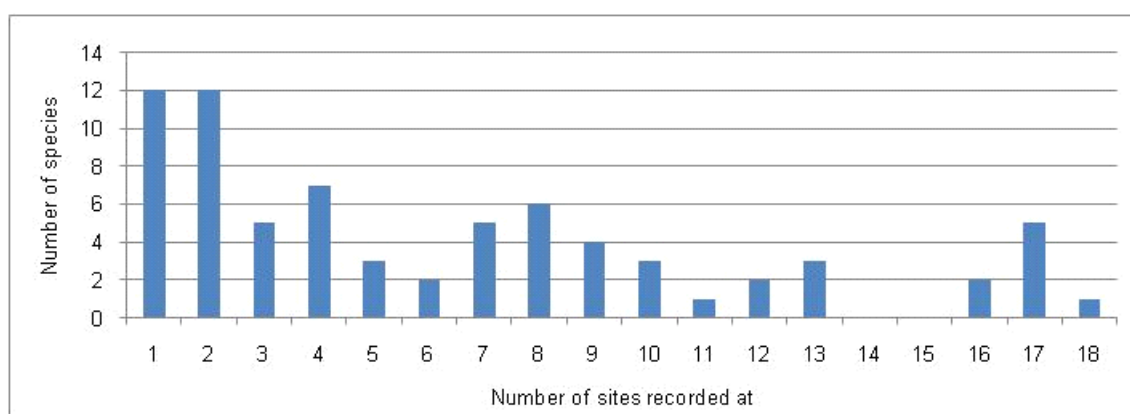
**Figure 37: Frequency distribution of native species.**
