Jacinth Ambrosia
Research and Monitoring Summary
2014 - 2015

Document Title:	Jacinth Ambrosia Research and Monitoring Summary 2014- 2015
Mine Status:	Operational
Revision:	Version 1.0
Date Issued:	27 April 2016
Review Frequency:	-
Compiled by:	J Lee and T Law
Owner:	JA Rehabilitation
Document No:

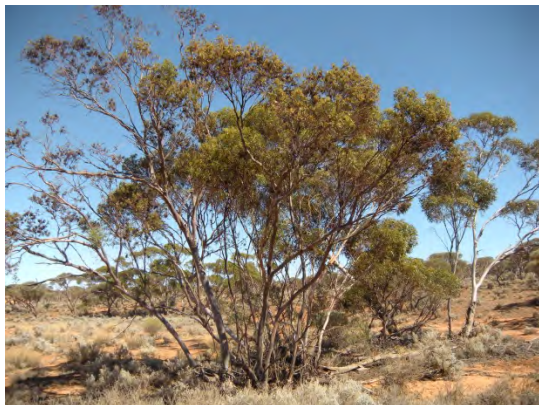
Plate 1 Mallee (Ma_0_49) presenting high insect damage (galls present in both old and new leaves)

- Ma_0_49 in an impact site had high levels of insect damage to both old and new leaves, however all other trees in that area were observed to be healthy (Plate 1).
- Ma_5_13 and Ma_0_25 in an impact site showed epicormic growth (Plate 2 and Plate 3).

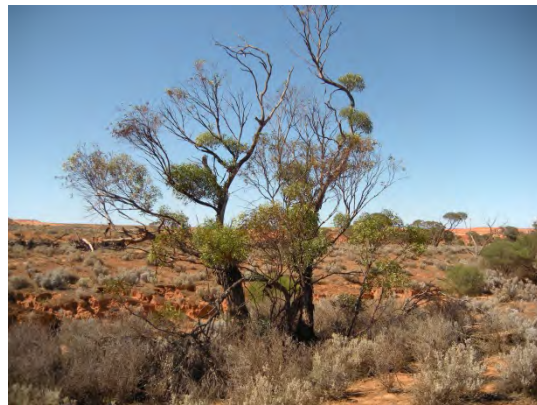
Plate 2 Mallee (Ma_0_25) presenting with epicormic growth

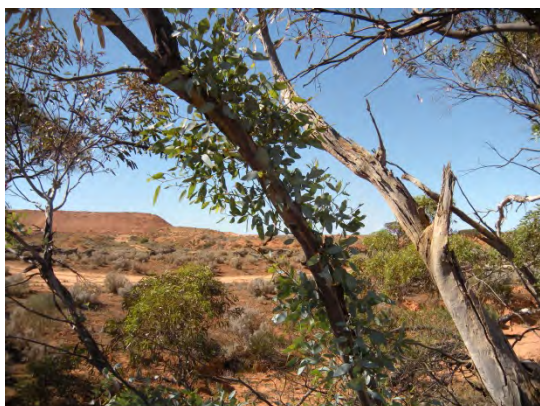
Plate 3 Mallee (Ma_5_13) presenting with epicormic growth

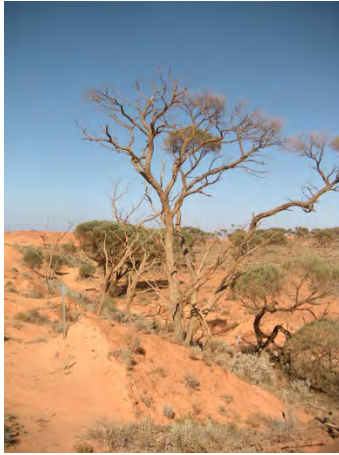
Plate 4 Myall (My_03_01) showing dieback in response to disturbance

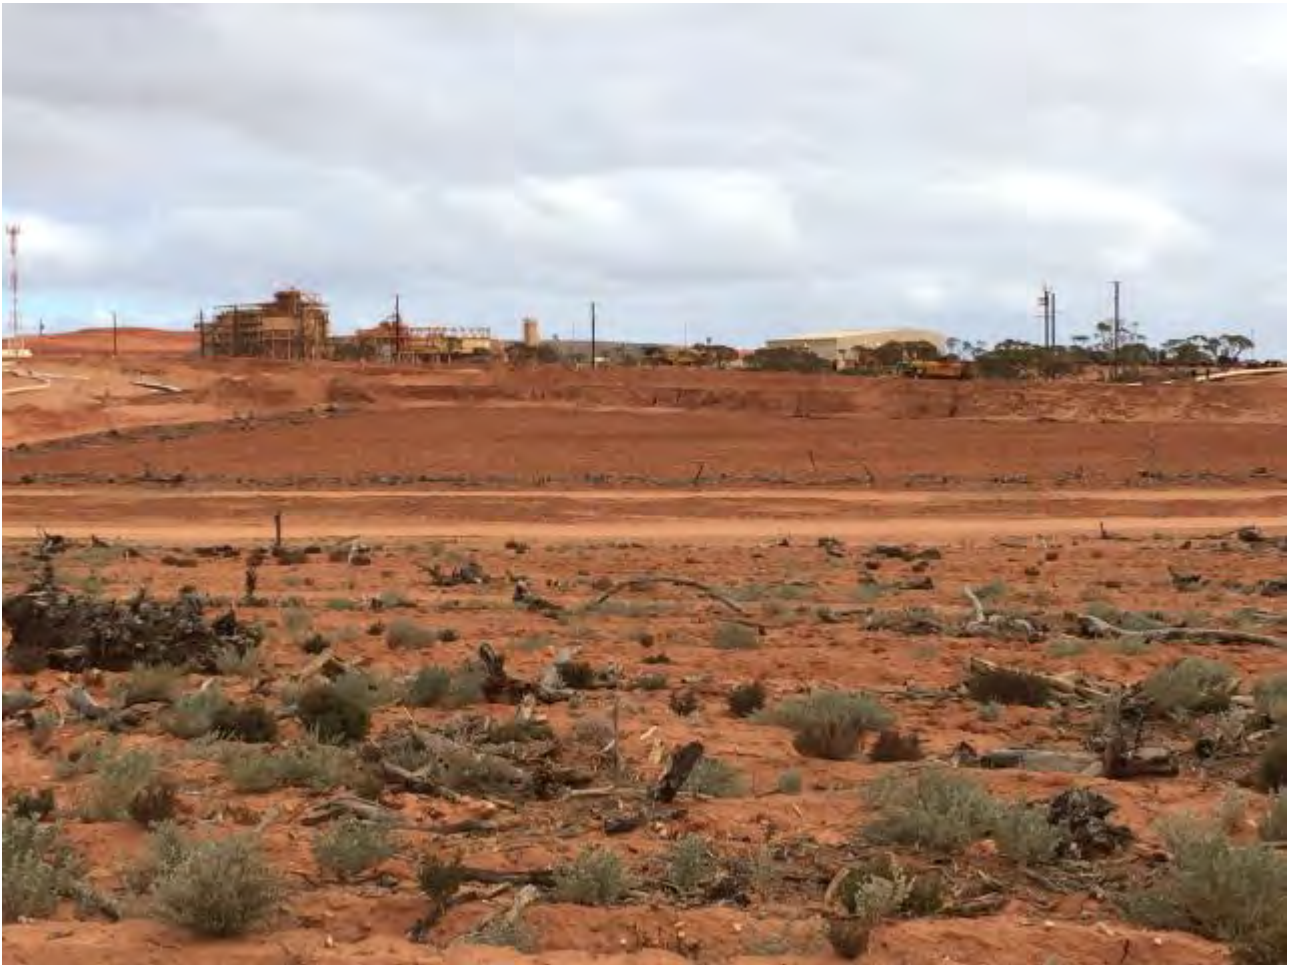
Plate A Photo of Cell 1 West taken 14/7/15 with Bay 1 in the background, Bay 10 in the foreground

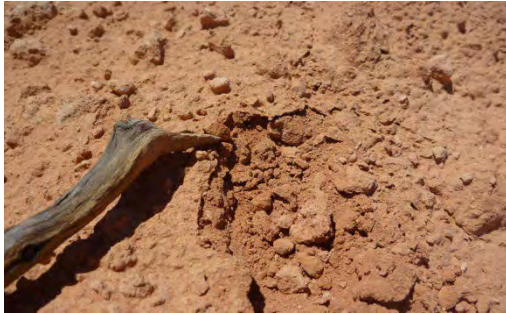
Figure 1 Class 0, no visible signs on surface or subsurface.

In addition to the traditional LFA measurements, an assessment of the successional phase of the biological soil crust (BSC) on the LFA transects was made using a method adapted from Budel et al. 2009 (Figure 1 - Figure 6). An additional category has been added, Type 0.5, where filaments are visible to the eye when the soil surface is excavated (Figure 2). Monitoring the successional recovery of biological soil crusts on rehabilitation areas adds to the understanding of how long it could take for highly disturbed BSC's to begin contributing ecosystem services such as soil stabilisation, nitrogen fixation, carbon sequestration and development of niches to capture resources.

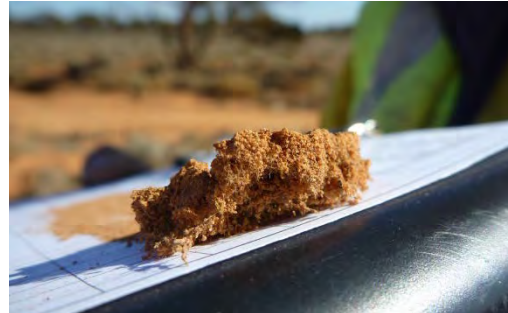
Figure 2 Class 0.5, no visible signs on surface, filaments visible subsurface

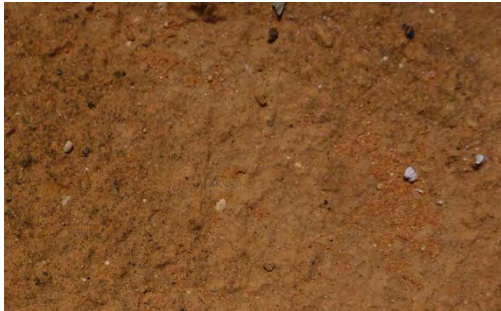
Figure 3 Class 1, light coloured, visible traces.

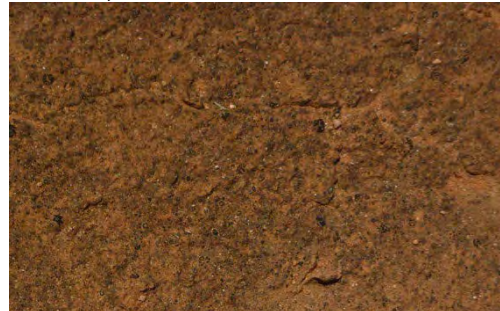
Figure 4 Class 2, light, thin, not diverse, irregular covering.

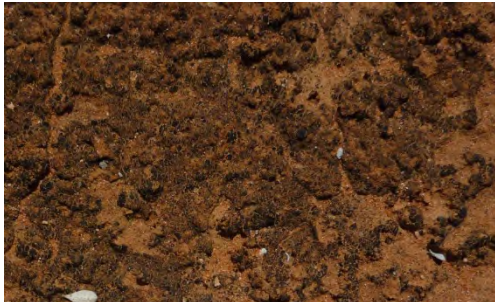
Figure 5 Class 3, dark, medium thickness, medium diversity, complete covering.

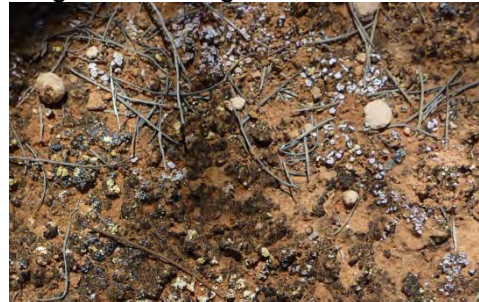
Figure 6 Class 4, dark, very thick, very diverse, complete covering. Lichen dominant, including light coloured lichens.

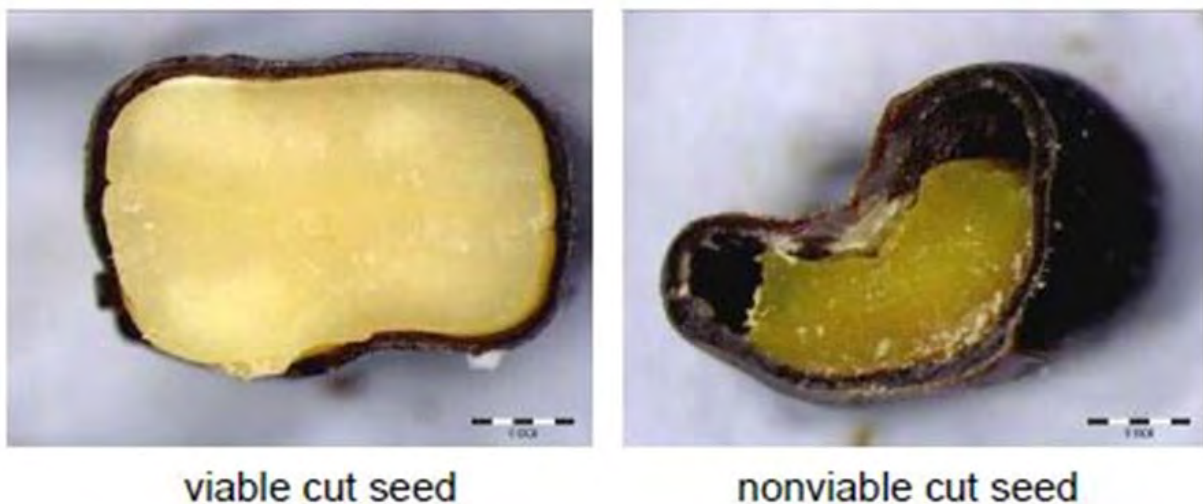
Plate 1 Examples of viable and nonviable seeds

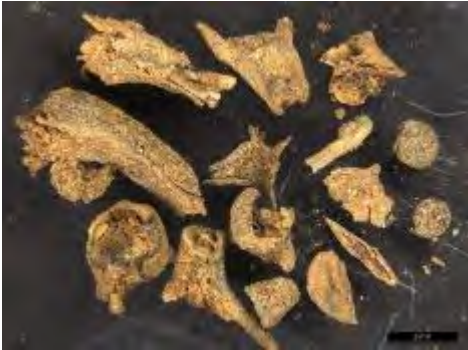
No filled seeds

Number of seeds identified per sample	Seed image	X-ray Image	Image of filled seeds after cutting
SP01D 11 seeds total 0 filled seeds

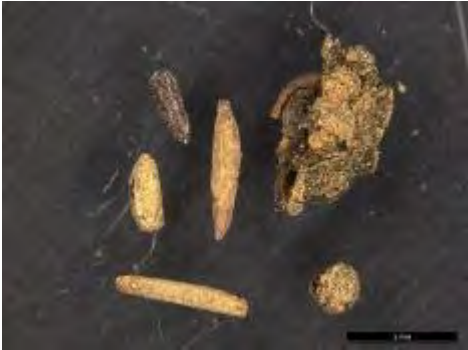
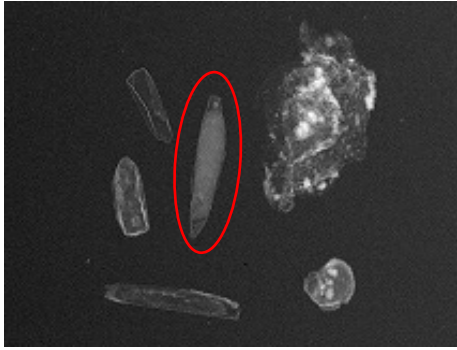
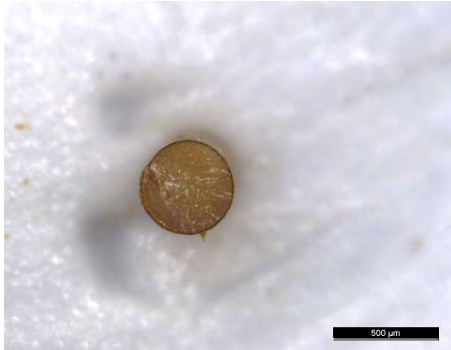
Number of seeds identified per sample	Seed image	X-ray Image	Image of filled seeds after cutting
SP7D 10 seeds total 0 filled seeds

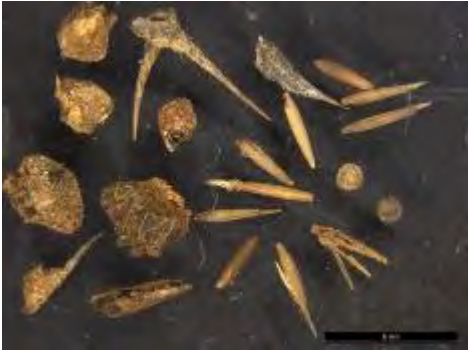
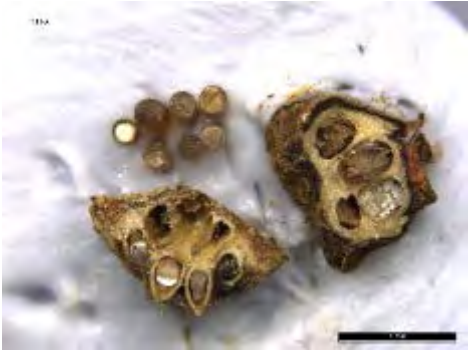
Number of seeds identified per sample	Seed image	X-ray Image	Image of filled seeds after cutting
SP8A 21 seeds total 8 filled seeds - 7 grasses - 2 Azioaceae (Tetragona sp)

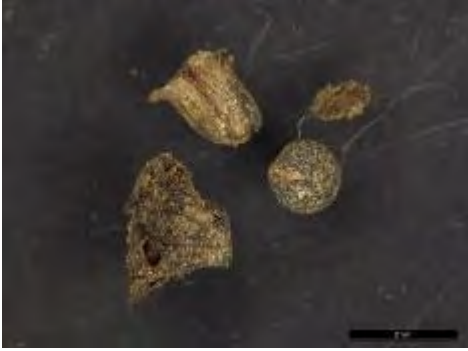
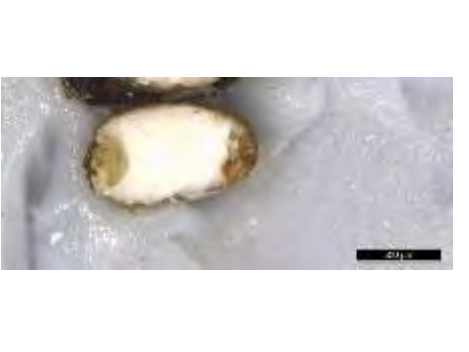
SP8C 4 seeds total 1 filled Chenopodium seed

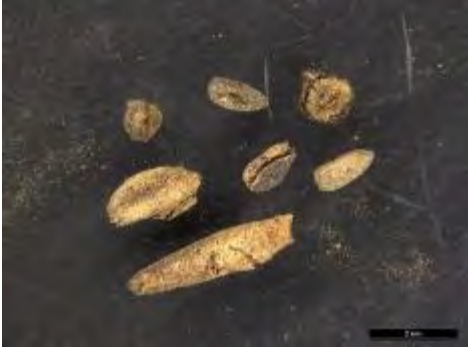
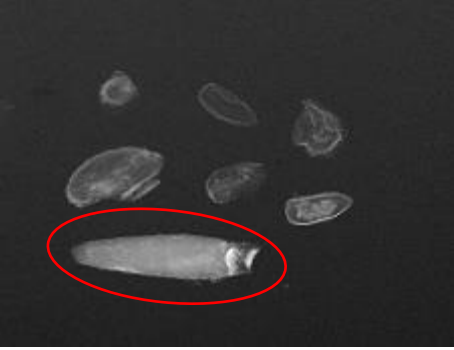
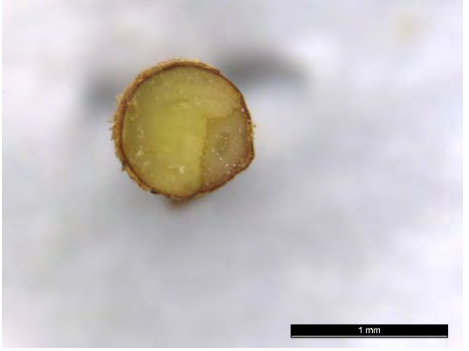
SP8D 7 seeds total 1 filled seed

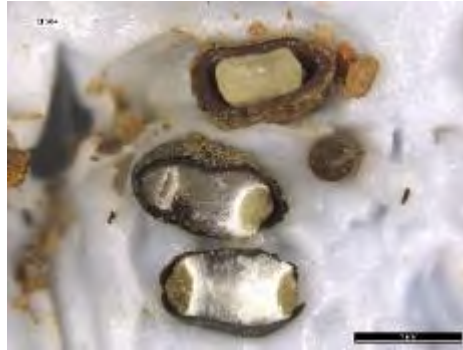
<p>Close-up photograph of SP26A seeds that have been cut open. It shows the internal contents of the seeds, which appear to be a light-colored, fleshy material. A scale bar is visible in the bottom right corner.</p>
SP26B 10 seeds total 3 filled seeds - 1 Chenopodium - 3 grass seeds

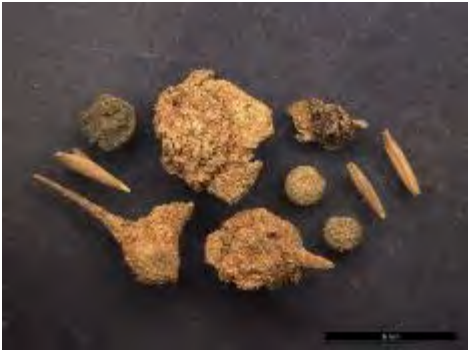
<p>Optical photograph of SP26B seeds. It shows several large, irregular, brownish clumps of sediment and several smaller, individual seeds. A scale bar is visible in the bottom right corner.</p>

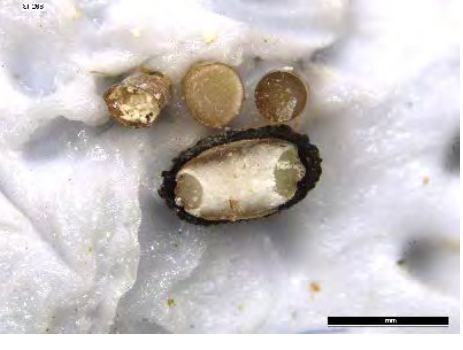
<p>Close-up photograph of SP26B seeds that have been cut open. It shows the internal contents of the seeds, which appear to be a light-colored, fleshy material. A scale bar is visible in the bottom right corner.</p>

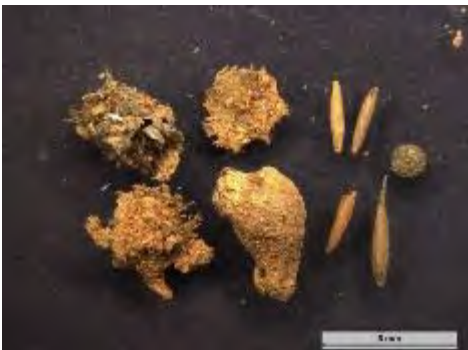
<p>Optical photograph of SP26C seeds. It shows several large, irregular, brownish clumps of sediment and several smaller, individual seeds. A scale bar is visible in the bottom right corner.</p>

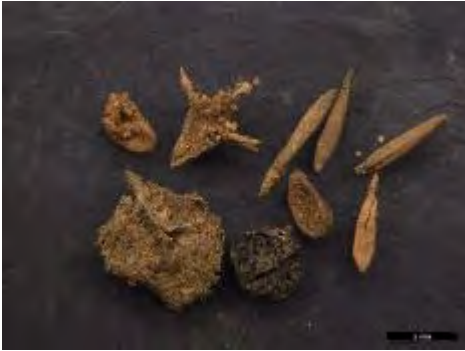
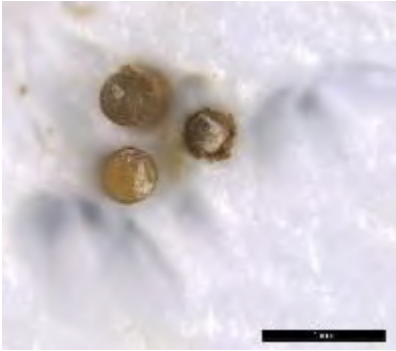
Number of seeds identified per sample	Seed image	X-ray Image	Image of filled seeds after cutting
SP26D 9 seeds total 3 filled grass seeds

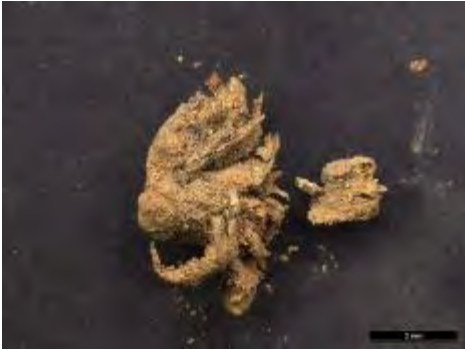
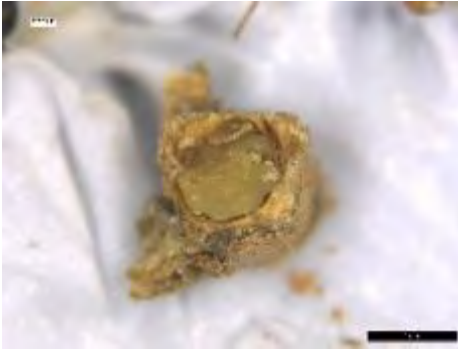
No filled seeds
SP26F 2 seeds total 1 filled Salsola seed

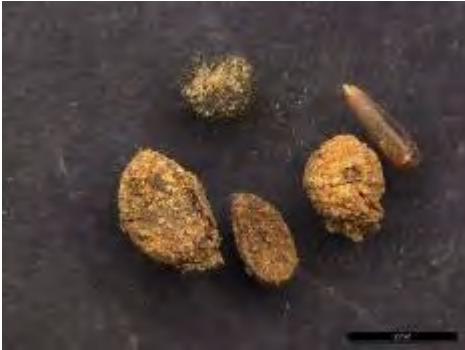
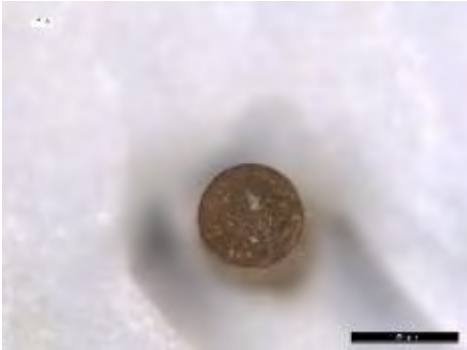
Number of seeds identified per sample	Seed image	X-ray Image	Image of filled seeds after cutting
UD1A 5 seeds total 1 filled seed

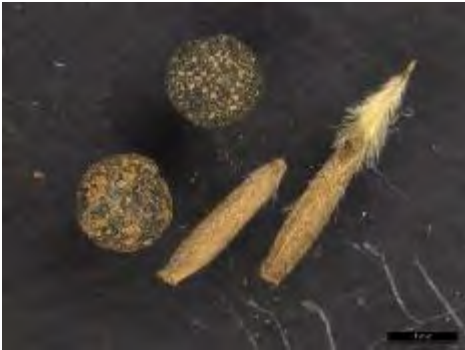
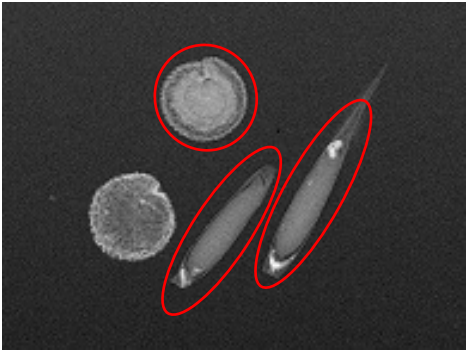
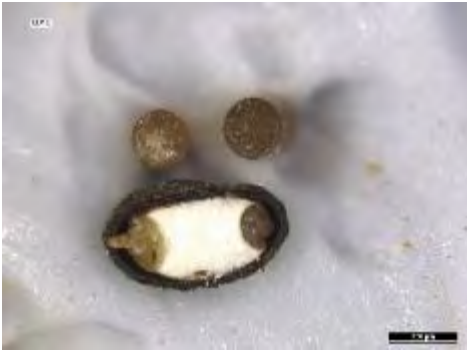
UD1B 4 seeds total 3 filled seed

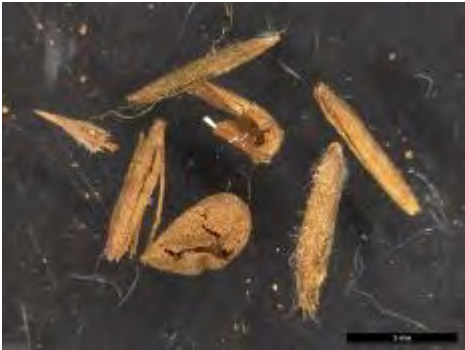
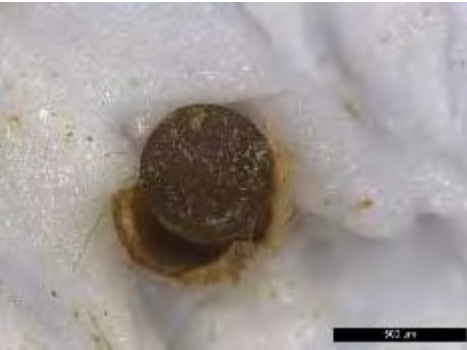
UD2A 6 seeds total 1 filled seed (grass)

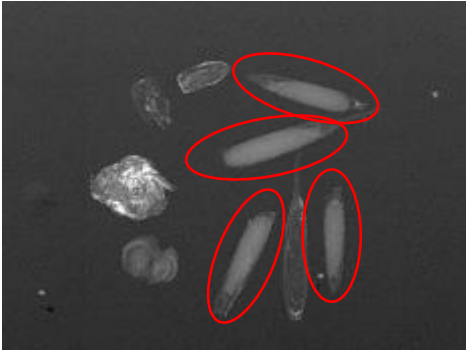
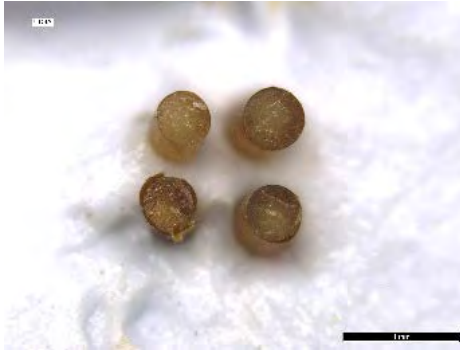
No filled seeds
UD3A 9 seeds total 4 filled seeds (grass)

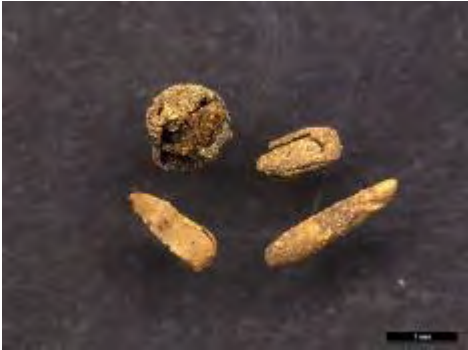
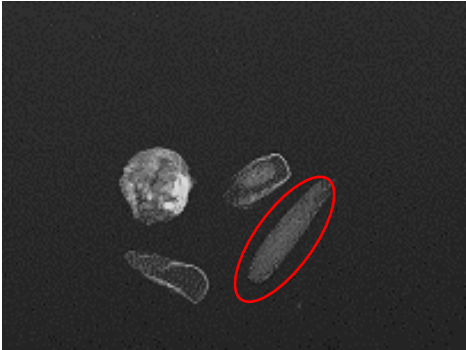
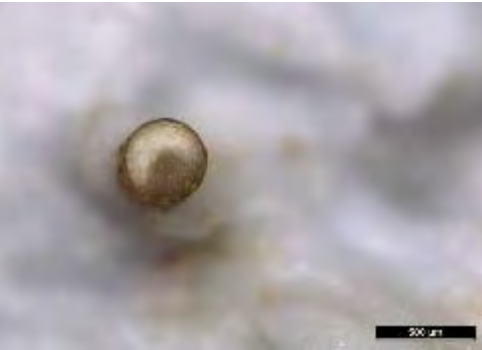
Number of seeds identified per sample	Seed image	X-ray Image	Image of filled seeds after cutting
UD3B 4 seeds total 1 filled grass seed

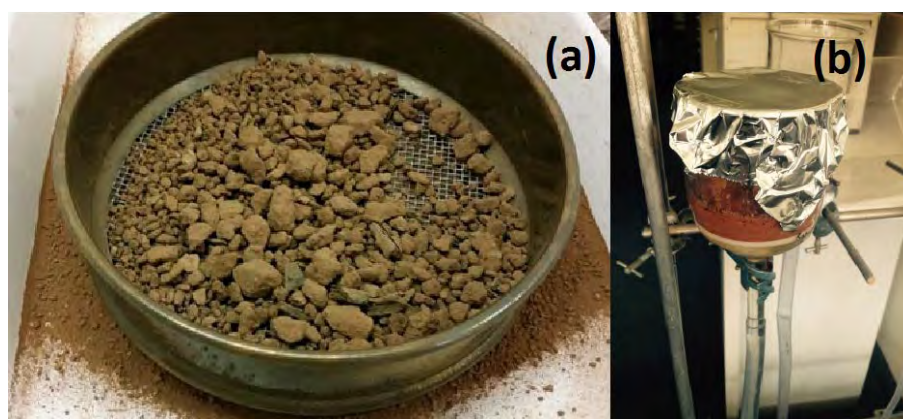
Figure 1. Soil (a) sieving and (b) water potential determination.

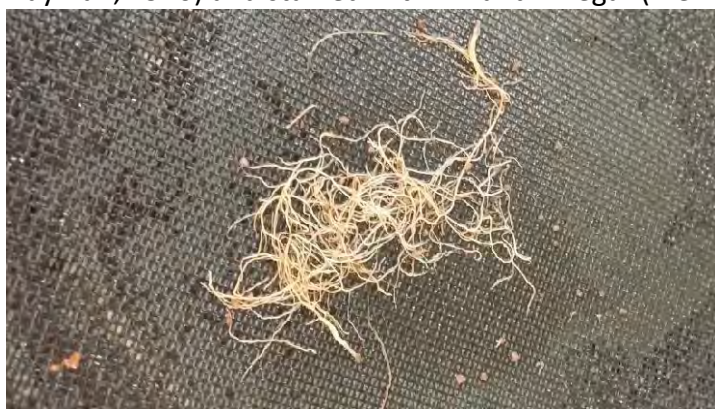
Figure 2. Roots washed from soil.

Soils were supplied to the University of Adelaide by Iluka Resources on the 30th of Sept, 2015. Samples were returned to the laboratory, weighed and sieved to remove rocks and coarse woody debris (Figure 1a). In order to grow test plants in the soil, it is first necessary to determine a suitable moisture content at which to water the plants. This is routinely set at 75% of water holding capacity (WHC). Ideally WHC is determined for each soil sample separately, but due to small sample sizes (~800g/sample), it was necessary to determine WHC on a composite soil sample made up of a sub-sample collected from all soil samples. Fortunately all soils were of a similar texture, and consequently WHC would be similar for all of the soils. The WHC was determined using a sintered glass funnel connected to a 100 cm water column ($\Psi_m = -10$ kPa) (Figure 1b). Soil was packed in the glass funnel to a bulk density of 1.4 g/cm³, saturated with water and allowed to drain for 48 hrs and weighed. The soil was then dried at 105 °C for 48 hr and gravimetric moisture content calculated. The gravimetric moisture content at field capacity was 0.14 g water g⁻¹ dry soil. Plants were watered during the growth phase of the study to 75% of WHC (i.e. 0.11 g water g⁻¹ dry soil).

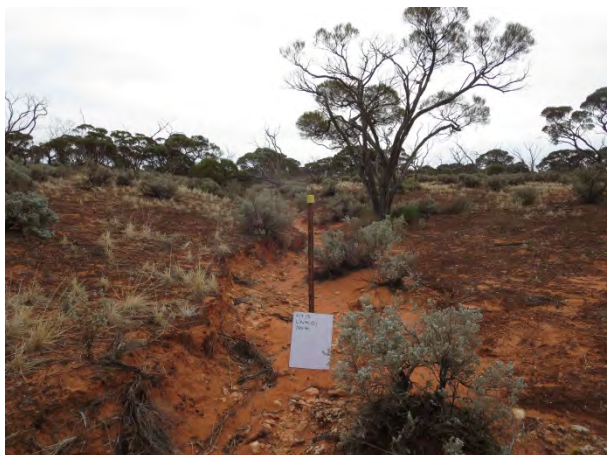
Figure 2 LWM001 photopoint facing north 2/5/2015

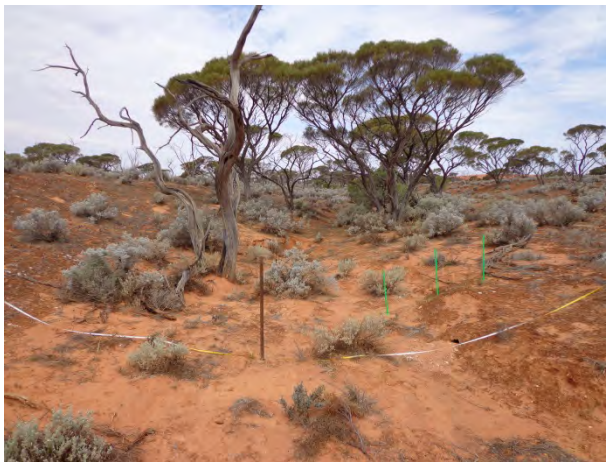
Figure 7 LWM002 Photopoint facing west 25/11/2015

River Style: Interdunal bank confined gully
Vegetation Association: myall/mallee woodland

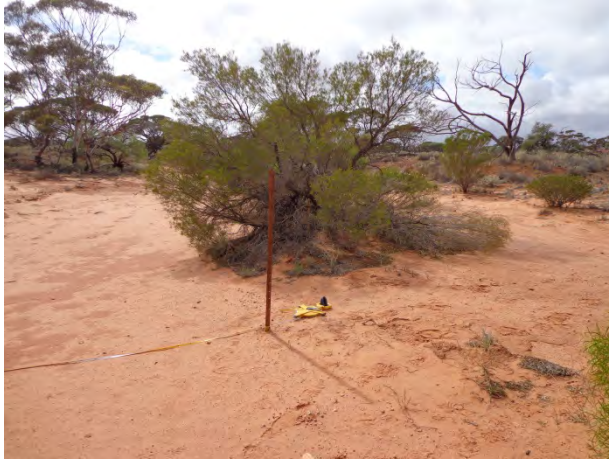
Figure 12 LWM003 photopoint facing west 26/11/2015

River Style: Interdunal bank confined channel
Vegetation Association: mallee woodland

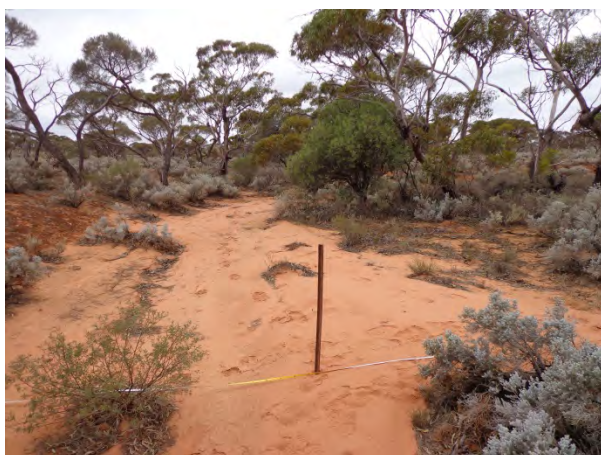
Figure 17 LWM004 photopoint facing east 26/11/2015

River Style: Interdunal wandering

Vegetation Association: mallee woodland

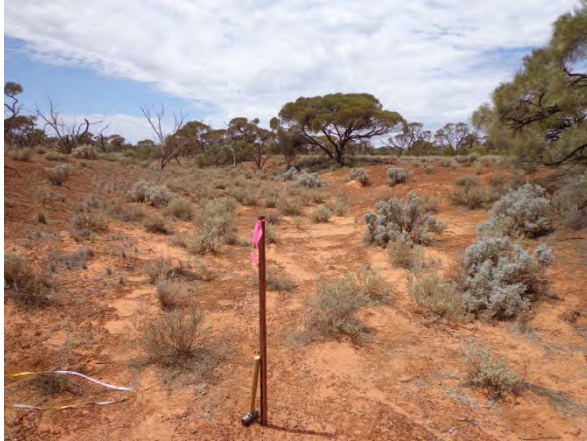
Figure 22 LWM005 photopoint facing east 27/11/2015

River Style: Interdunal bank confined channel
 Vegetation Association: myall/mallee woodland

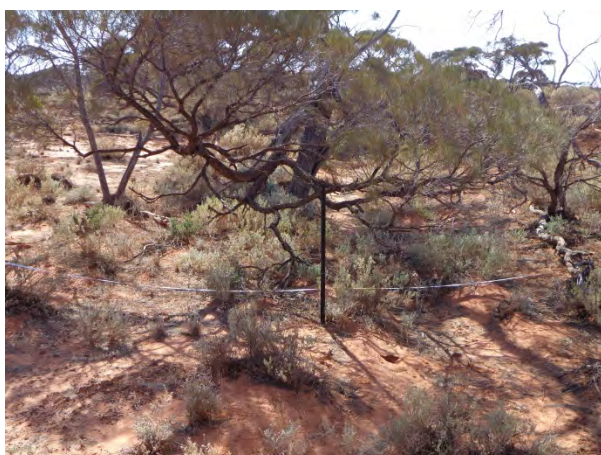
Figure 27 LWM006 photopoint facing east 30/11/2015

River Style: Interdunal wandering

Vegetation Association: myall/mallee woodland

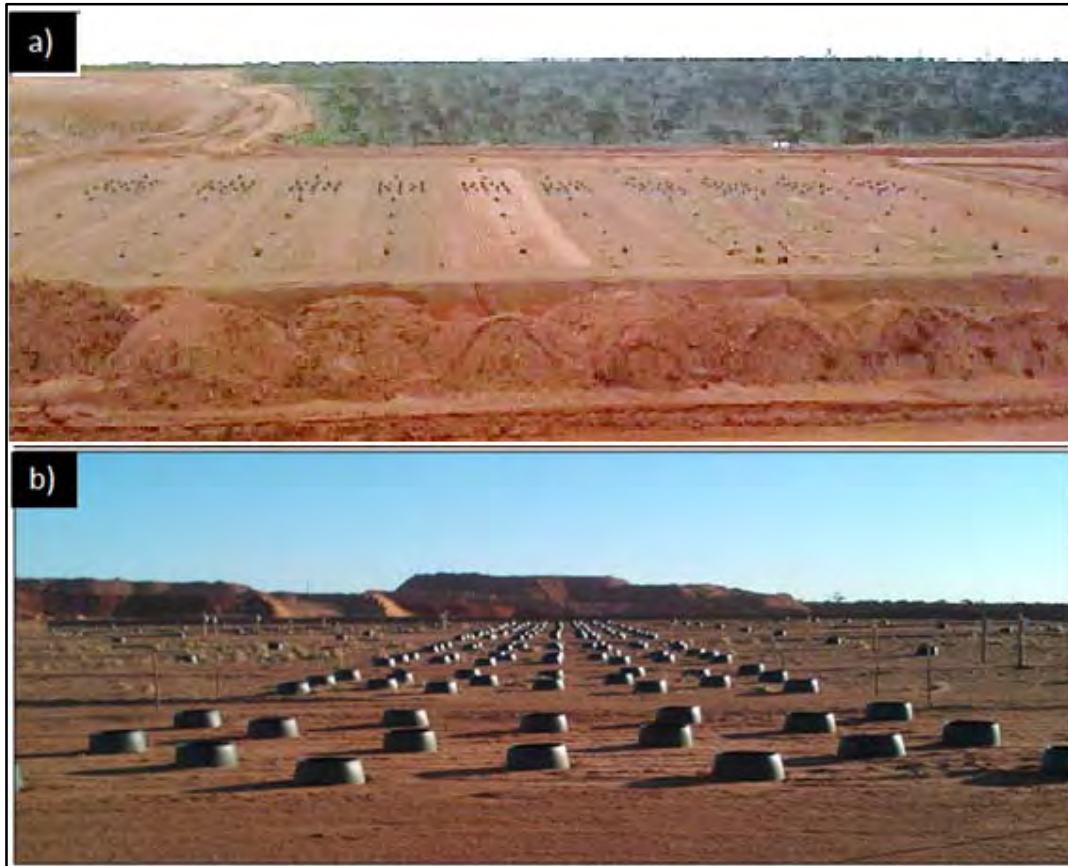
Figure 8: a) Facing north across the Cell 1 Trial. The reconstructed soil profiles are seen as strips running north-south. b) Facing west across the trial. The wells on the left and right edges contain the four month harvest seedlings.

Seedlings were planted between the 9th and 13th of May 2014. Nursery bags were removed from the plants with scissors to minimise shock and the visible root morphology of each seedling was photographed before planting. Each well was watered with nine litres of potable water after planting. Watering wells helped to maintain consistency between treatments when watering, as each plant received four additional litres of potable water every fortnight. This was necessary to ensure seedling survival due to the extremely low rainfall received at the site post planting and throughout the duration of this experiment.
