Jacinth-Ambrosia Mineral Sands Mine Annual Compliance Report 2019

28 April 2020

This Annual Compliance Report (ACR) for the compliance reporting period 1 January – 31 December 2019 has been prepared to comply with the conditions of the mineral tenements (granted under the provision of the *Mining Act 1971*) associated with the Iluka Resources Ltd (Iluka) Jacinth-Ambrosia (J-A) mining operations.

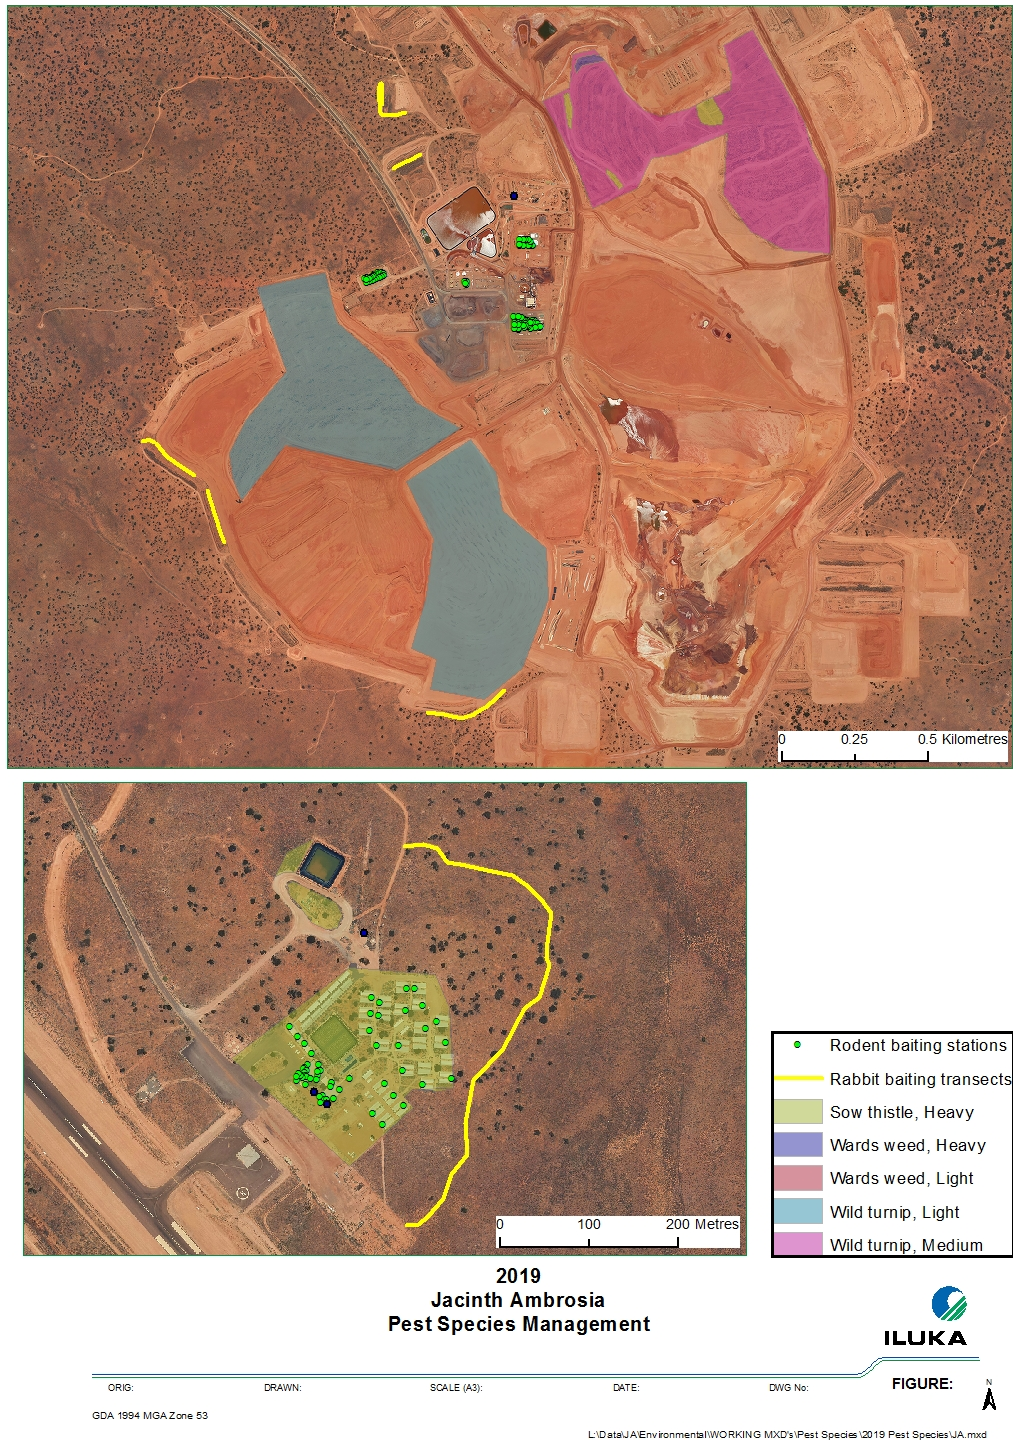
Figure 1: Distribution of weeds and pest species control points at J-A as recorded in 2019.

There were a total of 6 weed species recorded and managed in lease areas during the reporting period (Table 4). The most abundant weed species were long-fruited wild turnip (*Brassica tournefortii*), warden weed (*Carrichtera annua*), false sow thistle (*Reichardia* sp.) and milk thistle (*Sonchus oleraceus*). These species were more prominent in low lying areas where water pooling occurred and soil moisture was greater; which in turn were a focus for weed management. Following the previous years below average rainfall, 2019 was significantly lower than the long term average, with a total of 82.8mm recorded on site, which limited the growth of weed species.

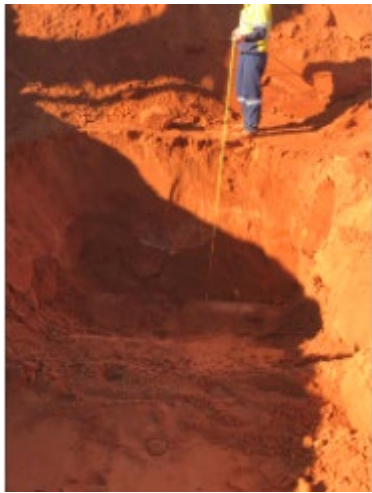
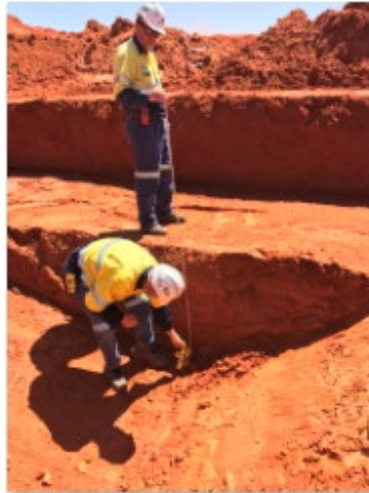
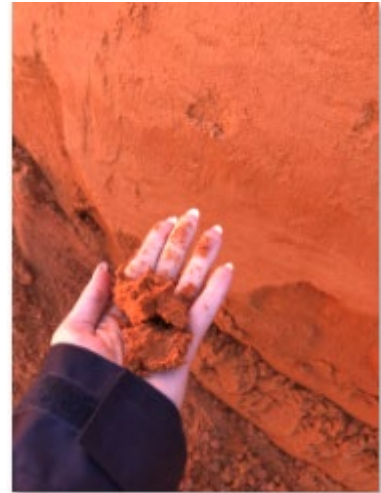
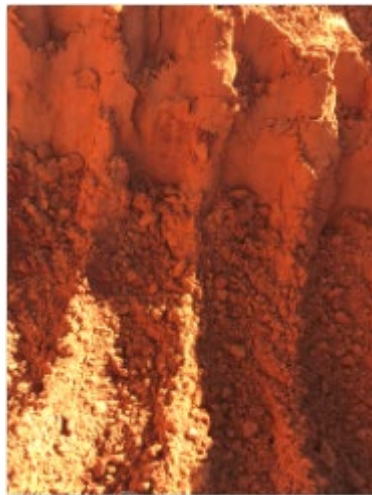
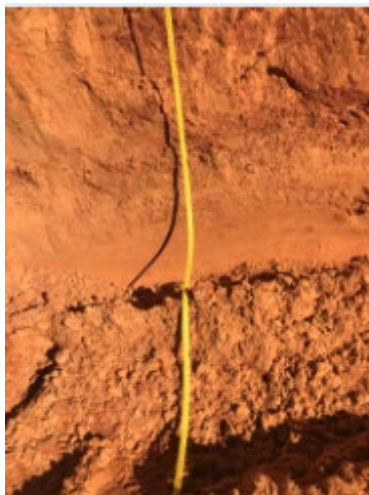
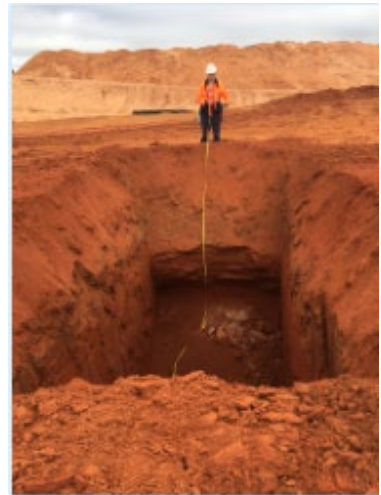
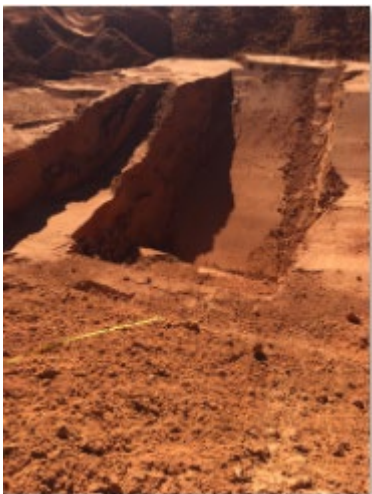
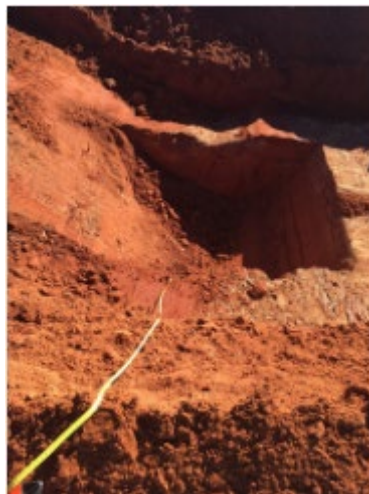
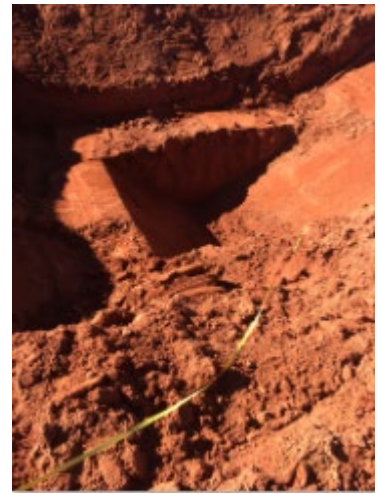
Test pits were excavated on the Cell 2 and Cell 3 A rehabilitation surface. Twenty four test pits were dug into tailings sand at the final profile (Figure 2). All test pits were visually inspected and photographed and confirmed that the phreatic surface was greater than 2.1 m from top of tailings surface.

No phreatic test pits showed any evidence of a phreatic surface, photos of the pits tested are shown in Plate 1 to Plate 9.

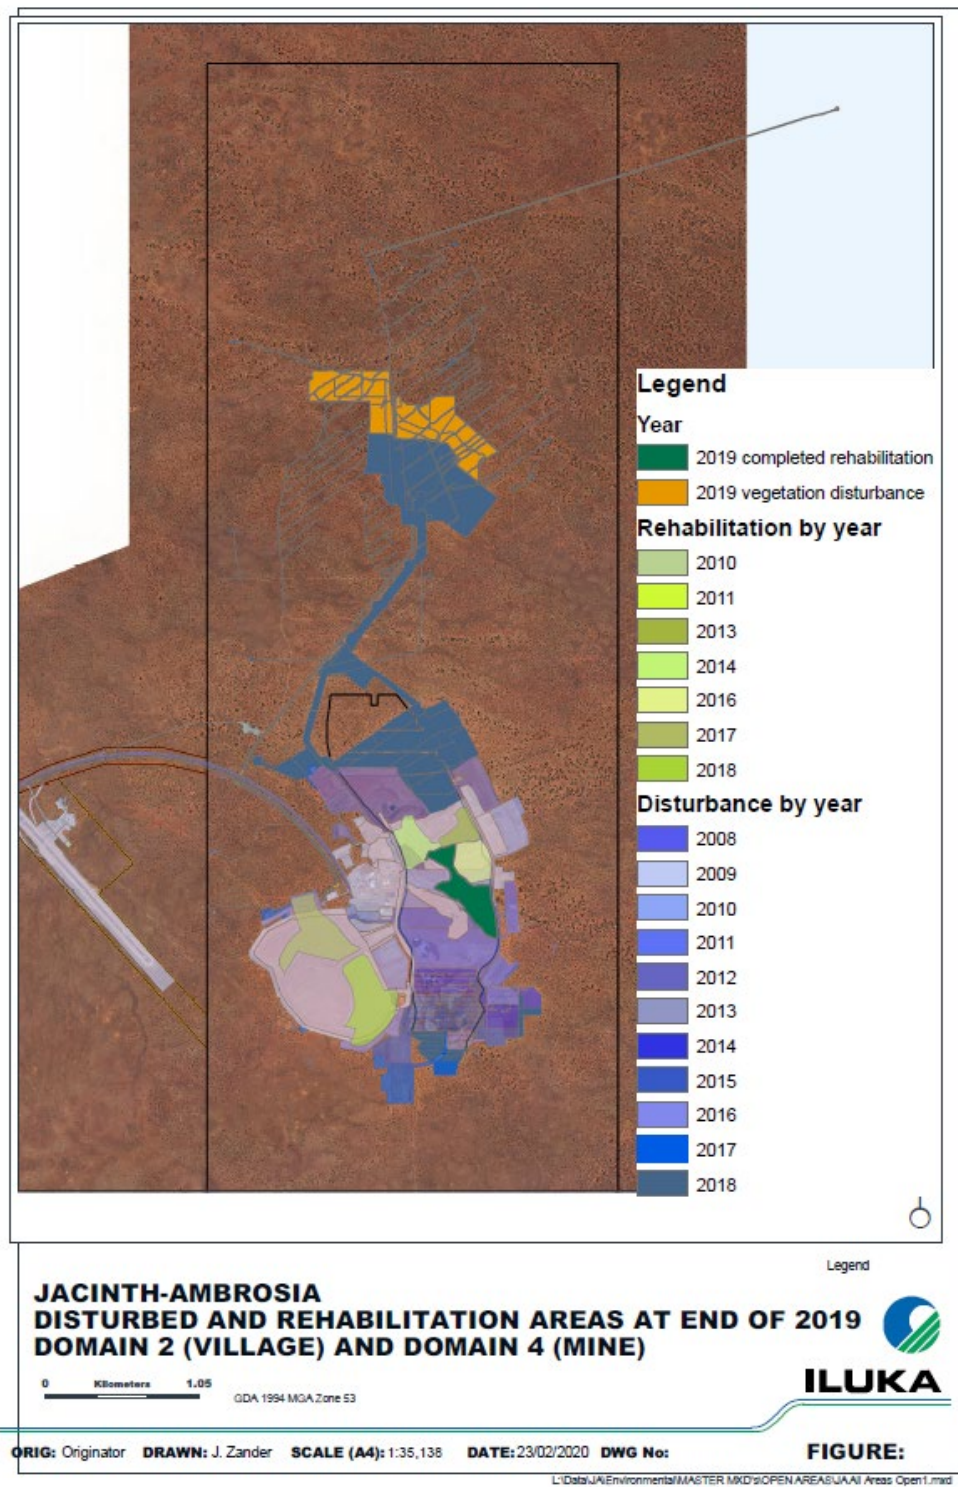
Figure 3: Disturbed and rehabilitated areas at end of 2019.

All vegetation clearance occurred within authorised boundaries as shown in Figure 3.

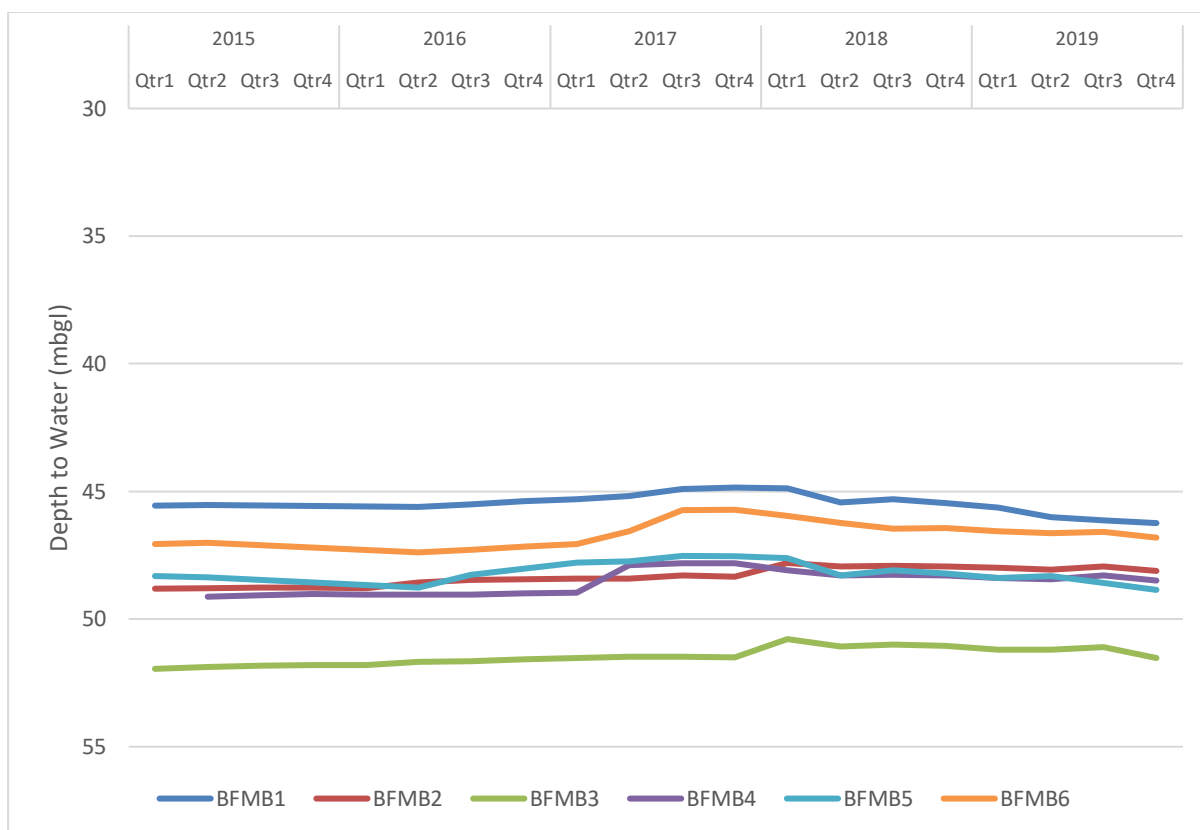
Figure 4: Standing water level (in mAHD) of borefield monitoring bores (BFMB01 to BFMB06)

Hydrographs of the SWL's at the borefield monitoring bores is shown in Figure 4. Water levels have been fairly stable throughout 2019 but show a drop from the general increasing trend evident from 2016. This change is likely due to recommencement of operations and increased drawdown on the borefield aquifer.

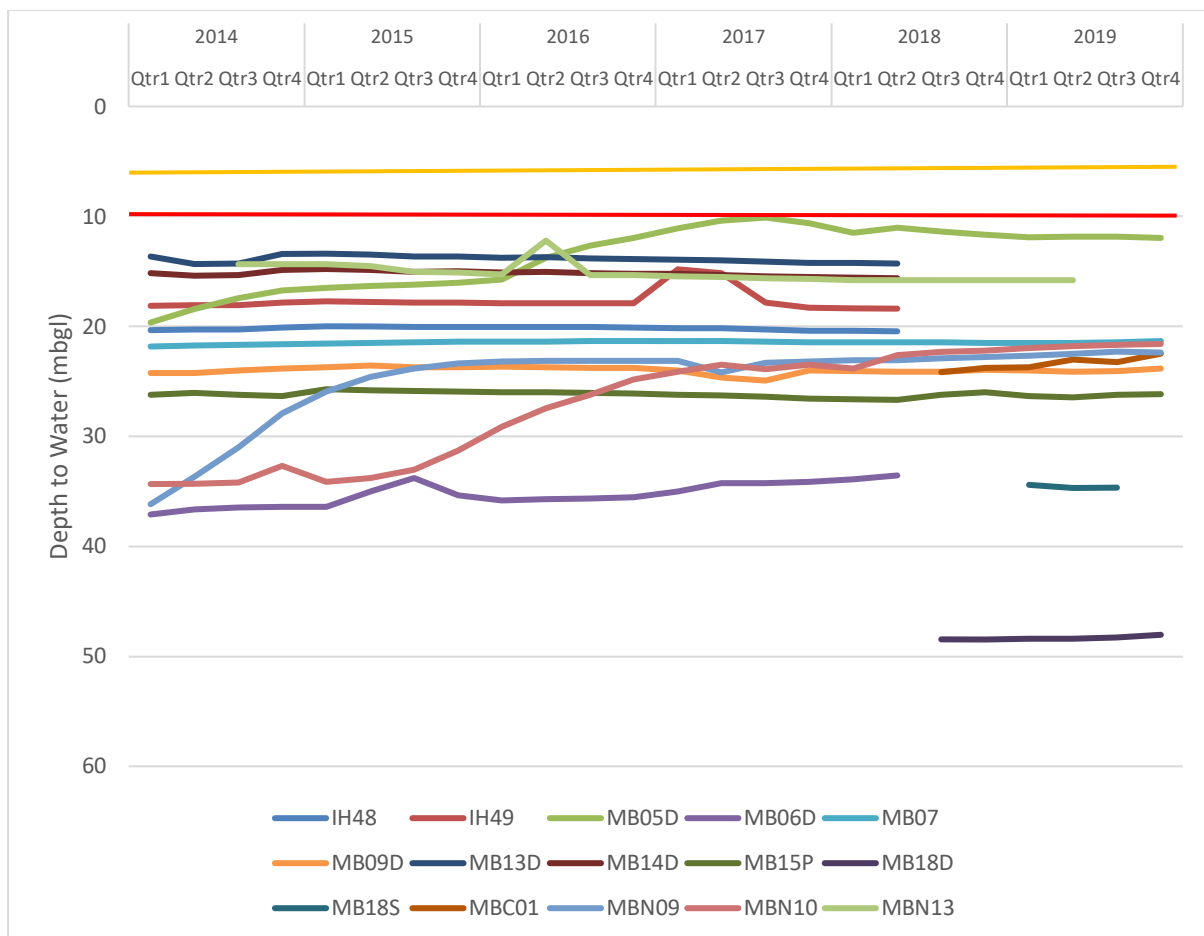
Figure 6: Depth to water level (m BGL) at mine working zone bores at Jacinth Pit North area.

Within the mine workings zone, SWLs were monitored at 39 wells located on a monthly basis in 2019. Although monthly SWLs for a number of wells were missed all water levels within the zone were above the safe trigger level and compliance of the outcome achieved (see Figure 6 to Figure 9).

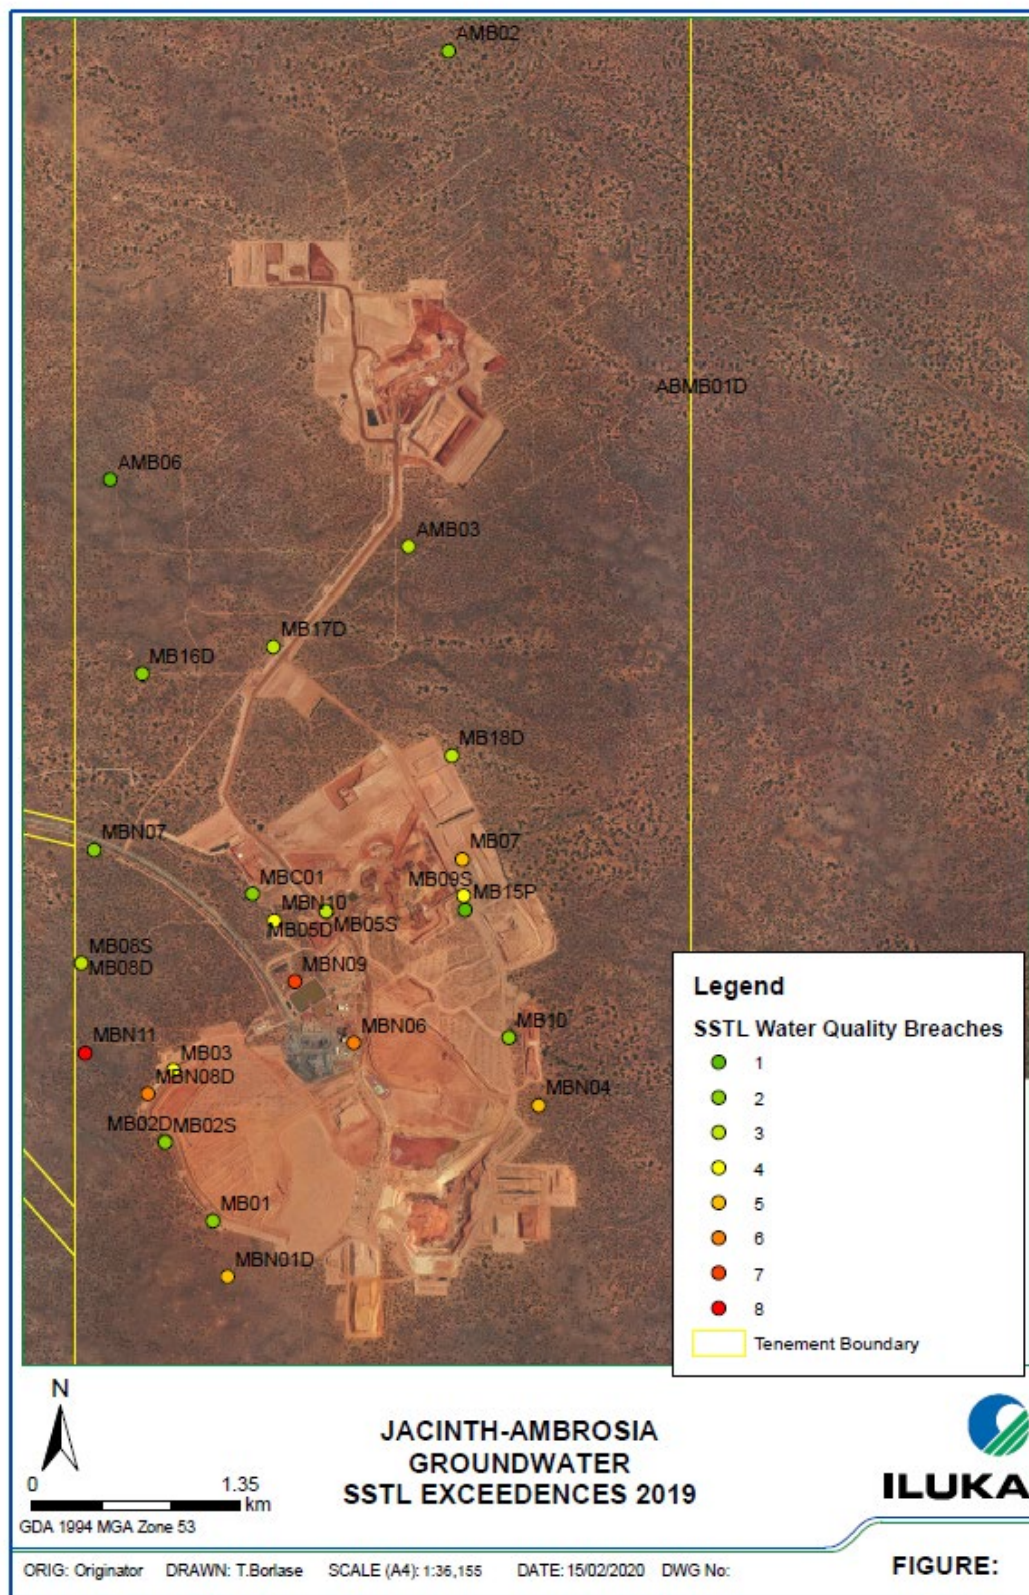
Figure 10 Groundwater Chemistry SSTLs Exceedences

The SSTLs were triggered on 108 occasions resulting in a non-compliant outcome. Despite being identified as non-compliance with the PEPR, the groundwater geochemistry results do not indicate any impact to groundwater quality outside the mine working area (LWC, 2018). It should also be noted that 11 of these non-compliant results were from recently installed background monitoring wells for the Ambrosia deposit, where there is no impact from mining activity and the results are thereby indicative of background water quality. A map showing the location of the monitoring wells with results above the SSTLs is shown below in Figure 10, noting that these are only the wells in which exceedances were recorded and the colour gradient shows the number of analytes breached; details on specific analytes for each well are below in Table 14.

A review of measurement criteria suitability is currently being undertaken in consultation with Department for Energy and Mining (DEM).
