Quarterly Compliance Report

1st April to 30th June 2015

Penrice Quarry & Mineral

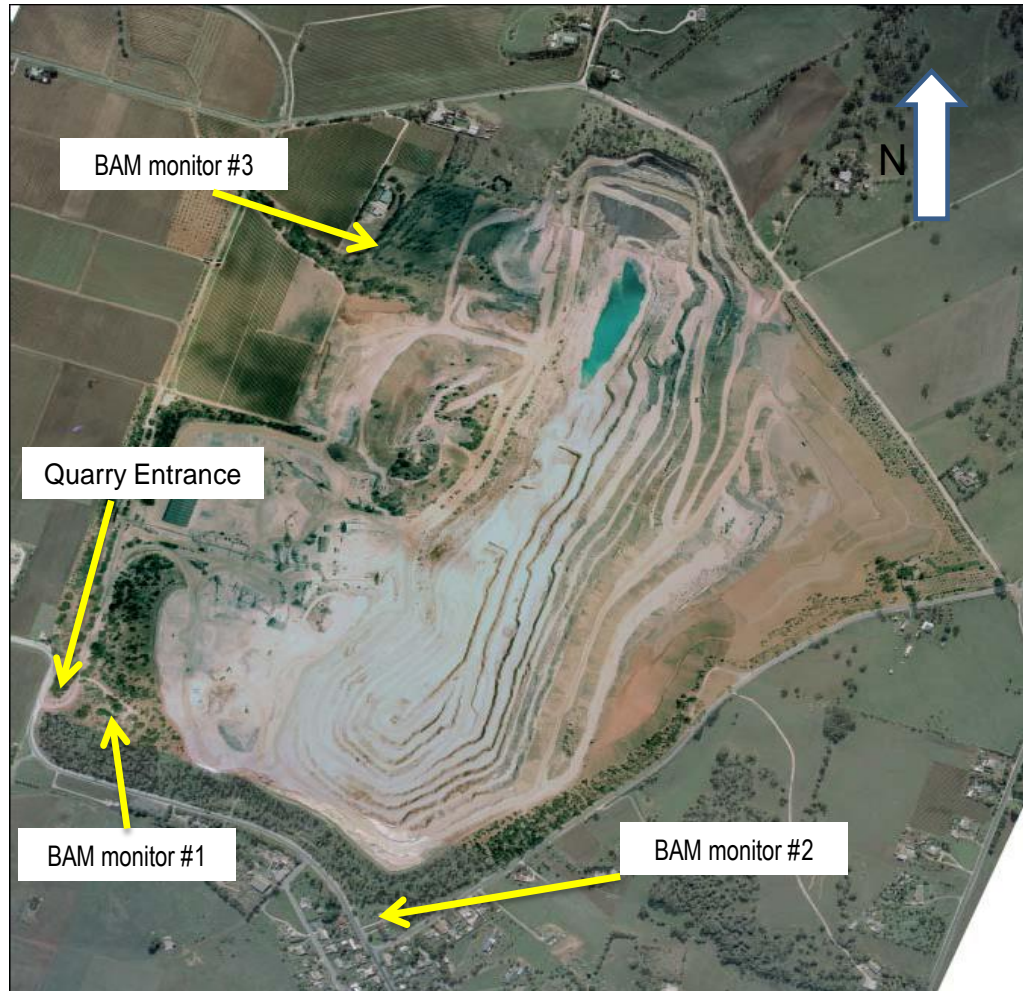
Appendix B – BAM Monitor Locations

- BAM unit locations are shown in Appendix B
- BAM unit data showing the 24hr daily mean for the reporting period is attached in Appendix C. Data is missing from BAM 1, due to modem issues during the period.

BAM Dust Monitor Locations

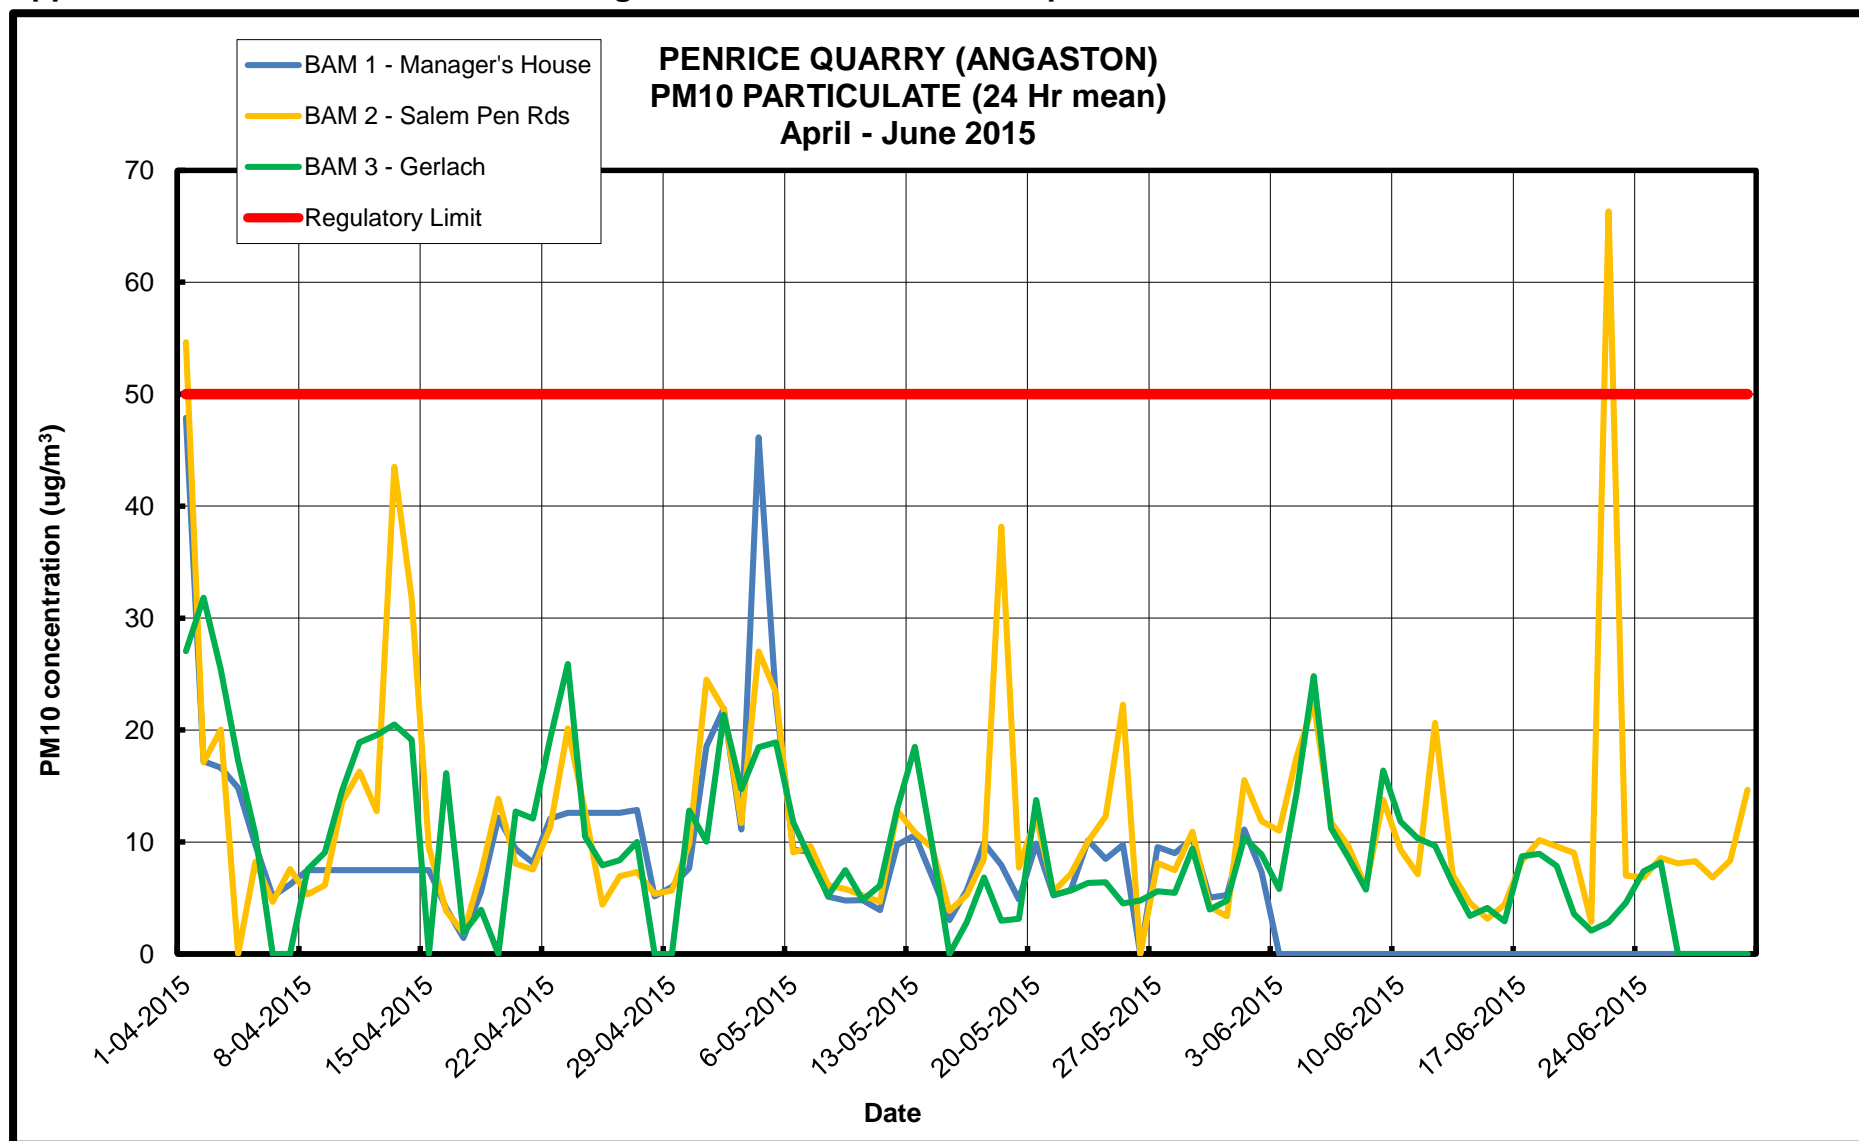
Appendix C – BAM Monitors 24hr Average PM10 Concentration 1st April 2015 – 30th June 2015

- Three PM10 24hr average notifications were provided to both DSD and EPA for the period. All of these notifications were deemed to be from sources external to the quarry:

- 1st April 2015 – BAM 1 and 2 exceedance due to nearby council work on Penrice Road and vineyard works (removal of vines and re-planting) directly opposite Quarry Entrance

- 5th May 2015 – BAM 1 exceedance due to vineyard works directly opposite Quarry Entrance
 - 22nd June 2015 – BAM 2 exceedance due to localised burning of green waste in the vicinity of BAM 2. Notification of this exceedance was provided on the 5th August 2015, due to BAM units not uploading data and SMS notifications not received. This has been rectified by setup of SMS notification, when no data has been received for 24 hours.
