CPSAN14 SEISMIC SURVEY
2014 MOOMBA NORTH MICRO SEISMIC

ACQUISITION REPORT

Compiled by: A. White
Santos Ltd.
15TH January, 2015

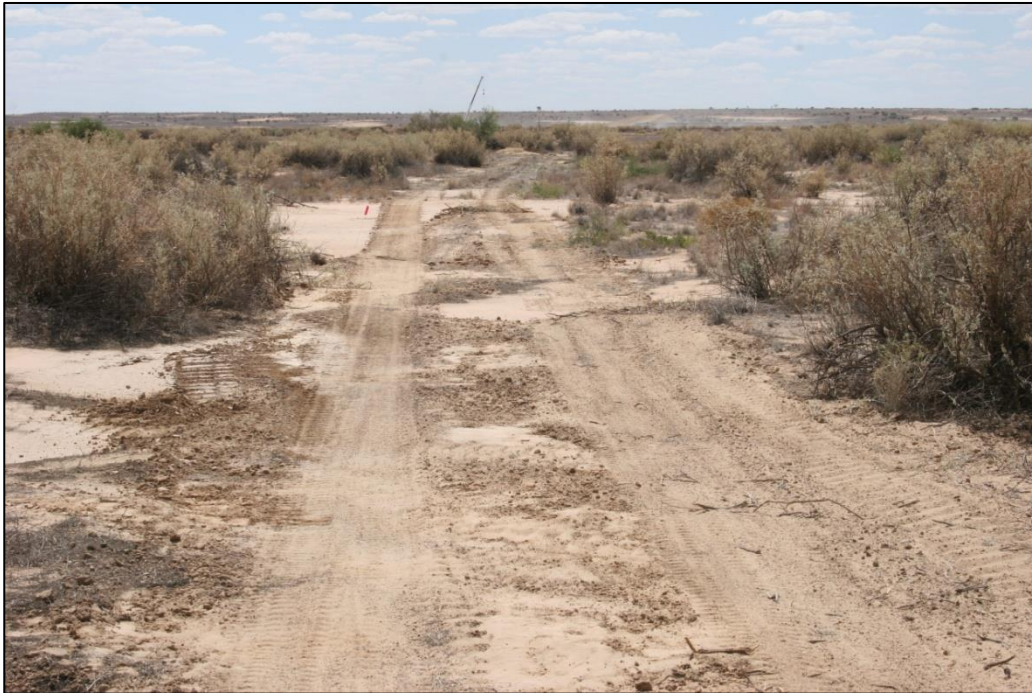
Photo 1: CPSAN14-04 Stn 1022 Looking west (towards well)

Due to the small area of the prospect there was a little variety in the terrain and vegetation encountered during the Moomba North Micro Seismic survey. The majority of the prospect was flat crabhole floodplain country with a moderate covering of saltbush, small shrubs and grasses. There were areas of dune field terrain in the north east, north and north west. The dune field terrain had occasional whitewood trees, smaller shrubs (e.g. marpoo) and light grasses.

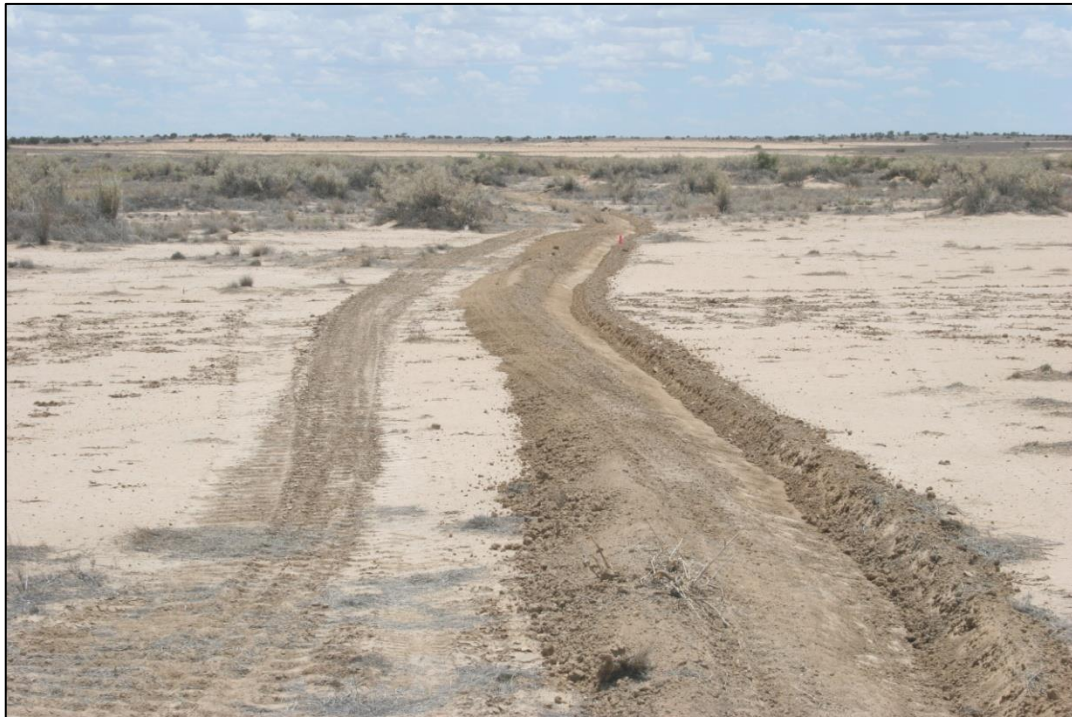
Photo 3: Example of geophone trench on CPSAN14-02
