# **CPSAN15 SEISMIC SURVEY**

## **2015 DELAWARE 3D**

**PEL 570  
AAL 231**

# **ACQUISITION REPORT**

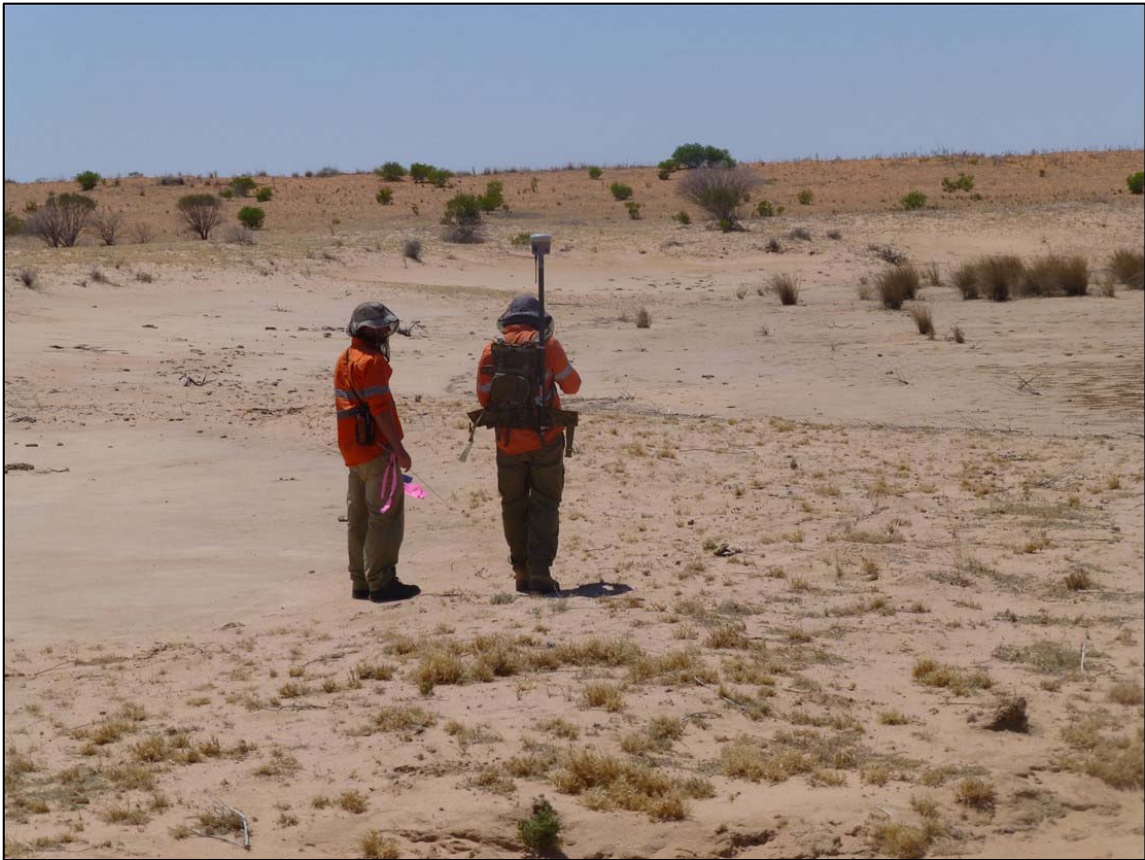
**Survey staff using the Trimble R10 GPS back pack to survey the hand carry sections on receiver lines**

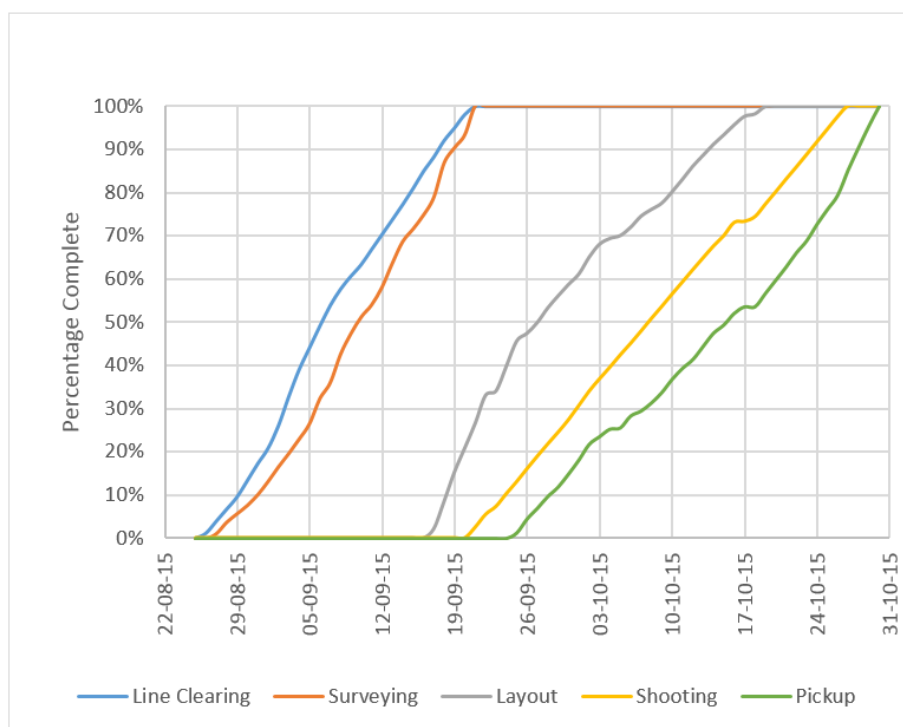
Figure 3 Cumulative daily production chart, for advance and recording crews.

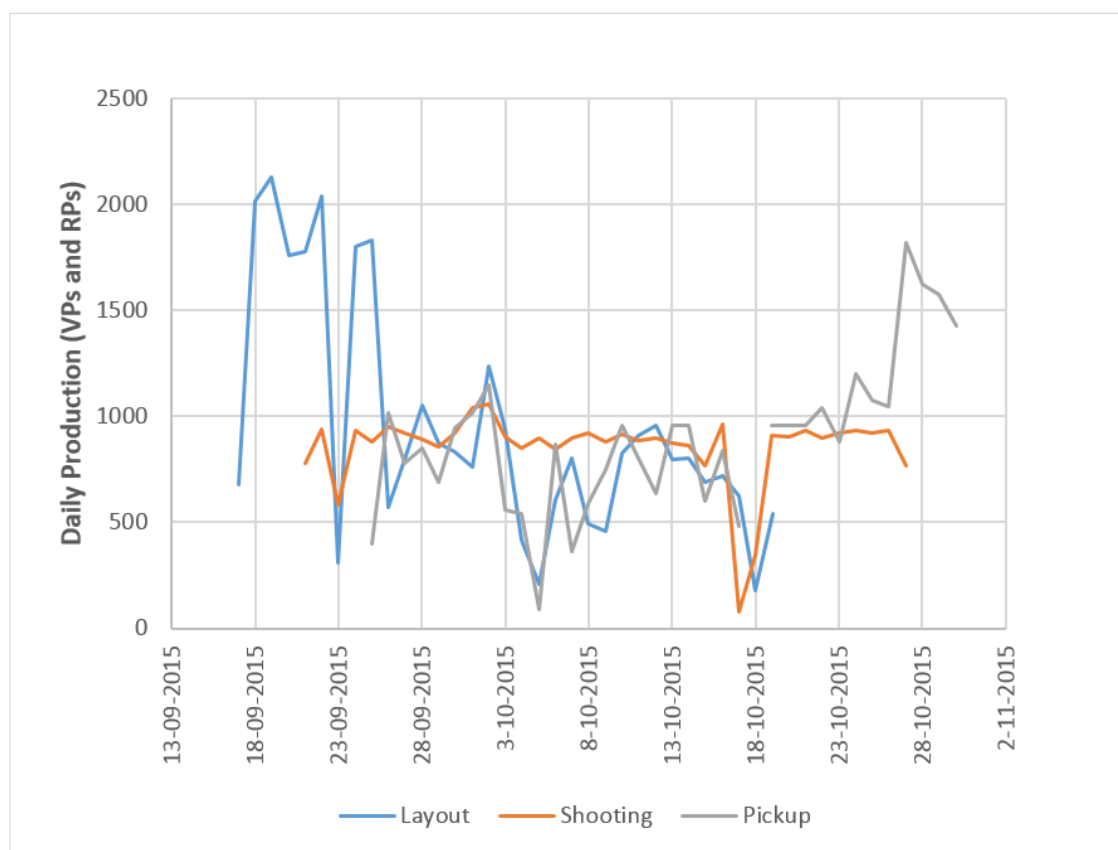
Figure 5 Acquisition daily production rate chart.

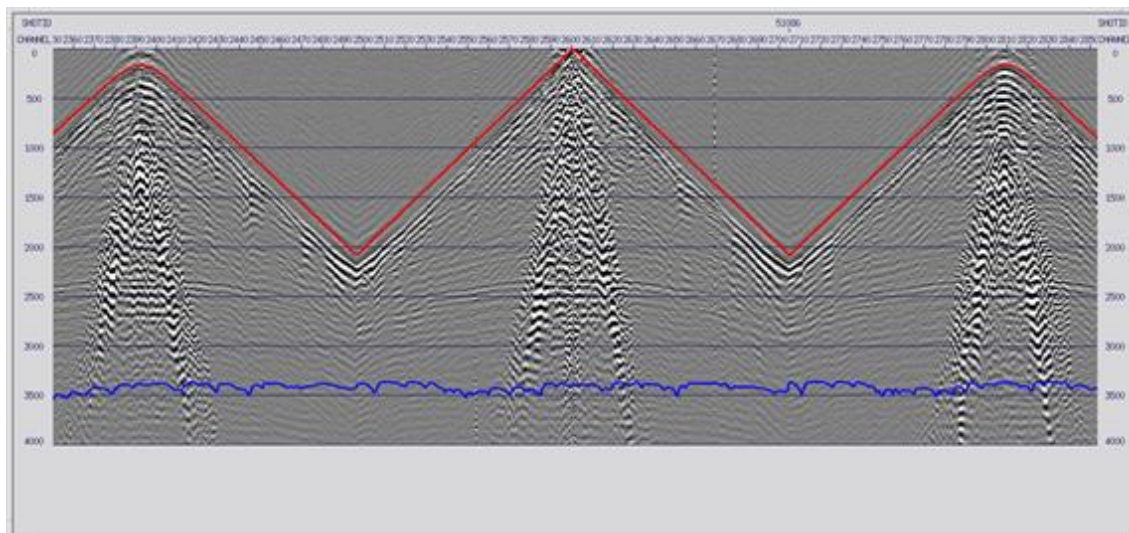
Figure 16 Near offset geometry check (FFID50844)

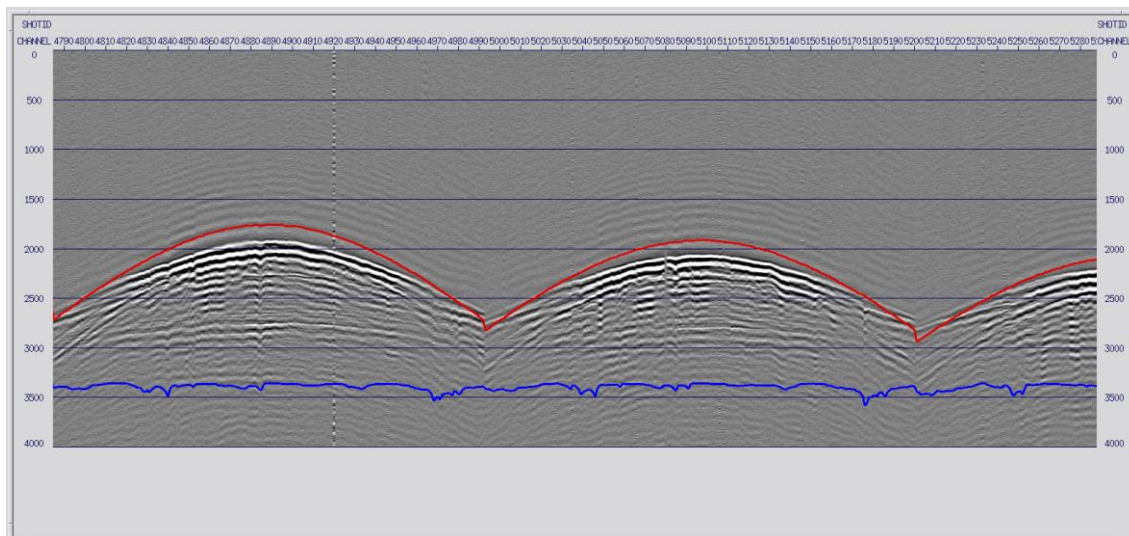
Figure 17 Far offset geometry check (FFID50844)

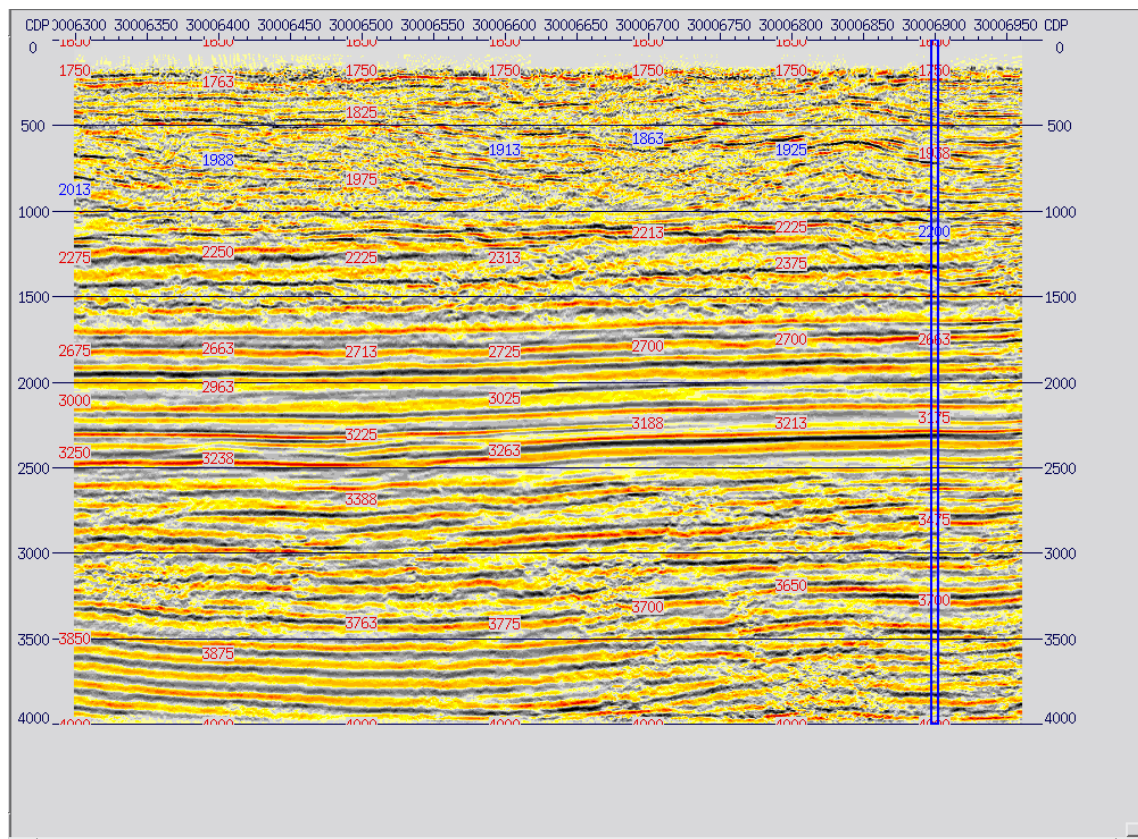
Figure 23 Stack window showing CDP picking

Velocities are picked interactively, by examining a range of analyses, as shown in the examples in Figure 23 and Figure 24.

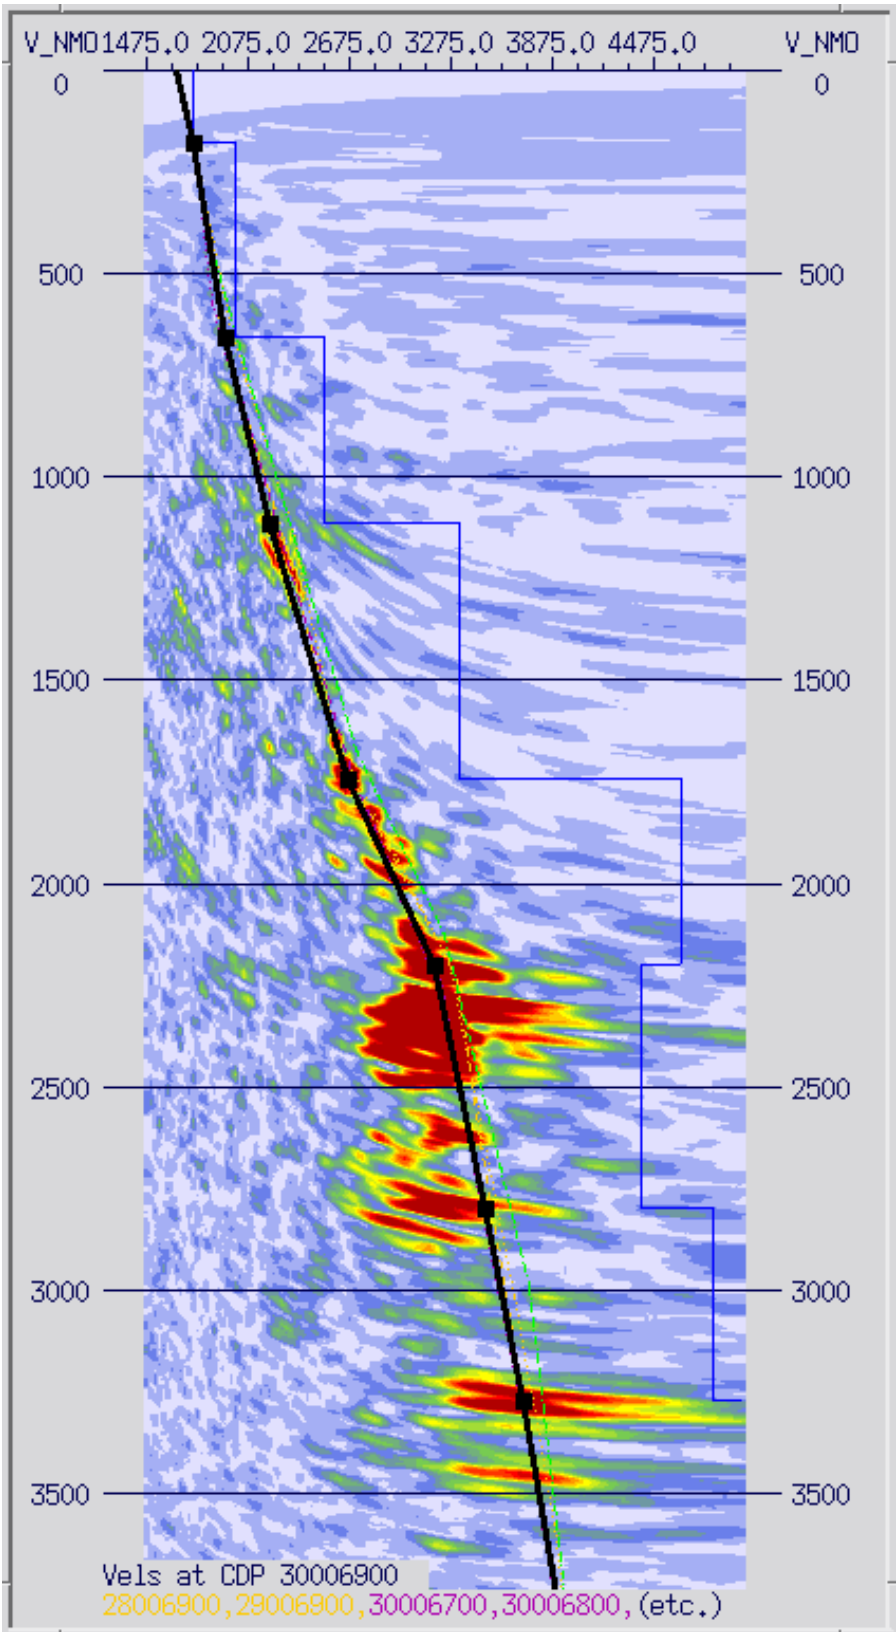
Figure 24      Semblance window

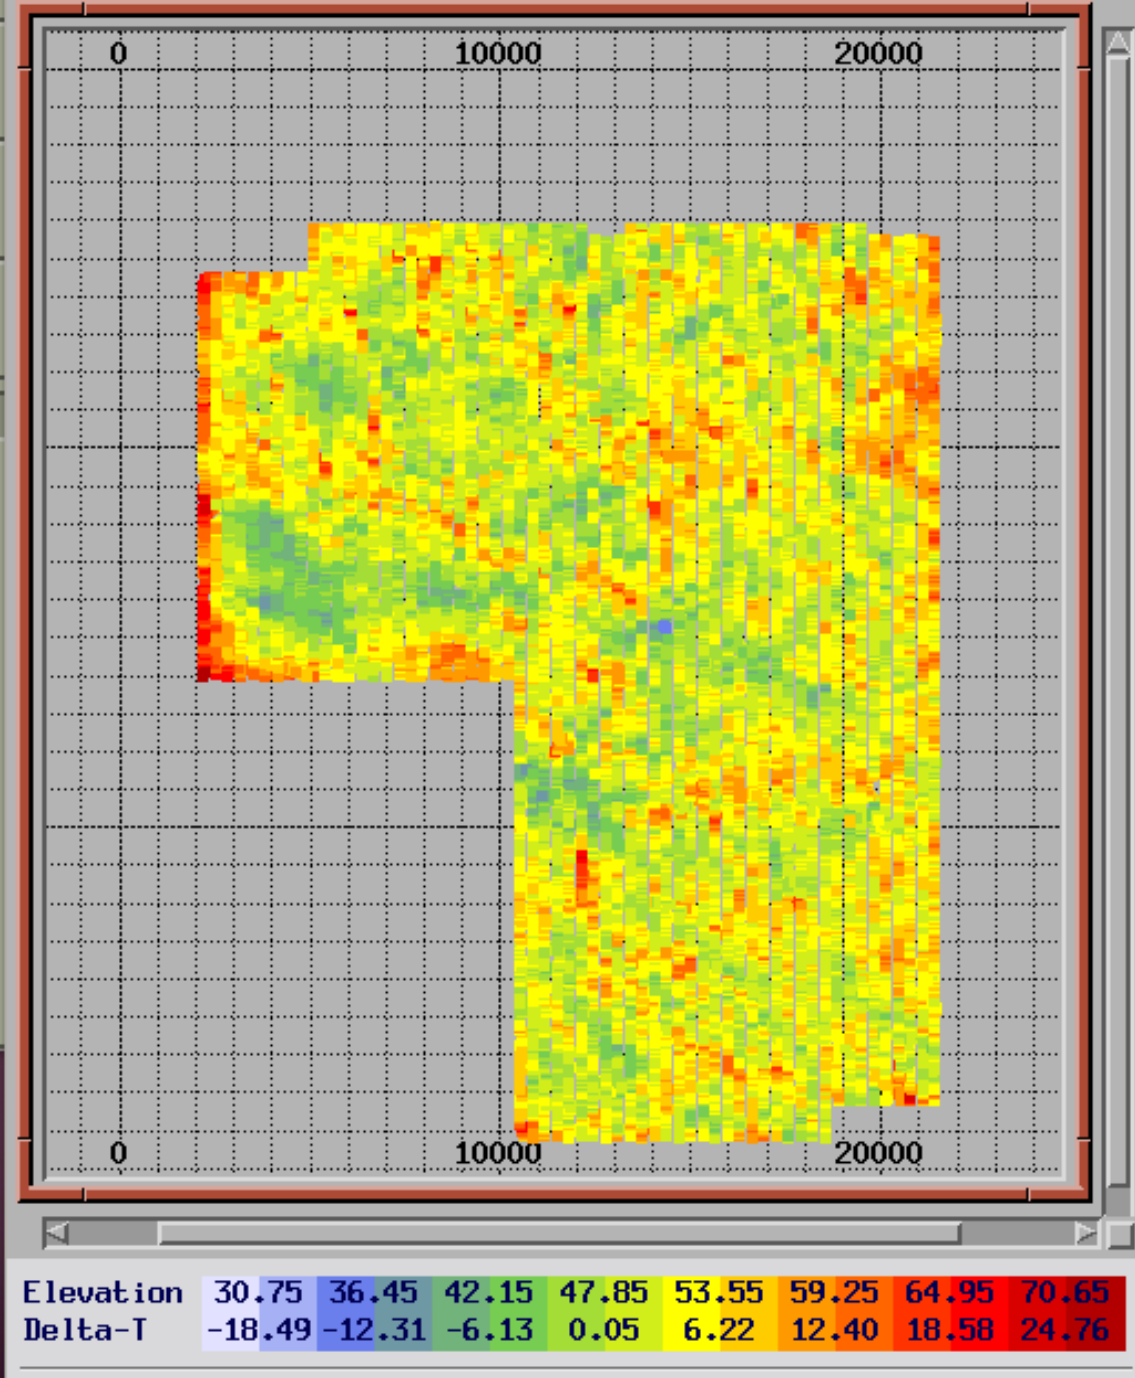
Figure 25 Source residual static map.

Time shifts between traces with the same reflection point were measured by cross-correlating the NMO corrected data over a window demonstrating the strongest reflections. This process is run iteratively to generate a surface consistent model of time shifts for each source and receiver that minimises the error with the measured time shifts. This process compensates for time shifts in the data caused mainly by velocity variations in the shallow weathering layer. The shifts are then applied to the data prior to stack. Maps of the calculated static shifts, can be found in Figure 25 and Figure 26. The static shifts generally follow the elevations of the dunes, indicating that they are correcting for the constant velocity assumption for the elevation replacement statics, both the source and receivers exhibit similar trends with minimal edge effects adding confidence to the veracity of the statics solution.

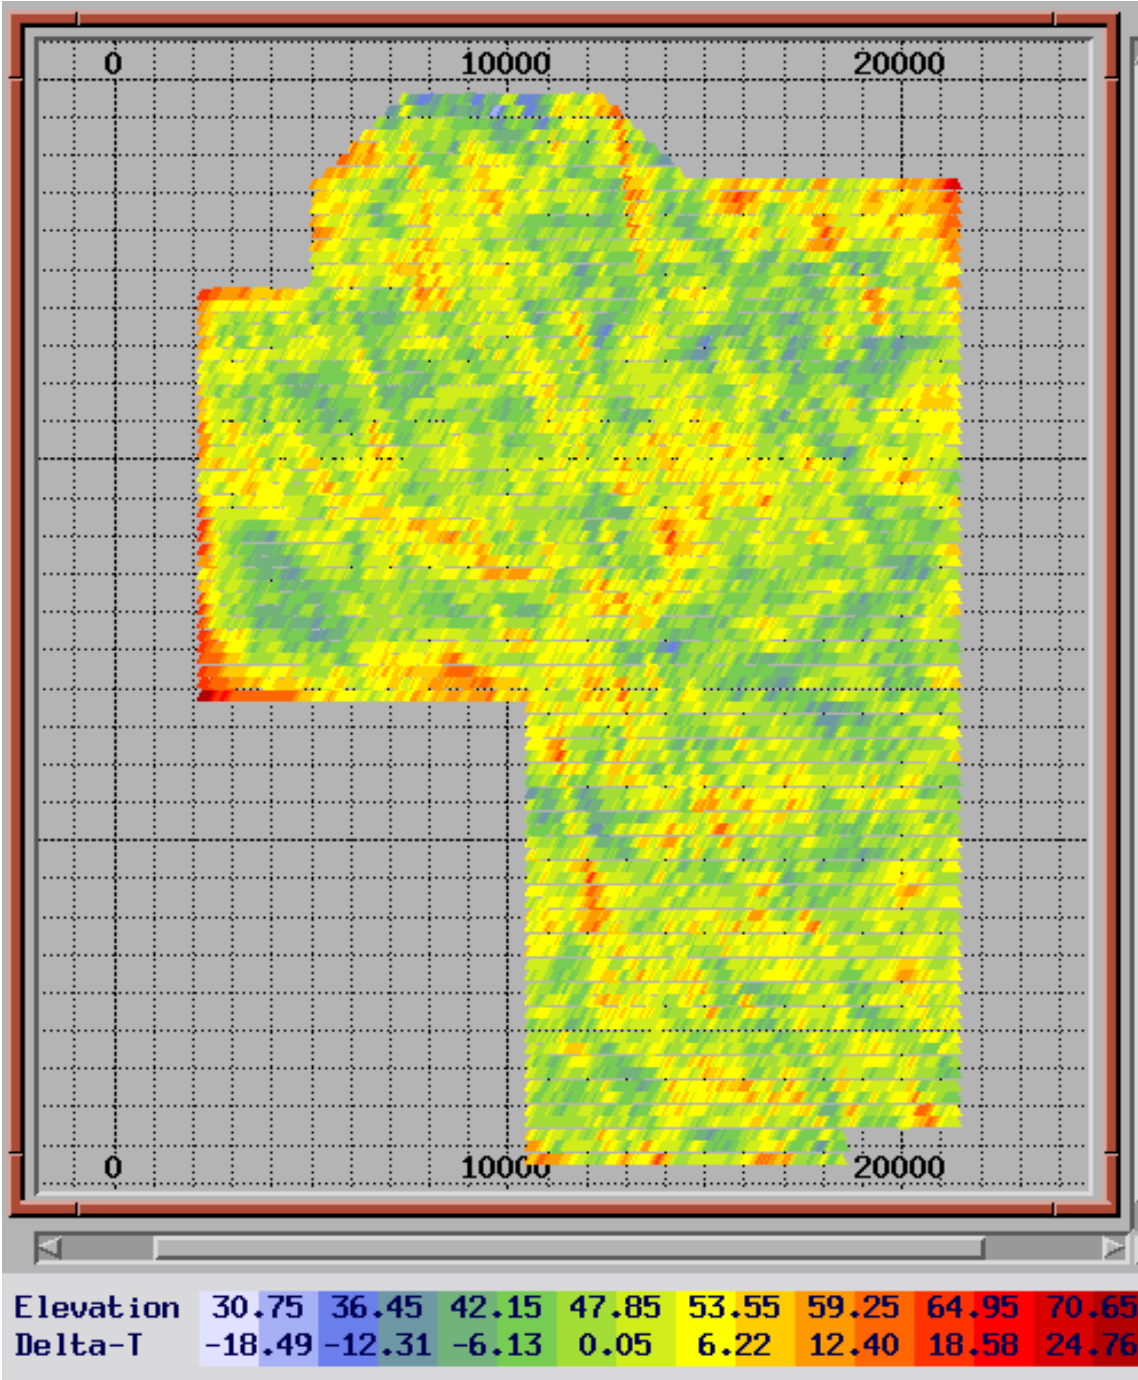
Figure 26 Receiver residual statics map.

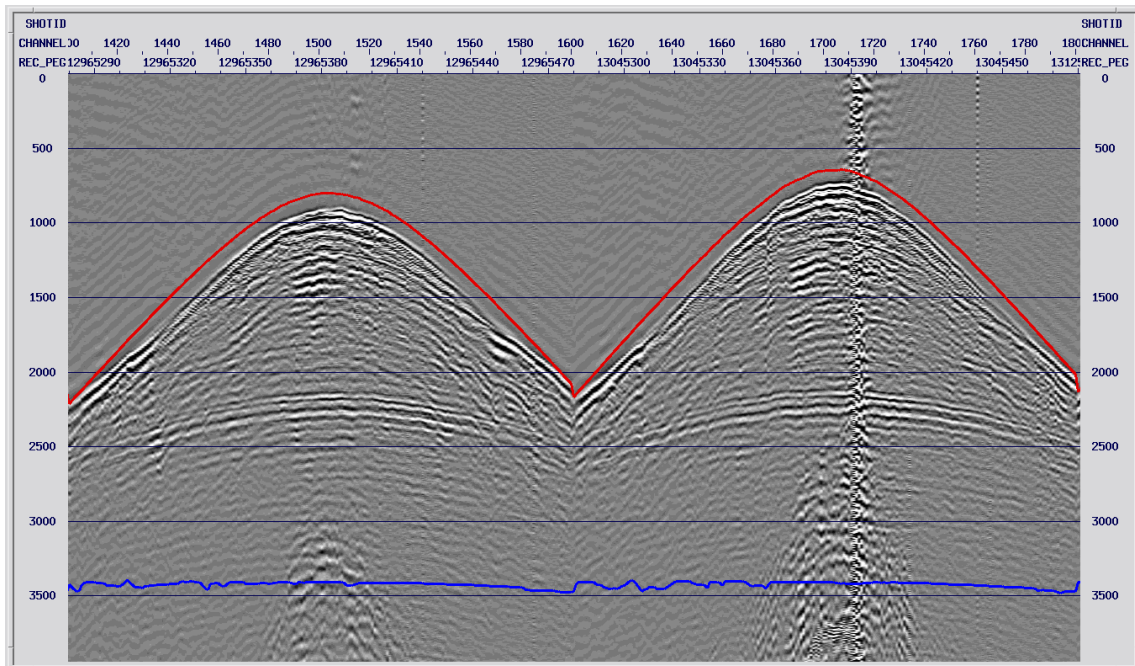
A typical raw shot record (Zoomed in for improved visibility) is shown in Figure 28. And It contains a limited amount of noise, is free of dead traces and clear reflectors can be observed on the shot record

Figure 28 Typical raw shot display

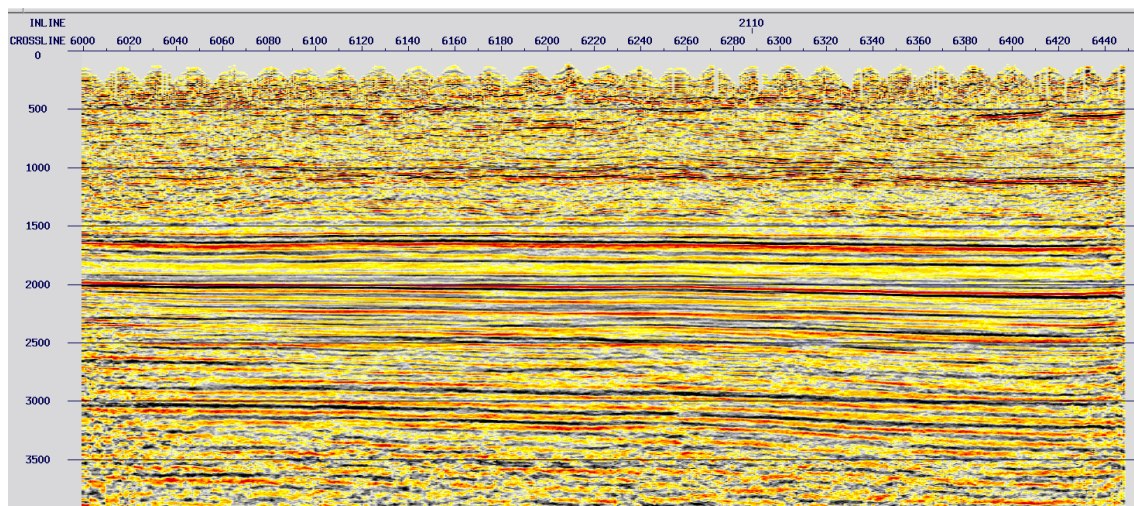
Figure 30 *Field brute stack, inline 2110*

Example stack displays can be found in Figure 30 and Figure 31 below. It should be noted that the processing applied in these field stacks is designed for efficiency with regards to the resources and time available on crew, to provide a quality control product in the stack domain and an early indication of the data and structures. Significant improvements would be expected after the data has been fully processed.

The stacks depict very obvious continuous reflectors throughout the entire line between 1500ms and 2500 ms two-way time (TWT). The overall structure shown is of west-east dipping beds. Deeper reflectors can be observed (at 3500 – 4000 ms) which may assist in the evolutionary history of the structures.

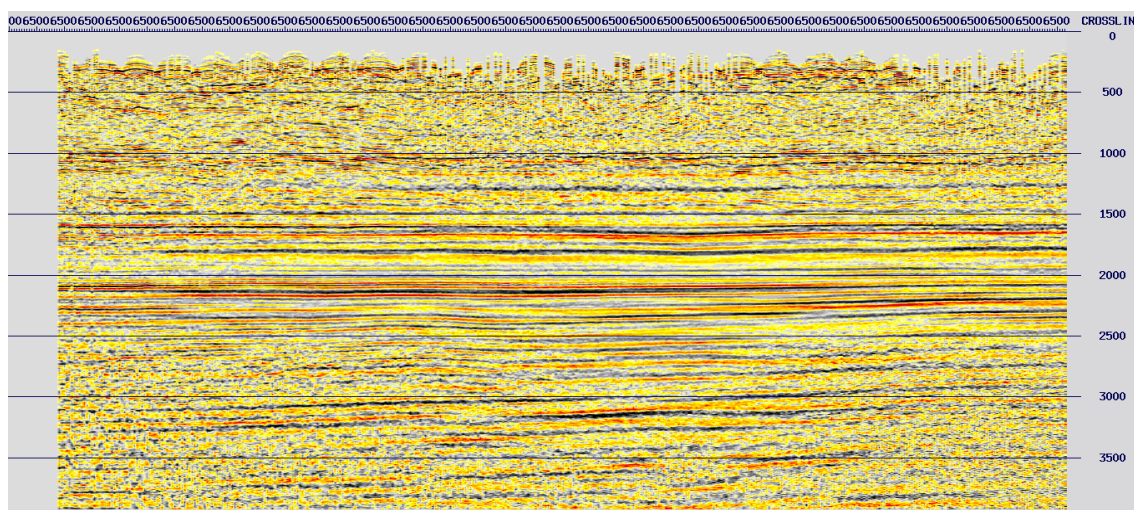
Figure 31 *Field brute stack, crossline 6500*

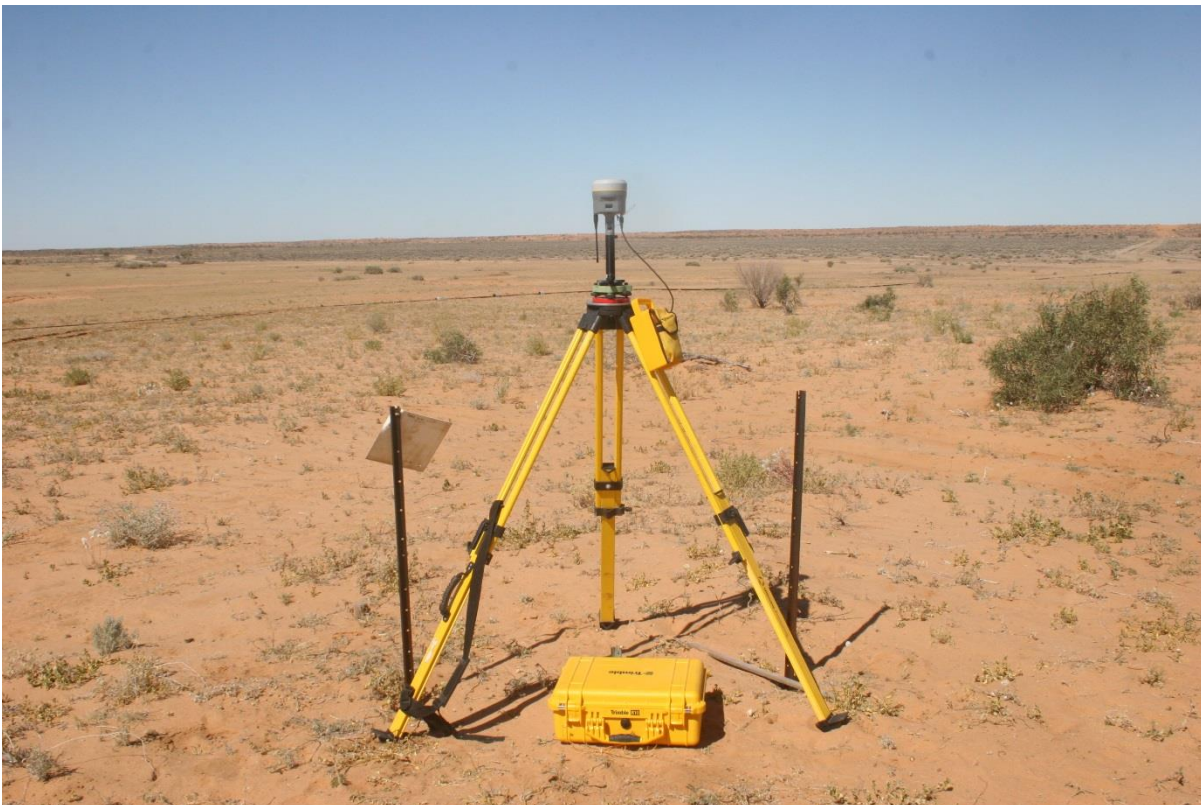
**Photograph 1** Trimble R10 on CON6 control station (Fyfe benchmark)

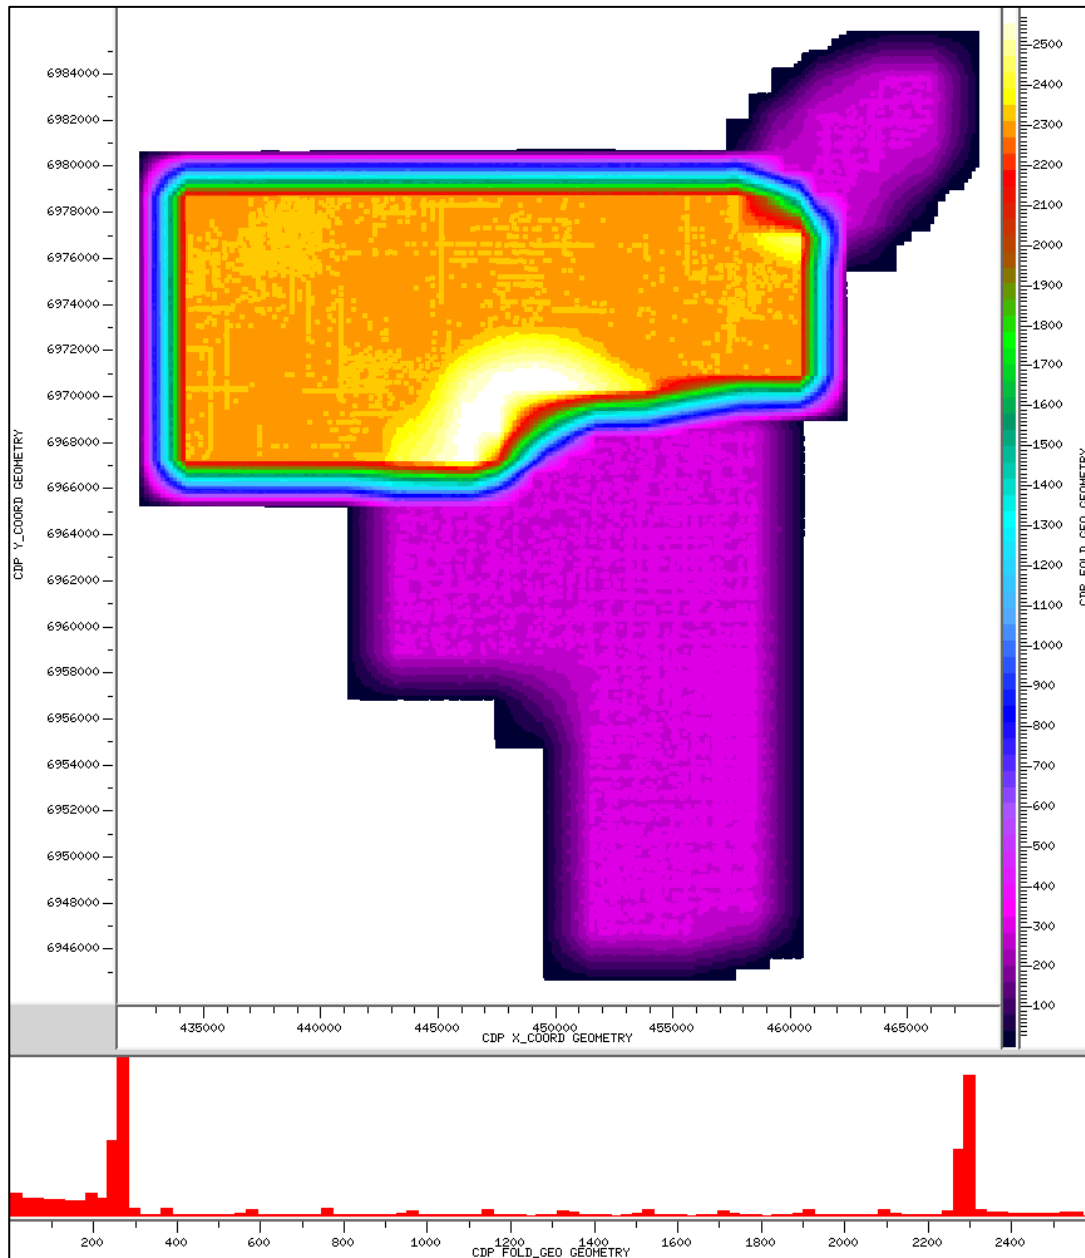
## CDP fold map using all offsets:
