24.27 Appendix AA – EPBC Protected Matters Report

Flinders Power commissioned CLD Mining to conduct a geotechnical stability assessment required under the Geotechnical Management System (GMS) during the mine rehabilitation period. An assessment will be completed on a monthly basis and this report refers to the assessment completed in August 2016. The purpose of this report is to identify any geotechnical stability issues and provide recommendations to reduce the risk of geotechnical issues on current pit walls. Water levels of pit voids will also be reviewed in this document.

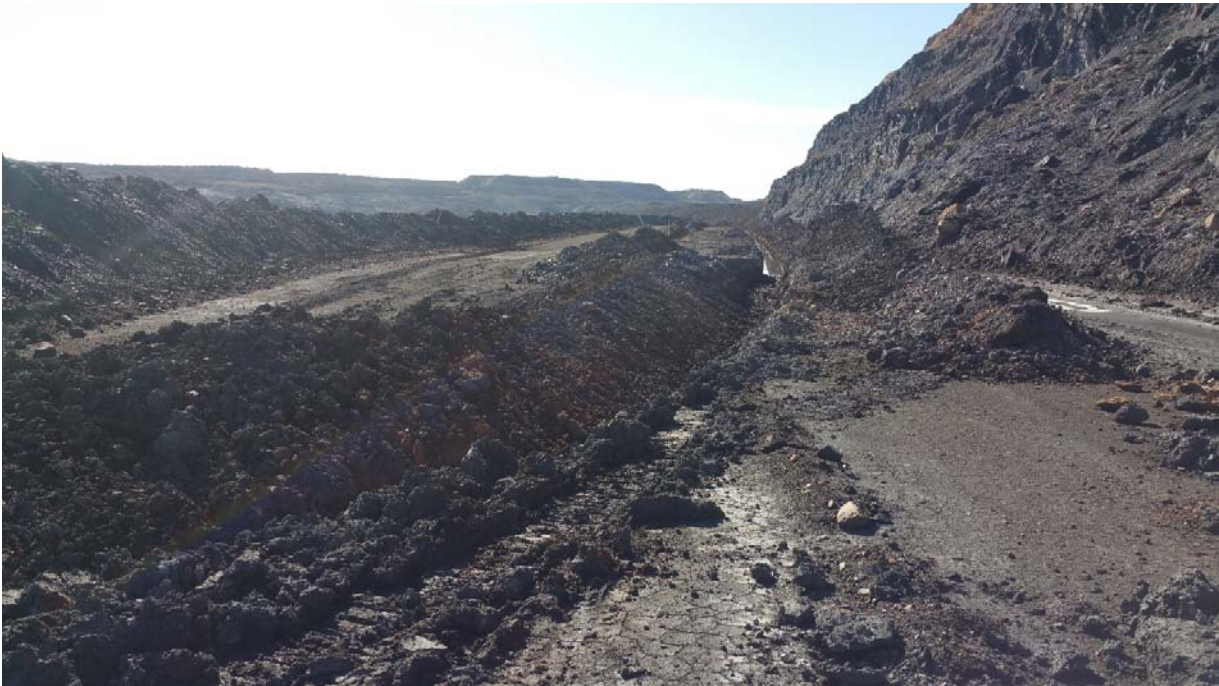
Main series high wall haul road EL 140 was inspected and no visible signs of cracking was observed. A drain has been excavated along the haul road to reduce the risk of water pooling and appears to be working effectively (see figure 1.5).

Figure 1.5 Excavated drain on Main Series EL140 haul road

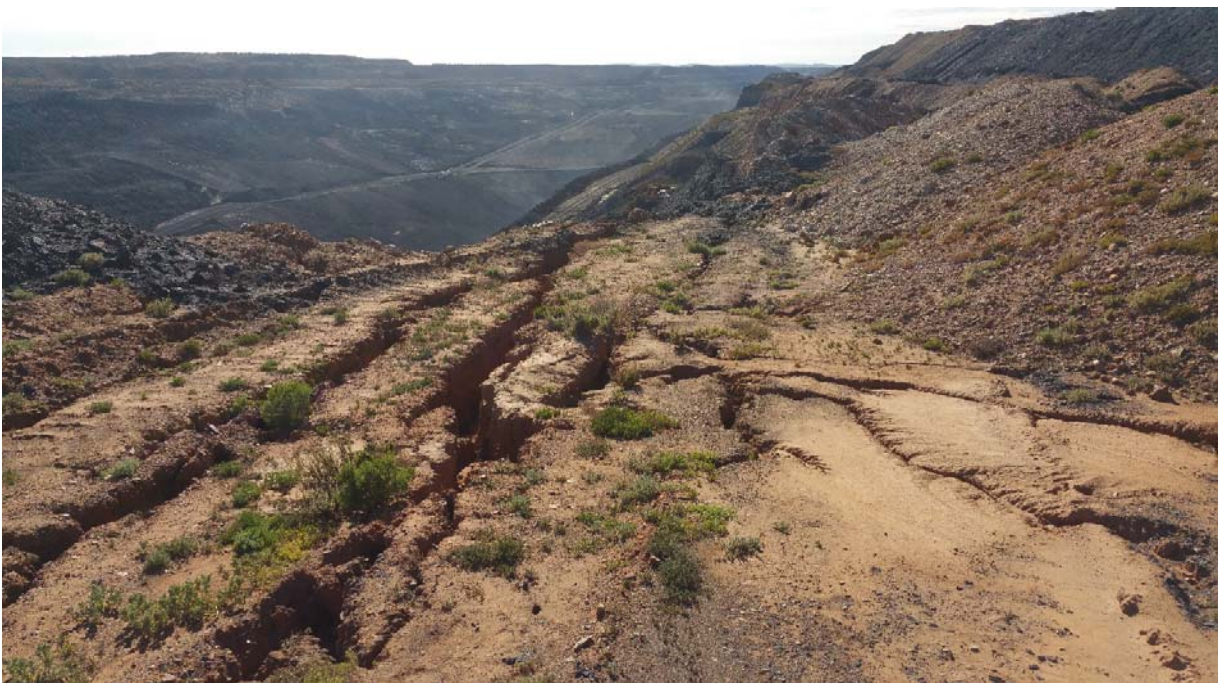
Main Series high wall surface road was inspected. Previously known cracks (see figure 1.6) were observed along the high wall but no new cracking was evident. The cracking is due to a previously mapped fault system and a safety bund has been built around the area.

Figure 1.6 Previously known cracking of M14 high wall

- Main Series high wall was inspected and no new cracking was observed. Old cracking is still visible in the M14 area along the surface road but shows no signs of propagation. A safety bund has been built and the area should be continually monitored for additional cracking.

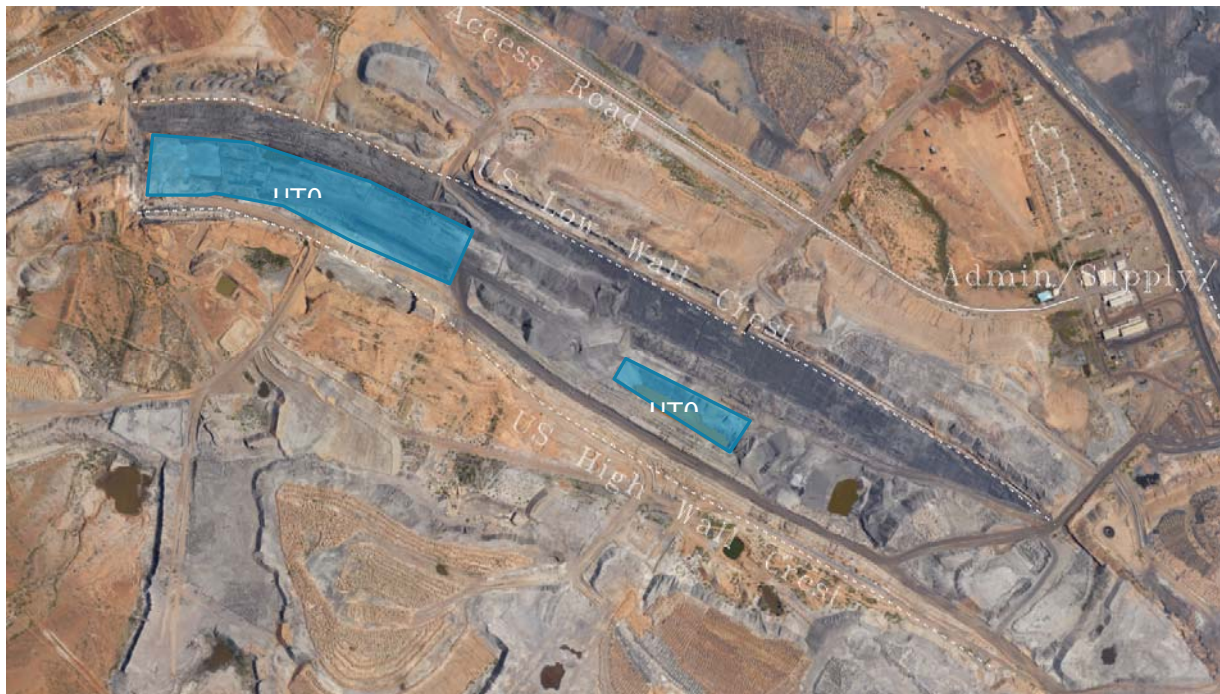
Figure 2.1 Aerial Image December 2015 of Upper Series showing UT07 and UT05 areas

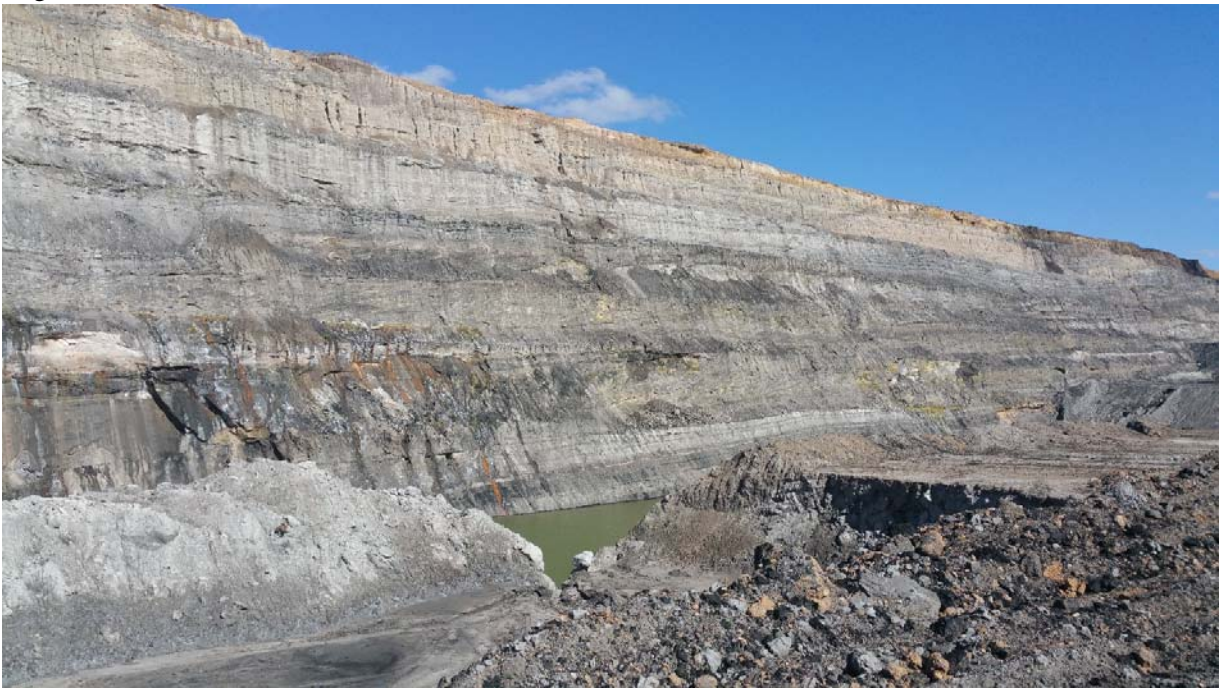
Water ingress from the Upper Series aquifers is still visible from the high wall (see figure 2.3) as pumping from the high wall bores has ceased. UT05 void water level has increased by approximately 2m since February 2016 (see figure 2.2) which is expected. This minor increase in water level does not pose any risk to the stability of the high wall and low wall.

Figure 2.3 Upper Series high wall

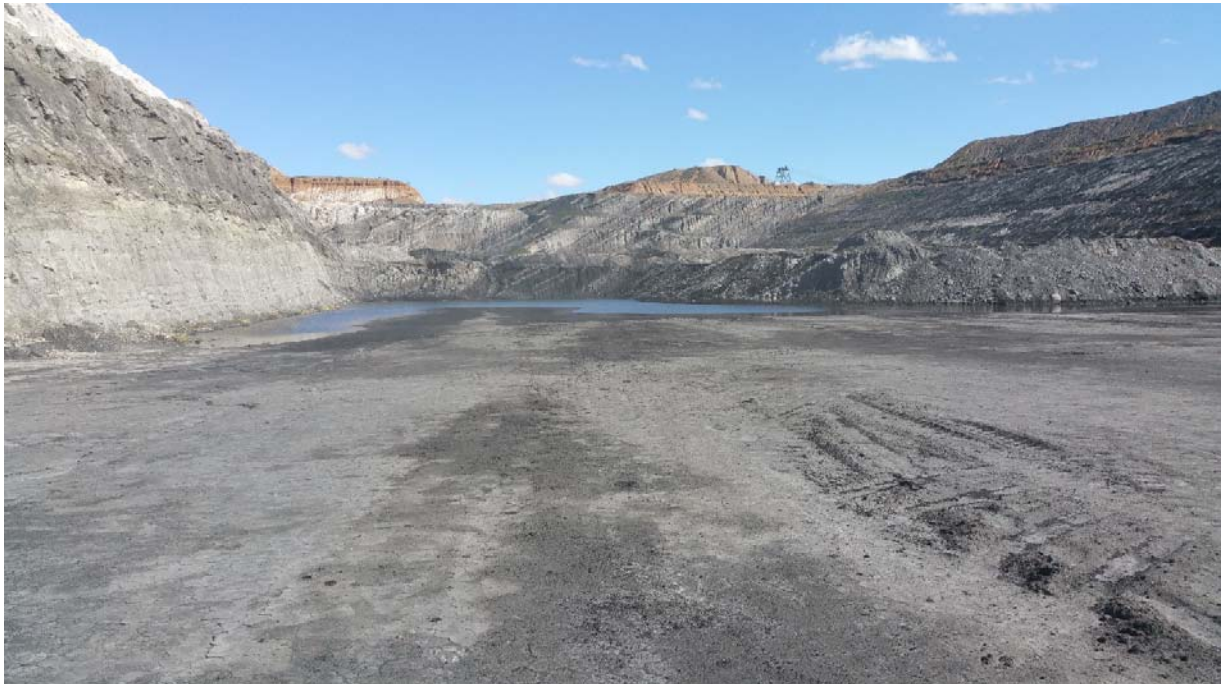
Water pooling in UT07 area is still visible. This water pooling doesn't pose any risk to stability of the low wall or high wall but will be managed to reduce the risk of erosion of in pit waste dumps and in turn reduce the risk of spontaneous combustion of the Upper Series coal units. The management of the UT07 surface water will be designed when the surface water management plan for this area is finalised.

Figure 2.2 UT07 looking West to East showing water pooling

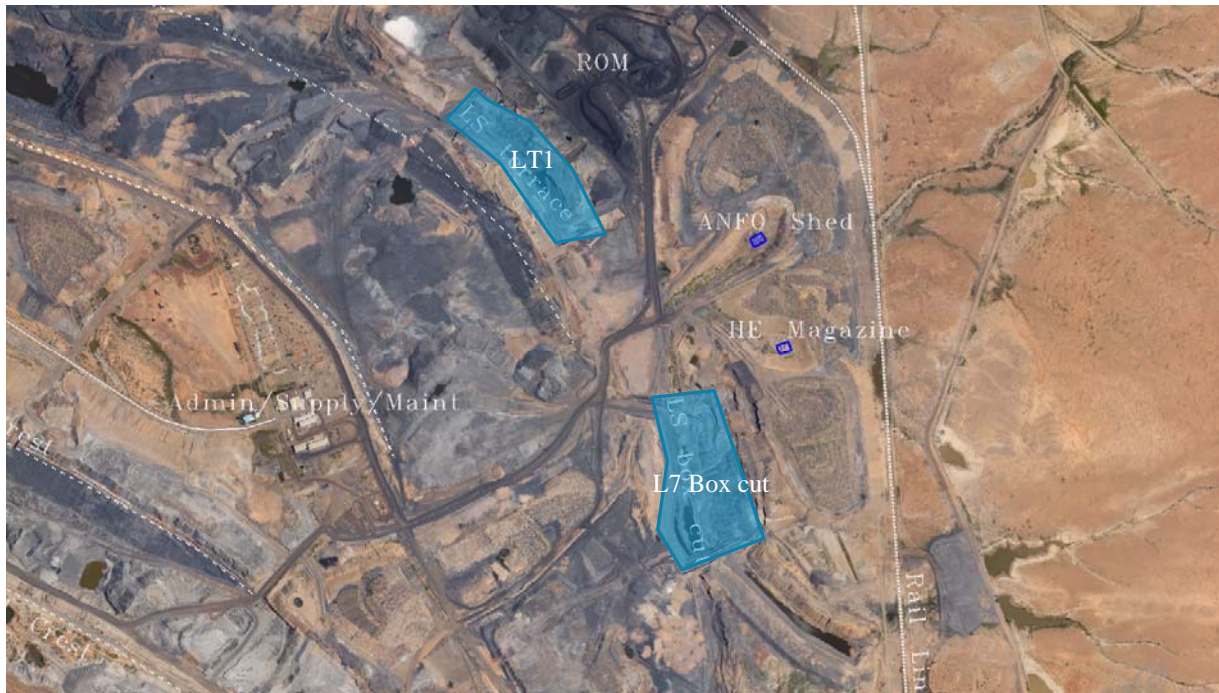
Figure 3.1 Aerial image December 15 of the Lower Series showing LT1 and L7 Box cut areas

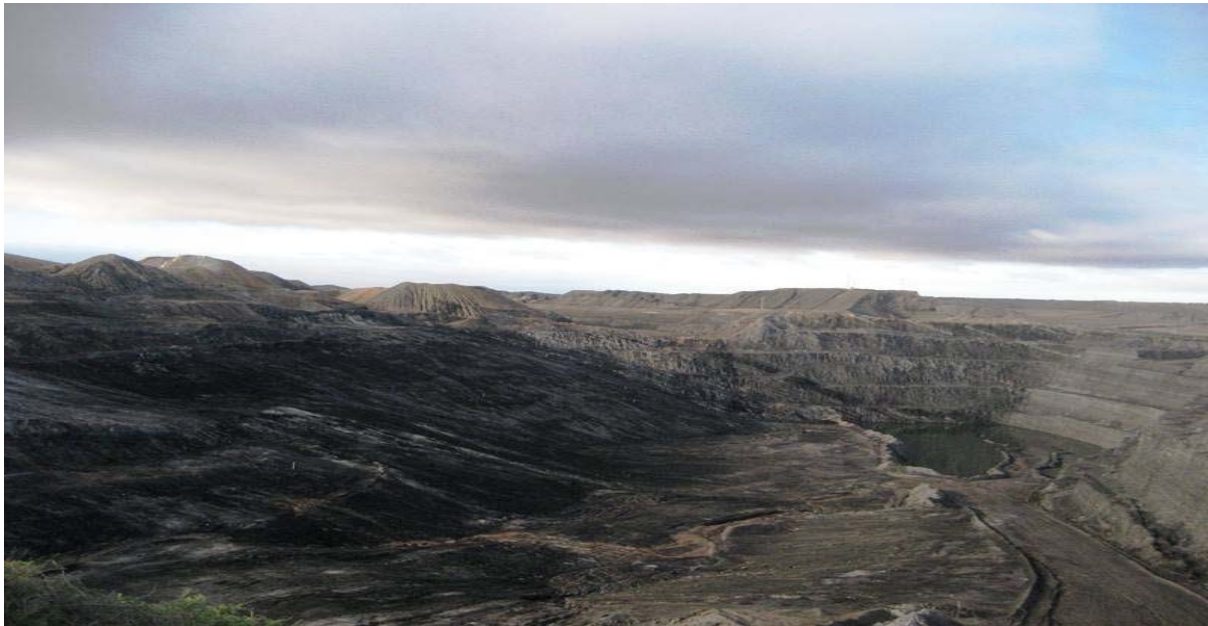
Figure 3.3 L7 Box cut looking in a North to South direction

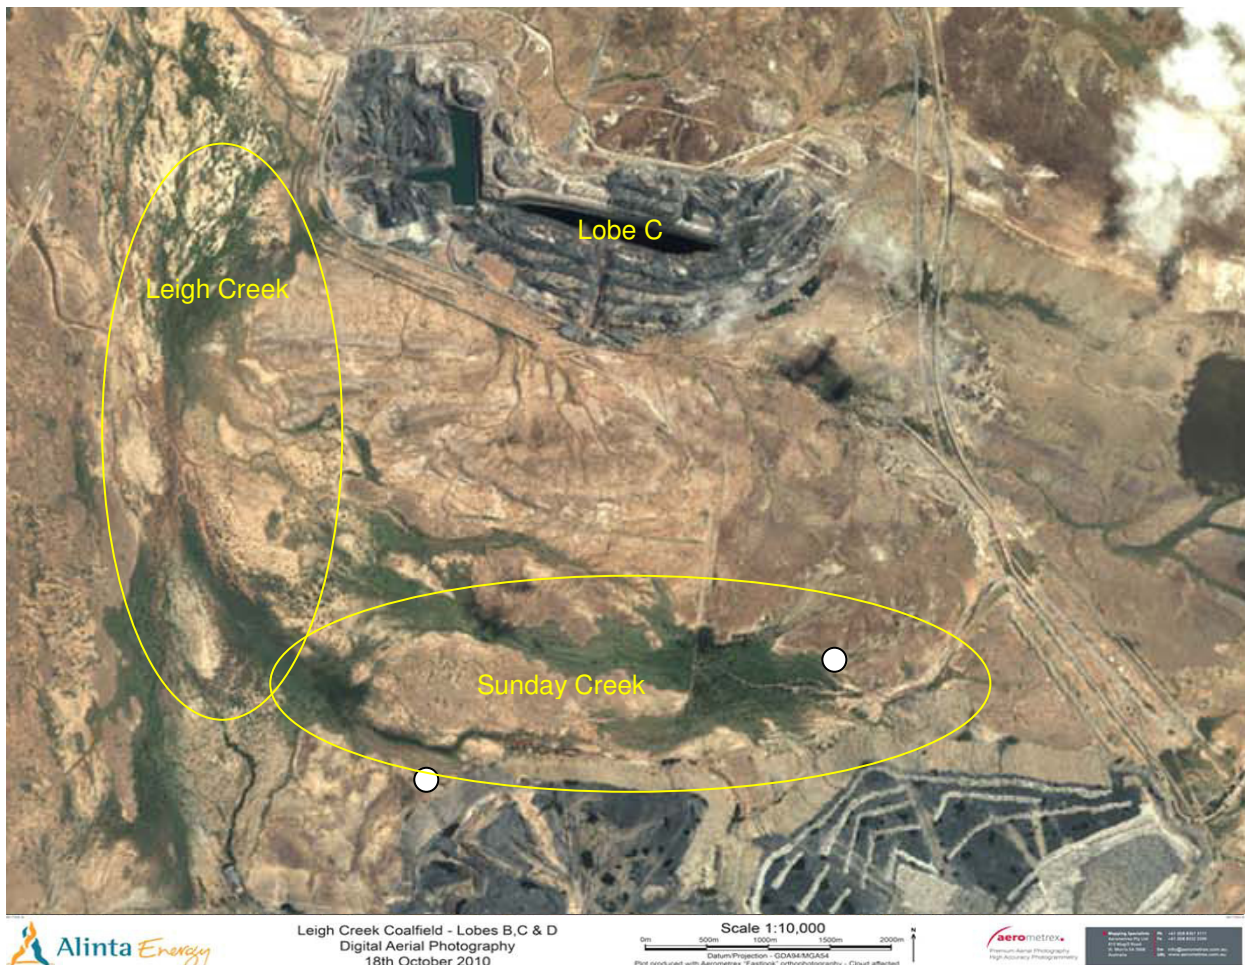
Figure1. Overview of the assessment area. The white dots show the positions of previous vegetation survey localities.

Above average rainfall in the period November 2009 – April 2011 severely impacted the Leigh Creek Coal mine operations. Because all on-site water storage areas are full there is a need to discharge water in order to open up new areas. The intention is to pump water from a number of pits and discharge about 700 ML of water with moderate to high salinity levels into Lobe C and discharge about 300 ML of low salinity water into the Sunday Creek that feeds into the Leigh Creek just north of the main coalfield (Figure 1).

1. Assess and report on the ecology of the Leigh Creek waterway, as demarcated in the yellow sections on figure 1. The assessment to include flora and fauna, and in particular the stygofauna residing in the shallow sands and gravels of the creek beds.
2. To assess the likely impact of discharge water on the ecology of the Leigh Creek waterway. The impacts to be assessed in the following ranges:
 - a. Low salinity, low nitrogen (<10,000 $\mu\text{S/cm}$ salinity, <0.5mg/L oxidised nitrogen)
 - b. Moderate salinity, moderate nitrogen (10,000-20,000 $\mu\text{S/cm}$ salinity, 0.5 – 1.5mg/L nitrogen)
 - c. High salinity, high nitrogen (>20,000 $\mu\text{S/cm}$ salinity, >1.5mg/L nitrogen)
