Shallow groundwater quality monitoring program for the Onkaparinga Catchment Water Management Board area

Report DWR 2001/018

November 2001

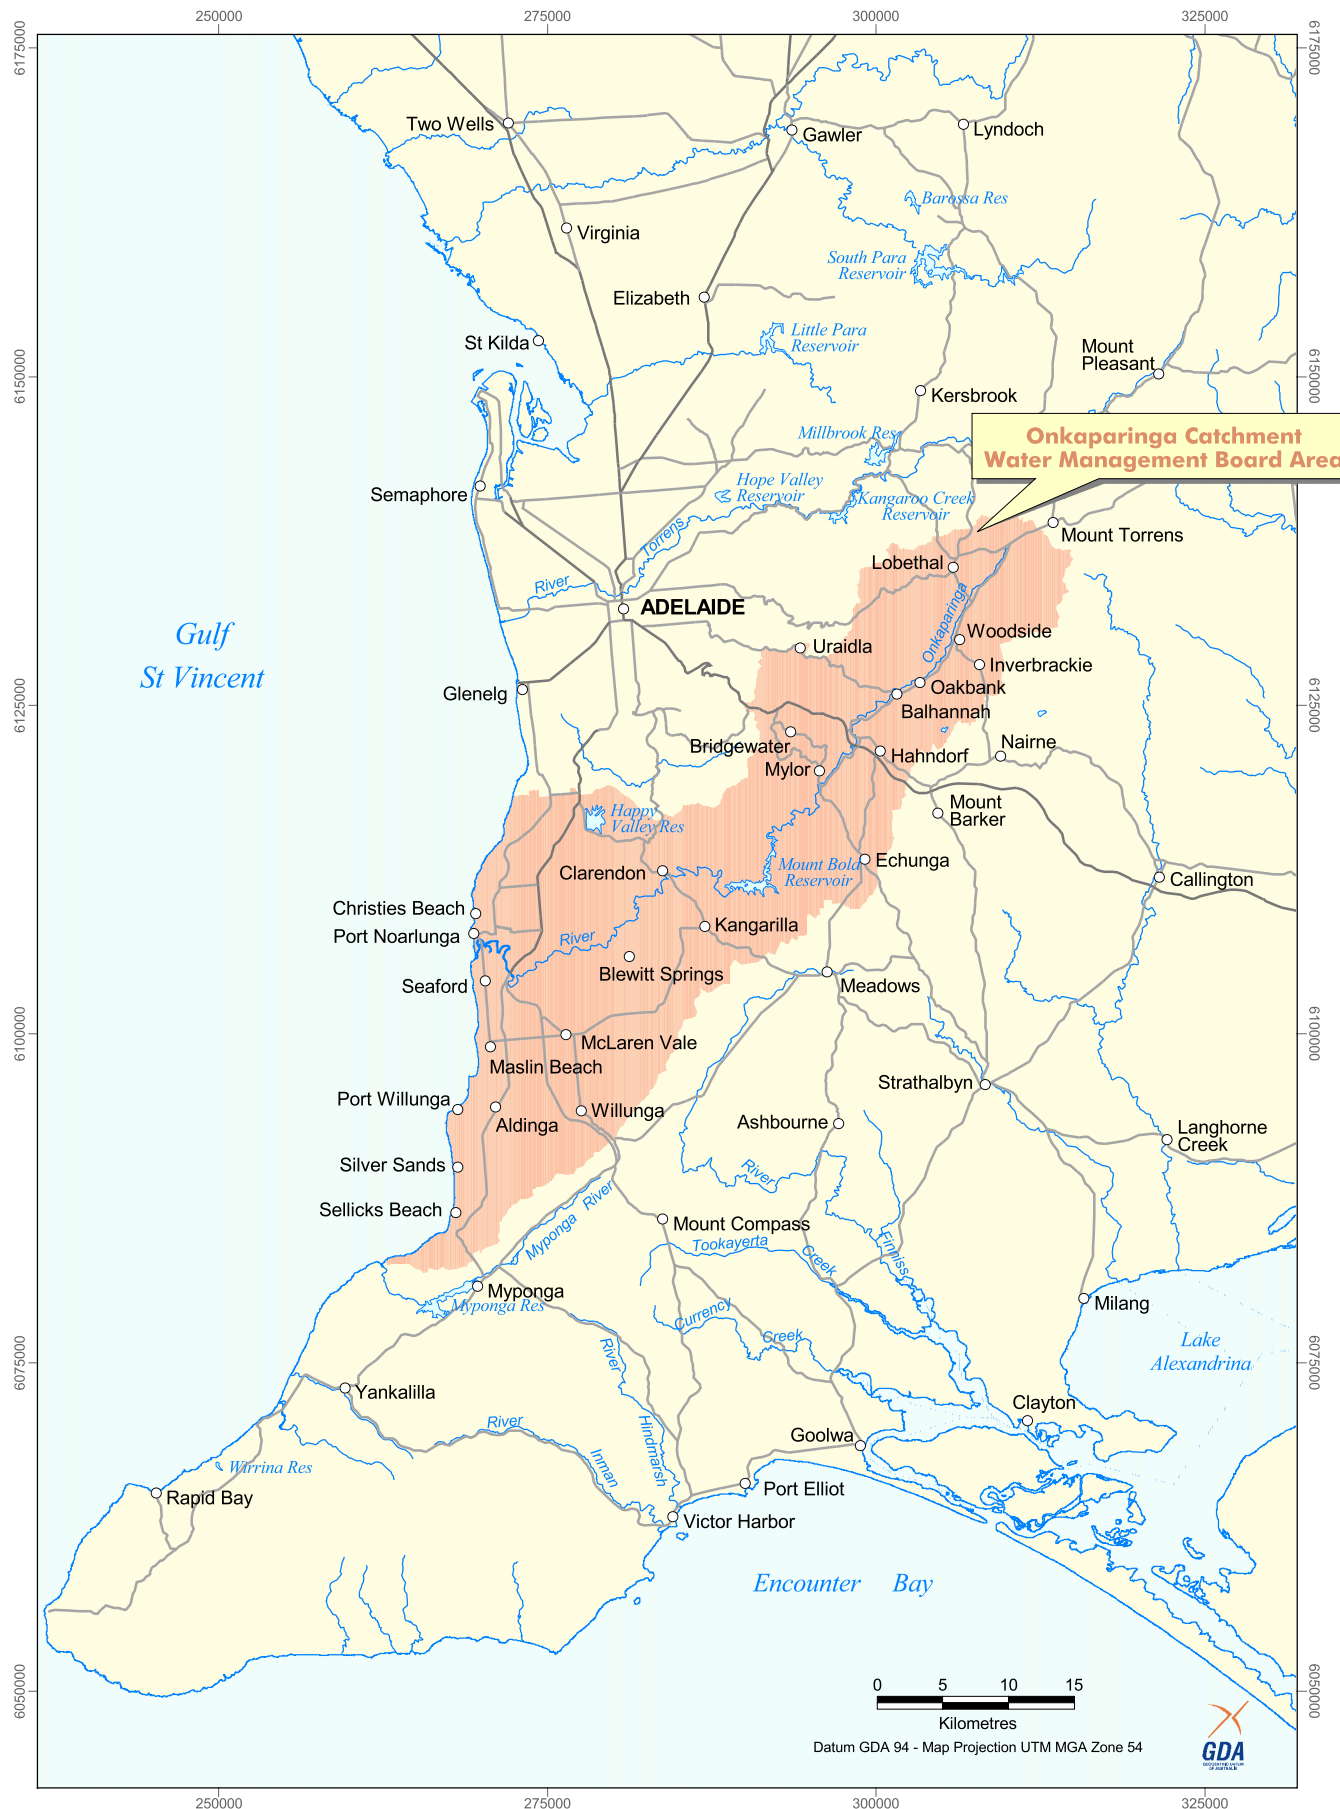
Figure 1

Onkaparinga Catchment Water Management Board Area

LOCATION PLAN

The Onkaparinga Catchment Water Management Board (OCWMB) is responsible for an area of ~920 km² which includes the Onkaparinga Catchment in the Adelaide Hills and the Noarlunga and Willunga sedimentary embayments south of Adelaide, South Australia (Fig. 1). Under the requirements of the South Australian *Water Resources Act 1997*, the board has prepared a five-year management plan to guide the management of water resources within its area. One of the goals of the management plan is to maintain and, if possible, enhance the quality of surface and groundwaters. The board has established a partnership with the Department for Water Resources to design an ongoing program to monitor the water quality within the shallow groundwater system throughout the catchment area.
