REEDY CREEK 1

TEST REPORTS

PEL 39
OTWAY BASIN
SOUTH AUSTRALIA
REEDY CREEK - 1
WELL SITE
ENVIRONMENTAL AUDIT

REEDY CREEK POST DRILLING SITE INSPECTION AND EVALUATION

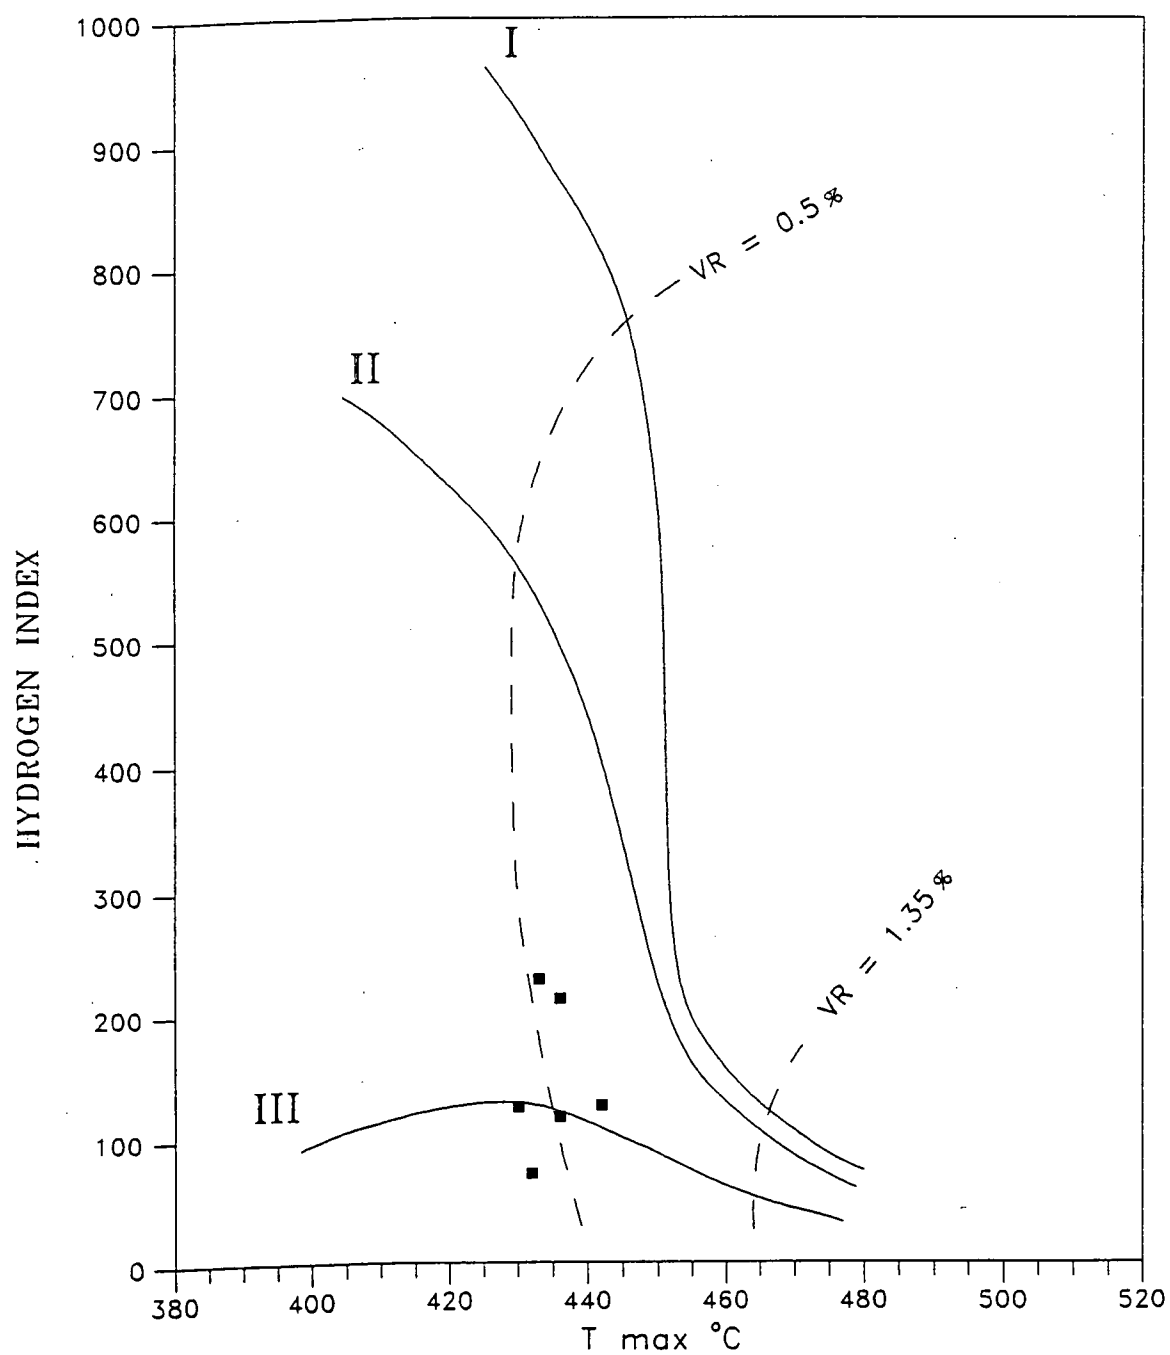
FIGURE 1

TOC and Rock-Eval data are listed in Table 1. Figure 1 is a plot of T_{max} versus Hydrogen Index illustrating kerogen Type and maturity. Table 2 is a summary of the vitrinite reflectance measurements which are presented along with histograms in Appendix 1, while Figure 2 is a plot of measured vitrinite reflectance versus depth.

HYDROGEN INDEX vs T max

suberinite) commences at $VR = 0.45\%$. The maturity versus depth profile indicates that this maturity was reached at approximately 1800 metres depth in this location. Oil generation from the less thermally labile exinites (cutinite, sporinite, etc) commences at higher maturities ($VR > 0.7\%$). Extrapolation of the available data indicates that these maturities should be reached in the sedimentary interval below approximately 2700 metres depth. Rock-Eval T_{max} values are generally in agreement with the measured vitrinite reflectance values, suggesting a maturity range of $VR_{EQUIV} \approx 0.40-0.60\%$ (Table 1, Figure 1).

Hydrogen Index and T_{max} values (Table 1, Figure 1) indicate that these samples contain organic matter which has a bulk composition of Type III kerogen, again with the exception of the two uppermost samples which contain organic matter which has a bulk composition of Type II-III kerogen.

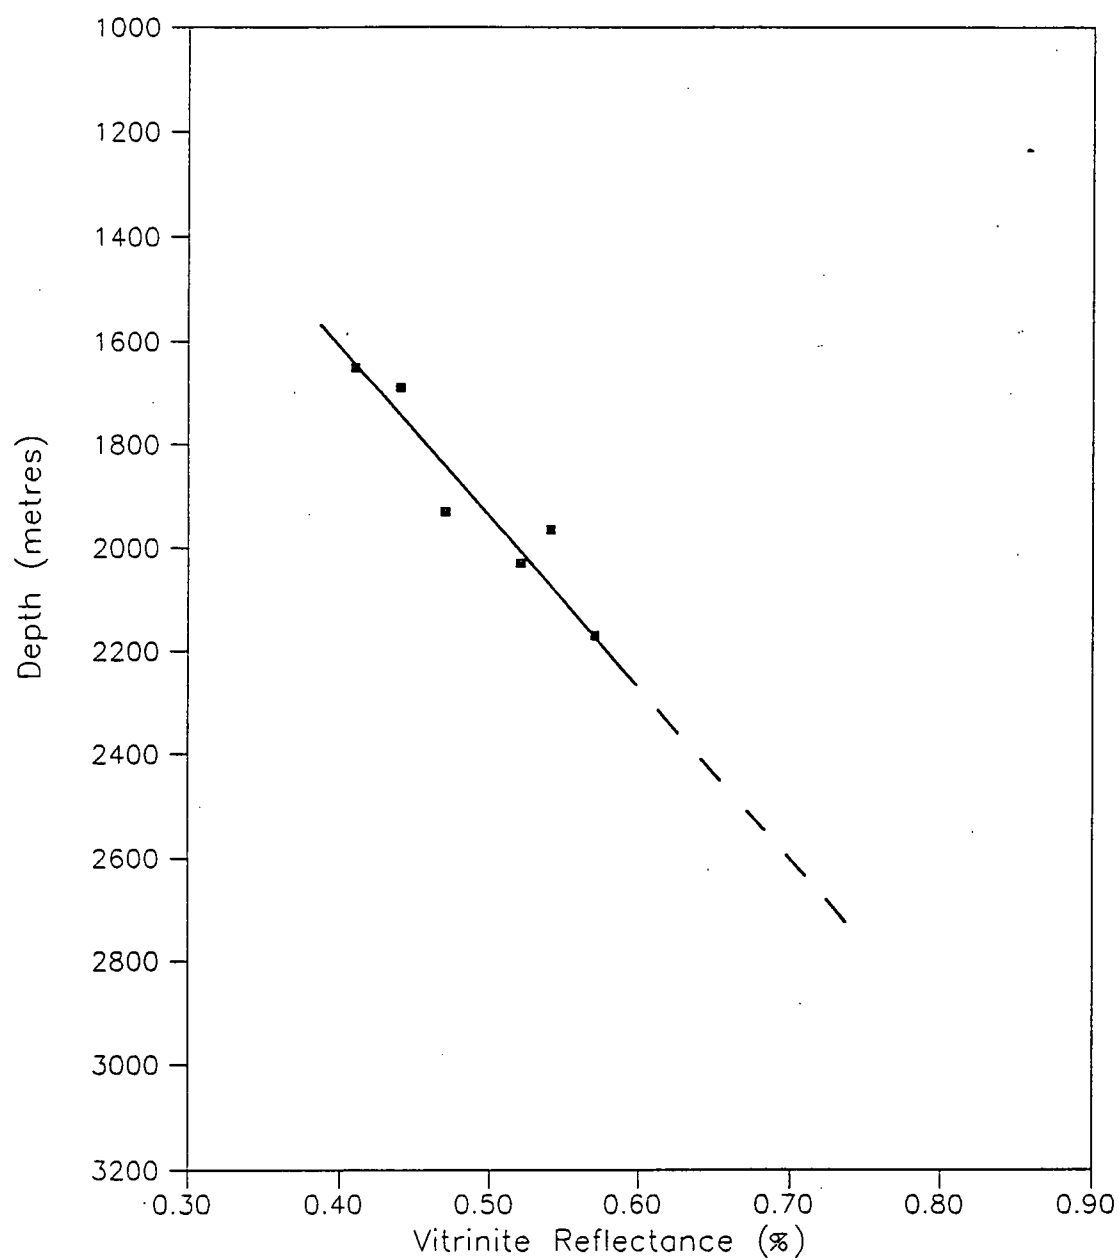
FIGURE 2

VITRINITE REFLECTANCE VERSUS DEPTH
REEDY CREEK-1

Reliable measured vitrinite reflectance values (Table 2, Figure 2) range from 0.41-0.57% over the section studied and indicate that the samples are marginally mature to mature for the generation of liquid hydrocarbons. Oil generation from thermally labile exinites (resinite, bituminite and

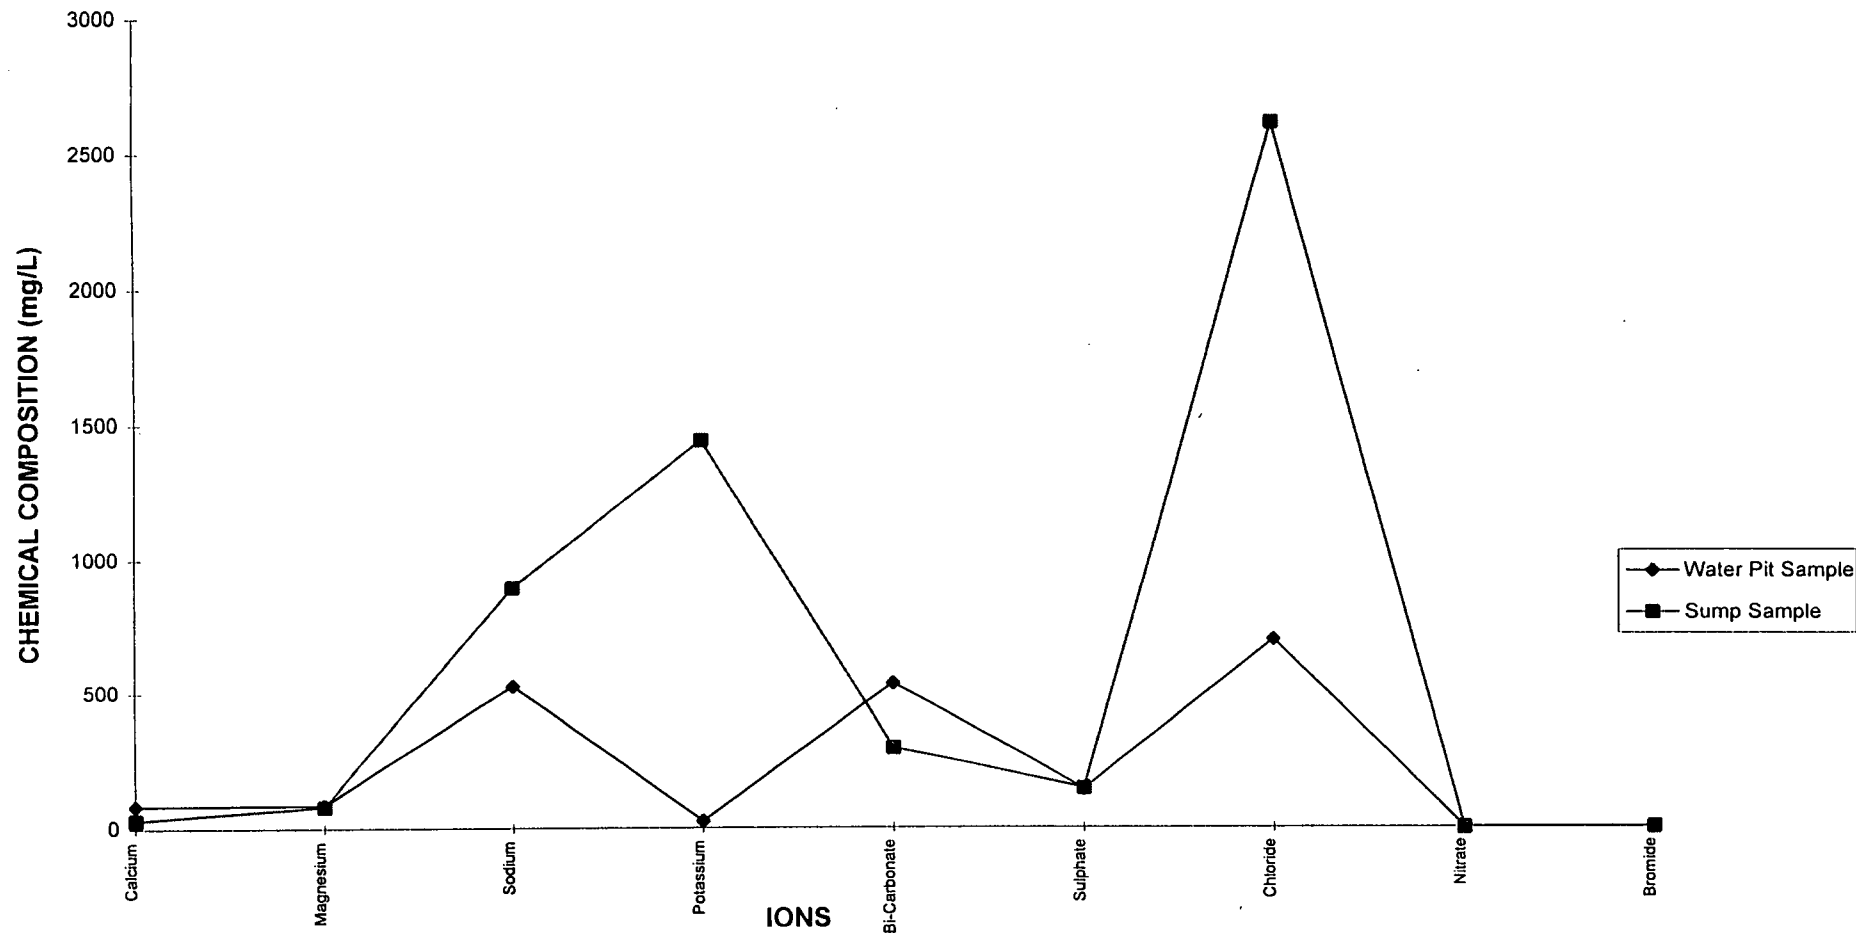
GRAPH -1

CHEMICAL COMPOSITION OF WATER PIT AND SUMP SAMPLE

Water samples from both pits have been taken for analysis (Appendix 1). Standard water analysis shows the salt content for the sump to be much greater than that for the water pit (Graph 1). The concentrations of Calcium, Magnesium, Sulphate and Nitrate ions appear to differ by only relatively small amounts (Graph 1). Potassium ions are of a much higher concentration in the sump sample than the water pit sample. Conversely Bi-Carbonate ions are greater in the water pit sample than the sump sample. Both samples have a neutral pH and the total dissolved solids are greater in the sump sample than the water pit sample (Graph 2). Total hardness is greater in the water pit sample than the sump sample and the Sodium/Total Cation Ratio is greater in the water pit sample than the sump sample (Graph 3). The Biochemical Oxygen Demand (BOD) measures the amount of oxygen consumed by a sample of water under standard conditions. It is an indicator of the level of wastes present and measures the organic pollution in a body of water. The greater the amount of wastes present, the higher the consumption of oxygen by organisms living in the water and the higher the BOD. The Biochemical Oxygen Demand was <1mg/L in the water pit and 15mg/L in the sump sample (Appendix 1). The BOD in the sump sample is higher than expected and the level is comparable to high quality sewage effluent. The water in the sump would be useful for irrigation and not for stock watering.

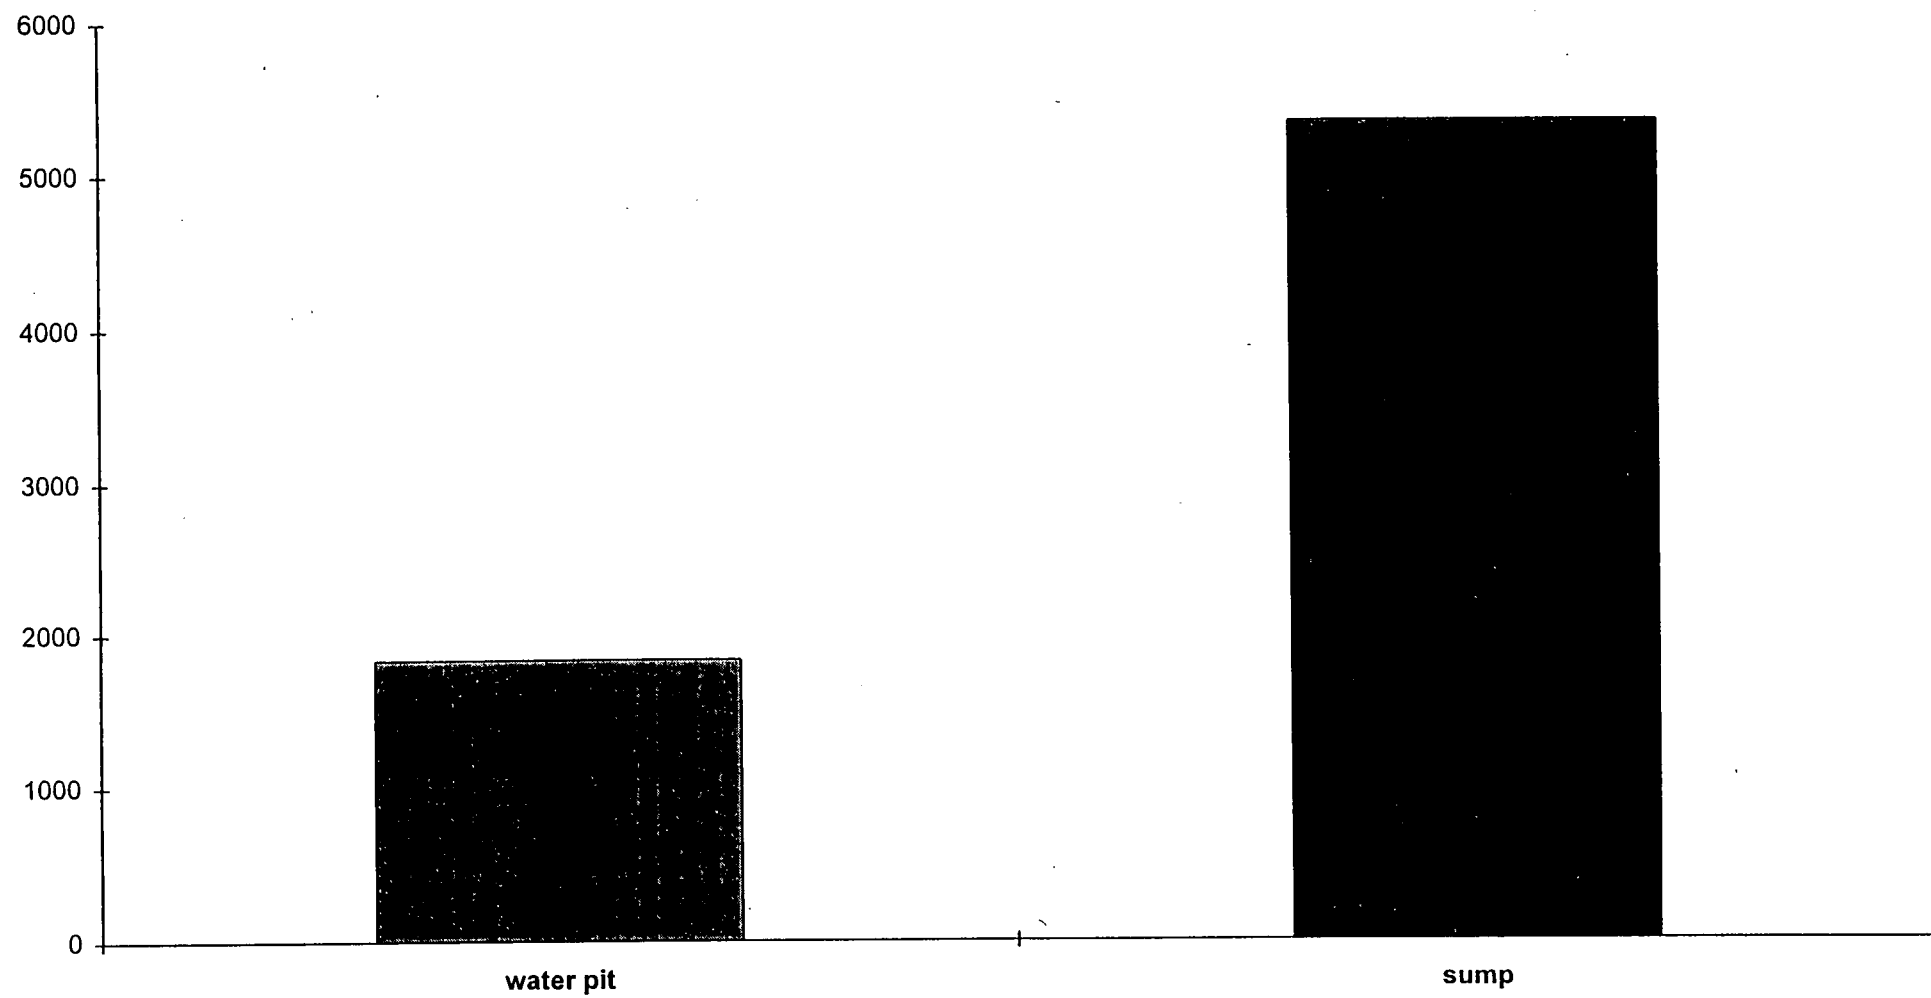
GRAPH - 2

Total dissolved solids (Calculated) (mg/L)

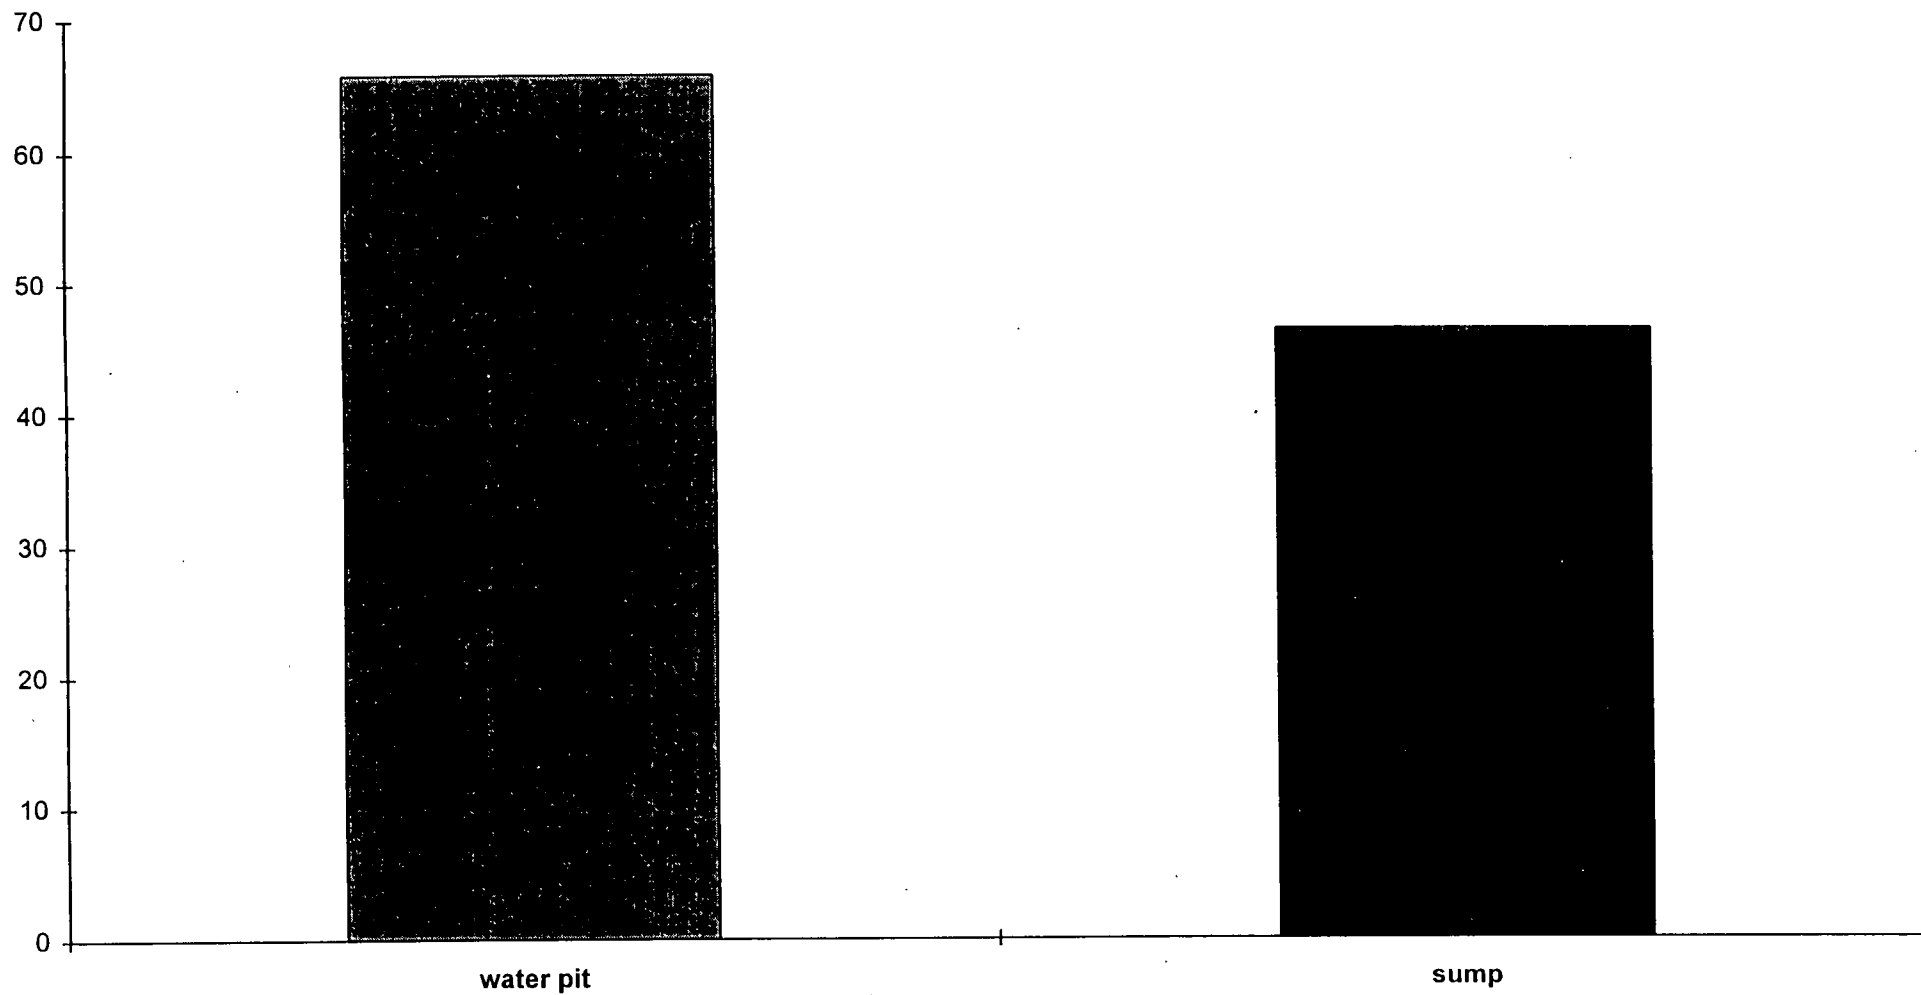
GRAPH -3

Sodium/Total Cation Ratio (%)

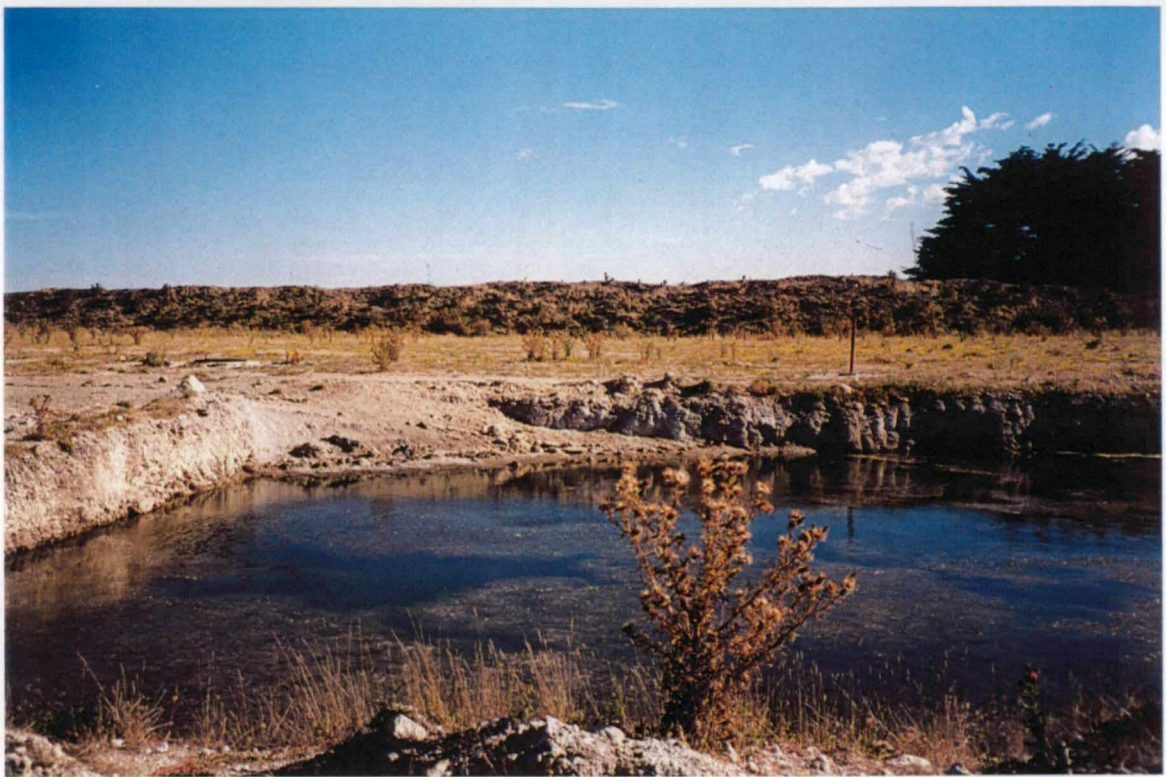
The topsoil stockpile and the pit spoil stockpile located at the southern end of the site have not been used to fill in the pits. Associated vegetation has not been respread over the affected areas. Vegetative growth upon these stockpiles consists predominantly of thistle and various native grasses.

Figure -1 Looking North onto site from spoil stockpile.

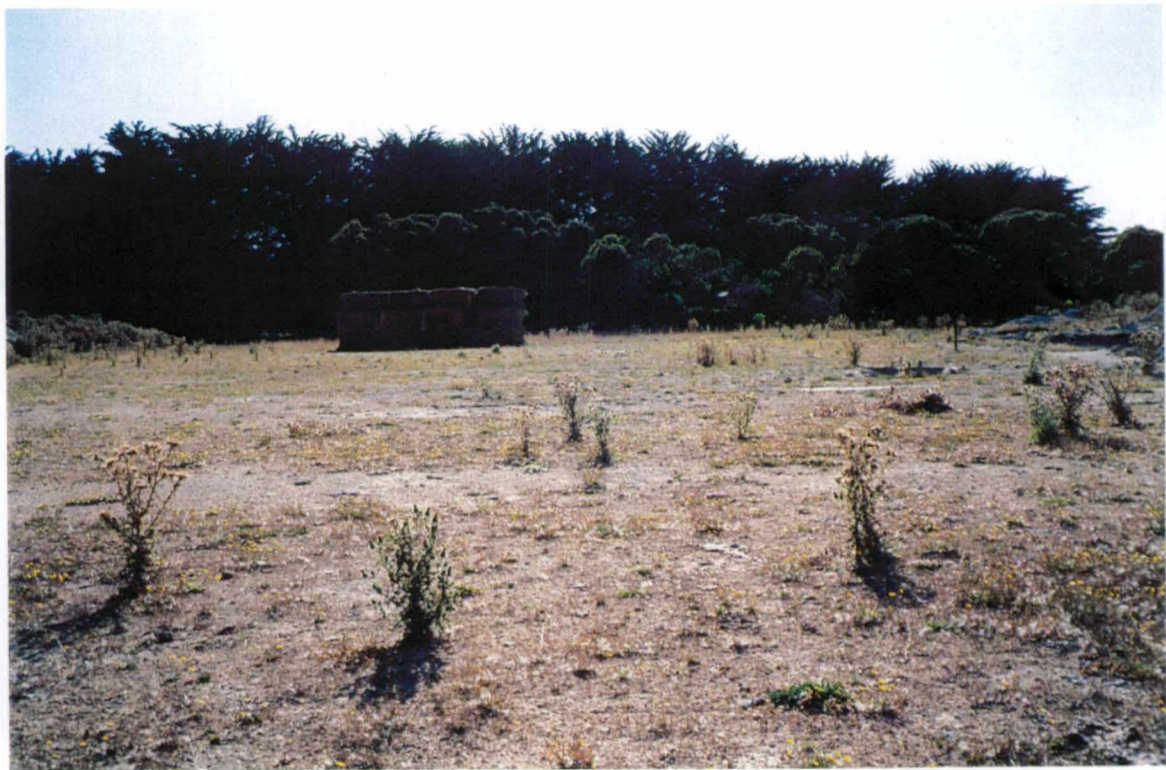
The drill site consists of compacted soil and shows very little regeneration of grass on site. It is mainly covered in thistle and interspersed with various native grasses and would most probably have to be deep ripped to break up the compacted layers. This would then allow an even distribution of native grasses to grow. No fragmentation of the land mass is evident. Erosion is not evident, although is possible due to strong winds present. The drill site has been cleared of all debris, including any fuel drums or chemicals used in the drilling process. No fuel appears to have been spilt. A rubbish pit Mr Lea has been using will be infilled.

Figure -2 Looking East onto site from Western end of drill area.

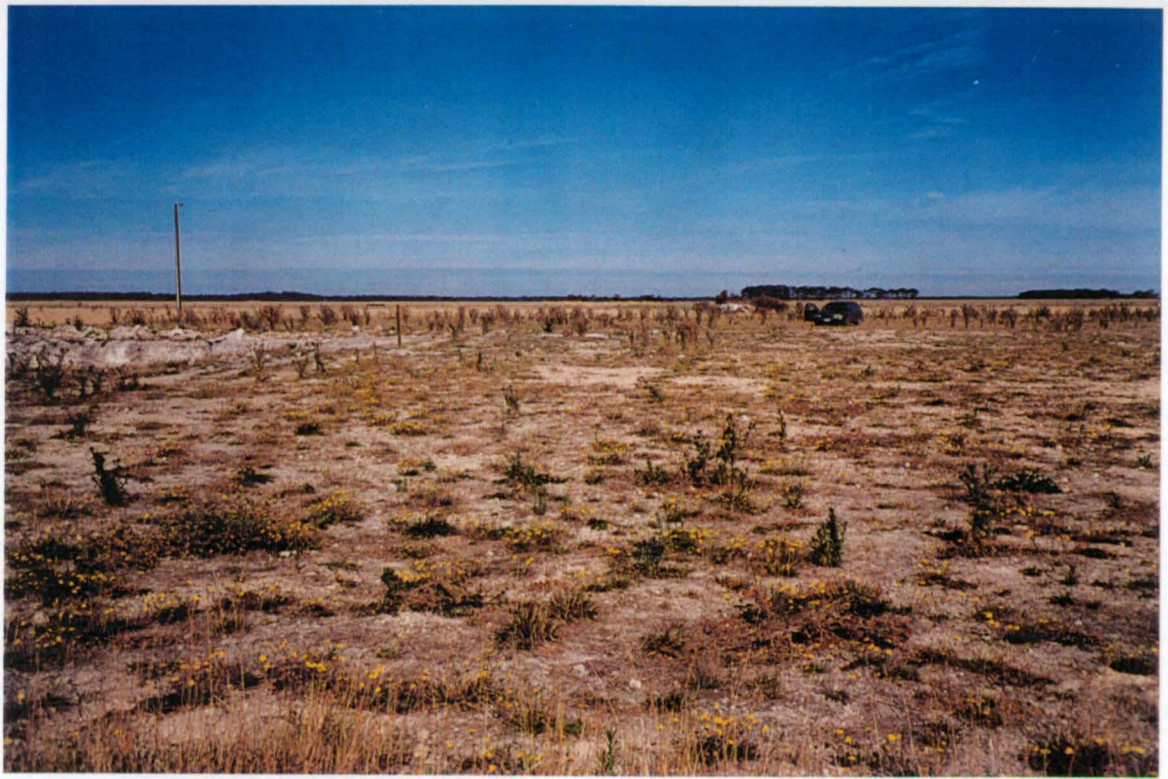
Figure -3 Looking West onto site from Eastern end of drill area.

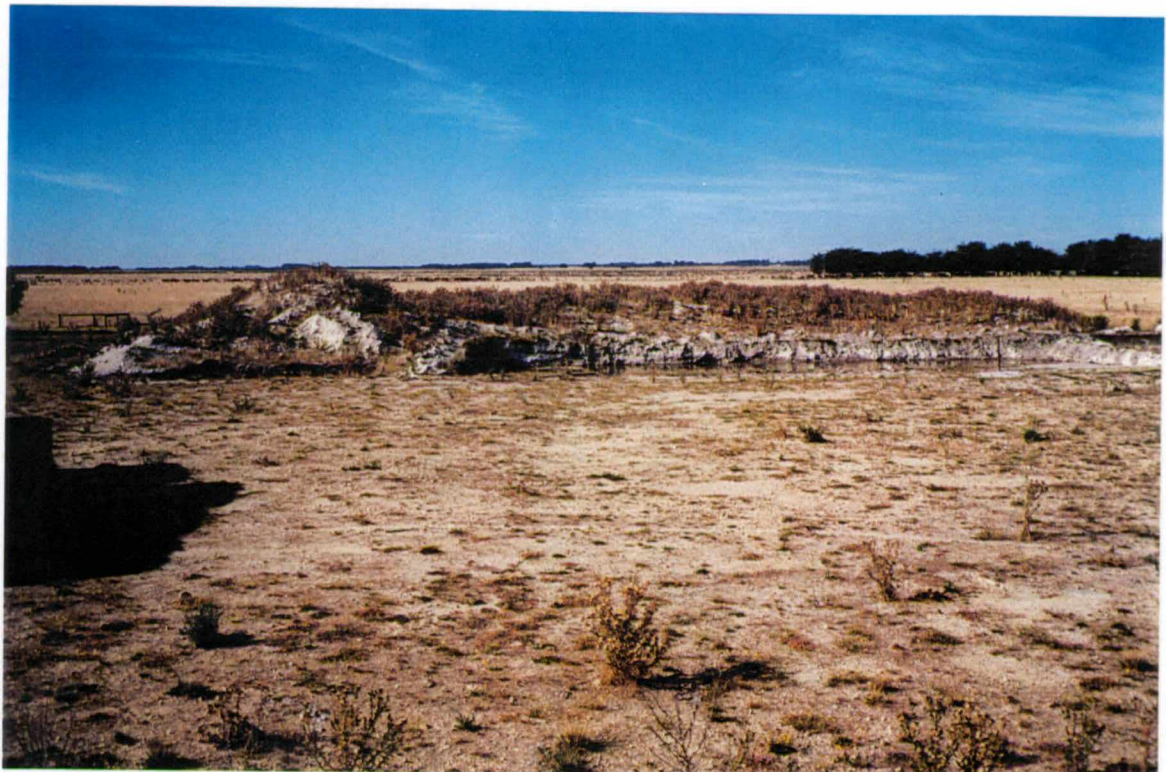
Figure -4 Looking South onto site from top of topsoil stockpile.

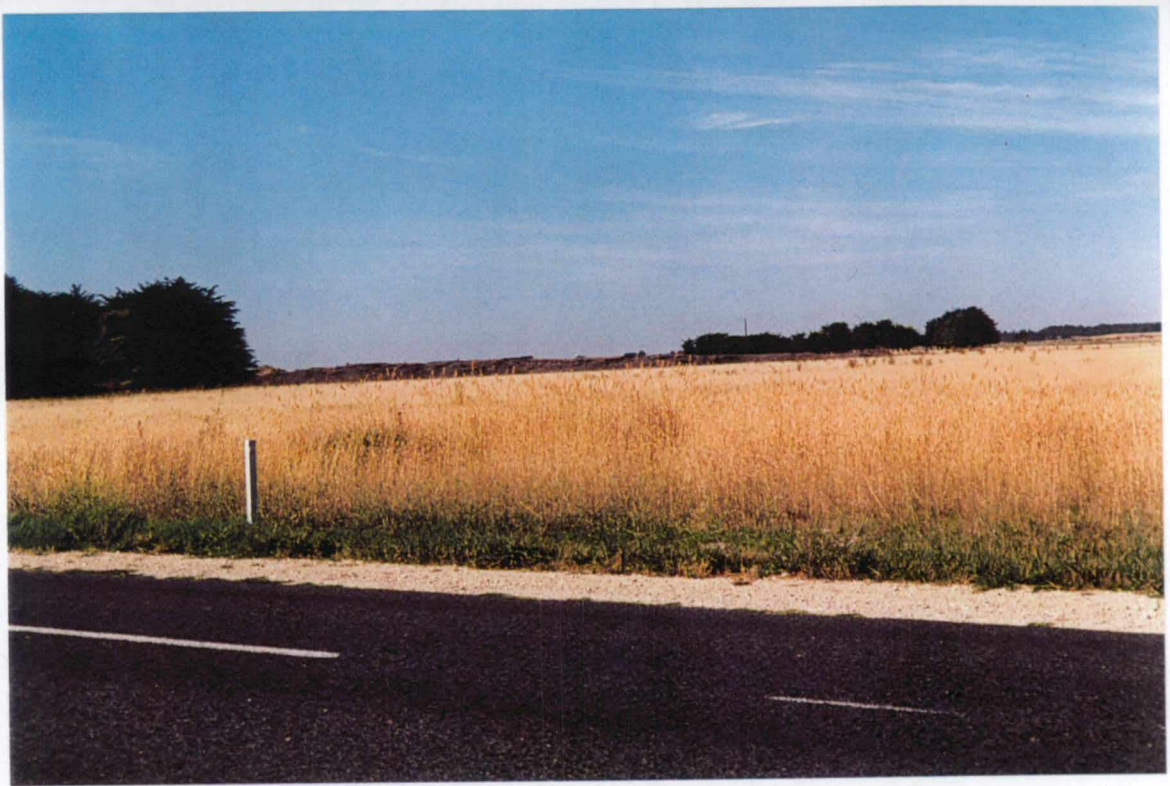
Figure -5 Looking South onto site from Robe-Penola Road.

The rig was released in March 1992. To date little rehabilitation/restoration work has been carried out on the well site. A fence completely surrounds the area and a gate leading into the drill area has been erected. Sown pastures with a cover of native grasses dominate the surrounding landscape. Land use in the area is dominated by livestock grazing. The site was photographed in all directions as a means of recording environmental disturbance (figures 1-4). Little land disturbance is evident when looking southerly from the Robe-Penola road onto the well site (figure 5). The only visible disturbance from the road is the topsoil stockpile situated to the north of the site.

SOIL SURFACE CONDITION: Average. Deep Ripping required for continuous cover of vegetative growth.

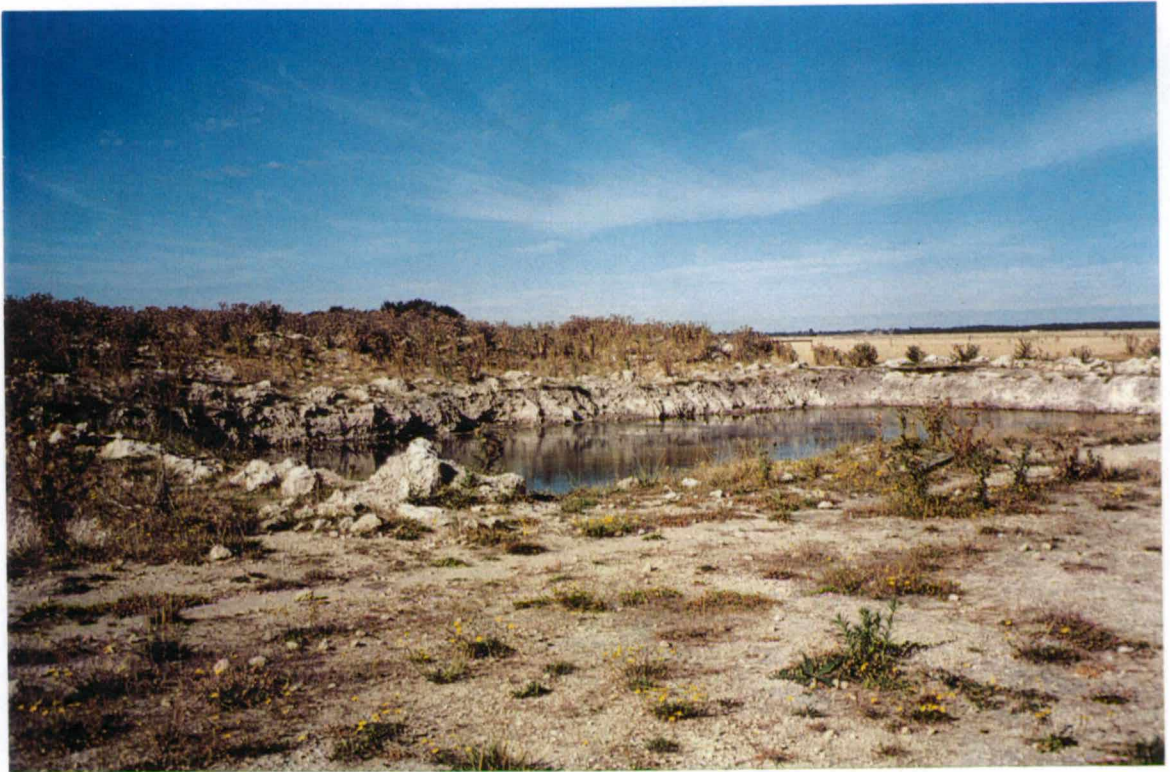
The current landowner Mr Lea, is completely satisfied with the state of the site and is using the site as an integral part of his ongoing farming operations. The hard standing is used for hay storage and distribution. The sump situated to the southern end of the drill area and to the forefront of the spoil stockpile is full of water and has some form of water weed growing within, which appears to attract various bird life (figure 6). Other biological life, namely various micro-organisms, is evident within the confines of the water. Mr Lea has mentioned using the pit for yabby propagation in the future. The water-pit is also full of relatively clear water and is used for stock watering and yabby propagation (figure 7).

Figure -6 Looking South Westerly onto sump.

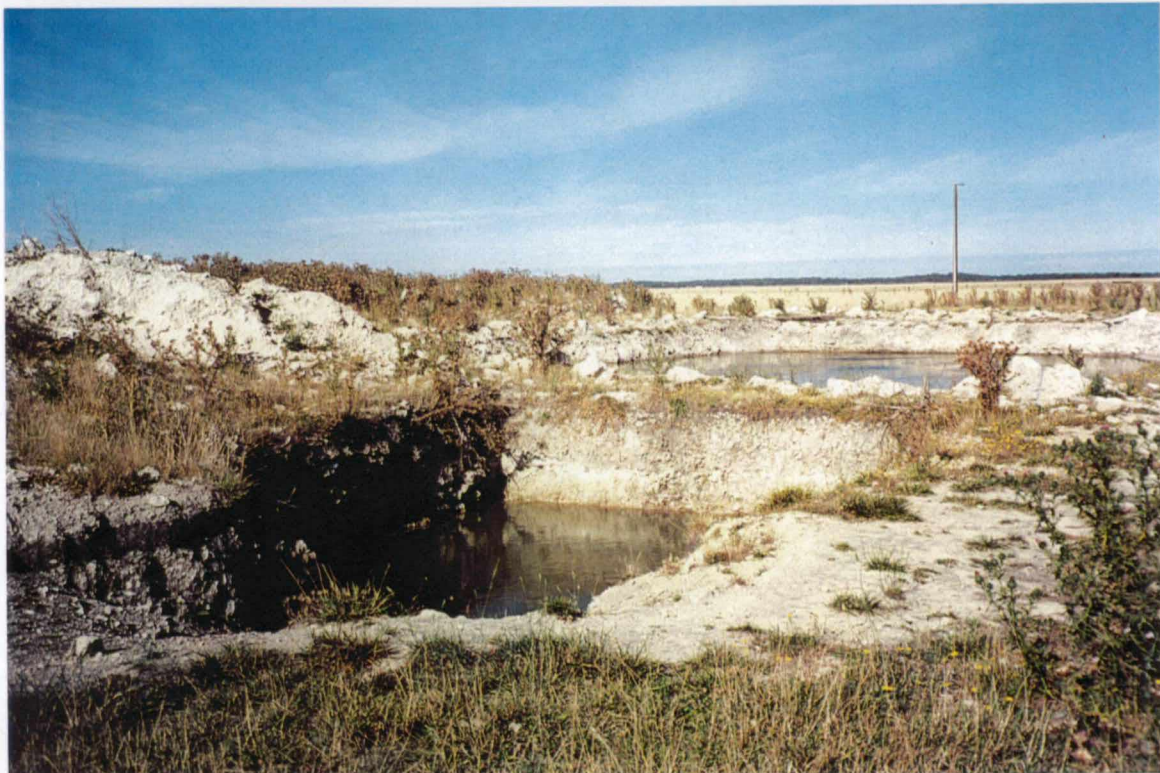
Figure -7 Looking Westerly onto water-pit.

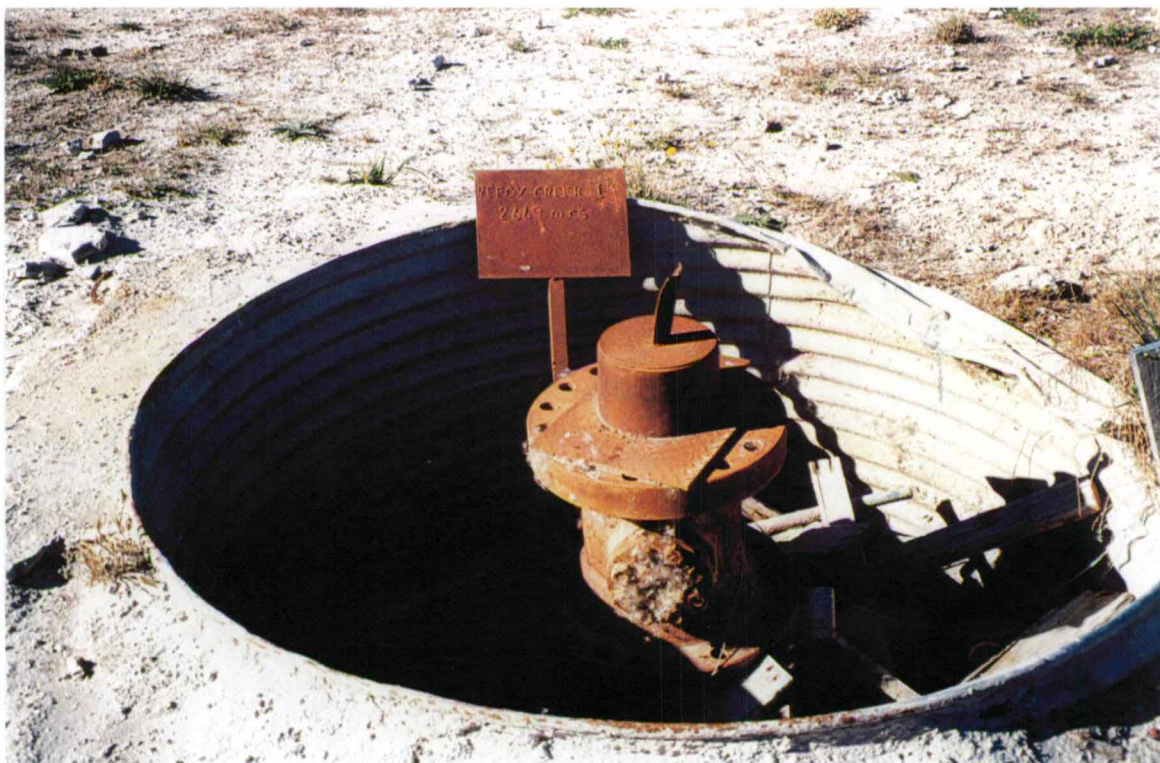
The flare pit situated at the western end of the sump is completely dry and has not been filled with subsoil and respread with associated vegetation. The cellar remains open and Mr Lea has agreed to fill this in before the end of February 1995. The well name and number are clearly displayed on the well head (figure 8).

Figure -8 Reedy-Creek well head.
