Mining application and proposal

Section 1: Description of the existing environment

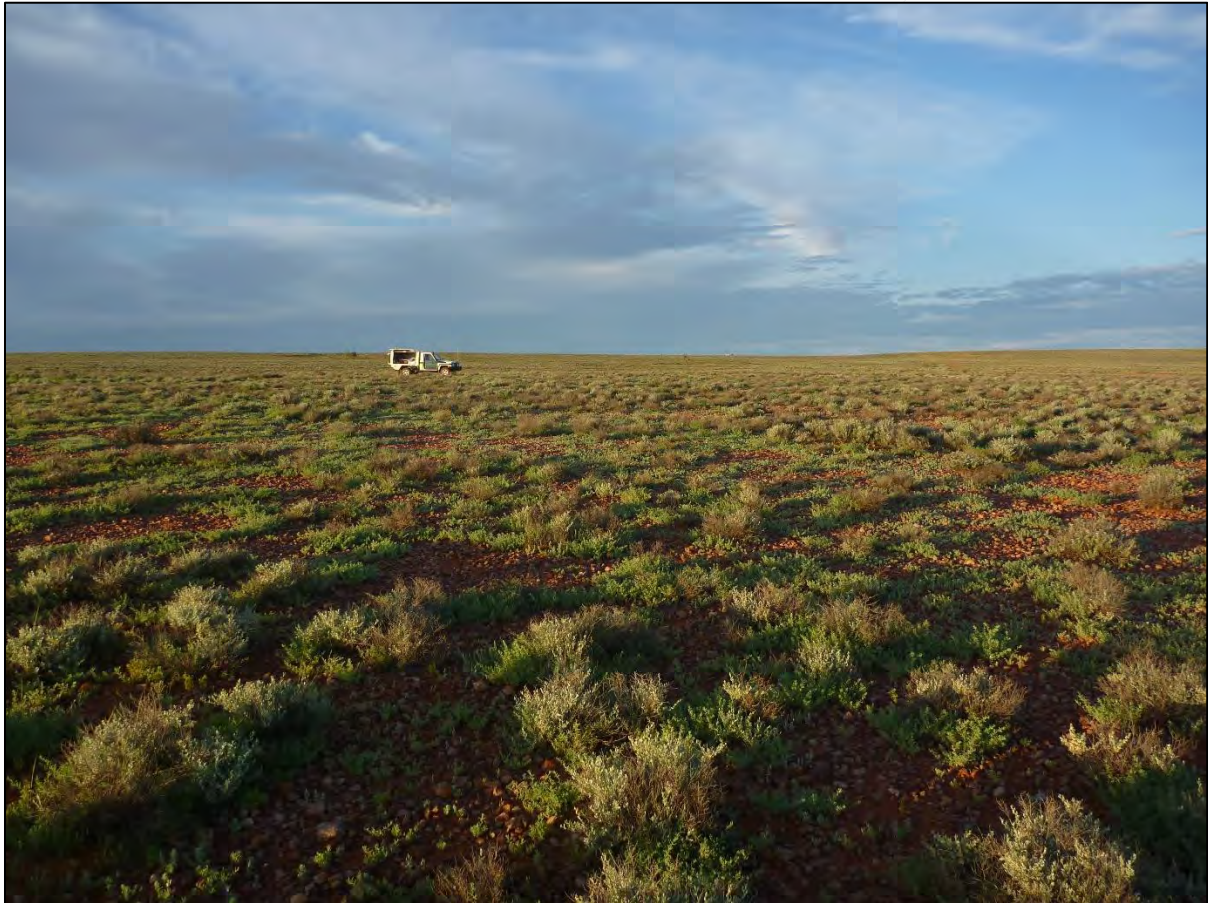
General Description	<p>Sparse, low shrubland dominated by <i>Atriplex vesicaria</i>, with emergent <i>Maireana</i> spp. Ground vegetation is sparse, with <i>Austrostipa nitida</i> and annual forbs such as <i>Gnephosis arachnoidea</i> dominant.</p> <p>Disturbances include light grazing and erosion close to some vehicle tracks and fence lines.</p> <p>Occurs on an Undulating plain with gibber pavement and clay soils.</p>	Survey Sites	A1a A1b
----------------------------	---	---------------------	------------

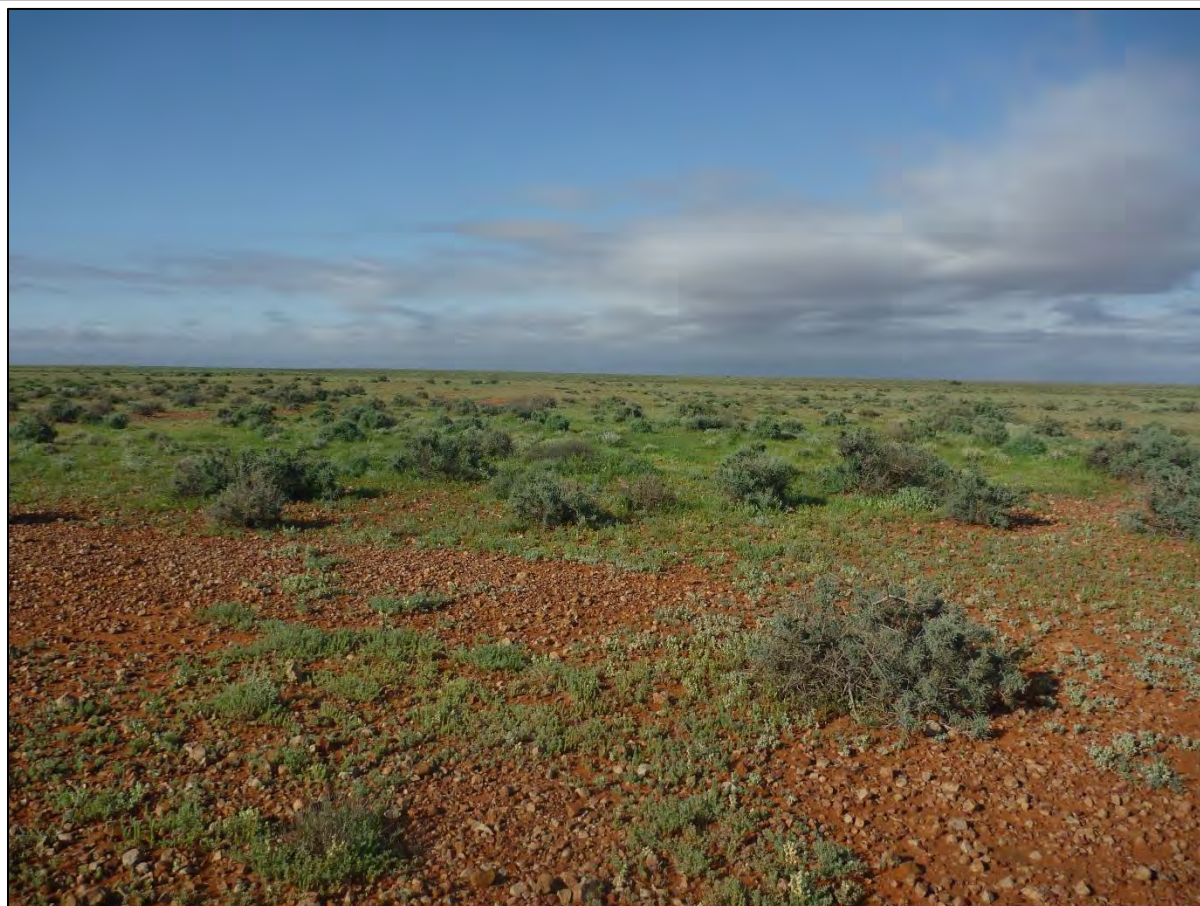
General Description	Run-on areas with heavy, stony soils and cracking clay gilgais.		Survey Sites	A2	
Threatened Species or Ecological Community	Likely: - Slender-billed Thornbill (<i>Acanthiza iredalei iredalei</i>) - Chestnut-breasted Whiteface (<i>Aphelocephala pectoralis</i>) - Plains Mouse (<i>Pseudomys australis</i>) Possible: - Thick-billed Grasswren (<i>Amytornis modestus</i>) - Grey Falcon (<i>Falco hypoleucos</i>) - <i>Ophioglossum polyphyllum</i> (Large Adder's Tongue) - <i>Santalum spicatum</i> (Sandalwood)				
Landscape Context Score	1.1	Vegetation Condition Score	49.34	Conservation Significance Score	1.1
Unit Biodiversity Score	59.71	Condition category	Medium

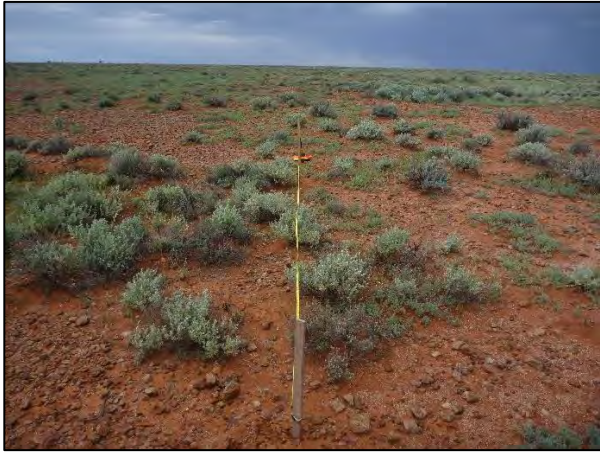
Figure 7. BHR003 impact monitoring site.

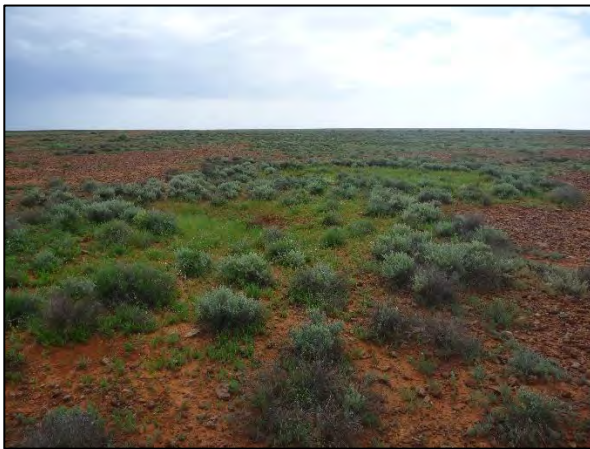
Figure 11. Gilgais and run-on areas, evident as green vegetation in this photograph, had a higher diversity of annual plant species and greater vegetation cover.

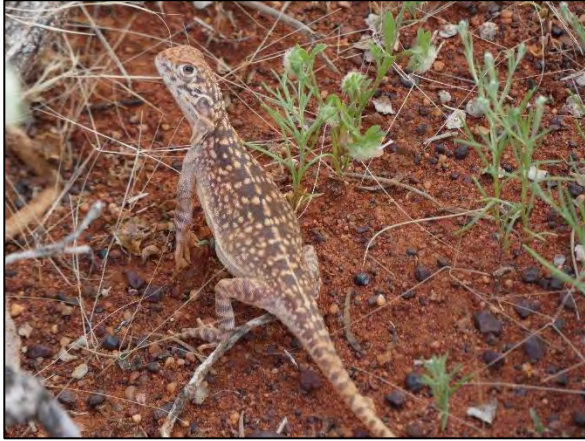
Figure 13. The Central Netted Dragon (*Ctenophorus nuchalis*) was one of the most commonly captured species.

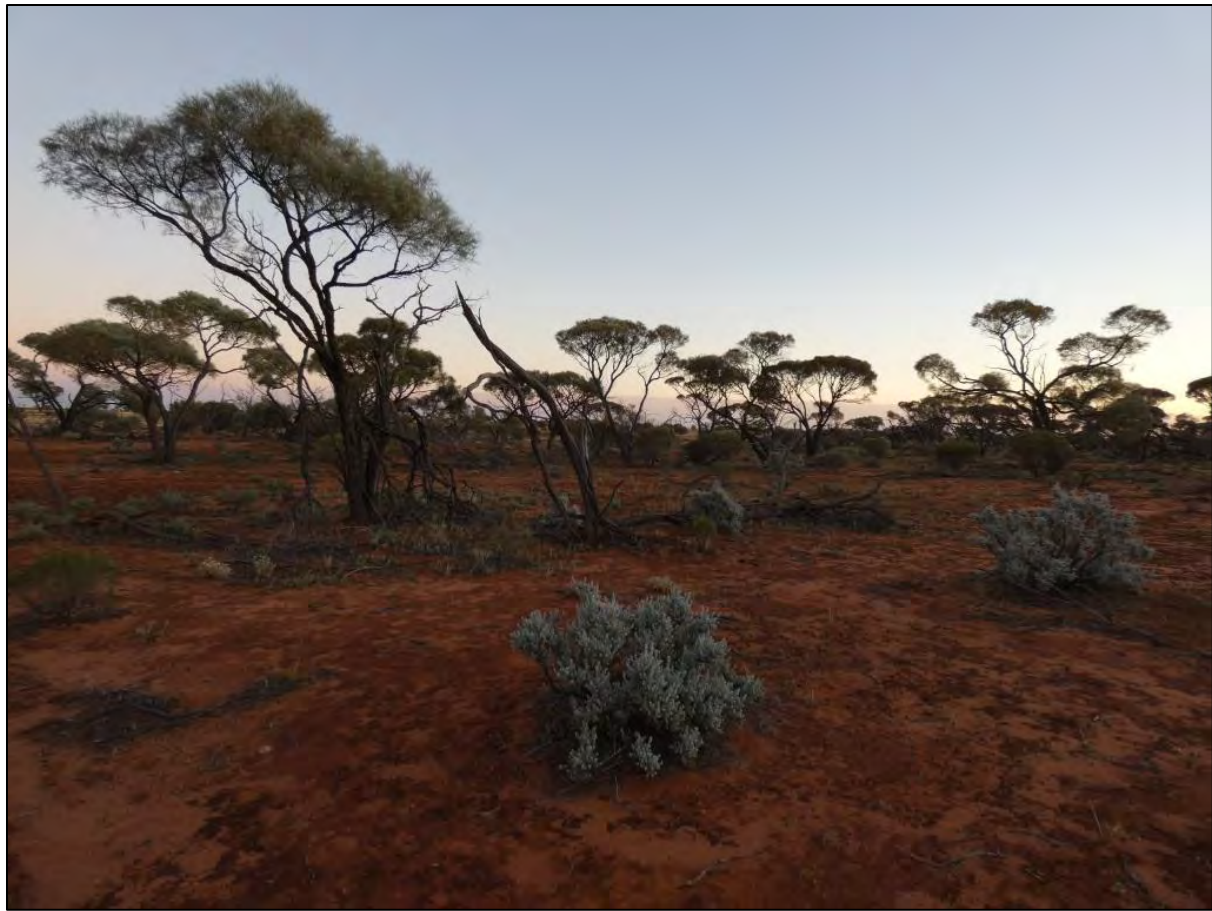
<p>General Description</p>	<p>Sparse, low woodland dominated by <i>Rhagodia spinescens</i> and <i>Senna artemisioides</i> ssp. <i>petiolaris</i> understorey. Ground vegetation is sparse, with <i>Austrostipa nitida</i> and annual forbs such as <i>Gnephosis arachnoidea</i> dominant. Disturbances include light grazing and erosion close to some vehicle tracks and fence lines. Occurs on an Undulating plain with sandy soils.</p>			<p>Survey Sites</p>	<p>Site B1</p>
<p>Threatened Species or Ecological Community</p>	<p>Possible: - Grey Falcon (<i>Falco hypoleucos</i>)</p>				
<p>Landscape Context Score</p>	<p>1.18</p>	<p>Vegetation Condition Score</p>	<p>65.14</p>	<p>Conservation Significance Score</p>	<p>1.02</p>
<p>Unit Biodiversity Score</p>	<p>78.40</p>	<p>Condition category</p>	<p>Medium-High</p>

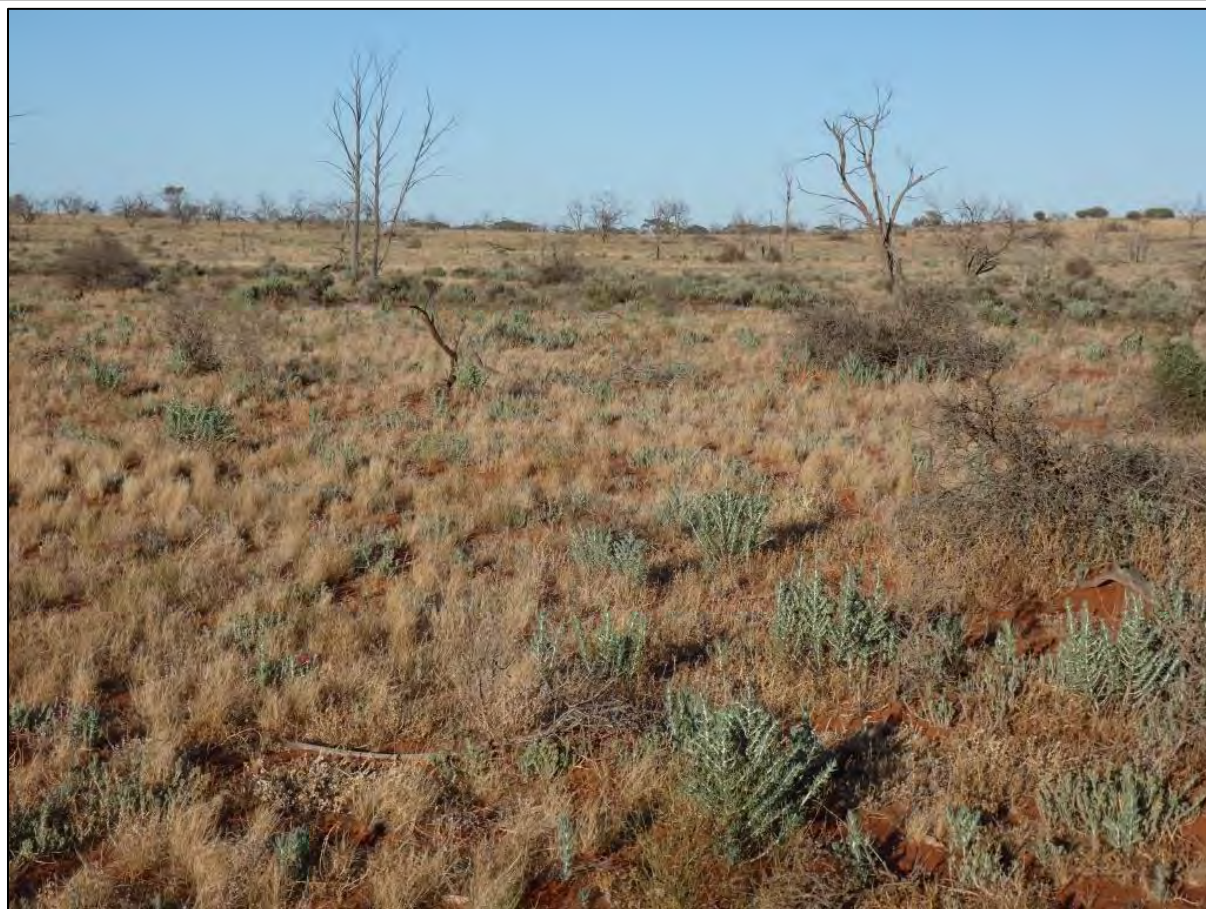
General Description	Very sparse <i>Acacia aneura</i> woodland over <i>Maireana pentatropis</i> and <i>Maireana georgei</i> . Occurs on a level plain with sandy soils.			Survey Sites	Site B3
Threatened Species or Ecological Community	Possible: - Grey Falcon (<i>Falco hypoleucos</i>)				
Landscape Context Score	1.18	Vegetation Condition Score	61.20	Conservation Significance Score	1.02
Unit Biodiversity Score	73.66	Condition category	Medium-High

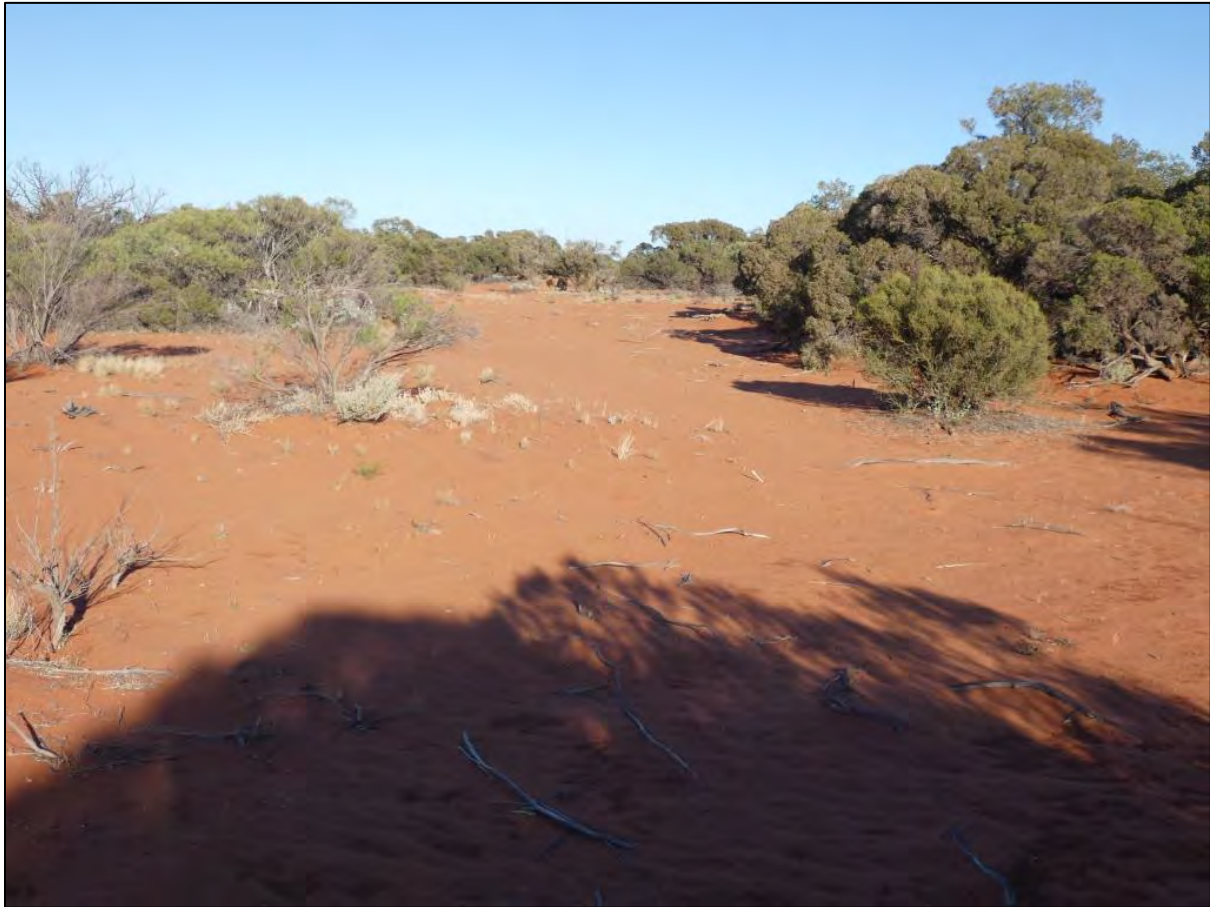
General Description	Open shrubland dominated by <i>Melaleuca sp.</i> over <i>Dodonaea viscosa</i> . Occurs on drainage lines/flood outs on sandy soils.		Survey Sites	Site B4	
Threatened Species or Ecological Community	Possible: <ul style="list-style-type: none"> - Grey Falcon (<i>Falco hypoleucos</i>) - <i>Ophioglossum polyphyllum</i> (Large Adder's Tongue) 				
Landscape Context Score	1.18	Vegetation Condition Score	57.55	Conservation Significance Score	1.06
Unit Biodiversity Score	71.98	Condition category	Medium-High

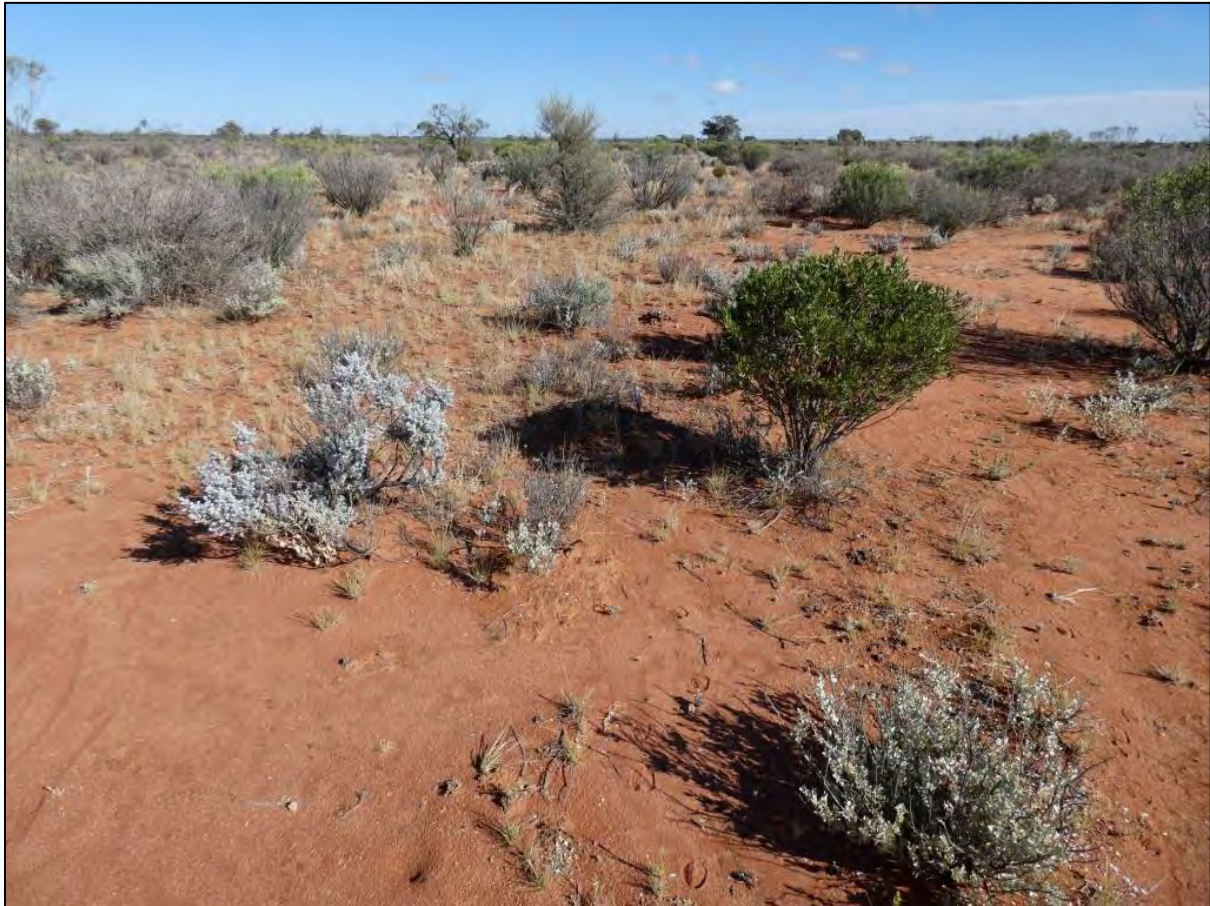
General Description	Open shrubland dominated by <i>Senna artemisioides</i> ssp. <i>petiolaris</i> and <i>Maireana sedifolia</i> with emergent <i>Myoporum platycarpum</i> . There is some evidence of grazing activity that is having an impact on plants. Occurs on a level plain on sandy soils.		Survey Sites	Site B5	
Threatened Species or Ecological Community	Possible: <ul style="list-style-type: none"> - Grey Falcon (<i>Falco hypoleucos</i>) - <i>Ophioglossum polyphyllum</i> (Large Adder's Tongue) 				
Landscape Context Score	1.18	Vegetation Condition Score	55.49	Conservation Significance Score	1.06
Unit Biodiversity Score	69.41	Condition category	Medium

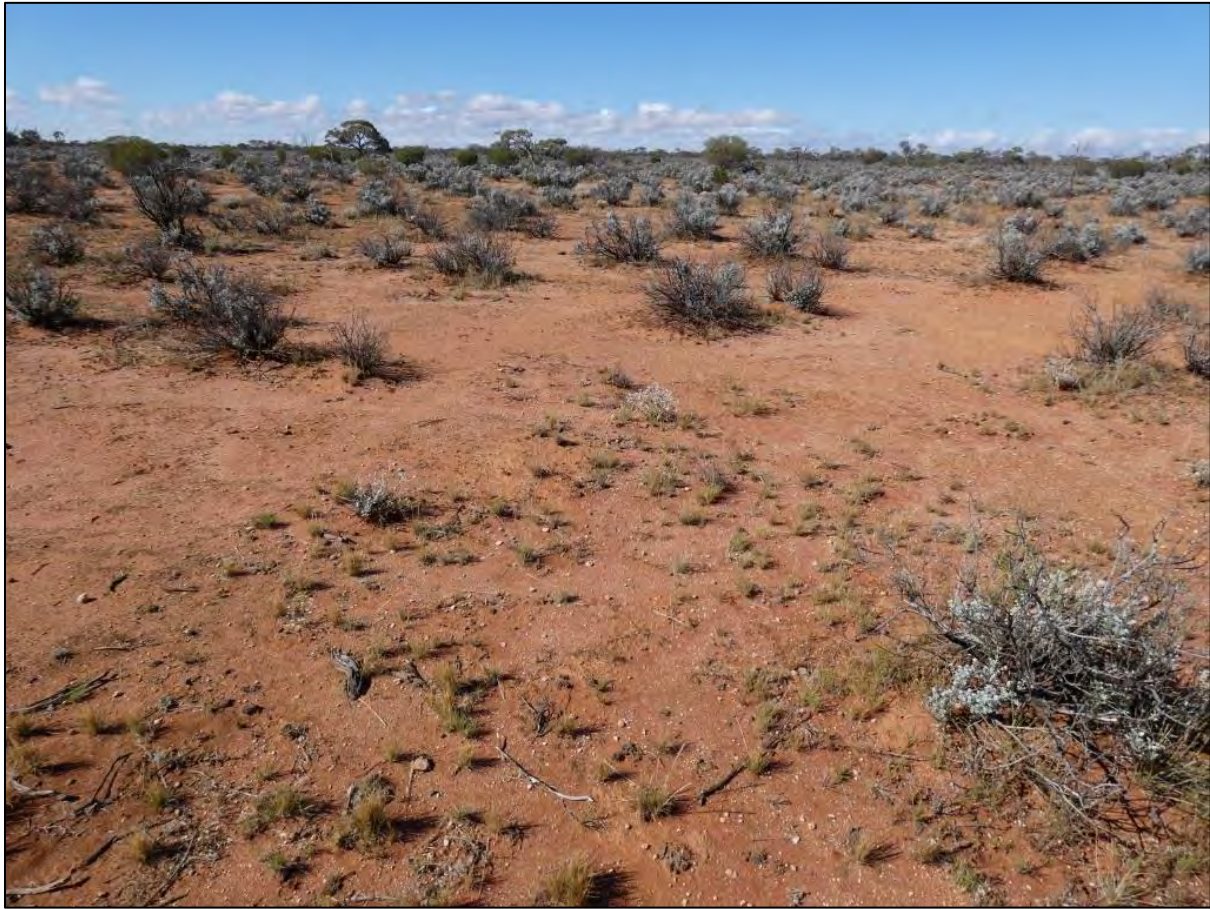
General Description	Open <i>Acacia aneura</i> woodland dominated by <i>Maireana sedifolia</i> understorey. Occurs on a level plain on sandy soils.		Survey Sites	Site B6
Threatened Species or Ecological Community	Possible: <ul style="list-style-type: none"> - Grey Falcon (<i>Falco hypoleucos</i>) - <i>Ophioglossum polyphyllum</i> (Large Adder's Tongue) 			
Landscape Context Score	1.18	Vegetation Condition Score	58.15	Conservation Significance Score 1.06
Unit Biodiversity Score	72.74	Condition category	Medium-High

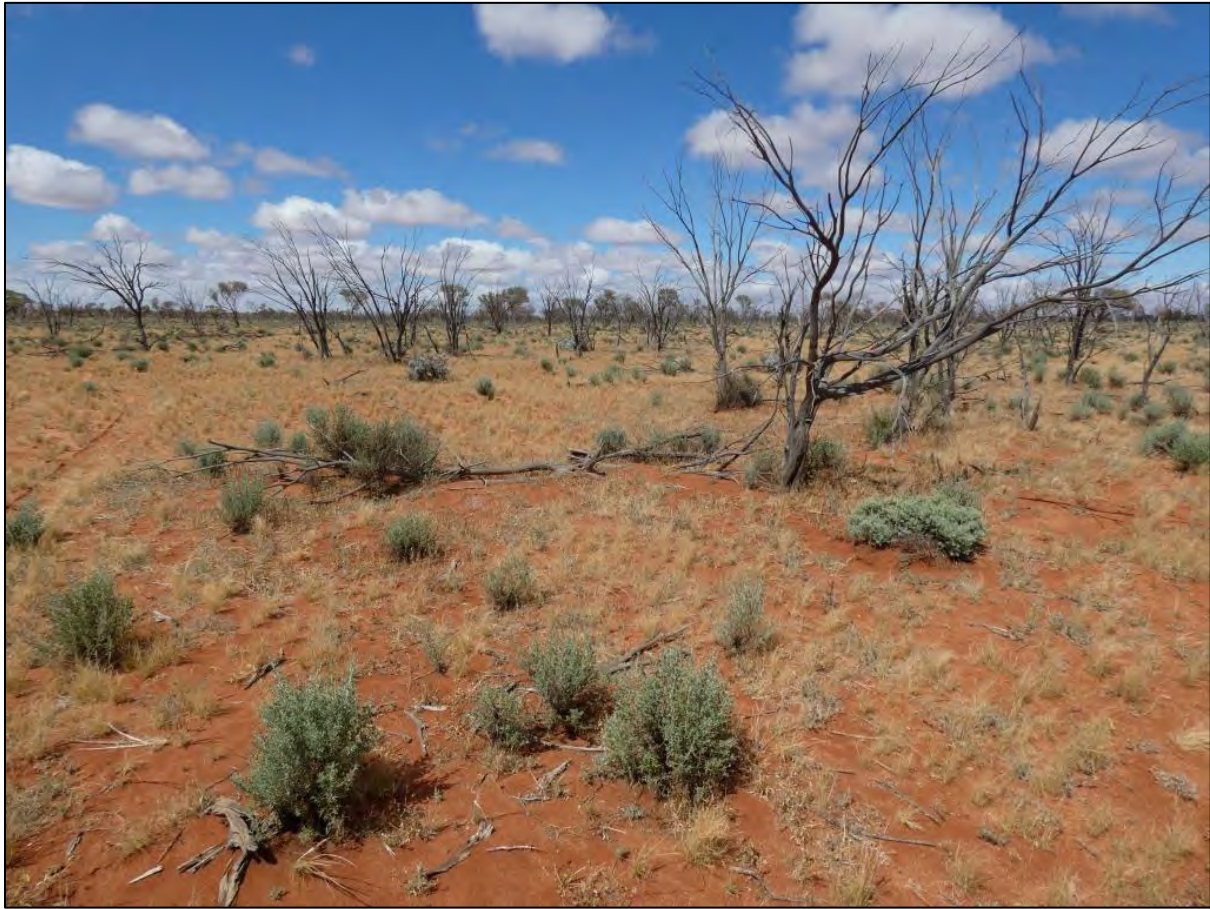
General Description	Open <i>Acacia aneura</i> woodland with an understorey of <i>Maireana sedifolia</i> , <i>Maireana georgei</i> and <i>Aristida contorta</i> . Occurs on a level plain on sandy soils.			Survey Sites	Site B7
Threatened Species or Ecological Community	Possible: <ul style="list-style-type: none"> - Grey Falcon (<i>Falco hypoleucos</i>) - <i>Ophioglossum polyphyllum</i> (Large Adder's Tongue) 				
Landscape Context Score	1.18	Vegetation Condition Score	61.86	Conservation Significance Score	1.06
Unit Biodiversity Score	77.37	Condition category	Medium-High

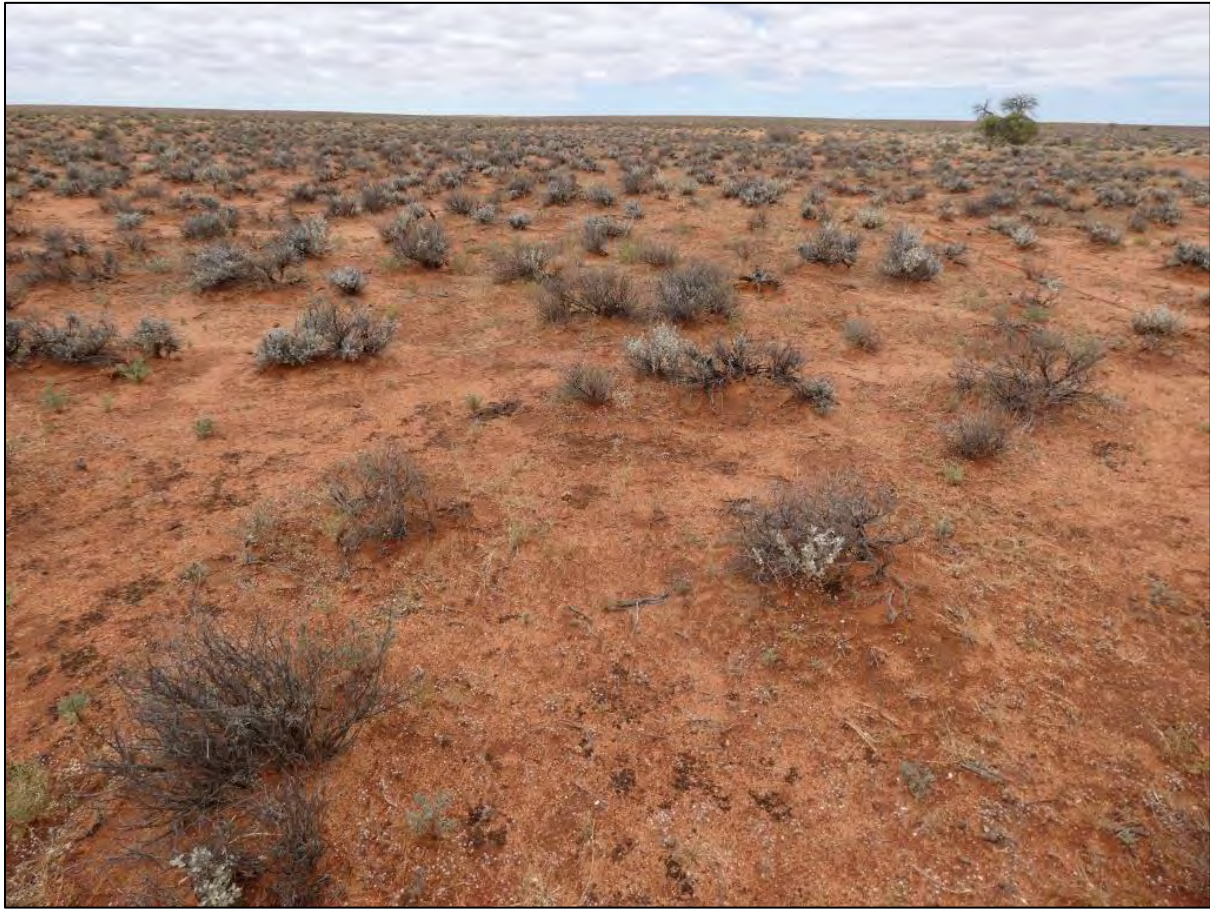
General Description	Very low open dominated by <i>Maireana sedifolia</i> and <i>Atriplex vesicaria</i> . Occurs on a level plain on sandy soils.		Survey Sites	Site B8
Threatened Species or Ecological Community	Possible: <ul style="list-style-type: none"> - Slender-billed Thornbill (<i>Acanthiza iredalei iredalei</i>) - Plains Mouse (<i>Pseudomys australis</i>) - Grey Falcon (<i>Falco hypoleucos</i>) - <i>Ophioglossum polyphyllum</i> (Large Adder's Tongue) 			
Landscape Context Score	1.18	Vegetation Condition Score	58.52	Conservation Significance Score 1.12
Unit Biodiversity Score	77.34	Condition category	Medium-High

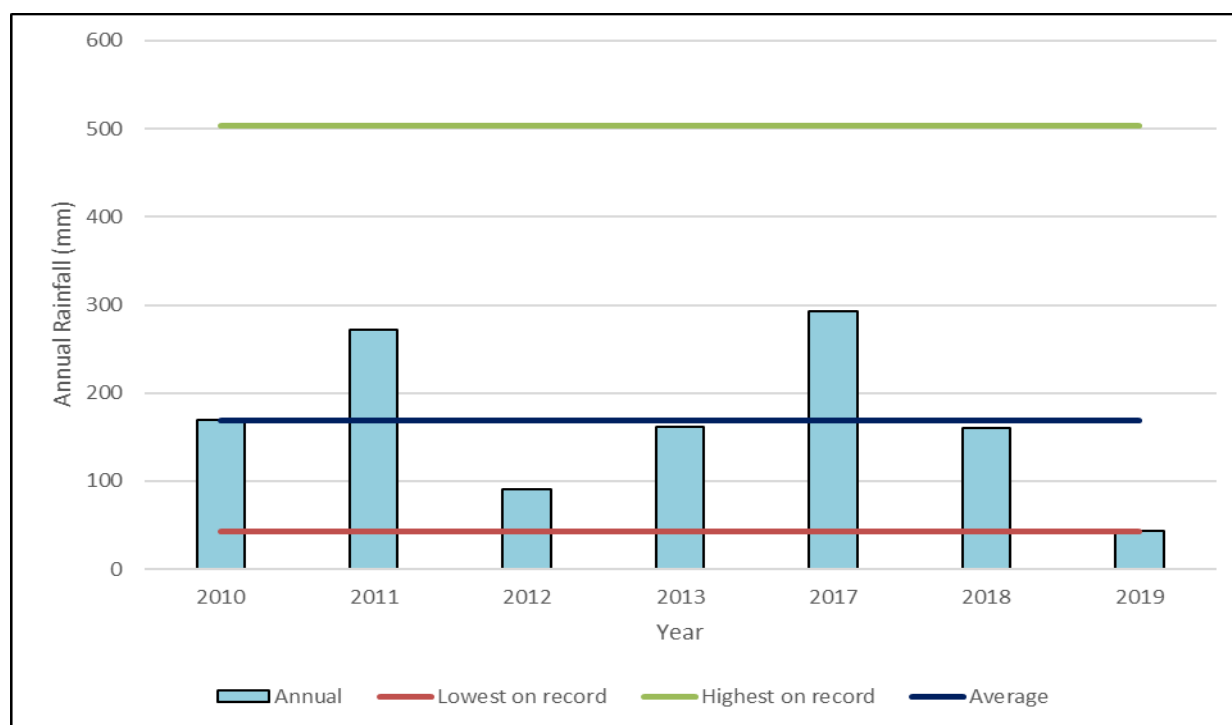
Figure 2. Annual rainfall since 2010 recorded at Coondambo, the closest Bureau of Meteorology rain recording station to the Project Area (Bureau of Meteorology, 2021). The figure also shows the average, highest and lowest annual rainfall on record. Note that data does not exist for all years.

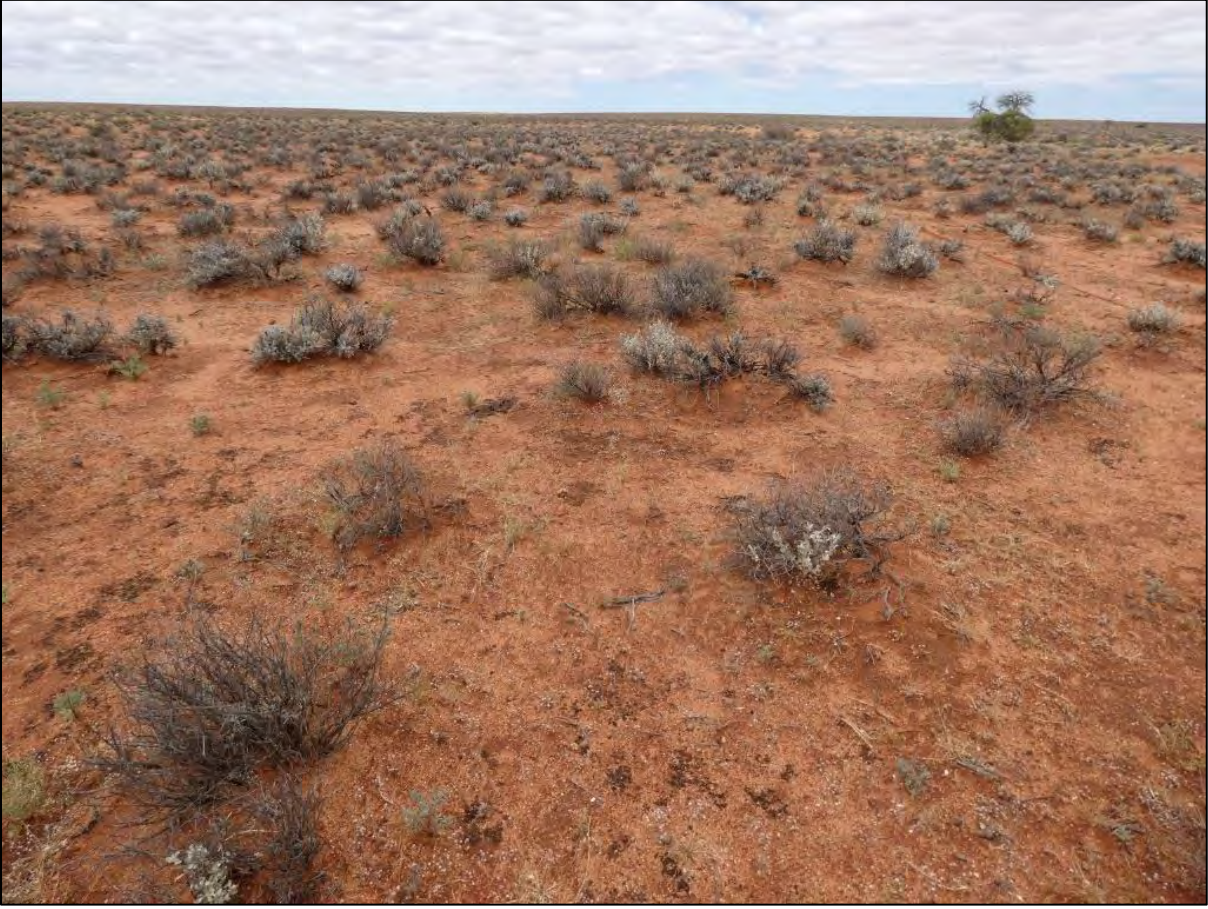
General Description	Very low open dominated by <i>Maireana sedifolia</i> and <i>Atriplex vesicaria</i> . Occurs on a level plain on sandy soils.			Survey Sites	Site B8
Threatened Species or Ecological Community	Possible: <ul style="list-style-type: none"> - Thick-billed Grasswren (<i>Amytornis modestus</i>) - Slender-billed Thornbill (<i>Acanthiza iredalei iredalei</i>) - Grey Falcon (<i>Falco hypoleucos</i>) - <i>Ophioglossum polyphyllum</i> (Large Adder's Tongue) 				
Landscape Context Score	1.18	Vegetation Condition Score	58.52	Conservation Significance Score	1.12
Unit Biodiversity Score	77.34	Condition category	Medium-High

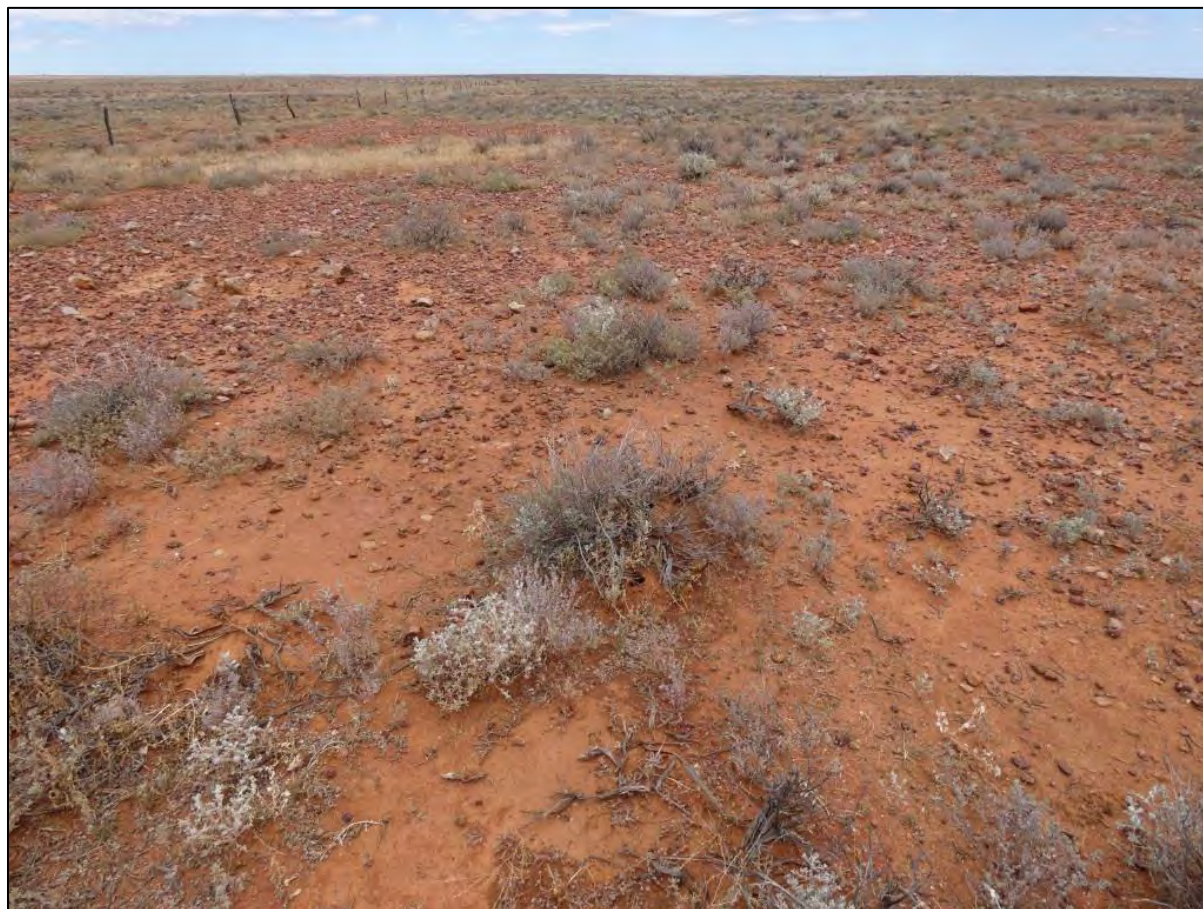
General Description	Very low open dominated by <i>Maireana sedifolia</i> and <i>Atriplex vesicaria</i> . Occurs on a level plain on sandy soils.		Survey Sites	Site B9	
Threatened Species or Ecological Community	Likely: <ul style="list-style-type: none"> - Slender-billed Thornbill (<i>Acanthiza iredalei iredalei</i>) - Chestnut-breasted Whiteface (<i>Aphelocephala pectoralis</i>) Possible: <ul style="list-style-type: none"> - Grey Falcon (<i>Falco hypoleucos</i>) - <i>Ophioglossum polyphyllum</i> (Large Adder's Tongue) - <i>Santalum spicatum</i> (Sandalwood) 				
Landscape Context Score	1.18	Vegetation Condition Score	48.50	Conservation Significance Score	1.16
Unit Biodiversity Score	66.39	Condition category	Medium

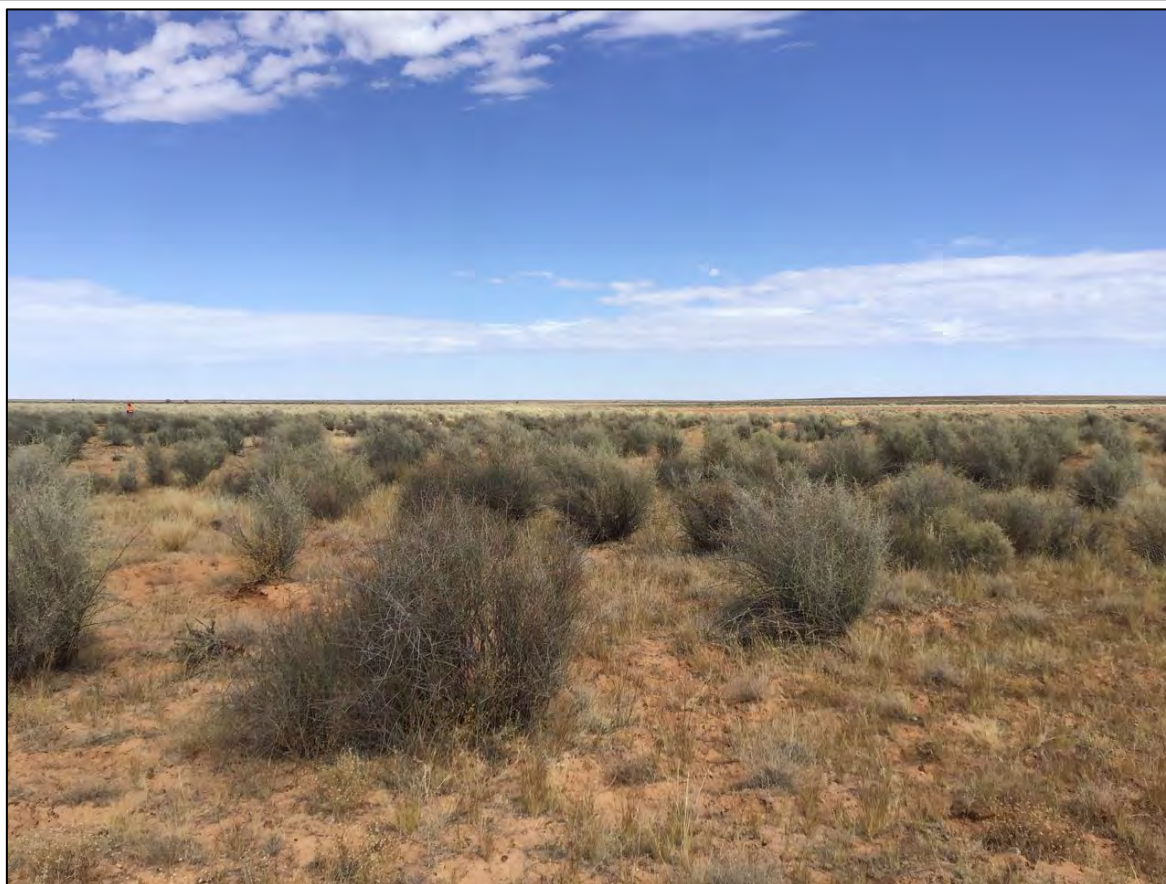
Chenopodium nitrariaceum +/- *Muehlenbeckia florulenta* Shrubland to Open Shrubland over *Eragrostis australasica*, *Eragrostis setifolia* and *Eleocharis pallens*.

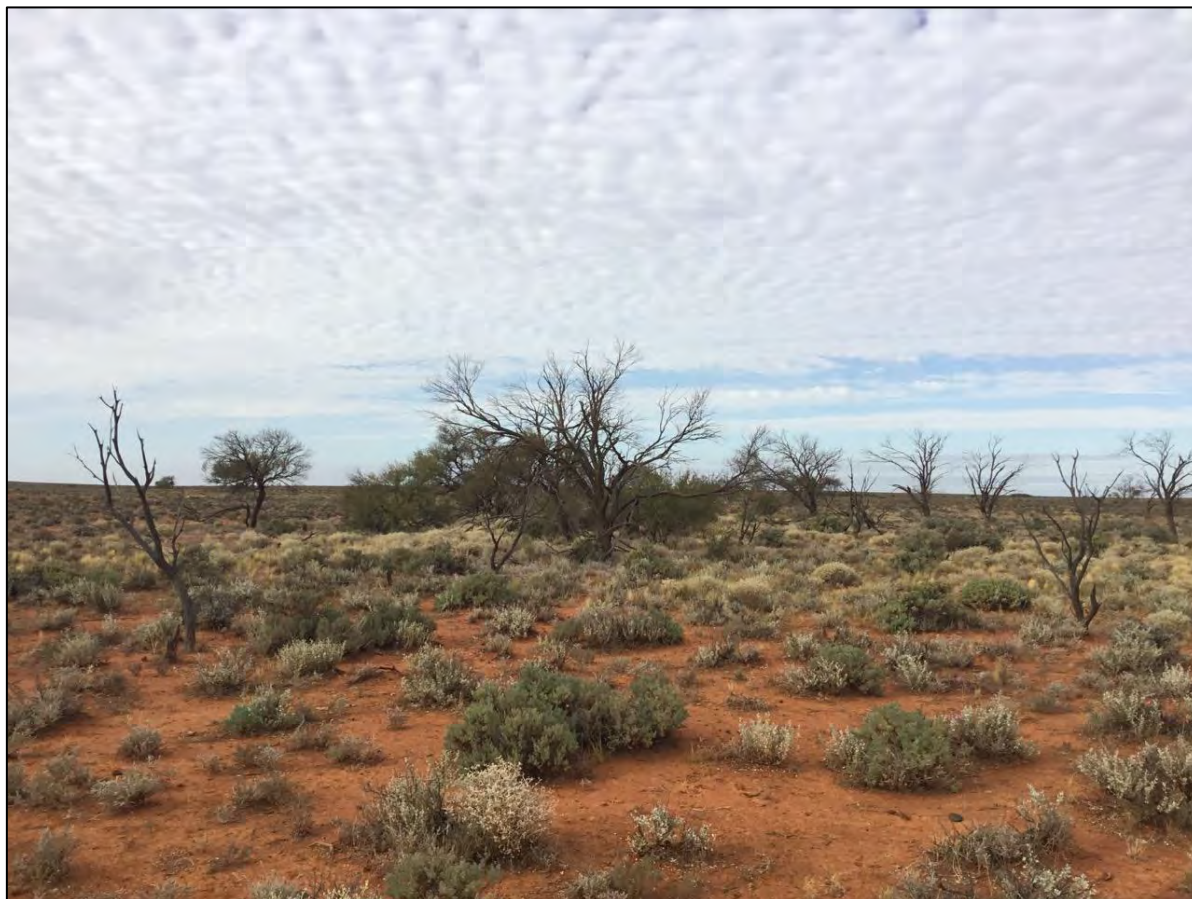
General Description	Low Open Woodland of <i>Acacia aneura</i> (Mulga) over a mixed Chenopod understorey and annual grasses such as <i>Aristida</i> spp. and <i>Enneapogon</i> spp. The Vegetation Association occurs in drainage lines and floodouts that dissect stony, undulating plains. Condition of the overstorey is poor, with many trees dead or dying. However, some regeneration is present, particularly understorey shrub species.		Survey Sites	BHR015 BHR015a	
Threatened Species or Ecological Community	Possible: <ul style="list-style-type: none"> - Grey Falcon (<i>Falco hypoleucos</i>) - Chestnut-breasted Whiteface (<i>Aphelocephala pectoralis</i>) 				
Landscape Context Score	1.14	Vegetation Condition Score	47.46	Conservation Significance Score	1.04
Unit Biodiversity Score	56.63	Condition category	Medium

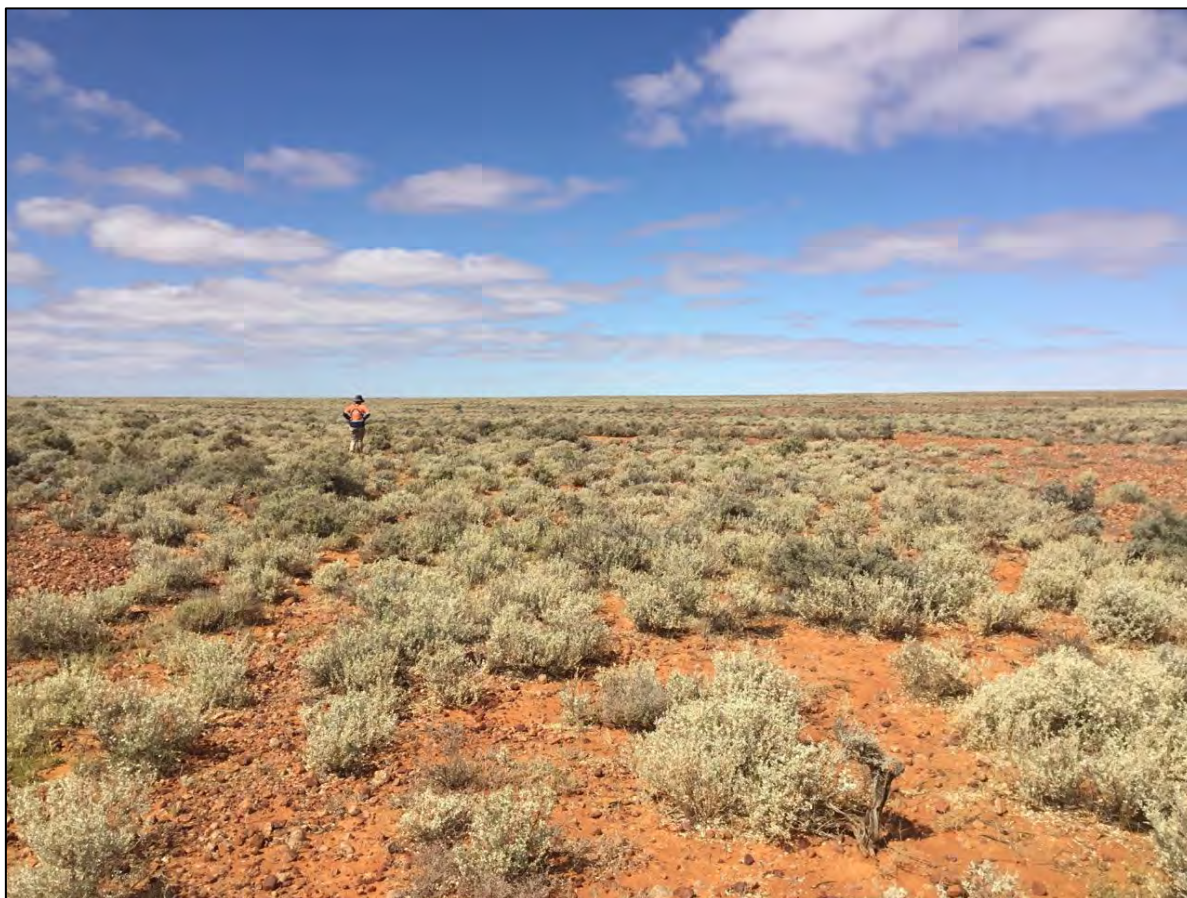
<p>General Description</p>	<p>A Low Shrubland on stony clay soils of the upper reaches of ill-defined drainage lines. Vegetation consists of a low shrub overstorey of <i>Maireana pyramidata</i> over <i>Atriplex vesicaria</i> and annual forbs and grasses. Gilgai are infrequently distributed throughout. Weeds are sparse to absent, with palatable shrubs lightly grazed.</p>		<p>Survey Sites</p>	<p>BHR014</p>	
<p>Threatened Species or Ecological Community</p>	<p>Possible:</p> <ul style="list-style-type: none"> - Plains Mouse (<i>Pseudomys australis</i>) - Thick-billed Grasswren (<i>Amytornis modestus</i>) - Grey Falcon (<i>Falco hypoleucos</i>) 				
<p>Landscape Context Score</p>	<p>1.14</p>	<p>Vegetation Condition Score</p>	<p>51.56</p>	<p>Conservation Significance Score</p>	<p>1.1</p>
<p>Unit Biodiversity Score</p>	<p>64.66</p>	<p>Condition category</p>	<p>Medium</p>

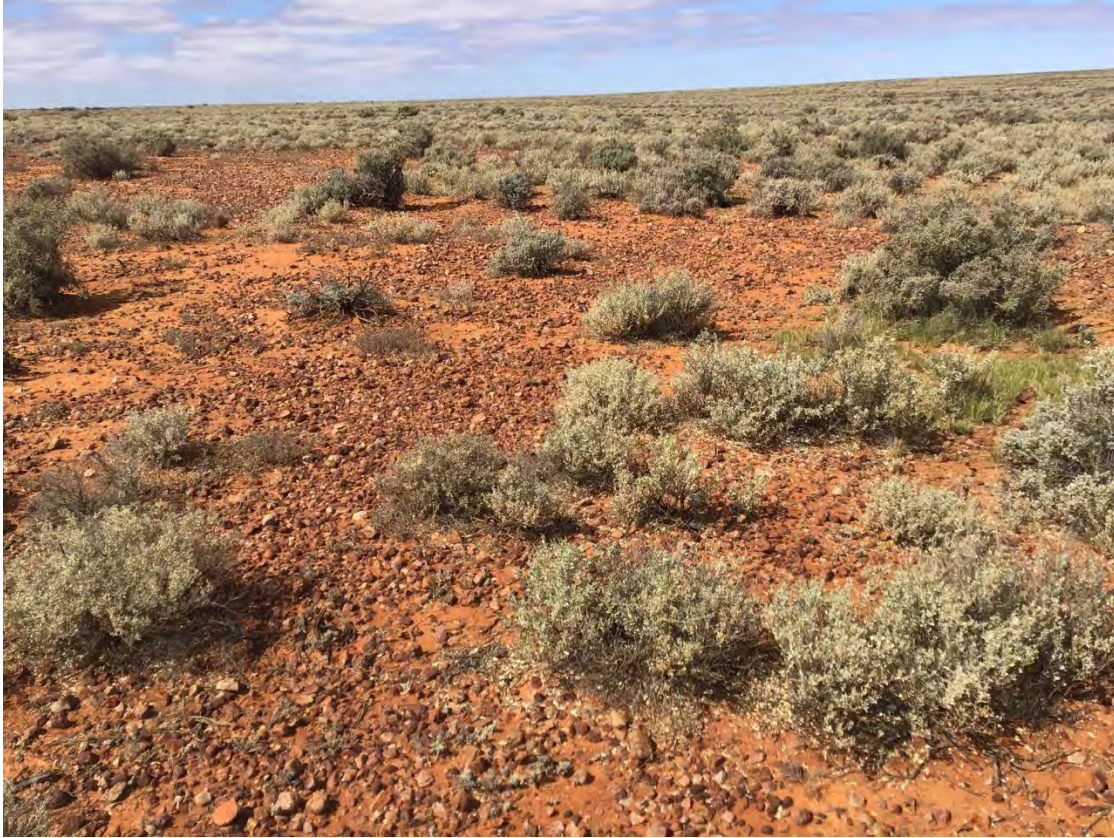
Appendix 2. Plant species recorded by the survey.
