# Wallaroo (Harlequin Dimension Stone) Quarry

Extractive Minerals Lease 5793 and  
Miscellaneous Purposes Licence 109

## Program for Environment Protection and Rehabilitation

July 2023

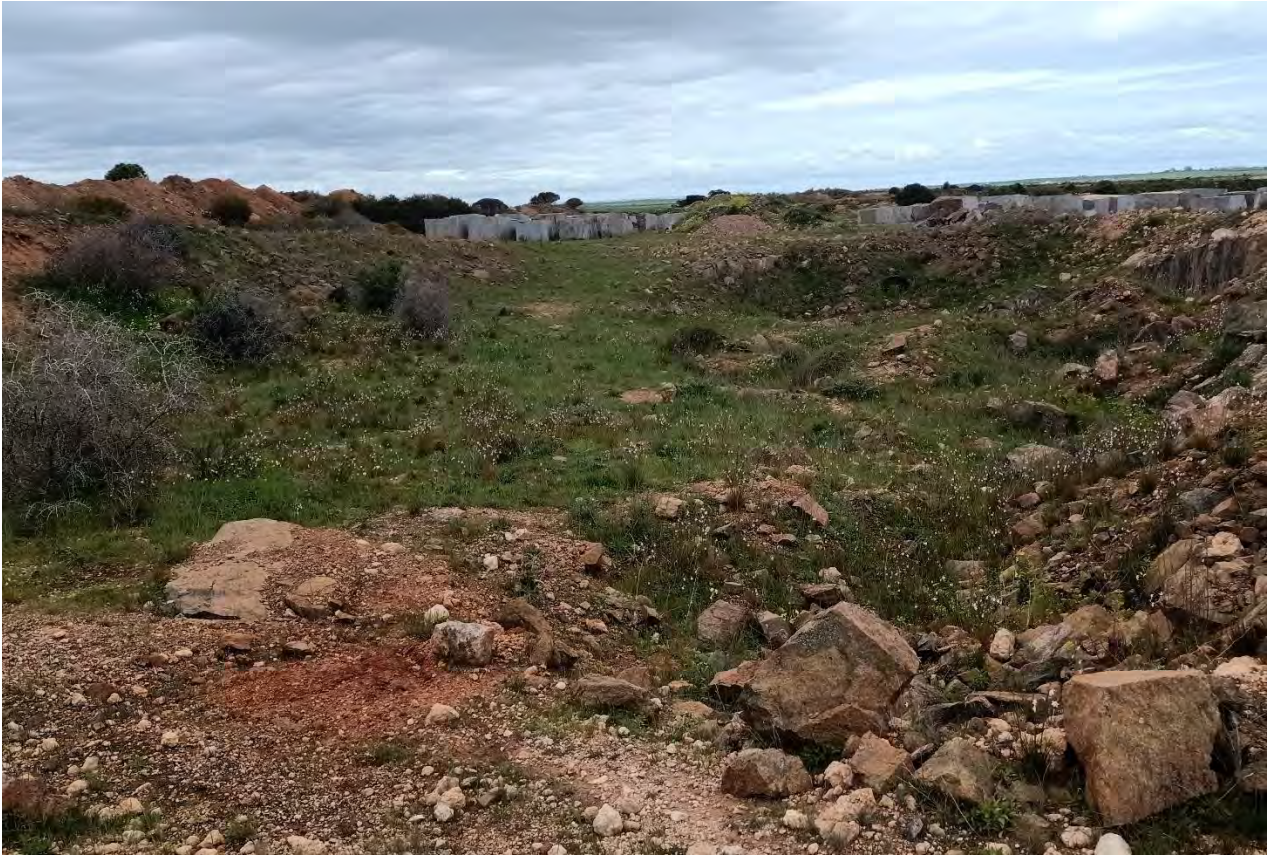
***Plate 5 – Onion weed (white flowers) observed during an inspection conducted on 8 September 2022***

During an inspection of the Site conducted on 8 September 2022, Onion weed was observed in abundance over the disturbed areas around the southern crest of the granite pit (refer **Plate 5**).

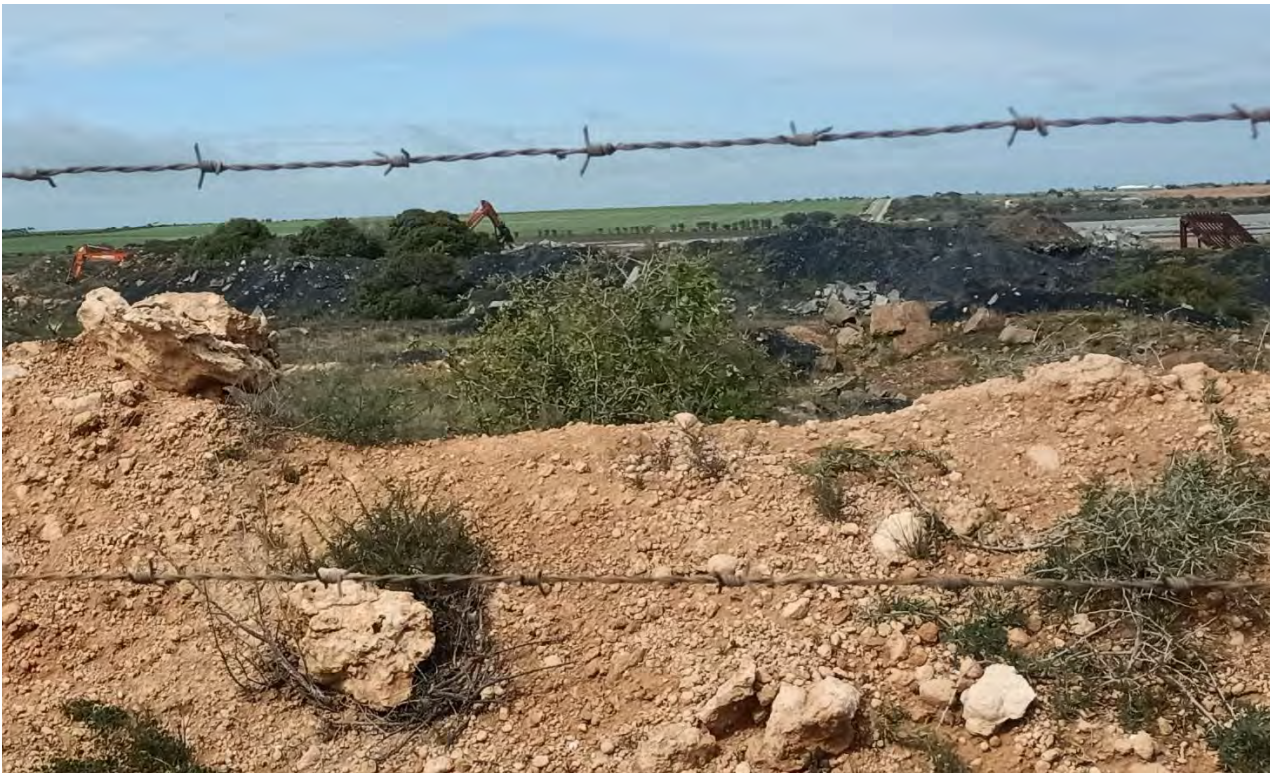
***Plate 6 – African boxthorn observed during an inspection conducted on 8 September 2022***

Infrequent occurrences of African boxthorn were also observed above the northern pit wall and on the eastern side of the granite pit (refer **Plate 7**).

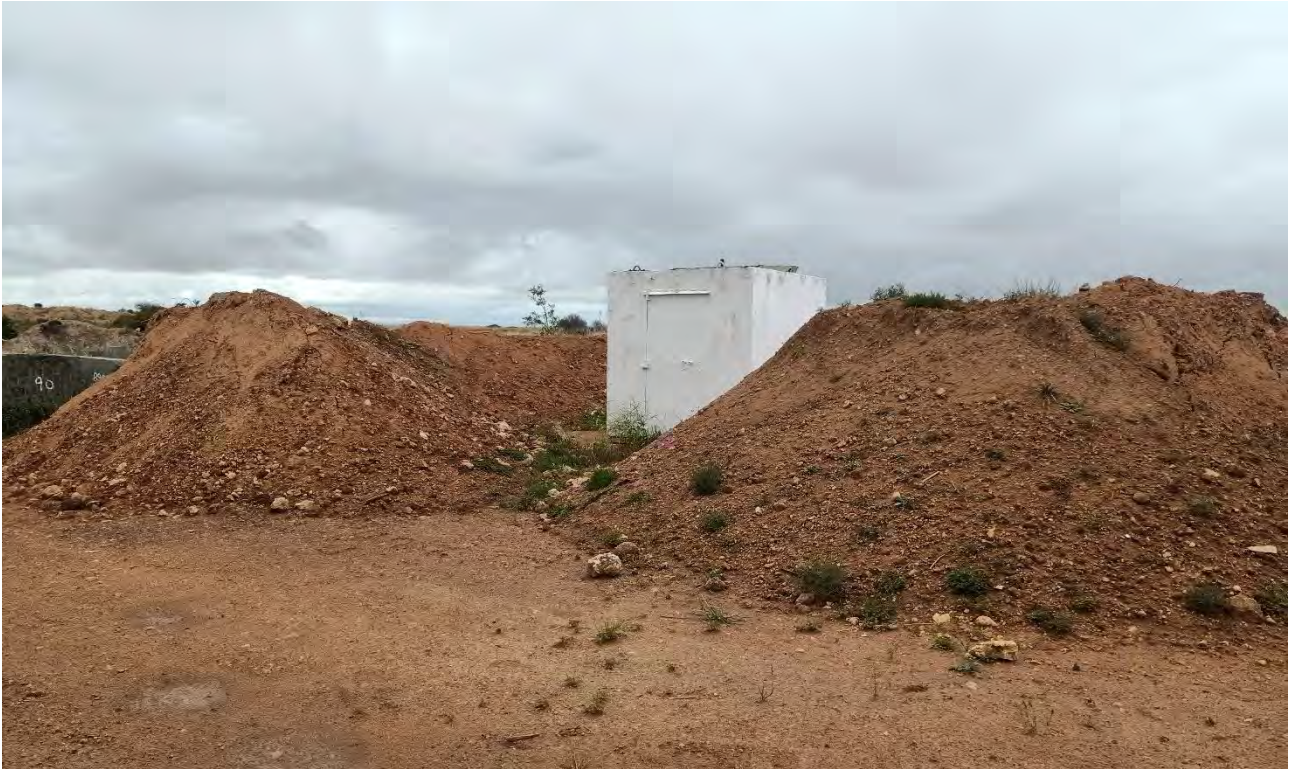
***Plate 9 – Explosives magazine located on EML 5793***

K-pipe explosives will be stored onsite in the magazine (refer **Plate 9**), which is inspected and approved by Safework SA under Explosives Magazine Licence 75340 (refer **Attachment 13**). The precise location of the magazine will not be provided on a map with this publicly available program for security reasons, but a separate map will be provided to the lead regulating agency showing the location of the magazine.

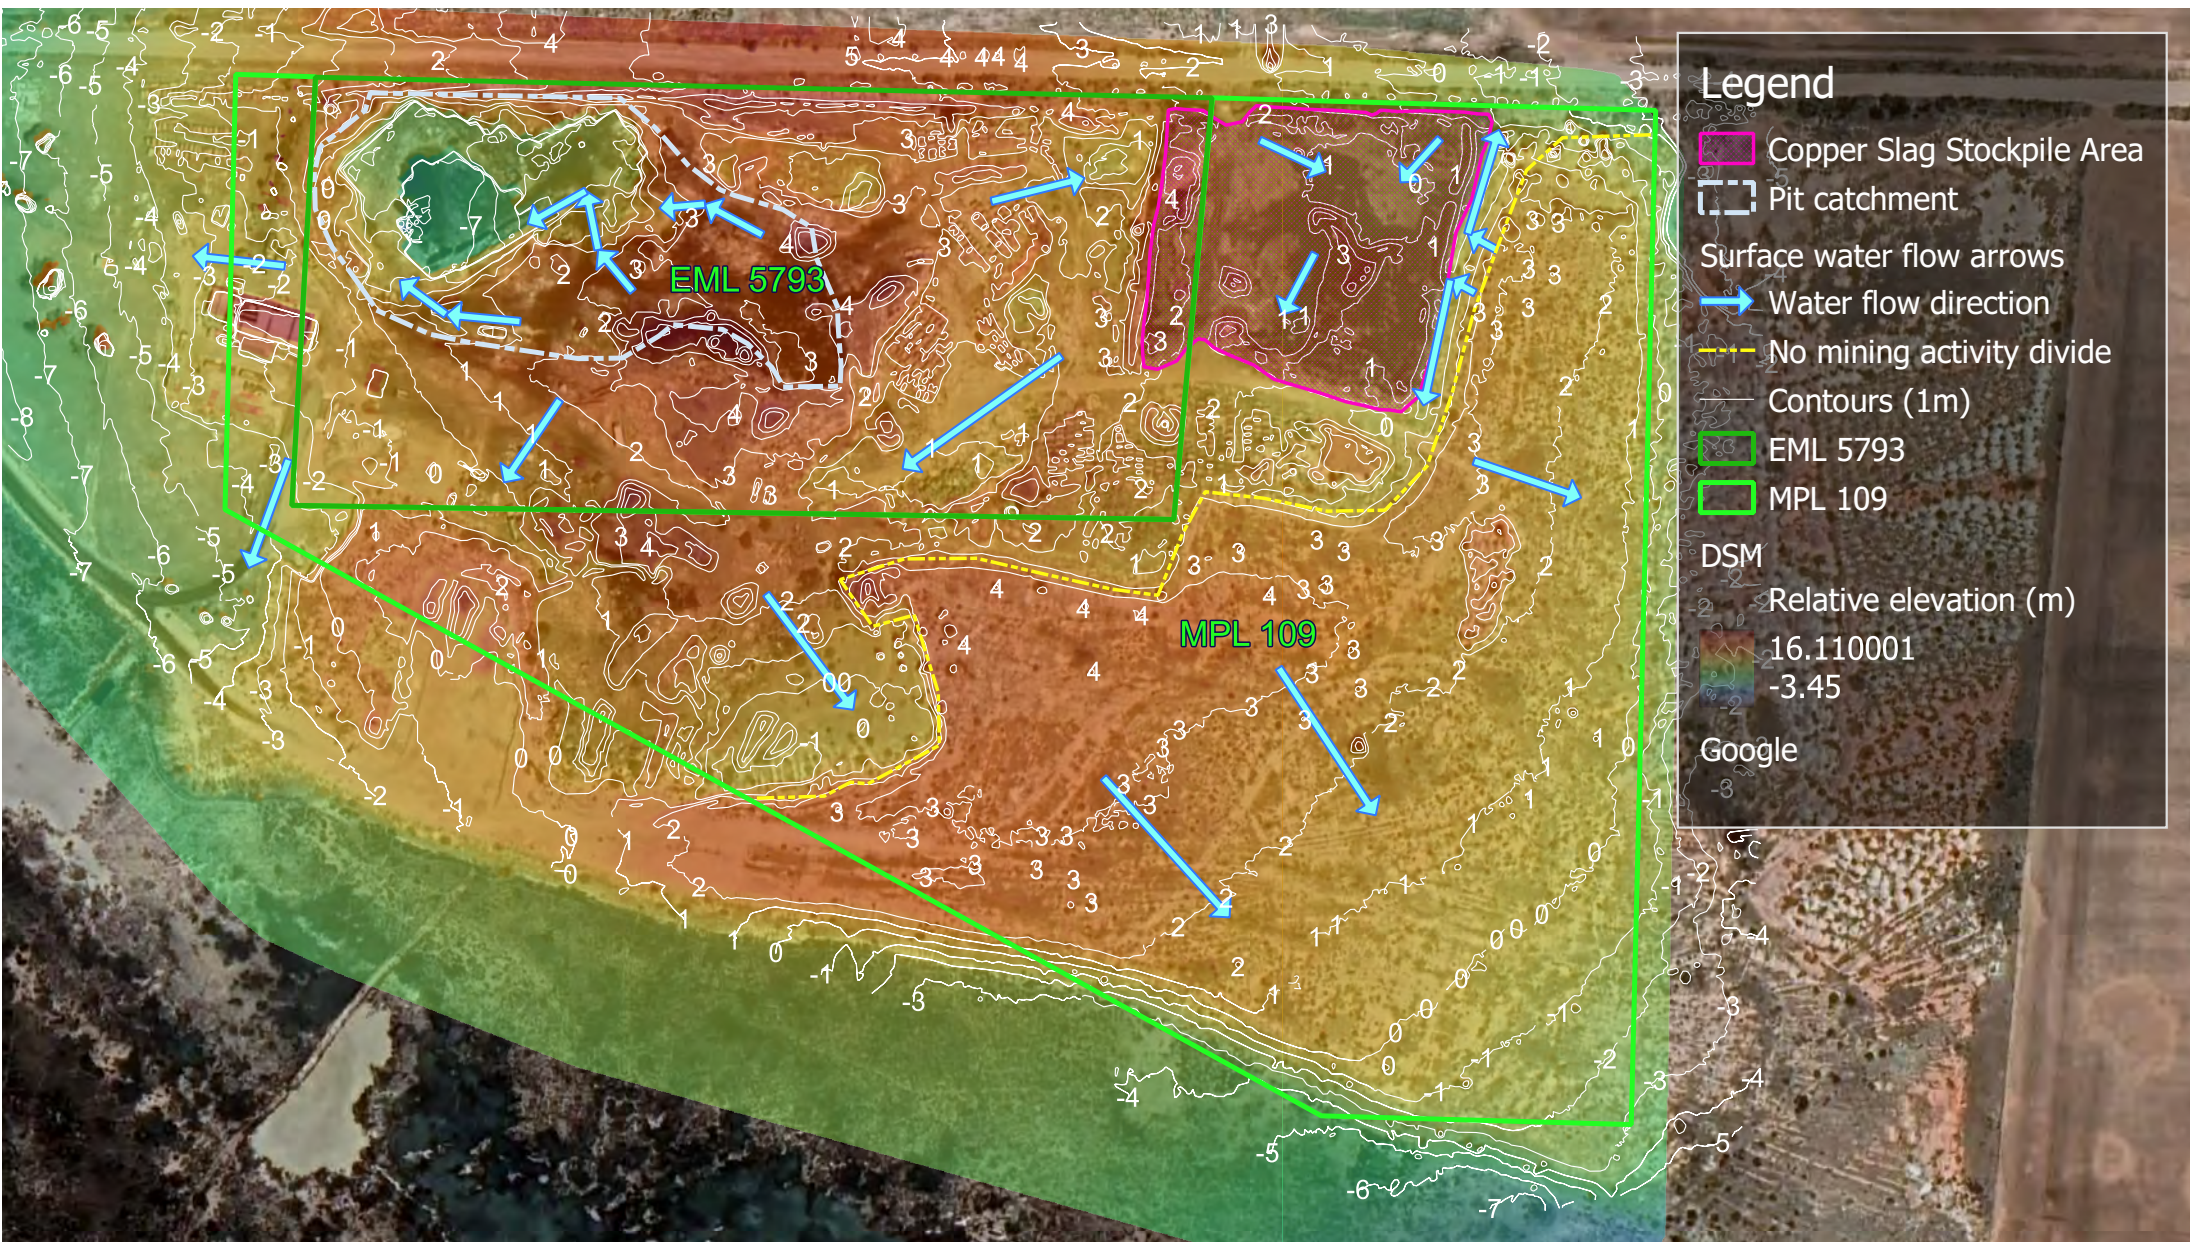
**Drawing 6 - Surface water map**

As shown in **Drawing 6**, the majority of water runoff from the disturbed area drains internally within EML 5793 and MPL 109. A review of a digital elevation model created using UAV imagery found that no significant discharge points are present that transport waterflows off the Site. This is largely due to the artificial waste soils landform being relatively level and being raised above the elevation of the disturbed areas and therefore preventing the flow of water to the east.

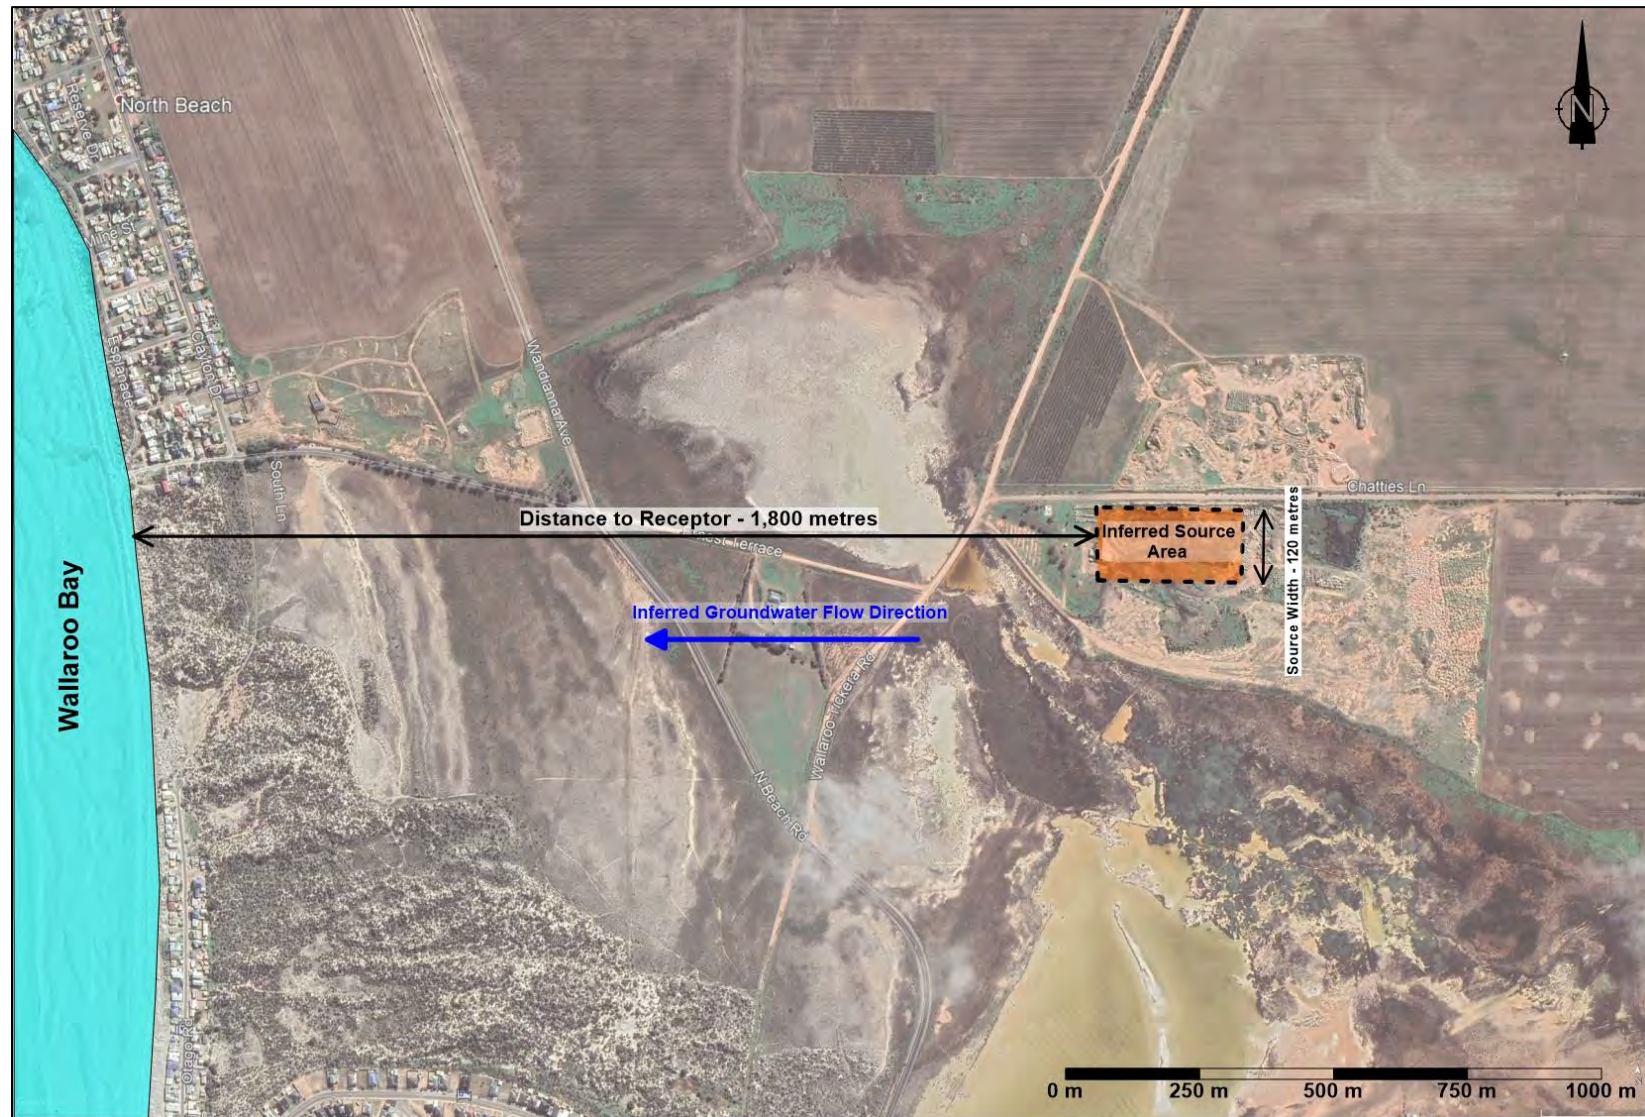
Figure 6: Source-Pathway-Receptor CSM

The only identified complete source-pathway-receptor linkage exists for the marine aquatic ecosystem of the Wallaroo Bay as illustrated on Figure 6.

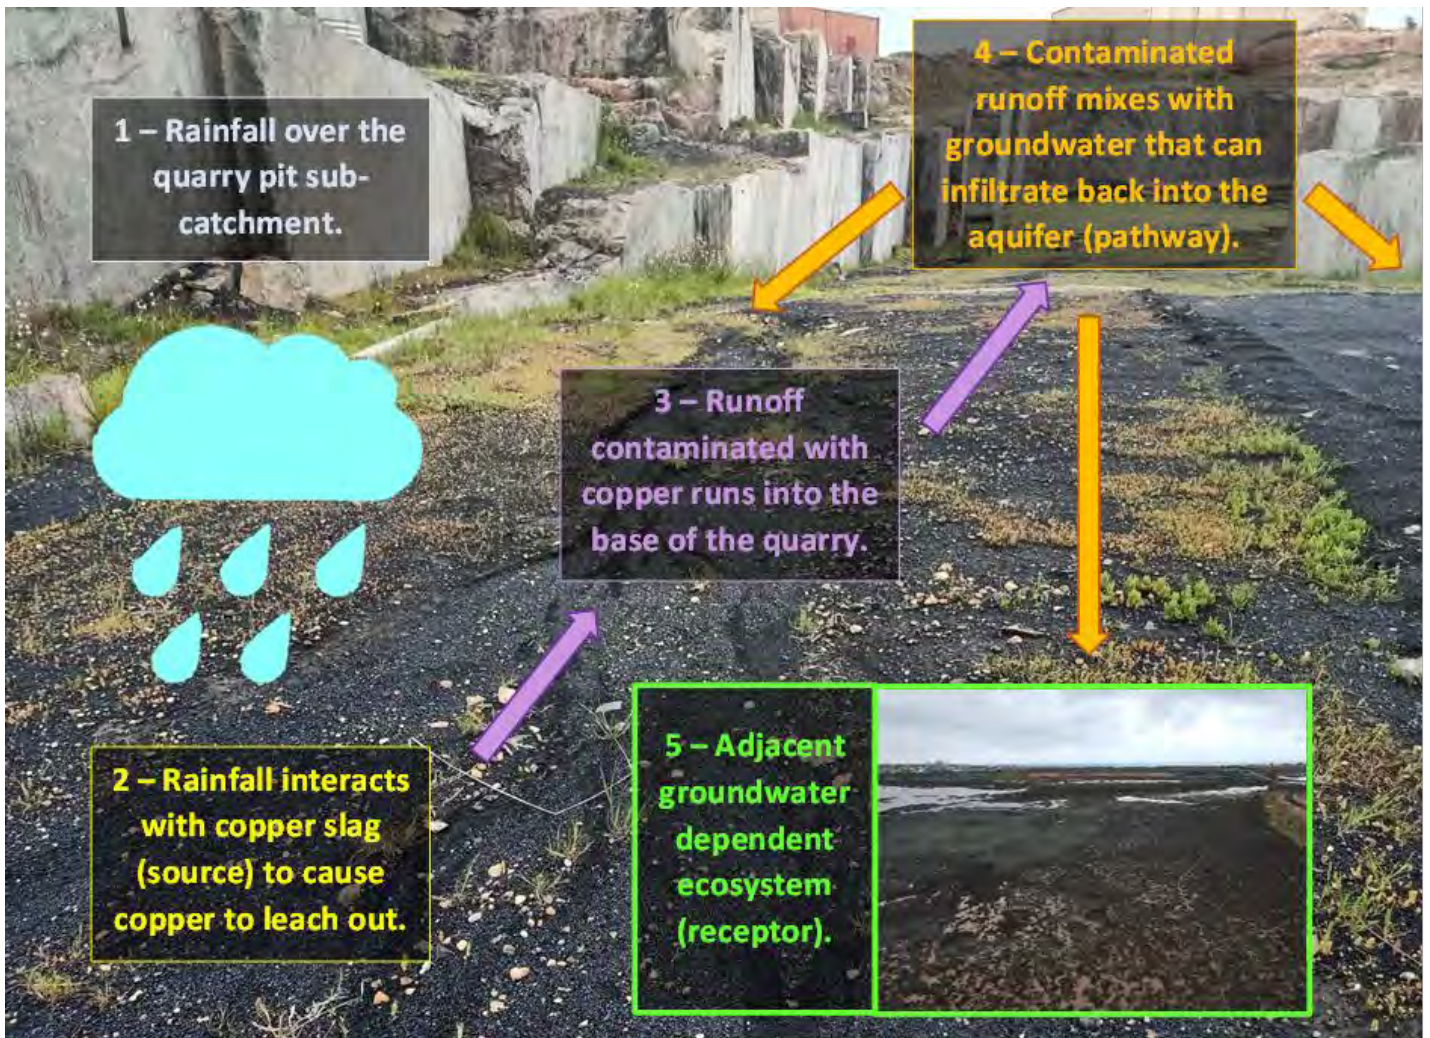
Figure 1 – Conceptual site model flow diagram

An updated CSM flow diagram is provided in Figure 1.
