# **2003 Albus Seismic Survey**

## **BEACH PETROLEUM LIMITED**

### **Final Operations Report**

### **PEL 91, 92, 107 & 110 – South Australia**

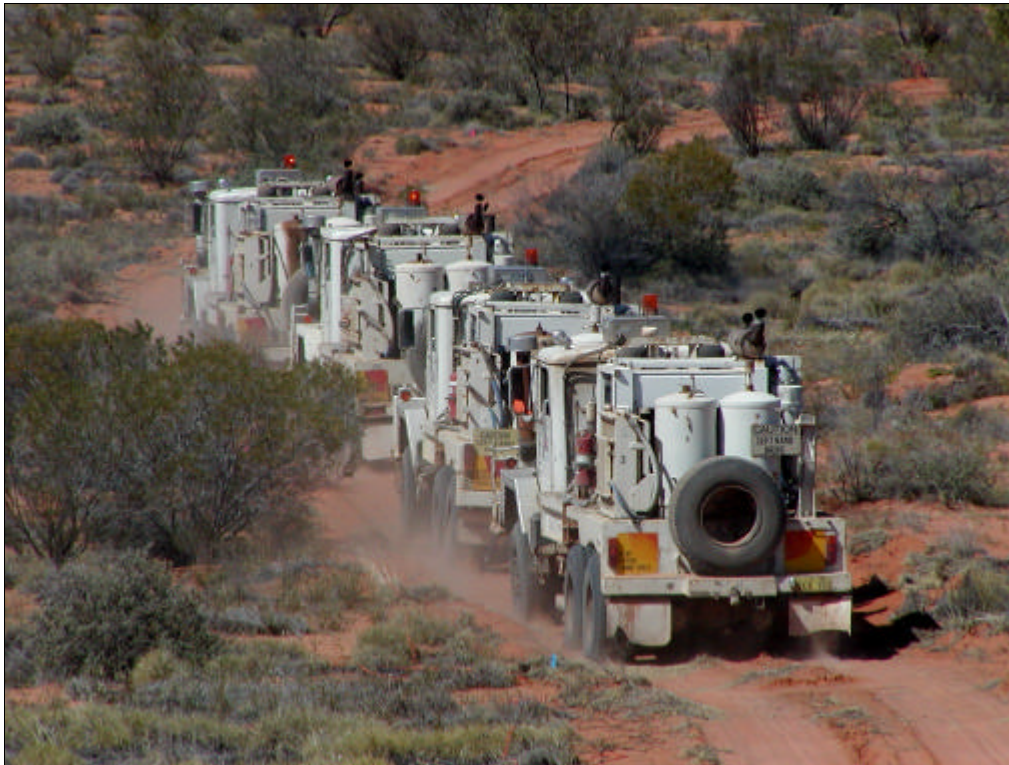
Picture # 2: vibrators on line BC03-07

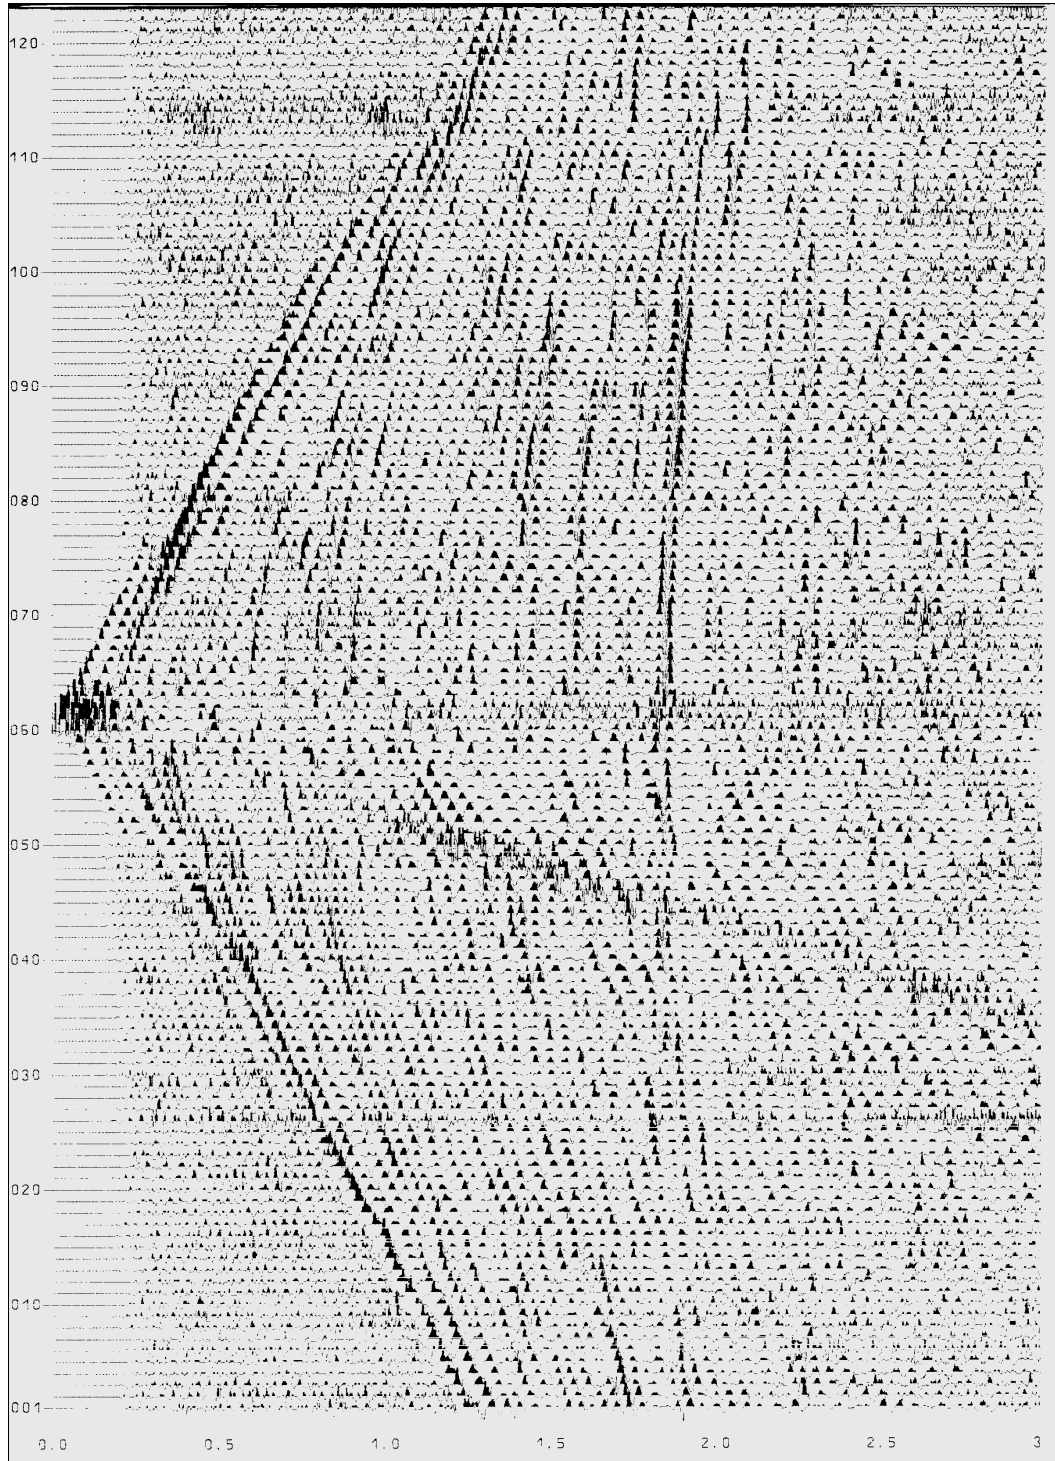
**Sample Monitor # 1: Line BC03-17 VP#260.5**

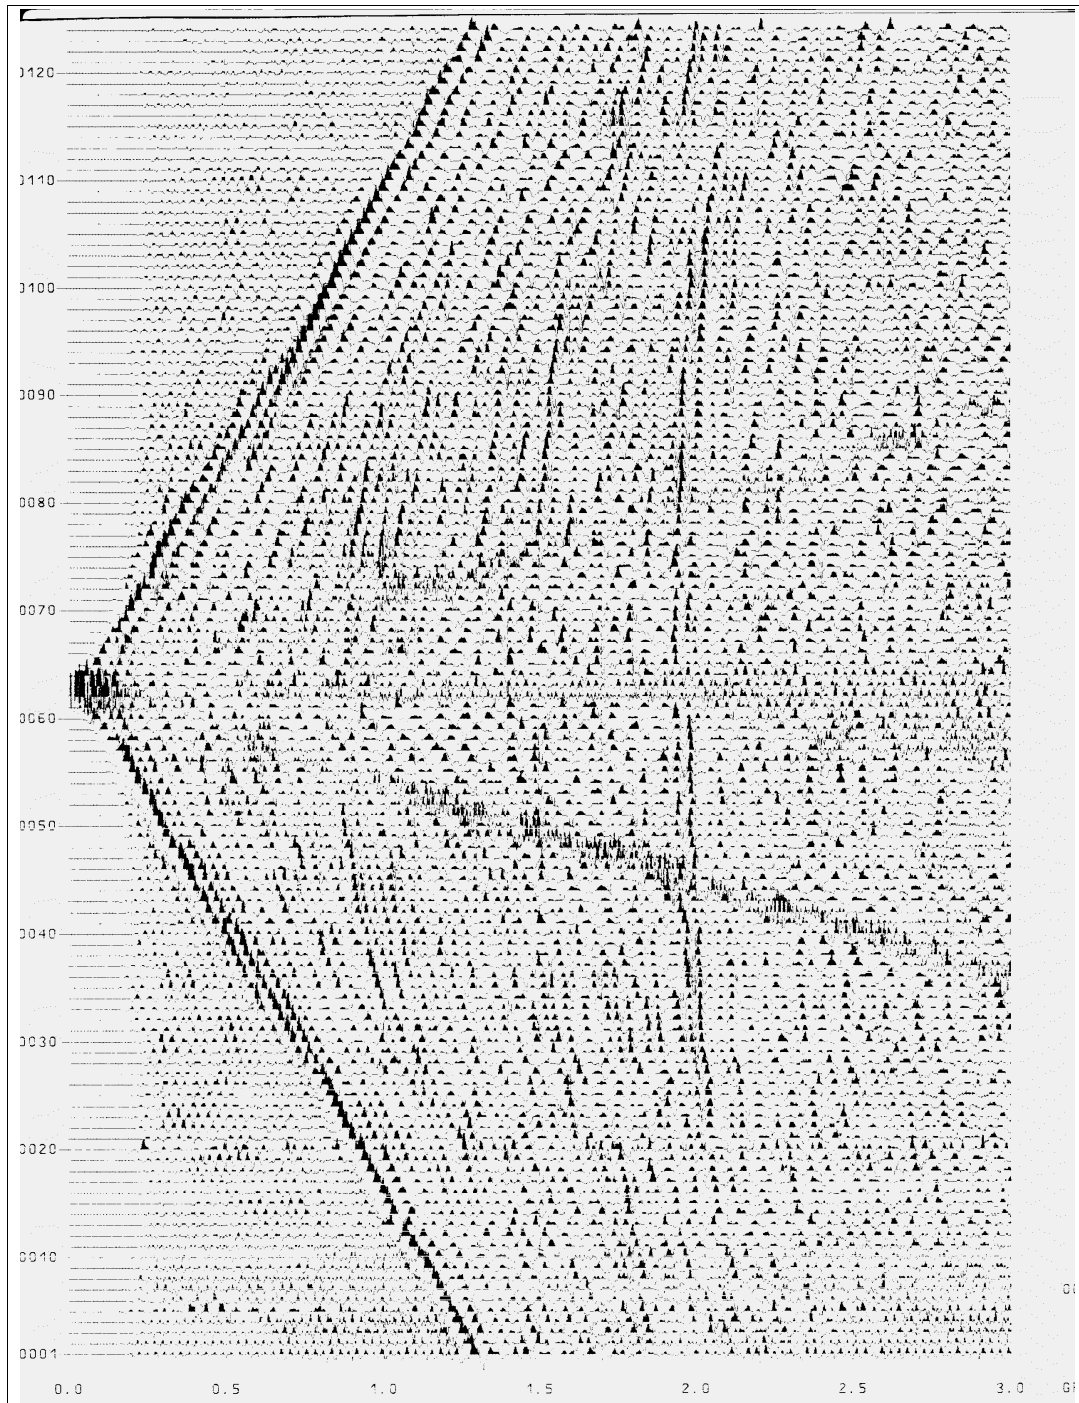
**Sample Monitor # 2: Line BC03-01 VP# 364.5**

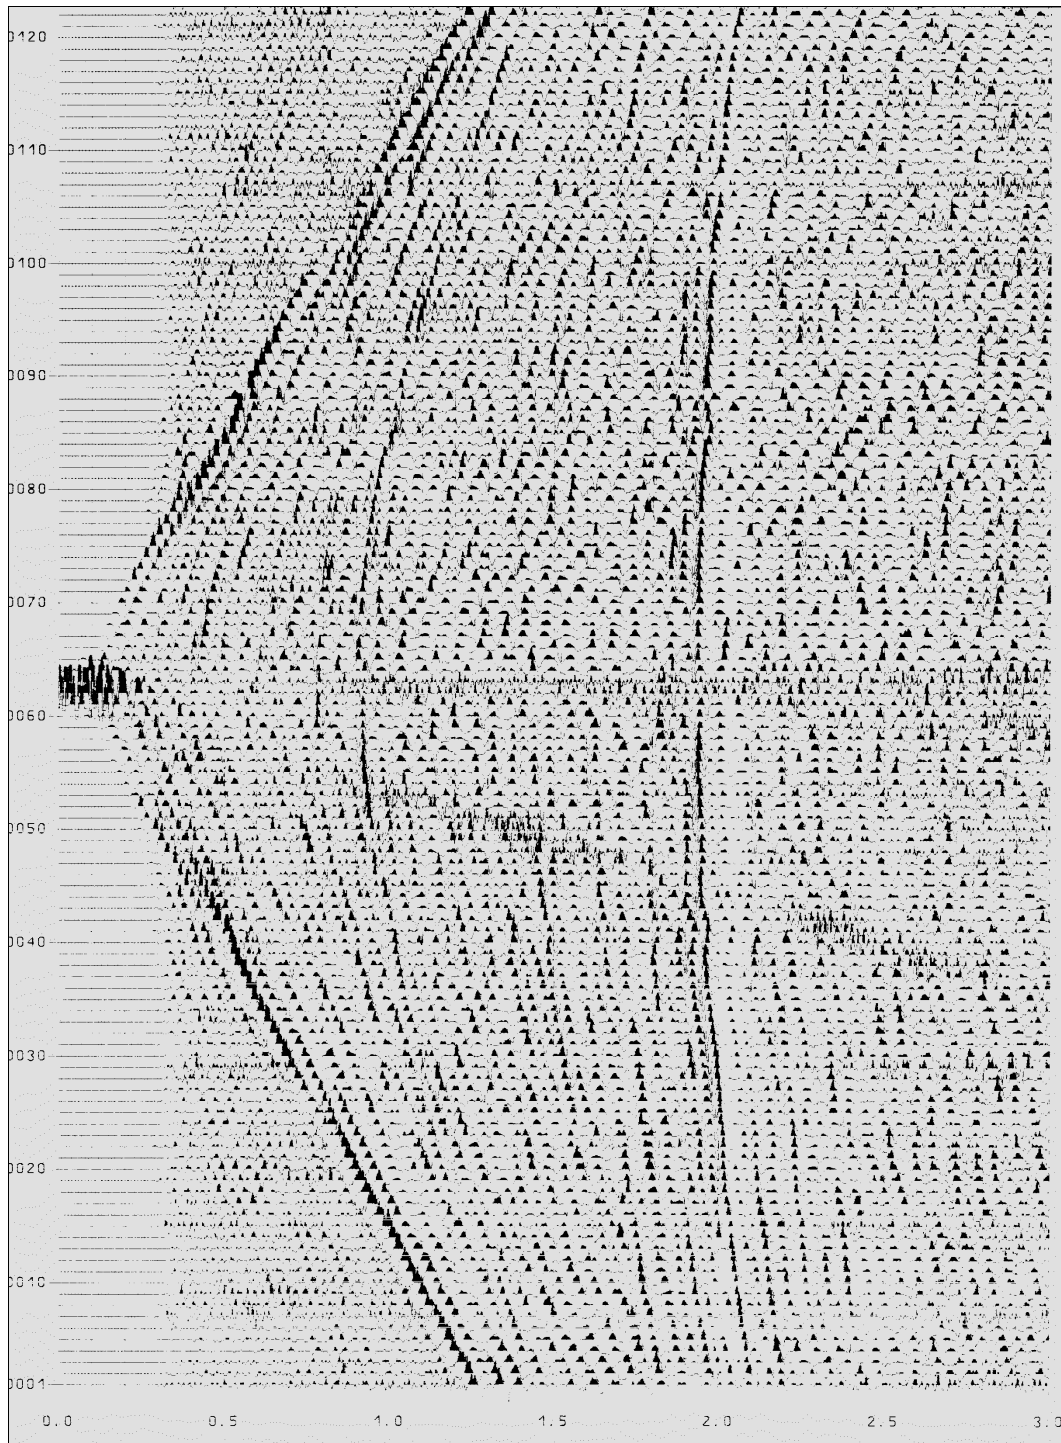
**Sample Monitor # 3: Line BC03-15 VP#262.5**

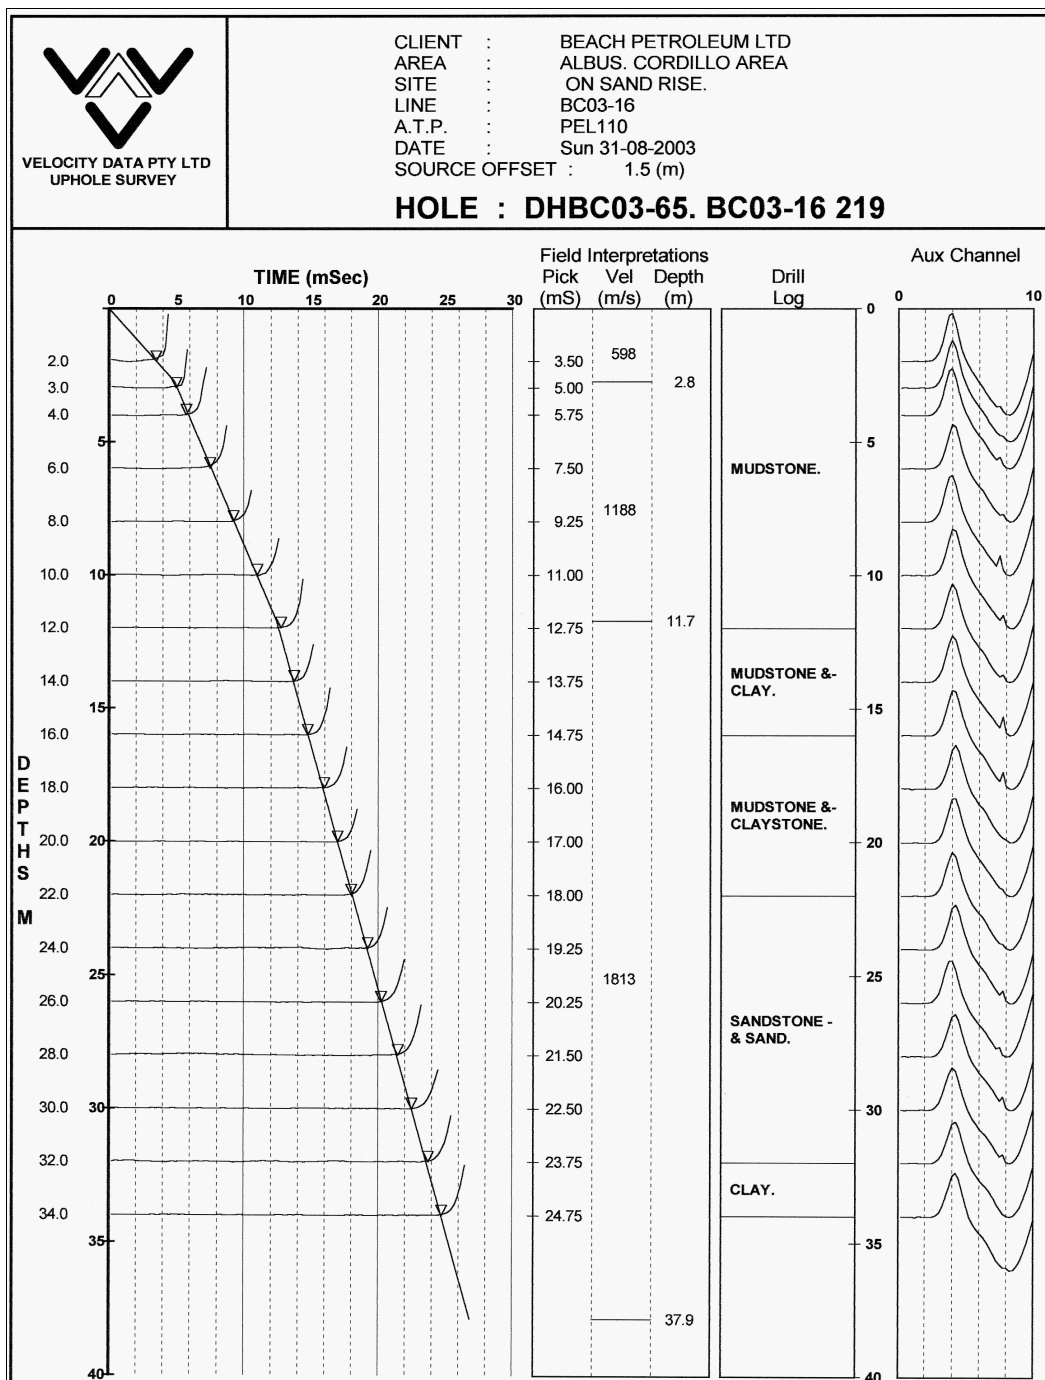
**Sample Uphole Plot # 1: Line BC03-16.**

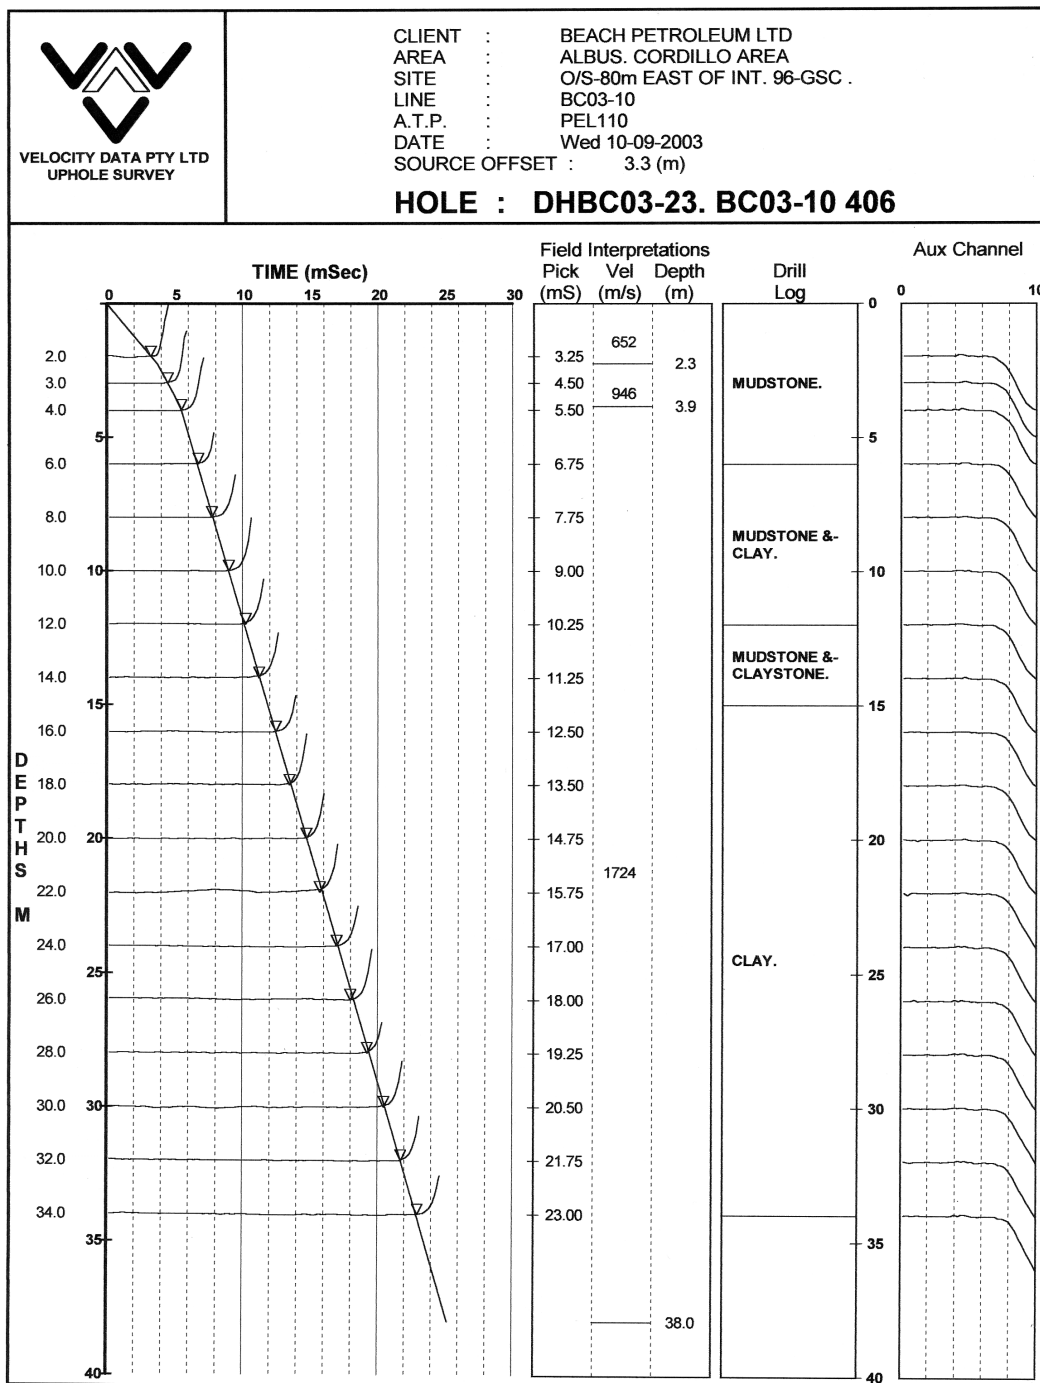
Sample Uphole Plot # 2: Line BC03-10 DH03-23; shows anomalous depth of weathering.

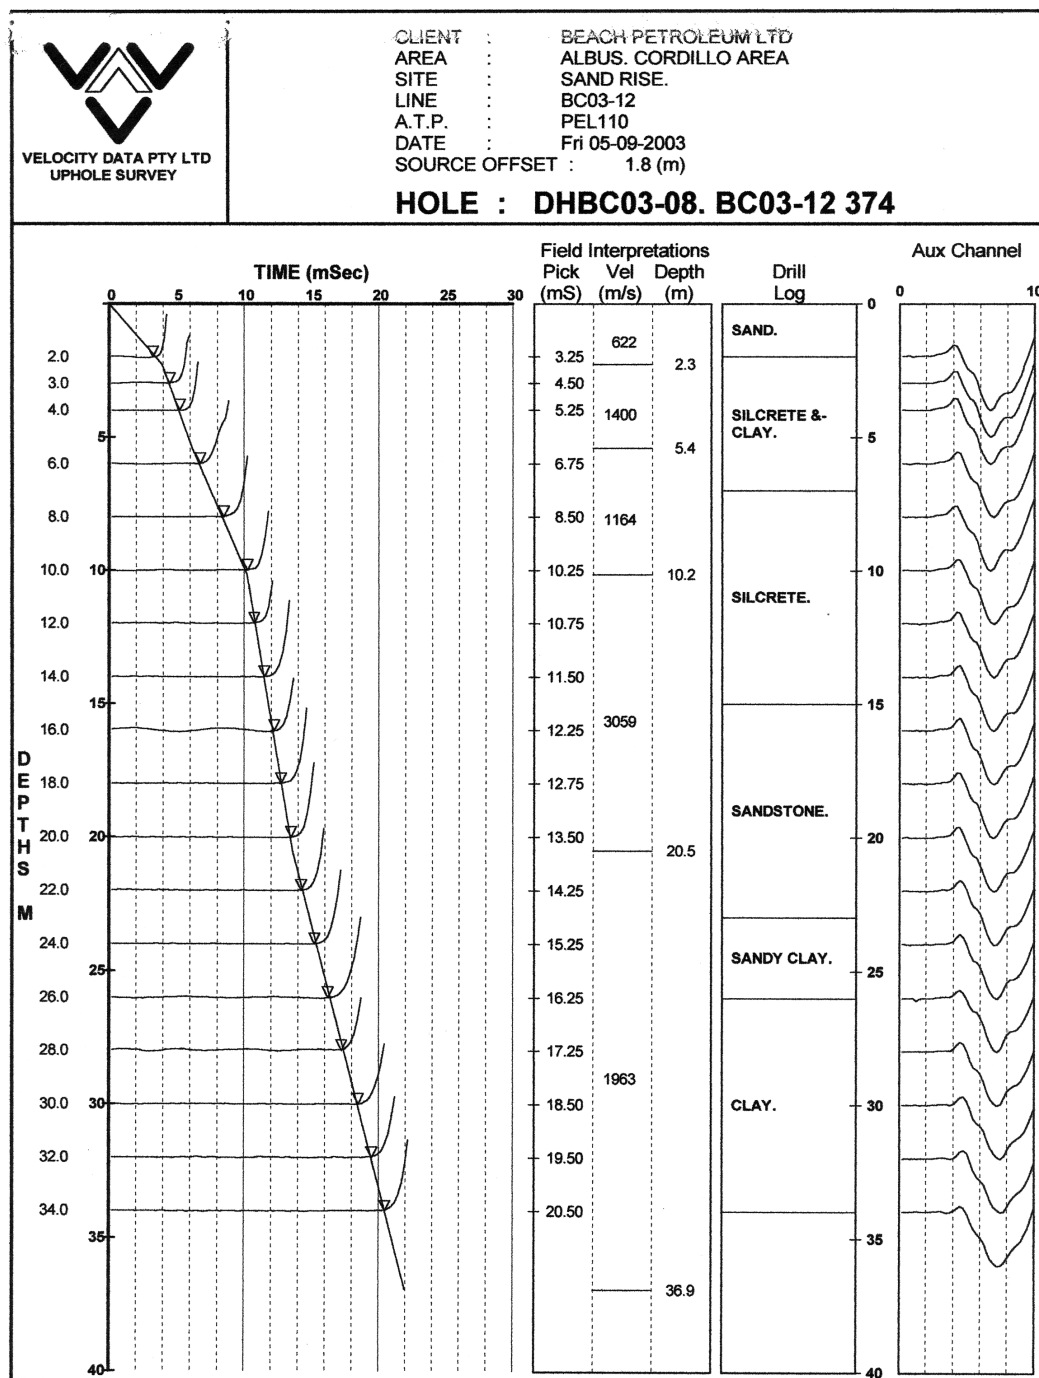
Sample Uphole Plot # 3: Line BC03-12; shows typical velocity inversion.

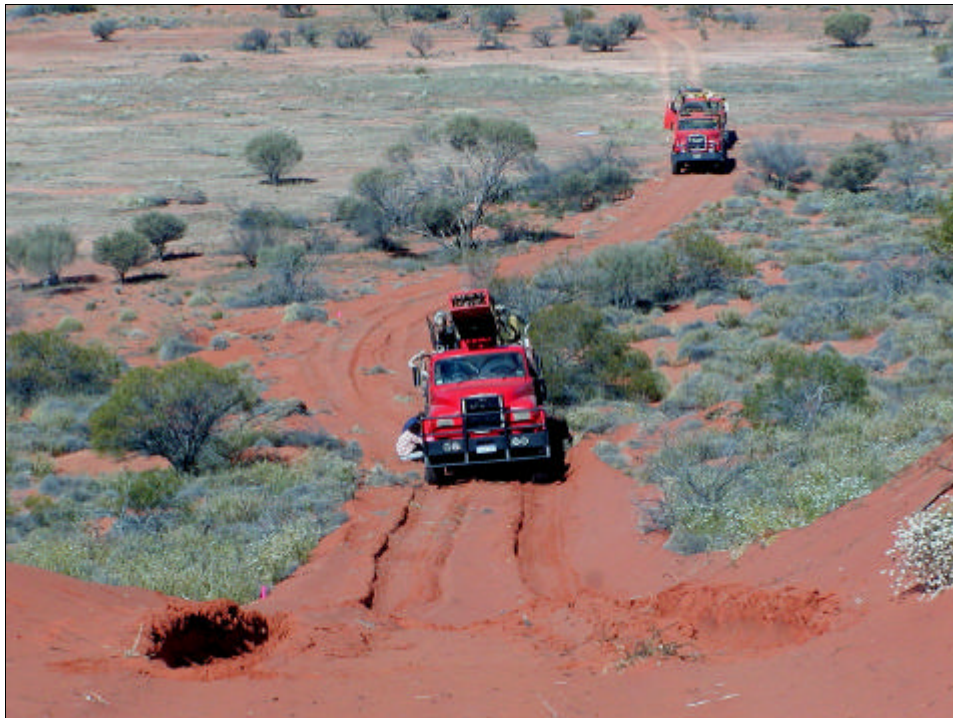
**Picture # 5: reducing rig tyre pressures in order to get over a steep soft dune on line BC03-09**

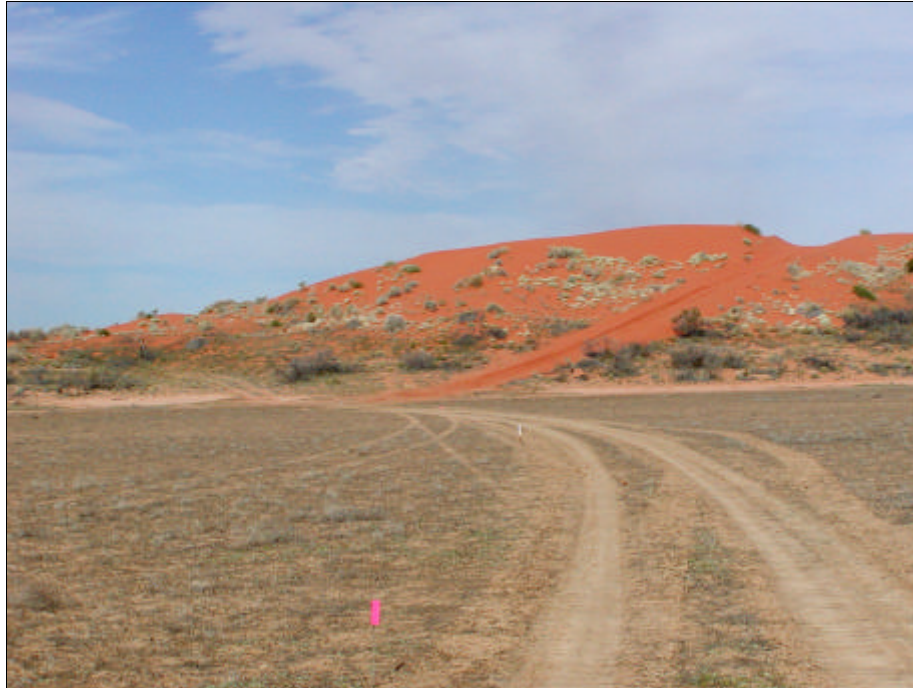
**Picture #6- 4: large dune on line BC03-10 where the dozer operator made two mistakes; the first was choosing the highest part of the dune to cross and the next was a climbing turn.**

DOK had not worked in the Cooper Basin for about a year before this job. Their “gun” operator Peter (Hi-rise) O’Keeffe was not available due to other work commitments. He was replaced by Darren Jonas and later his brother Mick Jonas. These men are usually grader operators so dozing was new to them. Many mistakes were made in line cutting, not just by them but also the experienced Bill Bebbington, who may have been out of practice. Examples of these mistakes included;

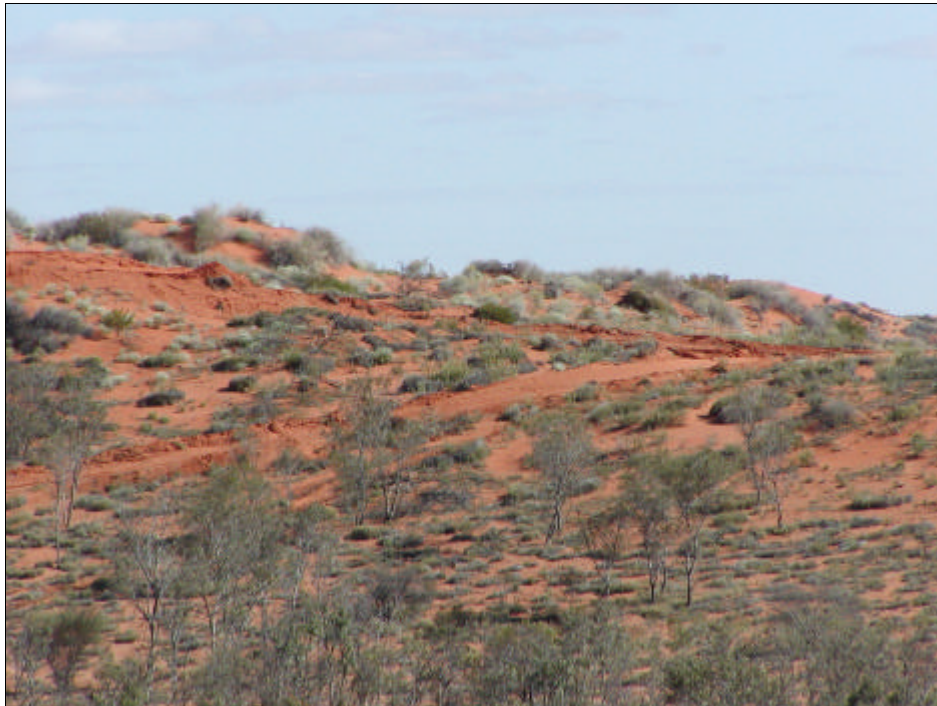
**Picture #6- 5: a unique hairpin climbing turn on a dune on line BC03-01; this is poor line prep.**

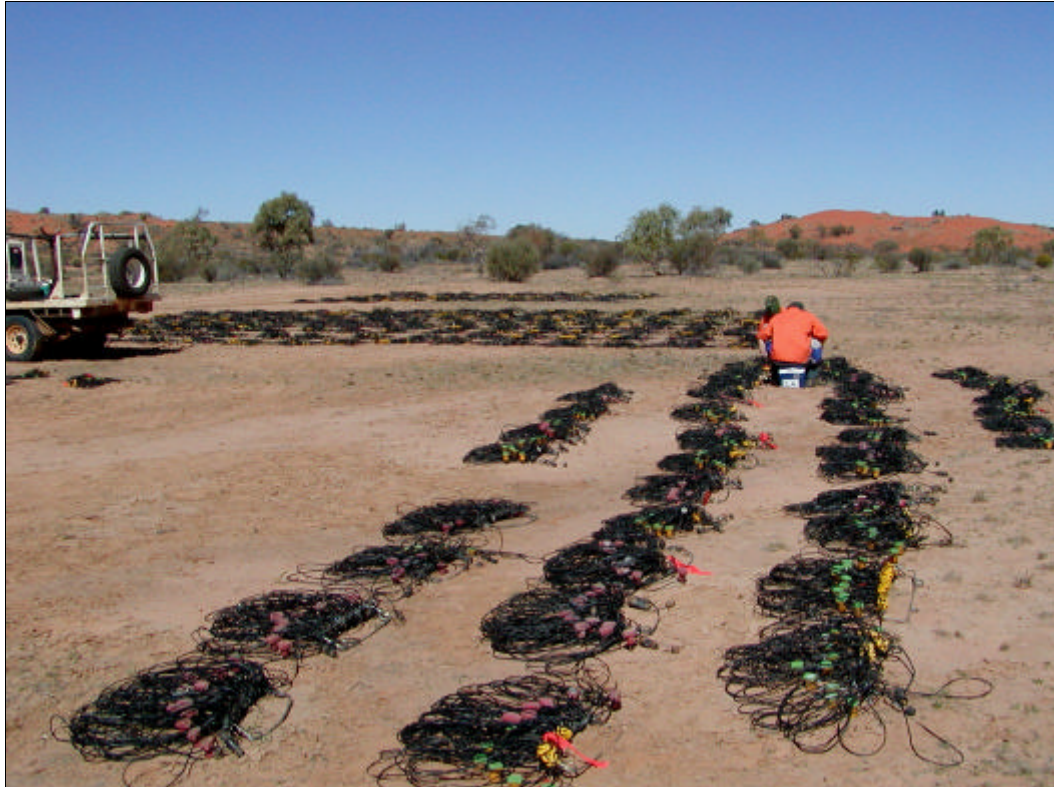
**Picture # 4- 2: testing geophones prior to the start of the Albus Seismic Survey**

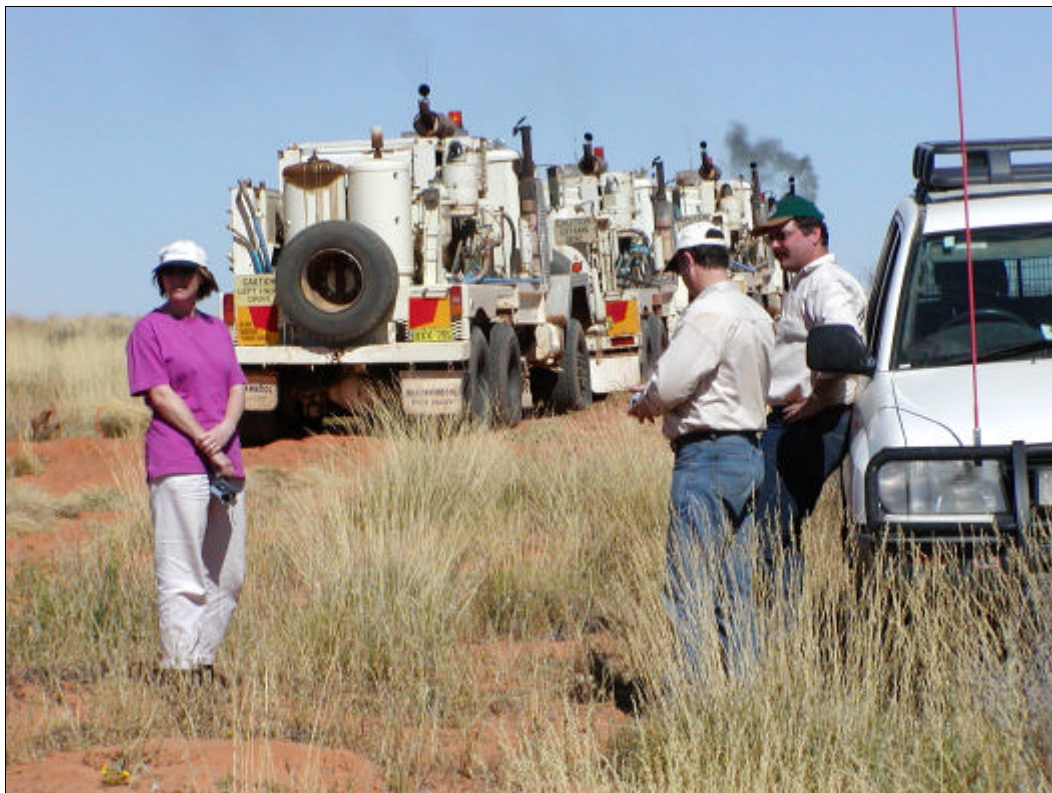
**Picture # 4- 3: Janet, Neil and Danny watch as the vibrators pass on Line BC03-27.**

The Trace vibrators were Litton LRS-315's mounted on International Paystar 6x6 trucks. These units were 20 years old but performed well. There were no instances of having to go down to three vibrators on line during the survey.

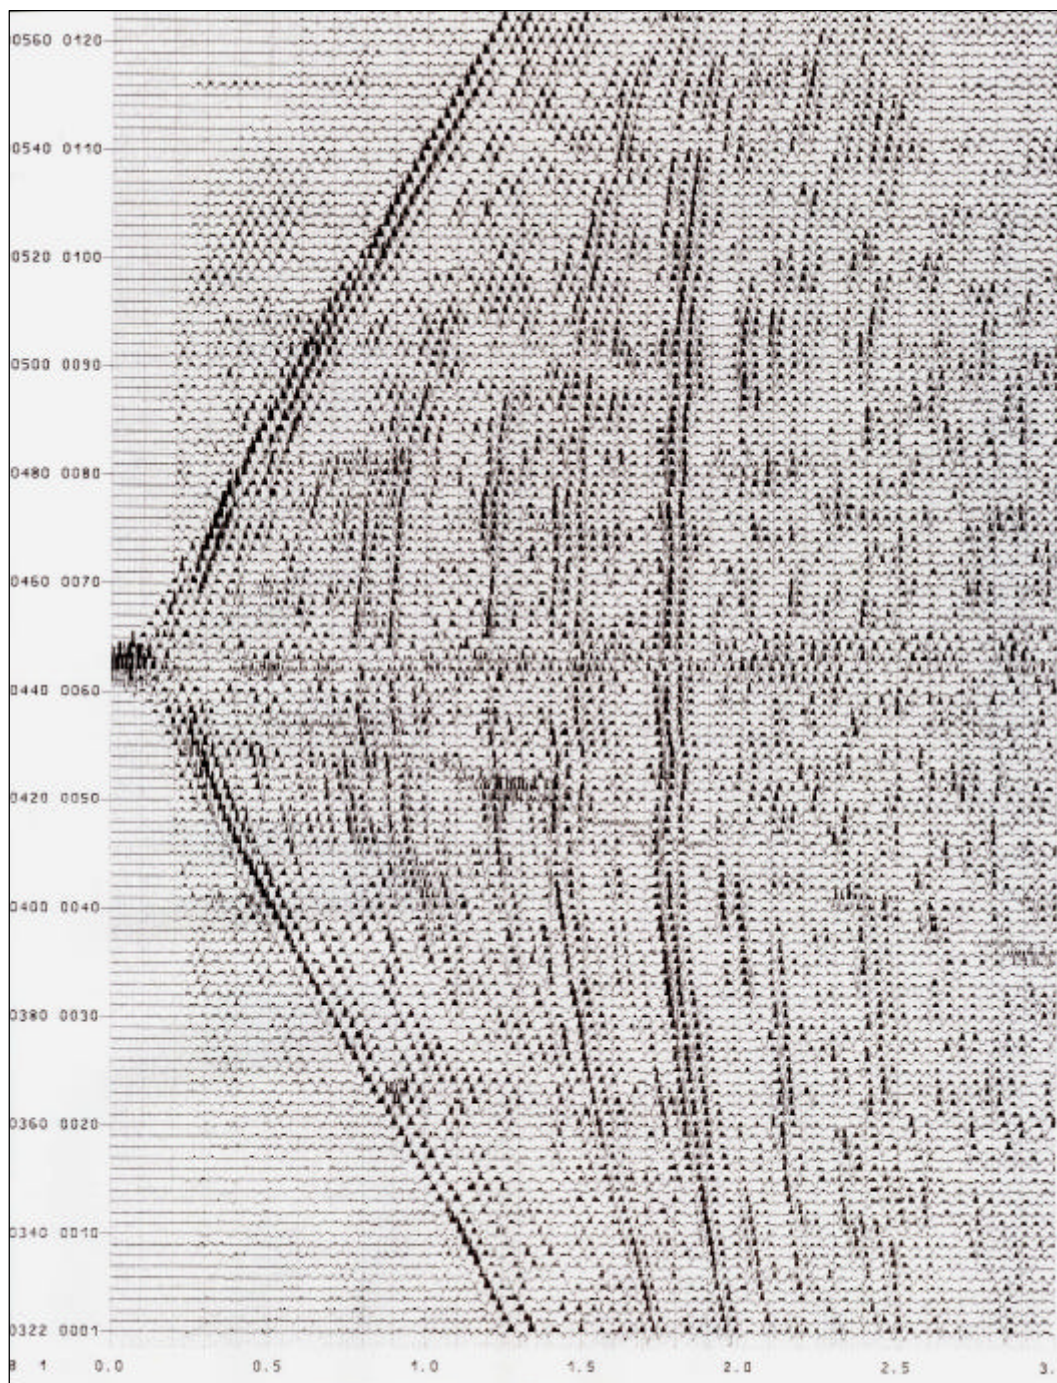
**Sample Monitor # 4- 1: Line BC03-33 VP # 322.5**

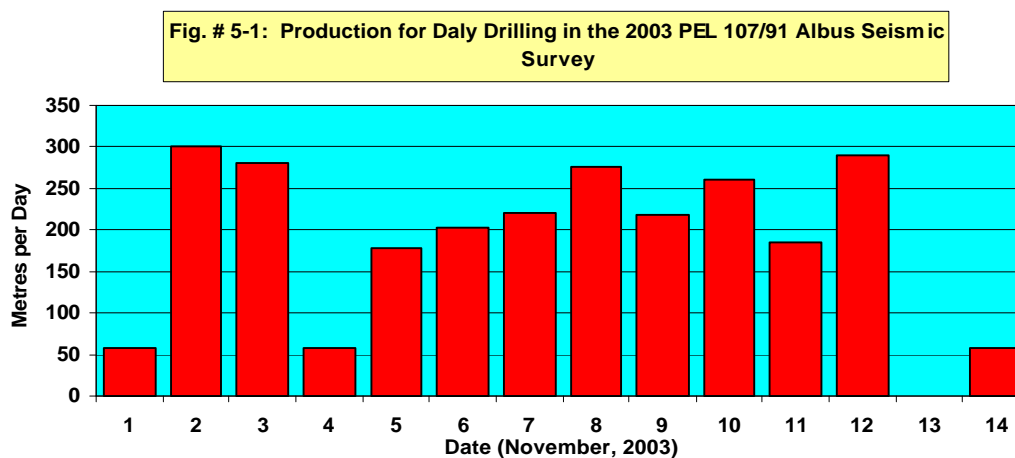
Fig. #5-1 shows daily production:

Production was inhibited by difficulty getting around the soft dunes which had blown in after a month and a half since cutting. The drillers were quite critical of the cutting procedures employed by DOK. One of the water trucks blew a transfer case and this led to downtime on November 4<sup>th</sup> and 5<sup>th</sup>.

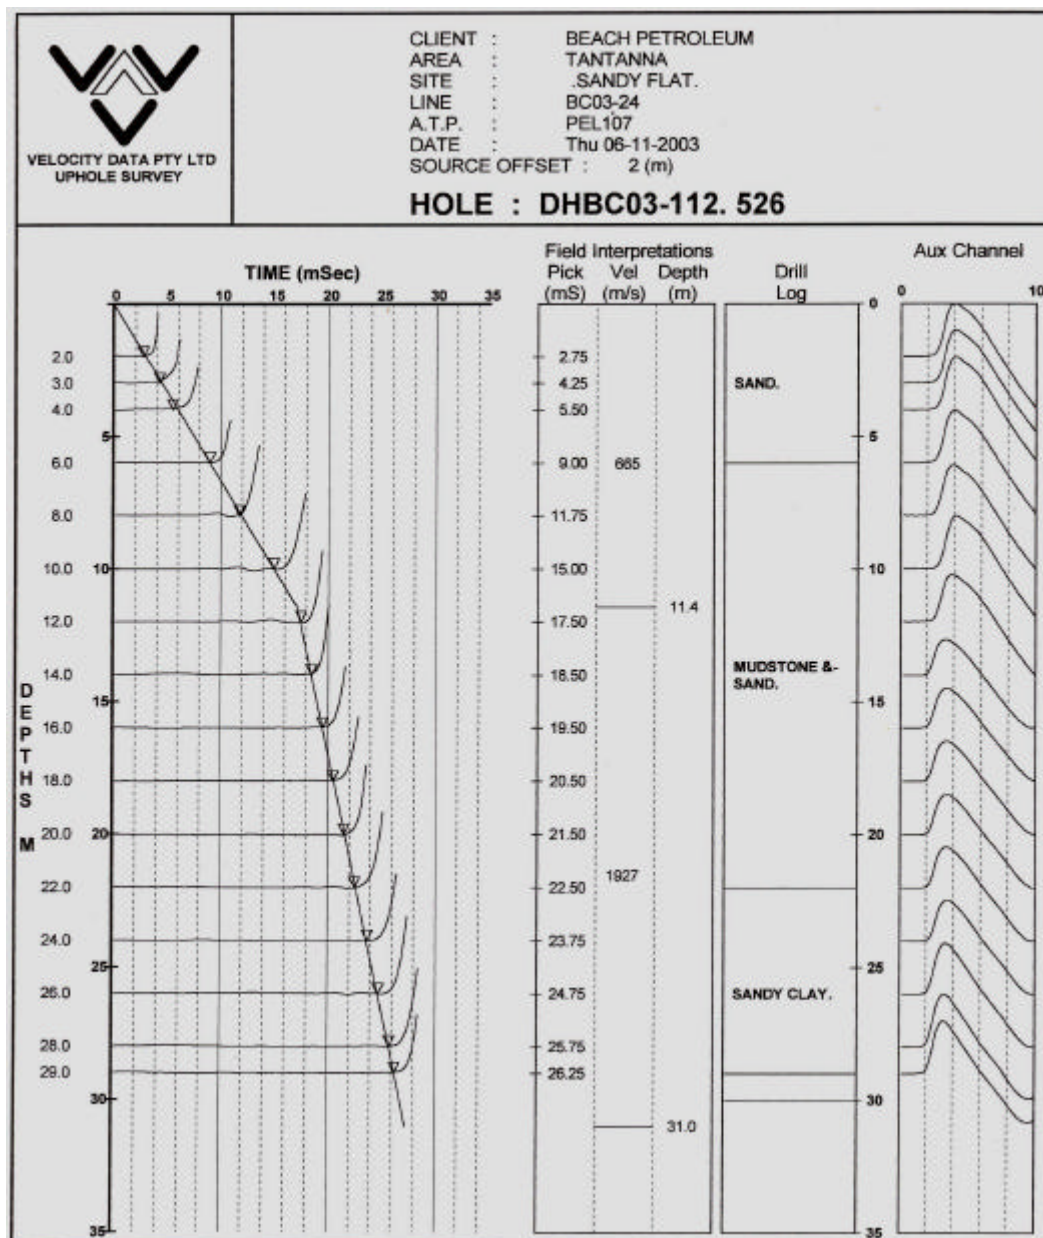
Sample Uphole Plot # 1: Line BC03-24.

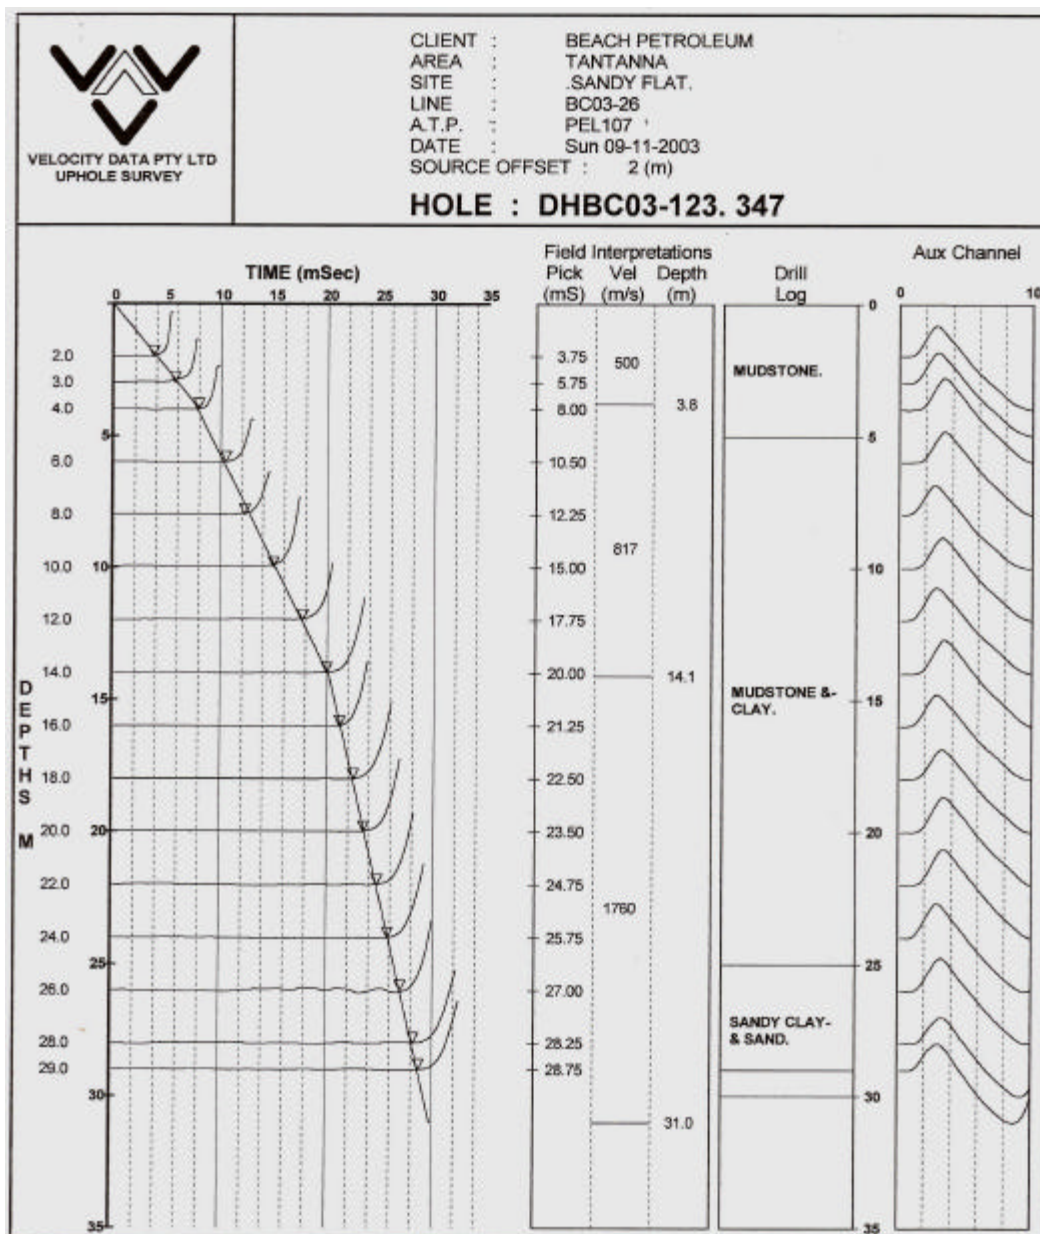
Sample Uphole Plot # 2: Line BC03-26 DH03-123.

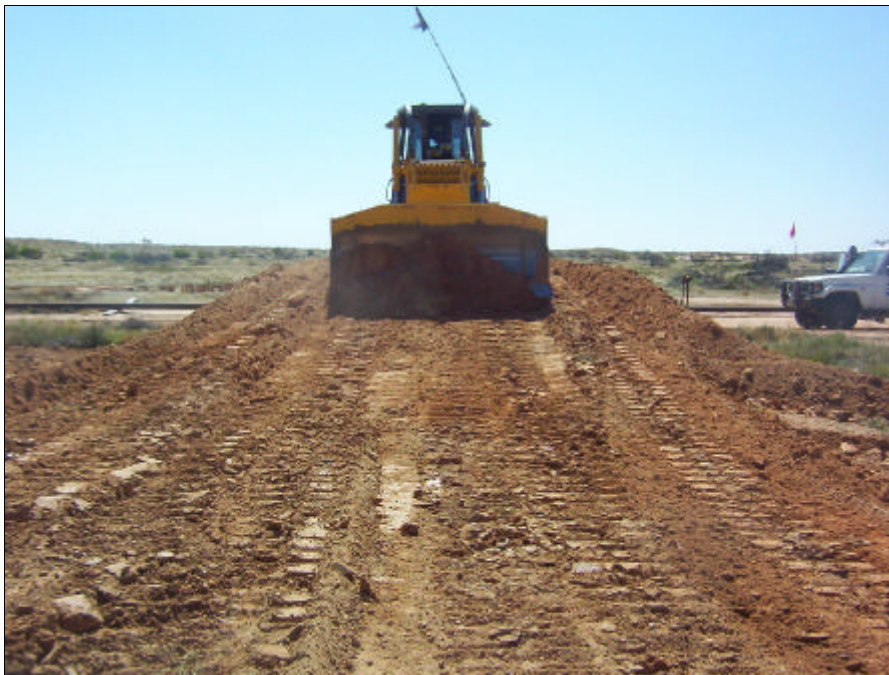
**Picture # 6- 2: constructing one of two ramp over the Tantana oil pipeline.**

The production rate of 0.83 km/charge hr is lower than usual and can be attributed to steep and difficult dunes, an inexperienced dozer operator on one dozer, the effect of a long move to Line BC03-39 in PEL 91 and the need to ramp the Tantana oil pipeline.

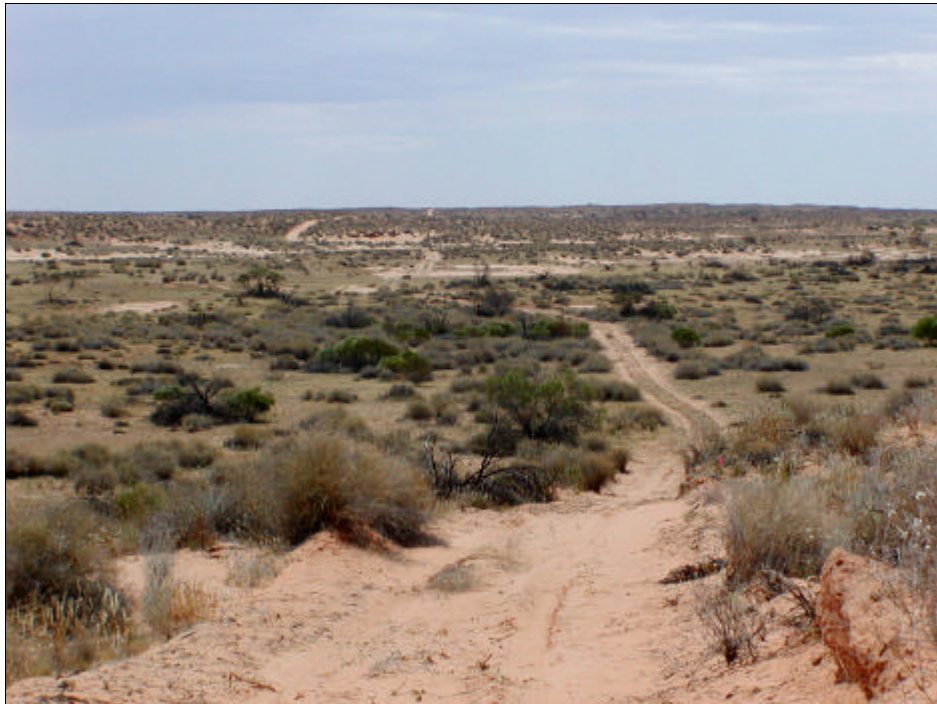
**Picture # 6- 6: Line BC03-28 looking north; typical of the treeless dune terrain of PEL 107**

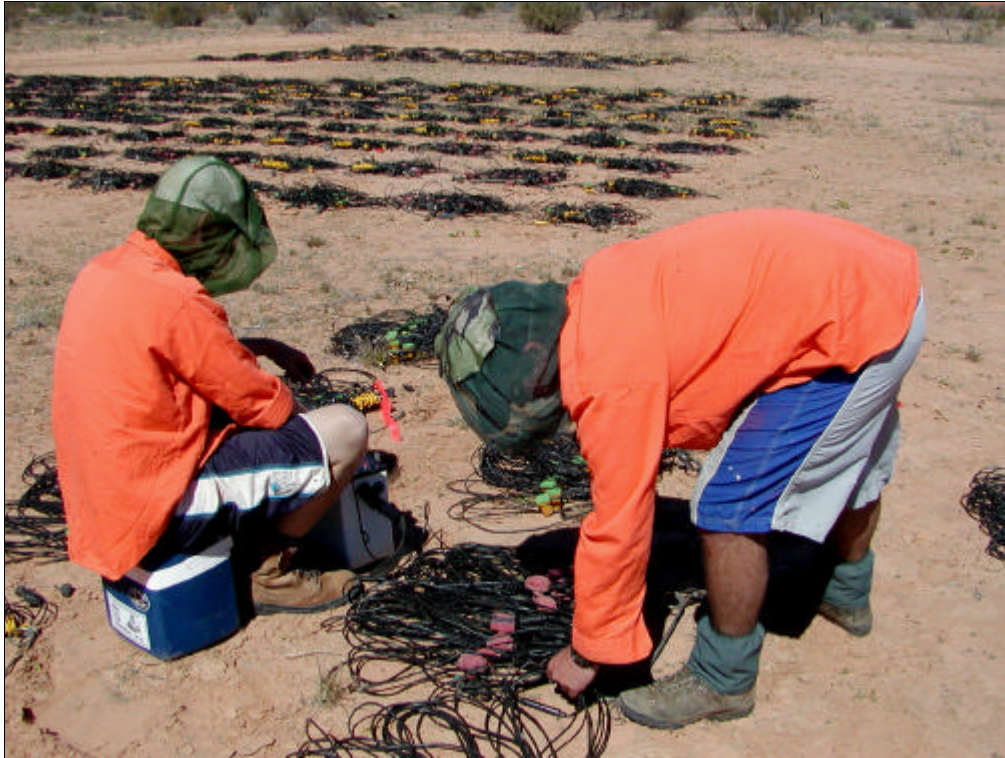
**Picture # 4- 2: testing geophones prior to the start of the Albus Seismic Survey**

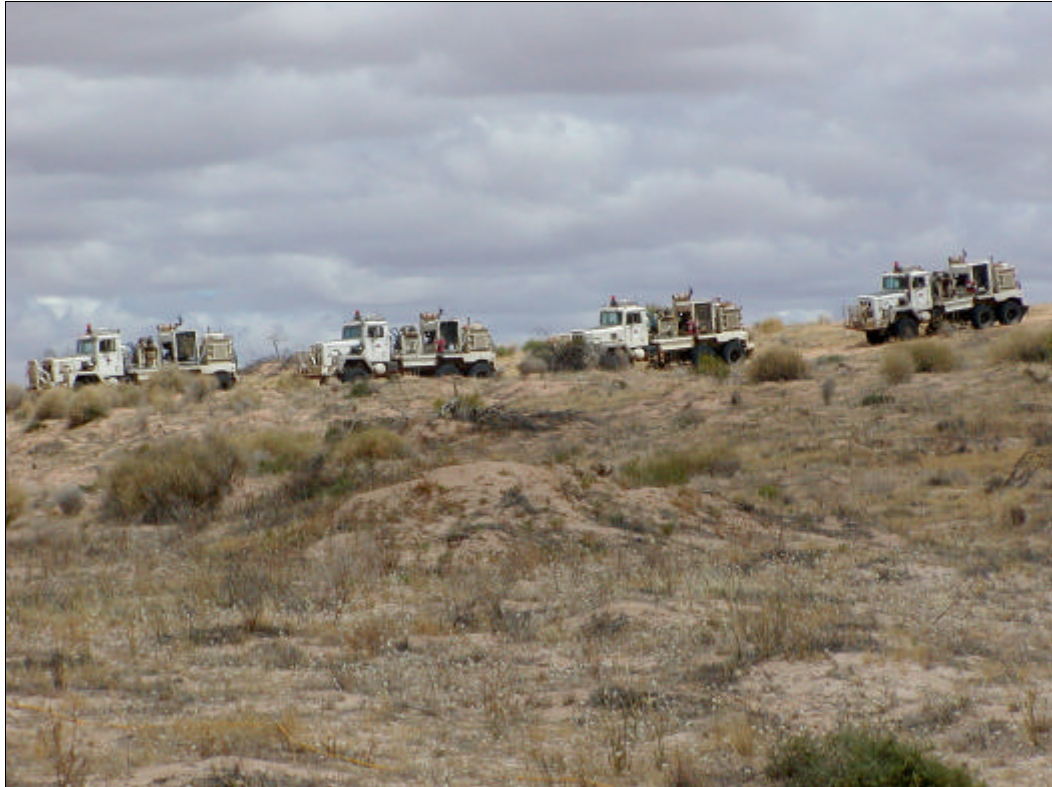
**Picture # 4- 3: vibrators on Line BC03-36.**

The Trace vibrators were Litton LRS-315's mounted on International Paystar 6x6 trucks. These units were 20 years old but performed well. There were no instances of having to go down to three vibrators on line during the survey.

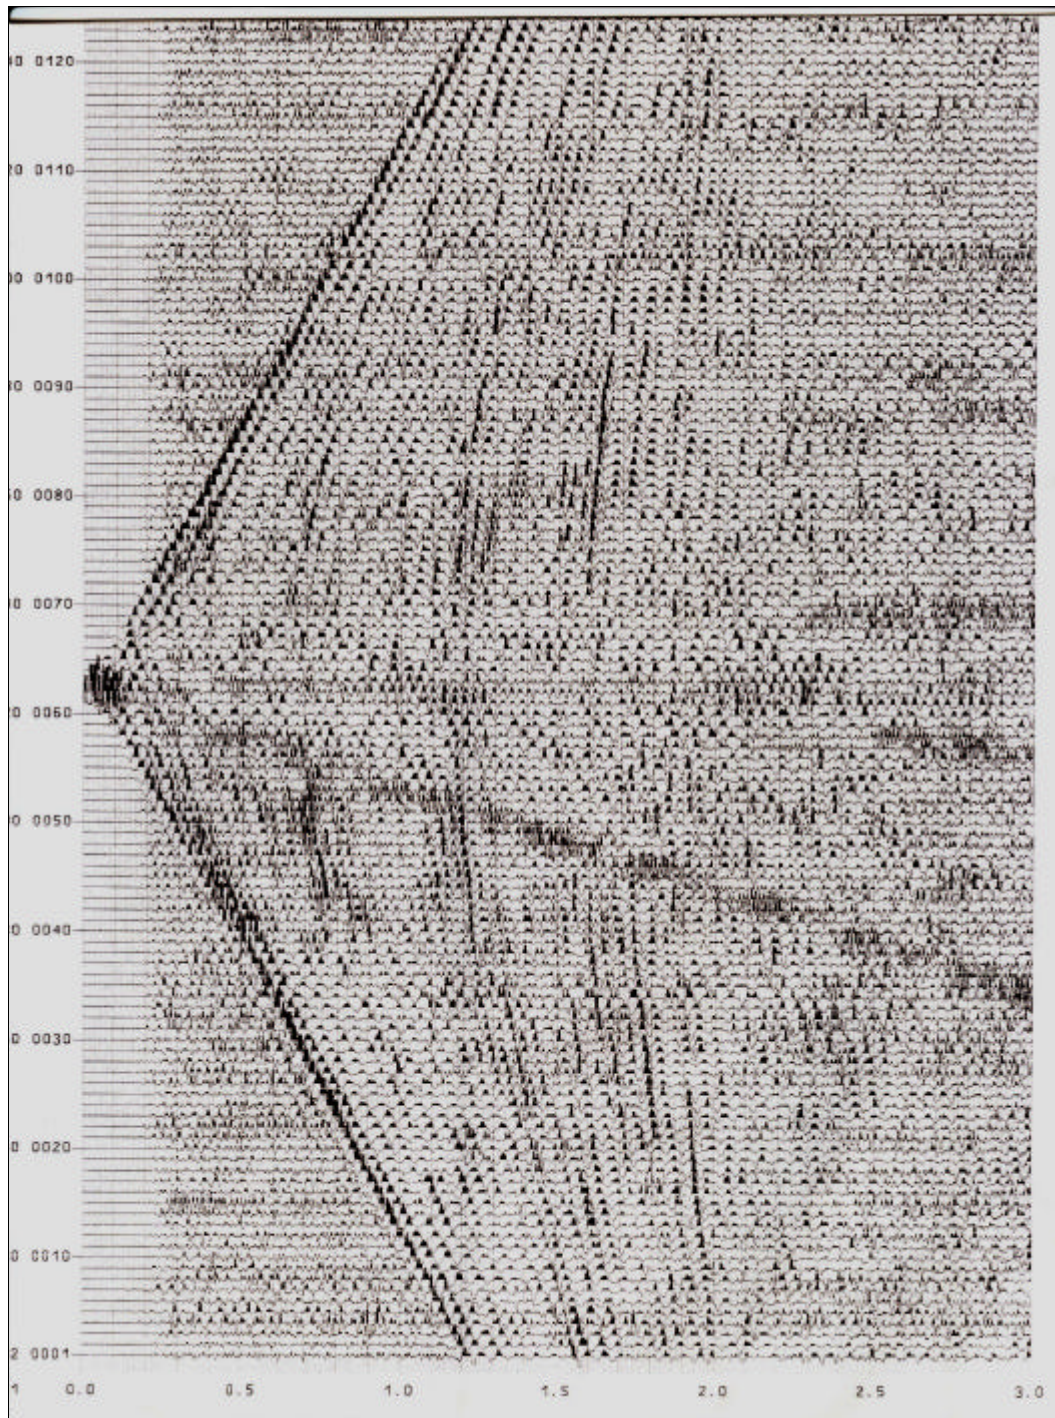
**Sample Monitor # 4- 1: Line BC03-38 VP# 262.5**
