# **2003 Albus Seismic Survey**

## **BEACH PETROLEUM LIMITED**

### **Final Operations Report**

### **PEL 91, 92, 107 & 110 – South Australia**

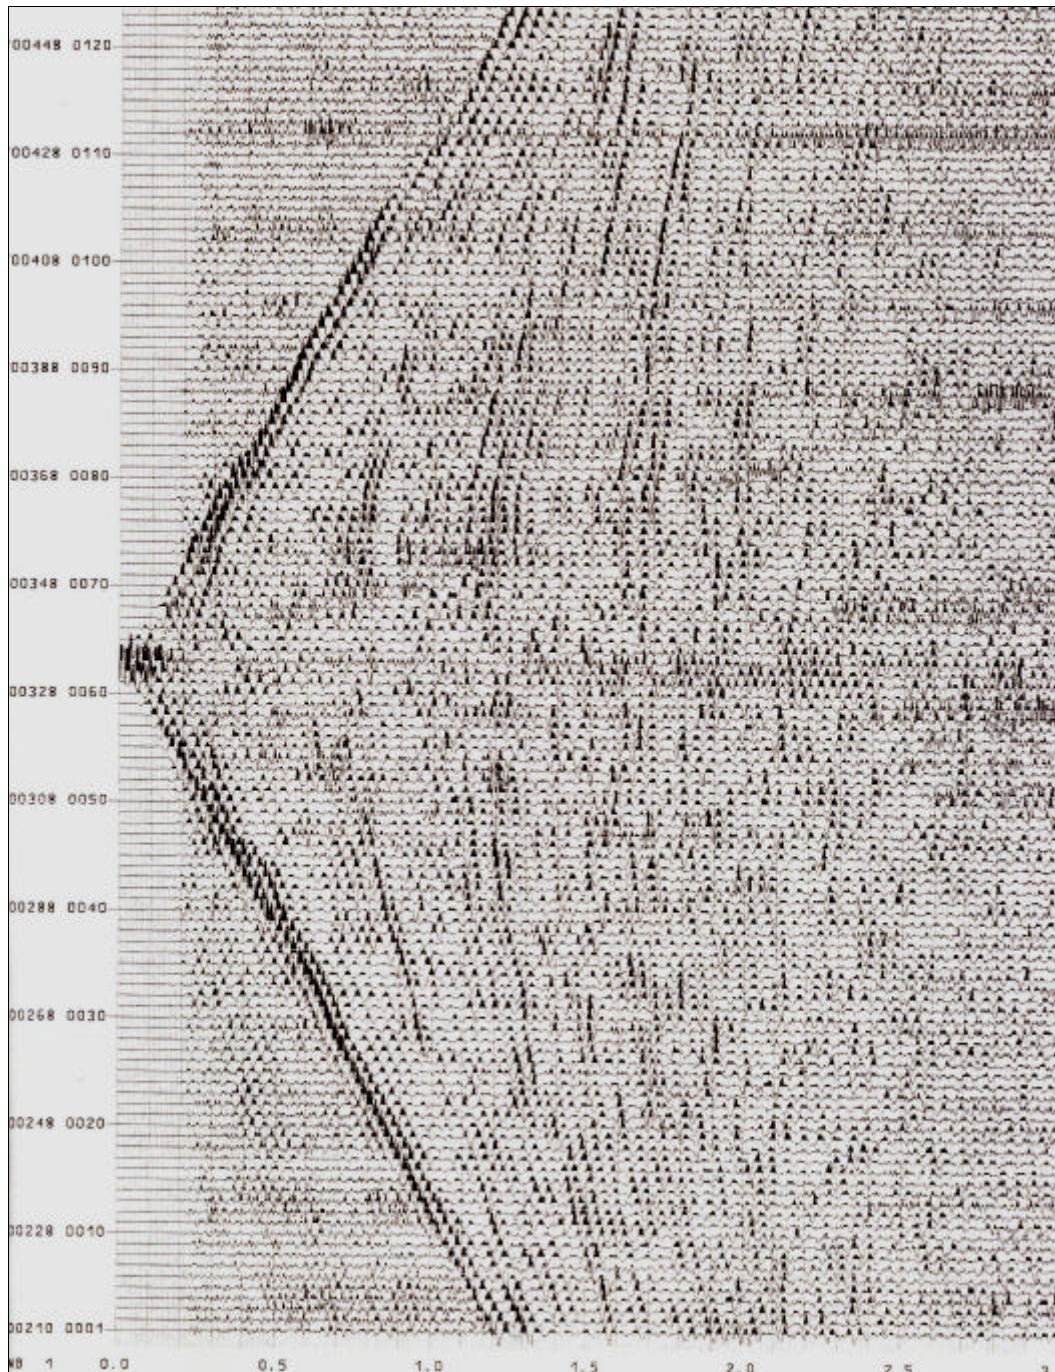
Sample Monitor # 4- 2: Line BC03-36 VP# 266.5

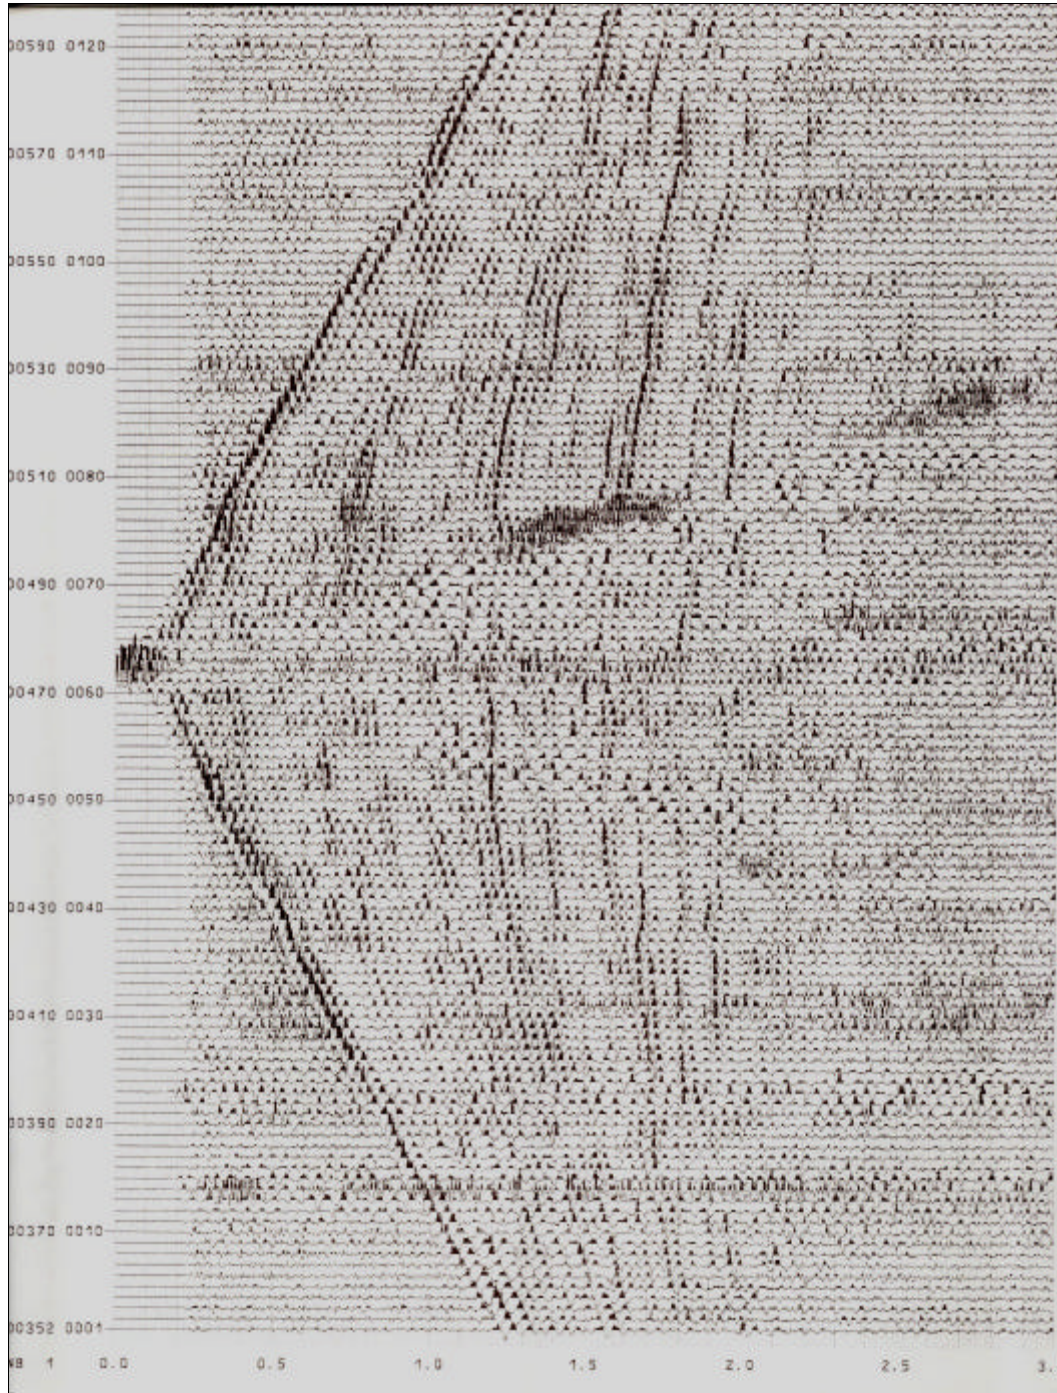
**Sample Monitor # 4- 3: Line BC03-34 VP# 337.5**

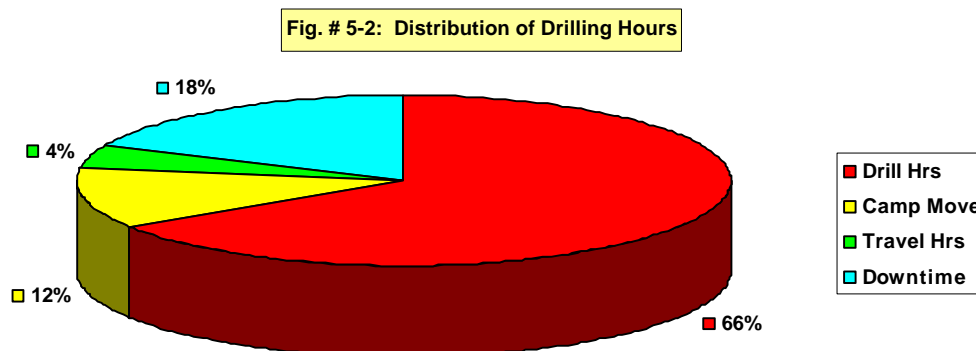
Fig. # 5-2 below shows the distribution of hours on the drill crew:

Fig. # 5-2 shows that downtime occupied 18%. The reason for the downtime was illness suffered by driller Keith Daly. Keith, who came in as an emergency replacement when regular driller Trevor Edwards had to go out on compassionate leave, suffers from vertigo and had an episode when he mounted the driller's step on November 16<sup>th</sup>. He decided (wisely) to rest for the remainder of the day.

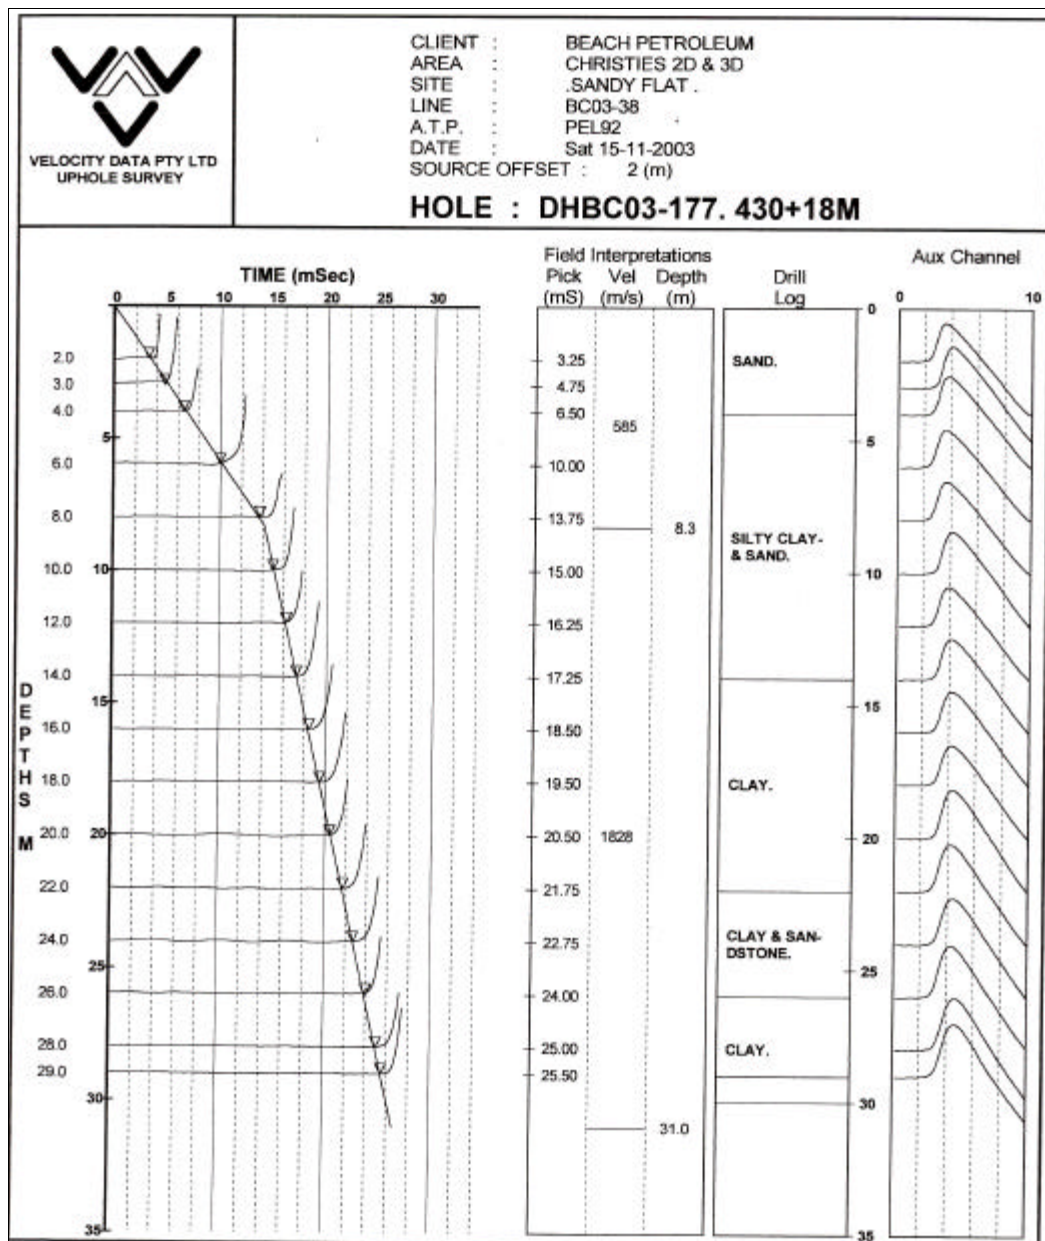
Sample Uphole Plot # 5- 1: Line BC03-38

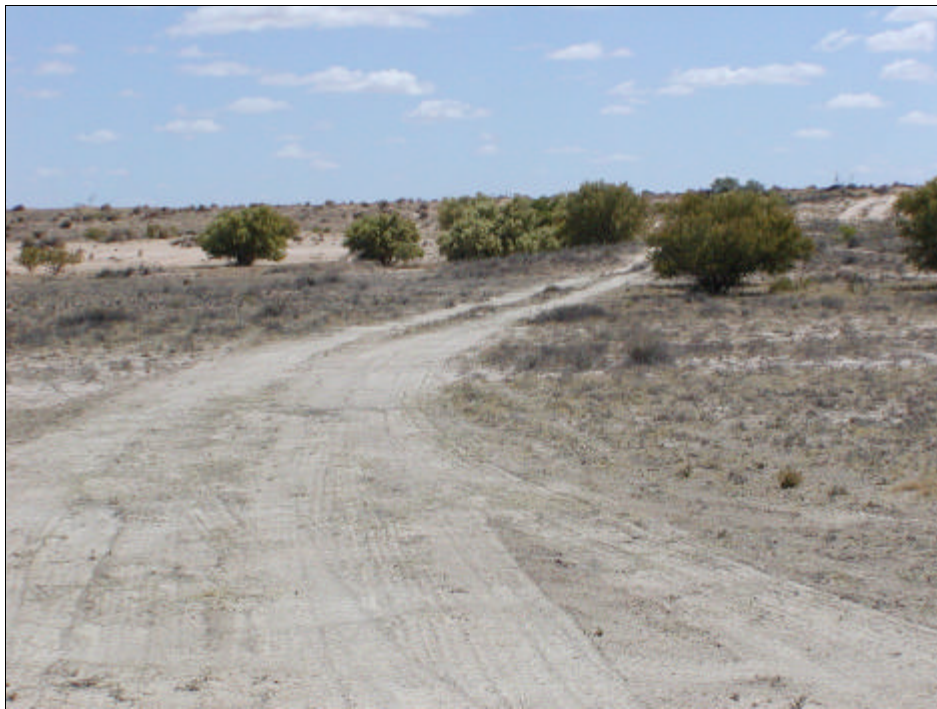
**Picture # 6- 3: Line BC03-35 station 277 looking west. Grey clay floodplain merging into low dunes with sand-dune wattle.**
