PEPR

PROGRAM FOR ENVIRONMENTAL PROTECTION AND REHABILITATION

ML 733, 734 & 665

"Mining Program of the Morgan Gypsum Deposit"

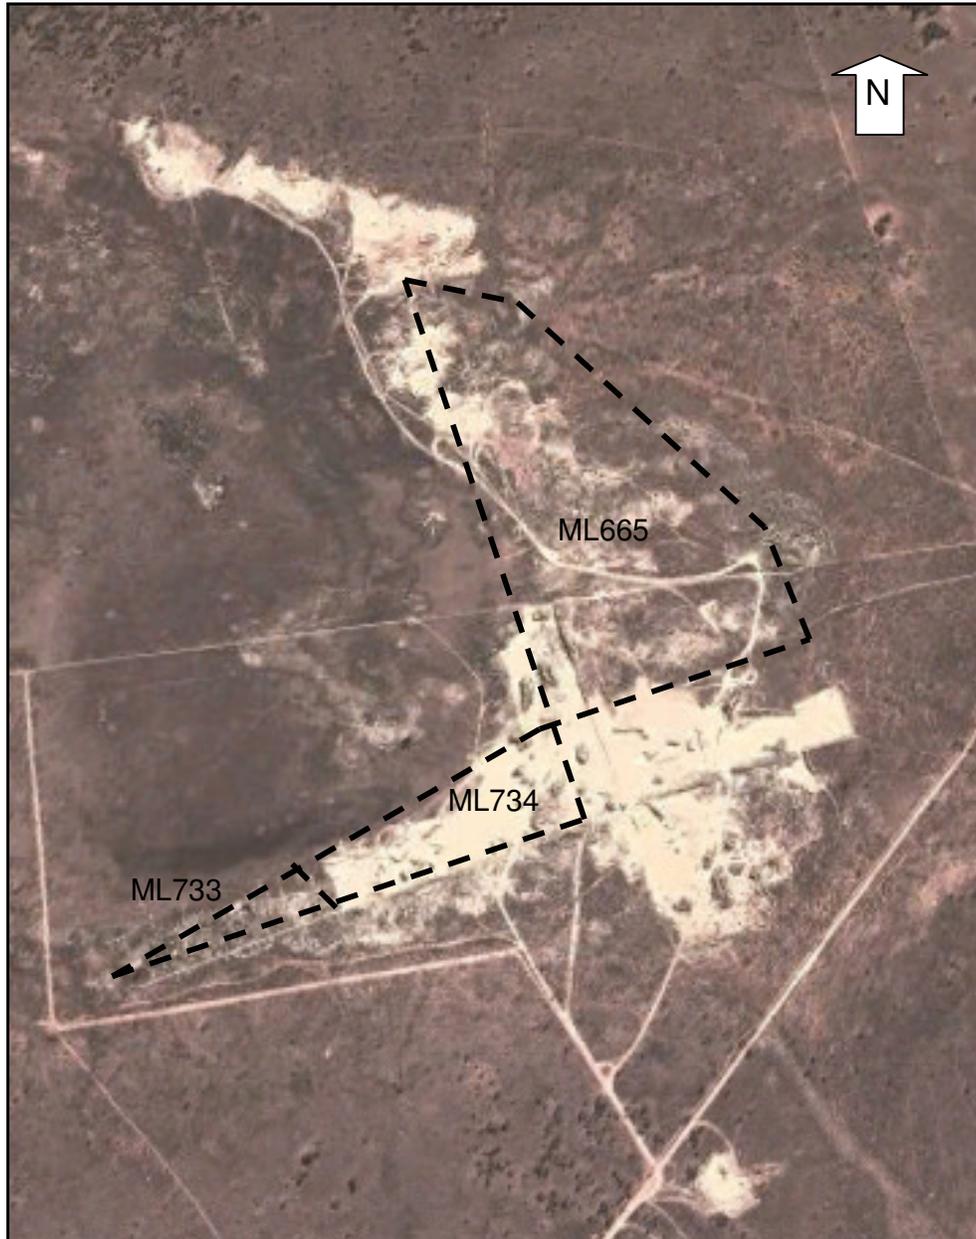
Appendix 3
PEPR ML 733, 734 & 665 (2014)

AERIAL MAP SHOWING GYPSUM MINE AREAS
(APPROX) AND ACCESS TRACKS

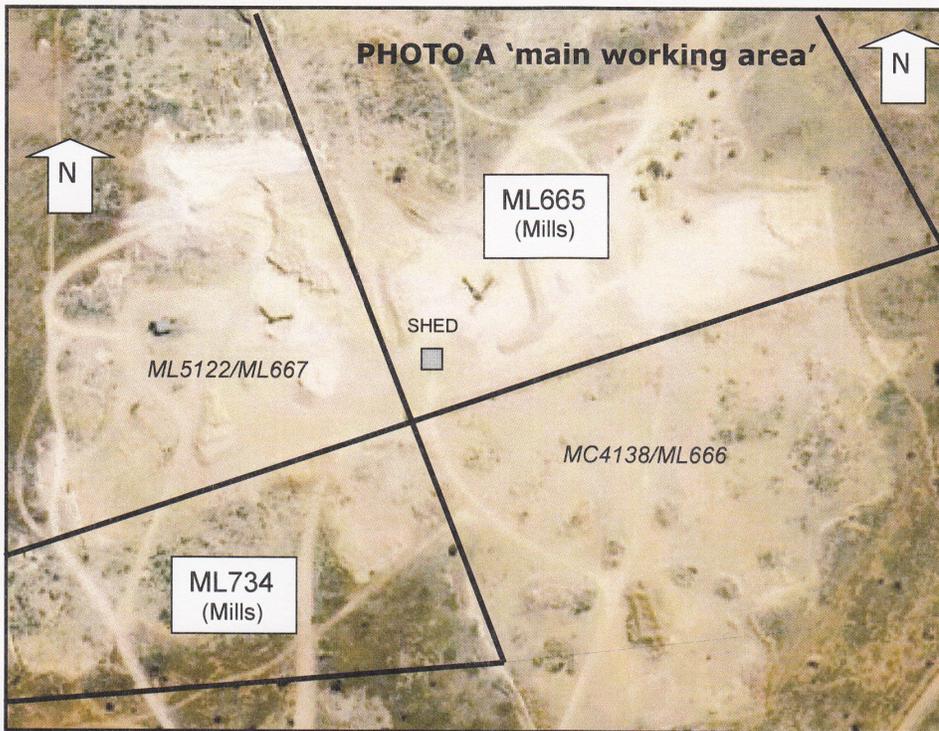
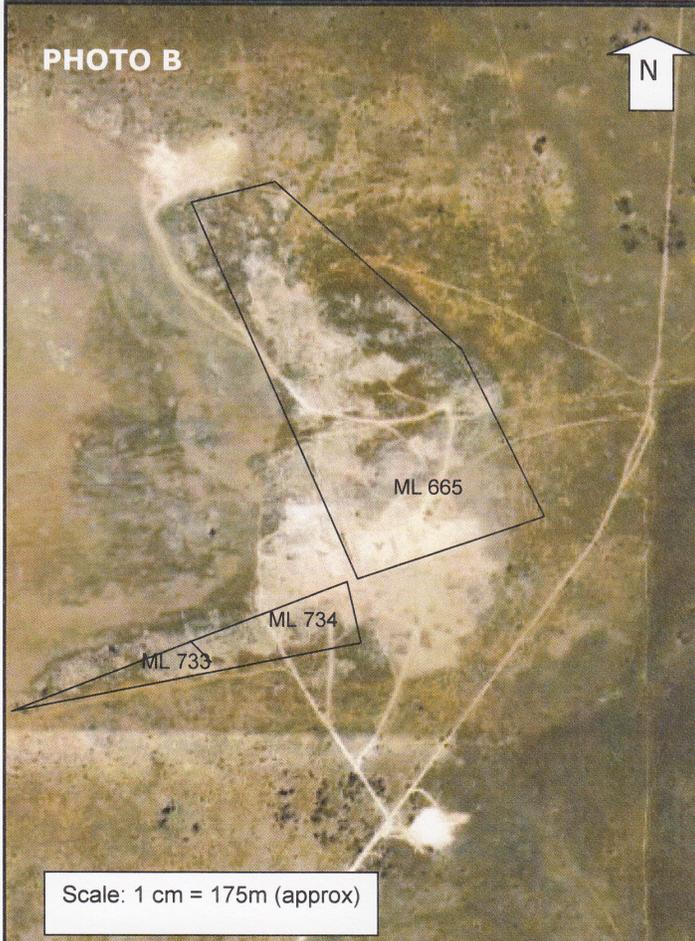
Appendix 4 page 3

The site is crossed by many tracks and former diggings by many contractors and operators since the gypsum site was opened in the 1970's. Some uncontrolled diggings were commenced prior to that date.

The areas to the left shows approx. the locations of the mining leases (Ref: SARIG map).

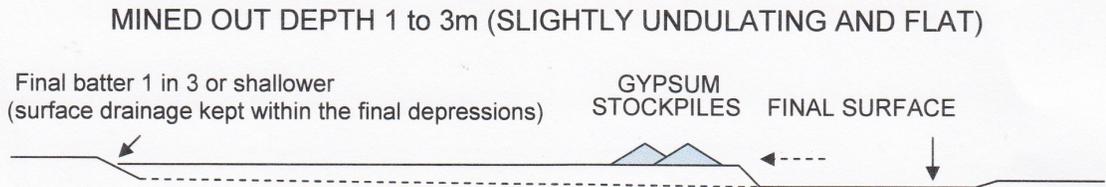
Appendix 4 page 4

CROSS-SECTION (Both east and west) SHOWING THE PROPOSED WORKING METHOD AND PLAN OF CONCEPTUAL OR FINAL REHABILITATION FOR THE THREE LEASES SHOWING TOPSOIL AND OVERBURDEN TEMPORARY PLACEMENT

- Commence rehabilitation as soon as possible to return the land to condition similar to surrounding landscape.
- Staging progressive rehabilitation during mining, starting with reshaping the worked out areas from the perimeter (as per PEPR sect 3.9.4 and appendix 4).

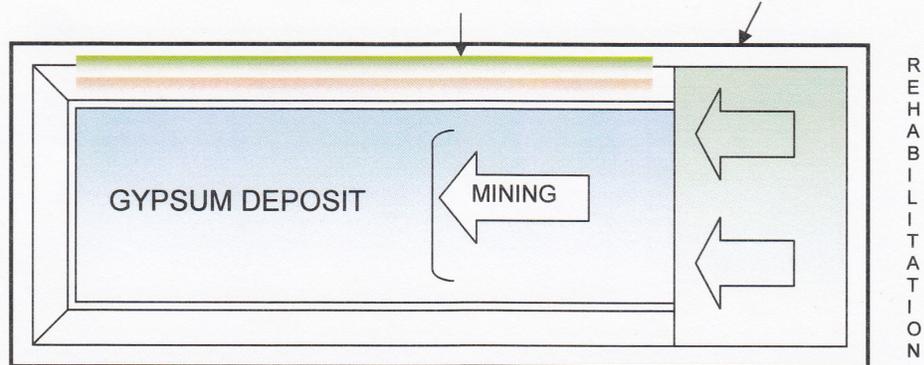
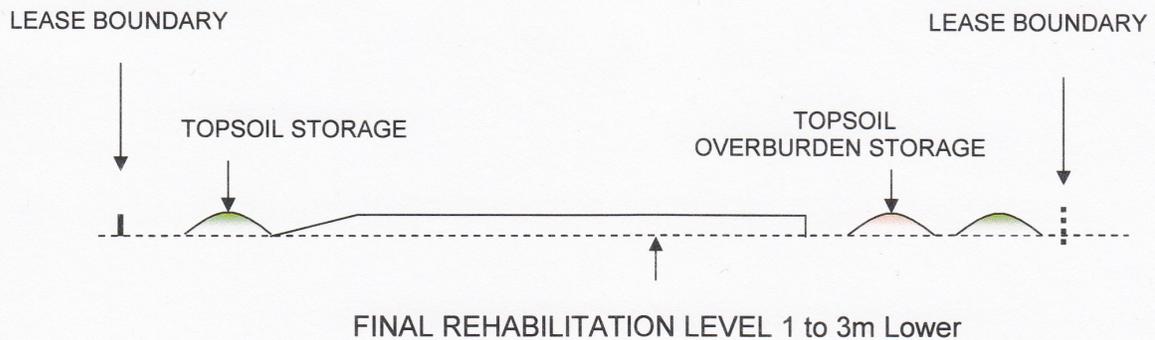
'TYPICAL' TOPSOIL AND OVERBURDEN STORAGE ALONG LEASE BOUNDARY

- Topsoil, subsoil and overburden are stored in separate areas to assist in the rehabilitation process, placed alongside the extremities of the working area all around the leases in low mounds up to 2 metres in height, averaging 500 tonne capacity.

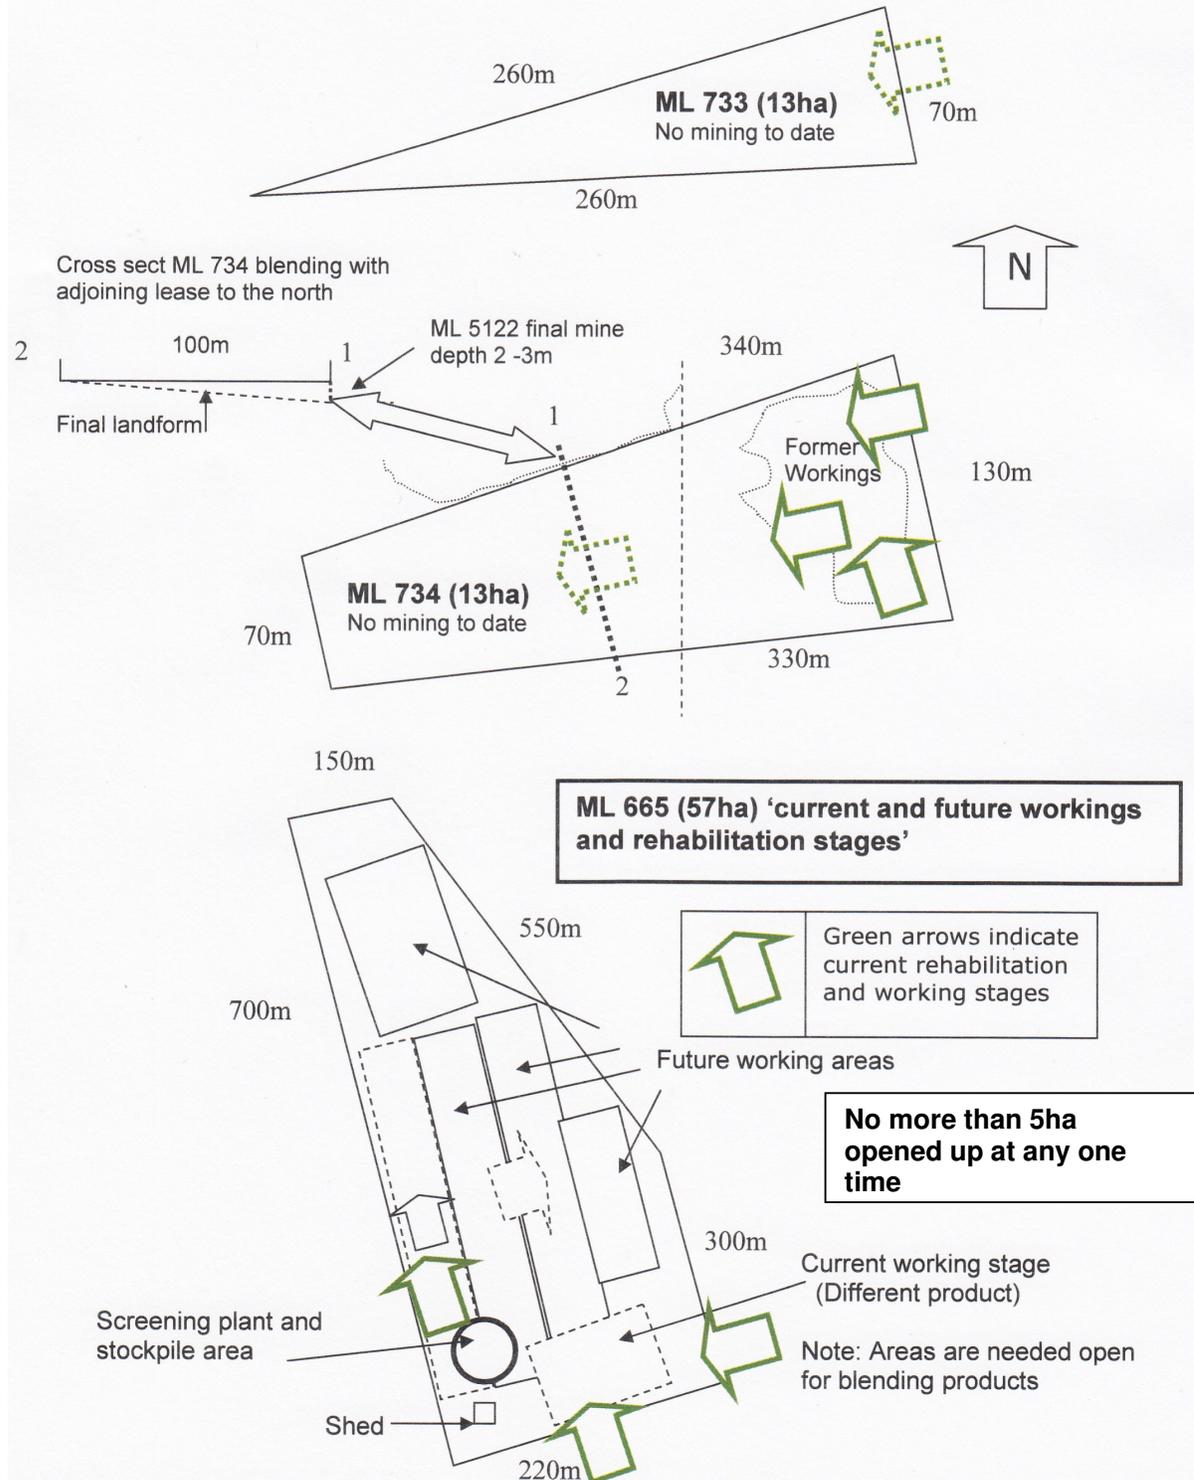
Appendix 4 page 5

THE THREE 'MILLS FREIGHTLINES' MINERAL LEASES
(Approximate scale 'No distances given on ML documents')

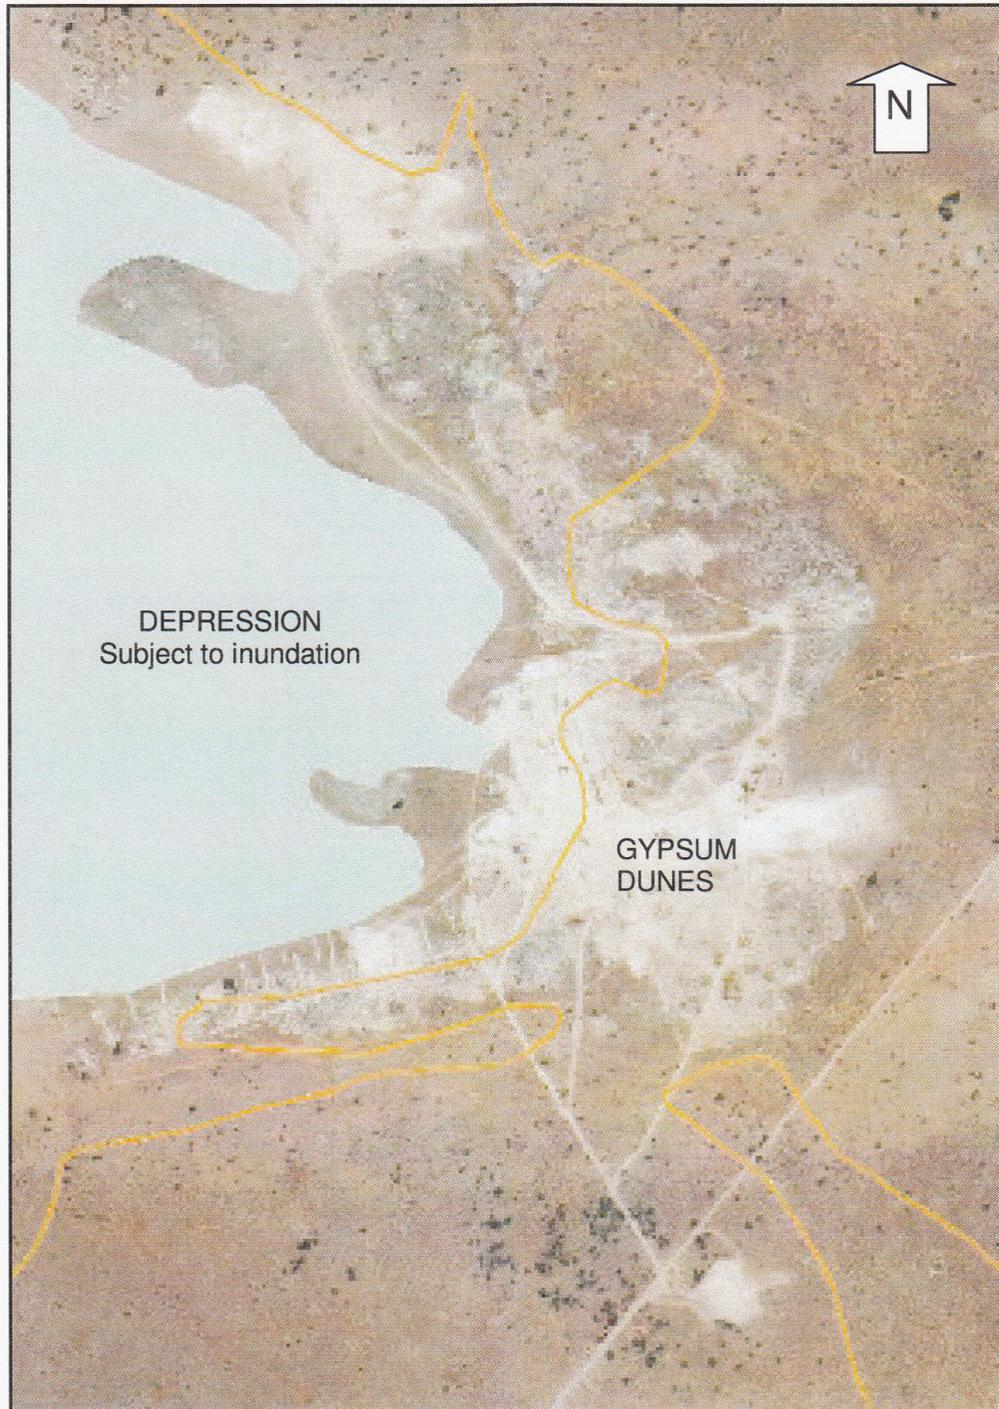
AERIAL MAP SHOWING MAIN GYPSUM MINE AREAS AND ACCESS TRACKS

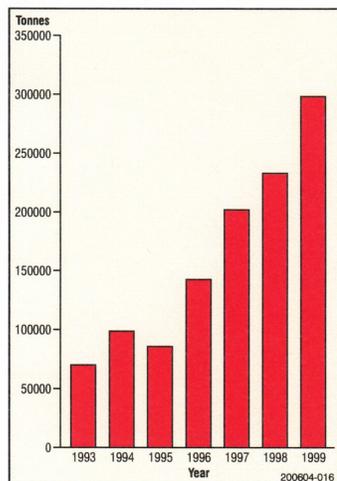
Fig. 1 SA gypsum sold for agricultural purposes, 1993–99.

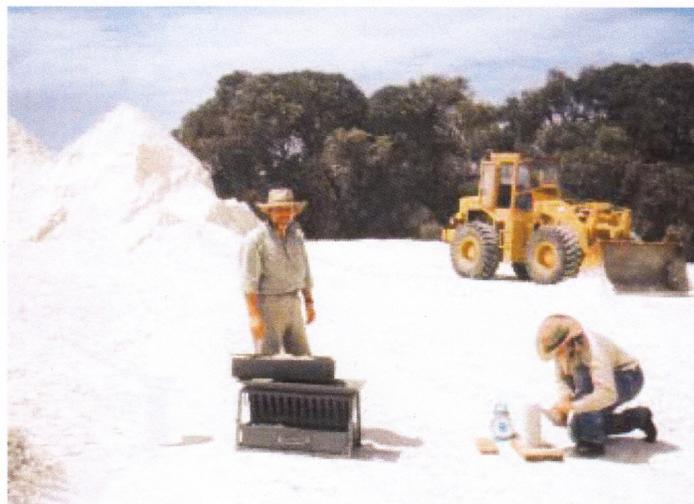
Splitting and weighing gypsum samples at Elephant Lake. (Photo 47712)

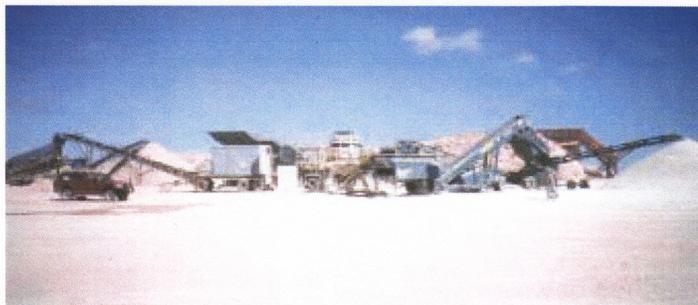
Crushing and screening plant at Blanchetown gypsum deposit. (Photo 47713)

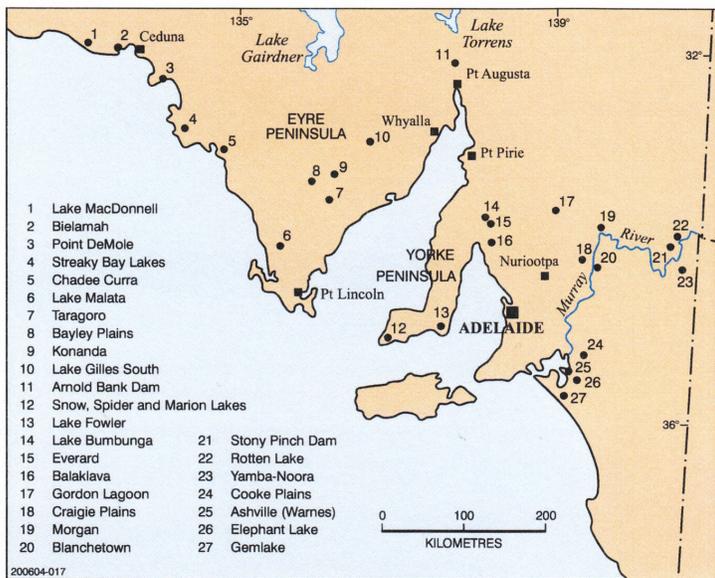
Fig. 2 Gypsum deposits in South Australia.

occurred under different climatic conditions to the present day; the last major phase of playa gypsum formation was 18 000–16 000 years ago (Bowler, 1978). Continental playas typically formed as depressions in a clayey substrate where the watertable is normally below the surface of the lake sediment. The lake filled only after heavy rain and, as the water evaporated, the salinity increased and fine-grained gypsum was precipitated. When the lake dried out, the top of the gypsum sediment was eroded by deflation into lunettes around the margin of the lake. Either the accumulated lake sediment or the adjacent lunettes contain the bulk of the resource. Playa lake deposits provide most of the gypsum used in agriculture. Some playa deposits are also important sources of cement-grade gypsum and can contain substantial resources suitable for plaster manufacture. Major SA deposits are at Blanchetown, Cooke Plains, Lake Malata, Gordon Lagoon, Everard, Morgan, Rotten Lake and Meningie (Fig. 2).

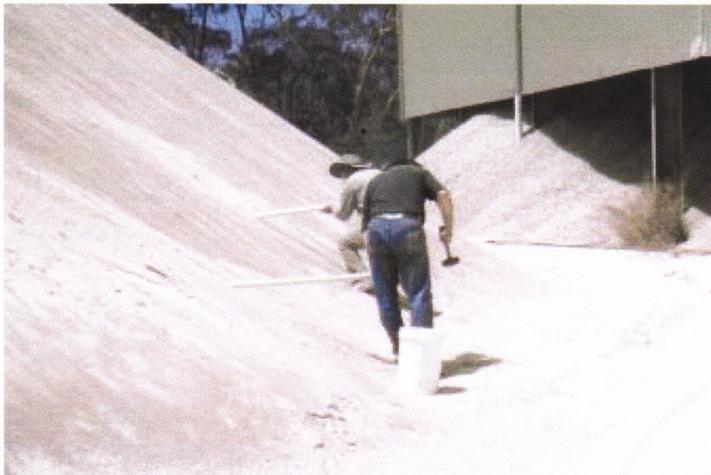
Sampling stockpiles of gypsum from the Blanchetown deposit. (Photo 47714)

To assist with introduction of the new legislation, PIRSA undertook a sampling program of gypsum stockpiles, where available, during January–March 2000. All 33 pits in SA currently producing gypsum product for agriculture were visited. The results were communicated to individual producers in May. Samples were collected using 1 and 2 m long, 50 mm diameter polypipe driven into the stockpile at a large number of points. These were reduced on site using a sample splitter to give ~5 kg bulk samples, which were sealed in plastic bags to minimise moisture loss. Where the miner produced more than one product, samples were taken from each of the stockpiles.

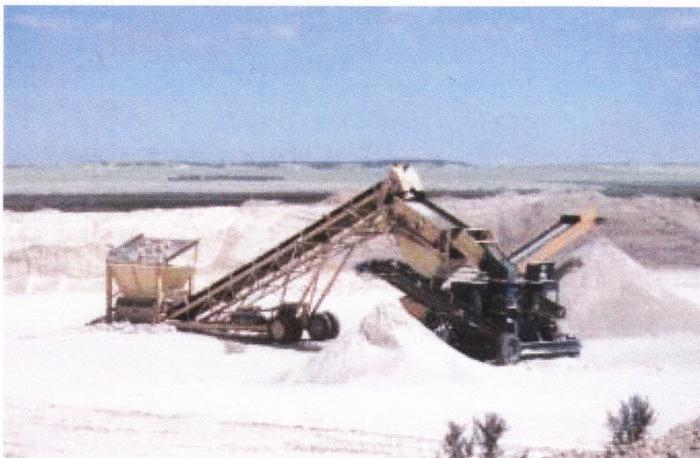
Gypsum screening plant at the Everard deposit. (Photo 47716)
