**Portia Gold Project**

**QUARTERLY COMPLIANCE REPORT**

**COMPLIANCE REPORT NO. 13 Q2 2018**

Portia ML 6346 Compliance Report No. 13 Q2 2018 (Quarterly)

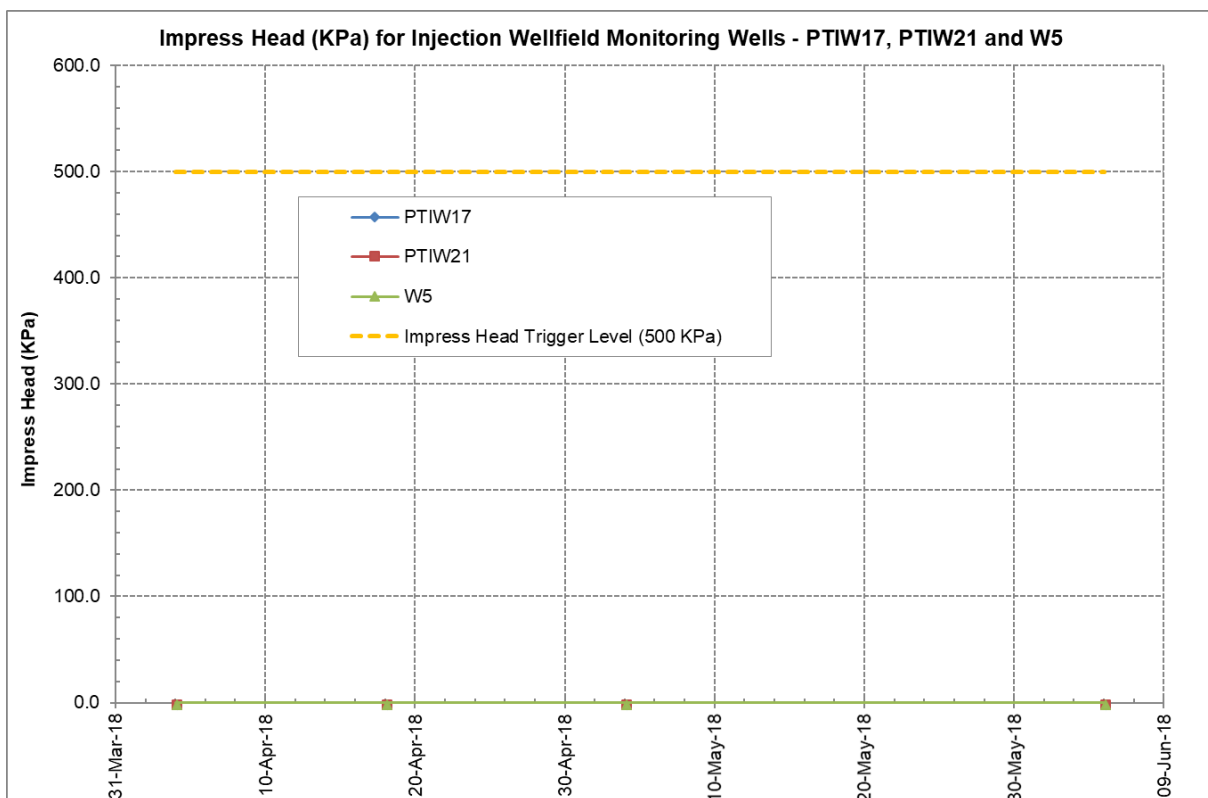
Figure 1: Impress Head (KPa) for injection wellfield monitoring wells – April to June 2018

Pressures heads in Shylock Palaeochannel re-injection wellfield monitoring wells PTIW17, PTIW21 and W5 were at zero at the start of the reporting period (see Figure 1). No re-injection occurred during the reporting period of 1 April 2018 to 30 June 2018. Pressures recorded at re-injection and monitoring wells remained at zero.

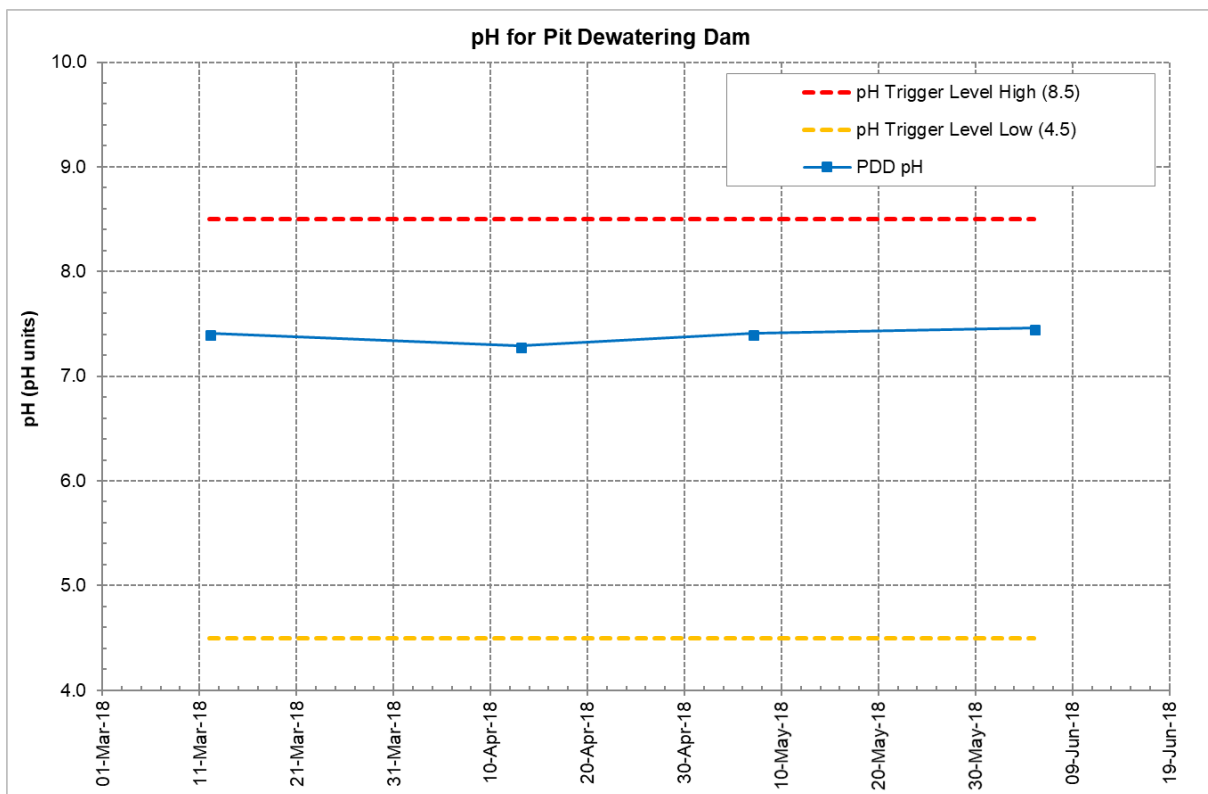
Figure 2: Field pH of Pit Dewatering Dam – April to June 2018

Field pH measured from the PDD during the reporting period ranged from 7.29 to 7.46 (Figure 2), within the compliance trigger levels of 4.5 and 8.5. A quarterly duplicate sample (PDD\_20180605) was sent for analysis to the ALS Laboratory on 5 June and returned a pH reading of 7.58.

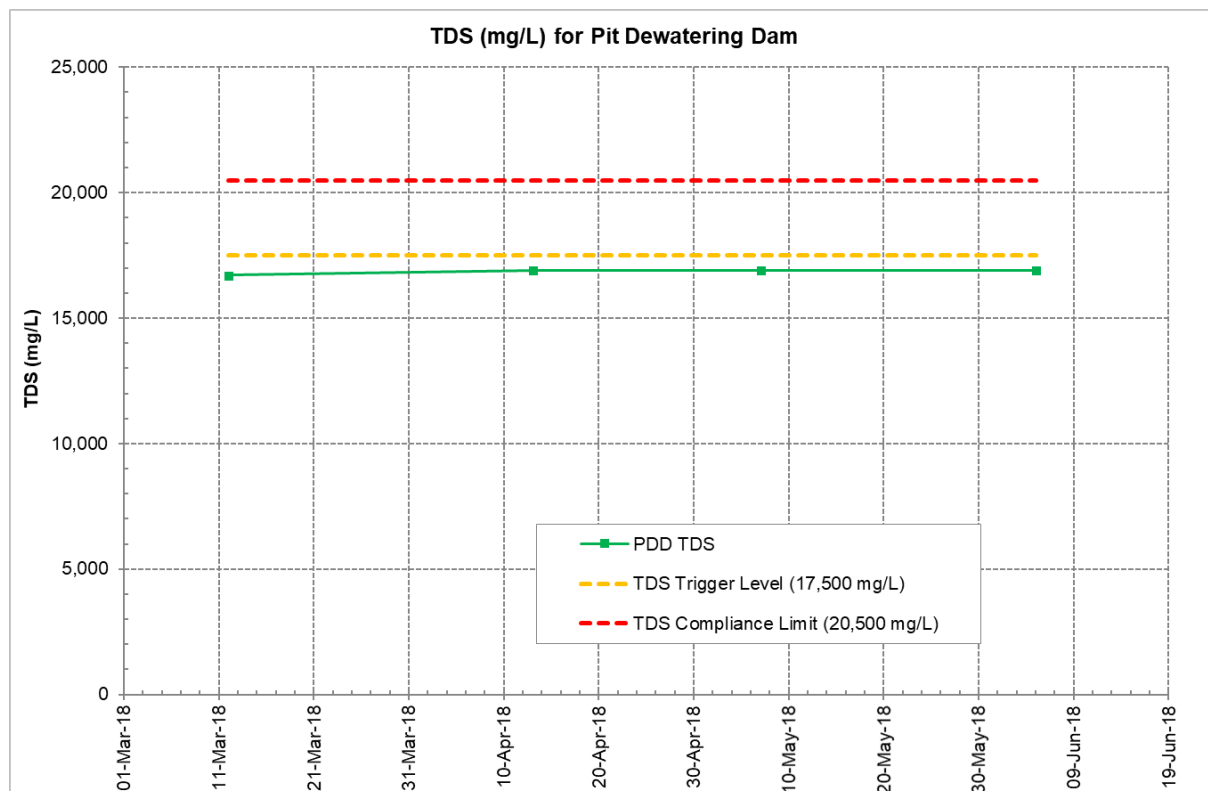
**Figure 3: Field Total Dissolved Solids (TDS) for Pit Dewatering Dam – April to June 2018**

Results during the reporting period show that field TDS<sup>1</sup> measurements in the PDD were less than the 17,500 mg/L trigger level (see

Figure 3). A quarterly duplicate sample collected on 5 June 2018 (PDD\_20180605) was sent for analysis at ALS Laboratory and results are shown in Table 1. The laboratory determined a TDS concentration of 18,700mg/L. While this is above the trigger level (17,500 mg/L) it remains well within the compliance limit of 20,500 mg/L. Benagerie Gold will monitor this closely to ensure continuing compliance going forward.

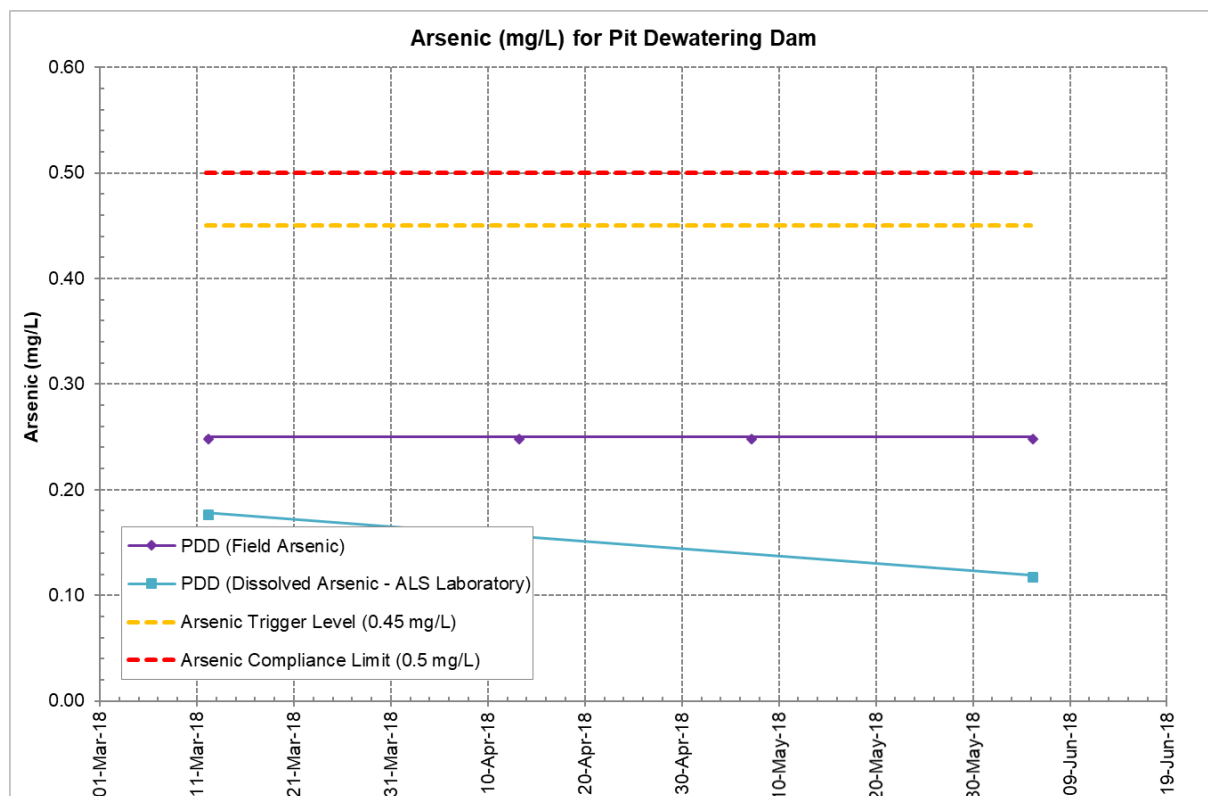
**Figure 4: Field vs Laboratory Arsenic Concentration for Pit Dewatering Dam – April to June 2018**

Monthly field arsenic measurements taken from the PDD during the reporting period were <0.5 mg/L (typically 0.25 mg/L), with 0.45 mg/L being the latest trigger level defined in the updated approved PEPR (PEPR2016/021) (see Figure 4). The quarterly duplicate sample collected 5 June 2018 (PDD\_20180605) was sent for analysis of dissolved arsenic and major cations at ALS Laboratory, with the reported dissolved arsenic being 0.119mg/L, well below the 0.45 mg/L trigger level (Table 1).

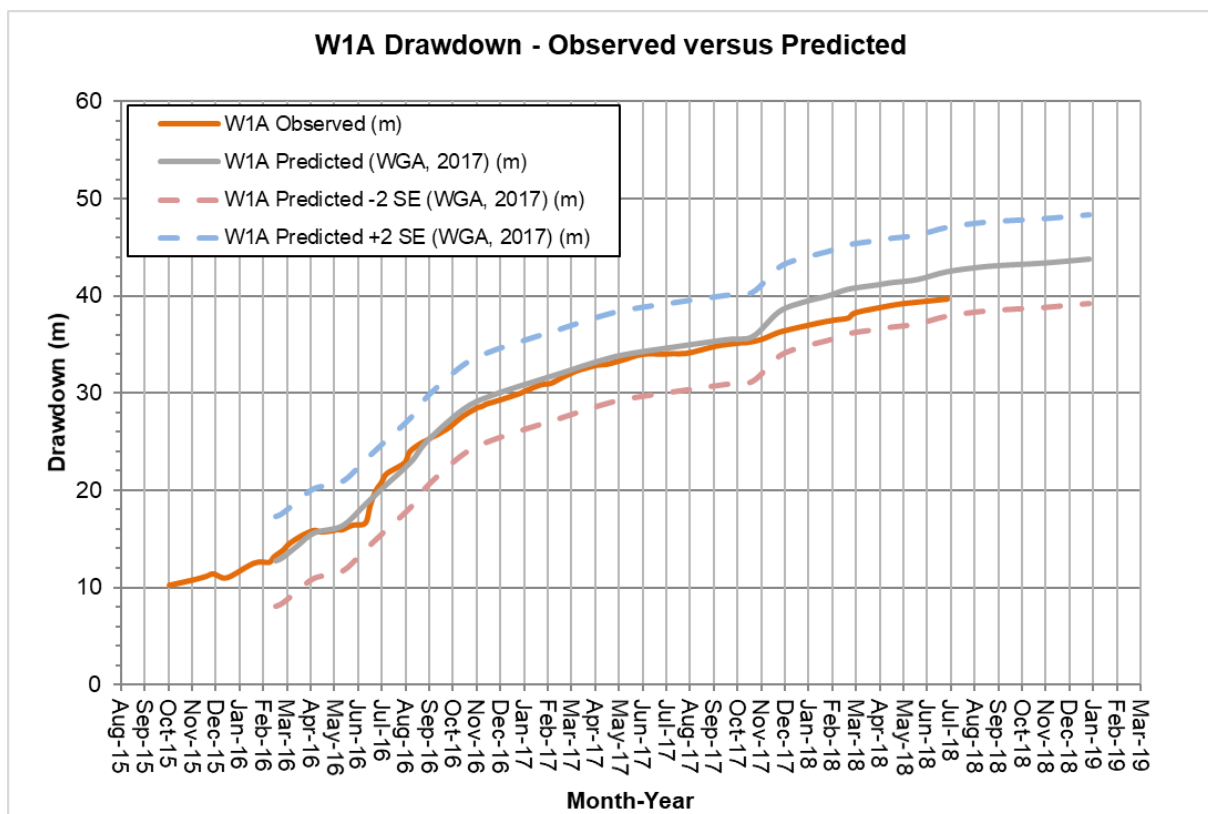
Figure 5: Operational drawdown (observed) versus modelled drawdown (predicted) for W1A

Operational drawdowns measured between April and June 2018 in model calibration wells W1A, W2A and W3A were reviewed and compared with the updated model predictions of WGA (2017) using the  $\pm 4.6$  m (2 standard error) limits. These results are shown in Figure 5 (W1A), Figure 6 (W2A) and Figure 7 (W3A).

When compared with the re-calibrated model predictions of WGA (2017), observed drawdowns in model calibration wells (W1A, W2A and W3A) are within compliance limits and showing a good overall 'fit' to the model predictions. Relatively low inflows into the pit were constant at approximately 23 L/s at the end of June.

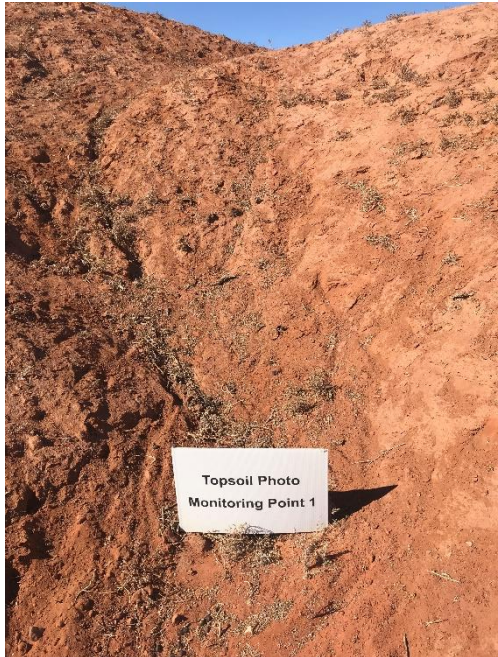
Name:	D Sawers	Date:	06/06/2018
1. New Process Dam Stockpile			
<ul style="list-style-type: none"><li>• Stable stockpile</li><li>• Minimal vegetation</li><li>• Minimal erosion gullies</li><li>• Minimal surface erosion</li></ul>

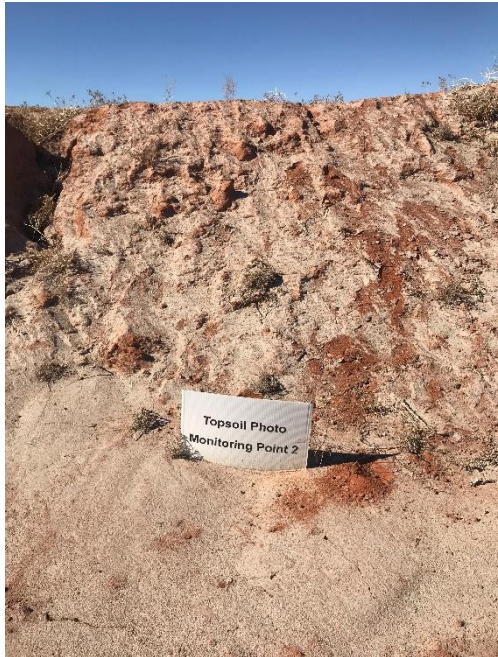
2. Plant Stockpile – Northern Side			
<ul style="list-style-type: none"><li>• Stable stockpile</li><li>• Slight surface erosion</li><li>• Large, established saltbush</li><li>• Medium vegetation</li><li>• Erosion gully evidence from sediment gathered at base of stockpile</li><li>• One large erosion gully forming</li><li>• White crust visible from dust output from plant</li></ul>

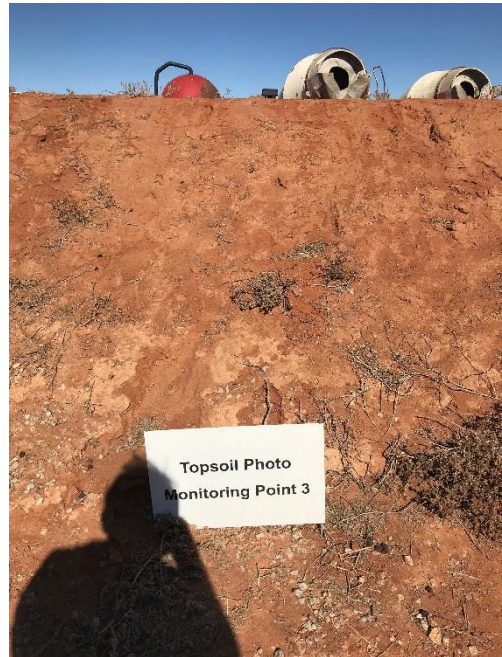
### 3. Mine Stockpile – Northern Side

- Stable stockpile
- Some major erosion gullies
- Minimal vegetation evident
- Some machinery parts visible
- Some disturbance from machinery
- Slight surface erosion

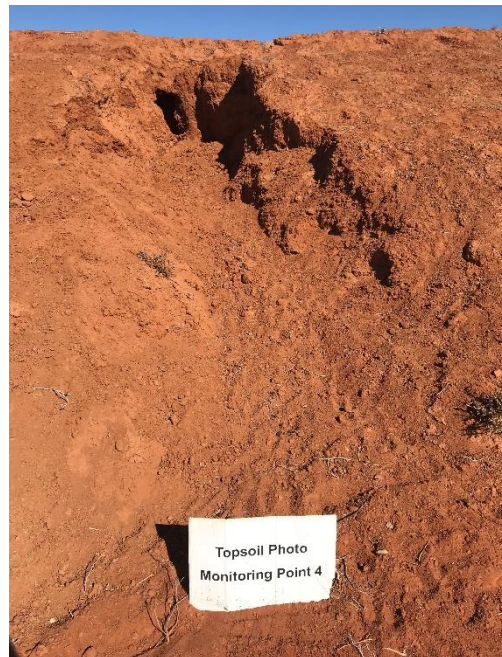
### 4. OWD – Northern Stockpile

- Generally stable
- One very large erosion gully evident
- Slight surface erosion
- Minimal vegetation observed
- Sediment collected at base of stockpile

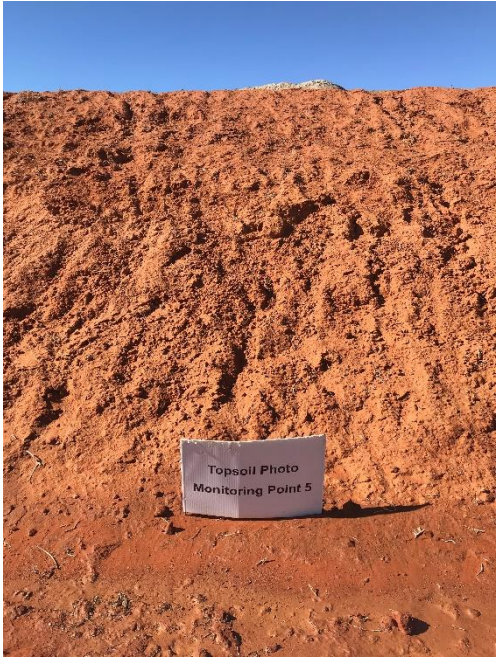
5. OWD – Western Stockpile	
<ul style="list-style-type: none"> <li>• Stable stockpile</li> <li>• Surface erosion evident</li> <li>• Minimal vegetation observed</li> <li>• Some erosion gullies becoming evident</li> </ul>

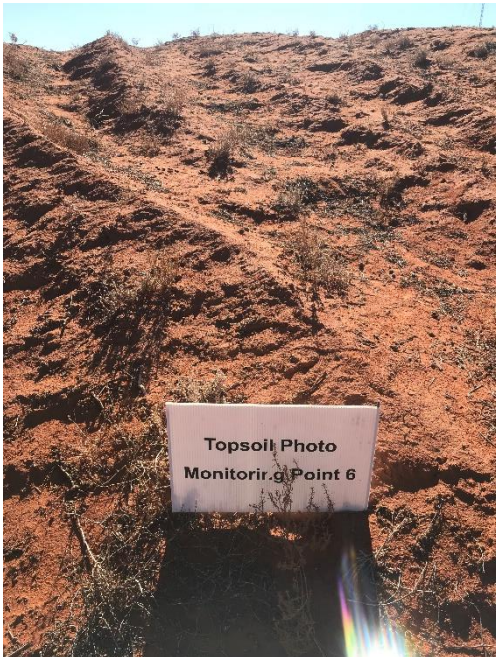
6. Camp Stockpile	
<ul style="list-style-type: none"> <li>• Stable stockpile</li> <li>• Moderate vegetation observed</li> <li>• No erosion on surface</li> <li>• No erosion gullies</li> <li>• Vegetation blending with surrounding area</li> </ul>

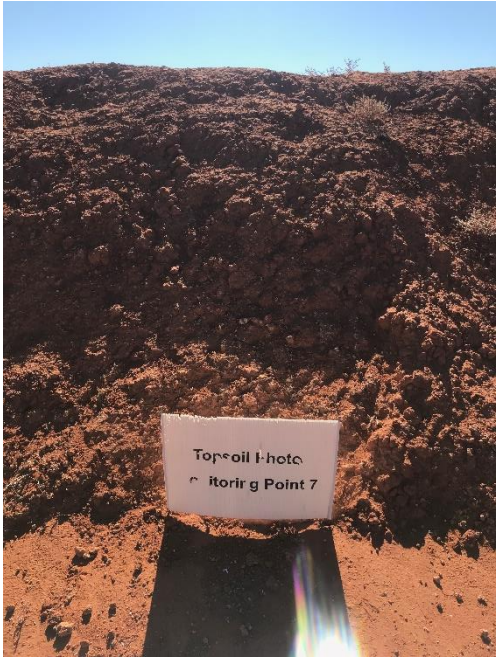
7. Waste Repository Stockpile	
<ul style="list-style-type: none"> <li>• Stable stockpile</li> <li>• Moderate vegetation observed</li> <li>• Slight surface erosion evident</li> <li>• No major erosion gullies</li> </ul>

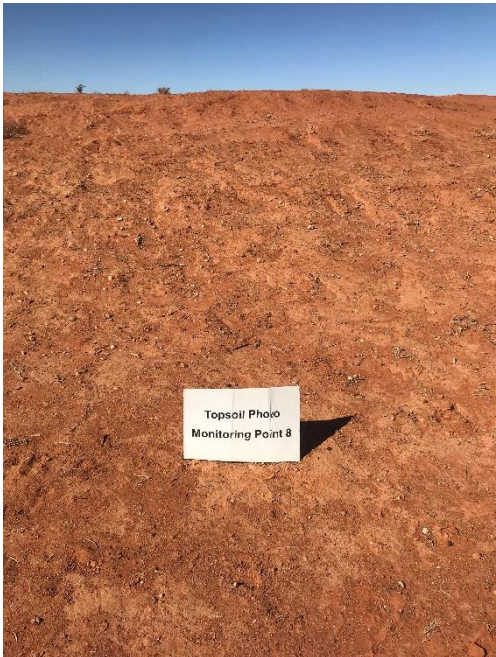
8. TFS – East Stockpile	
<ul style="list-style-type: none"> <li>• Stable stockpile</li> <li>• Slight surface erosion</li> <li>• No major erosion gullies</li> <li>• Minimal vegetation observed</li> </ul>

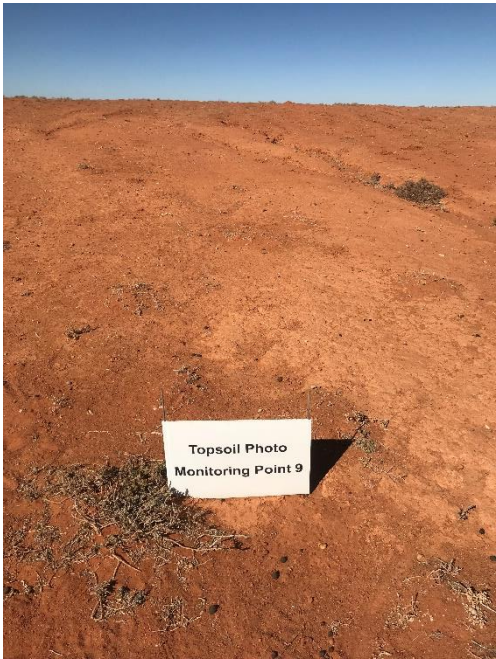
9. TFS – West Stockpile	
<ul style="list-style-type: none"> <li>• Stable stockpile</li> <li>• Some small gullies</li> <li>• Minimal vegetation observed</li> <li>• No surface erosion evident</li> </ul>

<p>A photograph of a reddish-brown soil surface under a clear blue sky. A white rectangular sign is placed on the ground, reading 'Topsoil Photo' and 'Monitoring Point 9'. The soil appears relatively stable with minimal vegetation.</p>

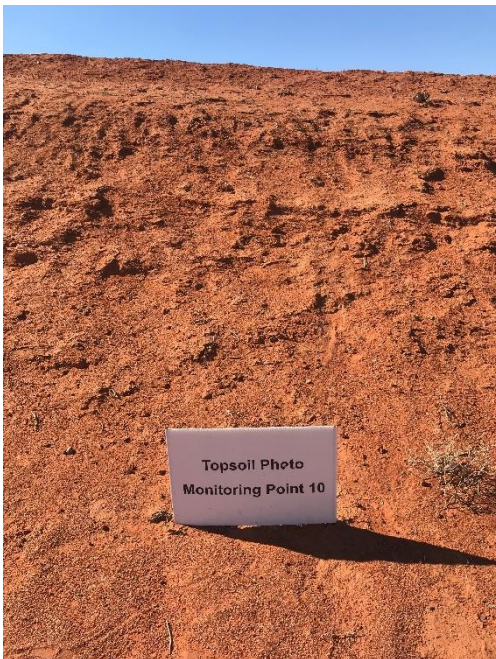
10. ROM – Western Stockpile	
<ul style="list-style-type: none"> <li>• Stable stockpile</li> <li>• Some surface erosion evident</li> <li>• Good vegetation observed</li> <li>• No erosion gullies</li> </ul>

<p>A photograph of a reddish-brown soil surface under a clear blue sky. A white rectangular sign is placed on the ground, reading 'Topsoil Photo' and 'Monitoring Point 10'. The soil shows some surface erosion and has more sparse vegetation compared to the previous point.</p>

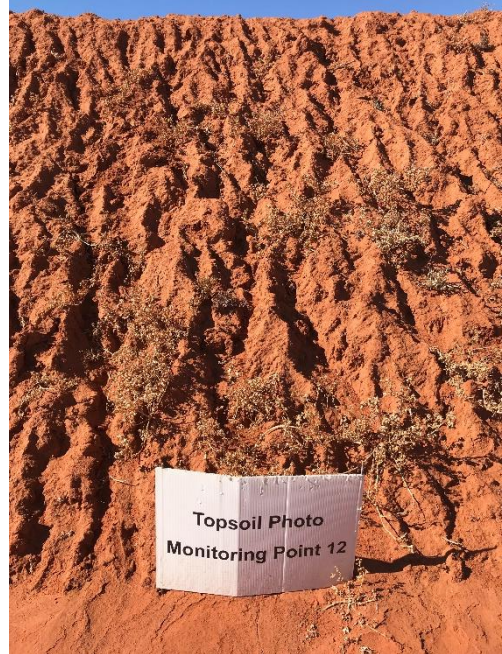
**12. Open Pit – Northern Stockpile**

- Stable stockpile
- Extensive surface erosion evident
- Moderate vegetation observed
- Some juvenile vegetation growth
- No large erosion gullies

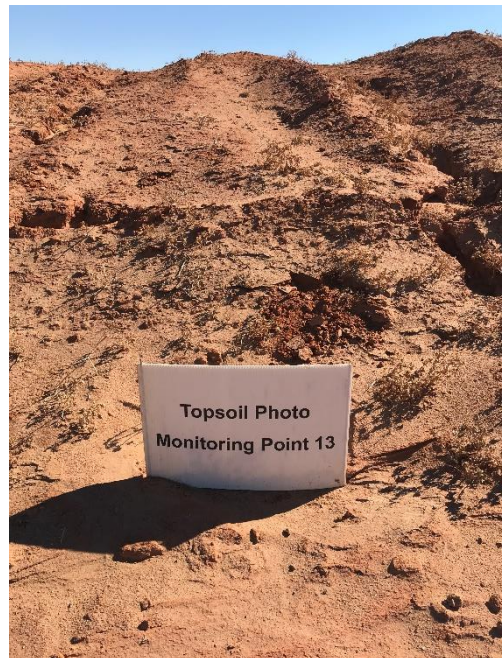
**13. Open Pit – South Eastern Stockpile**

- Stable stockpile
- Large erosion gullies becoming evident
- Some surface erosion observed
- Minimal vegetation observed

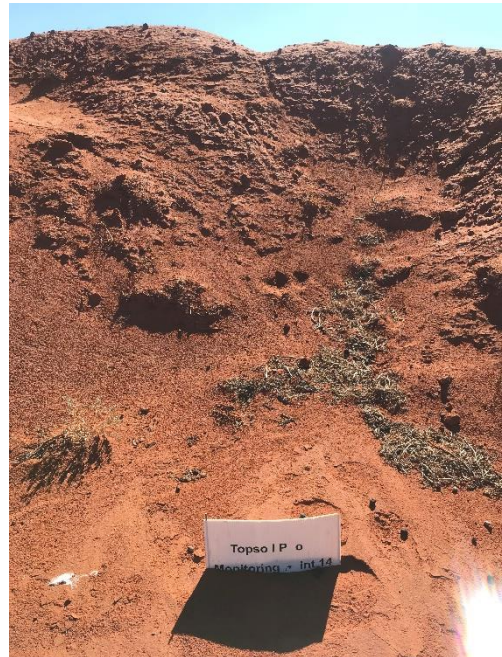
#### 14. Open Pit Stockpile – Between Pit and OWD

- Stable stockpile
- Erosion gullies becoming more prominent
- Minimal vegetation observed
- Slight surface erosion
- Sediment build up at base of stockpile

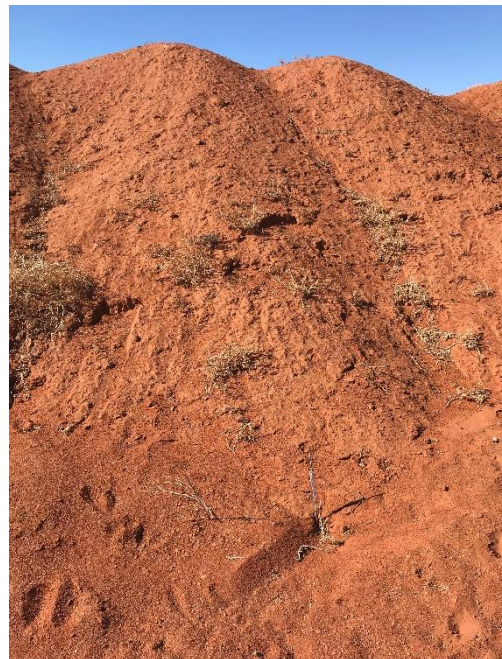
#### 15. OWD Extension – Southern Extent Stockpile

- Stable stockpile
- Surface erosion evident
- Saltbush regeneration evident
- No erosion gullies
- Some sediment build up at base of stockpile
