PROGRAMME FOR ENVIRONMENTAL PROTECTION AND REHABILITATION

Incorporating Final Closure Plan (Appendix C)

ANGAS ZINC MINE

May 2017

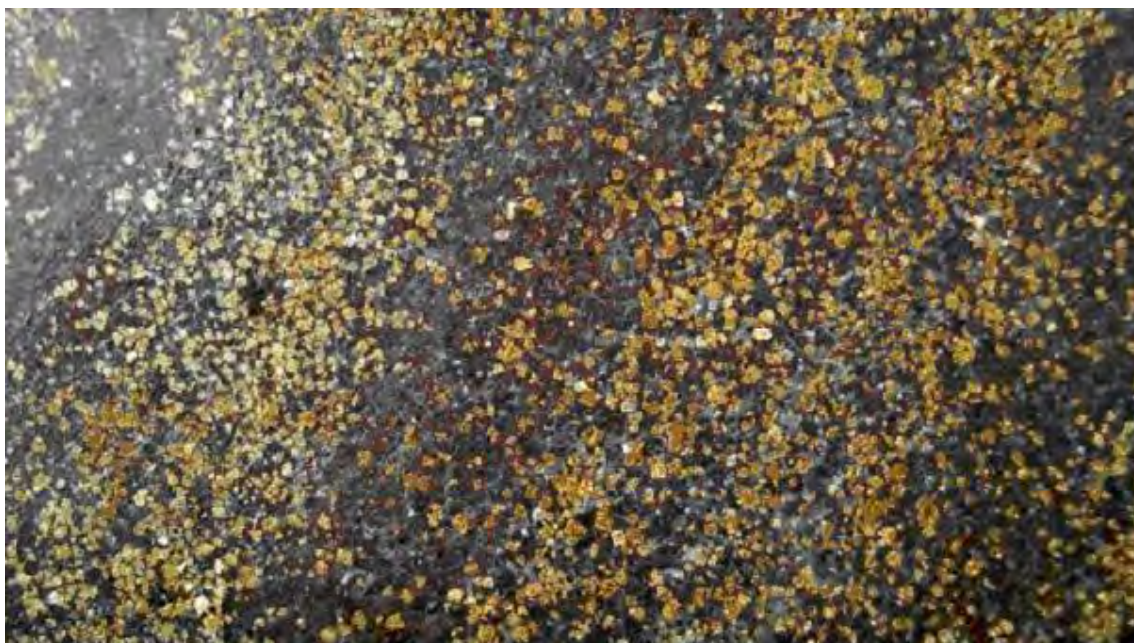
Figure 4: Type 1 Mineralisation

Intervals of Type 1 mineralisation are typically sulphide-dominant with only a minor host-rock component (0 – 40%). Compositional banding of pyrite and sphalerite is widespread. Individual bands vary from 5 to 20mm wide and are generally parallel or sub-parallel to the dominant host rock structural fabric (S2). In rare but significant intervals, compositional banding is deformed into open folds.

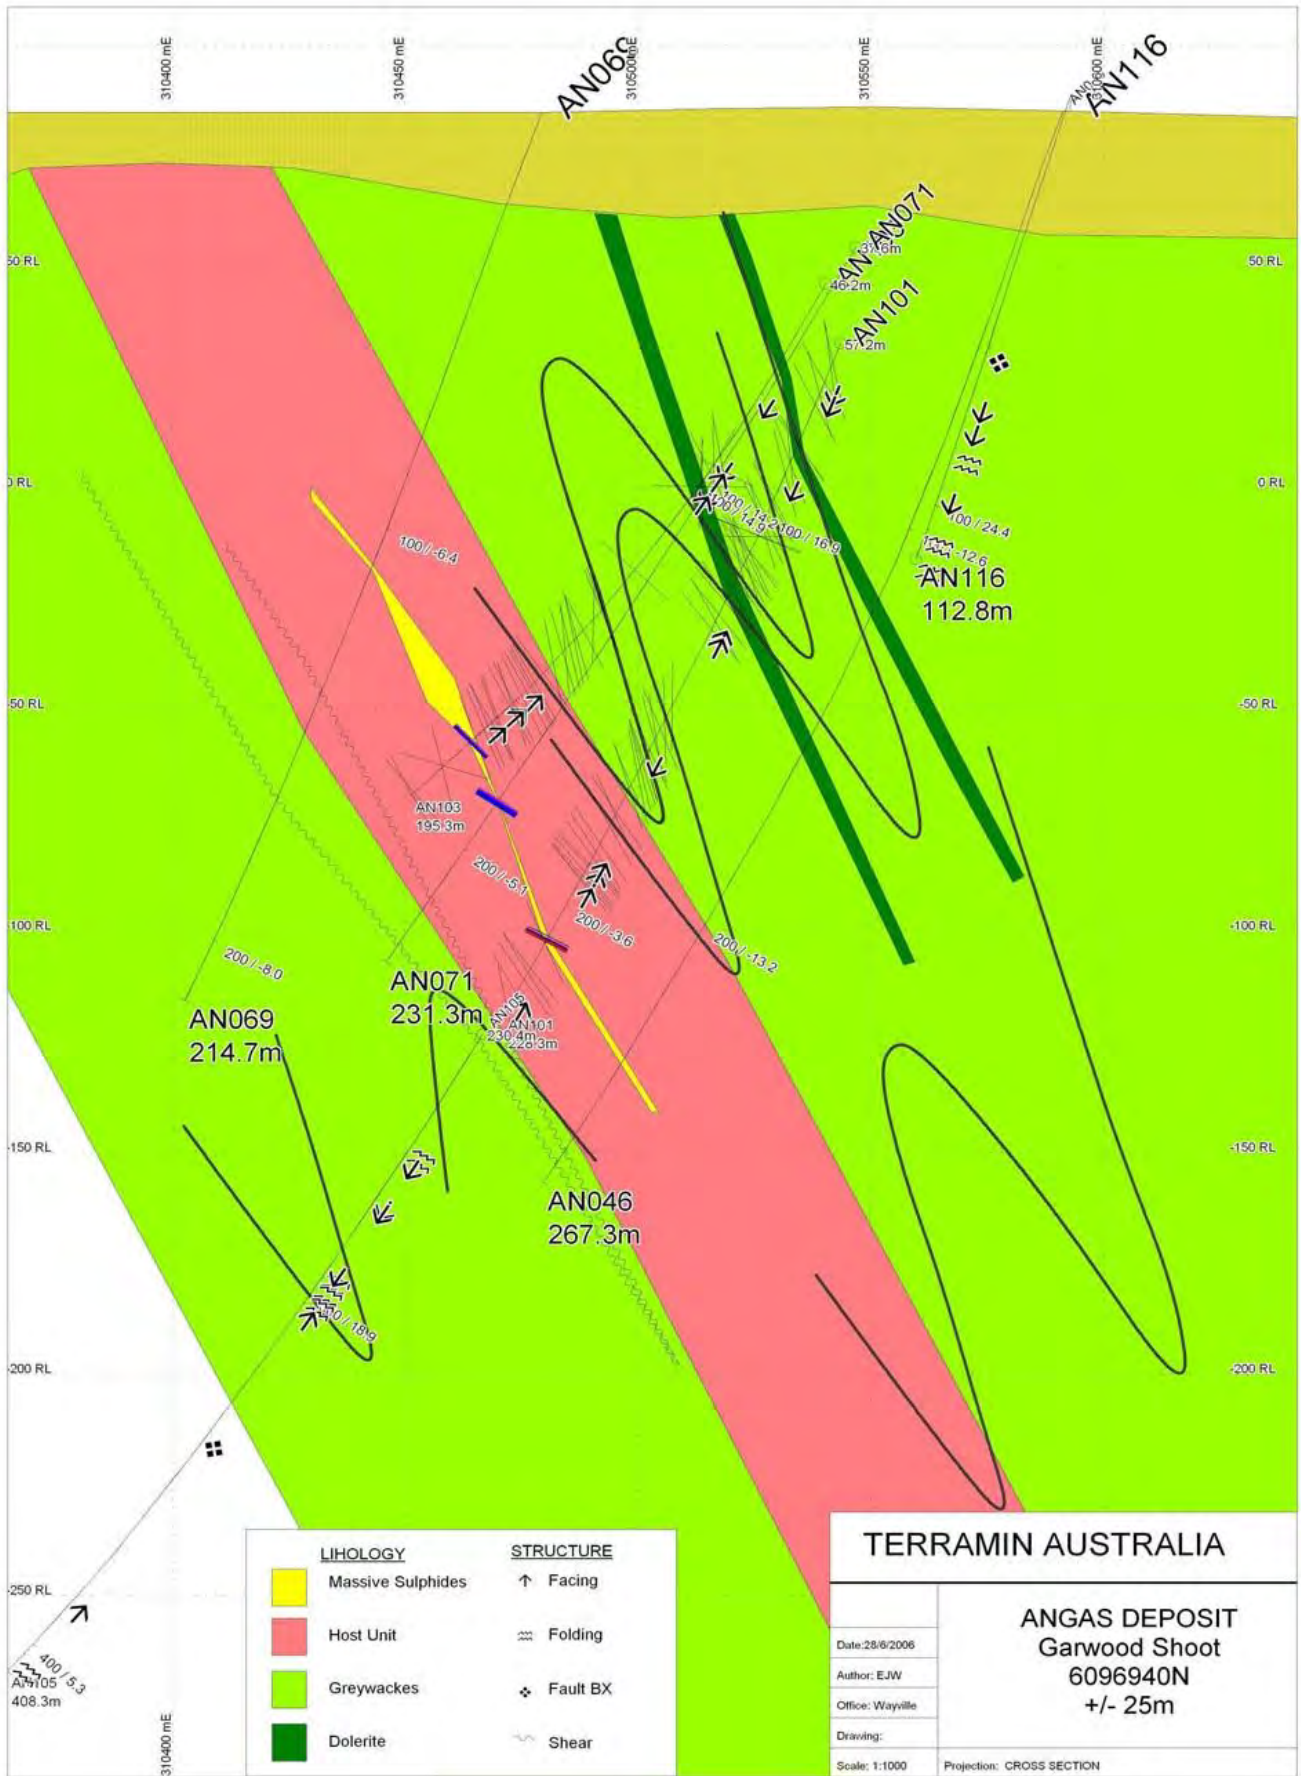
Figure 8: Section – Rankine – Garwood Shoots

Figure 8 depicts a typical geological cross-section of the mineralisation and geology in the vicinity of the Rankine-Garwood Shoots.

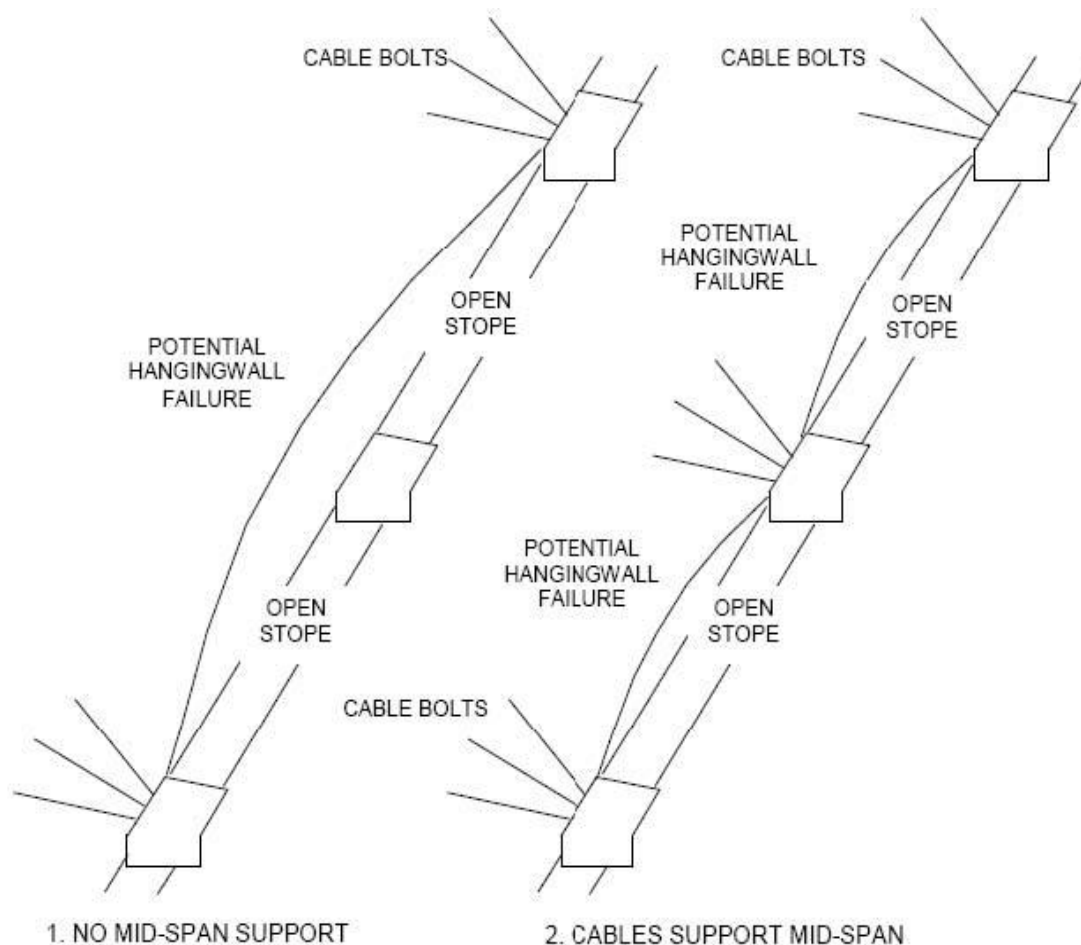
Figure 21: Illustration of Hangingwall Cablebolting

Every intersection has a specific cablebolt pattern designed for the intersection based on capacity calculation with a safety factor. The number and embedment of the cables increases according to the increase in the span. Prior to the cables being drilled the intersection structures are assessed and the requirement for additional cables evaluated. Typically the intersections are arched to facilitate stability and truck loading. Cablebolts at the intersection are installed and tensioned prior to the turnout being mined

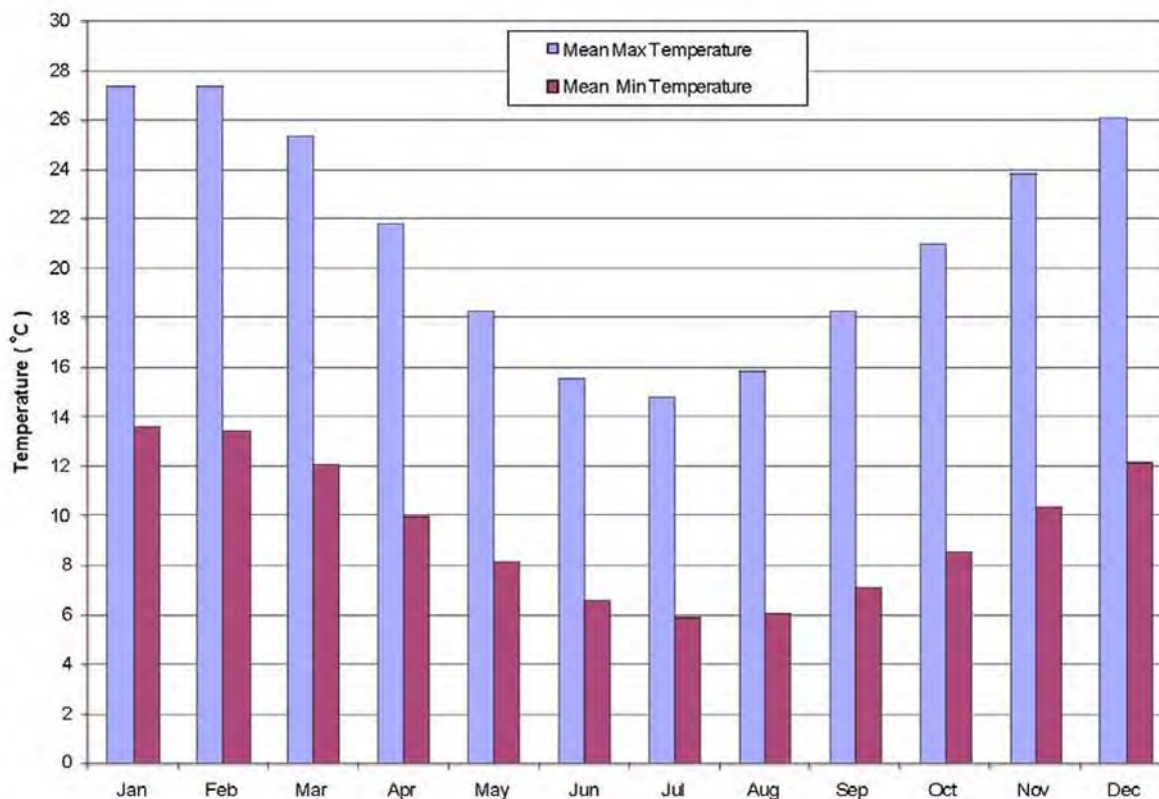
Figure 55: Mean Monthly Maximum and Minimum Temperatures

- The highest mean monthly temperatures occur in January and February, after which they gradually decline until a minimum is reached in July. After July, temperatures rise again through spring and into summer;
- The highest mean monthly maximum temperature (29.4°C) occurs in both January and February;
- The lowest mean monthly maximum temperature (14.8°C) occurs in July;
- The highest mean monthly minimum temperature (13.6°C) occurs in January;
- The lowest mean monthly minimum temperature (5.9°C) occurs in July.
