# Buckland Dry Creek PEPR Compliance Report

For Holding Pattern and Residual Operations

#### **Buckland Dry Creek Pty Ltd**

(ACN 114 007 153; ABN 82 114 007 153) 1 November 2018

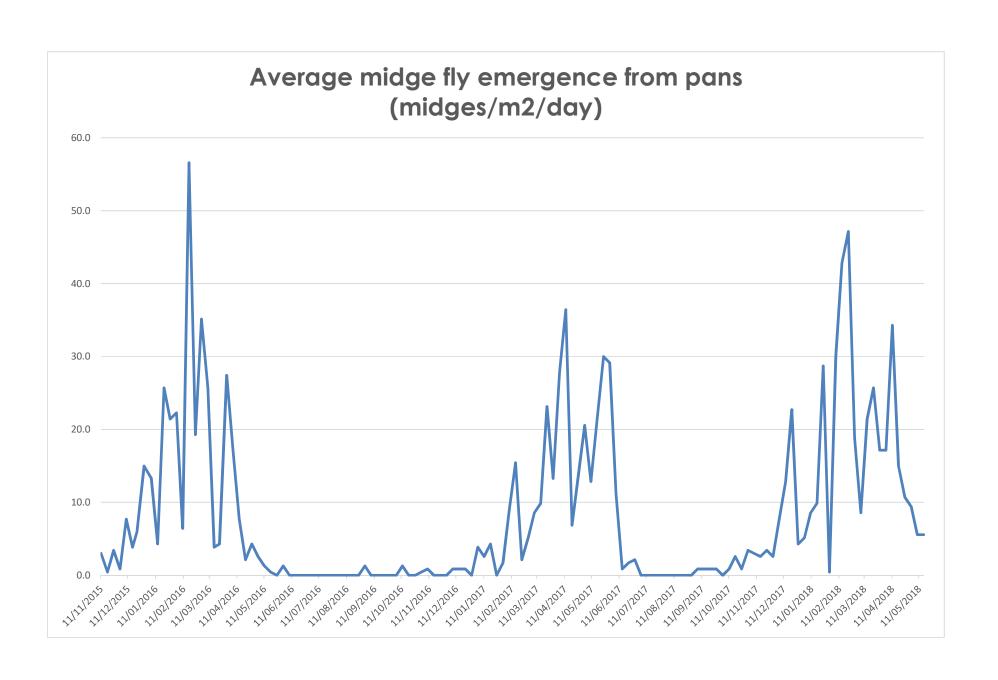
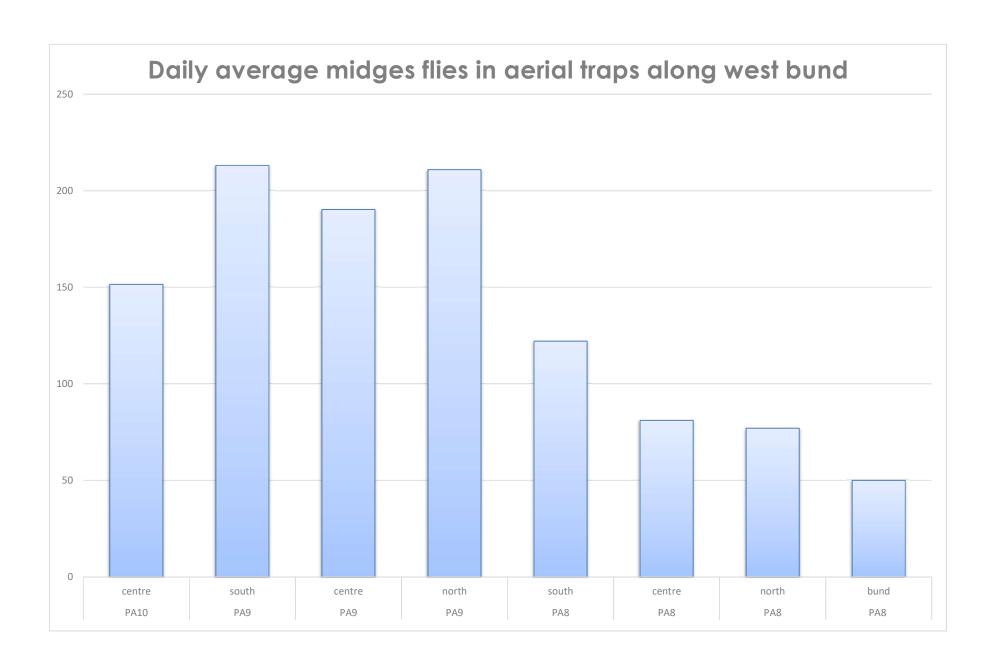
The number of midge flies emerging from the pans over the 2017/18 season (Figure xx) was similar to the numbers observed in previous years. This suggests that, while the development of a benthic sediment layer would be expected to provide a more suitable habitat for midge larvae, the pond ecosystem is also developing and providing a sufficient level of biological control that has prevented midge fly number from increasing.

Overall, the midge fly monitoring data indicate that the number of midge flies breeding in the ponds are not in sufficient numbers to cause a nuisance to residents in the St Kilda and Waterloo Corner areas.

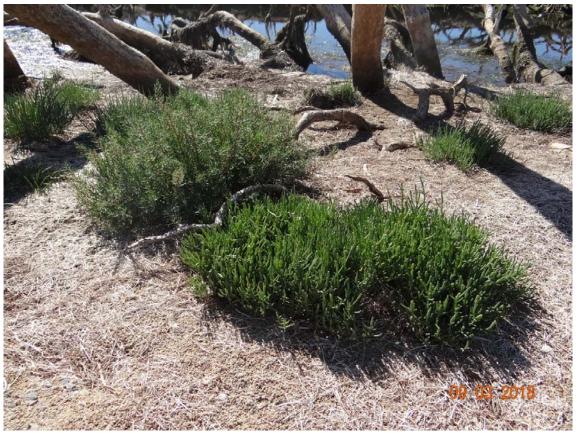
Figure 2. Sarcocornia quinquiflora and Suaeda australis species of saltmarsh on the edge of the Pumping Creek channel in Pond XB8A.

Similarly, within the pond saltmarsh plants are establishing and growing rapidly as shown in Figure 2 below.

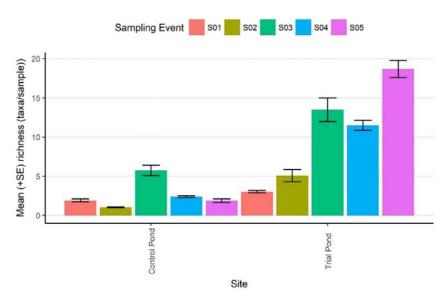
Figure 6 Mean richness (individuals/ 2m) of aquatic infauna per location, for each sampling event.

Taxonomic richness within the control pond varied between 2 and 5 taxa across all five sampling events. Taxonomic richness in the trial pond pre-tidal reconnection was comparable to that of the control pond (4 taxa), and increased significantly across the sampling events, reaching a maximum of 18 taxa per sample in April 2018 (Figure 6). Interestingly, in both trial and control ponds, the taxonomic richness in sampling event S03 (November 2017) had a higher taxonomic richness compared to both sampling event S02 and S04, suggesting a seasonal trend.

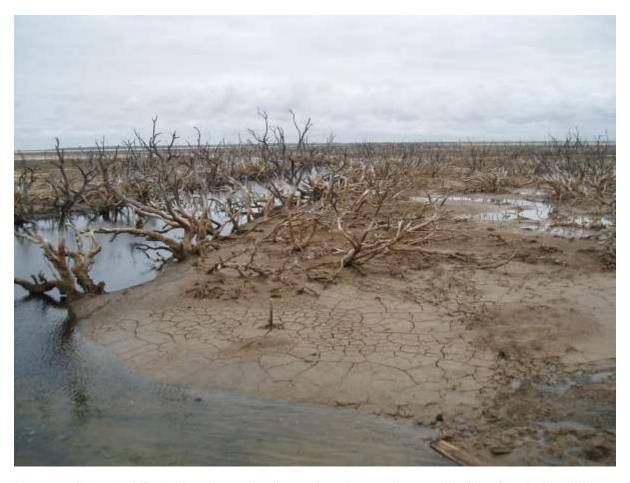
New conditions in XB8A showing main channel and extensive muddy flats flooded on high tides.

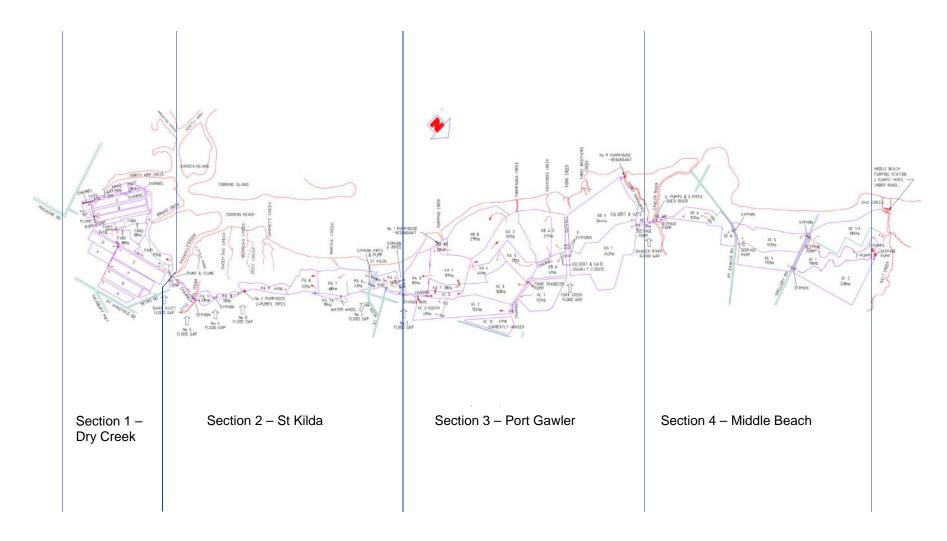
Figure 1: Dry Creek Salt Fields – Southern Leases

For the purposes of the PEPR, the site has been divided into 4 sections – named Sections 1 to 4. Section 1, at the southern end of the salt field, comprises the crystallisers and salt production facilities. Sections 2 to 4 include both inundated and drained / dry condenser ponds and, coastal lease boundaries. The latter are the subject of this report.

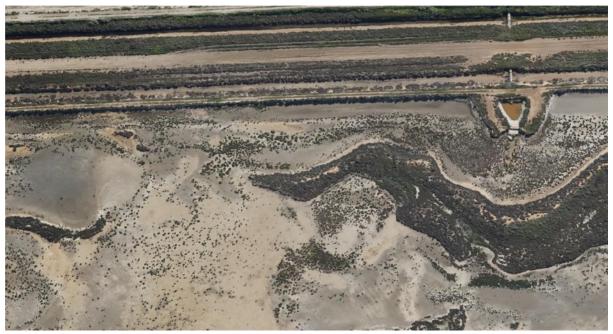
Figure 5: Vegetation analysis at 1:500 scale

The georeferenced images produced by the Pix4D software were uploaded as raster files into QGIS open source GIS software. Analysing the vegetation was undertaken at a 1:500 scale (refer to figure 5). This scale was deemed the most suitable for mapping vegetation and, estimating cover abundance. Mapping of vegetation was separated into two parts; bund vegetation and patches within a pond. The basis of this approach was to simplify the mapping process.

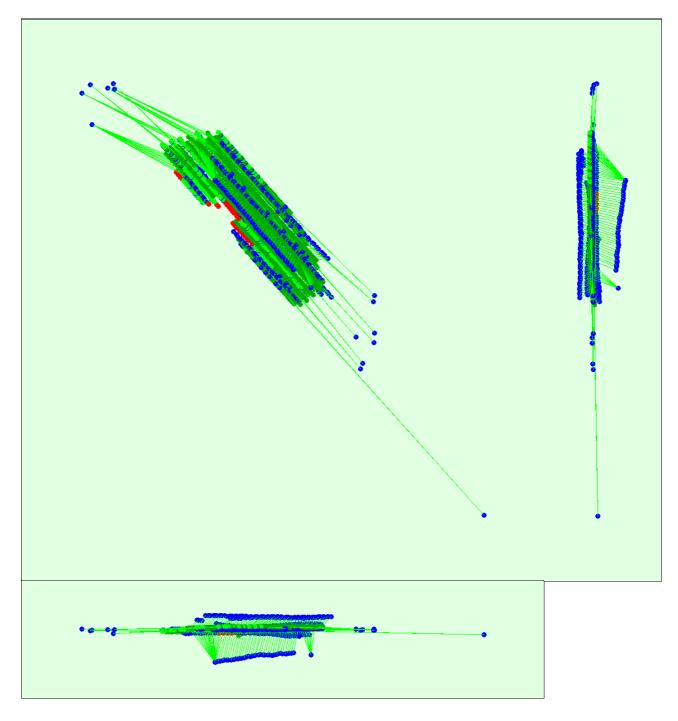
Figure 3: Offset between initial (blue dots) and computed (green dots) image positions as well as the offset between the GCPs initial positions (blue crosses) and their computed positions (green crosses) in the top-view (XY plane), front-view (XZ plane), and side-view (YZ plane). Red dots indicate disabled or uncalibrated images.

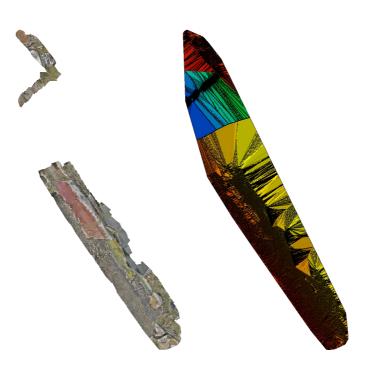
Figure 1: Orthomosaic and the corresponding sparse Digital Surface Model (DSM) before densification.

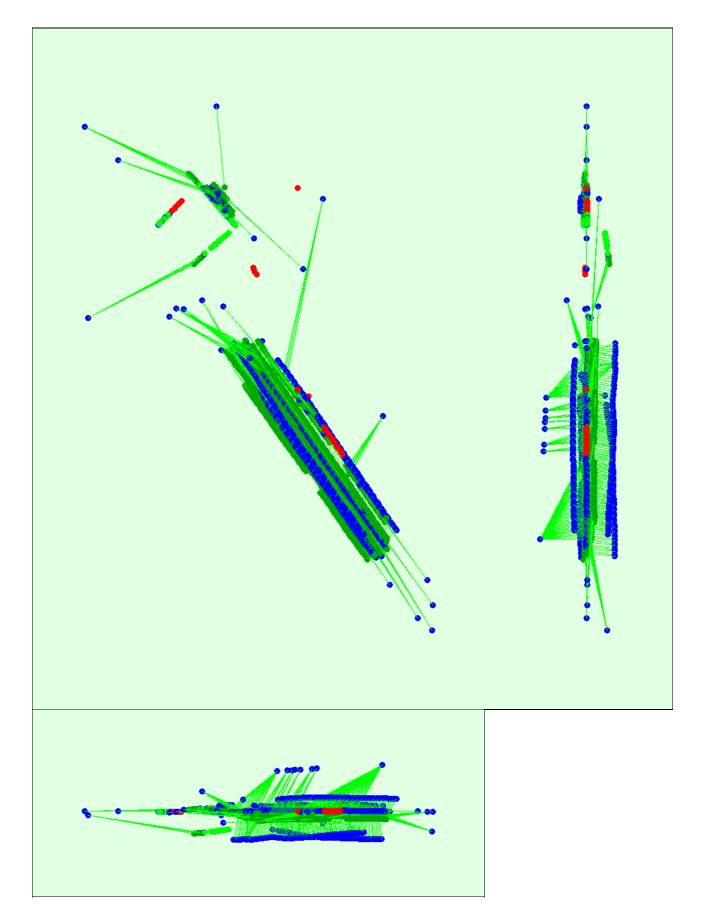
Figure 3: Offset between initial (blue dots) and computed (green dots) image positions as well as the offset between the GCPs initial positions (blue crosses) and their computed positions (green crosses) in the top-view (XY plane), front-view (XZ plane), and side-view (YZ plane). Red dots indicate disabled or uncalibrated images.

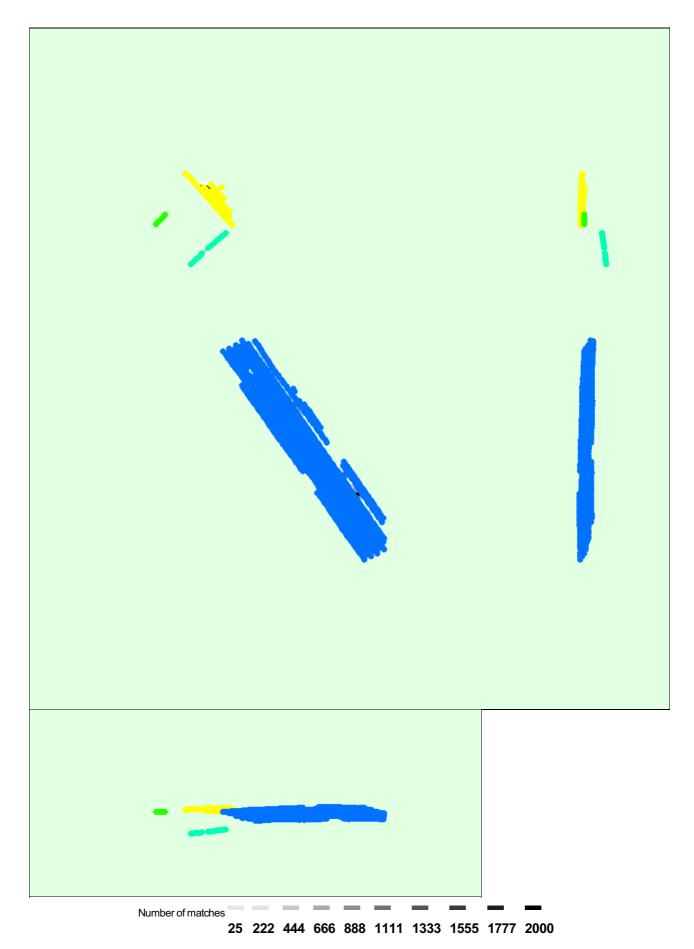
Figure 5: Computed image positions with links between matched images. The darkness of the links indicates the number of matched 2D keypoints between the images. Bright links indicate weak links and require manual tie points or more images.

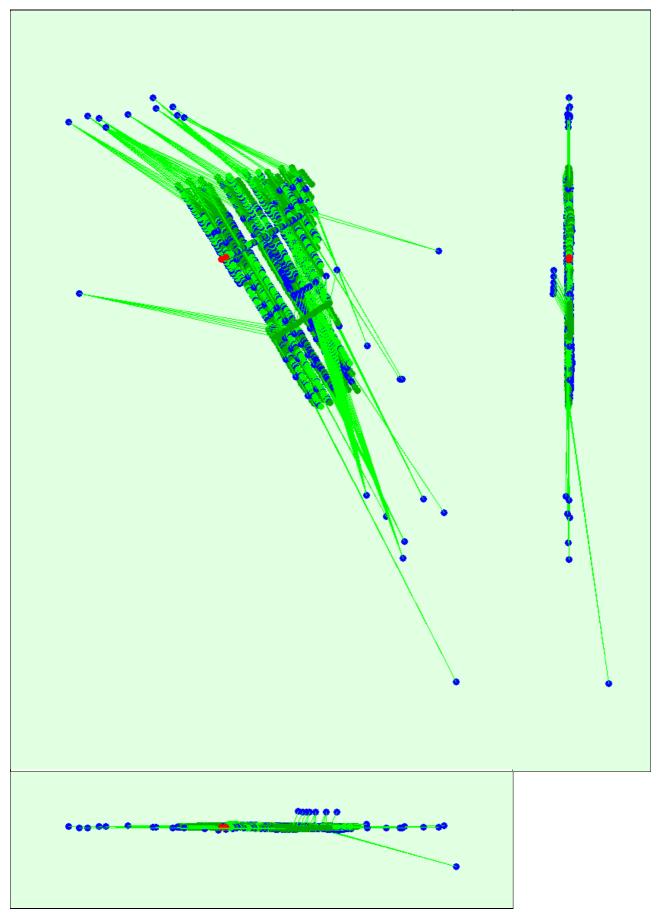
Figure 3: Offset between initial (blue dots) and computed (green dots) image positions as well as the offset between the GCPs initial positions (blue crosses) and their computed positions (green crosses) in the top-view (XY plane), front-view (XZ plane), and side-view (YZ plane). Red dots indicate disabled or uncalibrated images. Dark green ellipses indicate the absolute position uncertainty of the bundle block adjustment result.

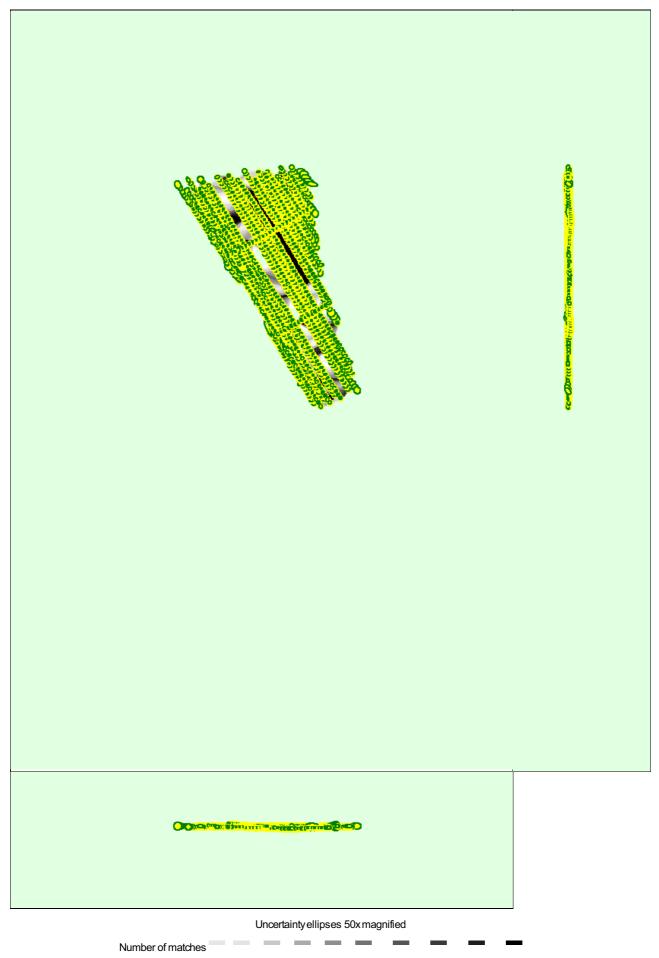
Figure 5: Computed image positions with links between matched images. The darkness of the links indicates the number of matched 2D keypoints between the images. Bright links indicate weak links and require manual tie points or more images. Dark green ellipses indicate the relative camera position uncertainty of the bundle block adjustment result.

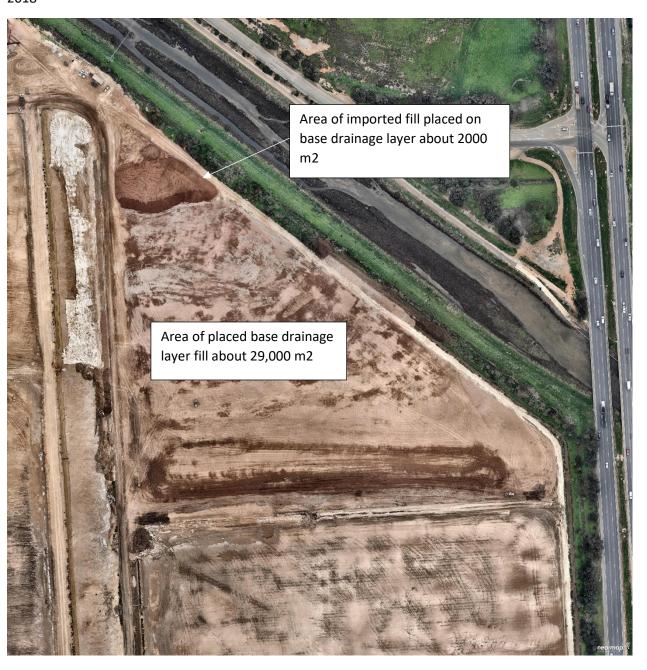
The following Nearmaps photo was taken on 3 July 2018 and illustrate progress made with the trial in the northern end of H Row.Area of fill. This shows that the trial had just commenced by 30 June 2018

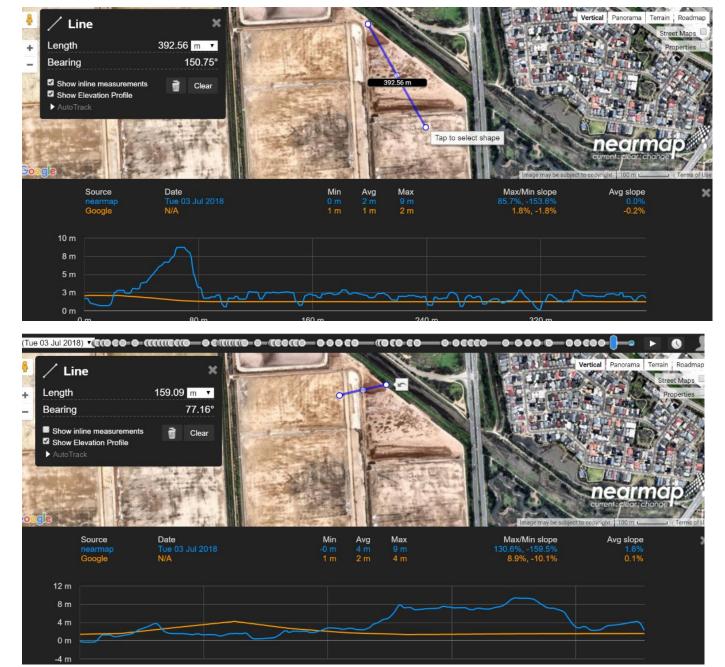
The next figures show that the fill as placed in the 200 m2 area reached an elevation of about 9 m AHD above the top of the base drainage layer at about 3 m AHD. The level information from Nearmaps is very approximate. The impression from the photo of the fill mound (see further below) is that the top of the mound is more like 4 m above placed base filter / drainage layer – not 6 m.

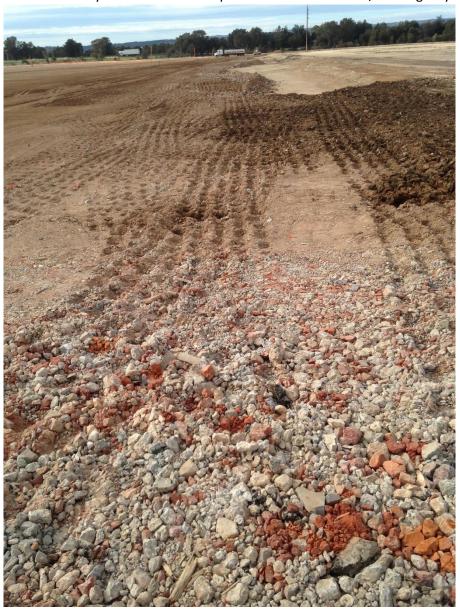
This photo taken on 4 July 2018 shows the fill placed for the base filter / drainage layer

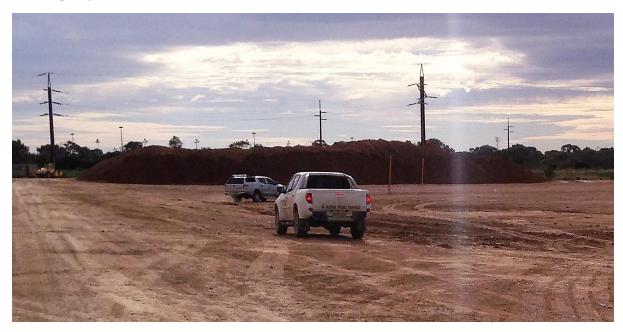
This photo taken on 4 July 2018 shows the 2000 m2 mound of imported fill placed on the base filter / drainage layer

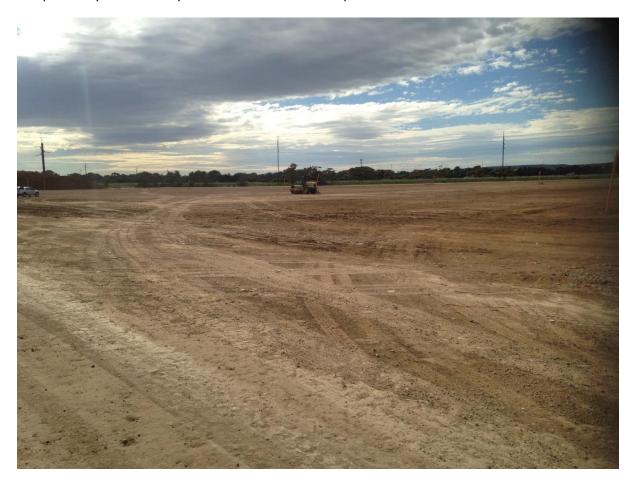
This photo taken on 4 July 2018 provides a view to the north east from the south west corner of the area on which the base filter / drainage layer had been placed and was in the process of being compacted by a small sheepsfoot roller – visible in the photo
