Tarcoola Gold Mine 2021 Annual Compliance Report

Barton Gold Holdings Ltd

Project Name	Tarcoola Gold Mine Annual Compliance Report
Project Number	19468
Project Manager	Louise Swann
Prepared by	Adam Garthwaite and Paul Belfrage
Reviewed by	Louise Swann
Approved by	Jasmine Richards
Status	Final
Version Number	v2
Last saved on	9 October 2021

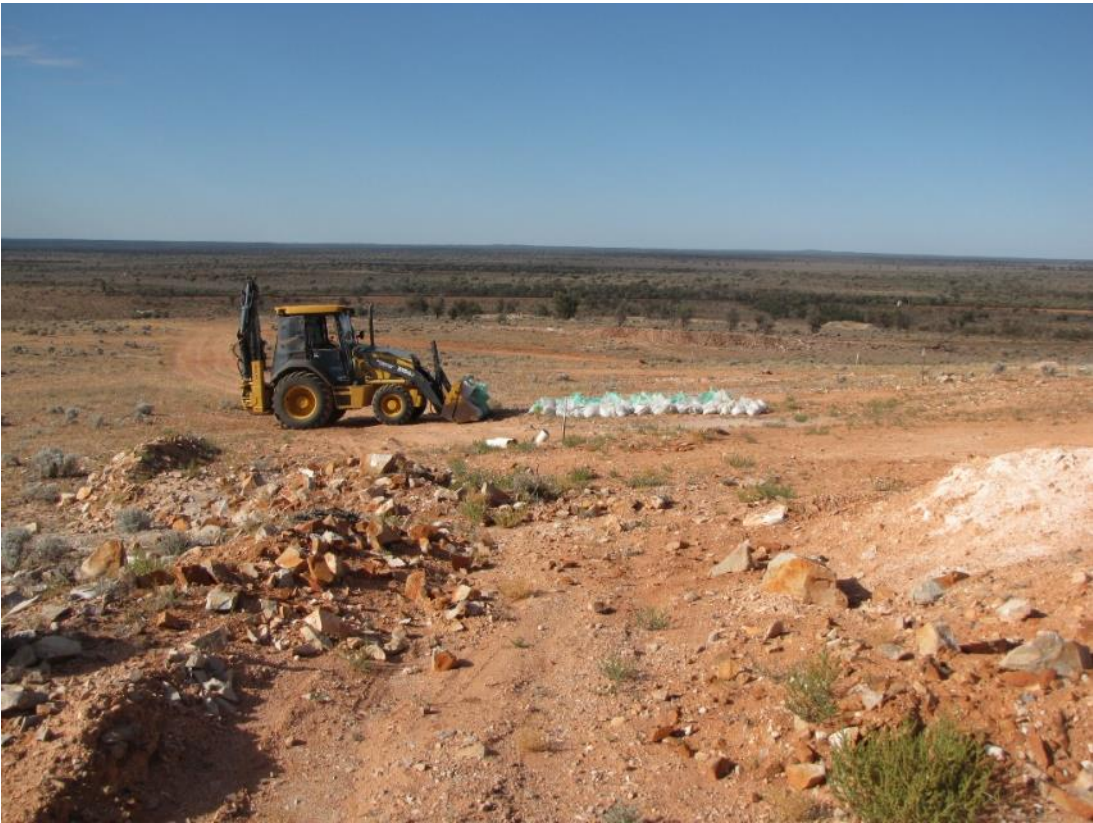
Site identification or details	Date taken	Easting (GDA 2020)	Northing (GDA 2020)	Zone	Comments	Photo
Drillhole TBM0015	14/12/2020	454753	6602674	Zone 53	Drill site conditions prior to rehabilitation taken looking to the southwest.

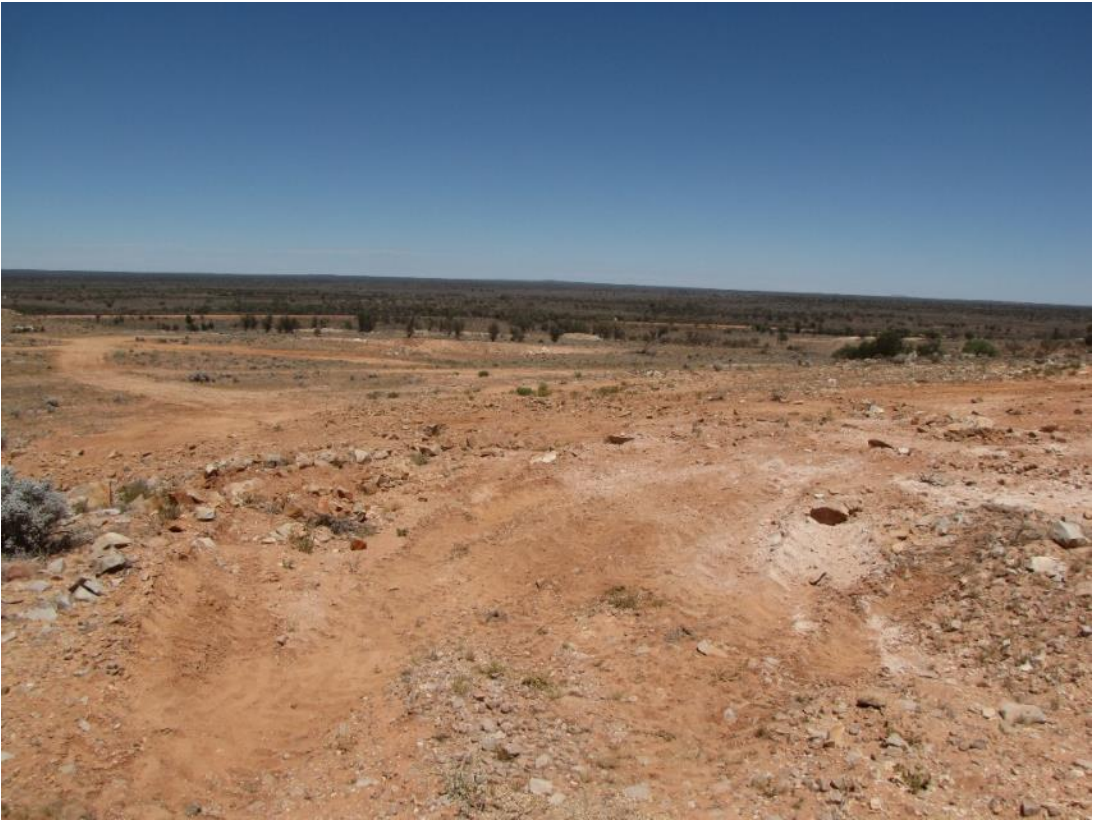
Drillhole TMB0015	09/02/2021	454776	6602651	Zone 53	Photograph taken after rehabilitation looking to the southwest

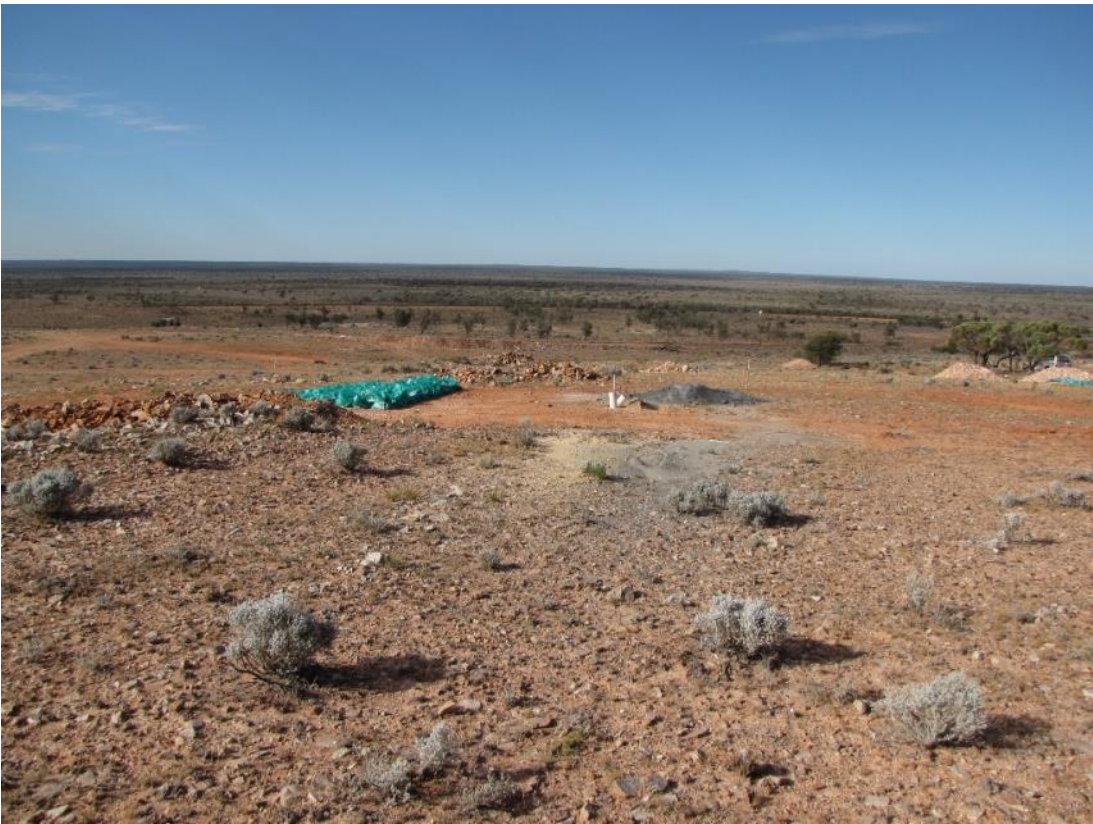
Site identification or details	Date taken	Easting (GDA 2020)	Northing (GDA 2020)	Zone	Comments	Photo
Drillhole TBM0019	14/12/2020	454753	6602674	Zone 53	Photograph looking southwest taken before rehabilitation

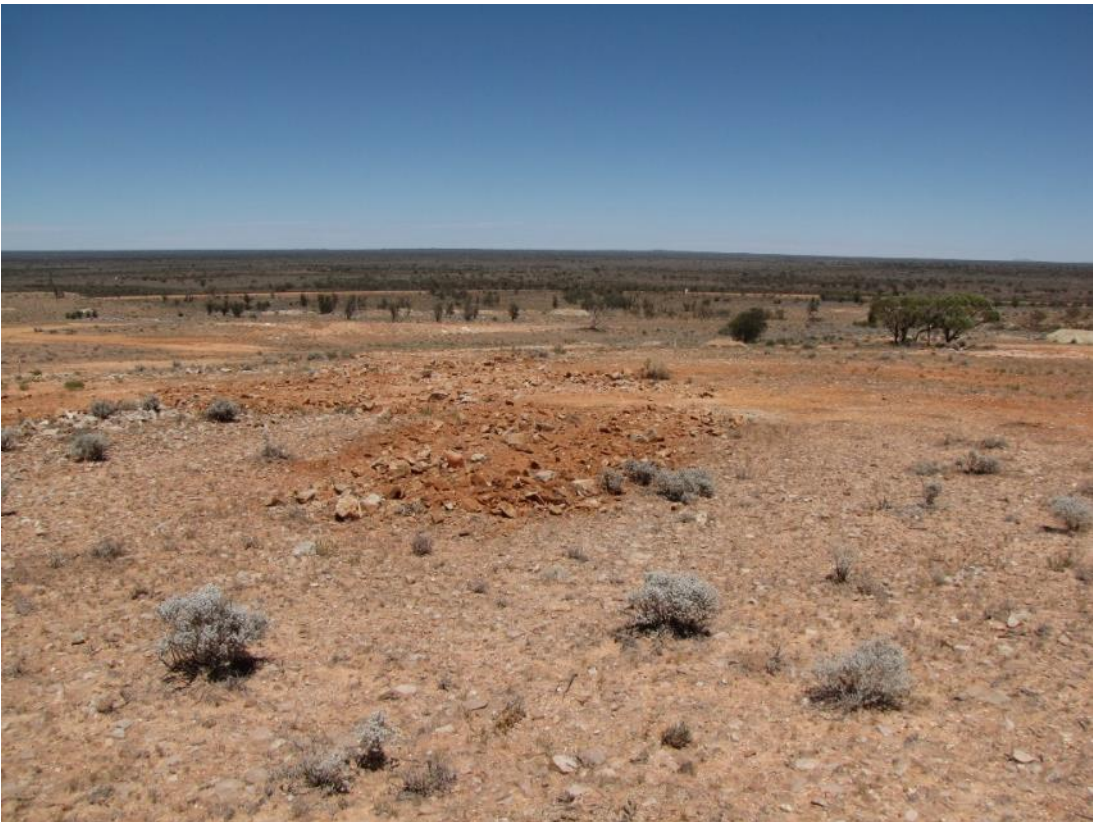
Drillhole TBM0019	09/02/2021	454753	6602674	Zone 53	Photograph taken after rehabilitation looking toward the southwest

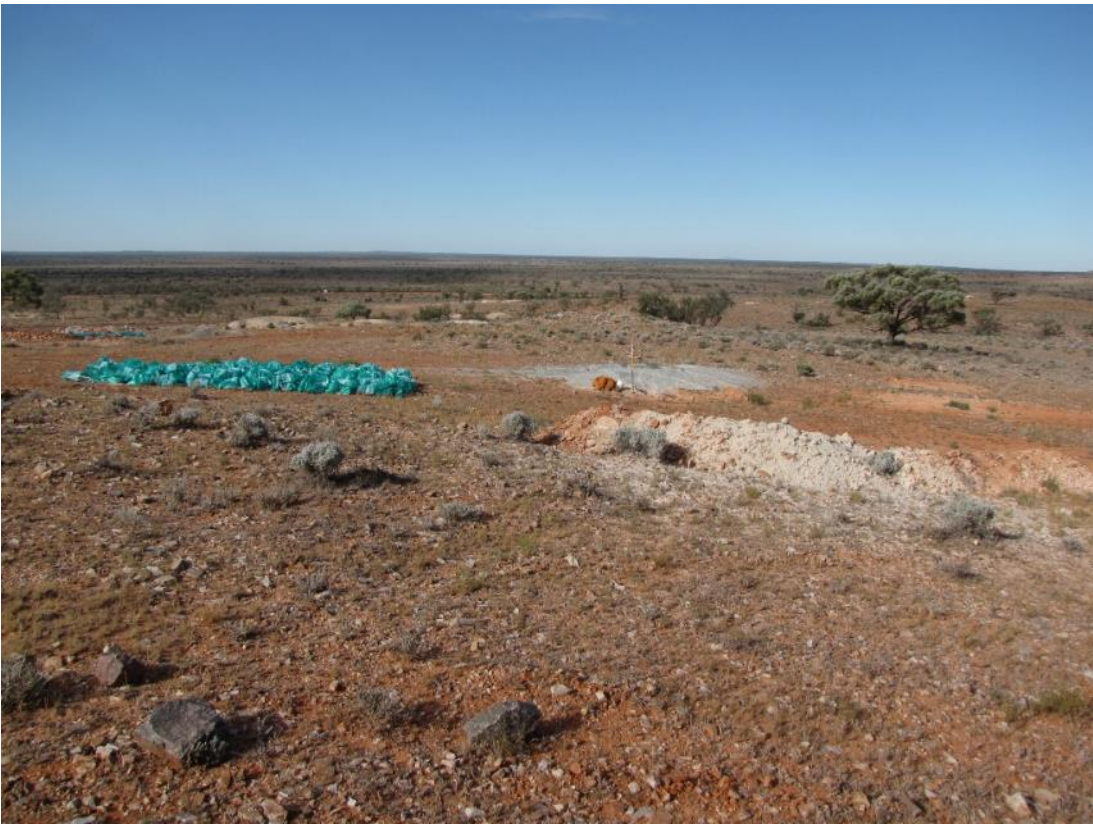
Site identification or details	Date taken	Easting (GDA 2020)	Northing (GDA 2020)	Zone	Comments	Photo
Drillhole TBM0021	14/12/2020	454700	6602727	Zone 53	Photograph looking southwest taken before rehabilitation

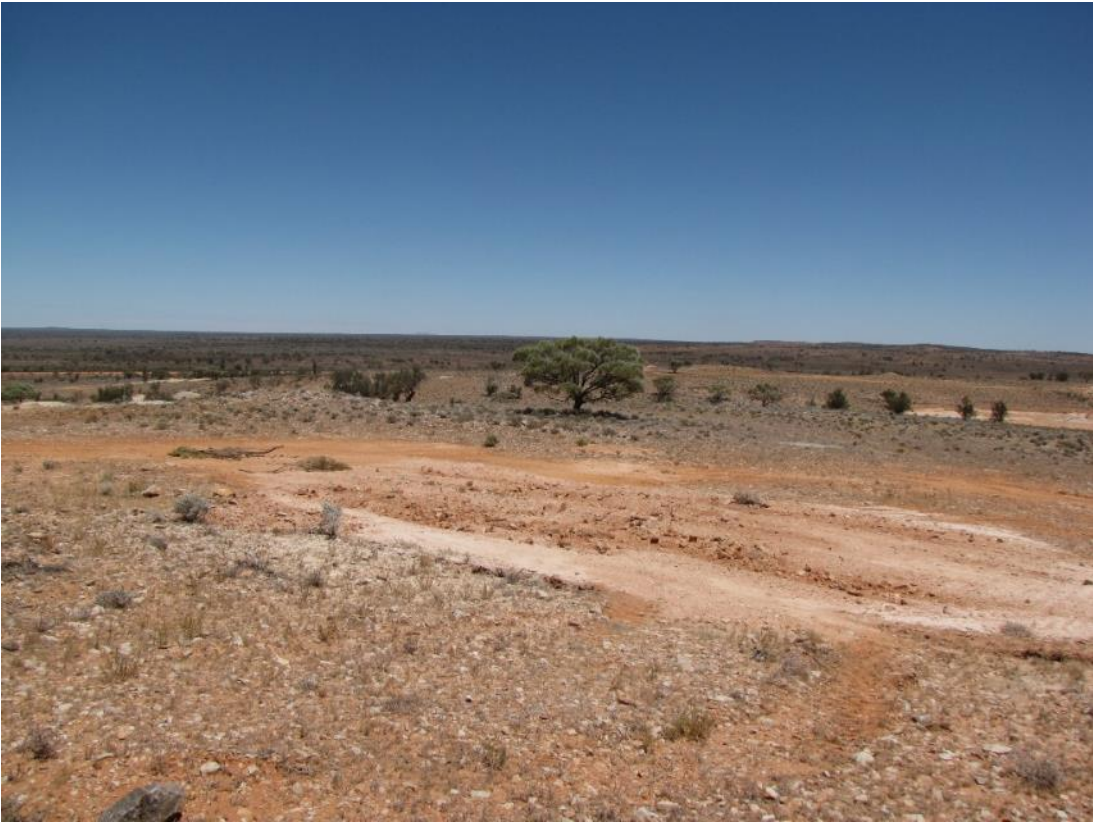
Drillhole TBM0021	09/02/2021	454700	6602727	Zone 53	Photograph taken after rehabilitation looking southwest

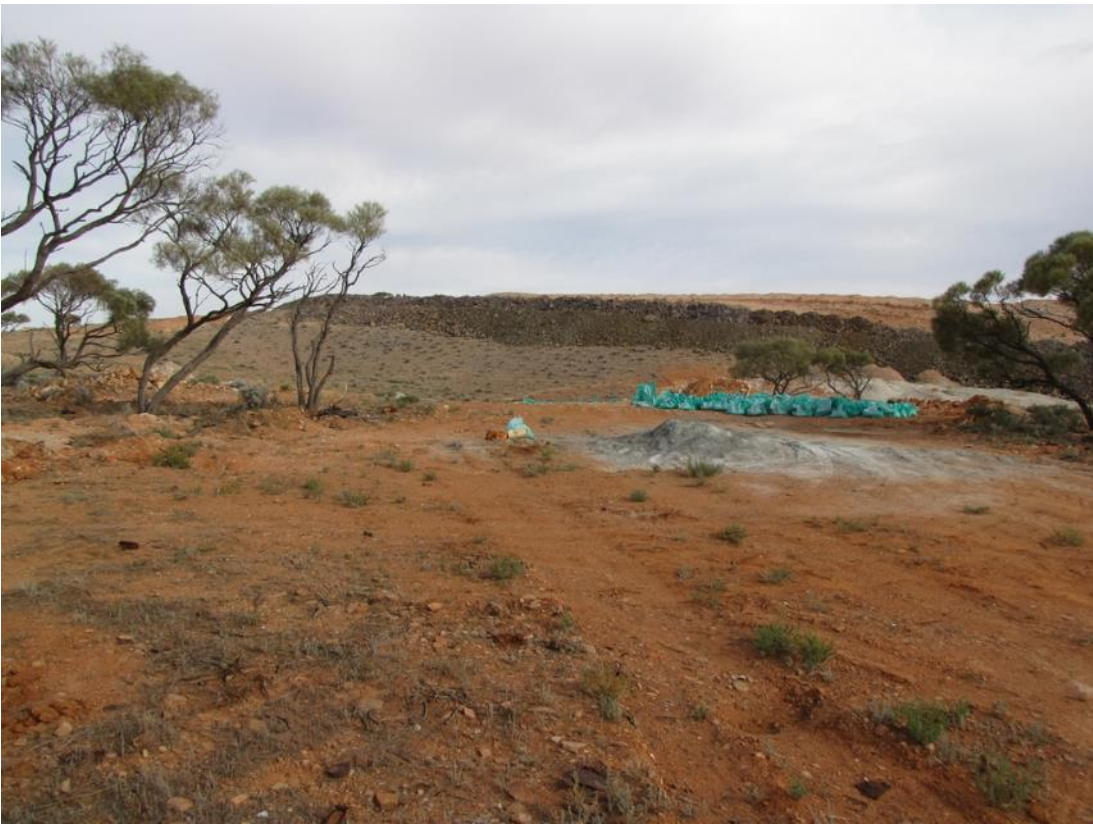
Site identification or details	Date taken	Easting (GDA 2020)	Northing (GDA 2020)	Zone	Comments	Photo
Drillhole TBM0032	14/12/2020	454887	6602545	Zone 53	Photograph looking northwest taken before rehabilitation

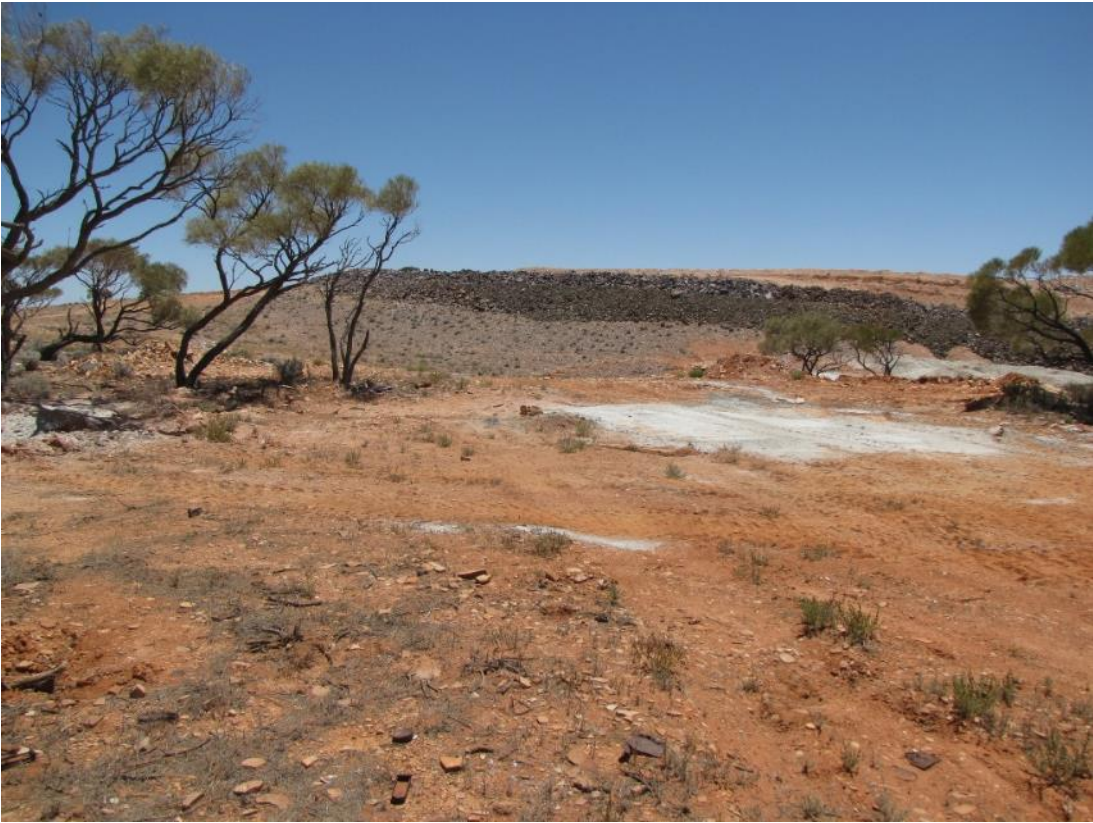
Drillhole TBM0032	09/02/2021	454887	6602545	Zone 53	Photograph taken after rehabilitation looking northwest

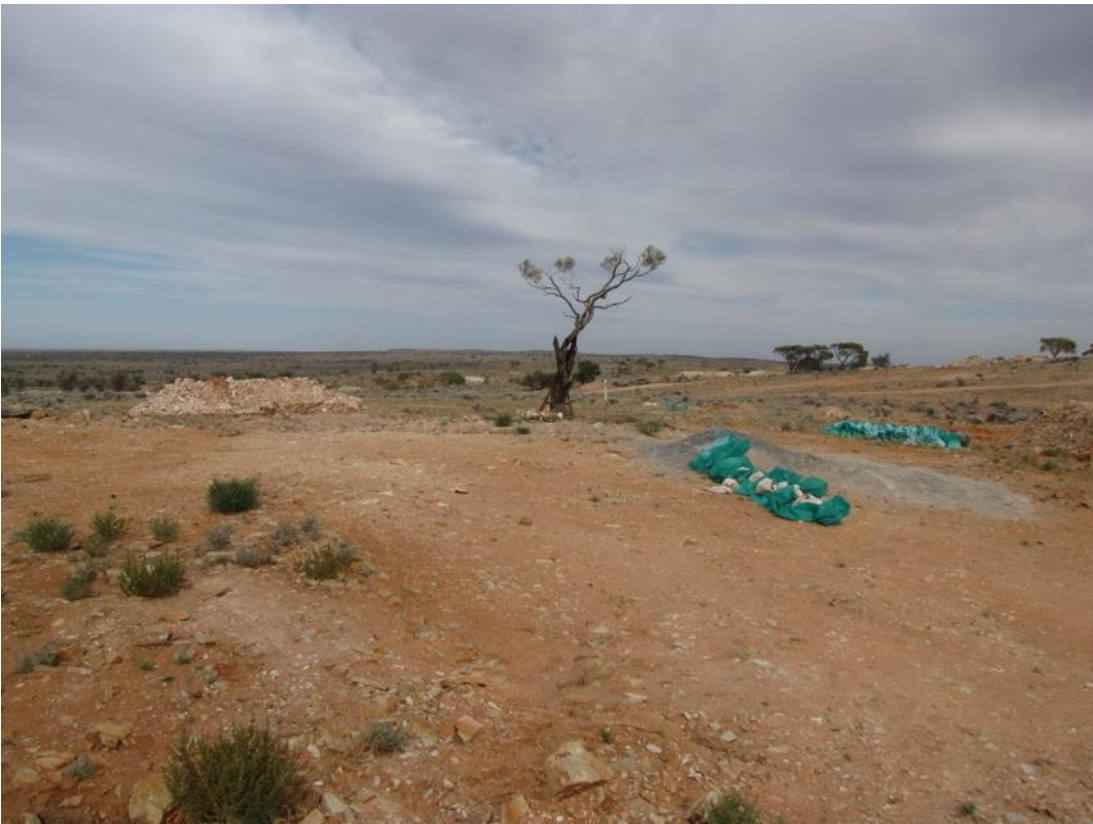
Site identification or details	Date taken	Easting (GDA 2020)	Northing (GDA 2020)	Zone	Comments	Photo
Drillhole TBM0033	17/01/2021	454830	6602567	Zone 53	Photograph looking west taken before rehabilitation

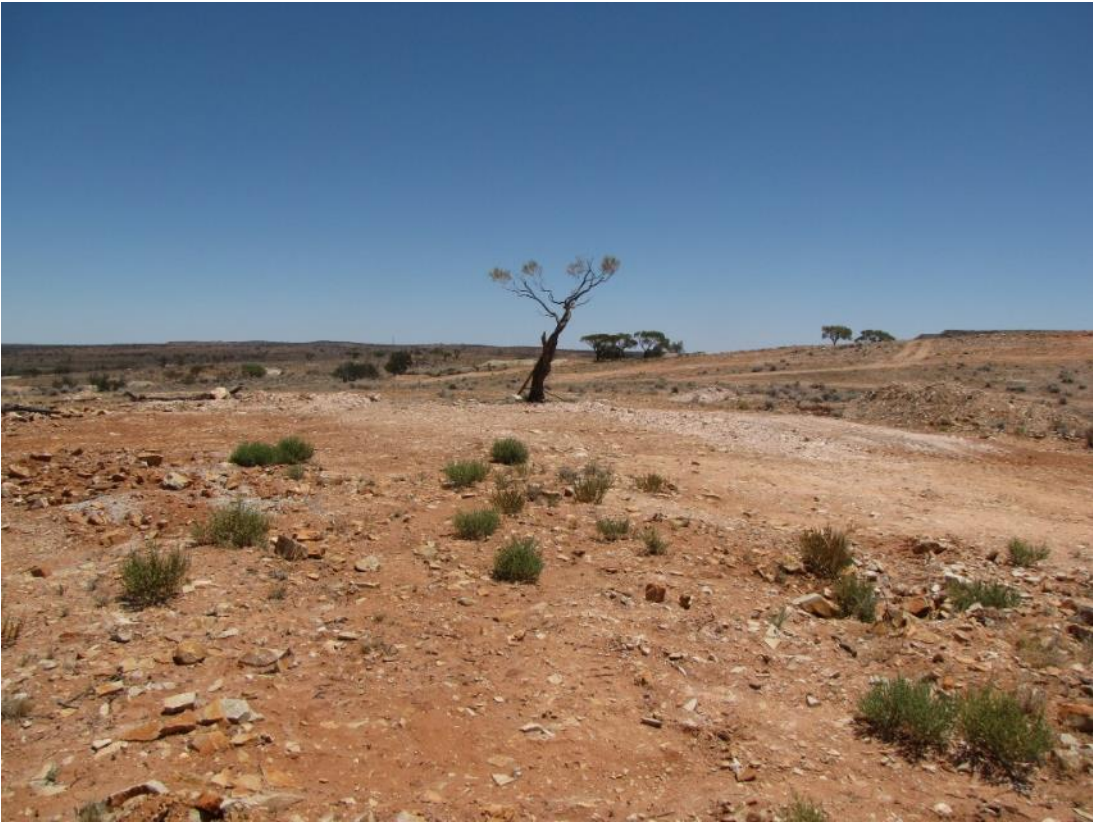
Drillhole TBM0033	09/02/2021	454822	6602563	Zone 53	Photograph taken after rehabilitation looking west

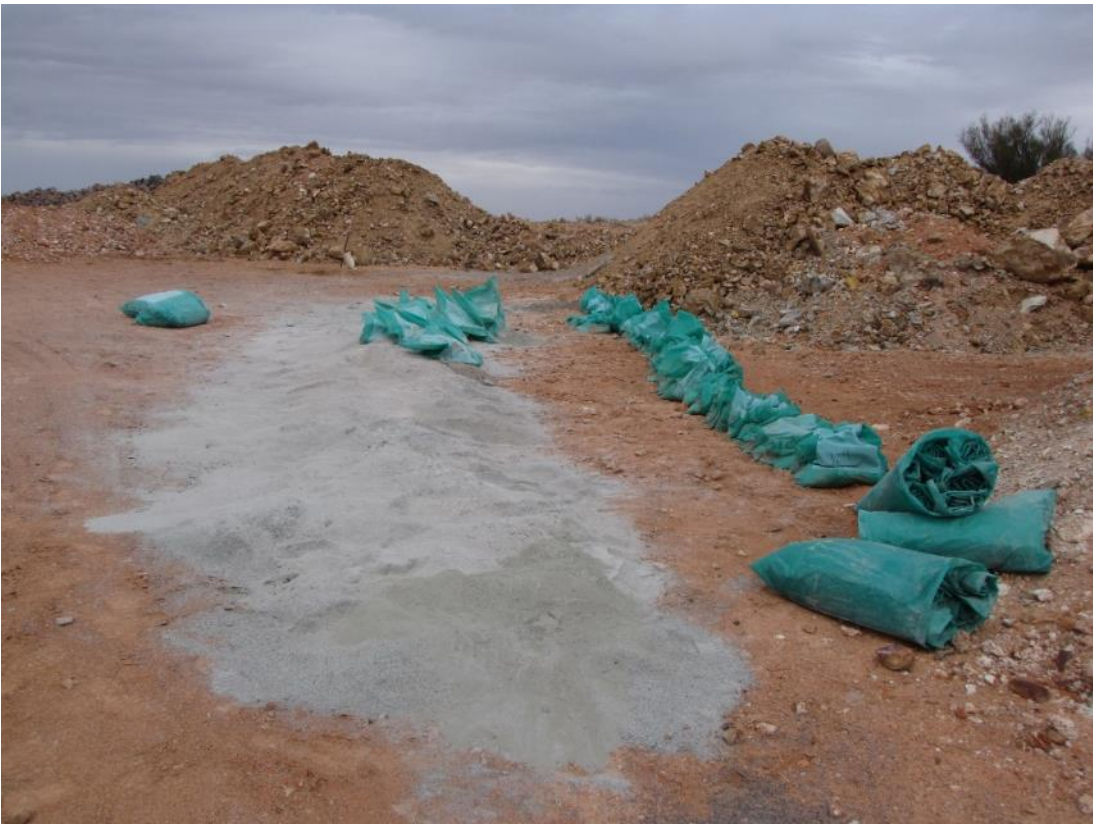
Site identification or details	Date taken	Easting (GDA 2020)	Northing (GDA 2020)	Zone	Comments	Photo
Drillhole TBM0035	17/12/2020	454770	6602925	Zone 53	Photograph before rehabilitation facing toward northeast

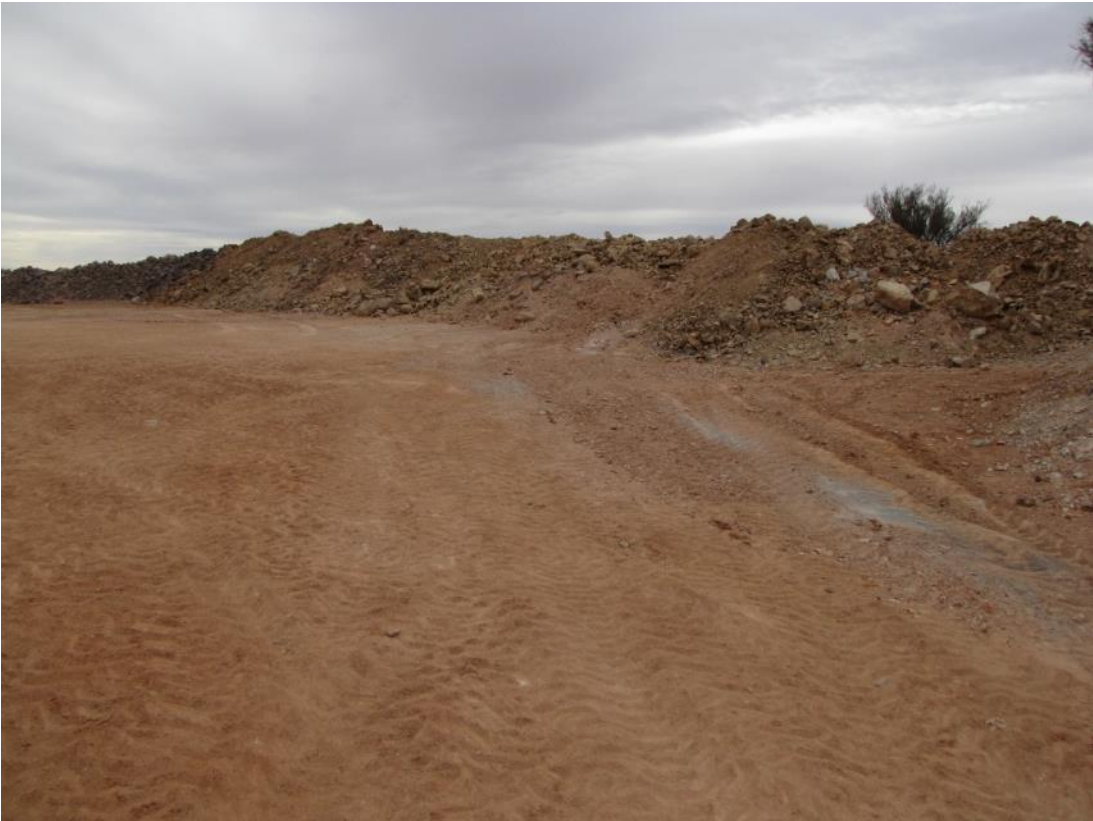
Drillhole TBM0035	11/02/2021	454770	6602925	Zone 53	Photograph taken after rehabilitation looking northeast

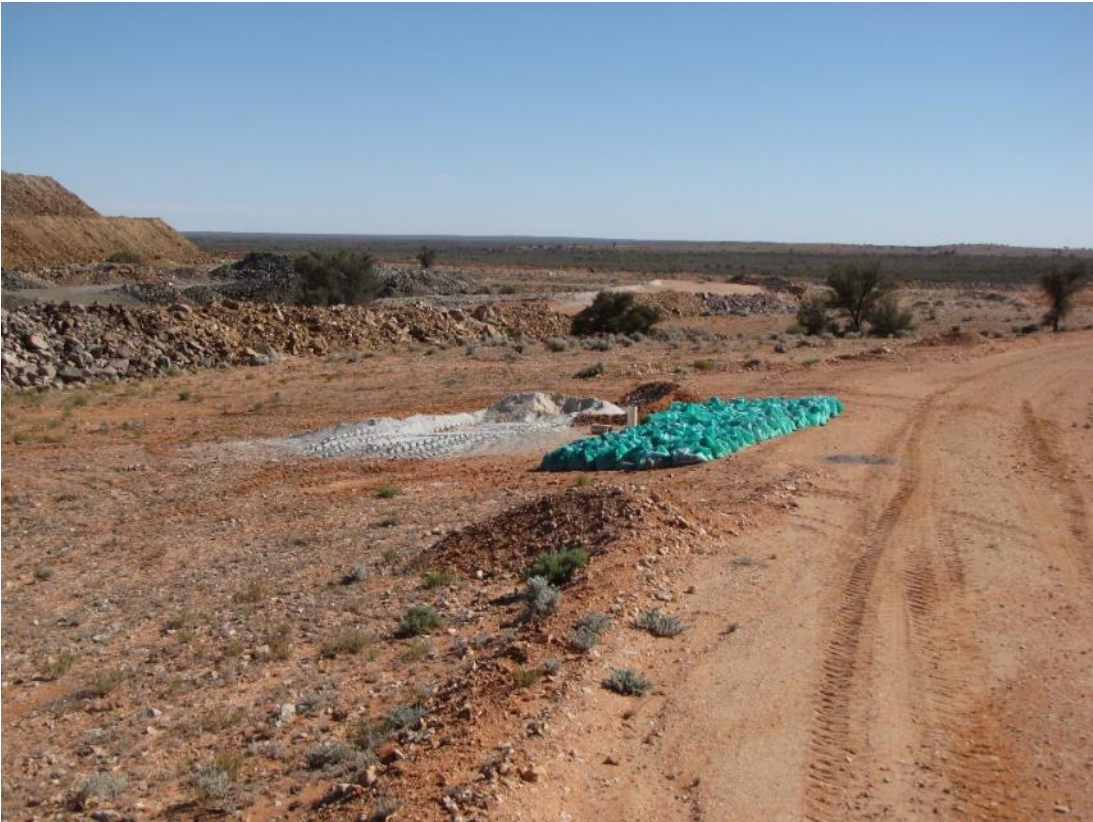
Site identification or details	Date taken	Easting (GDA 2020)	Northing (GDA 2020)	Zone	Comments	Photo
Drillhole TBM0037	20/01/2021	454750	6602825	Zone 53	Photograph taken from the south before rehabilitation

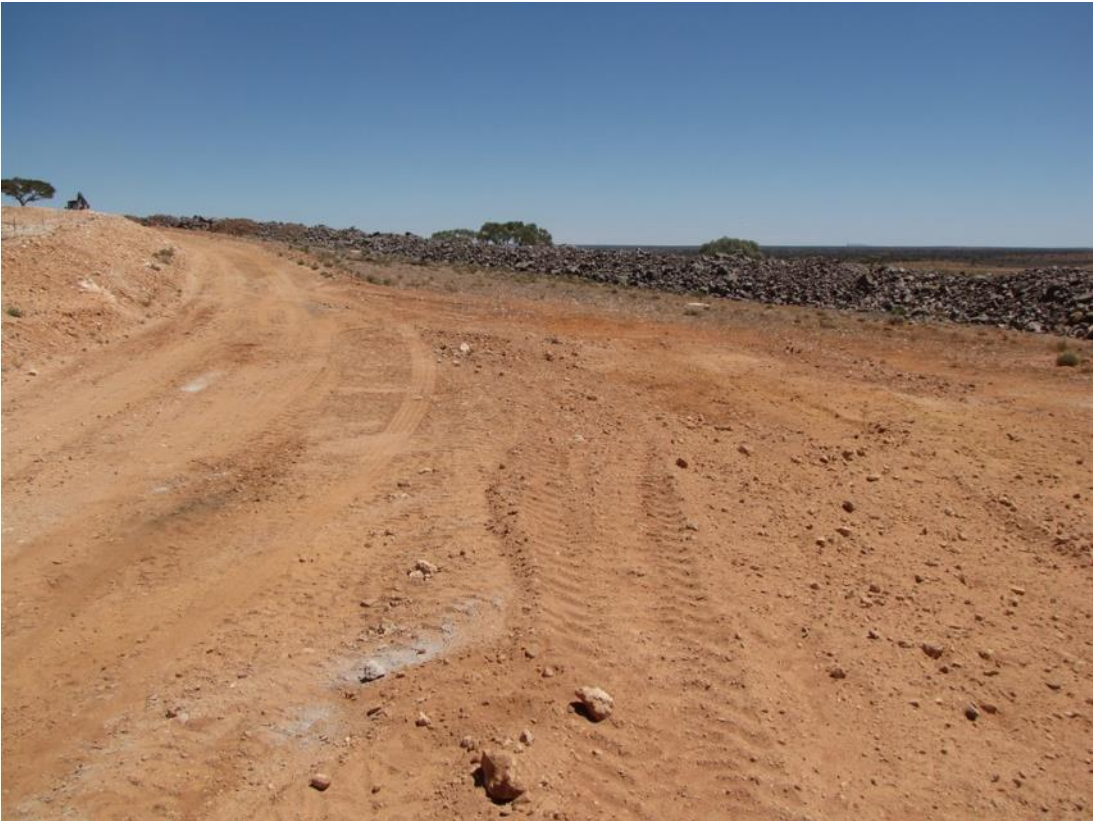
Drillhole TBM0037	09/02/2021	454750	6602841	Zone 53	Photograph taken after rehabilitation viewed from the north

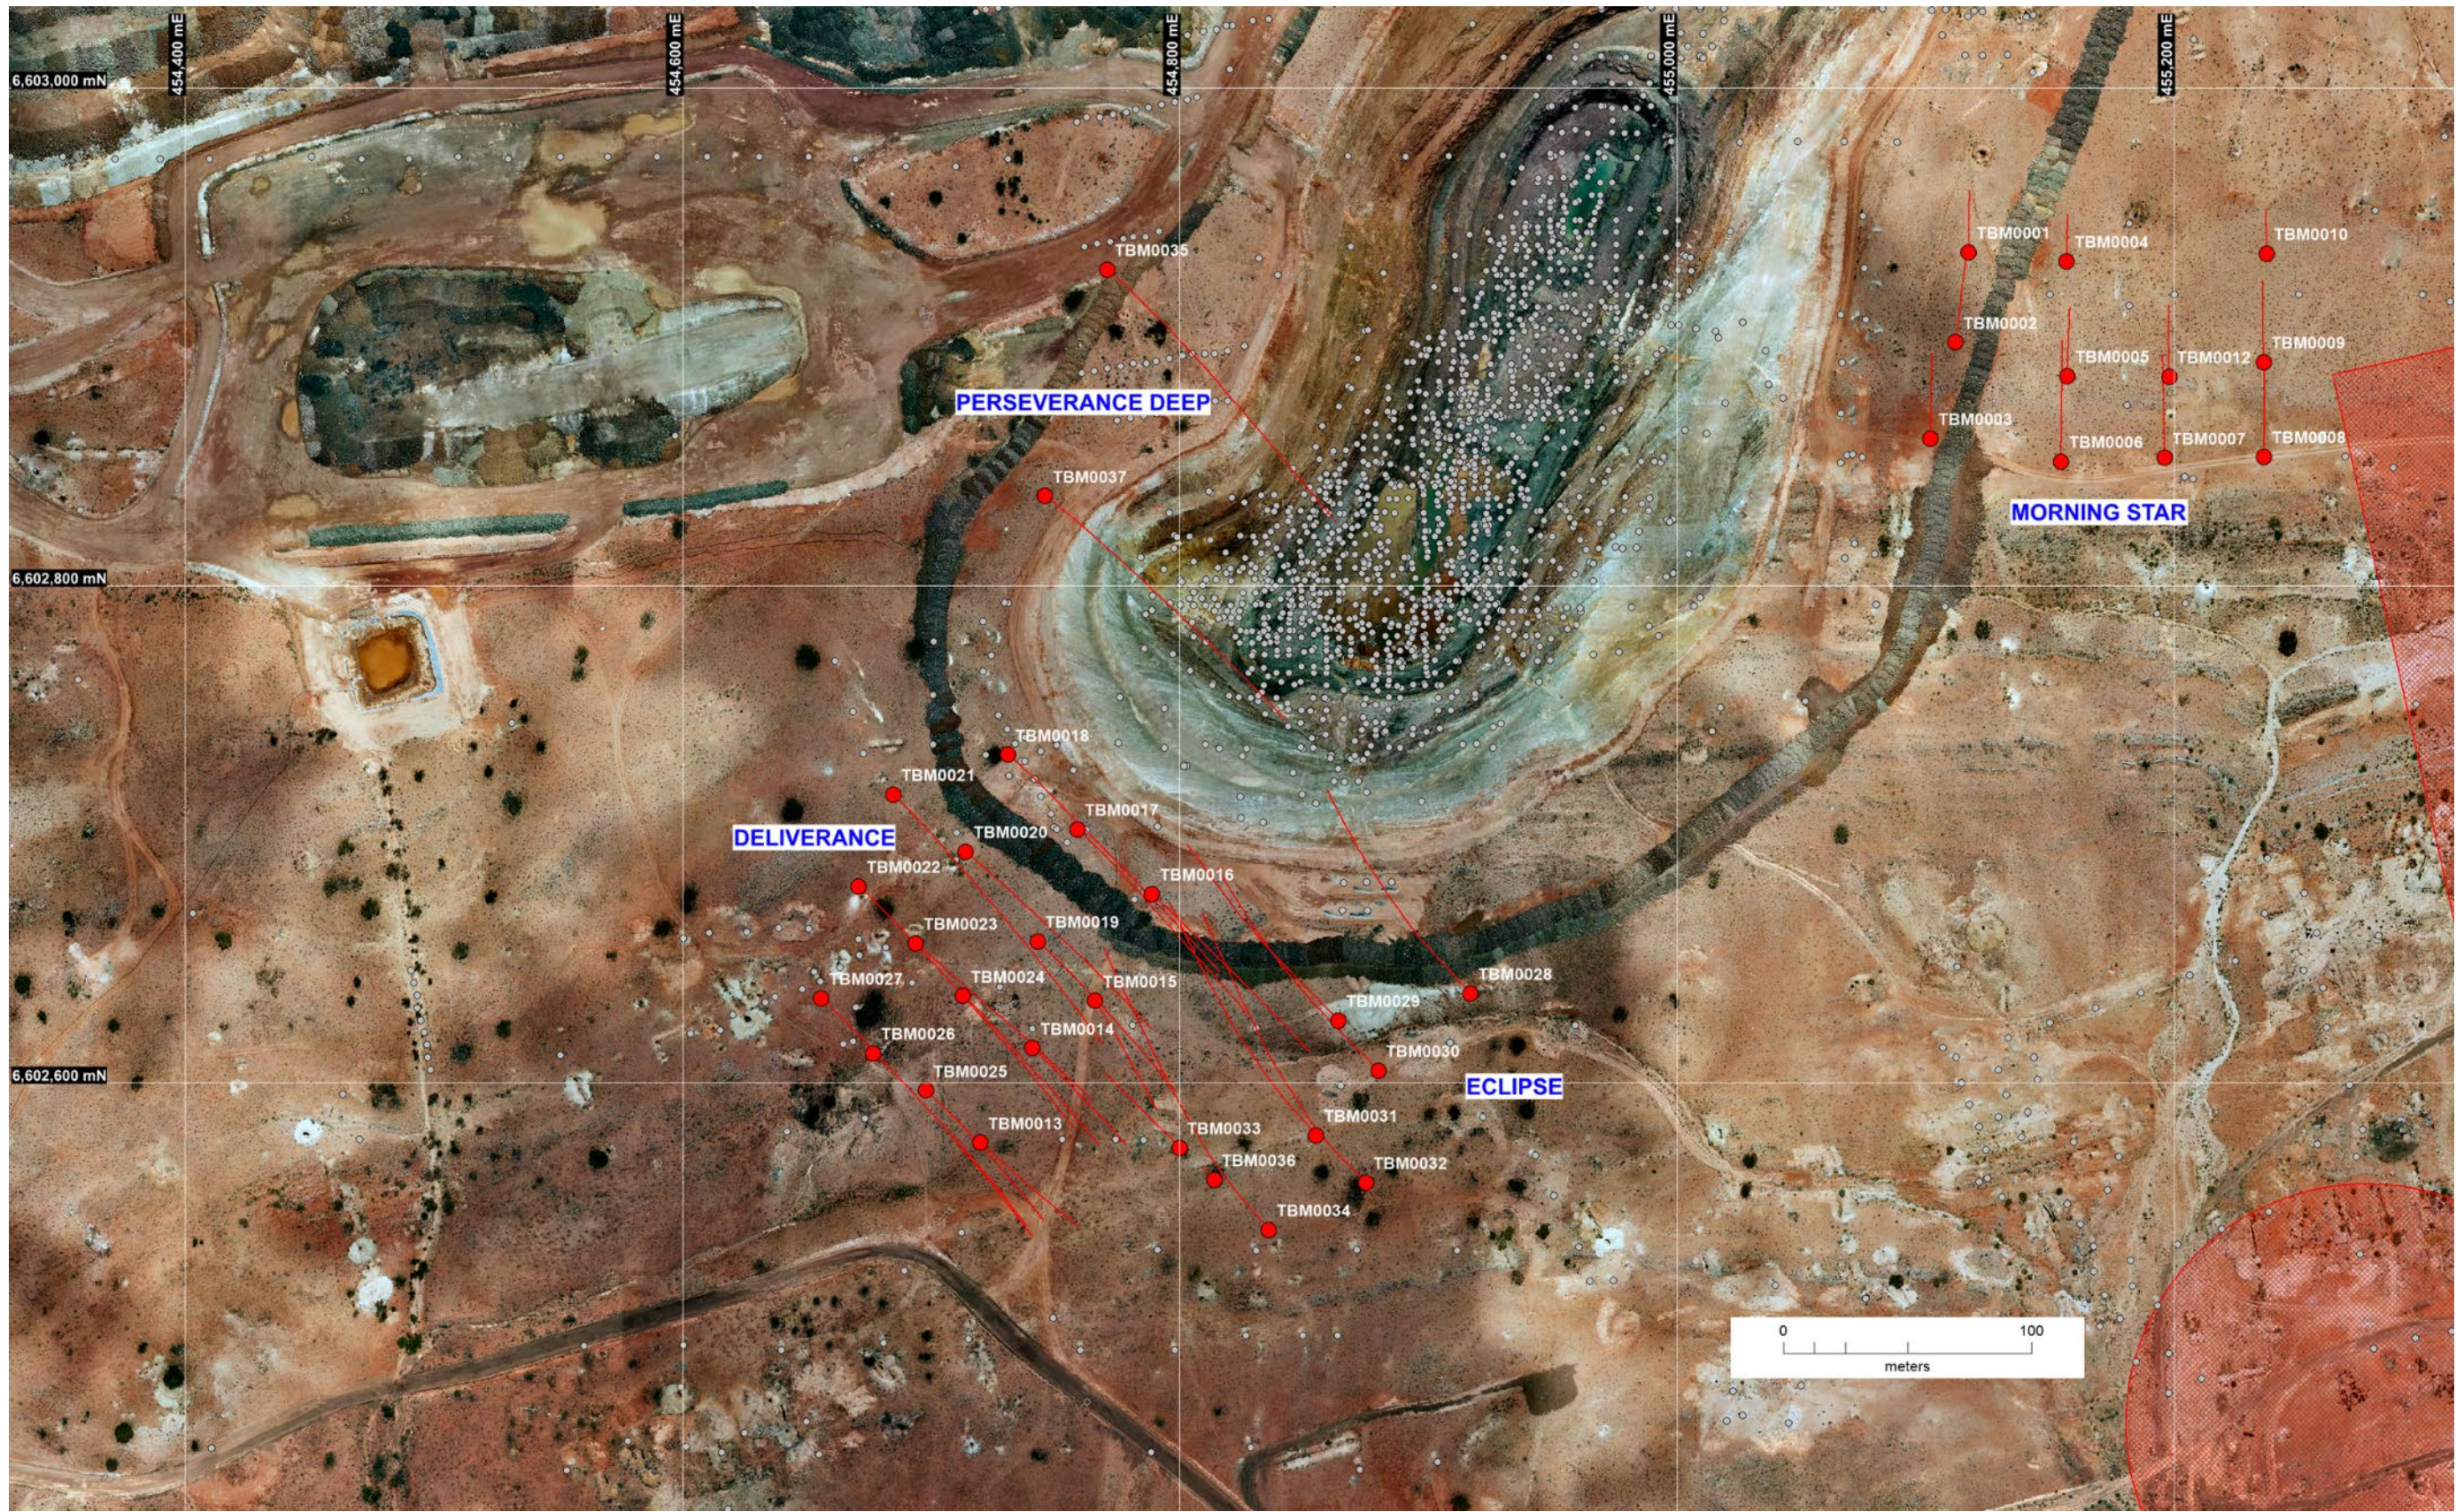
Date Prepared	Site Identification / details	Comments
March 2021	ML 6455	Inset map showing drilling completed during the 2020 program with the majority of drillholes close to the Perseverance open pit and within previous WPG drilled areas.
