**MOONTA WALLAROO
MINES
SITE & ITEM
IDENTIFICATION**

Site & Item Identification

The Moonta Wallaroo Mines
Planning Study
Co-ordinating Committee

Bone & Tonkin Planners Pty. Ltd.
17 Hutt Street, Adelaide, S.A. 5000

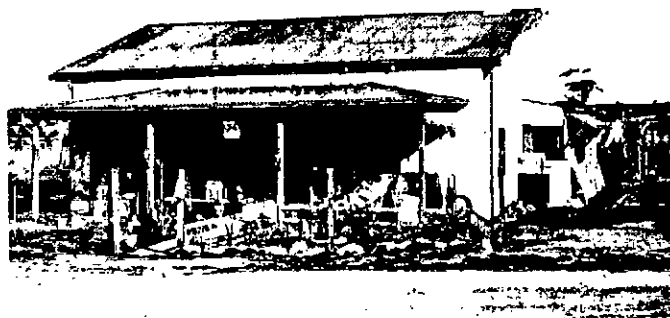
MOONTA/WALLAROO MINES - MANAGEMENT PLAN**ITEM IDENTIFICATION SHEET****ITEM NO.:** 085**Type of Item:** 0302, 0511**Date:** 1870**ITEM NAME:** National Trust Miner's Cottage**Former or Other Names:** National Trust Museum**CONDITION:** Good**PERIOD:** 1852 - 1883**LOCATION:** Moonta Mines**No.:** **Street:****Hundred:** Wallaroo**Section:** 2091**C/T No.:****Architect:****Builder:****CURRENT STATUS:** **State Heritage List:** Registered**National Estate:****National Trust:** Classified**HERITAGE SIGNIFICANCE****Description:**

Cottage with rendered random rubble stone walls and brick quoins. Multi-gabled roof clad with corrugated galvanised iron. Sheet iron and brick gables. Brick chimneys. Raked verandah with simple timber posts. Multi-paned double hung sash windows. Screen door with pressed metal panels. Brick lean-to. Rustic picket fence.

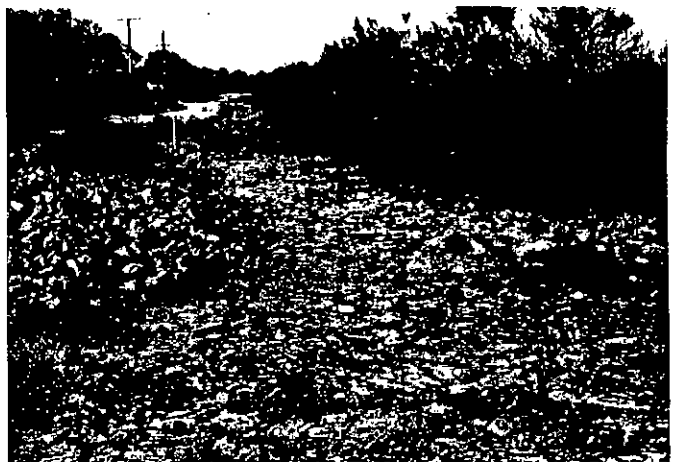
ITEM NO.: 100 **Type of Item:** 1108, 1103 **Date:** c. 1880
ITEM NAME: Treuer's Engine House and Shaft
Former or Other Names:
CONDITION: Ruin **PERIOD:** 1852 - 1883
LOCATION: Moonta Mines
No.: **Street:** off Karkarilla Road
Hundred: Wallaroo
Section: 1903 **C/T No.:**
Architect: **Builder:**
CURRENT STATUS: **State Heritage List:**
 National Estate:
 National Trust:

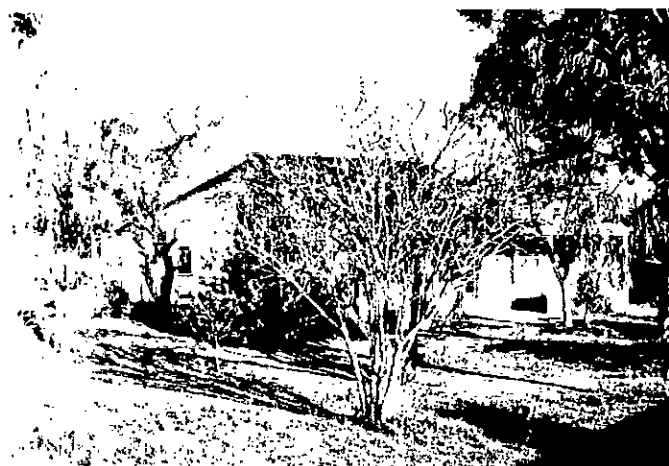
ITEM NO.: 115**Type of Item:** 0302**Date:** c. 1880**ITEM NAME:** House**Former or Other Names:** "Myna Mana"**CONDITION:** Good**PERIOD:** 1852 - 1883**LOCATION:** Moonta Mines**No.:** **Street:** Bower Street**Hundred:** Wallaroo**Section:** 2853**C/T No.:** 4188/55**Architect:****Builder:****CURRENT STATUS:** **State Heritage List:****National Estate:****National Trust:** Filed

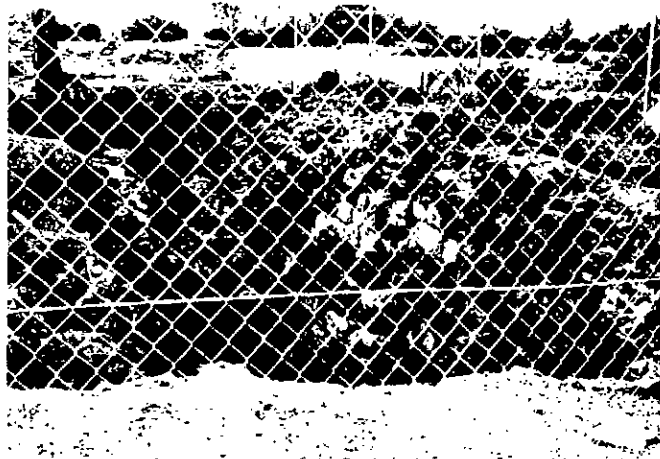
MOONTA/WALLAROO MINES - MANAGEMENT PLAN**ITEM IDENTIFICATION SHEET****ITEM NO.:** 172**Type of Item:** 1108**Date:** 1900**ITEM NAME:** Taylor's Engine House**Former or Other Names:****CONDITION:** Ruin**PERIOD:** 1884 - 1914**LOCATION:** Moonta Mines**No.:****Street:****Hundred:** Wallaroo**Section:** 2630**C/T No.:****Architect:****Builder:****CURRENT STATUS:** State Heritage List:
