CPSAN13B SEISMIC SURVEY 2013 GASCHNITZ 3D

ACQUISITION REPORT

Compiled by: A. White Santos Ltd. 7th December, 2013

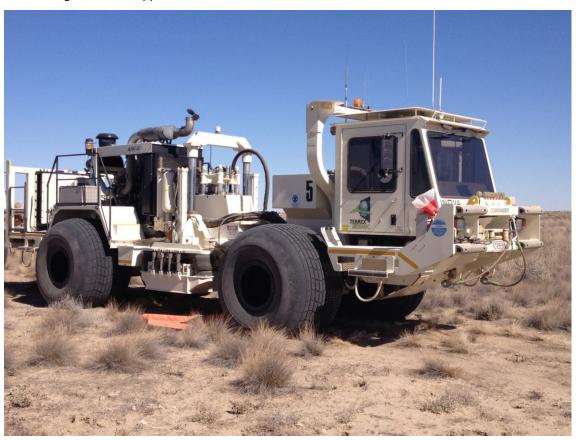
Photograph 1 - Vibrator ready for refuelling in the field with orange spill mat under the machine

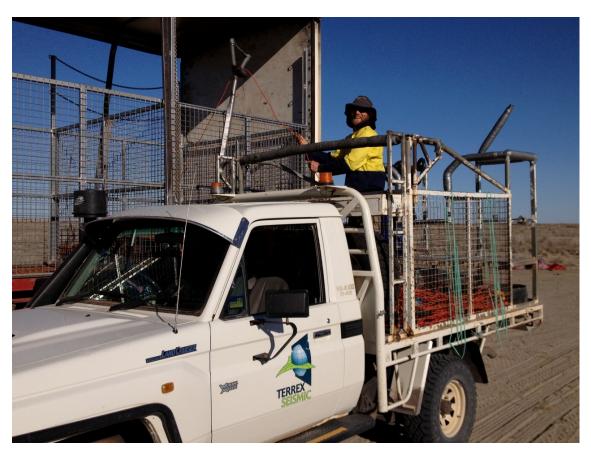
Photograph 2 - Cable truck pulling cable from the spread trailer

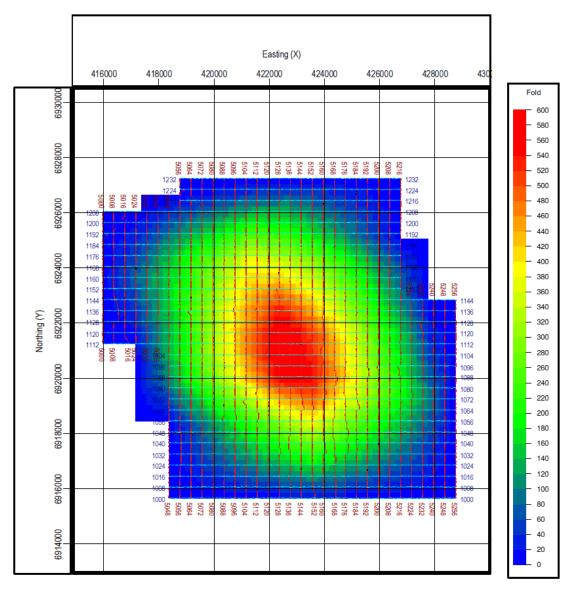
Figure 2 – 3D Panel fold of coverage map

The survey was acquired as a single panel, with all stations set live once laid out. The full fold of coverage is shown in Figure 2.

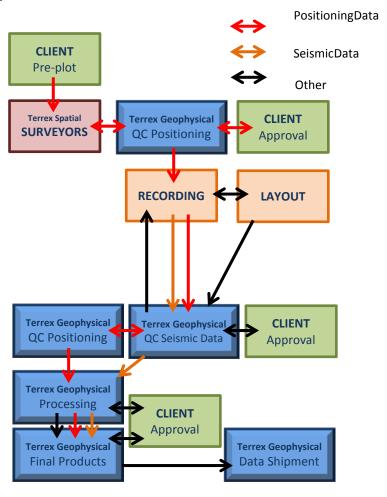
Figure 3 – In-Field QC process diagram

The schematic in Figure 3 outlines the interaction and data flows between the QC department and the other crew operations.

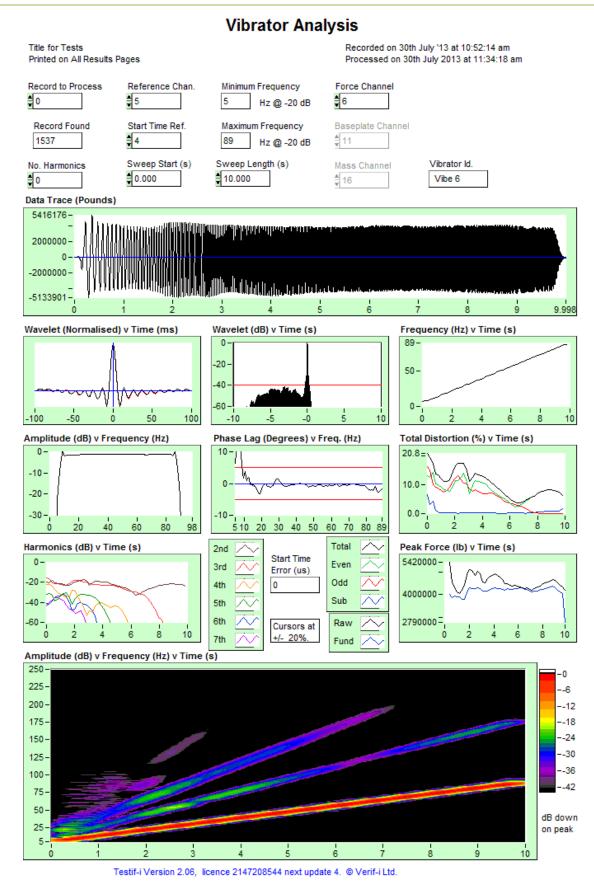
Figure 4– Hardwire similarity test using a Sercel VE464 to receive the data

It must be noted that hardwire tests are very dependent on sweep parameters and ground conditions. Harsh sweep parameters that fall outside the manufacturer specifications for the vibroseis and hard, uneven ground surface will adversely affect the results. An example hardwire test from the start-up can be found in Figure 4.

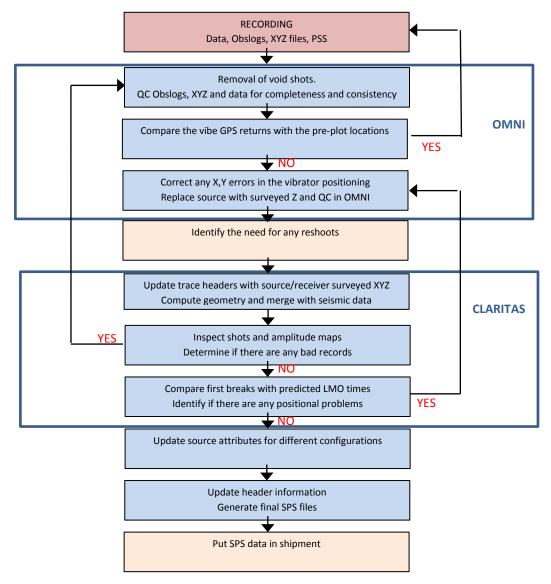
Figure 5- Flowchart of the navigational QC process

Particular attention was given to this part of the operation as coordinating shots and receivers are critical to the integrity of the acquired seismic data. A well-developed Terrex Geophysical system utilised dedicated seismic positioning software called OMNI, propriety software, automated scripts and templates to generate an accurate final SPS dataset containing only valid records. A schematic of the process flow from receipt of data from the recorder, through verification to generation of final corrected SPS files is shown in Figure 5.

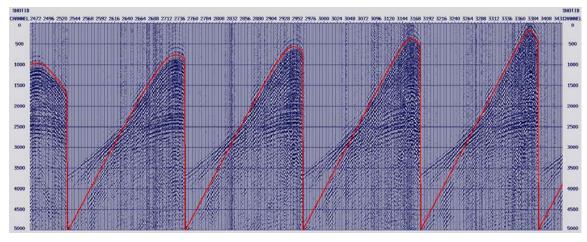
Figure 6- Geometry check

The first stage of the data processing includes a QC of the navigational data. The valid seismic data was merged with the navigation data. Each shot is reviewed to identity any noise or data issues, first arrival times are predicted using a constant velocity linear move-out based on the observed moveout of the first breaks and overlaid on the gathers (as shown in Figure 6) to identify any mis-positioning issues.

The geometry check image in Figure 6 indicates the first arrivals are coming back at a high velocity, especially at the mid to far offsets where the recorded event is a refraction from a shallow interface, giving a flatter profile than is usual and indicative of a fast layer below the refracting horizon. The red line is a velocity profile for a given offset using an average arbitrary velocity setting.

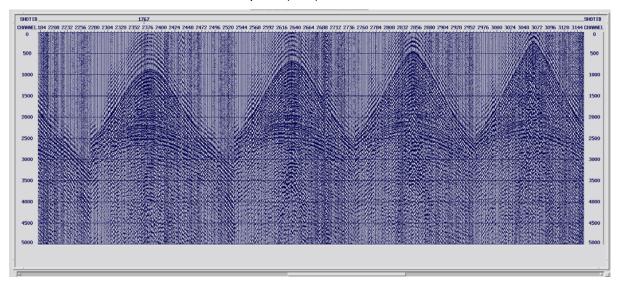
Figure 7- Typical raw shot display

A typical raw shot record is shown in Figure 7. It contains a limited amount of noise and strong reflectors can be observed around 2.5 seconds two-way time (TWT).

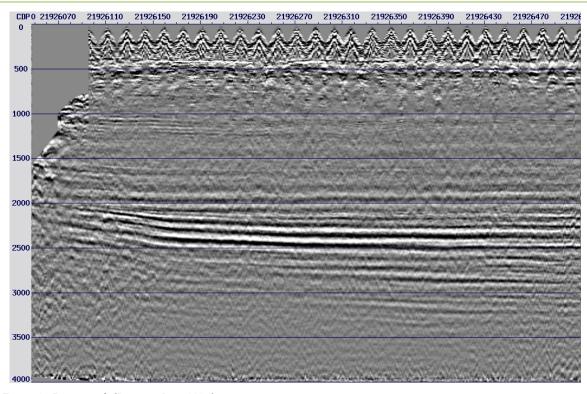
Figure 8– Brute stack (Receiver Line 1096)

Example stack displays can be found in Figure 8 to Figure 12 below. It should be noted that the processing applied in these brute stacks is designed for efficiency with regards to the resources and time available on crew, to provide a quality control product in the stack domain and an early indication of the data and structures. Significant improvements would be expected after the data has been fully processed.

Significant events and trends in all the lines are obvious even at the early field stack stage and it is expected that these events can be enhanced further in the processing centre. It should be noted that the brute stacks had no signal processing applied and only elevation statics.
