Mindarie Mineral Sands Project

Compliance Report January - December 2015

February 2016

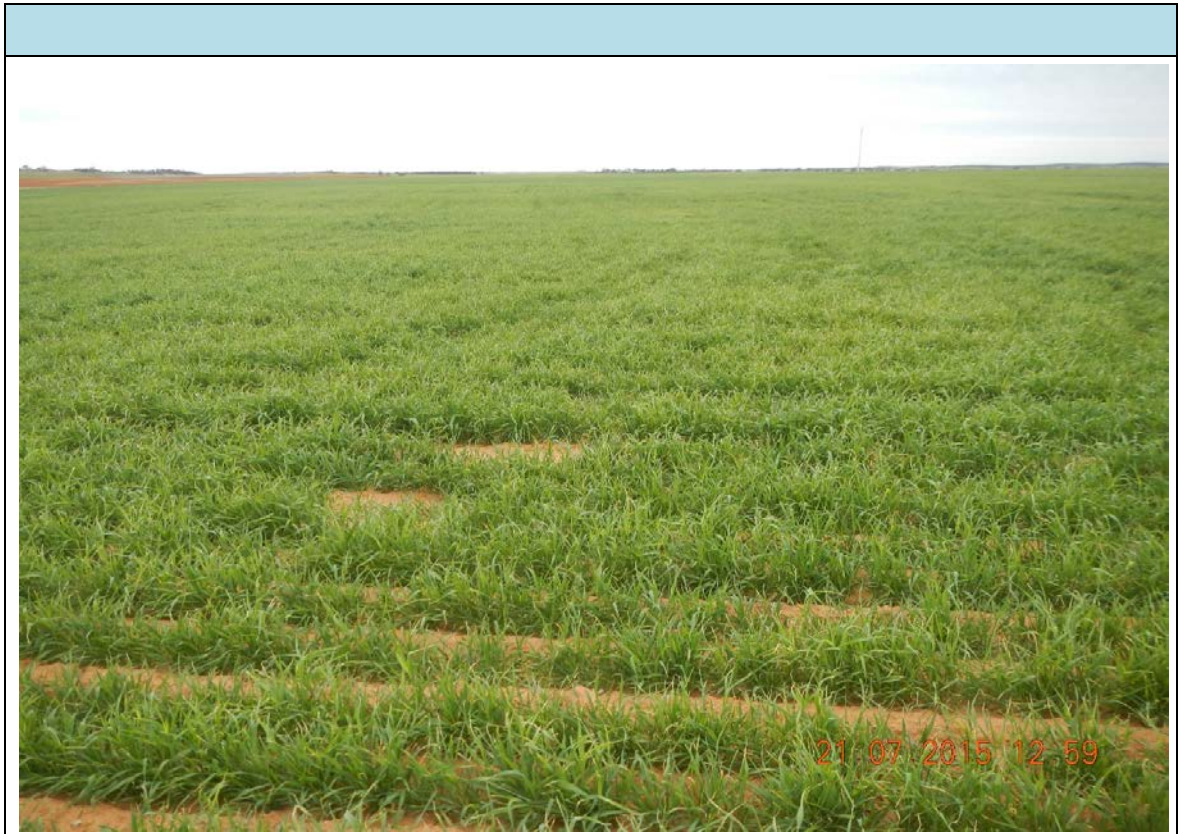
- replacement of overburden onto Cells 23 to 26;
- rehabilitation of Cells 18 to 26 with subsoil and topsoil; and
- seeding of Cells 18 to 26 with the sowing of a cover wheat crop.

Photo 1: Mindarie C West cover crop

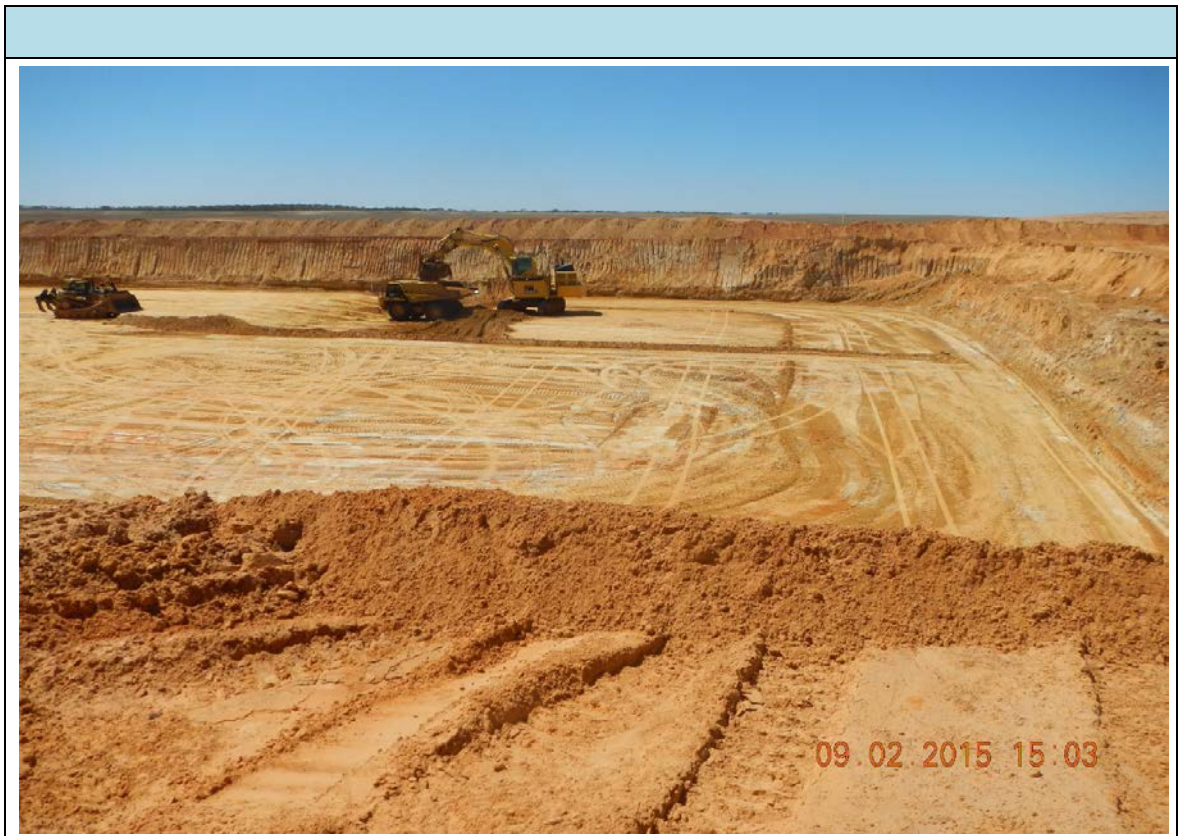
- mining Cells 59 to 71 were stripped of topsoil and subsoil;
- overburden removal occurred from Cells 57 to 67 with ore mined from Cells 47 to 67;
- tailings were deposited in two separate in-pit tailings cells at Cells 1 to 4 and Cells 26-29;
- overburden was directly returned to Cells 39 to 67;
- rehabilitation of Cells 1 to 67 with subsoil and topsoil; and
- seeding of Cells 1 to 67 with the sowing of a cover wheat crop.

Photo 2: Mindarie C East mining pit

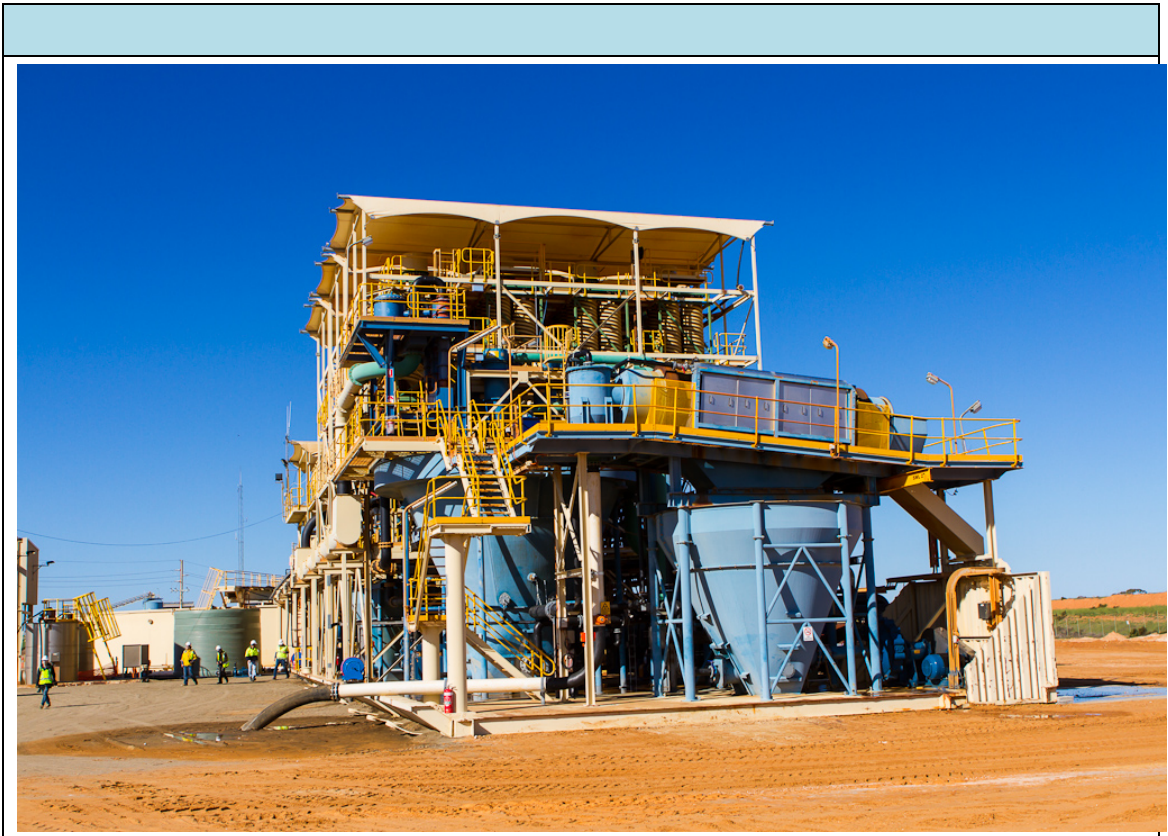
Processing of the ore was undertaken on site at the Primary Concentration Plant (PCP) which processed approximately 500 tonnes per hour of ore at a feed grade of approximately 3% heavy mineral to produce approximately 120,000 tonnes per annum heavy mineral concentrate (HMC). HMC was stockpiled on site and off loading was undertaken by a third party contractor who maintained a separate EPA approved occupational radiation monitoring program.

Photo 3: Mindarie project primary concentration plant

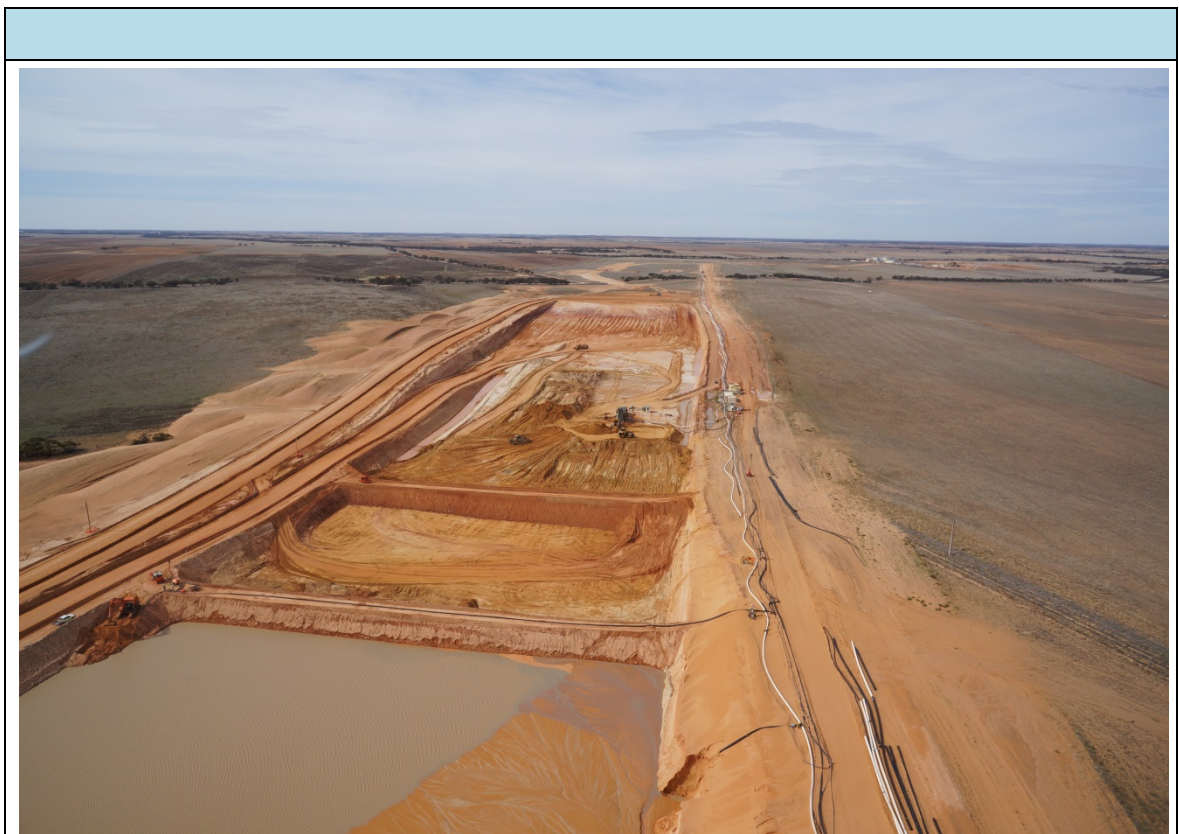
Description of change	Date submitted	Document Number	Date approved
Increase of mine maximum operational footprint	March 2015	PEPR Amendment 02	In Progress
Change of mining methodology and cell size	March 2015	PEPR Amendment 02	In Progress

Photo 4: Original mine methodology footprint

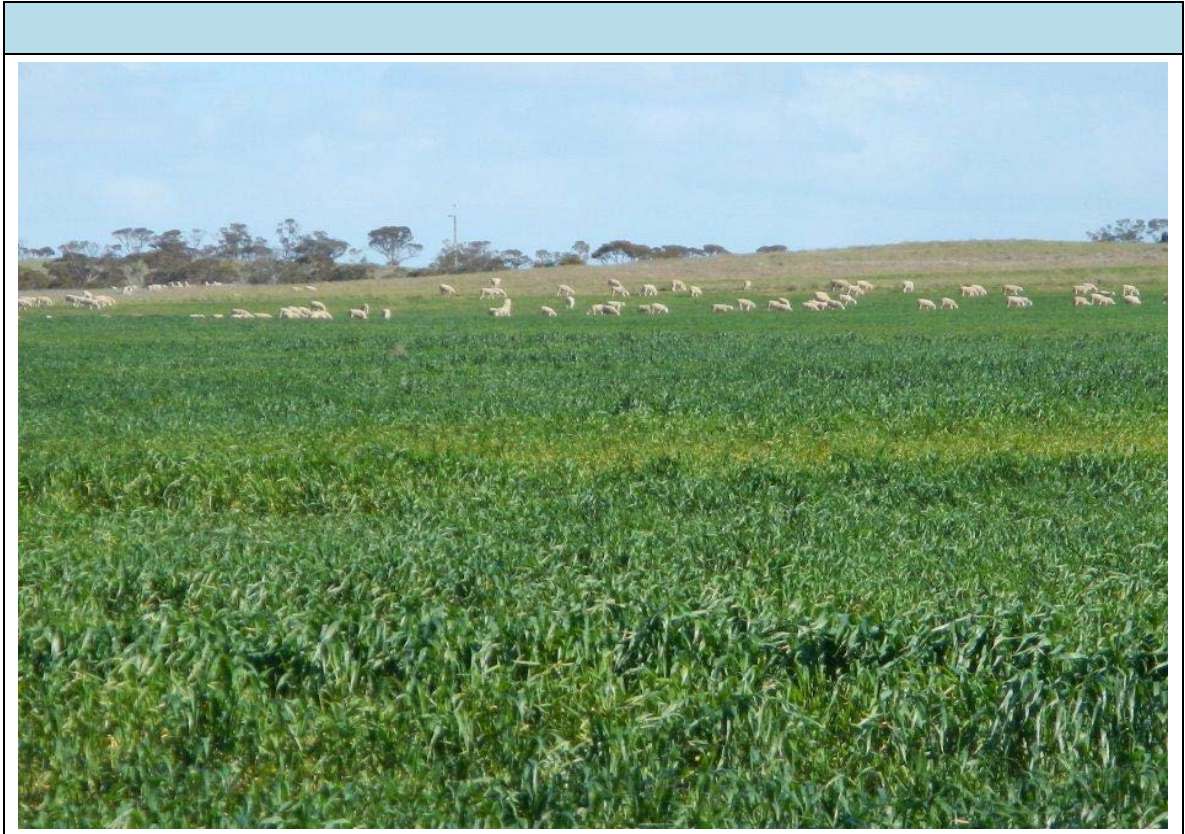
Photo 5: Rehabilitated Mindarie A(2) strandline

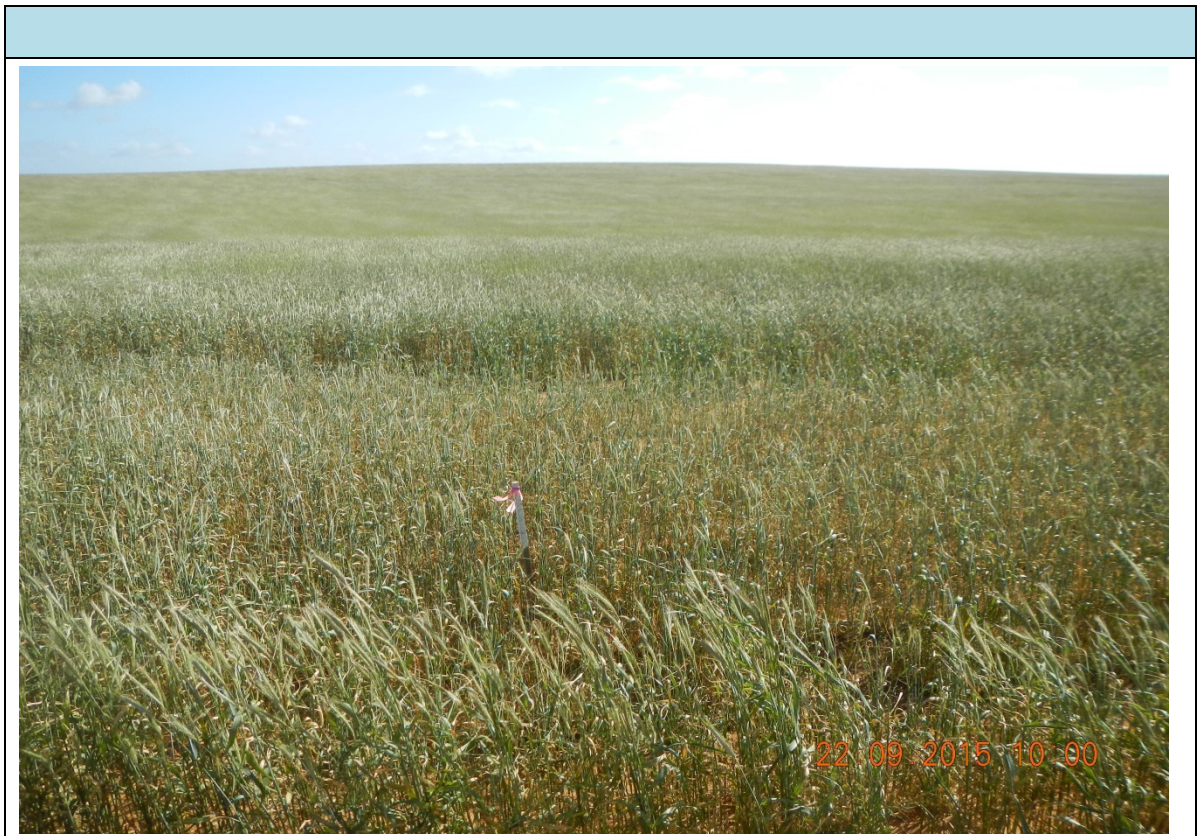
- grain yields were generally below average due to low weight and poor quality grain as a result of the heatwave;
- there were no observable differences between mined and unmined rehabilitated land; and
- areas of stockpiles on some of the western cells Mindarie A(2) and the far east (Mindarie C) showed issues with root growth as a result of potential compaction.

Photo 6: Rehabilitated Mindarie C West strandline

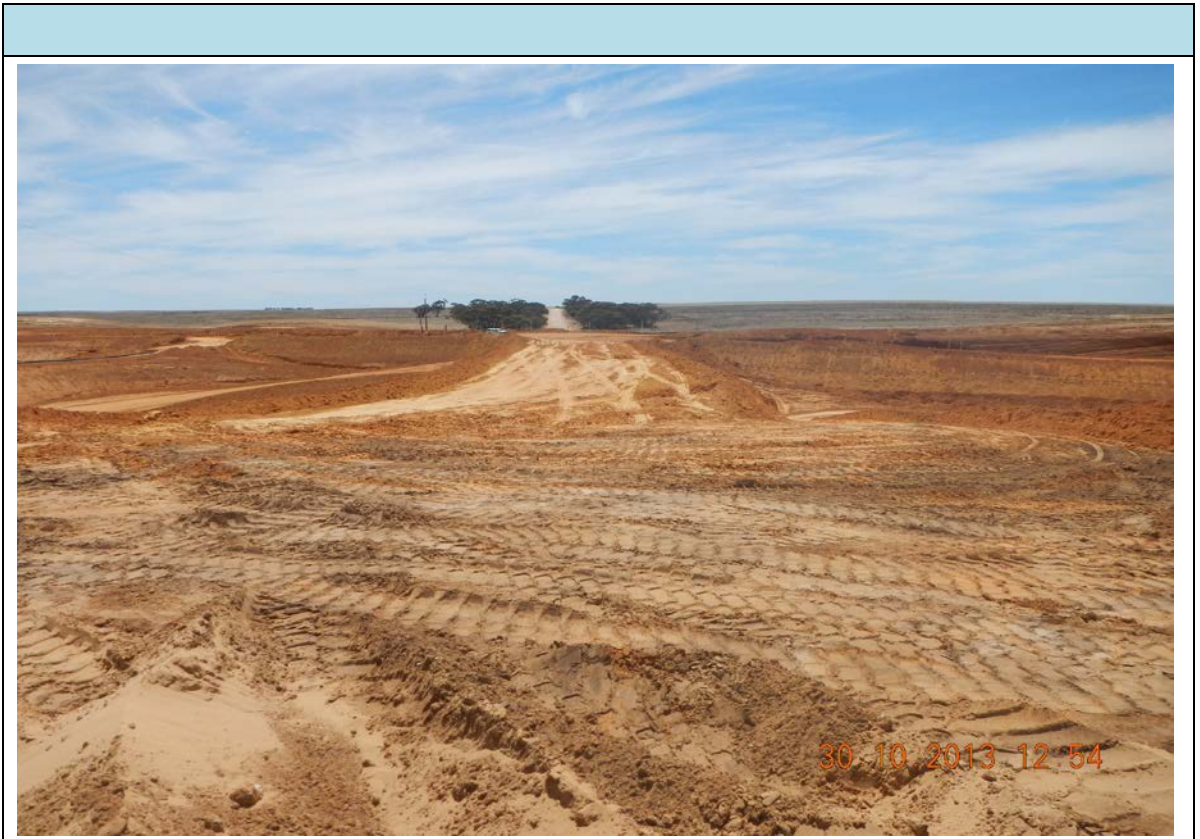
During the reporting period two areas native revegetation of approximately 2ha each were removed from areas on Knights Well Road and McCabes Road as per the Significant Environmental Benefit (SEB) provided in the PEPR. The condition assessment of this native vegetation ranged from very poor to poor and it was noted the remnant vegetation was dominated by weed species. It should be noted that no flora species with a State or National conservation rating were identified in this area.

Photo 7: Mining through Knights Well Road

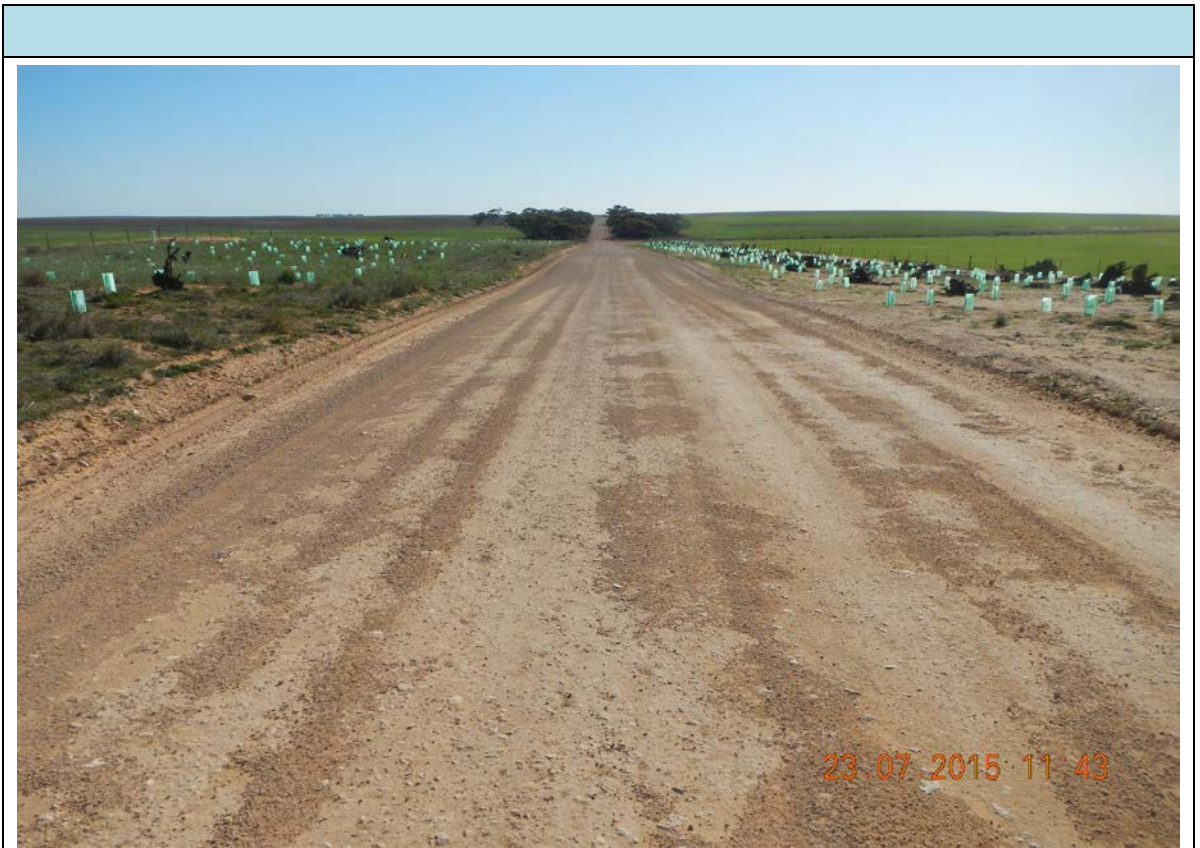
A re-planting regime was developed in conjunction with the local NRM Officer and Greening Australia (based on SEB assessments by COOE) and commenced in May and was completed in October.

Photo 8: Reinstated gravel pavement and native vegetation along Knights Well Road

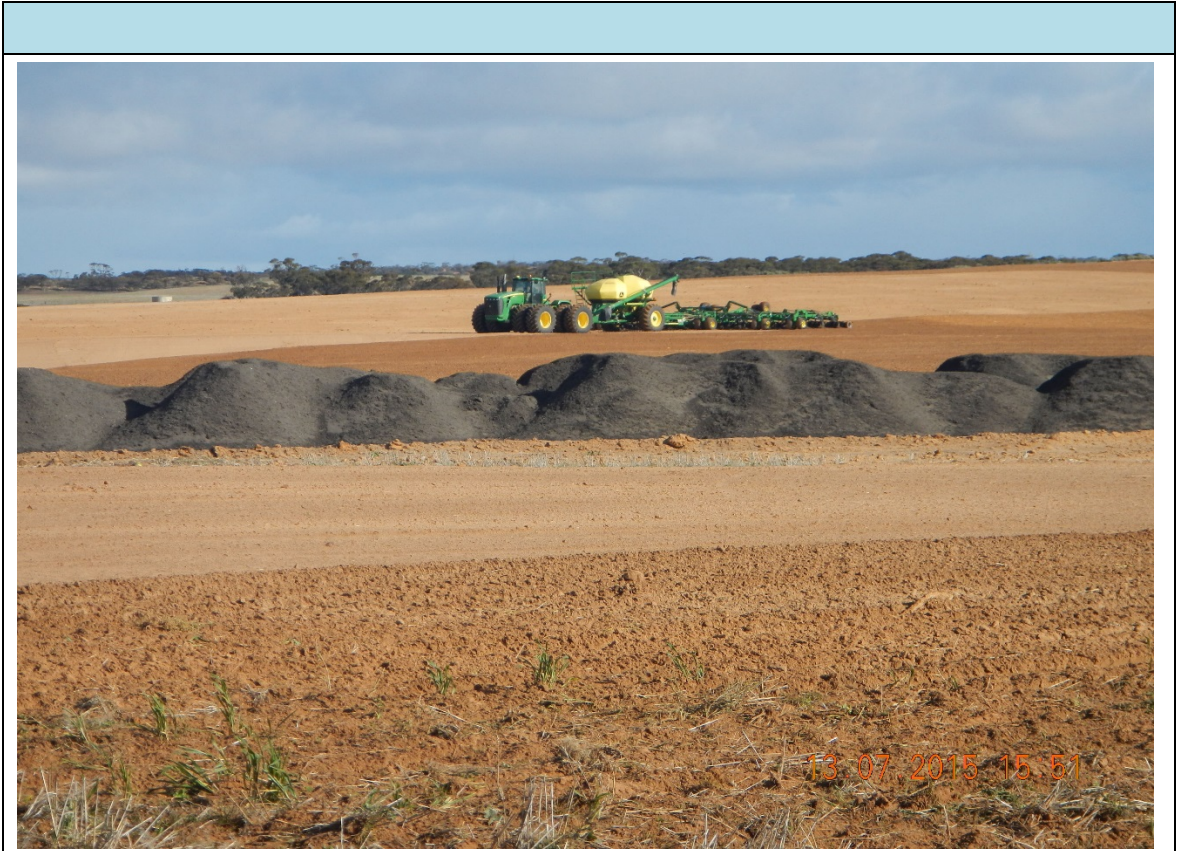
Photo 9: Worm compost being spread before cover crop seeding

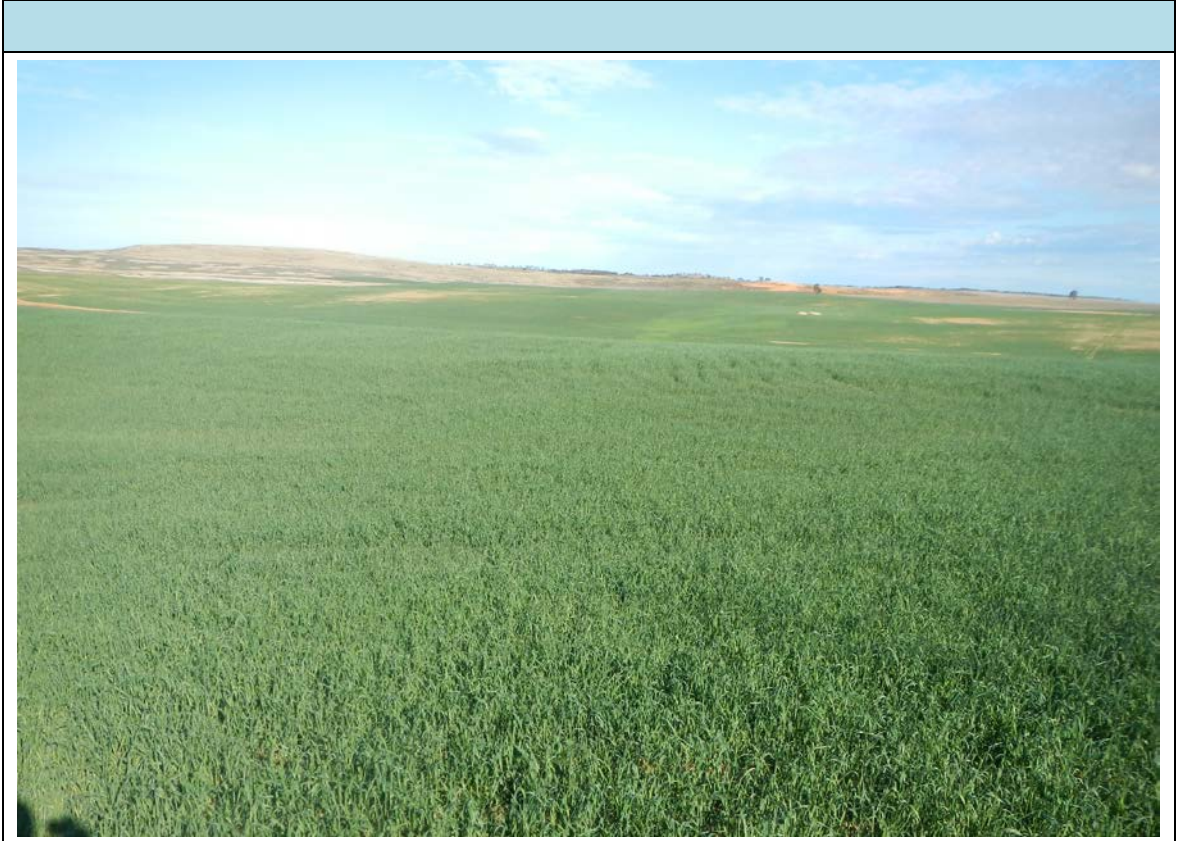
Photo 10: Emergent cover crop Mindarie C East
