Engineering Geology of Little Para Dam

W.R.P. Boucaut and J.C. Beal

Report of Investigations 54 Geological Survey of South Australia

Report of Investigations 54

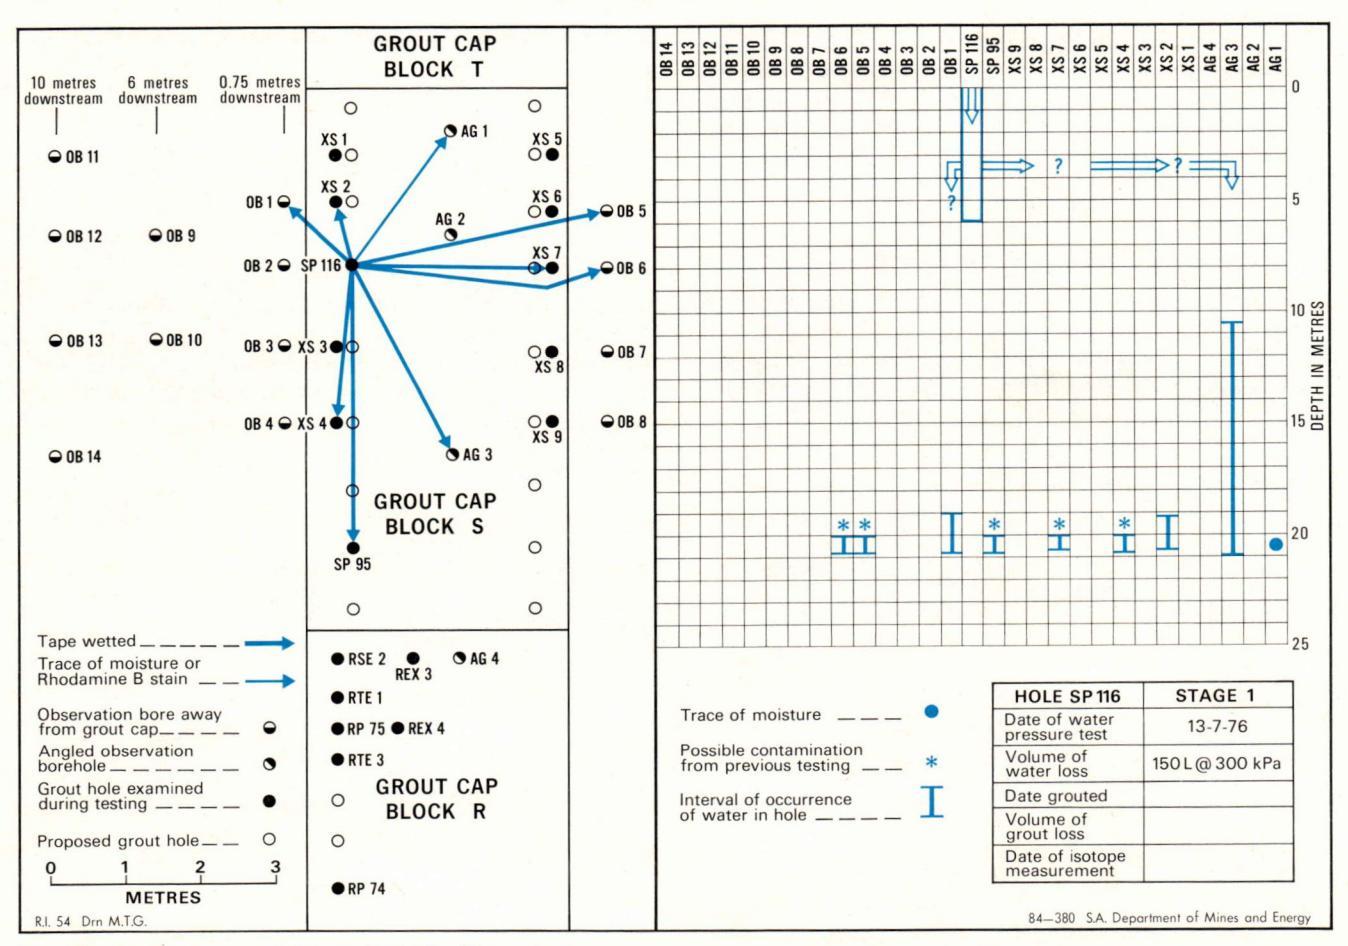
Fig. 24 Grout curtain: Drillhole SP116-Water tests.

- This connection at 8.5 m was also shown during the first stage water pressure testing of SP 116 (Fig. 24). It is expected therefore that the flowing connections observed between SP 116 and the observation bores during all three grouting stages probably took place within the transitional strata at the same depths as the measured interconnections.

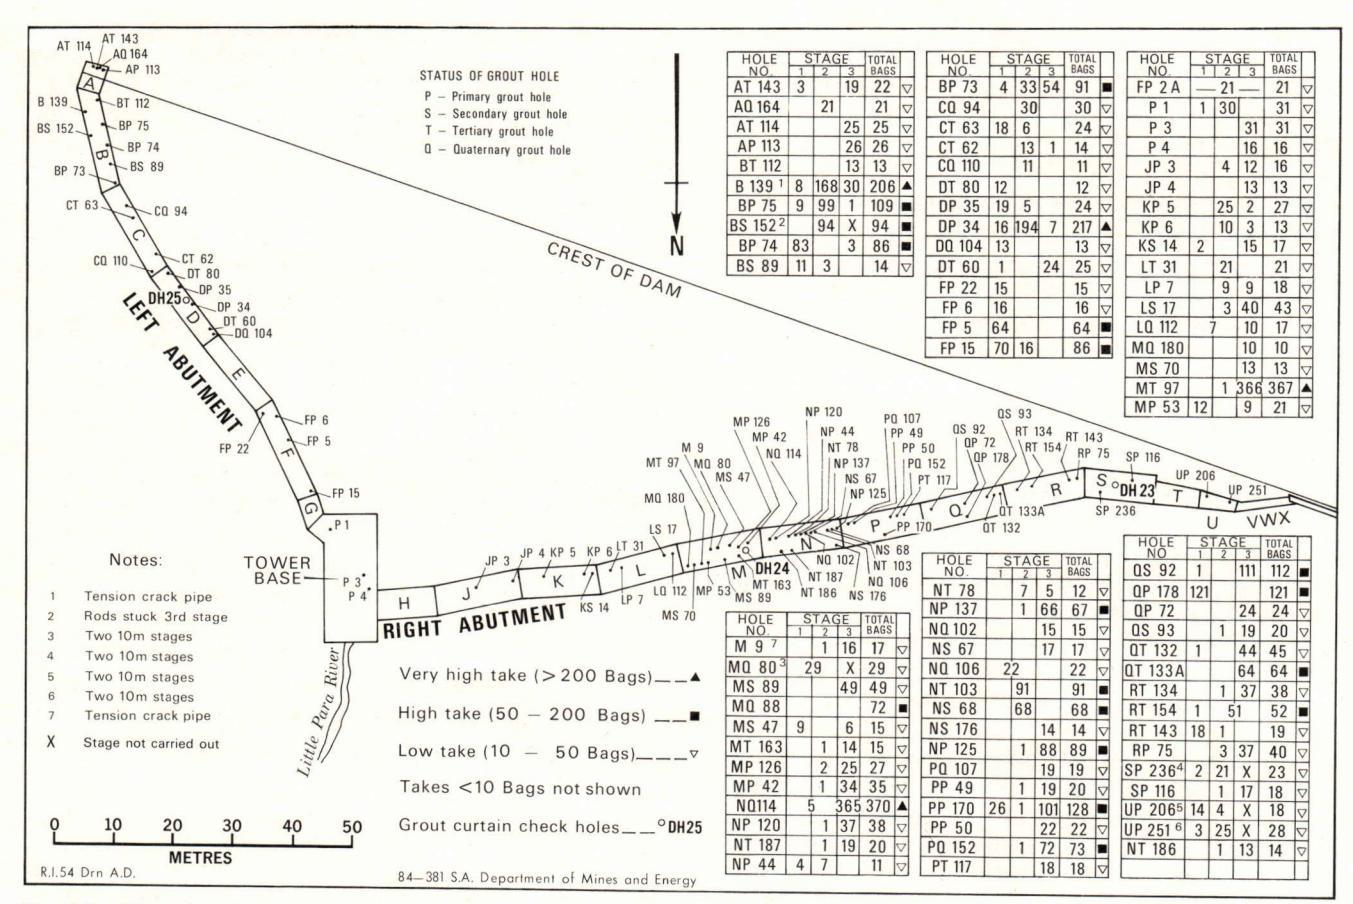
Fig. 25 Plan of major grout takes.

Uplift occurred during the grouting of Blocks M and N when 366 bags of cement were used in the grouting hole MT 97 (third stage) and 365 bags in grouting hole NQ 114 (third stage) as shown in Figures 25 and 26. It is believed that the high third stage pressures caused dilation of the transitional strata bedding planes, in turn causing uplift of the overburden and allowing the grout to travel away from the hole being grouted.

Groundwater levels from two observation wells are being continuously monitored. These wells (MOB 1 and MOB 2 in Figure 25) are located adjacent to the downstream toe of the rockfill dam. MOB 2 (El. 146.6 m) remained dry during the early months of reservoir filling but water was recorded at El. 126 m on 8 August 1978 at reservoir El. 134 m. Prior to filling of the reservoir MOB 1 (El. 124 m), gave a static water level 11.45 m below natural ground level (El. 112.55 m). The water level rose to El. 123 m during reservoir filling and remained stable at this level.

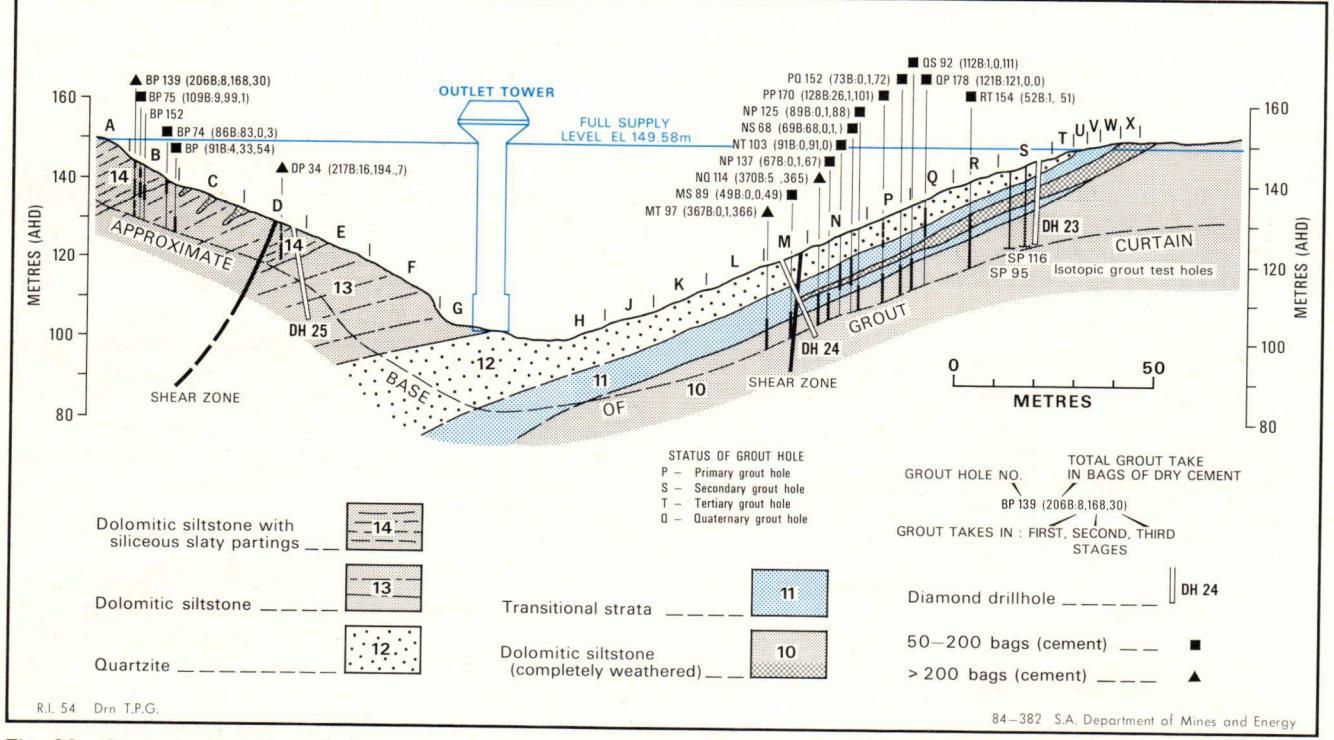
Fig. 26 Geological section showing grout takes.

This was confined to the upper half of the right abutment. As shown in Figure 26, the quartzite band (Unit 12) underneath the grout cap feathers out at the top of the right abutment. Between the quartzite and the underlying dolomite (Unit 10) is a band of weathered dolomitic siltstone (Unit 11) susceptible to solution cavities. In addition a shear zone, open joints, and open bedding planes were discovered through Blocks M and N and uplift was observed when these blocks were grouted using the normal pressures. Very high takes were also observed and a great number of additional holes were required to close the grout curtain in this area which included Blocks P and Q.

It was decided to lower the grouting pressures and to change stage depths and grouting procedure to minimise uplift and still ensure that the rock was effectively grouted (Fig. 30). The start mix was changed to 3:1 to ensure localised grouting of the area around the hole instead of driving a thinner grout long distances from the curtain. This method effectively reduced the grouting time for holes with large takes while still sealing the larger fractures and solution cavities in the foundation. No further indication of uplift on these blocks was observed.

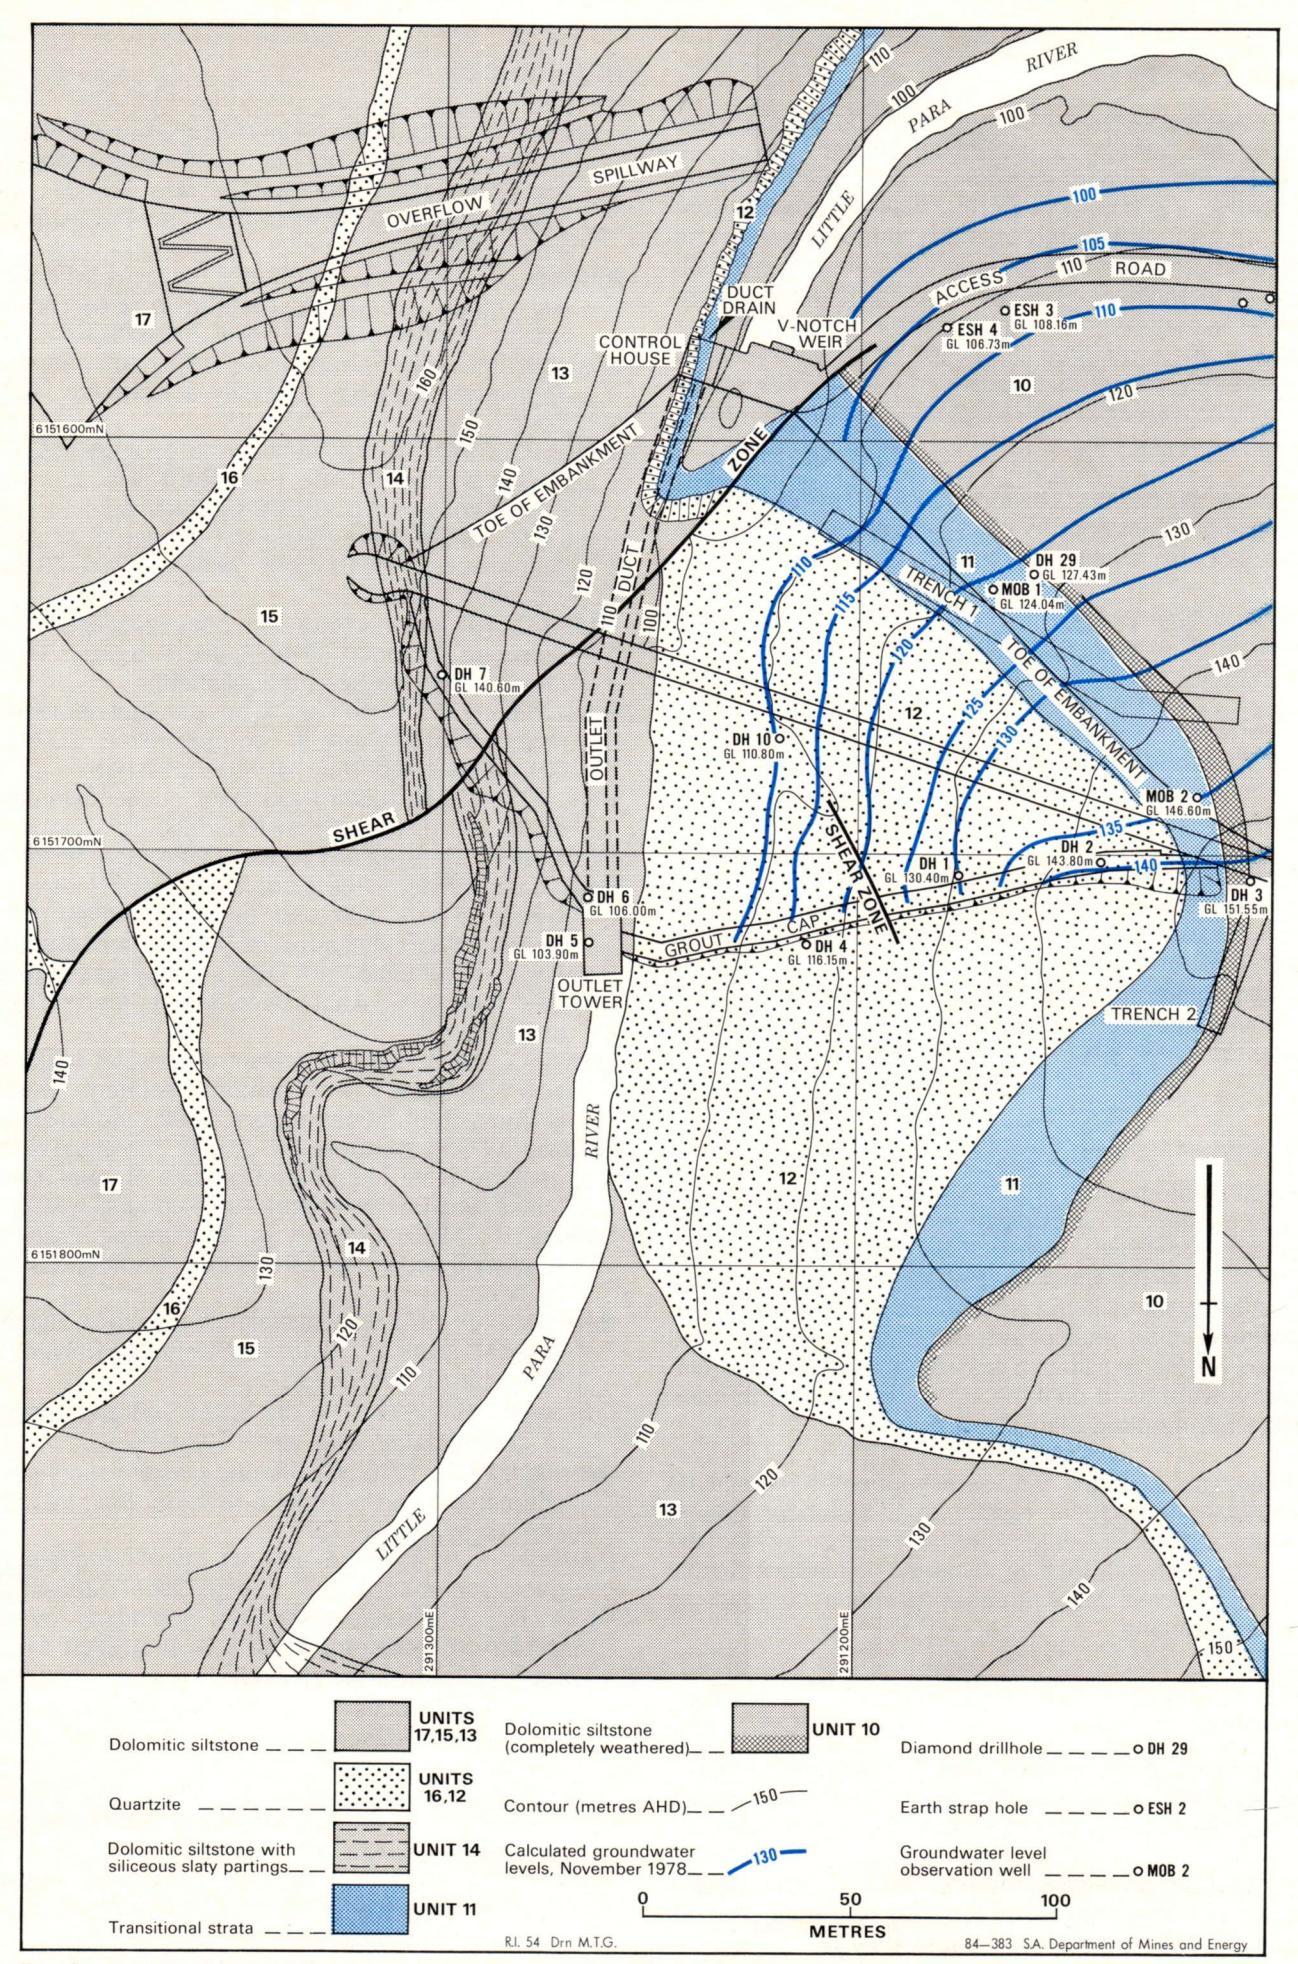
Fig. 27 Surveillance programme: Observation wells and groundwater contours.

Groundwater contours (Fig. 27) approximate surface contours and do not indicate water flow away from the dam. Springs are evident in a few locations where groundwater levels intersect topographic contours, for example the springs from earth-strap hole ESH 2 and from the quartzite at El. 110 m and El.100 m respectively.

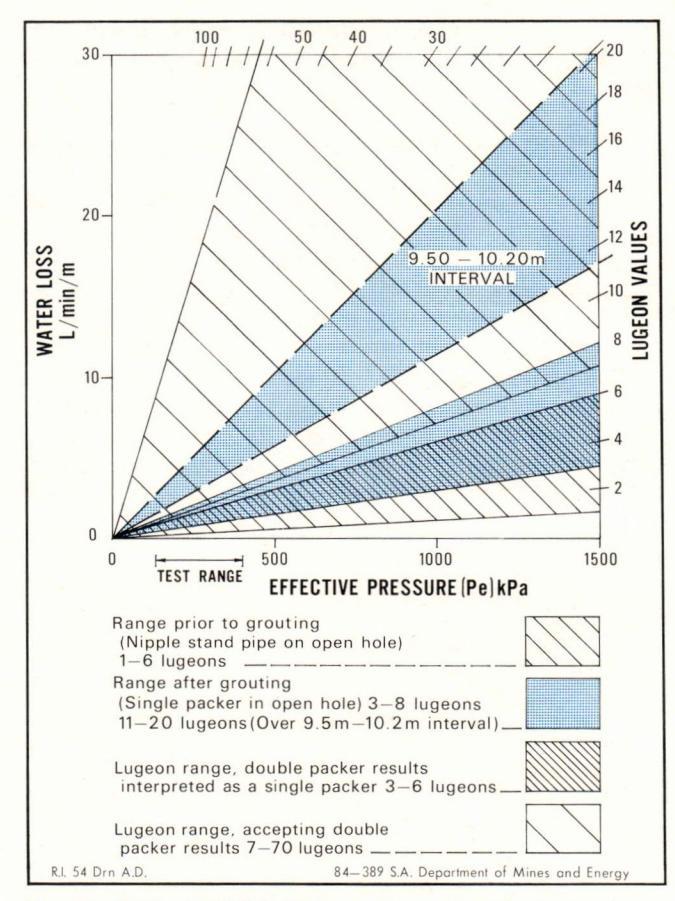
Fig. 31 Drillhole DH24: Water pressure test-lugeon values.

Check hole DH 24 (Appendix 1) was located and angled to intersect the most likely area of potential leakage, at approximately 10 m beneath grout cap Block M where a shear zone intersects the weathered transitional strata immediately beneath the massive quartzite (Unit 12). Losses of from 11 to 20 lugeons were measured over the interval 9.5-10.2 m. This is the same interval where the earlier self potential and point resistance logs indicated a change in rock groutability. It is considered that the presence of the shear zone within the fluctuating groundwater table, and the resultant localised weathering of the transitional strata, can account for the relatively high water losses over this interval.

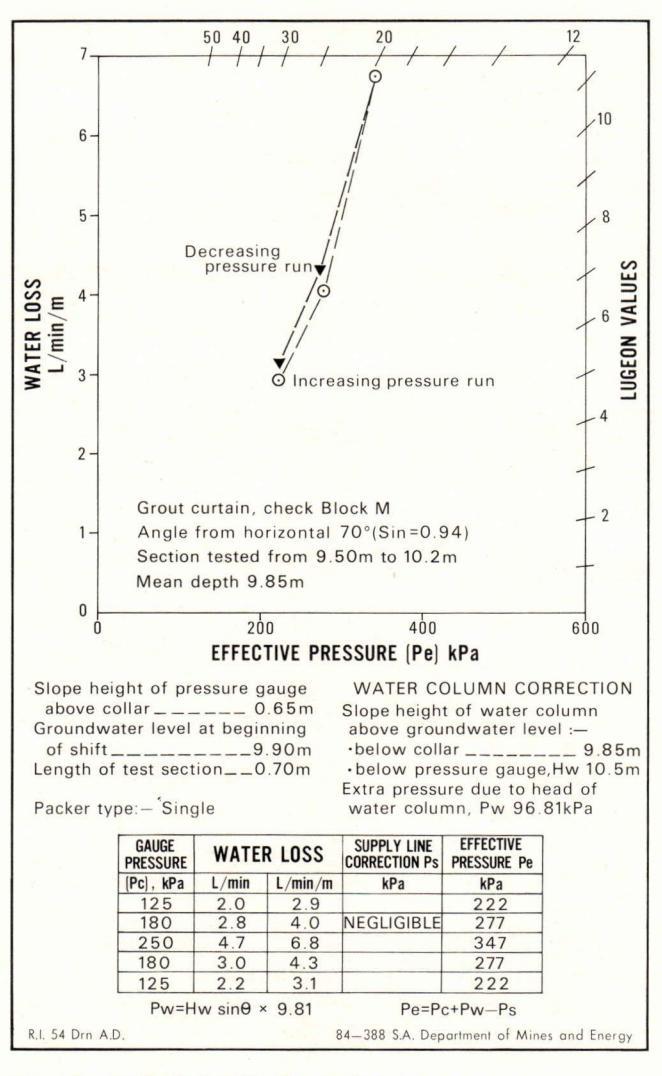
Fig. 32 Drillhole DH24: Geological log.

To check the effectiveness of the grout curtain, three drillholes, DH 23, 24 and 25 (Figs 25 and 26) were drilled within the grout curtain and pressure tested. Lugeon values obtained were compared with values obtained prior to grouting. A geological log is shown in Figure 32 and results of pressure testing given in Figures 33 and 34. An example of recorded data is shown in Figure 34.

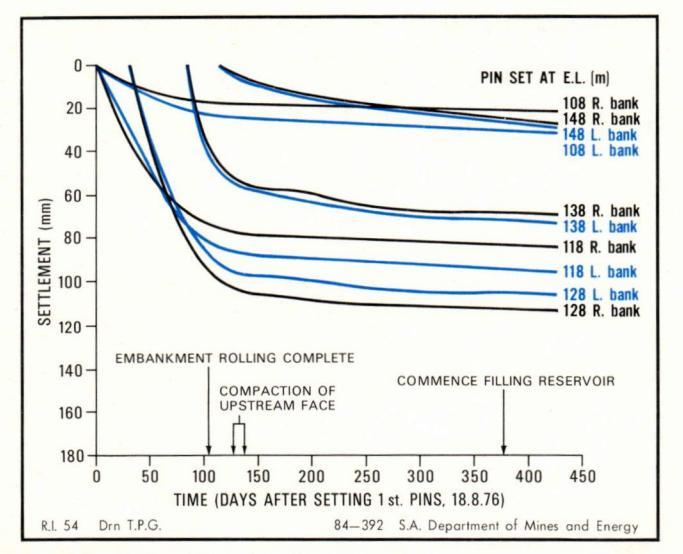
Fig. 36 Embankment settlement rate.

Embankment settlements are shown in Figure 36.

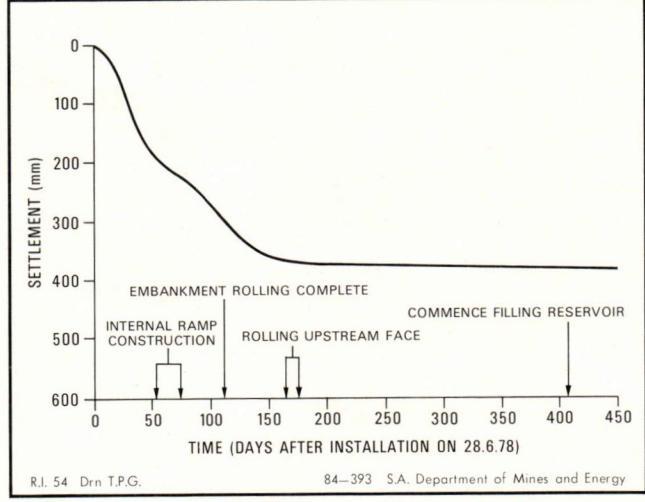
Fig. 37 Embankment settlement-Gauge No. 2.

Typical results of fill settlement indicated by the hydraulic settlement gauges are shown in Figure 37. The results indicate that the settlement rate slowed considerably after placement of the embankment was complete, as would be expected for a granular material.

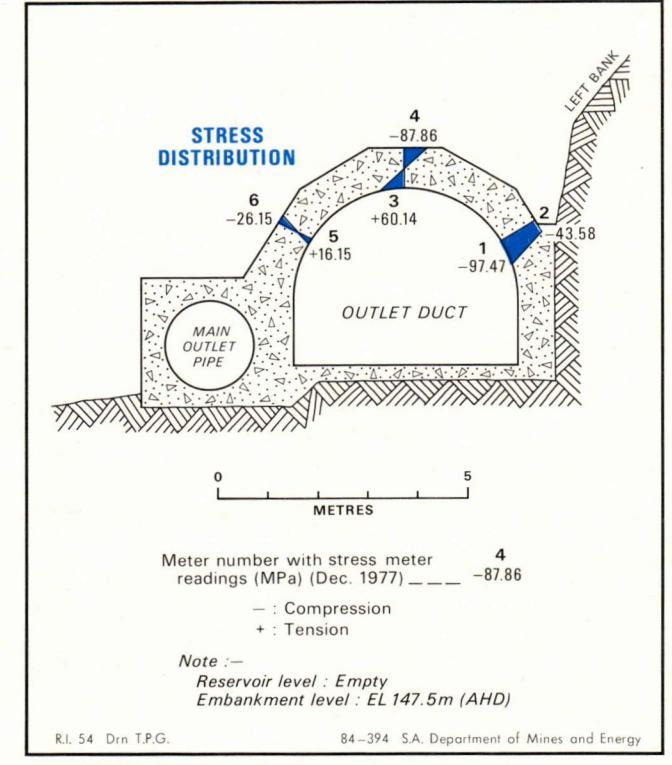
Fig. 38 Outlet duct: Pressure distribution.

Stress distribution in transverse reinforcing steel at the centre reading station in the outlet duct is shown in Figure 38 and indicates that stresses are within acceptable limits.

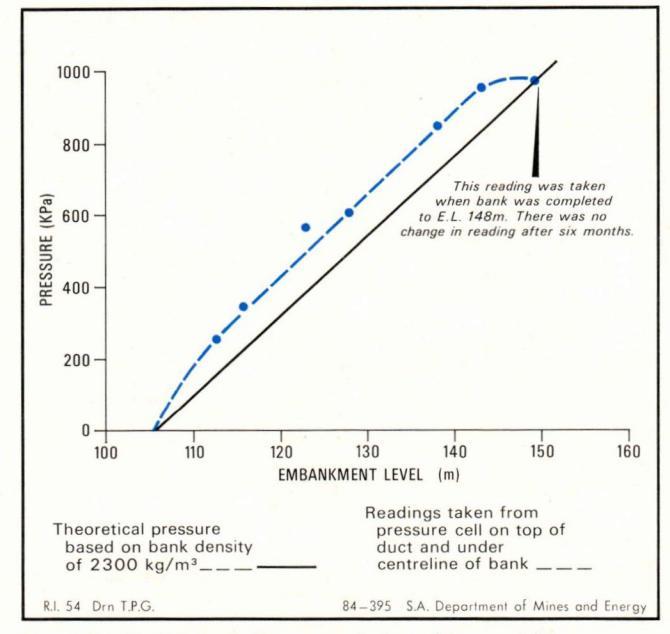
Fig. 39 Outlet duct: Pressure induced by rockfill.

Pressures induced by fill loads on the outlet duct during construction are shown in Figure 39. A comparison of measured pressure and theoretical pressure indicates construction pressures in excess of the theoretical value, which was based on fill density and embankment height at the time of reading. After embankment completion, measured values have relaxed to a value quite close to the theoretical pressure.

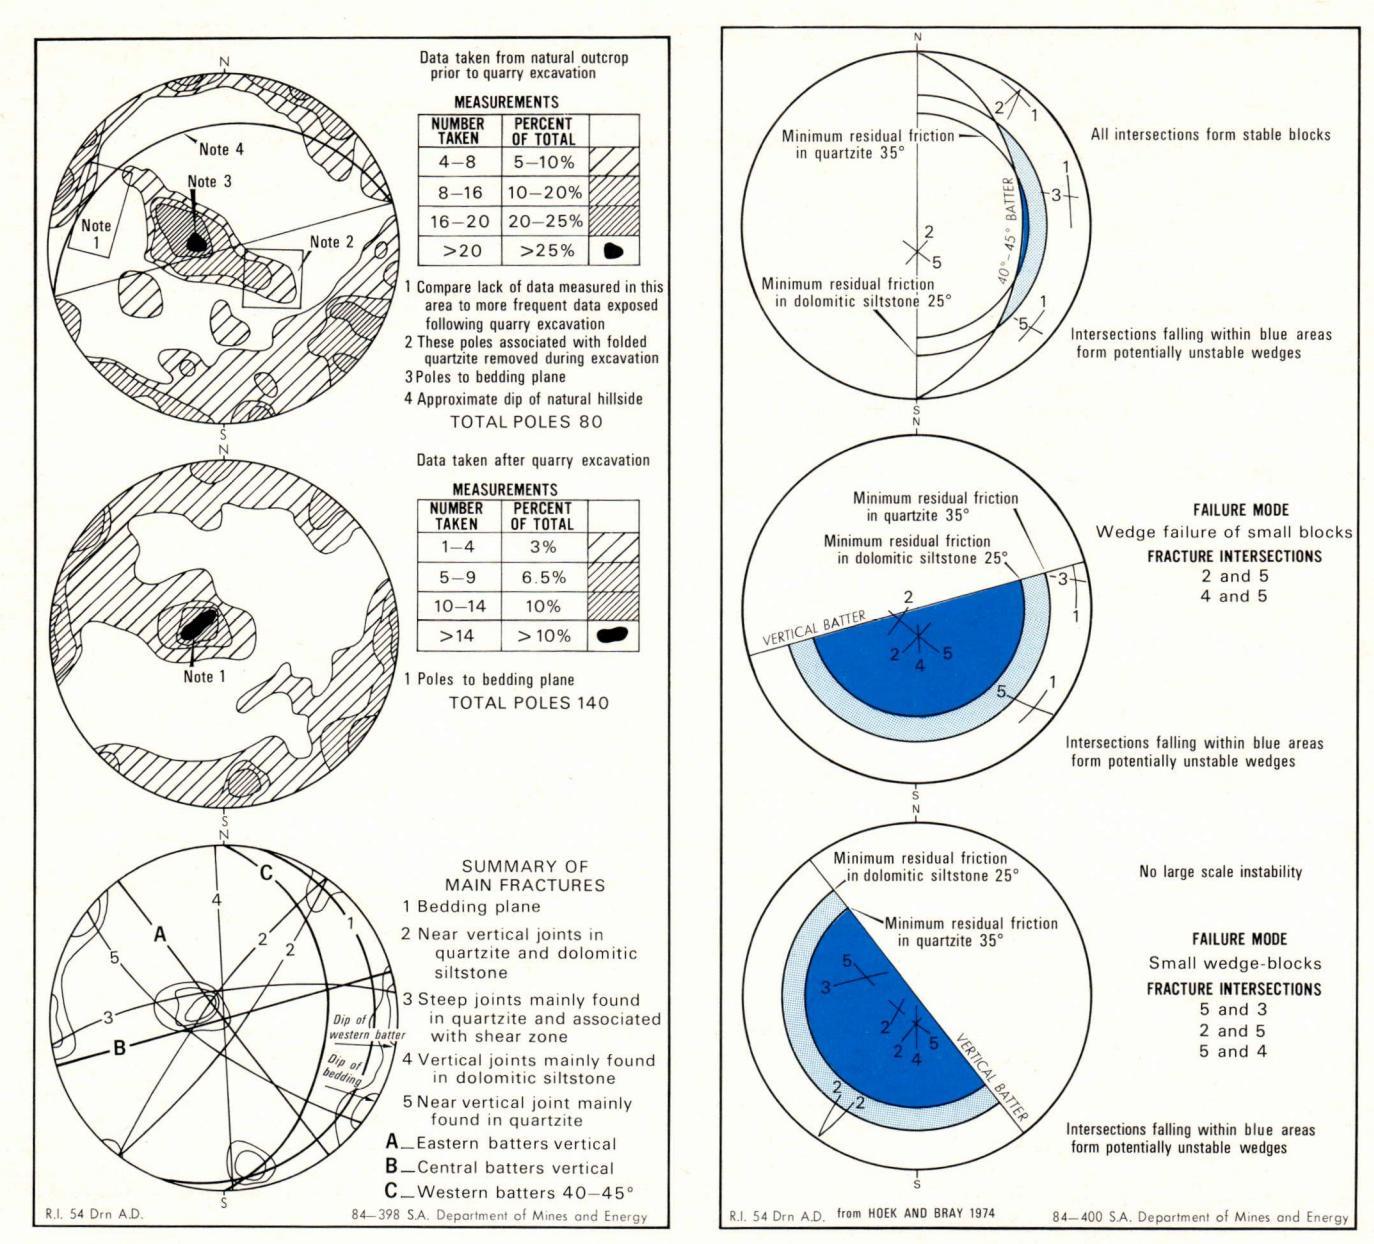
Fig. 41 Quarry: Slope stability analyses.

Prior to quarry excavation, field data (Figs 41 and 42) indicated the potential instability of quartzite boulders during excavation of a fold in the quartzite stratum (Unit 9) which traverses the quarry. Using this data, a safe sequence for the early quarry excavation was therefore suggested:

Field data for this fracture analyses are shown as poles plotted on a stereogram in Figure 42. A summary of the field data for the eastern, central, and western batters is shown in Figure 42 and the batters are referred to respectively as Regime I, II and III (Fig. 43). Rock falls from the vertical batters of the central and eastern faces of the quarry can be expected with maximum block sizes of up to $1.0 \times 1.0 \times 0.5$ m. Placement of a shallow ditch and cyclone fence at the foot of the batters has been advised, to prevent falling boulders from reaching the treatment works.

Small rock falls could also be expected from the western batter excavated at 40° and a low safety barrier is to be placed at the foot of the batter. Because bedding plane angle of friction is greater than bedding plane dip a planar failure of the batter into the excavation, although geometrically possible, is highly unlikely. Table 17 gives typical fracture data and their description and Figure 44 shows the stereographic calculation of the stability of rock masses formed by the intersection of fracture planes.
