DEPARTMENT OF MINES
GEOLOGICAL SURVEY OF SOUTH AUSTRALIA

ENGINEERING GEOLOGY OF THE KANGAROO CREEK DAM

by
J. P. Trudinger
Assistant Senior Geologist

Bulletin 44

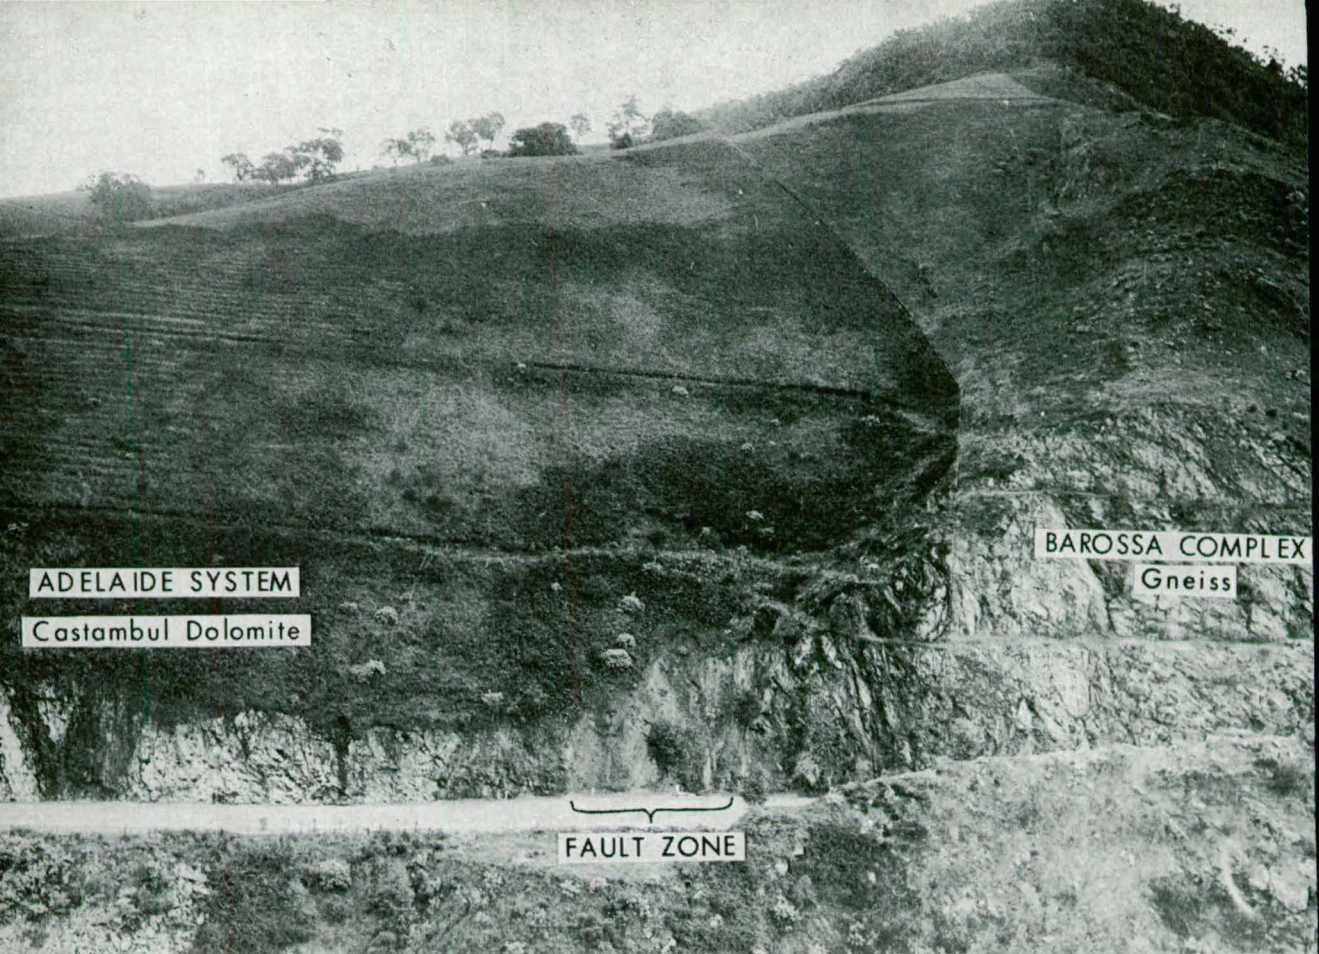
Fig. 7. Prominent fault separating Adelaide System rocks from Barossa Complex rocks; Gorge Road deviation excavation, 4,000 feet downstream from Kangaroo Creek Dam.

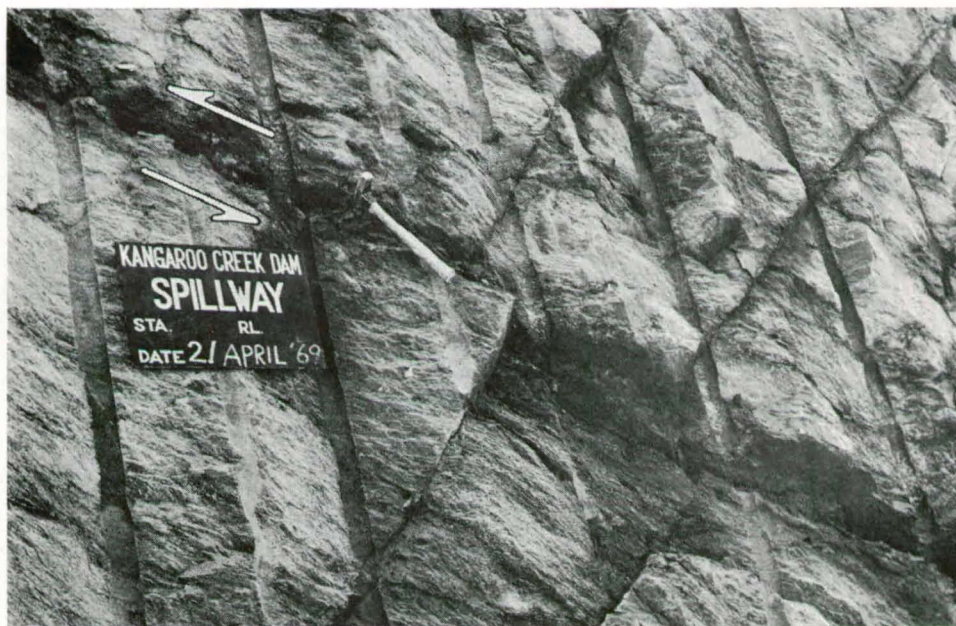
Fig. 12. Sheared, partly crushed zone exposed in excavation for spillway block LB; Set (2) joints indicate displacement of 10 cm across seam.

Sheared and crushed zones intersect the rock mass throughout the site, spaced less than 100 feet apart and extending for more than 300 feet. In some places (Fig. 12) displacements of joints along sheared zones, indicate that relatively recent overthrust movements have occurred along these

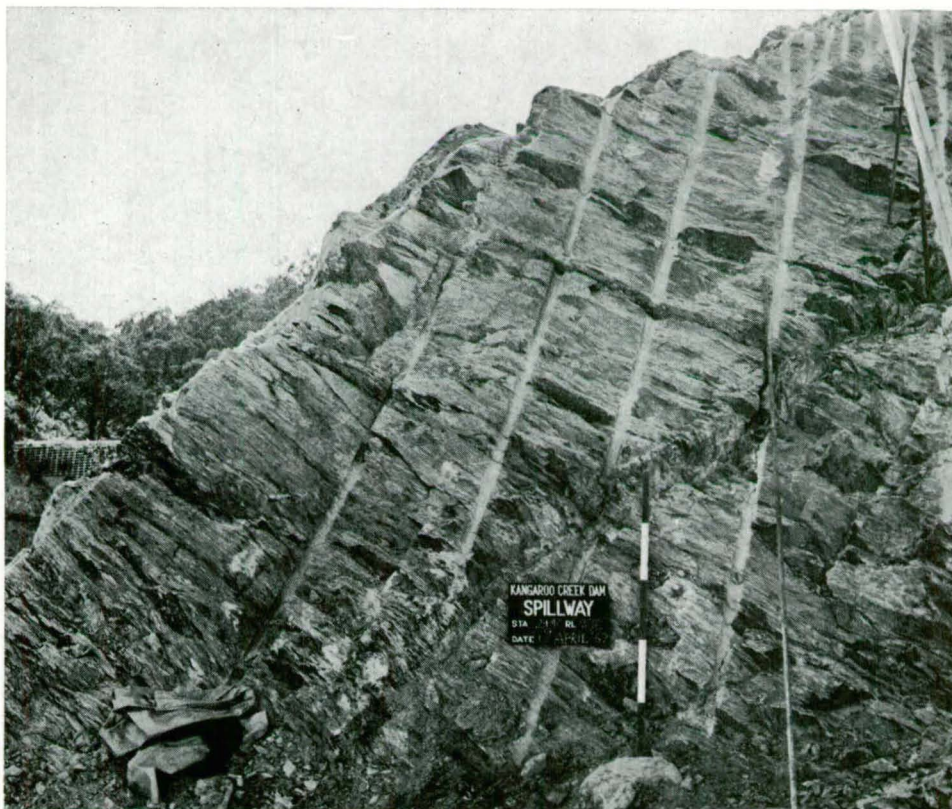
Fig. 13. Steeply dipping kink band exposed in initial excavation for spillway block LE; the zone also contains a seam of infilled clay 8 cm wide.

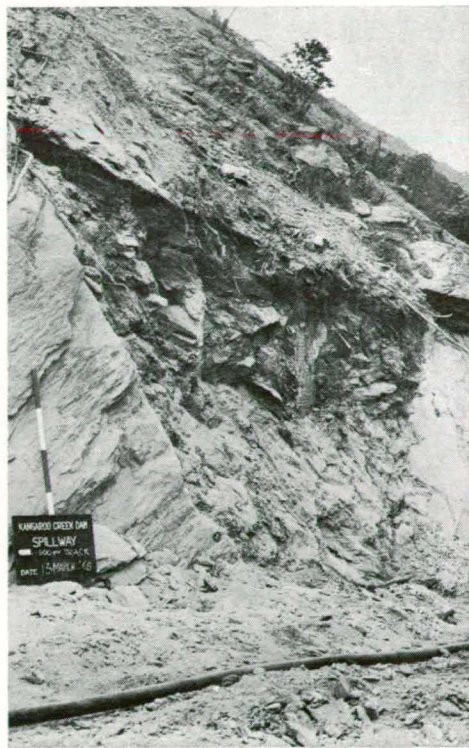
Fig. 18. Soil mass of rock fragments and clay, filling a V-shaped gully formed by sliding of wedge mass bounded by Set (1) and Set (2) joints; central part of spillway excavation.

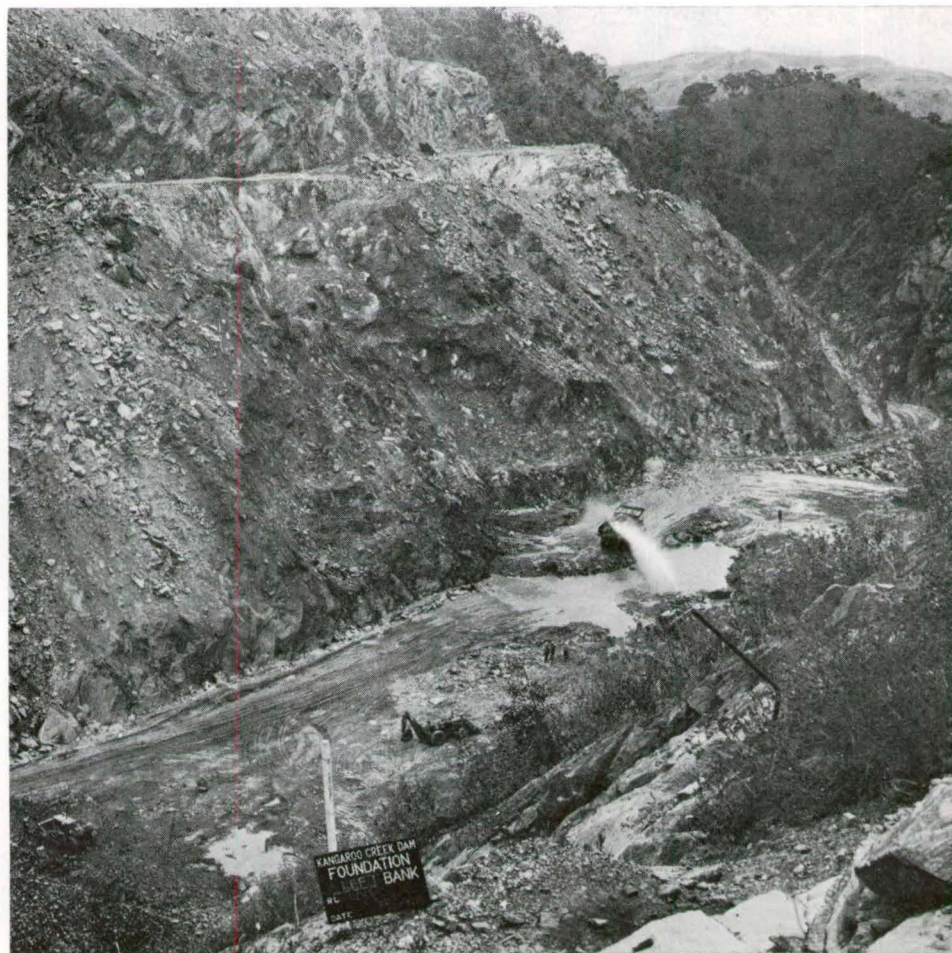
Fig. 22. Left abutment after removal by D8 bulldozer of soil materials up to 20 feet thick, which occurred beneath a shallow gully up to 200 feet wide.

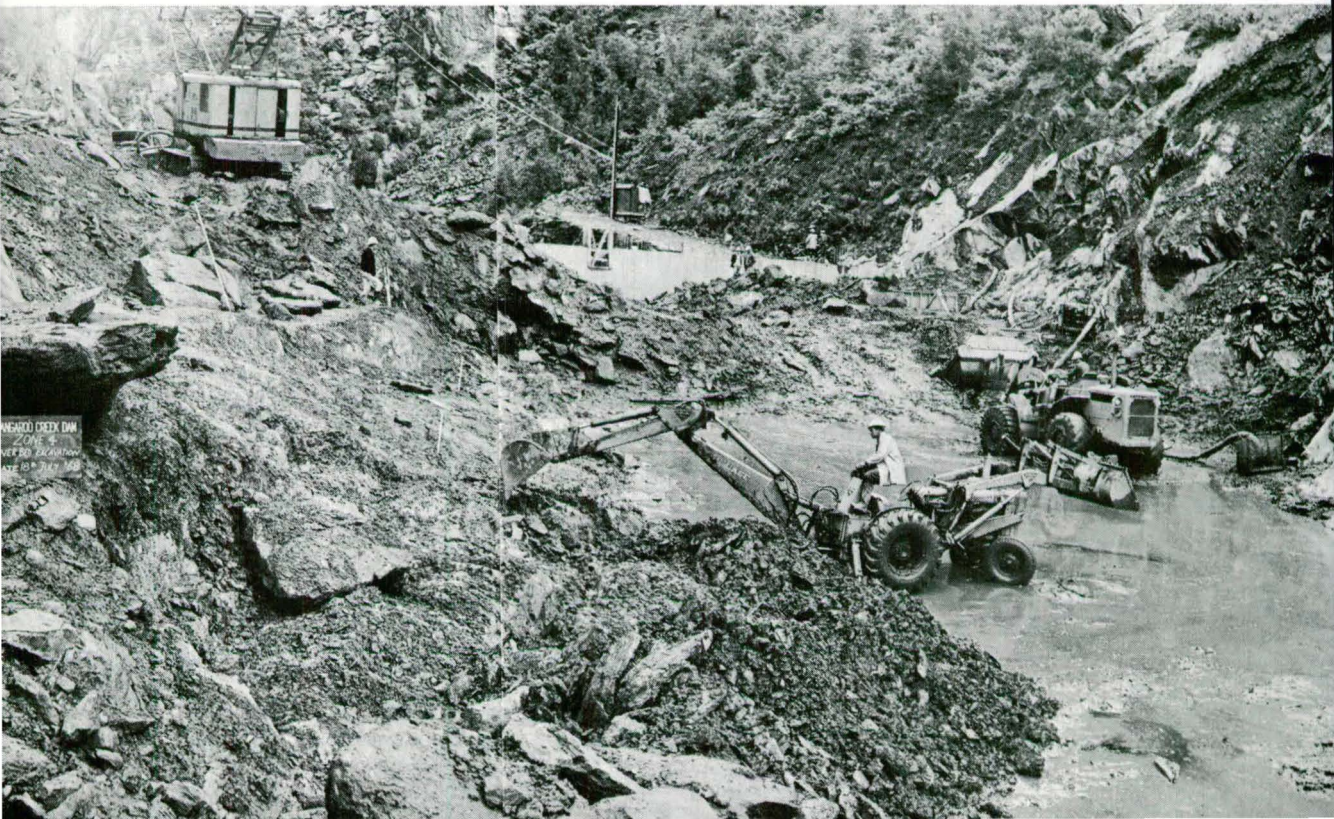
The lower part of the right abutment, and the river channel were covered by up to 20 feet of road spoil, which was removed using front-end loaders, followed by more detailed cleaning of the remaining pockets of soil using back-hoe machines (Fig. 23).

Fig. 23. Foundation clean-up in downstream part of river bed.

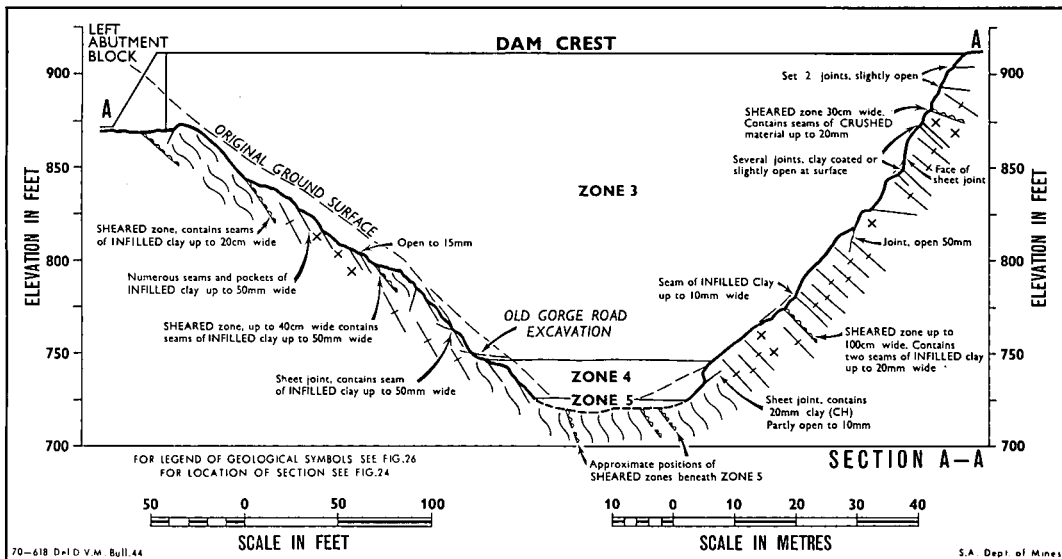
Right bank. The rock substance in the foundations consists mainly of fresh to slightly weathered gneiss with minor amounts of fresh schist and bands of slightly to moderately weathered granitic gneiss up to 10 feet wide.

The rock mass is relatively intact and appears to be undisturbed except for the presence of numerous sheet joints and Set (1) joints containing up to five centimetres of highly plastic clay. Sheared zones up to 100 centimetres wide, some containing crushed seams up to two centimetres wide, are spaced from five feet to 80 feet apart.

Fig. 25. Embankment foundation; geological section along dam axis.

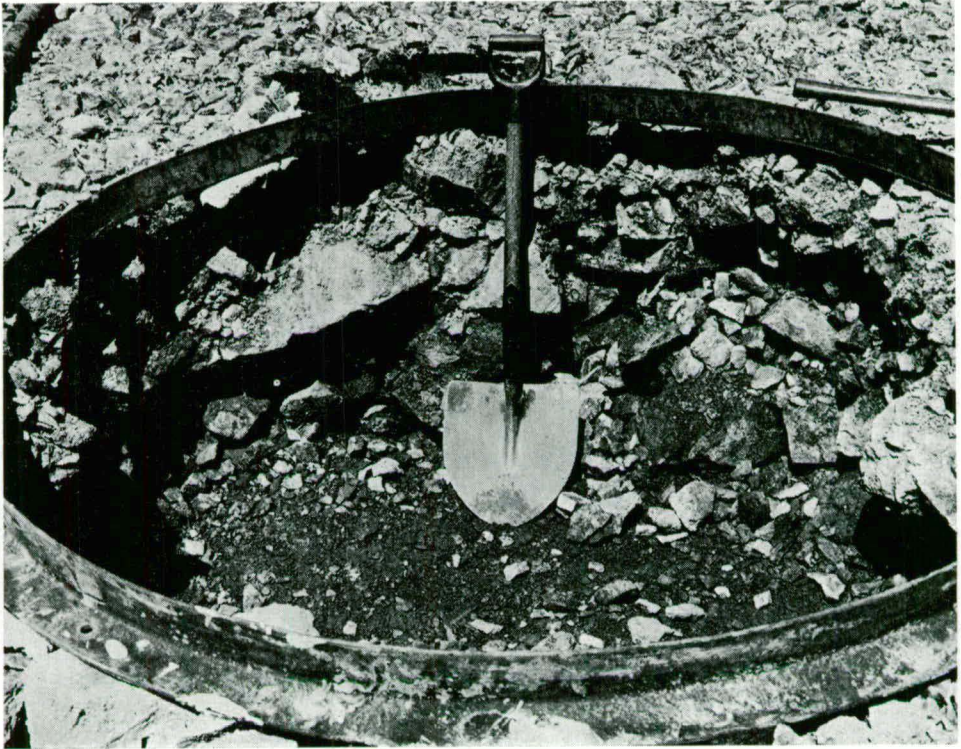
Ring density tests through typical layers of zone 1 (Table 13 and Figs. 62 and 63) indicated dry densities averaging 120 pounds per cubic foot which corresponded to porosities of approximately 25 per cent. A test in a contaminated area indicated a density of 141 pounds per cubic foot and a porosity of 16.4 per cent.

Fig. 62. Ring density test hole No. 5 excavated in zone 1 at RL792, through gneiss from zone 1 quarry.

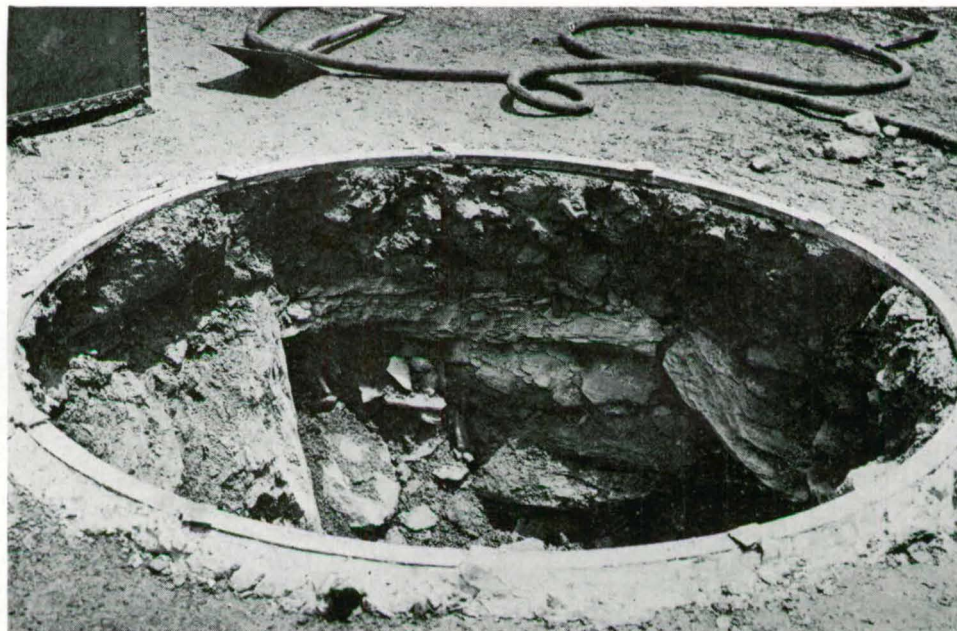
Fig. 63. Ring density test hole No. 1 excavated in zone 3 at RL751, through schist from quarry No. 1.

A variety of materials were used in the construction of zone 3 with the result that the characteristics differ markedly from place to place. The quality of much of the material used, particularly between RL745 and RL770, was far higher than the minimum standard required, and would have been suitable for placement in zone 4. The bulk of the material above RL770 consisted of slightly weathered schist with some moderately weathered schist. Breakdown of the weaker rock which occurred during placing and compaction, added to the existing fines to form a total of 25 to 40 per cent of minus one inch material, most of which was concentrated in the upper foot of the layer (see section in Figs. 61 and 63).

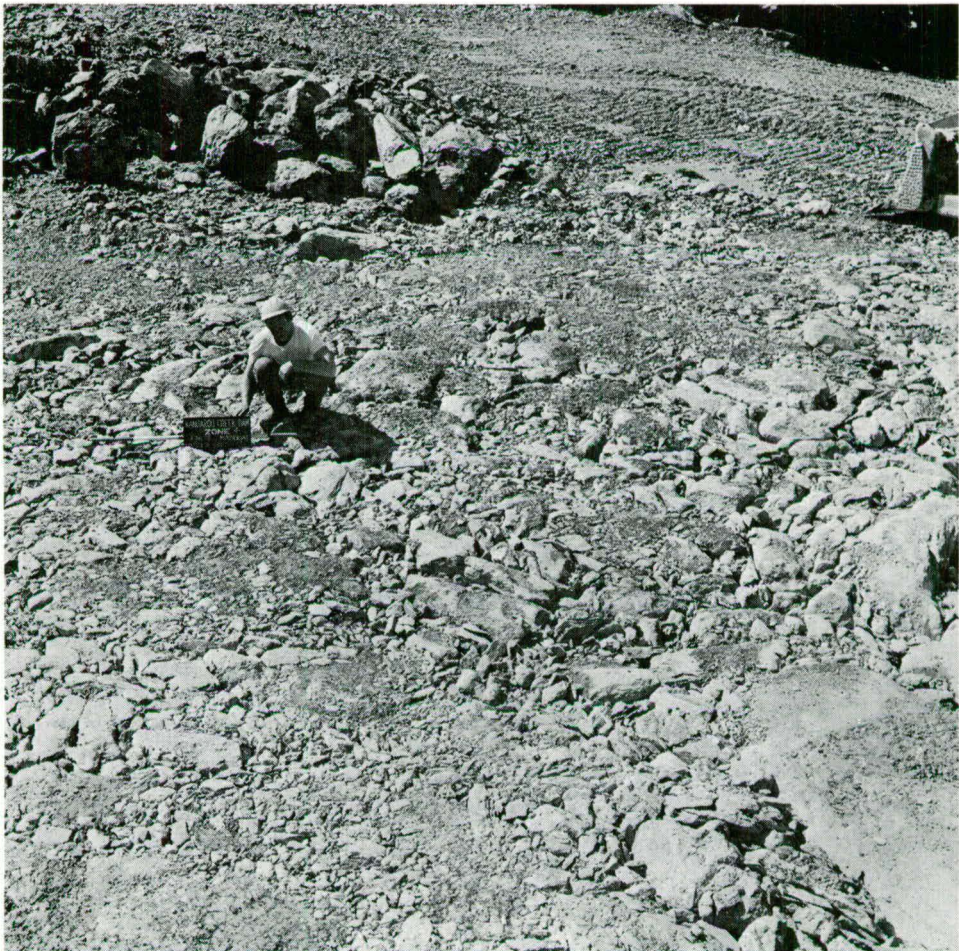
Fig. 64. Surface of typical zone 4 layer; material is gneiss from knob excavation.

Above RL737, zone 4 consisted mainly of very strong to strong gneiss with a low proportion of fines (Figs. 61 and 64). This material withstood compaction with very little crushing and remained free-draining in all directions.

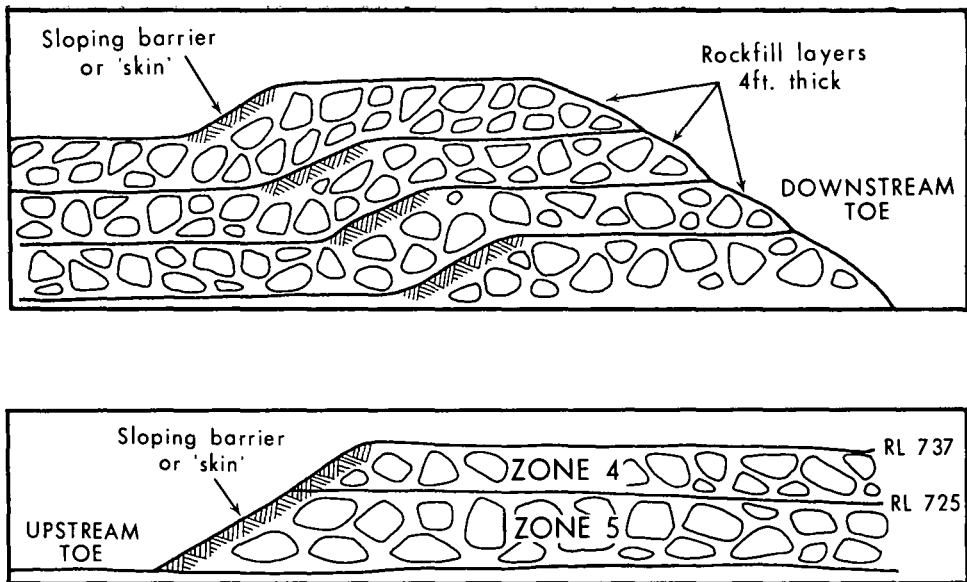
The construction of the steel mesh protection at the downstream end of each layer necessitated a large amount of traffic travelling across the sloping face of each layer. The resulting breakdown and contamination caused the formation of silty barriers or "skins" sloping upstream as shown in Fig. 65.

In a similar way, delays in placing of rockfill at the upstream end of the dam resulted in the formation of a sloping barrier extending from the upstream toe of zone 5 to RL737 (see Fig. 65).

Fig. 65. Sloping barriers or "skins" developed on zone 4 and zone 5.

Prolonged sluicing was carried out in several areas to increase the permeability through these barriers.

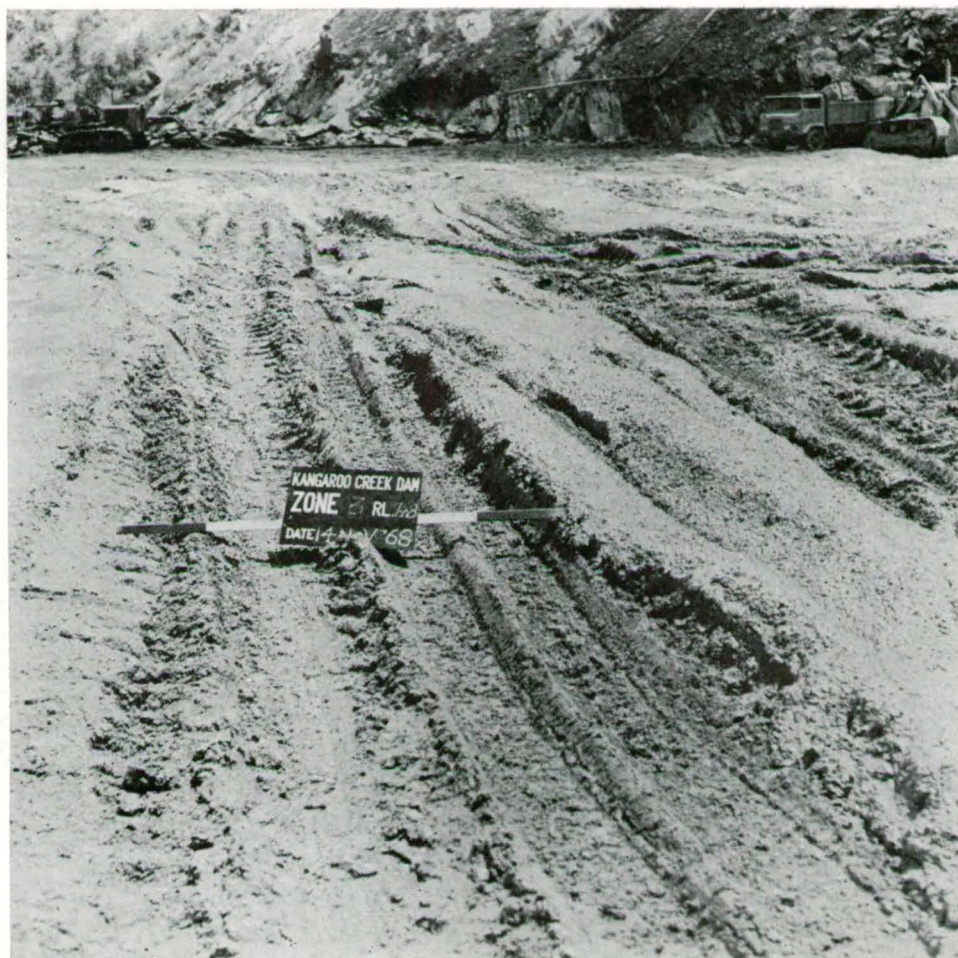
In most of zone 3 above RL770 and in the upper parts of zone 2, spreading and compacting of rockfill material caused considerable crushing of rock, resulting in the formation of bands of silty material in the upper parts of the layers (Figs. 61 and 66). The development of these surface skins is in direct proportion to:—

Skins in the central part of zone 3 were commonly five to 15 centimetres thick and in some places attained a thickness of 50 centimetres. In some layers a continuous skin developed across the zone, but in most cases were interrupted by areas where rock fragments protruded through the skin. Sluicing water tended to form ponds on the surfaces, and most of this water eventually flowed across the surface and down the upstream or downstream face of the embankment.

Fig. 66. Surface of typical zone 3 layer; weak schist has broken down to form cohesive skin.

The skin material consisted of rock fragments separated by a matrix of sandy silt (ML). The grading of the matrix indicates that considerable crushing had occurred of the weathered schist to its constituent minerals—mainly silt-sized mica and quartz. Detailed examination revealed rock to rock contact throughout the skins.

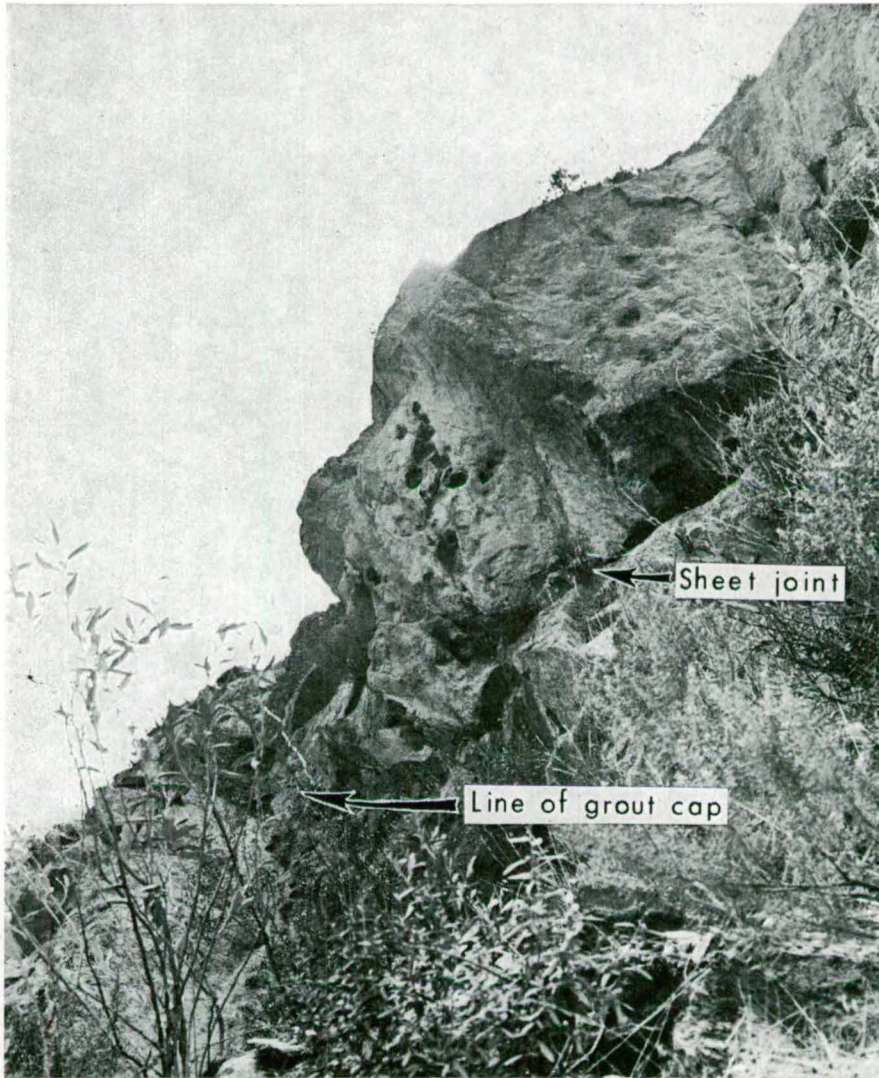
Fig. 67. Steep knob of rock in upper part of right abutment.

This knob was located immediately above the proposed grout cap excavation. Several gaping sheet joints and numerous small cavities occurred in the lower part of the knob (Fig. 67). Water-flows from these joints indicated that they were connected with open joints near the level of the existing access road. It was considered that the knob if allowed to remain, would constitute a major hazard during and after excavation particularly as it would be undercut in part by the grout cap excavation. Approximately 4,300 cubic yards of rock were excavated to a pre-split batter dipping at 50 degrees towards the river. The slope was chosen to remove as much as possible of the mechanically disturbed rock and at the same time preserve a minimum width of 30 feet of access road.

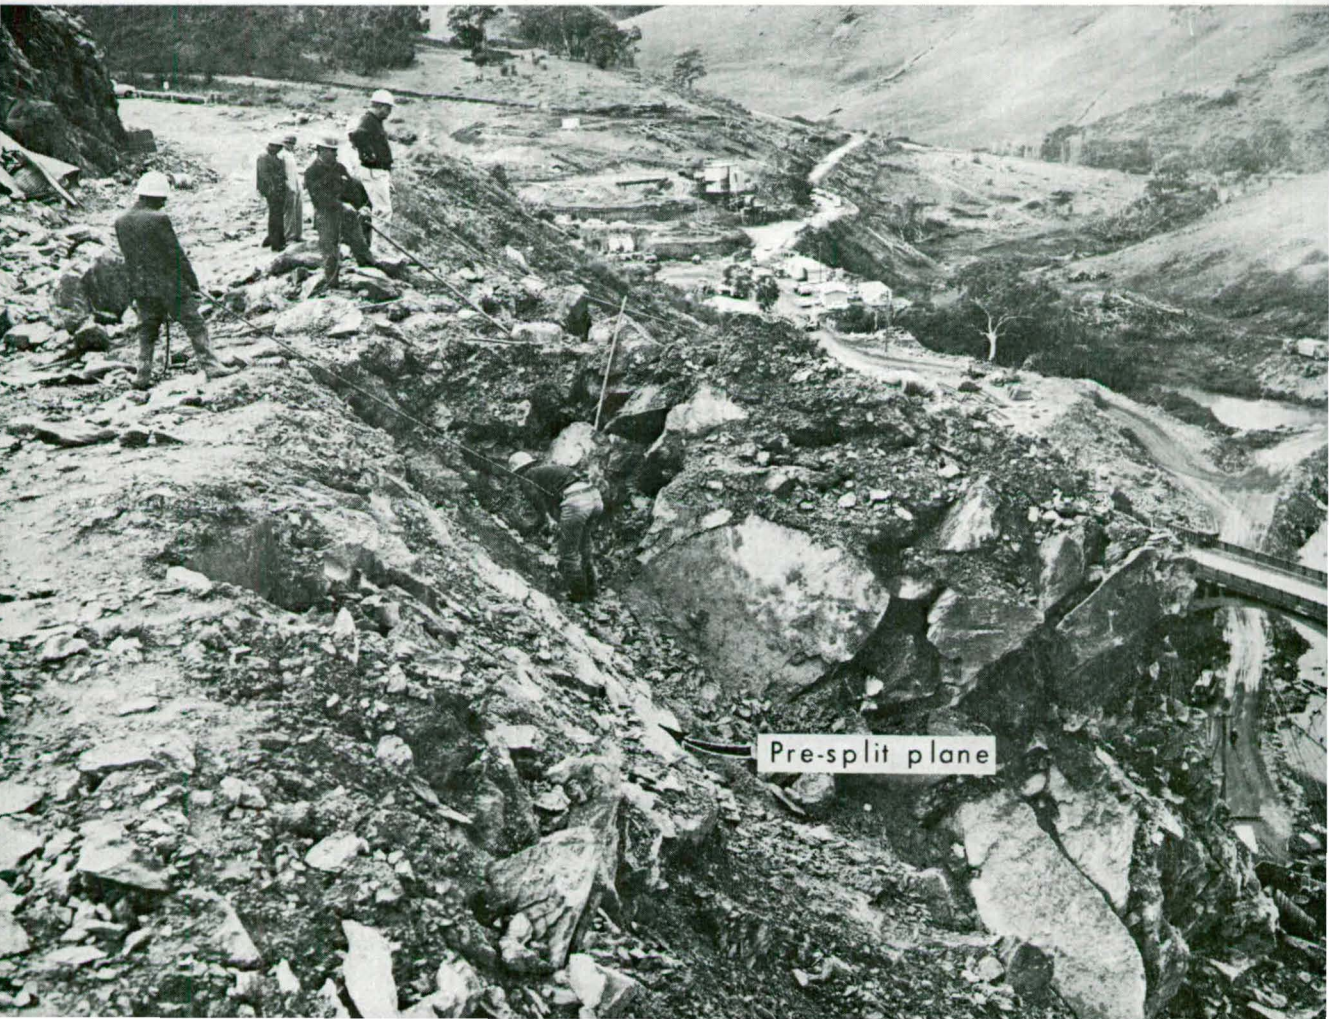
The blast resulted in less than half of the material being removed from the knob. The remainder of the rock, although considerably disturbed by the blast (Fig. 68) proved extremely difficult to remove. When it was eventually removed by a variety of means including jetting, barring and a considerable amount of further blasting it became evident that the failure of the blast was attributable to two main causes.

Fig. 68. Loose rock remaining on pre-split batter after blasting of knob on right abutment.

The excavation for the grout cap exposed several prominent sheet joints underlying and approximately parallel to the knob excavation surface. The rock overlying these sheet joints was stabilized by the installation of grouted rock bolts, some of which were installed in the face of the pre-split batter (Fig. 35).

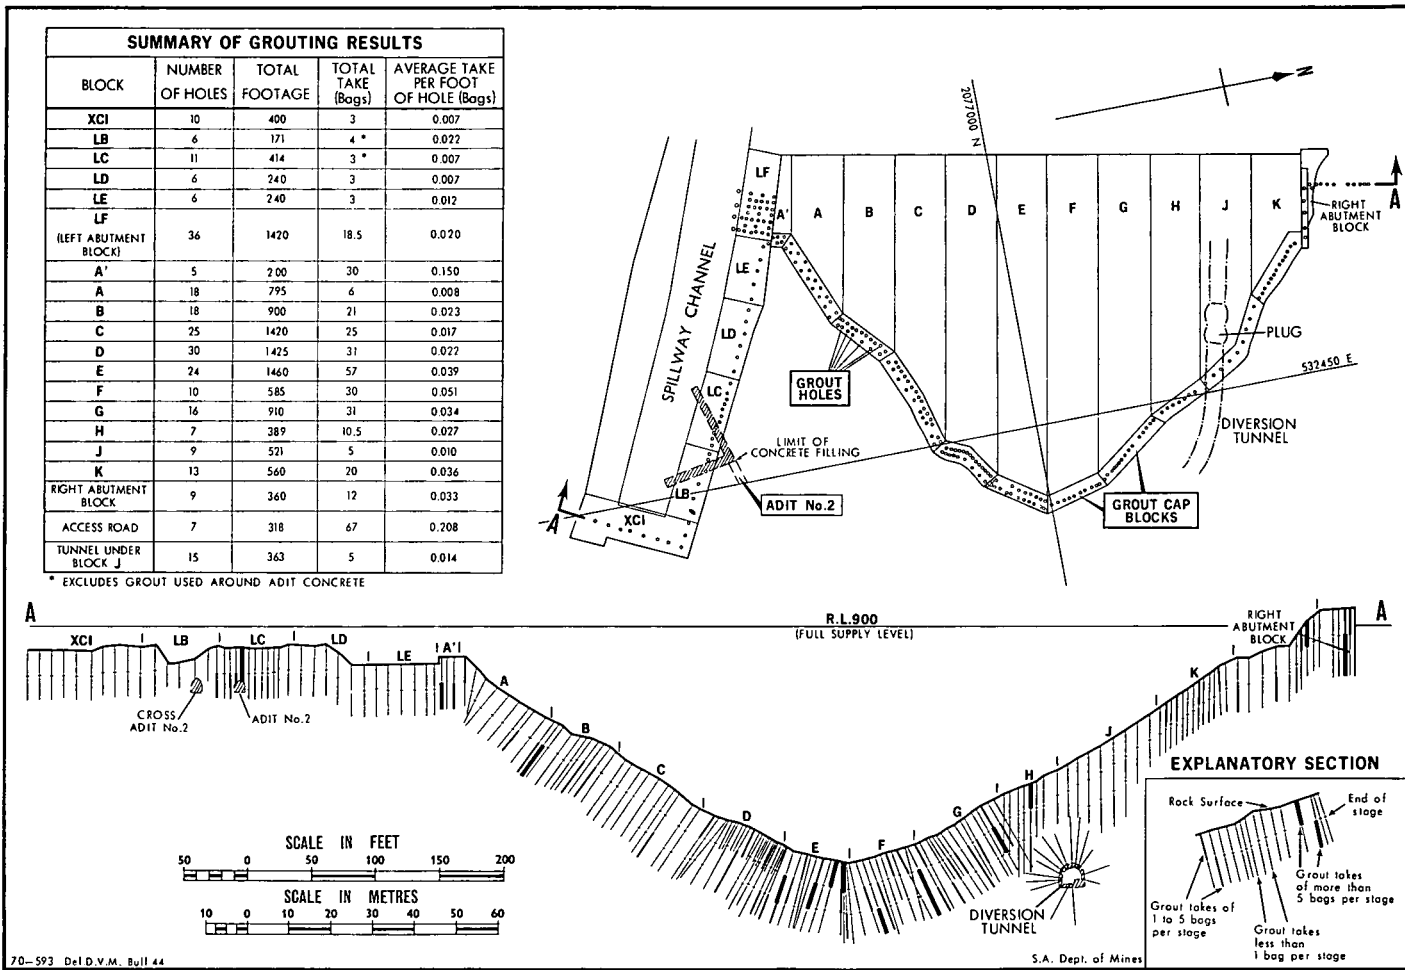
Fig. 71. Distribution of grout holes; plan and section, also summary of grouting results.

The grout "takes" are summarized on Fig. 71 which also gives the average "take" per foot of hole drilled in each area.

Small leakages occurred in several areas, mainly on the left bank. The maximum distance of surface leakage from the point of injection was 30 feet. In the spillway overflow lip area where the grout holes were collared directly into the rock foundations, widespread surface leakages in the vicinity of the grout holes made it difficult to accurately estimate grout takes.

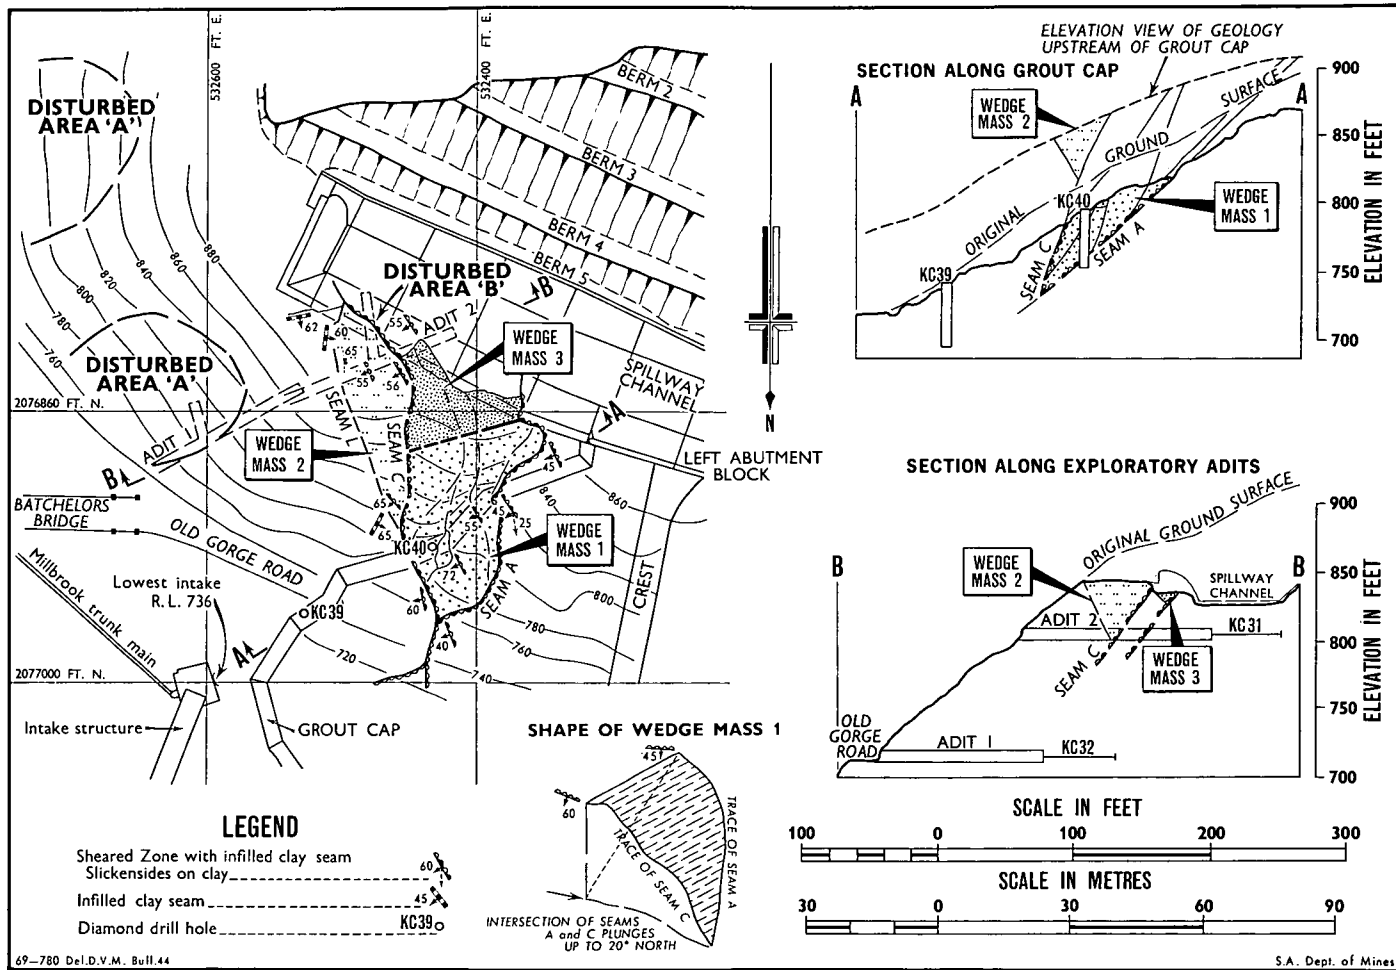
Several slides in this area were delineated during exploration for a concrete arch, and two are outlined on Fig. 72. They are best explained by postulating that movement has occurred along flat-lying seams near river level. Some evidence for the presence of such seams was obtained from the core of exploratory diamond drill holes (Stapledon, 1965).

Fig. 72. Disturbed areas upstream of embankment; plan and sections.

Originally it was considered that the rock mass in this area had been disturbed by sliding movements along one or more flat-lying seams situated near the floor of the valley. However, exploratory drilling of holes KC39 and KC40 (Fig. 72) and detailed mapping of grout cap and embankment foundations, failed to reveal any such weakness. Slickensides on infilled seams (see Fig. 72) suggested that the movements had been towards the north, *i.e.* in a direction partly downslope and partly downstream. This consideration led to an understanding of the disturbances as movements of wedge-shaped masses in a downstream direction. The boundaries of the main disturbed area have been delineated by detailed mapping of exposures in the grout cap and spillway excavations, and are shown in Fig. 72.

Disturbed area B has been divided into three wedge masses (Figs. 72, 74 and 75).

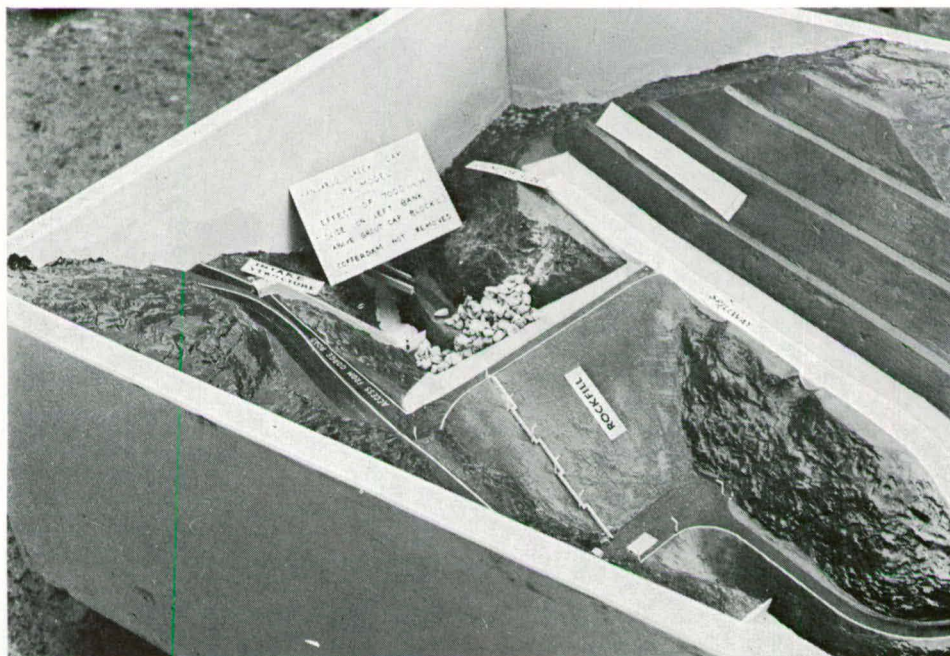
Wedge mass 2 is apparently free to slide onto the embankment, and calculations made by the Engineering and Water Supply Department Design Branch suggest that failure is likely to occur under operating conditions. It

was considered that failure of this wedge would cause damage to the concrete upstream face and grout cap and that the resulting debris could possibly damage the intake structure and block the lowermost intake portal. Studies of simulated slides were carried out using a plaster model of the site, and the results (see Fig. 78) indicated that the slide debris was unlikely to reach the intake structure.

Fig. 78. Plaster model of project, with aggregate simulating a slide of 7,000 cubic yards of material from wedge mass No. 2.

A programme of stressed cables or bolts was considered to stabilize wedge mass 2. However, such a programme would have proved extremely inconvenient and expensive. It was considered that damage to the upstream face and grout cap concrete would be avoided if the impact could be “cushioned” by a protective layer of loose material. A layer of three-quarter inch aggregate, three feet thick, was placed on the upstream face below wedge mass 2 (Fig. 79).

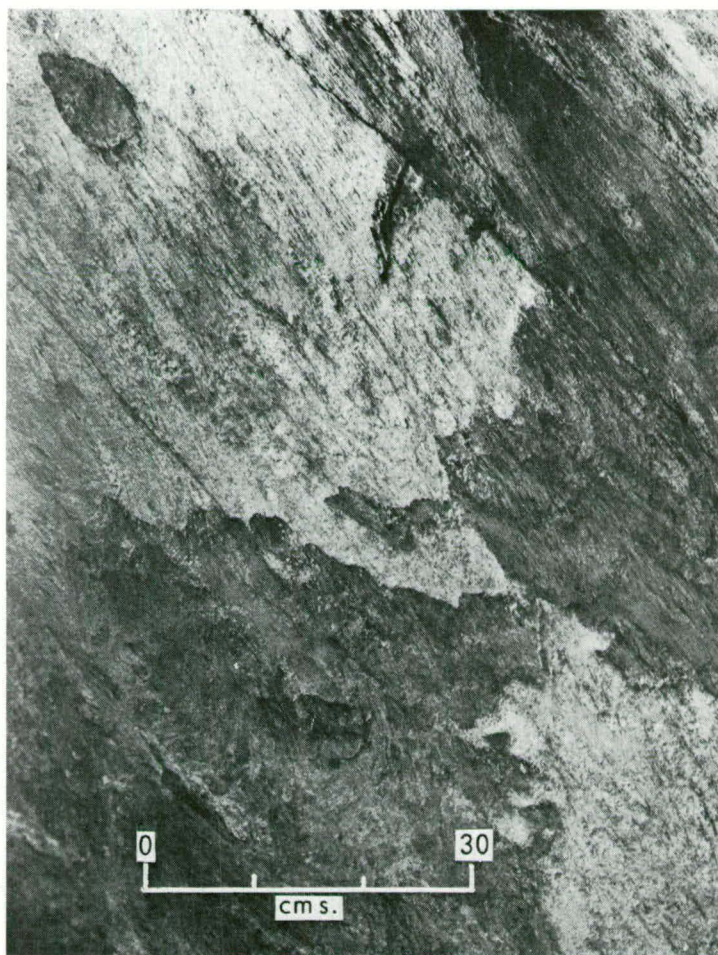
(1) *Surface fretting.* This type of deterioration occurs in the exploratory adits, in several surface caves (Figs. 80 and 81) and in a few protected parts of road cuttings (Fig. 82). It consists of the progressive flaking

Thin section examination of surface rock (sample 12, Appendix 2) shows that the fretted flakes are no more chemically weathered than the intact material. Limonite-filled microfractures which occur in the intact material appear to be related to the weathering of sulphides.

Fig. 81. Close-up view of inner surface of cave shown in Fig. 80. Lighter areas are actively fretting. Dark areas are case-hardened and show no signs of fretting.

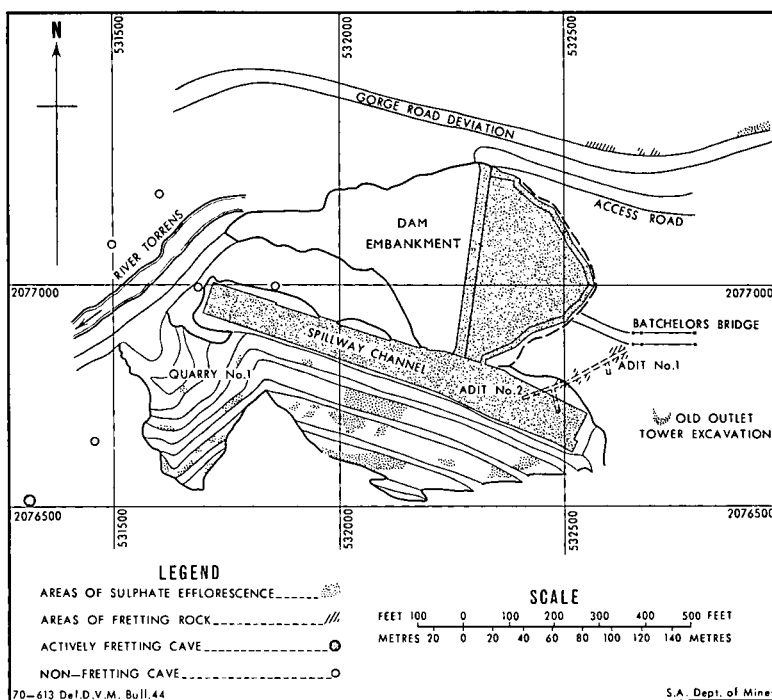
Fig. 82. Rapid deterioration of rock surface; plan showing affected areas.

(2) *White encrustations.* This type of deterioration occurs in parts of road excavations and spillway and quarry open cuts (Figs. 82, 83 and 84). It consists of white crystalline salts filling microfractures in the rock (Fig. 84) and encrusting parts of the exposed surface. Schist and gneiss rock substances ranging from almost fresh to slightly weathered, have been affected in this way. These substances are considerably weaker than similar unaffected rock substances. A typical sample of this material was treated with distilled water and the resulting solute evaporated. The salts obtained by this evaporation were bianchite and halite which together comprised 6 per cent by weight of the sample.

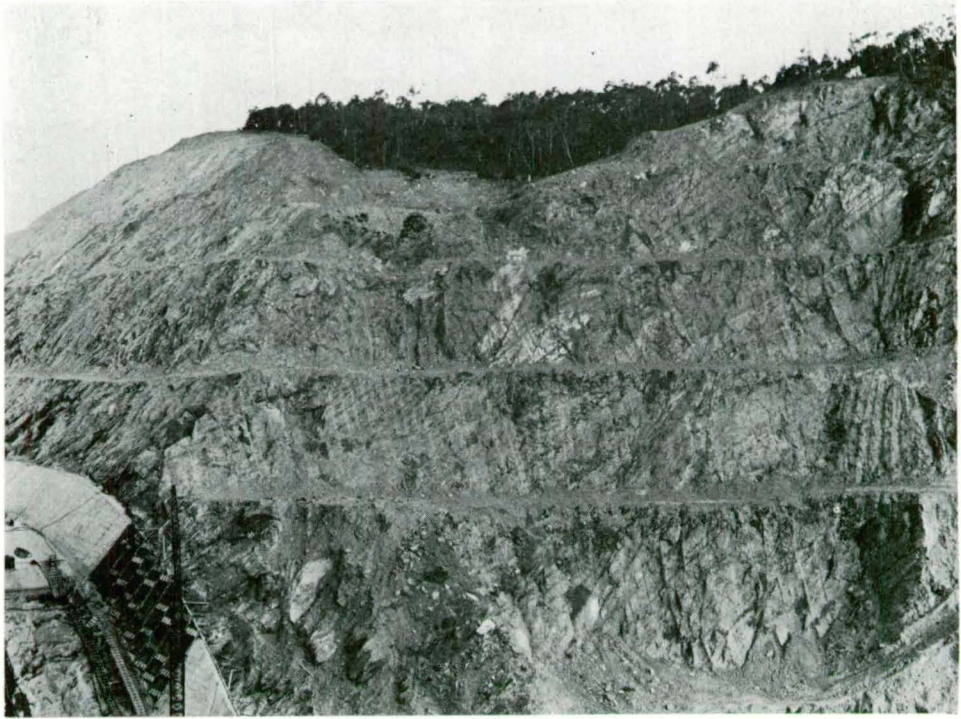
The areas of most pronounced encrustation are associated with relatively high amounts of sulphides in the rock, up to 5 per cent pyrite and chalcopyrite in some localized bands. Thin section examination of affected rock substances (sample 13, Appendix 2) indicates that the sulphides are partly weathered to limonite and that the weathering is associated with microfracturing of the rock. In spite of the fact that no water was used in the preparation of thin sections, no sulphates were identified.

Fig. 83. White patches of efflorescent sulphate salts encrusting surface of weathered schist, upper part of quarry No. 1.

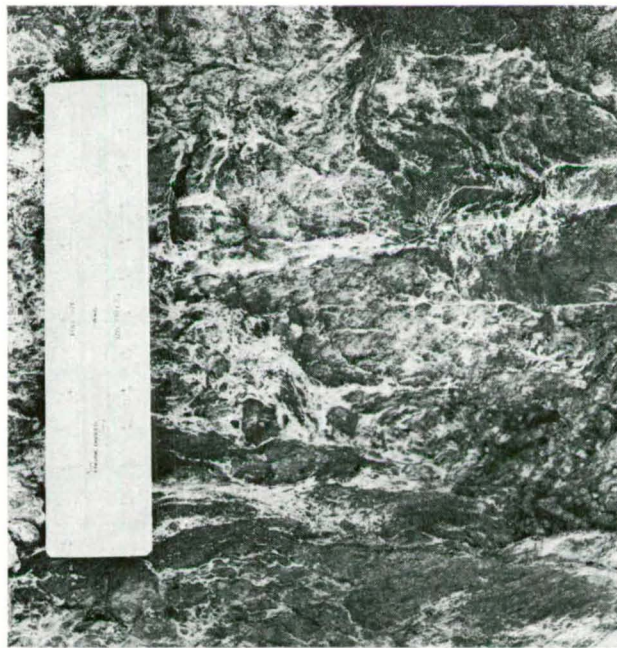
Fig. 84. Efflorescent sulphate salts concentrated in microfractures at the surface of weathered gneissic schist; Gorge Road deviation.

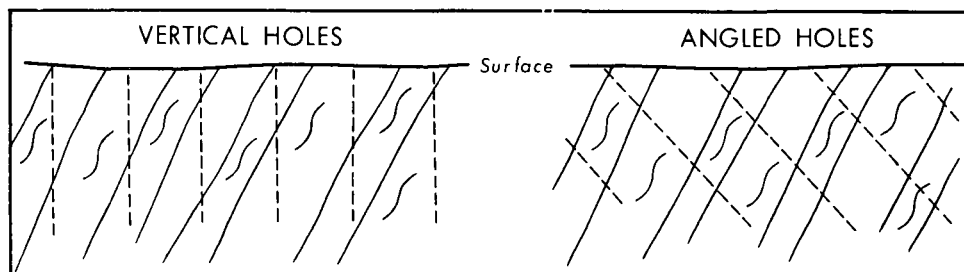
The highly flaky shape of the rock fragments produced by blasting of weak schist materials, caused considerable concern due to the tendency of this material to break down during handling and placing. Fig. 54 shows this flaky material and Fig. 55 shows the more bulky fragments typical of the excavation of gneissic rock. It is considered that the shape of the fragments could have been improved with consequent decrease in fines content, if blast holes had been drilled near-normal to the foliation direction as shown in Fig. 85.

Fig. 85. Blast hole directions, showing how fragmentation of gneissic rock could have been improved.

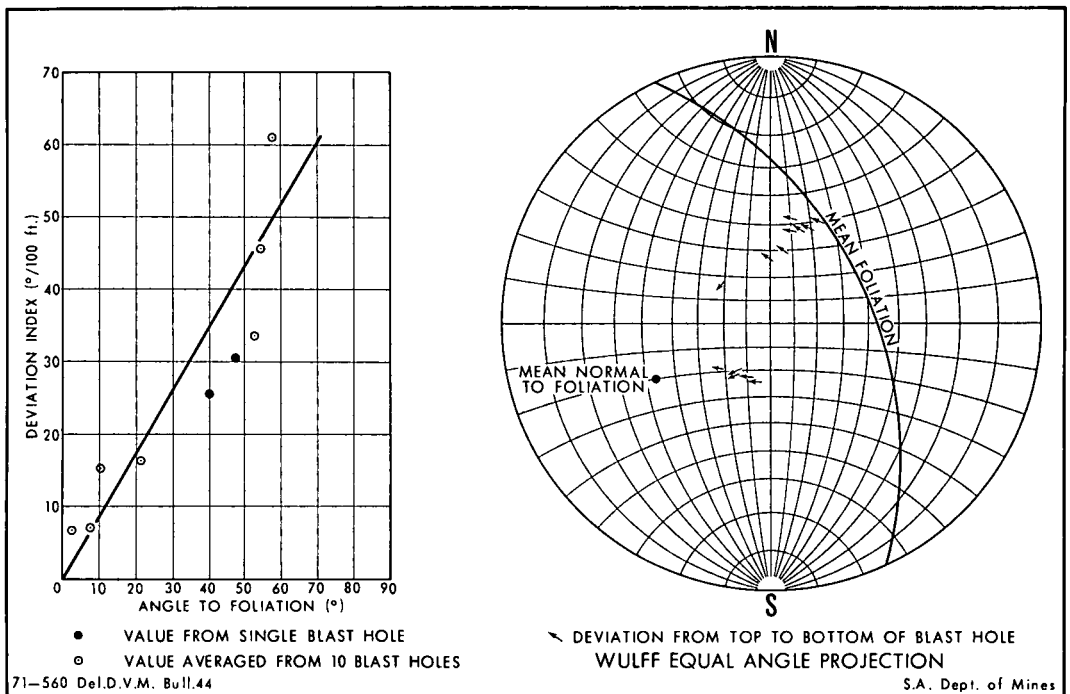
Much of the inaccuracy of pre-split planes is attributable to the deviation or "wandering" of drill holes. This phenomenon occurs to some extent in all holes drilled with rotary/percussion drills such as the Air-trac machines used at Kangaroo Creek. The deviations resulted in substantial overbreak and underbreak in many of the batters at Kangaroo Creek Dam, necessitating in some cases the use of extra concrete and in others, extra excavation at the toes of the batters. In the lower benches of the spillway, the holes were steepened in the belief that they would flatten out, however they tended to steepen, resulting in a substantial volume of extra concrete in the spillway channel wall.

Fig. 88. Deviation of blast holes; stereographic projection. Graph showing relation between foliation and deviation of blast holes.

It is shown on Fig. 88 that the deviation tends towards the pole of the foliation or foliation normal and that the curvature as given by the deviation index is proportional to the angle between the drill hole and the foliation. Although the broad trends are evident from this work, a considerable amount of further work of this type is necessary to establish definite relationships and to determine the characteristics of blast hole deviations in other rock types. Such work would provide a basis for the accurate prediction of the deviation to be expected for any particular hole direction at any site. Research is also necessary into the effects of various drilling factors such as pressure, bit sharpness, rate of penetration, *etc.* The results to date suggest that these factors are not of prime importance, however they may explain the wide scatter of results.
