REPORT ON SITE INVESTIGATION
DAMAGED E.T.S.A. SUB-STATION BUILDING
BERRI
HD. LOVEDAY

28th April, 1960

PLAN SHOWING WALL DAMAGE
E.T.S.A. SUB-STATION, BERRI
HP LOVEDAY

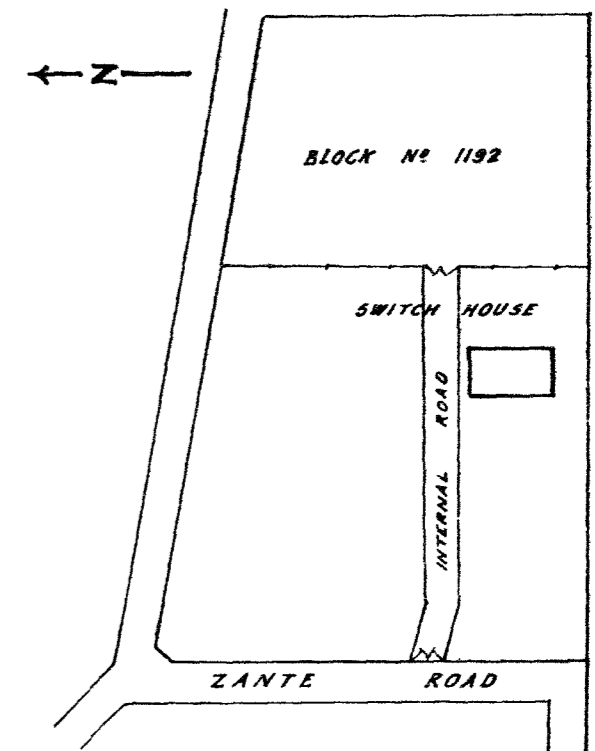
The extensive cracking present in the walls of the switch-house is attributed mainly to settlement of the north-west and south-west corners of the building. Remedial action is obviously necessary to prevent a worsening of the present structural damage, and further settlement must be prevented before the wall damage is repaired. To prevent further settlement corrective measures must be adopted, and the method to be used will depend upon the following factors.

From the soil profile it is considered that the major cause of the settlement has been the failure to provide adequate drainage for the disposal of surplus water. However the loadings on the soil are near the maximum estimated for such a soil, and possibly some settlement due to shear failure has occurred. The soil beneath the foundations has probably reached a state of equilibrium due to compaction because of the settlement, and further settlement is unlikely provided constant moisture conditions are maintained in the foundation area by the adoption of special drainage precautions.

The first is to assume that further settlement will not occur, provided drainage precautions are observed. The drainage precautions should consist of ensuring that constant moisture conditions are maintained in the foundation area. All roof water should be carried well away from the foundations in properly constructed drains of adequate capacity. Surface drainage, particularly from the walls of the excavation should be diverted away from the building. A concrete or some other impervious pavement surrounding the building would assist in this respect, and is virtually essential on this type of soil. The pavement should be at least 6 feet wide, preferably wider, and if concrete is to be used the pavement should be bonded to the foundation with a bitumastic compound to permit some differential movement and still maintain a waterproof seal.

The second approach would be to under pin the north-west and south-west corners with a reinforced concrete pad. No strong horizon, suitable for underpinning is present down to a depth of at least 12 feet, so that underpinning will be confined to reducing the load on the soil beneath the existing foundations. The pad would be easily placed into position in the south-west corner, and in this corner the foundation could be jacked up to reduce the foundation drop which has occurred. However the north-west corner of the building apparently presents some construction difficulties in this respect, particularly as the settlement is not confined solely to the corner. Consequently it may not be possible to jack up this corner, and underpinning would be confined to the placing of a concrete slab beneath the existing foundations. Following the underpinning drainage precautions as previously stated should be adopted.

The low margin of safety for the existing foundation due to the loading being the maximum permissible, suggests that it would be advisable to place additional pads at the north-west and south-west corners to decrease the loading at these points.

Repairs to the walls should not be carried out until at least three months after the underpinning and drainage precautions have been completed. This is to enable the soil beneath the foundations to reach a state of moisture equilibrium, and any settlement that may accompany the change in moisture content to occur. If the cracks are repaired before the equilibrium is reached the slight settlement may cause them to reopen.
