MIDDLE RIVER DAM - KANGAROO ISLAND
FEASIBILITY STAGE GEOLOGICAL INVESTIGATIONS
PRELIMINARY REPORT - SUMMARY OF RESULTS
~~DECEMBER~~ 1964

by
D. H. Stapledon
Senior Geologist

and
S. Robson
Geologist

8th December, 1964.

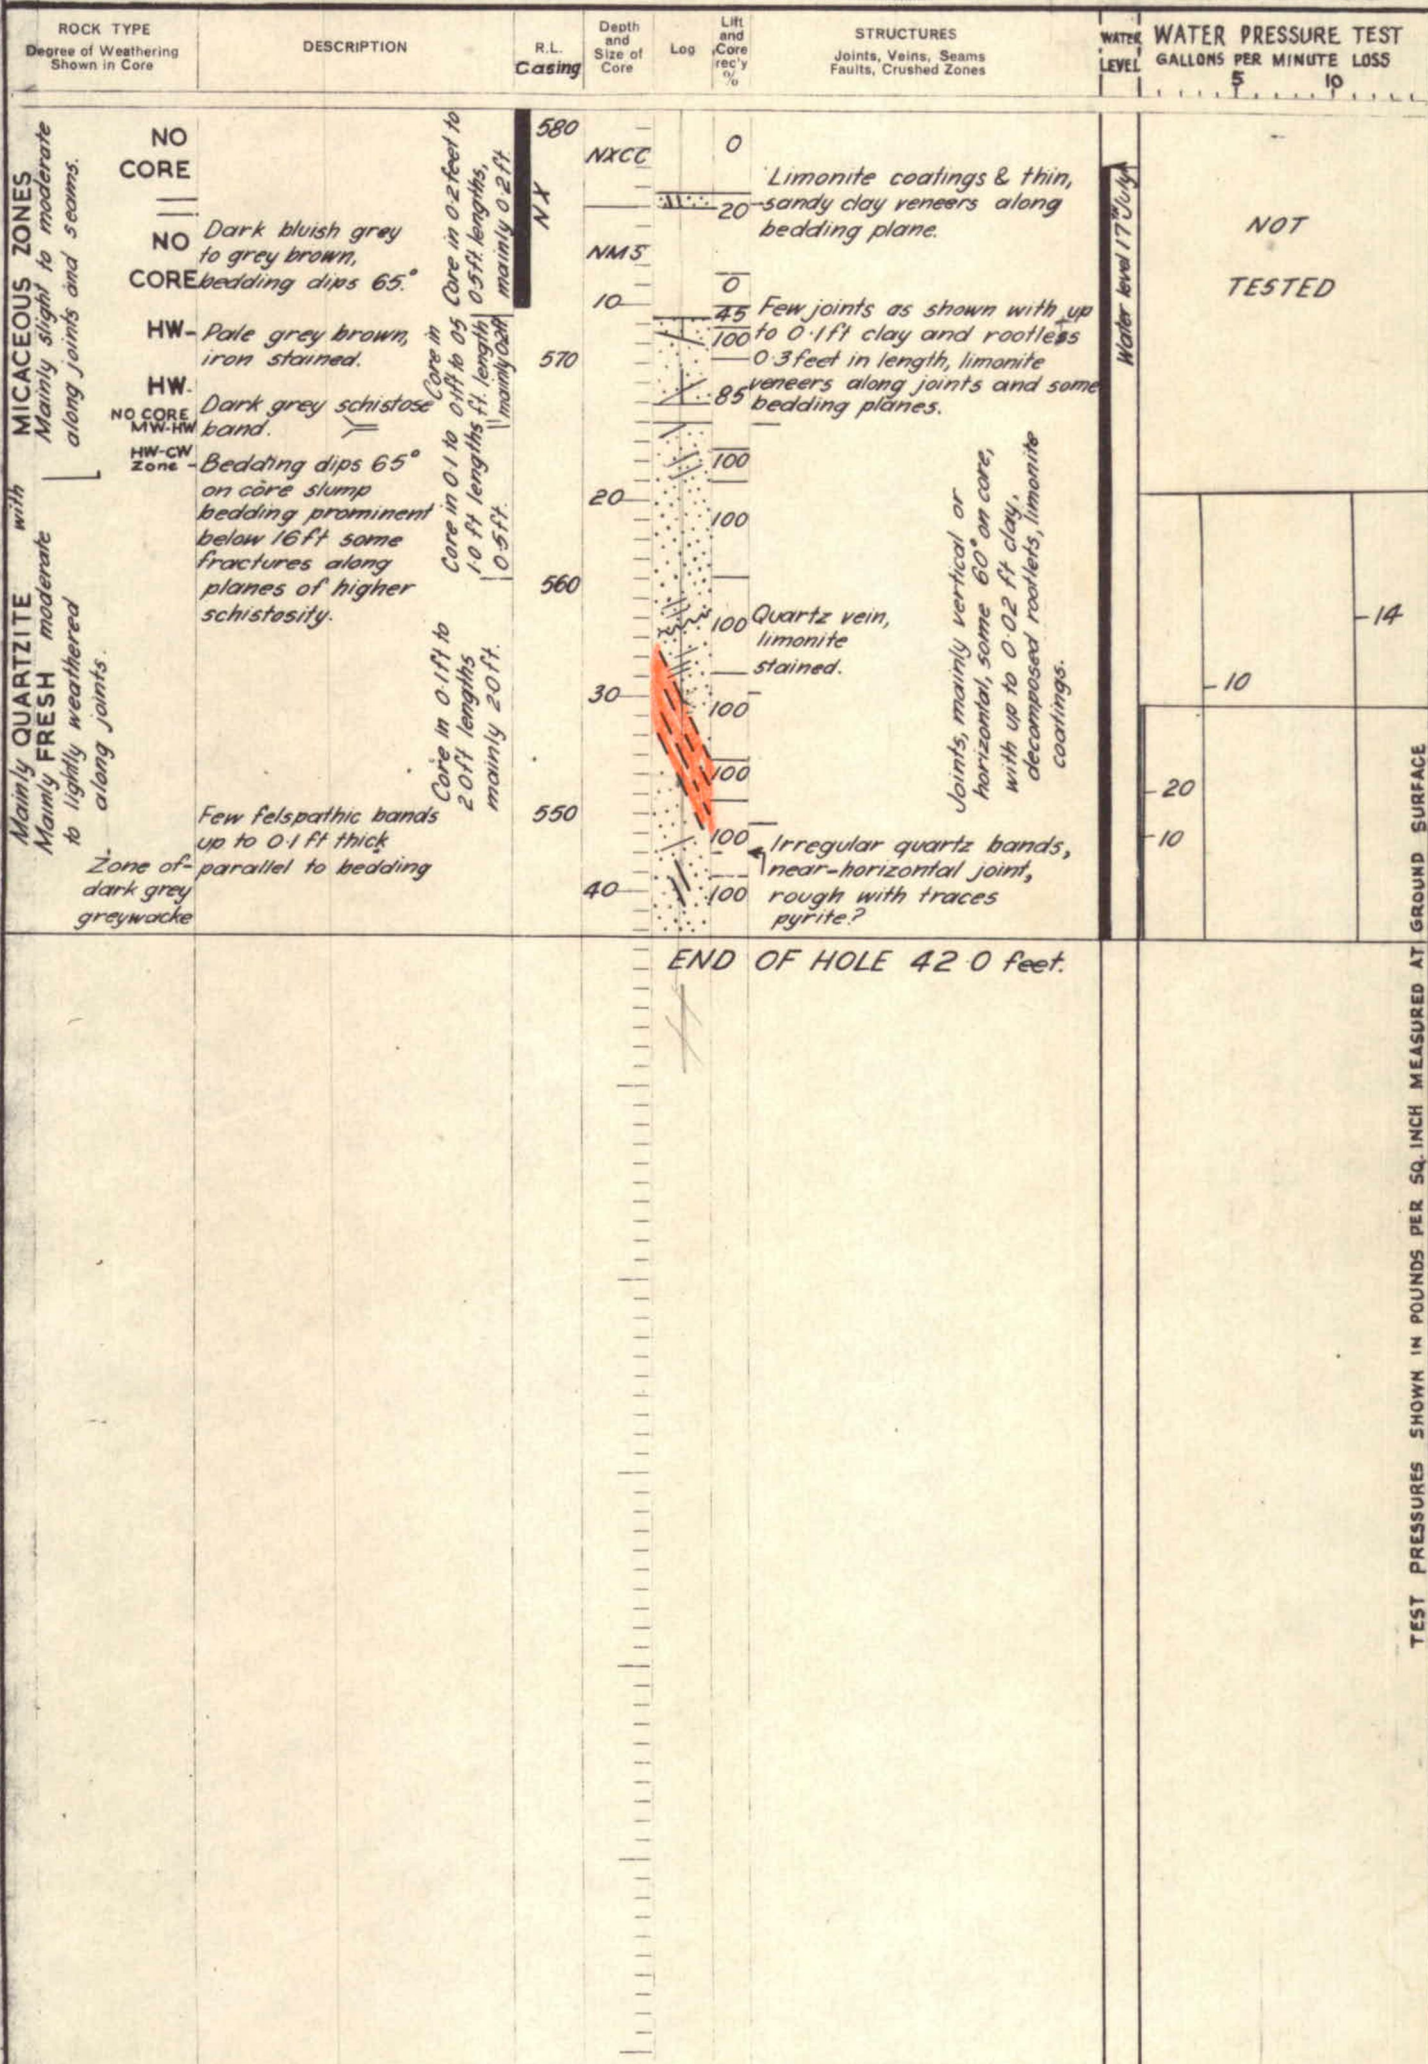
Hole No. 2

PROJECT MIDDLE RIVER DAM CO-ORDINATES R.L. 581 FT
FEATURE FOUNDATION HUNDRED DUNCAN DIRECTION 215M °
LOCATION RIGHT ABUTMENT SECTION 179 ANGLE FROM HORIZONTAL 60 °

Drill No. 7
Type F100
Driller T. BRIGGS
Commenced 14 July '64
Completed 17 July '64
