BLACKWOOD RAILWAY CUTTING

GEOLOGICAL INVESTIGATIONS, PROGRESS REPORT NO. 1

Client: South Australian Railways

12th August, 1966.

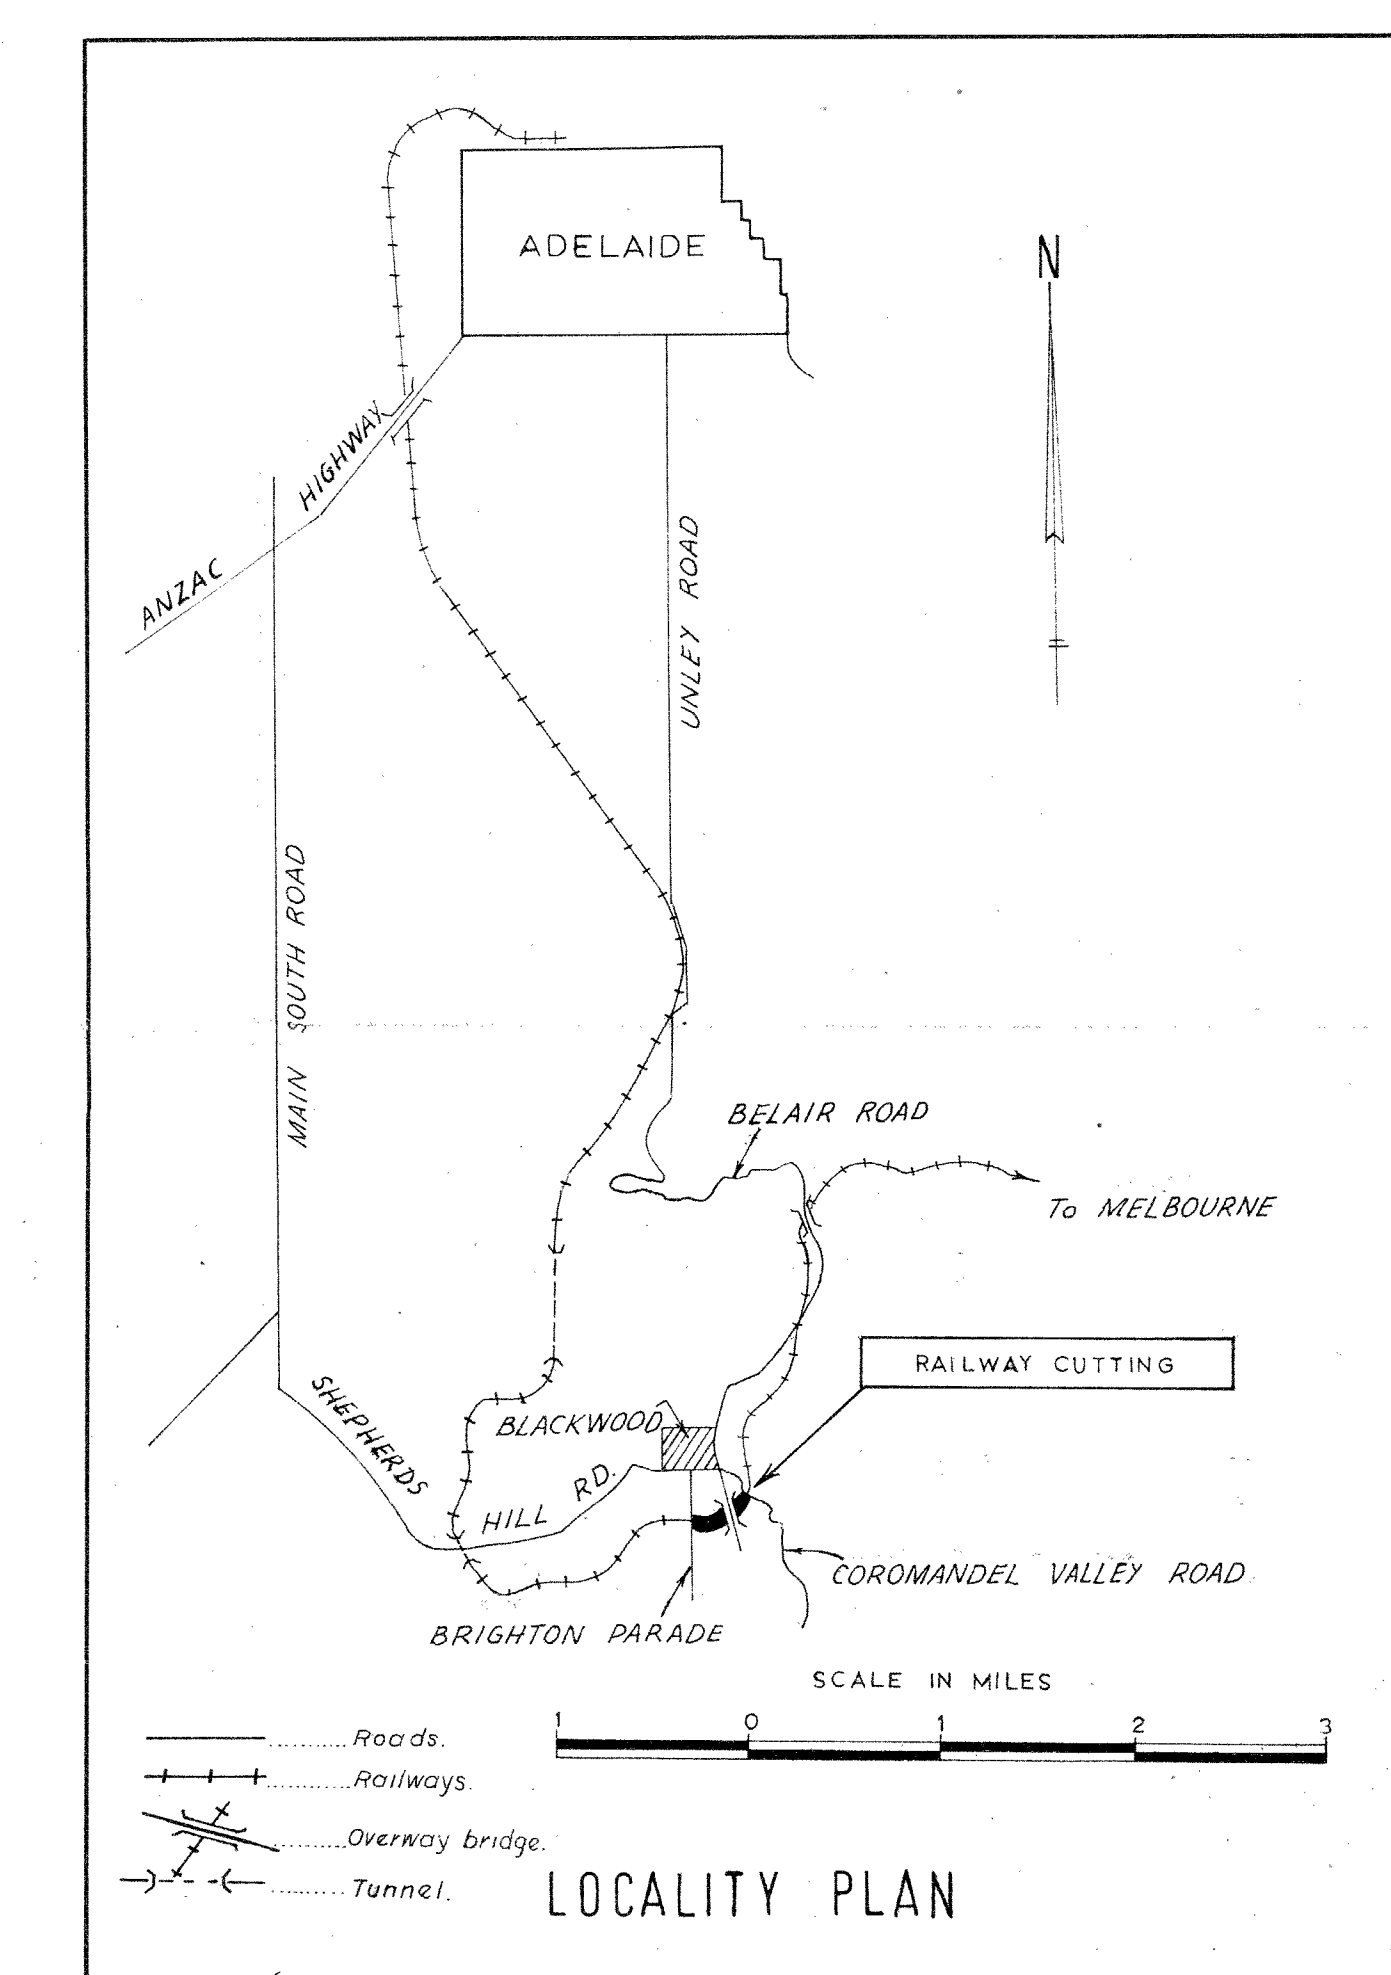
CROSS SECTIONS
LOOKING UP LINE
SCALE
10 0 10 20 30
FEET

The bedrock is stable, and the topsoil is of no consequence in the stability problem. It is evident that initially failure has occurred in the sand and clay horizons, resulting in eventual failure of the overlying laterite.

It is considered that failure of the cutting will continue slowly until stable slope angles (probably 35° to 40°) are attained, unless some form of remedial action is taken. During discussions at the site with Mr. Reed, several possible methods of treatment were considered and are summarised on Fig. 1. A summary of geological conditions in the cutting showing the sections which require treatment is given on Fig. 2.

(1)			NOTES ON GEOLOGY	(2)	(3)
CHAINAGE (Ft.) From. To.		DISTANCE Ft.		SUGGESTED TREATMENTS	PRIORITY
NORTH SIDE					
0	200	200	Low cutting height, entirely in clay or topsoil. No signs of slope movement – apparently stable angles.	None (5)	C
200	350	150	Cutting mainly in clay; bedrock exposed at base in parts. Several small landslide scars.	4, 5	A
350	725	375	Clay and sand horizons relatively thick, both showing signs of recent failure. Laterite undercut, with stress-relief joints.	1, 2, 3.	A
725	800	75	BRIDGE	None	—
800	875	75	As for Chainage 350 to 725	1, 2, 3	A
875	925	50	Bedrock high above base of cutting. Clay and sand horizons well cemented.	1, 2, 3.	B
925	985	60	Clay and sand horizons relatively thick, both showing signs of recent failure. Laterite undercut, with stress-relief joints.	1, 2, 3.	A
985	1030	45	Bedrock high above base of cutting, sand and clay horizons relatively thin. Few signs of recent failure in sands.	4, 5	B

1030	1260	230	Bedrock high above base of cutting. Sand, clay and laterite wedging out. No signs of slope instability.	None (5)	C
SOUTH SIDE					
0	300	300	Low cutting height, mainly in clay or topsoil. Several erosion gullies. No sign of slope instability.	None (5)	C
300	355	55	Full height of cutting in partly cemented clay. Several erosion gullies.	4, 5	B
355	730	375	Clay and sand horizons relatively thick, both showing signs of recent failure. Laterite undercut, with stress-relief joints.	1, 2, 3.	A
730	780	50	BRIDGE	None	—
780	830	50	Clay and sand horizons relatively thick, but generally well cemented.	1, 2, 3.	B
830	965	135	As for Chainage 355 to 730	1, 2, 3.	A
965	1260	295	Bedrock high above base of cutting. Sand, clay and laterite wedging out. No signs of slope instability.	None (5)	C

Failure of the Blackweed cutting has occurred mostly during winter, and it seems certain that the seasonal increase in moisture content in the materials is an important contributing factor. For long term stability, the provision of adequate drainage is considered necessary. Subsurface drainage of the geological materials, and of any backfill material used, may be determined by the form of treatment. However, improvement of the existing surface drainage, by interception and diversion of surface run-off in lined catch drains, should be carried out as part of any type of treatment decided upon.

- Flatten slopes of cutting to stable angle (1 1/2:1)
- Protect faces by grassing or other means
- Drainage
- Remove loose materials, boulders, etc.
- Protect faces by grassing, etc.
- Drainage
