DEPARTMENT OF MINES
SOUTH AUSTRALIA

LITTLE PARA DAM
GEOLOGICAL ASSESSMENT OF THE
QUARRY AND WATER TREATMENT WORKS

J.C. BEAL
ENGINEERING GEOLOGY SECTION

Rept.Bk.No. 77/93
G.S. No. 5915
Eng.Geol.No. 77/65
D.M. No. 428/77

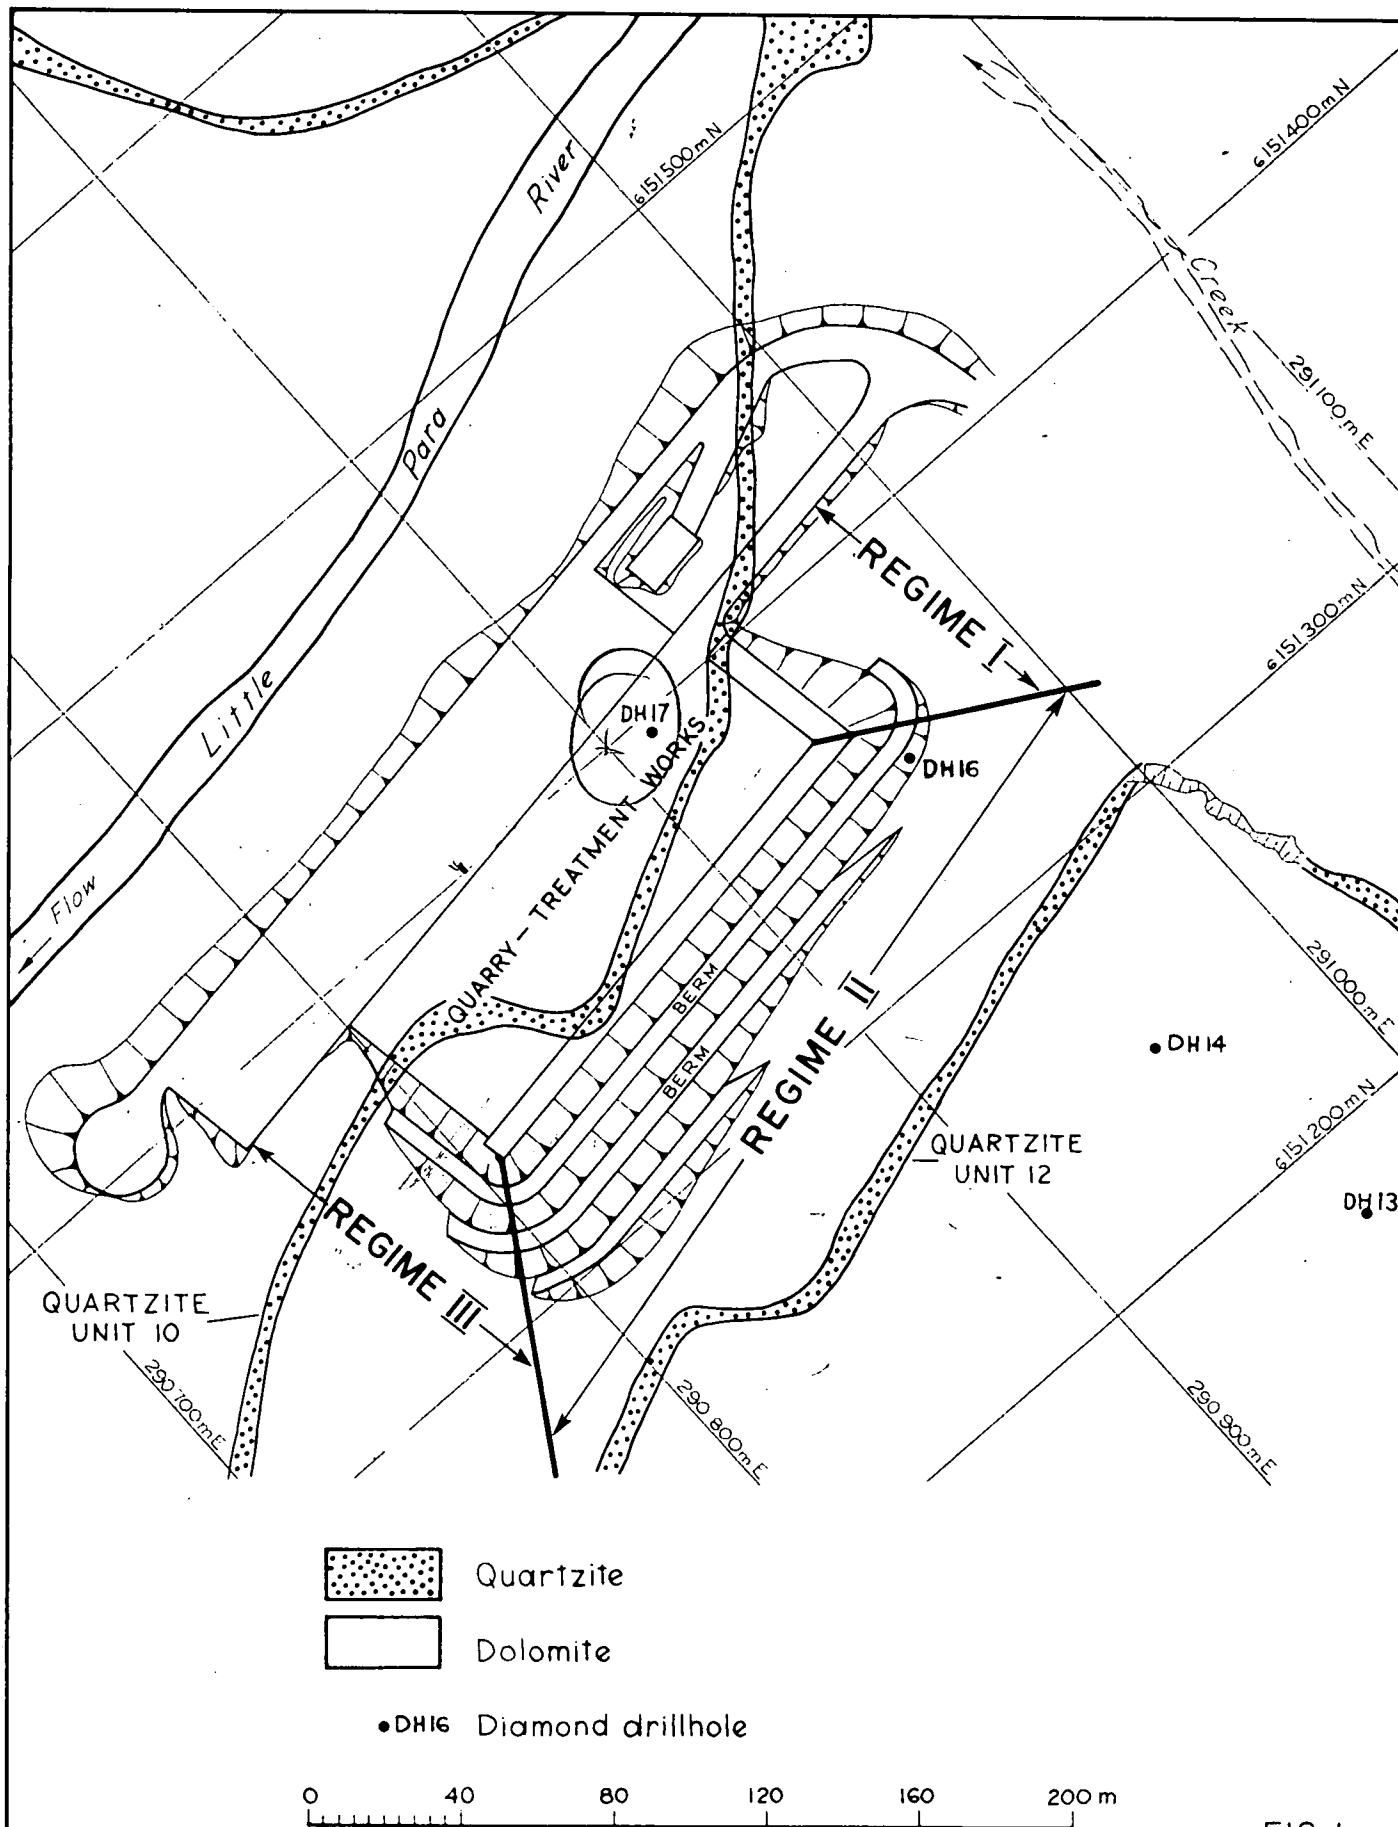
FIG. 1

The western batter (See Regime III Fig. 1) excavated at 40° will also suffer falls of small blocks and a low safety barrier should be placed at the foot of the batter. Because bedding plane angle of friction is greater than bedding plane dip a planar failure of the batter into the excavation, although geometrically possible, is highly unlikely.

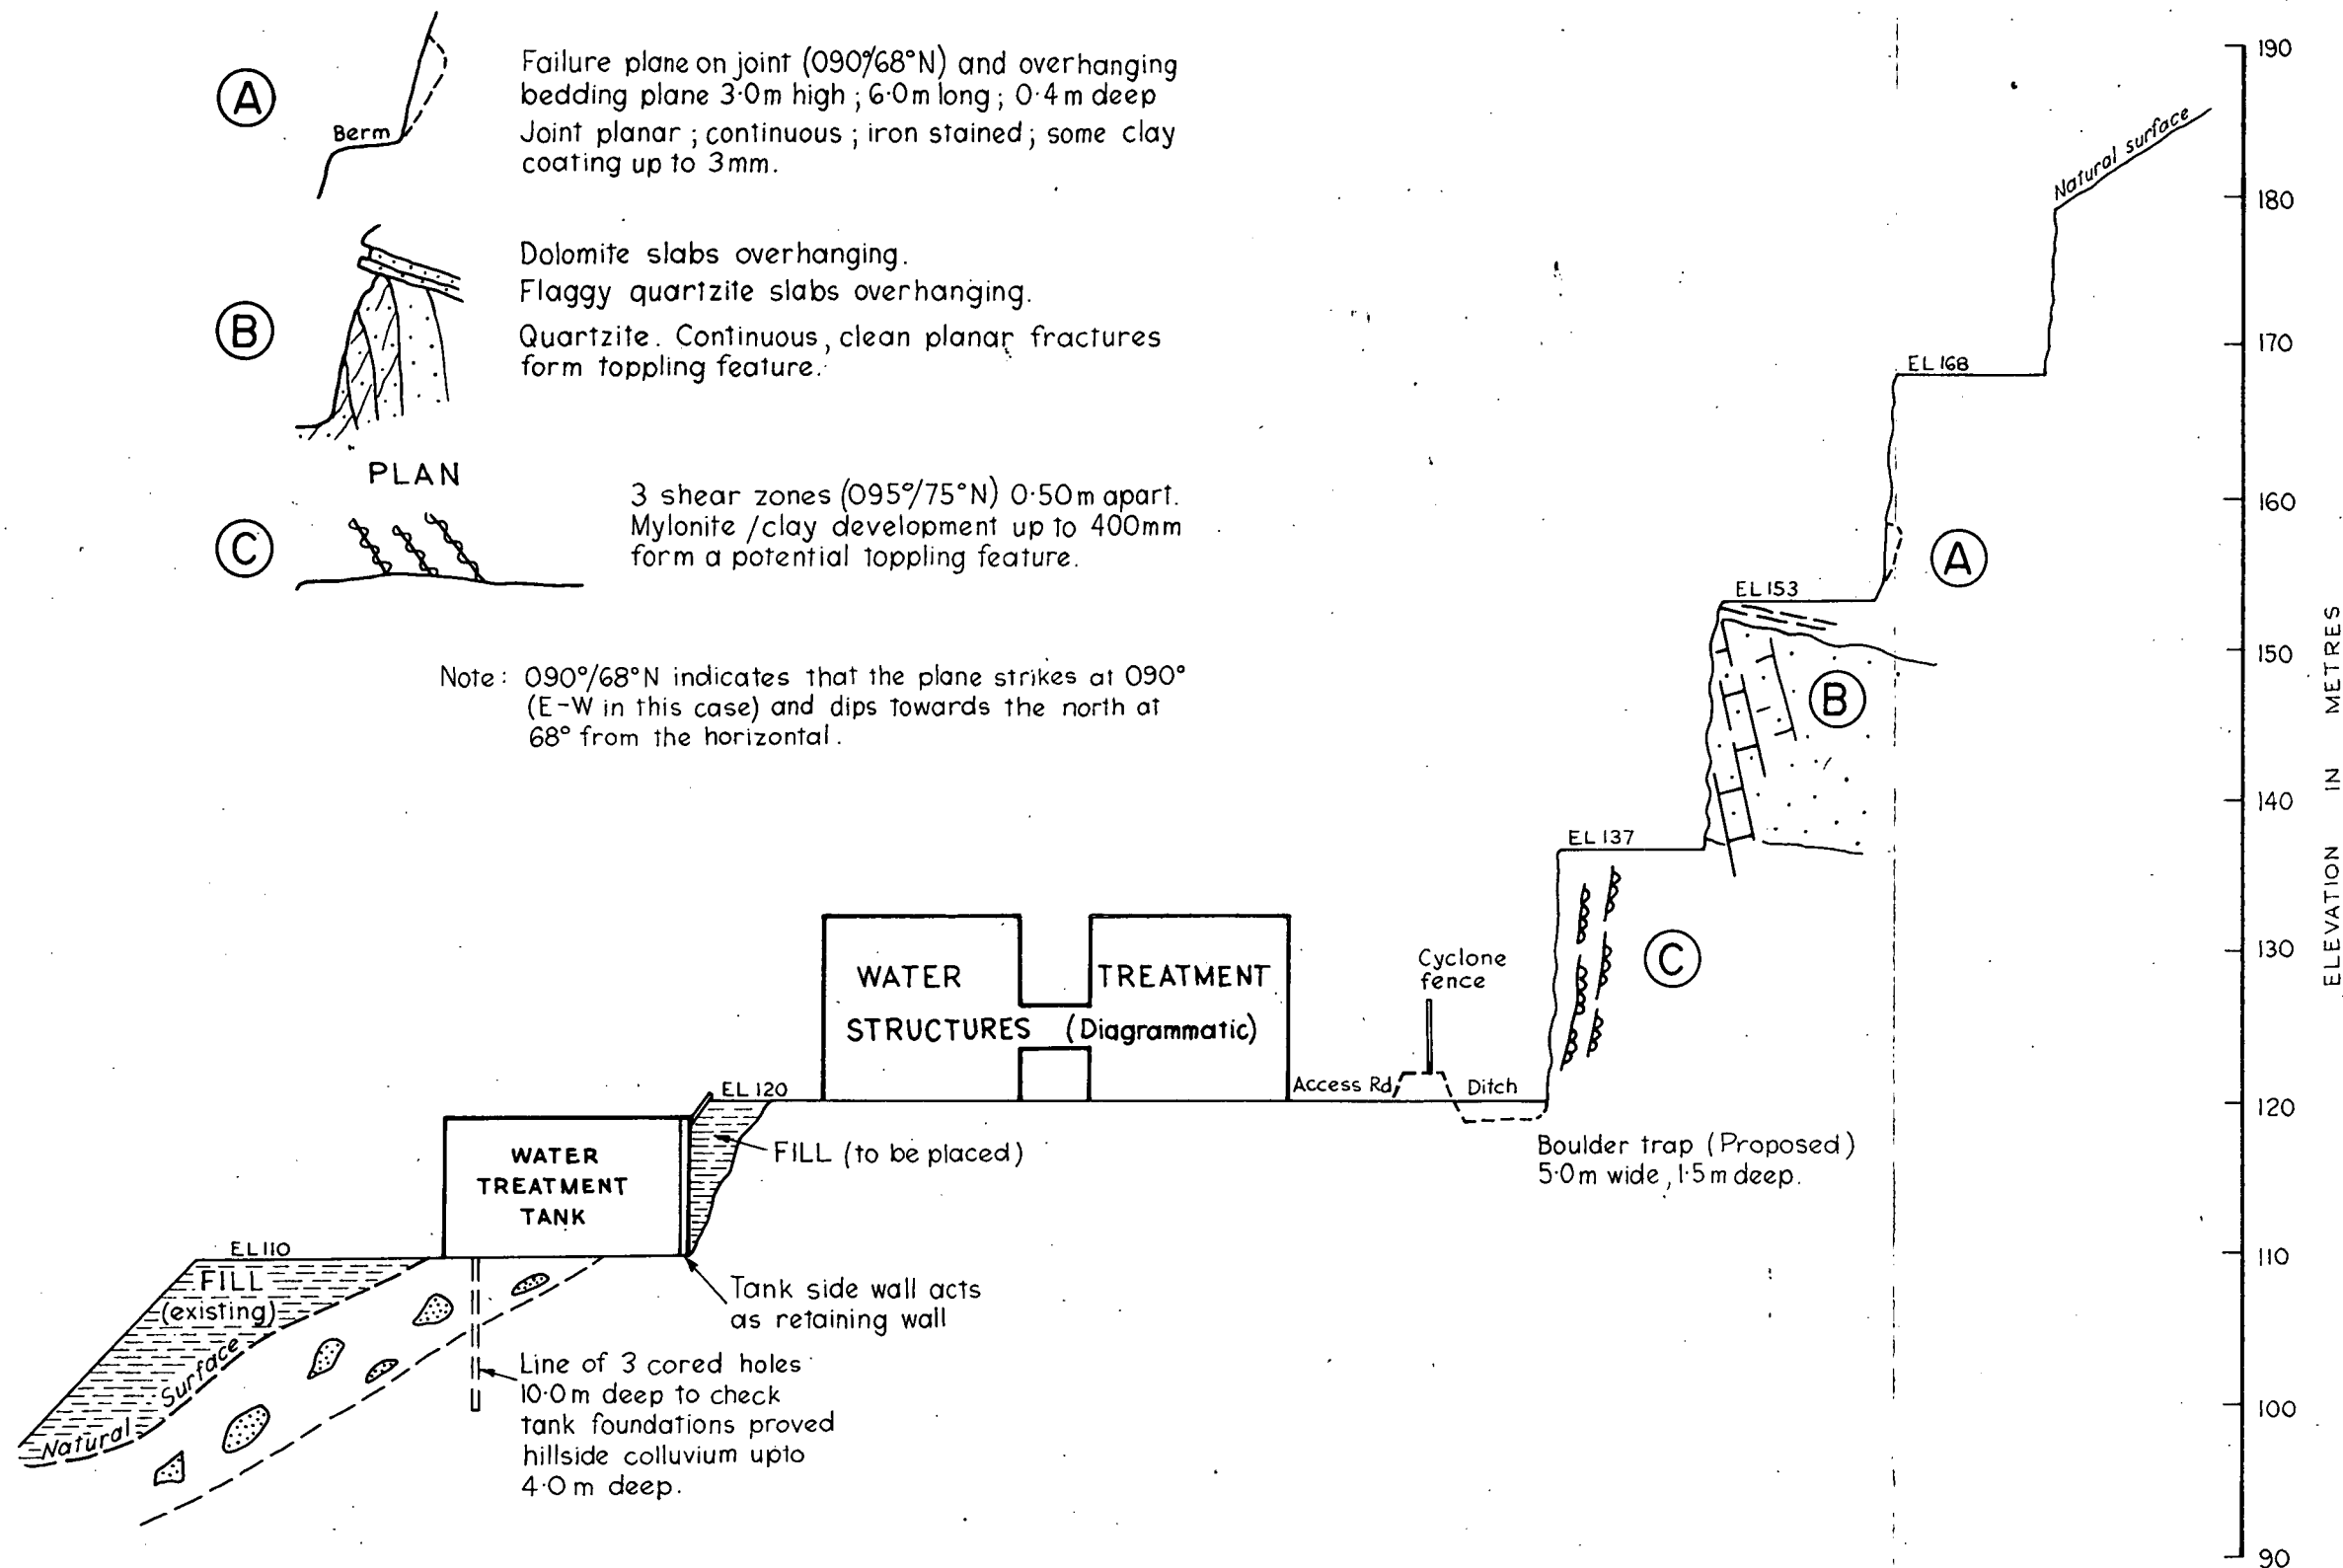
FIG. 2

Figures 2 to 8 and Table I summarise the results of the stability and analyses and calculation of Factors of Safety. Table II is a summary of fractures and their description.

LOCATION	TYPICAL MEASUREMENTS TAKEN	DESCRIPTION	NOTE
Eastern Regime I	090/90° 160/75°E Bedding 010/20°E	All joints in dolomite are planar curvilinear, uneven iron stained, tight to open up to 2 mm clay coating Average block sizes are in the range: 0.60 m x 0.50 m x 0.20 m to slabs: 1.40 m x 1.00 m x 0.30 m up to large blocks: 2.20 m x 2.10 m x 0.80 m. and rarely 2.70 m x 2.20 m x 1.70 m the last two sizes will require breakdown before use in the embankment.	
E.L.153-168 Quarry Centre Regime IIA	020/80°NW, 020/80°NW, 022/75°NW 080/80°N, 080/78°N, 080/80°N	Planar; uneven; clay coated up to 3 mm; discontinuous, against 090/68°N; iron stained. Similar orientation to 090/68°N but not planar uneven, semi continuous, fresh clean.	SEE NOTE A Fig. 2.
E.L.137-153 Quarry Centre Regime IIB	040/75°NW, 042/80°NW, 040/85°NW 125/80°SW, 126/78°SW, 125/81°SW 070/55°N, 070/55°N, 068/55°N	Toppling fracture; planar, smooth-uneven continuous; clean, Tight-open (up to 4 mm) occur, 300 mm - 500 mm apart. Form wedges when intersect with above group; planar, discontinuous, open up to 10 mm showing clay coating, carbonate or quartz crystals. Planar, even, thinly clay coated, form very unstable wedges when intersect with above two groups	SEE NOTE B Fig. 2

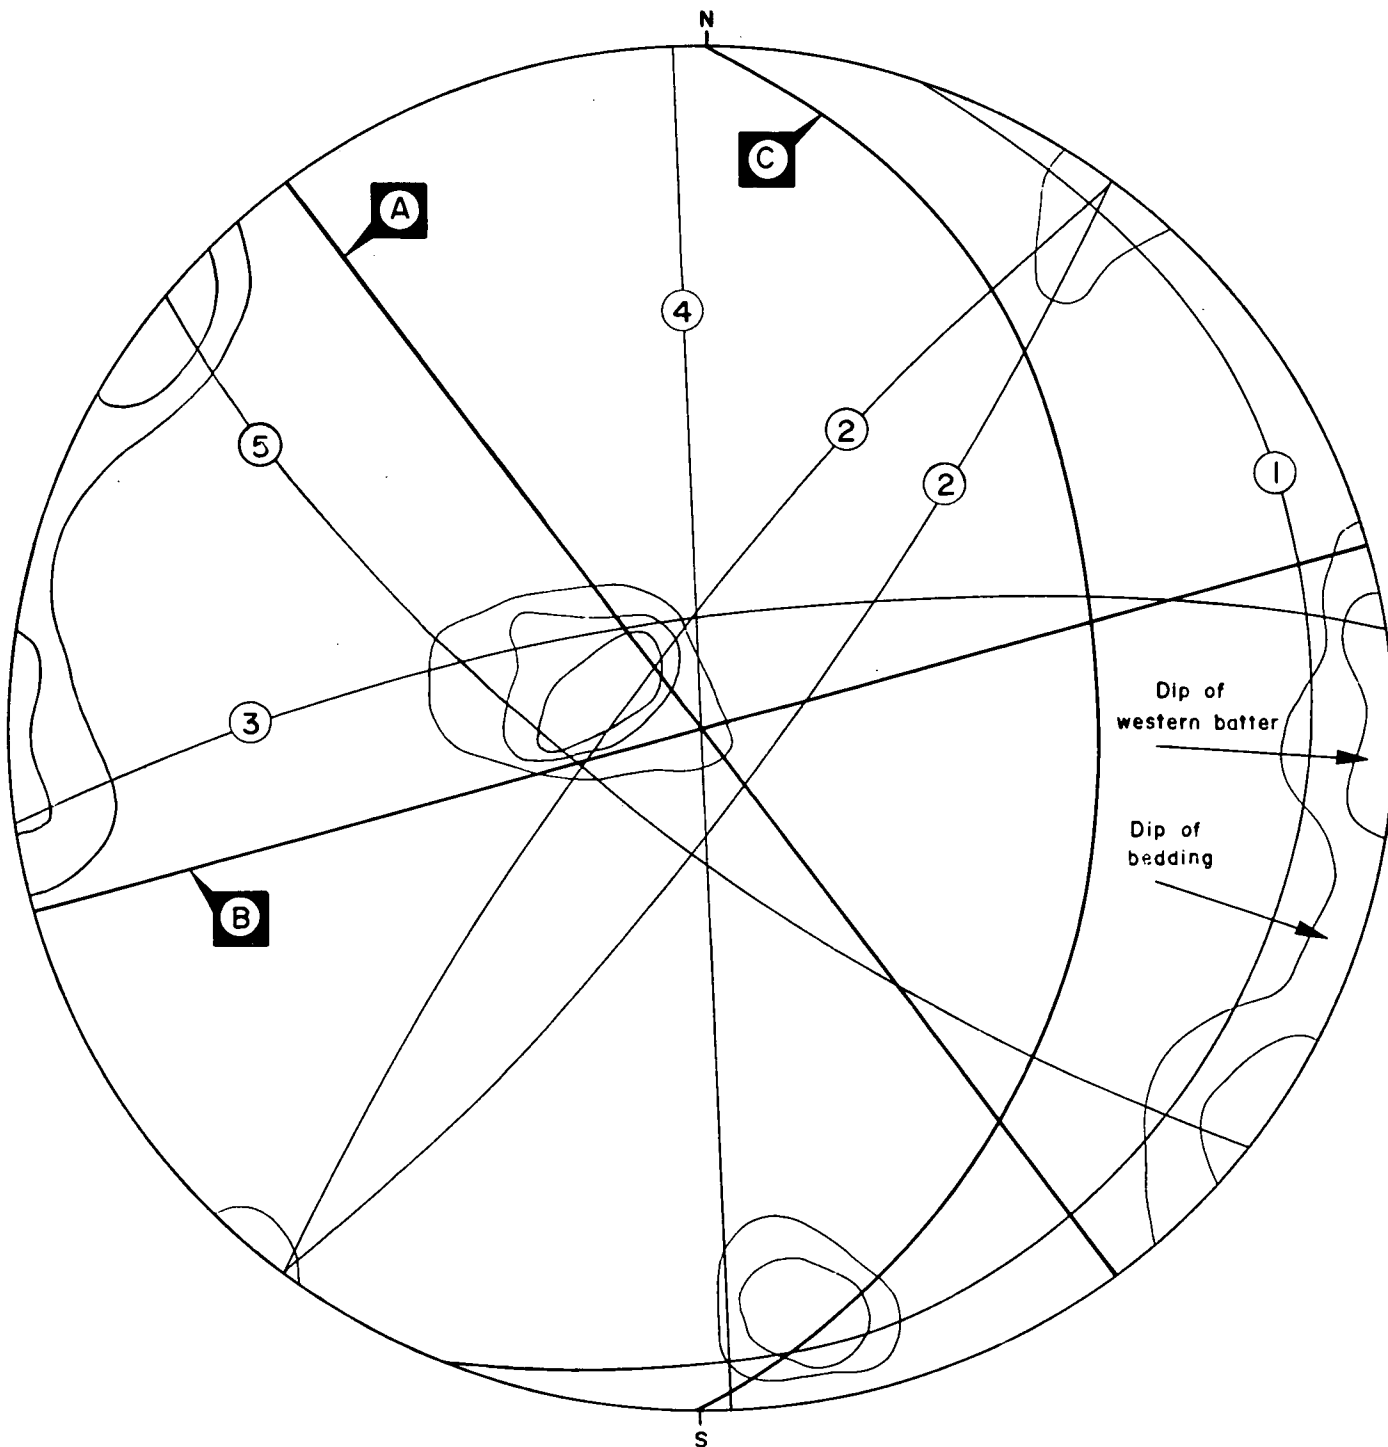
FIG. 3

Plane A taken as least steep plane. *F.O.S. = $A \tan \phi A + B \tan \phi B$. + See Fig.3. for identification and location of planes.

- ① Bedding plane.
- ② Near vertical joints in quartzite and dolomite.
- ③ Steep joints mainly found in quartzite and associated with shear zone.
- ④ Vertical joints mainly found in dolomite.
- ⑤ Near vertical joint mainly found in quartzite.

- A** EASTERN BATTERS VERTICAL
- B** CENTRAL BATTERS VERTICAL
- C** WESTERN BATTERS 40°-45°

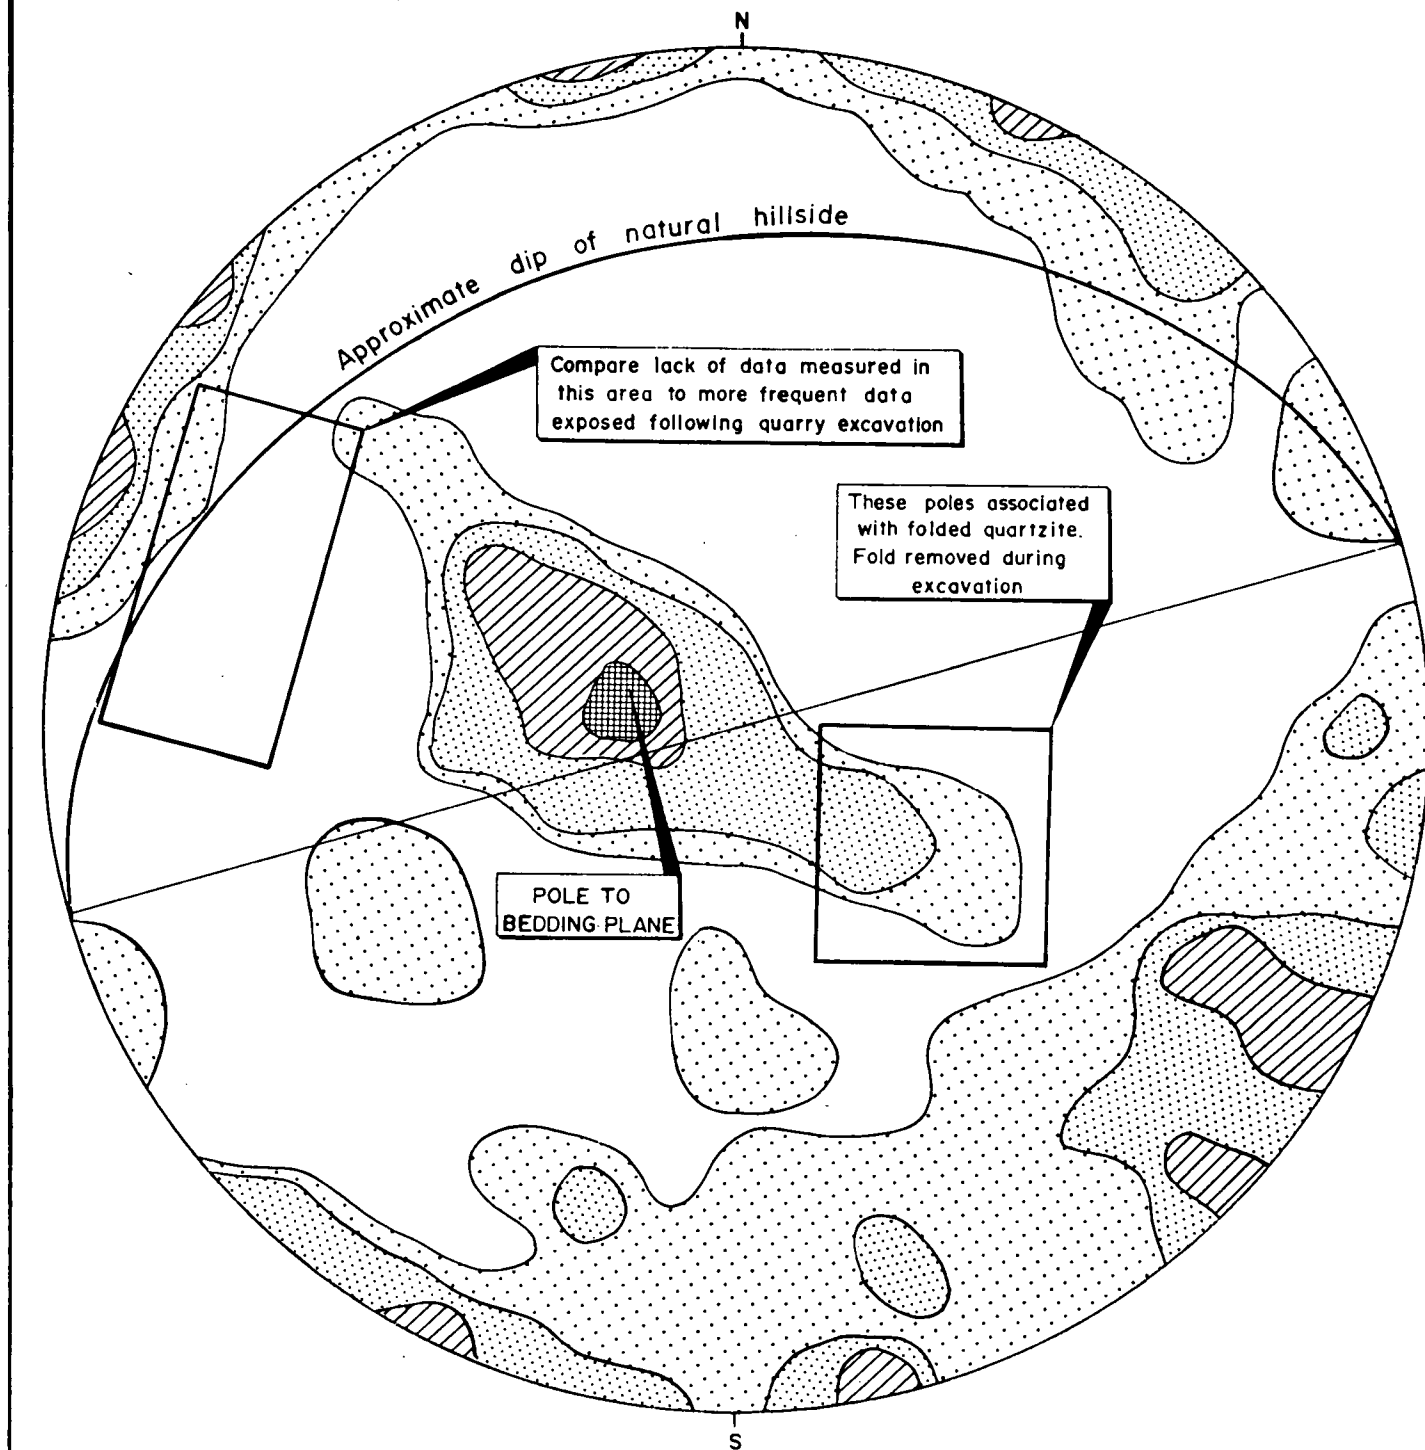
FAILURE MODE	FRACTURE INTERSECTIONS
Small wedge-blocks	5 and 3 ; 2 and 5 ; 5 and 4

FAILURE MODE	FRACTURE INTERSECTIONS
Wedge failure of small blocks	2 and 5 ; 4 and 5
