DEPARTMENT OF MINES AND ENERGY
SOUTH AUSTRALIA

REPORT OF INVESTIGATIONS

THE ENGINEERING GEOLOGY
OF THE LITTLE PARA
DAM SITE

October, 1979

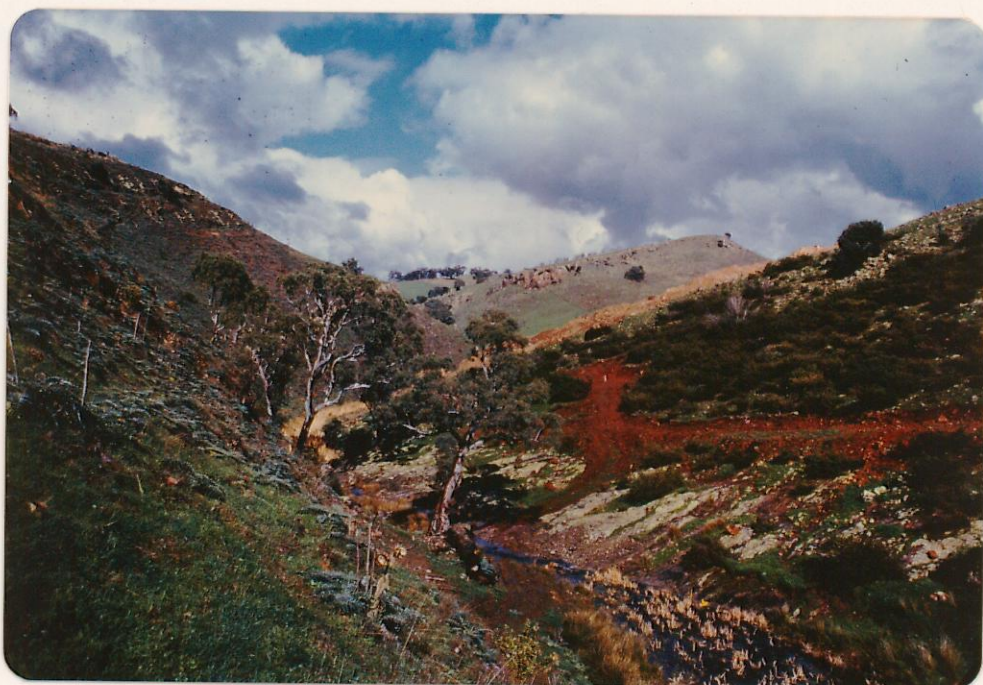
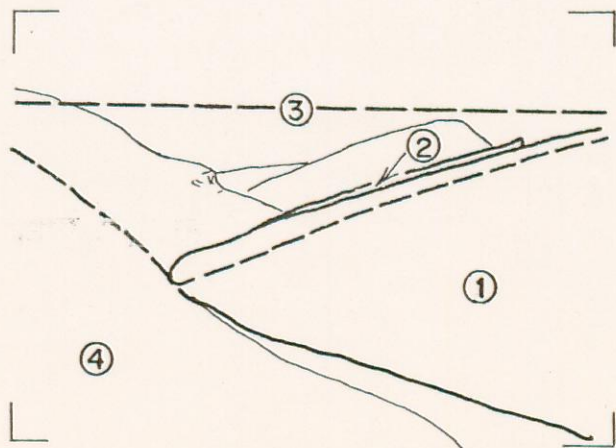
NEGATIVE NO. 13066 - July 1973
CHOSEN DAM SITE

1. Quartzite stratum (UNIT 12)
forming dip slope on right
abutment.
2. Spoil from exploration trench.
3. Dam axis.
4. Dolomitic siltstone, left
abutment.

By the end of 1972 from five alternative sites, a rockfill dam site was chosen (Figure 4) on the basis of geologically suitable foundations and abutments.

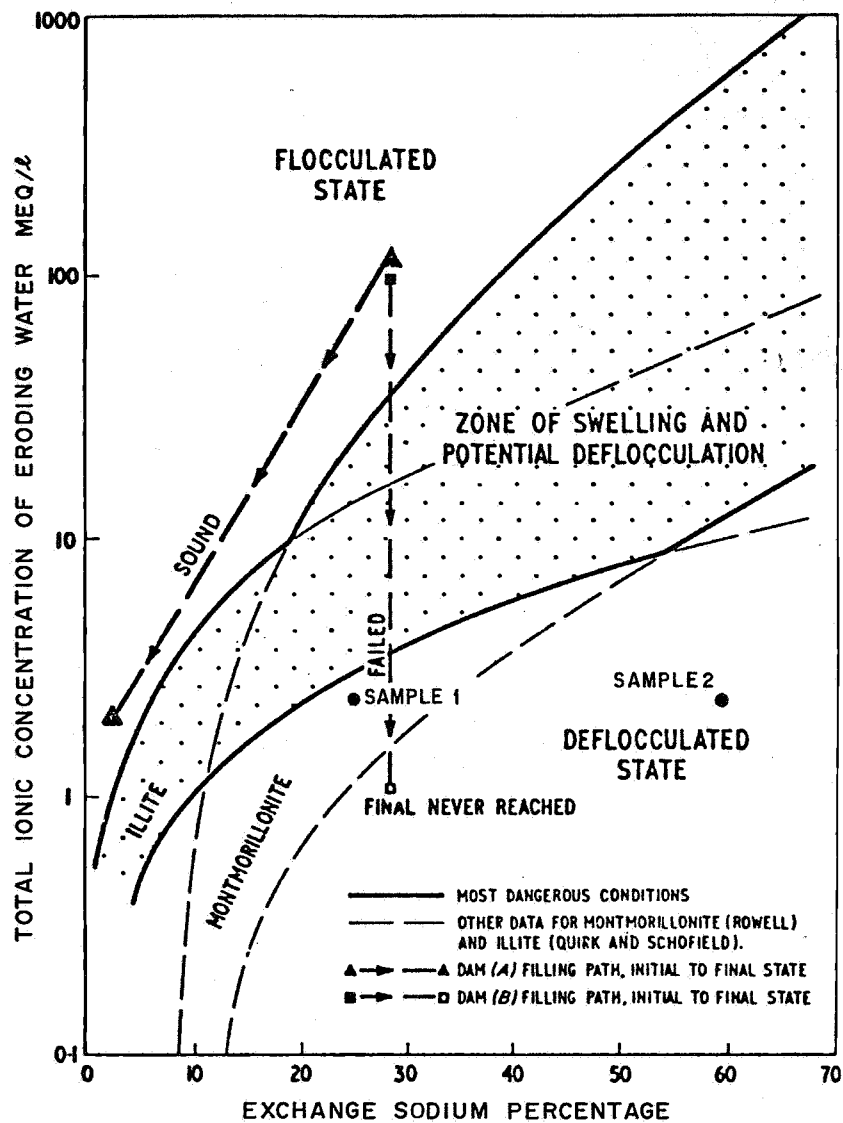
FIG. 14

The lowest likely cation content of Adelaide water is 3 Milli-equivalents/ litre (Information from Bolivar Laboratories, Engineering and Water Supply Dept.). According to Figures 14 and 15 the clay fraction in Sample 2 is a dispersive clay, and Sample 1 may be dispersive (Sherard et al. 1976).

Sample 1 — Taken from Inspection Trench.
Little Para Dam.

Sample 2 — Taken from Spillway Channel Wall.
Little Para Dam.

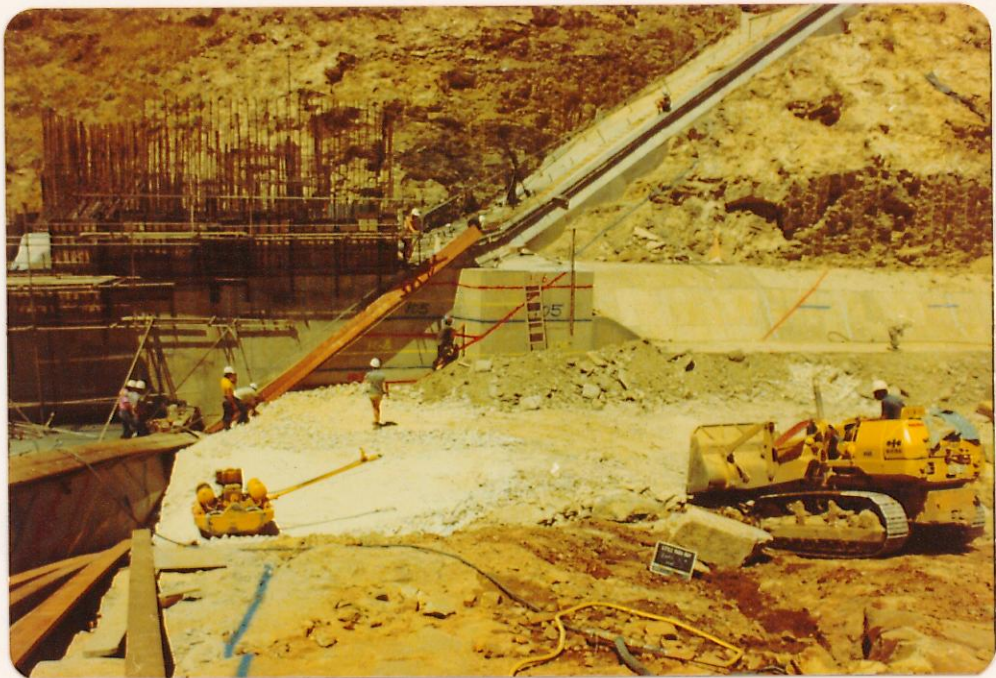
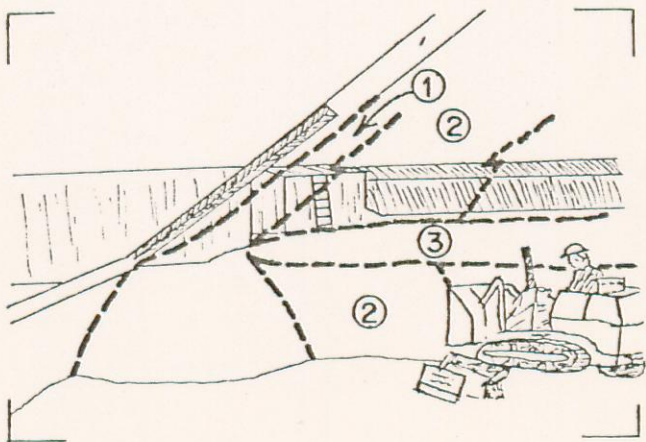
FIG. 16

Average results gave dry densities in the range 2 010 kg/m³ (125.41b/cu ft) - 2 280 kg/m³. An early ring test on Zone 1 (Figure 16) gave a low dry density value of 1 840 kg/m³ resulting from accidental mixing with unacceptably low quality zone 2 material. The top 0.5 metres of this contaminated material was removed and replaced with clean, fresh quartzite.

NEGATIVE NO. 27028 - Nov. 1976
EMBANKMENT
Looking towards left abutment.
1. Zone 1 rock fill.
2. Zone 2 rock fill.
3. Zone 6 rock fill.

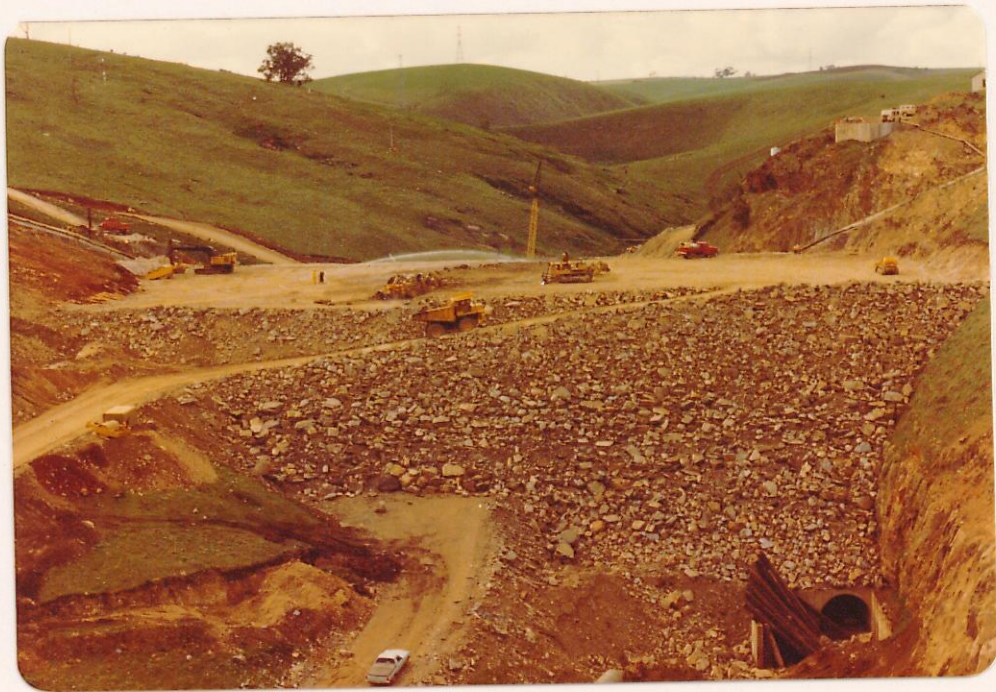
FIG. 17

Up to this stage the embankment had been compacted dry but because the general rock quality had deteriorated from then onwards water was sprayed onto the rockfill during compaction (Figure 17).

NEGATIVE NO. 27985 - July 1976
SLUICING OF ROCK FILL
Looking upstream.

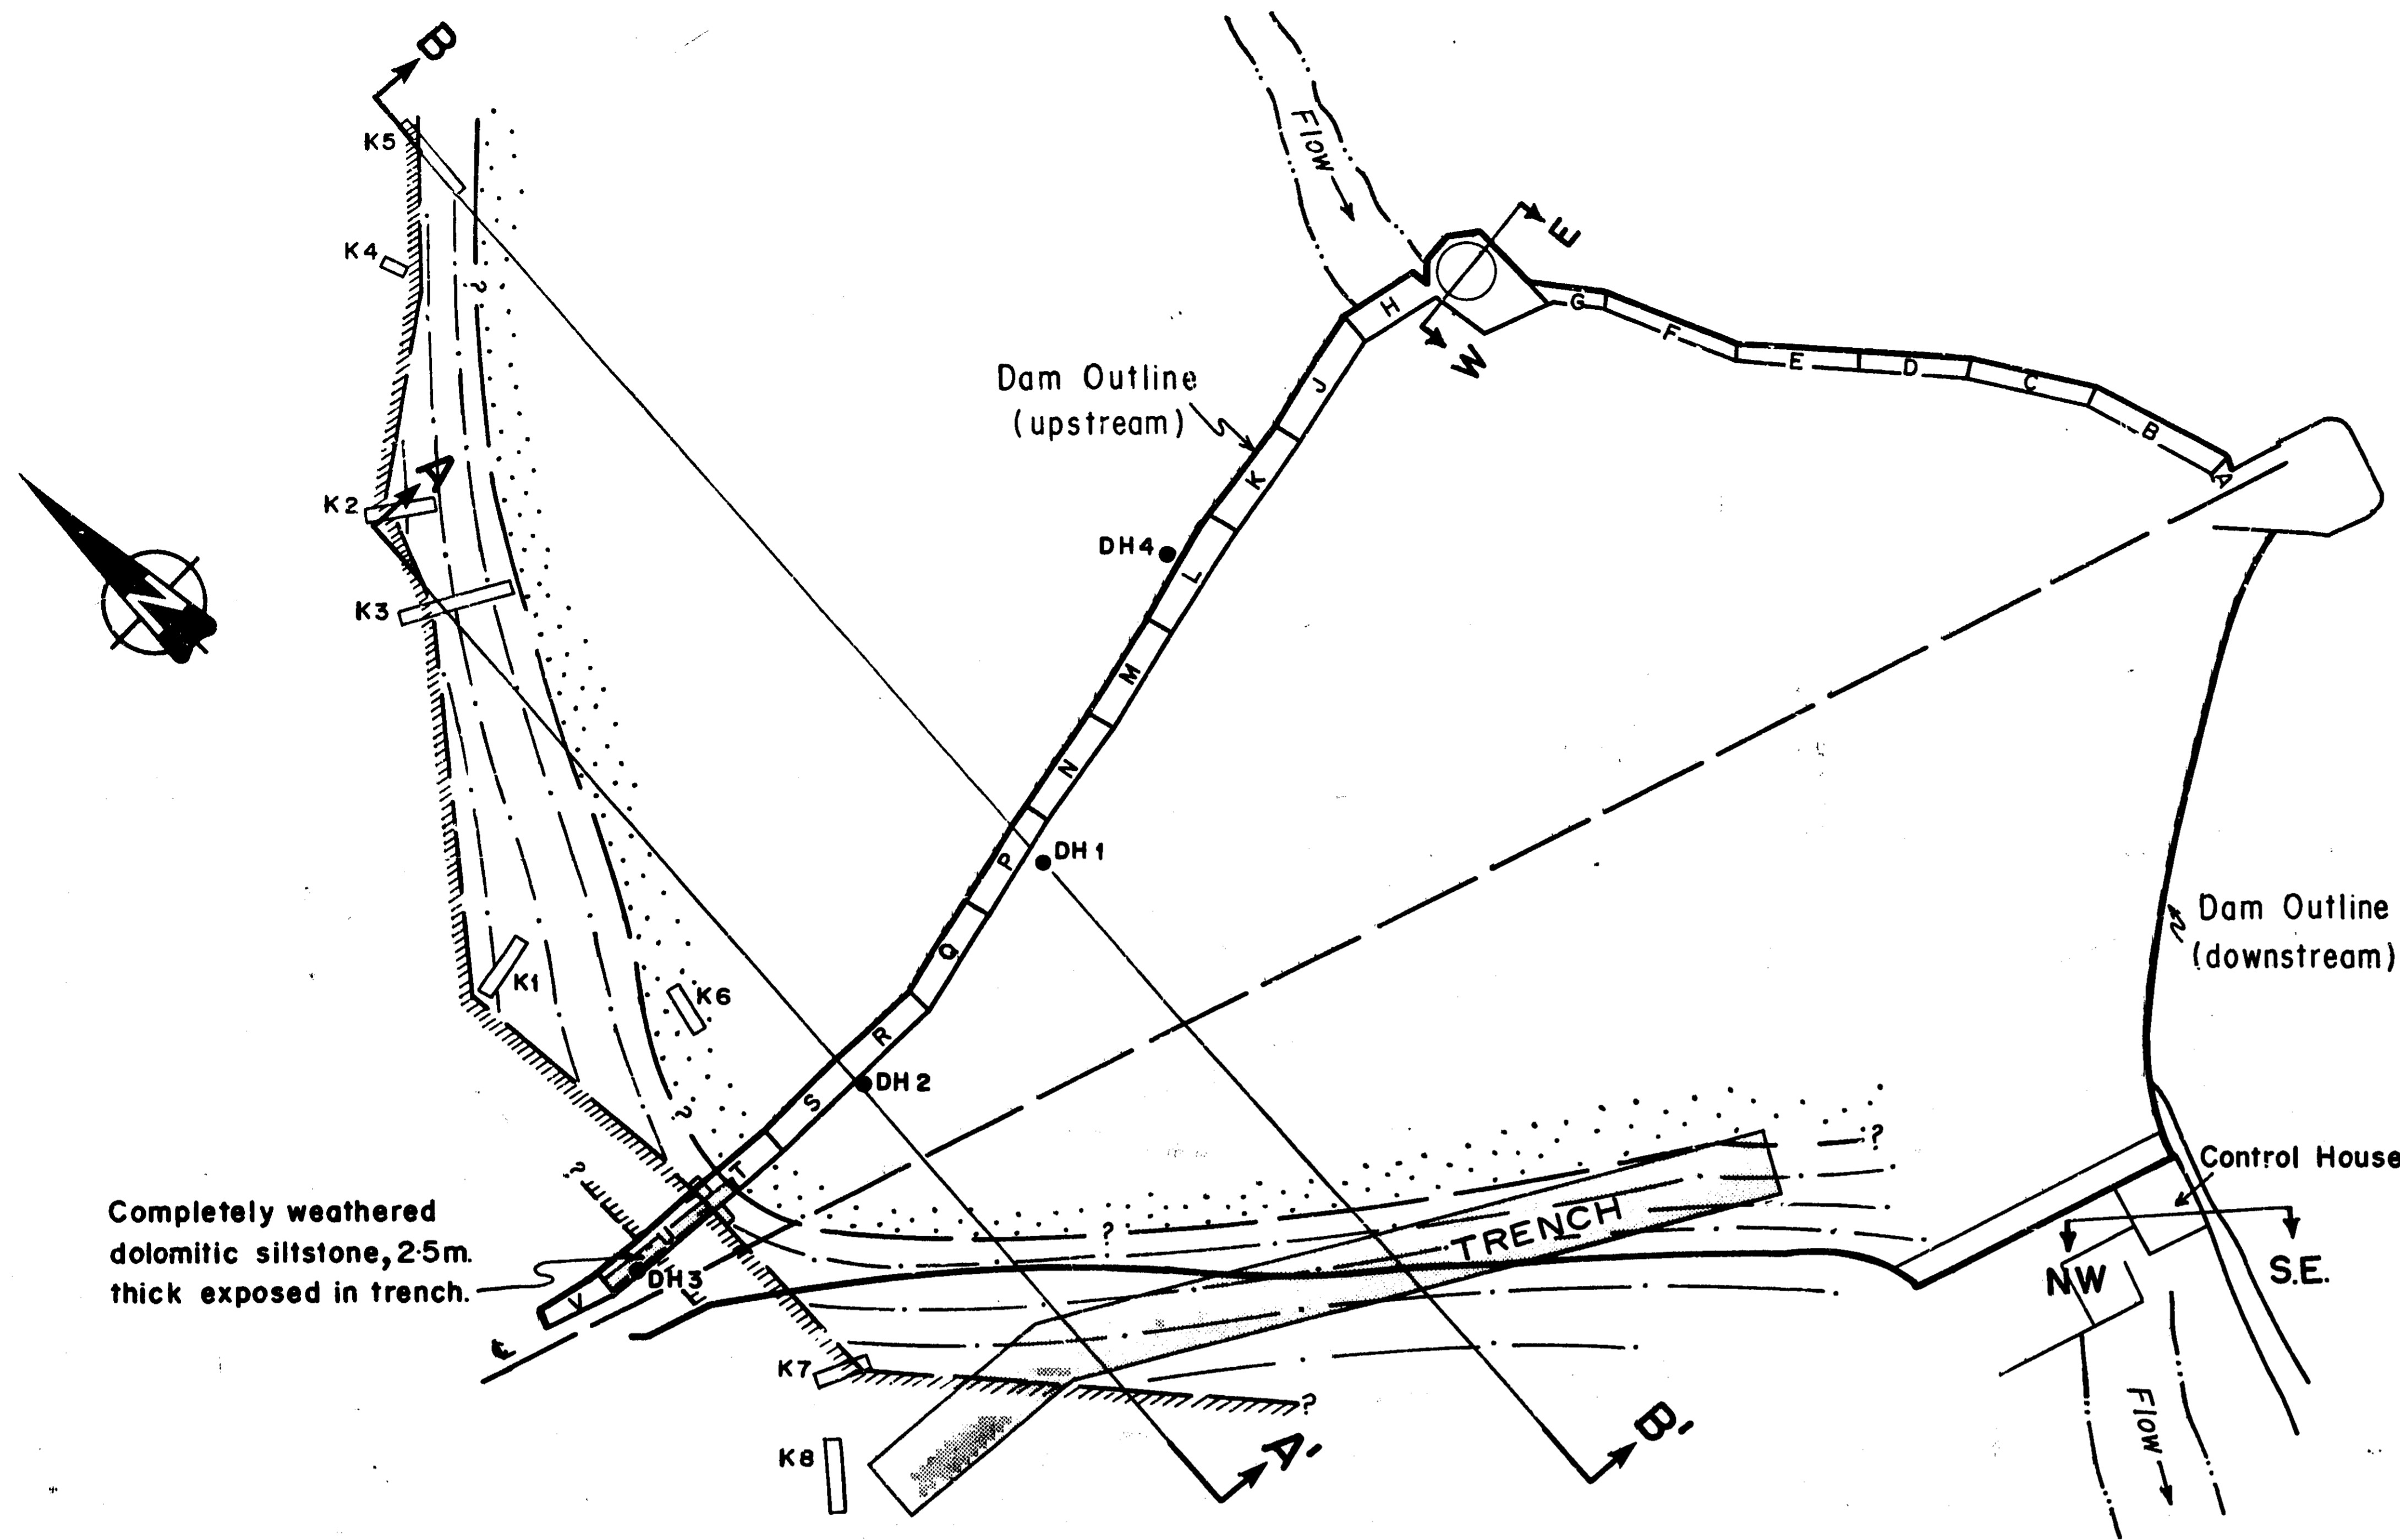
Fig. 18

A diagrammatic summary of the different kind of construction features which required geological attention is shown in Figure 18.

ENGINEERING SERVICES	DEPARTMENT OF MINES - SOUTH AUSTRALIA	SCALE DIAGRAMMATIC
COMPILED J.C. BEAL	LITTLE PARA DAM	DATE 22 ND APRIL '77
DRN A.R. CKD	TREATMENT OF GEOLOGICAL FEATURES DURING DAM CONSTRUCTION	PLAN NUMBER 77-475

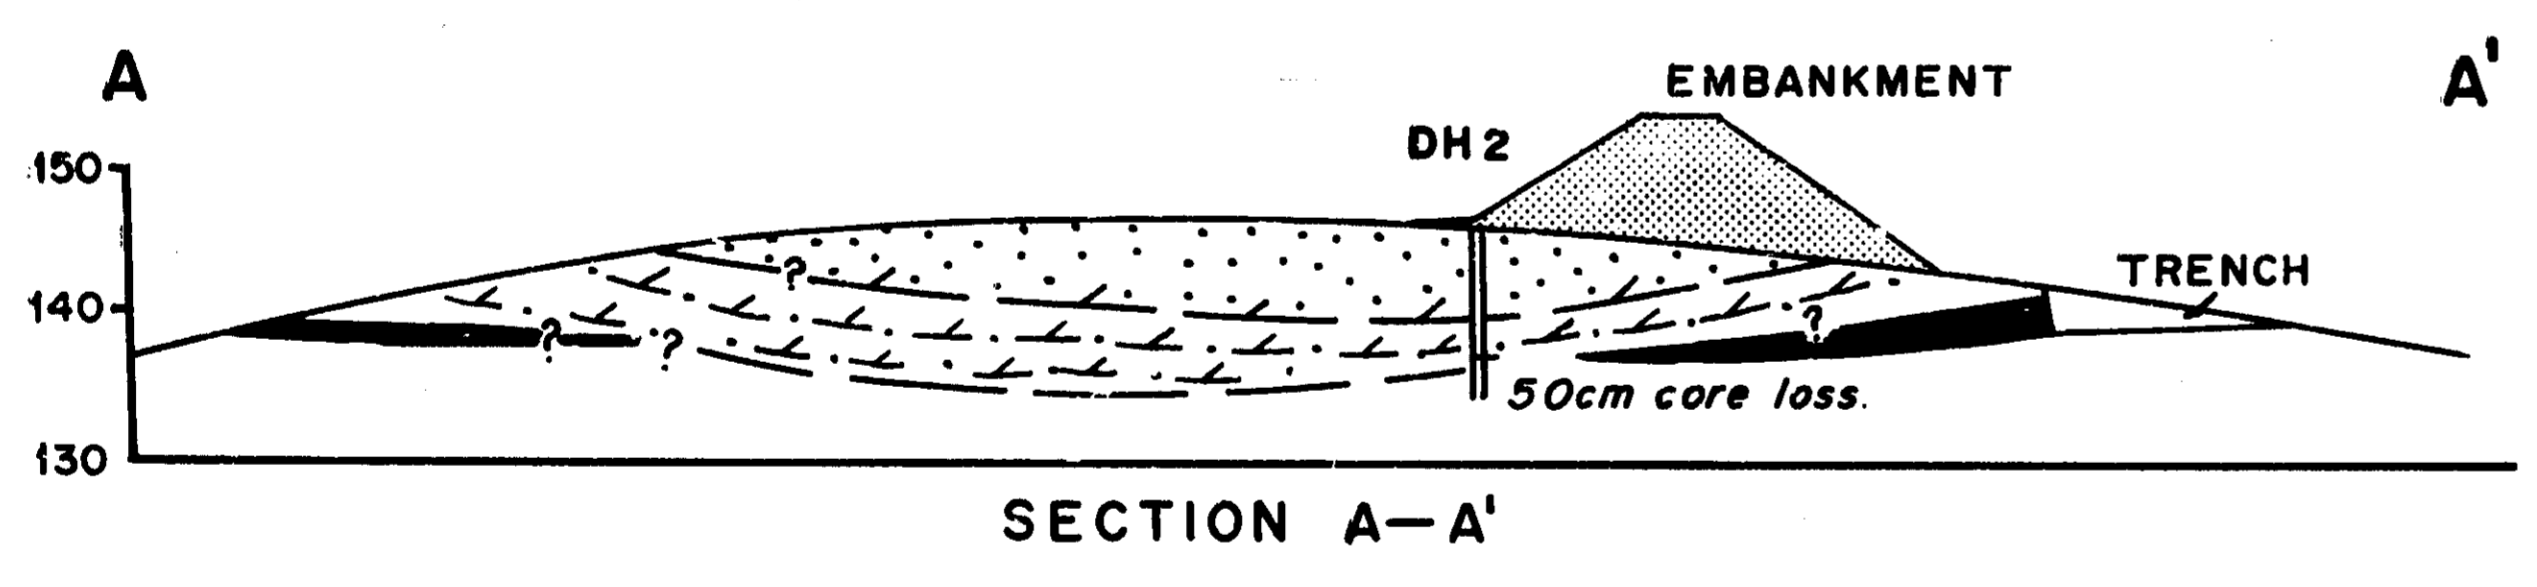
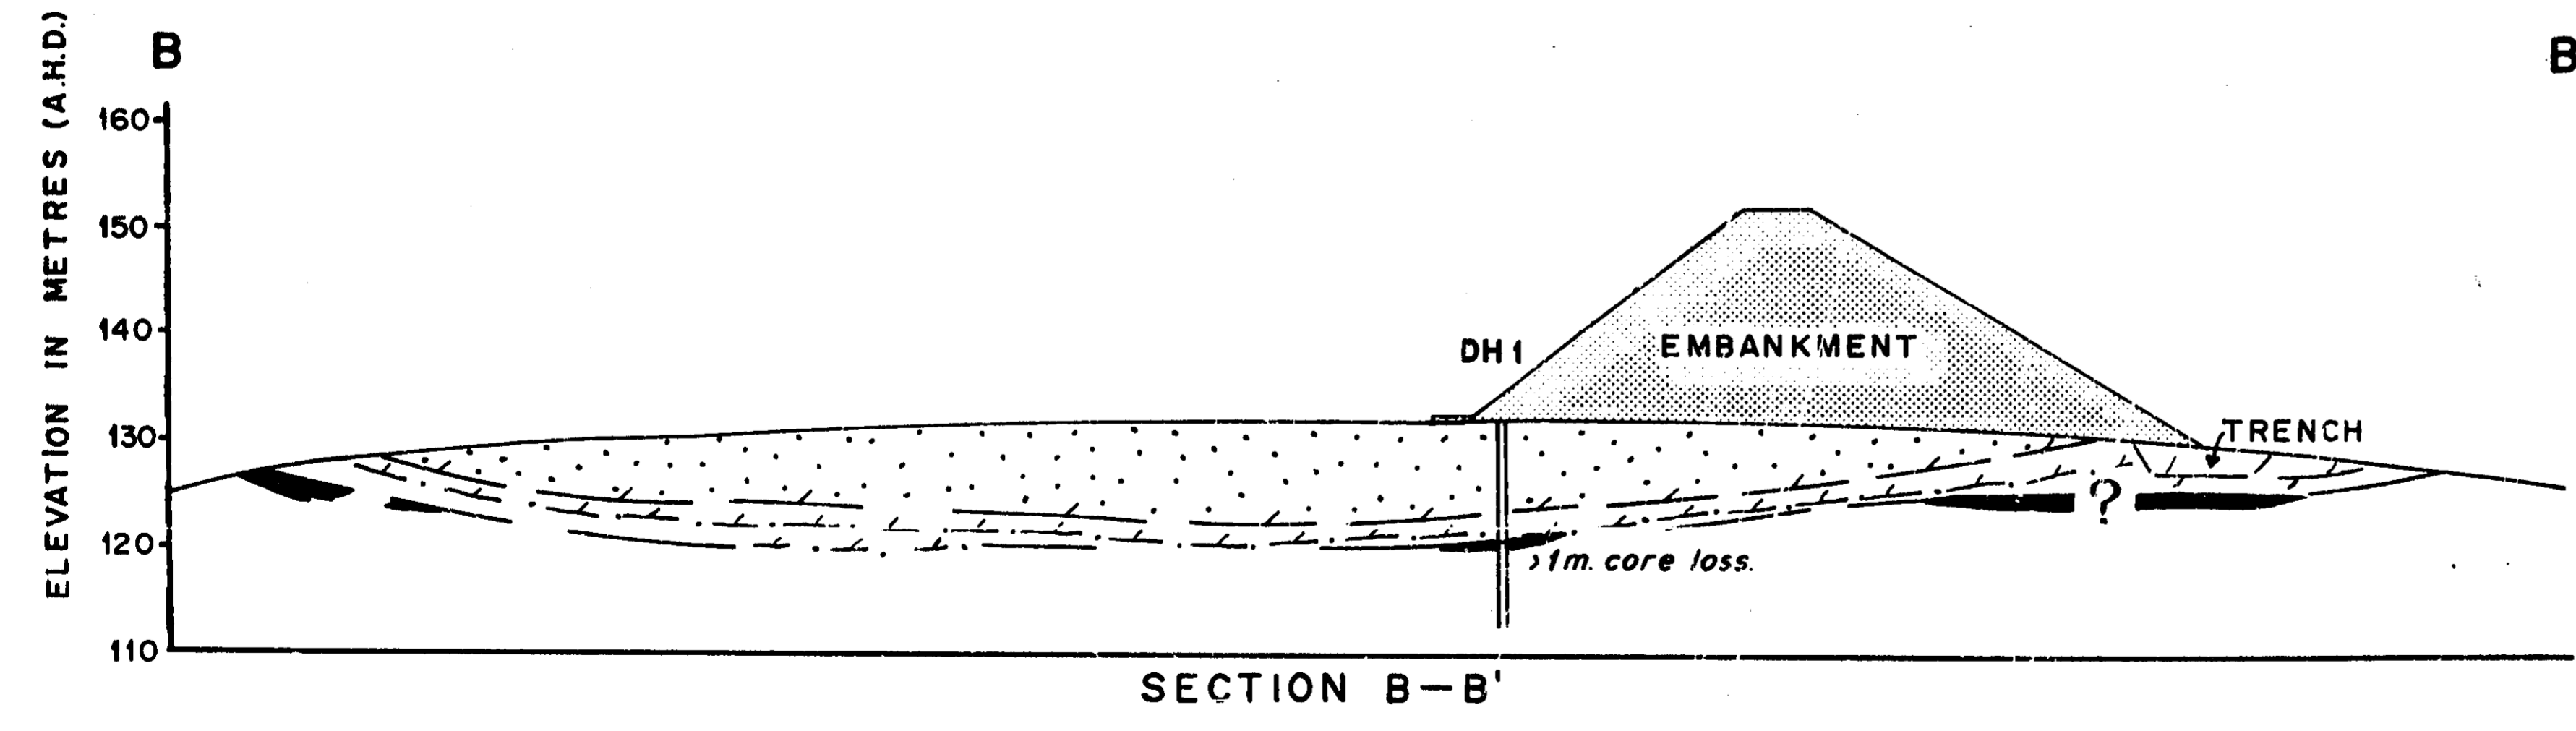
Fig 19

Although early mapping proved a watertight reservoir an area of concern for possible leakage was on the right abutment adjacent to the dam where completely weathered outcrops of dolomitic siltstone occur immediately upstream of the dam (Figure 19). A weathered seam of dolomitic siltstone passes beneath the right abutment near to the full supply level of the dam and it was thought that impounded water could find a leakage path beneath the right abutment of the dam via these seams. For this reason some thought was given to sealing off any potential leakage path by placement of a clay blanket across the outcrops of the weathered

DEPARTMENT OF MINES AND ENERGY SOUTH AUSTRALIA		SCALE As shown
COMPILED J. C. Beal.		LITTLE PARA DAM RIGHT ABUTMENT GEOLOGY LOCATION OF WEATHERED SEAMS OF DOLOMITIC SILTSTONE		DATE MAY 1978
DRN. G. J. T.	CKD.			PLAN NUMBER 78-385

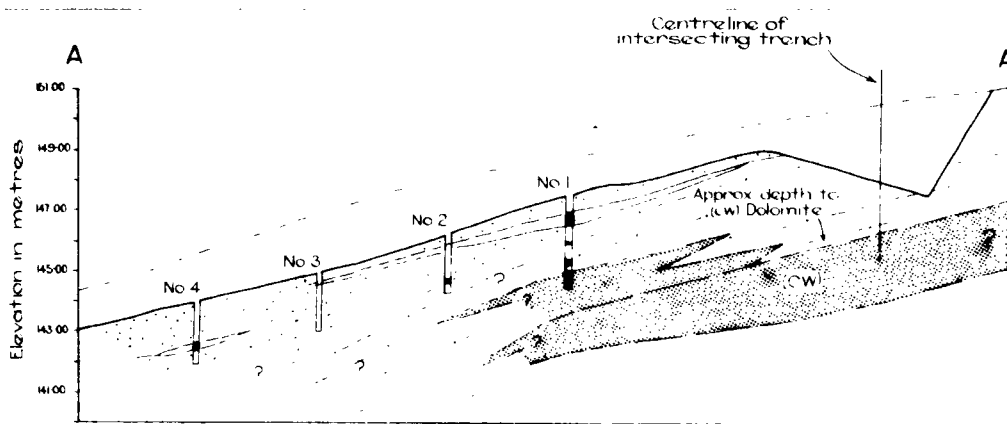
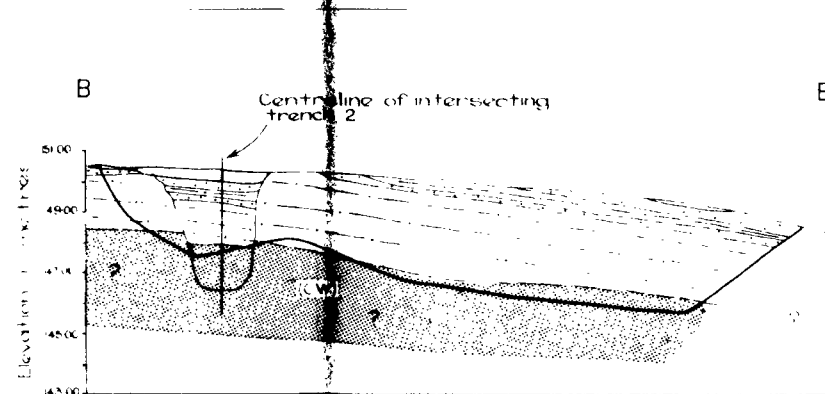
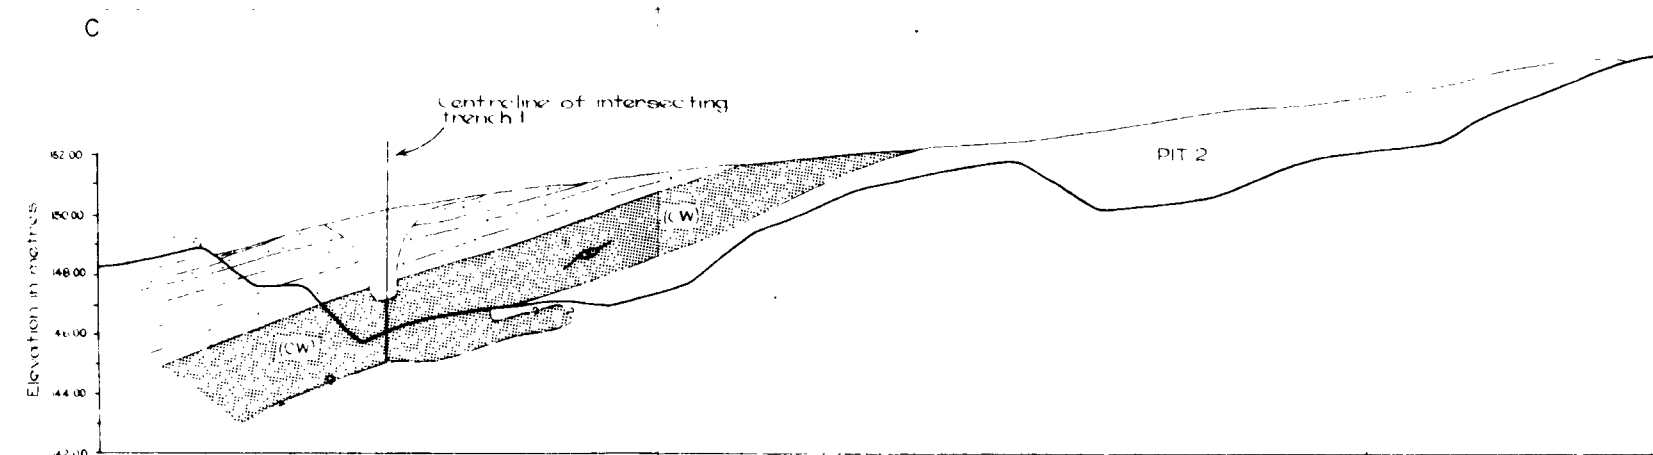
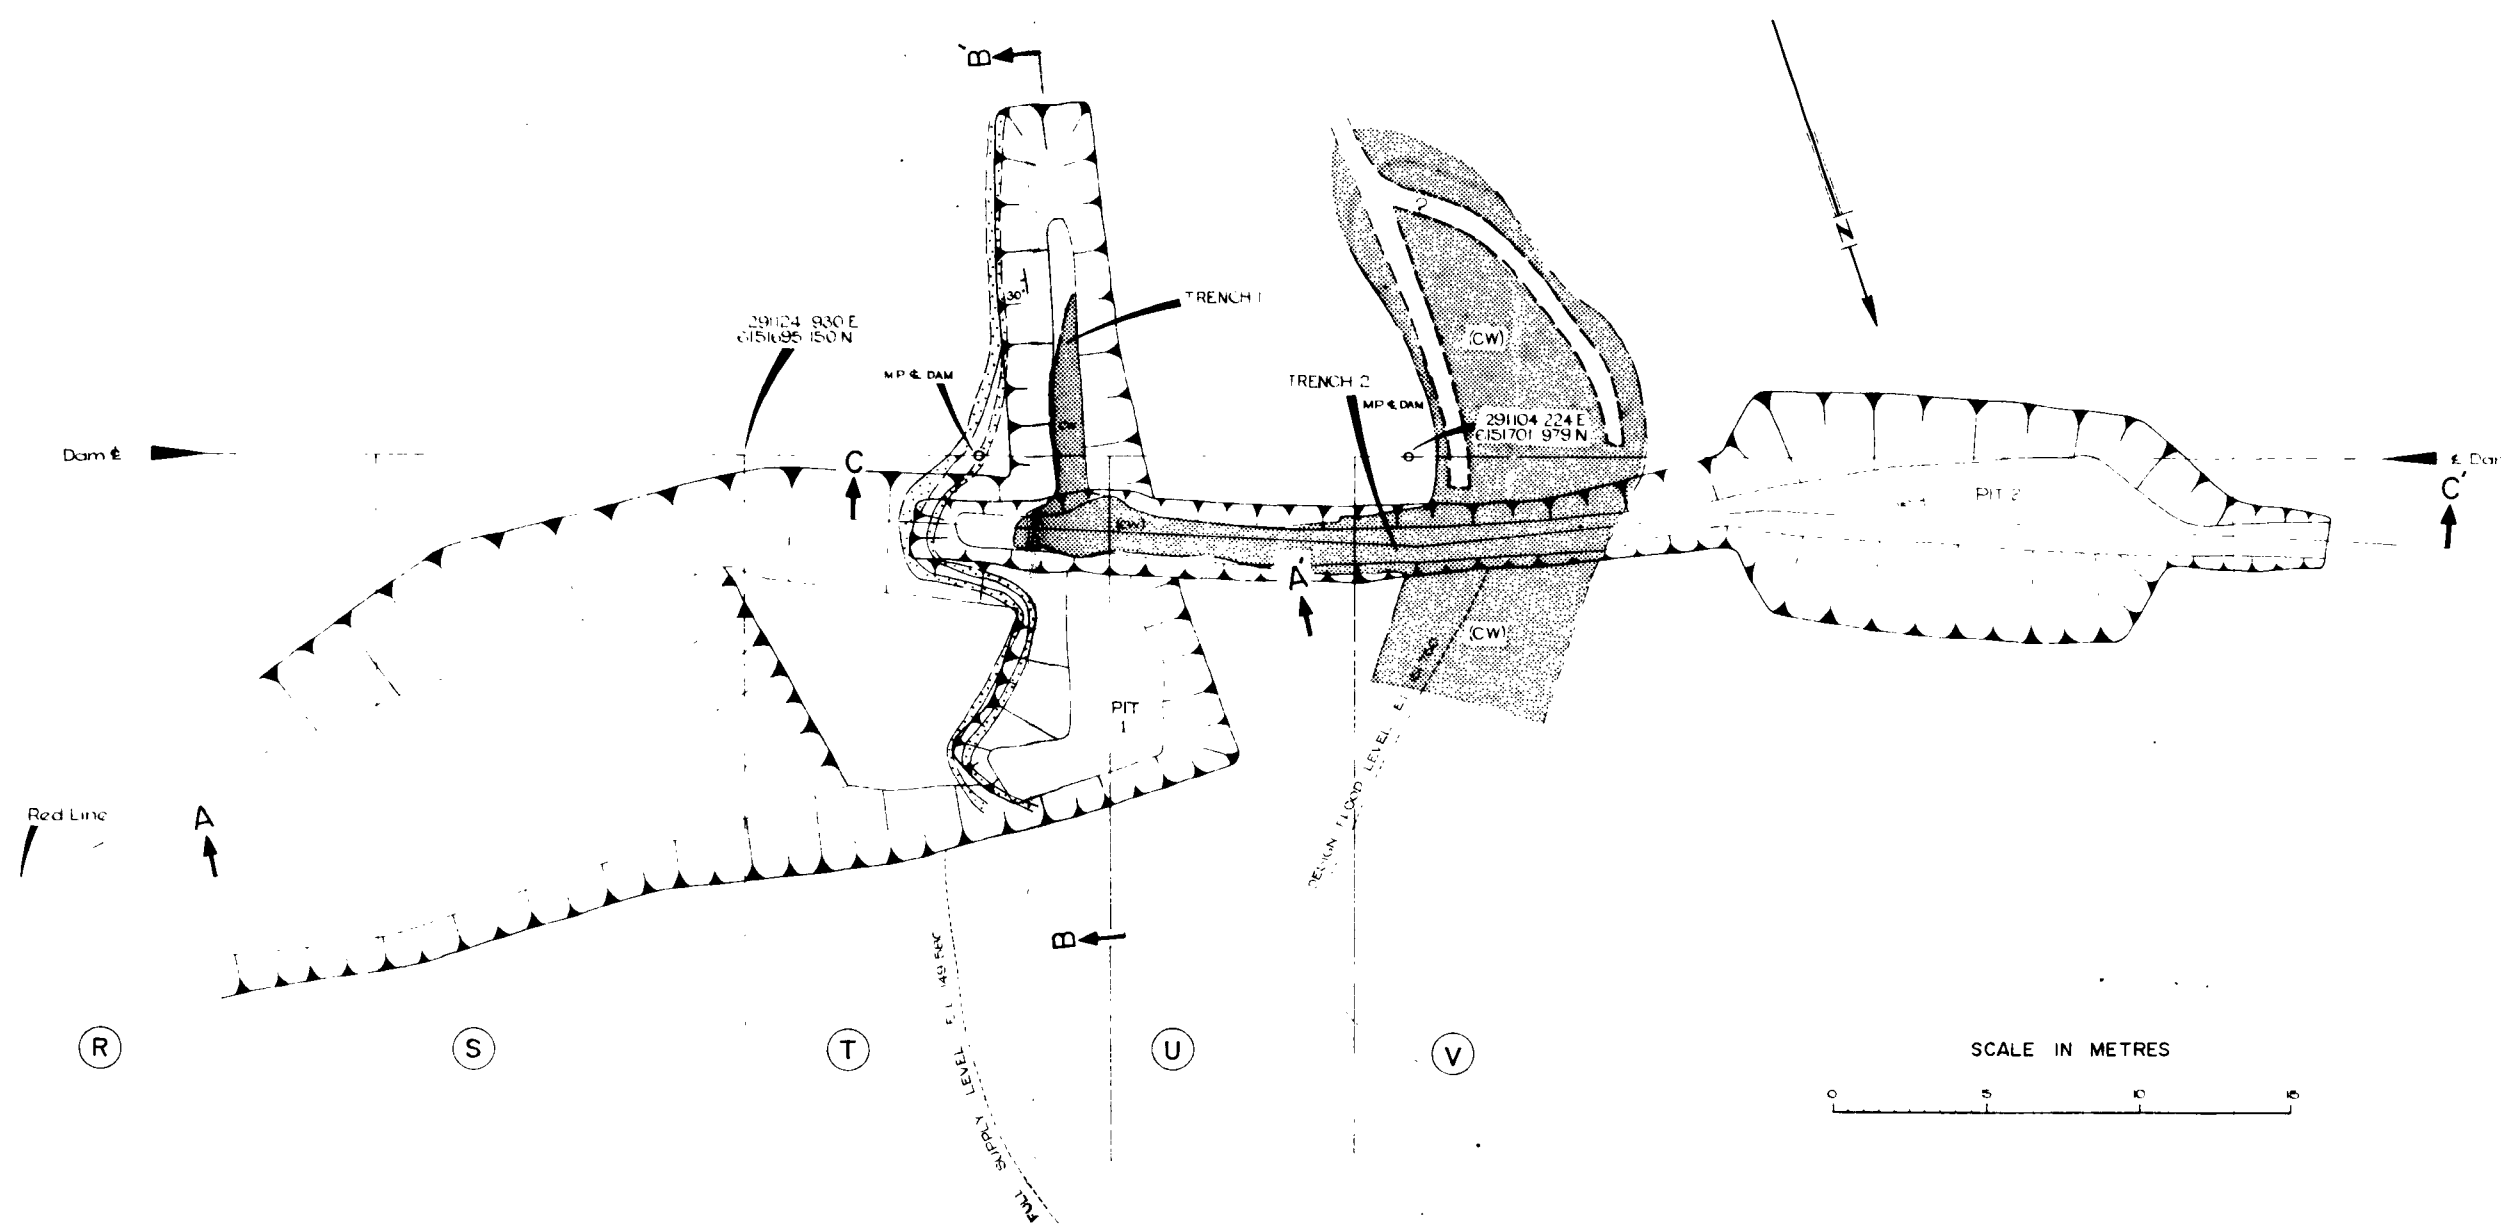
Fig. 20

Because of these weathered seams consideration was given early in the design of the dam to placing a reverse filter (Figure 20) at the top of the right abutment, beneath the downstream embankment rockfill, as a precaution against dispersion and subsequent erosion of the weathered dolomitic siltstone.

DEPARTMENT OF MINES-SOUTH AUSTRALIA			
LITTLE PARA DAM RIGHT ABUTMENT GROUT CAP EXCAVATION OF DOLOMITIC SILTSTONE AND LOCATION OF FILTER TRENCHES			
COMPILED JCB	DRN JMW	SCALE	PLAN NUMBER
DIRECTOR OF MINES	CPD	DATE 24.8.76	76-688

ITEM NO.	FEATURE	LOCATION	TREATMENT OF BLOCK	MODIFICATION OF DESIGN
6	Presence of completely weathered dolomitic siltstone (2.5 - 3.0 m thick) beneath the quartzite.	Right Bank Beneath Block U.	Complete removal of dolomitic siltstone along a trench parallel to dam axis beneath the parapet wall.	Trench infilled with concrete and formed contiguously with the parapet wall. Reverse filter placed beneath rockfill across dam width in this area.
7	Calcrete adhering to grout cap block surface.	Right bank	Removal of all but the hardest calcrete.

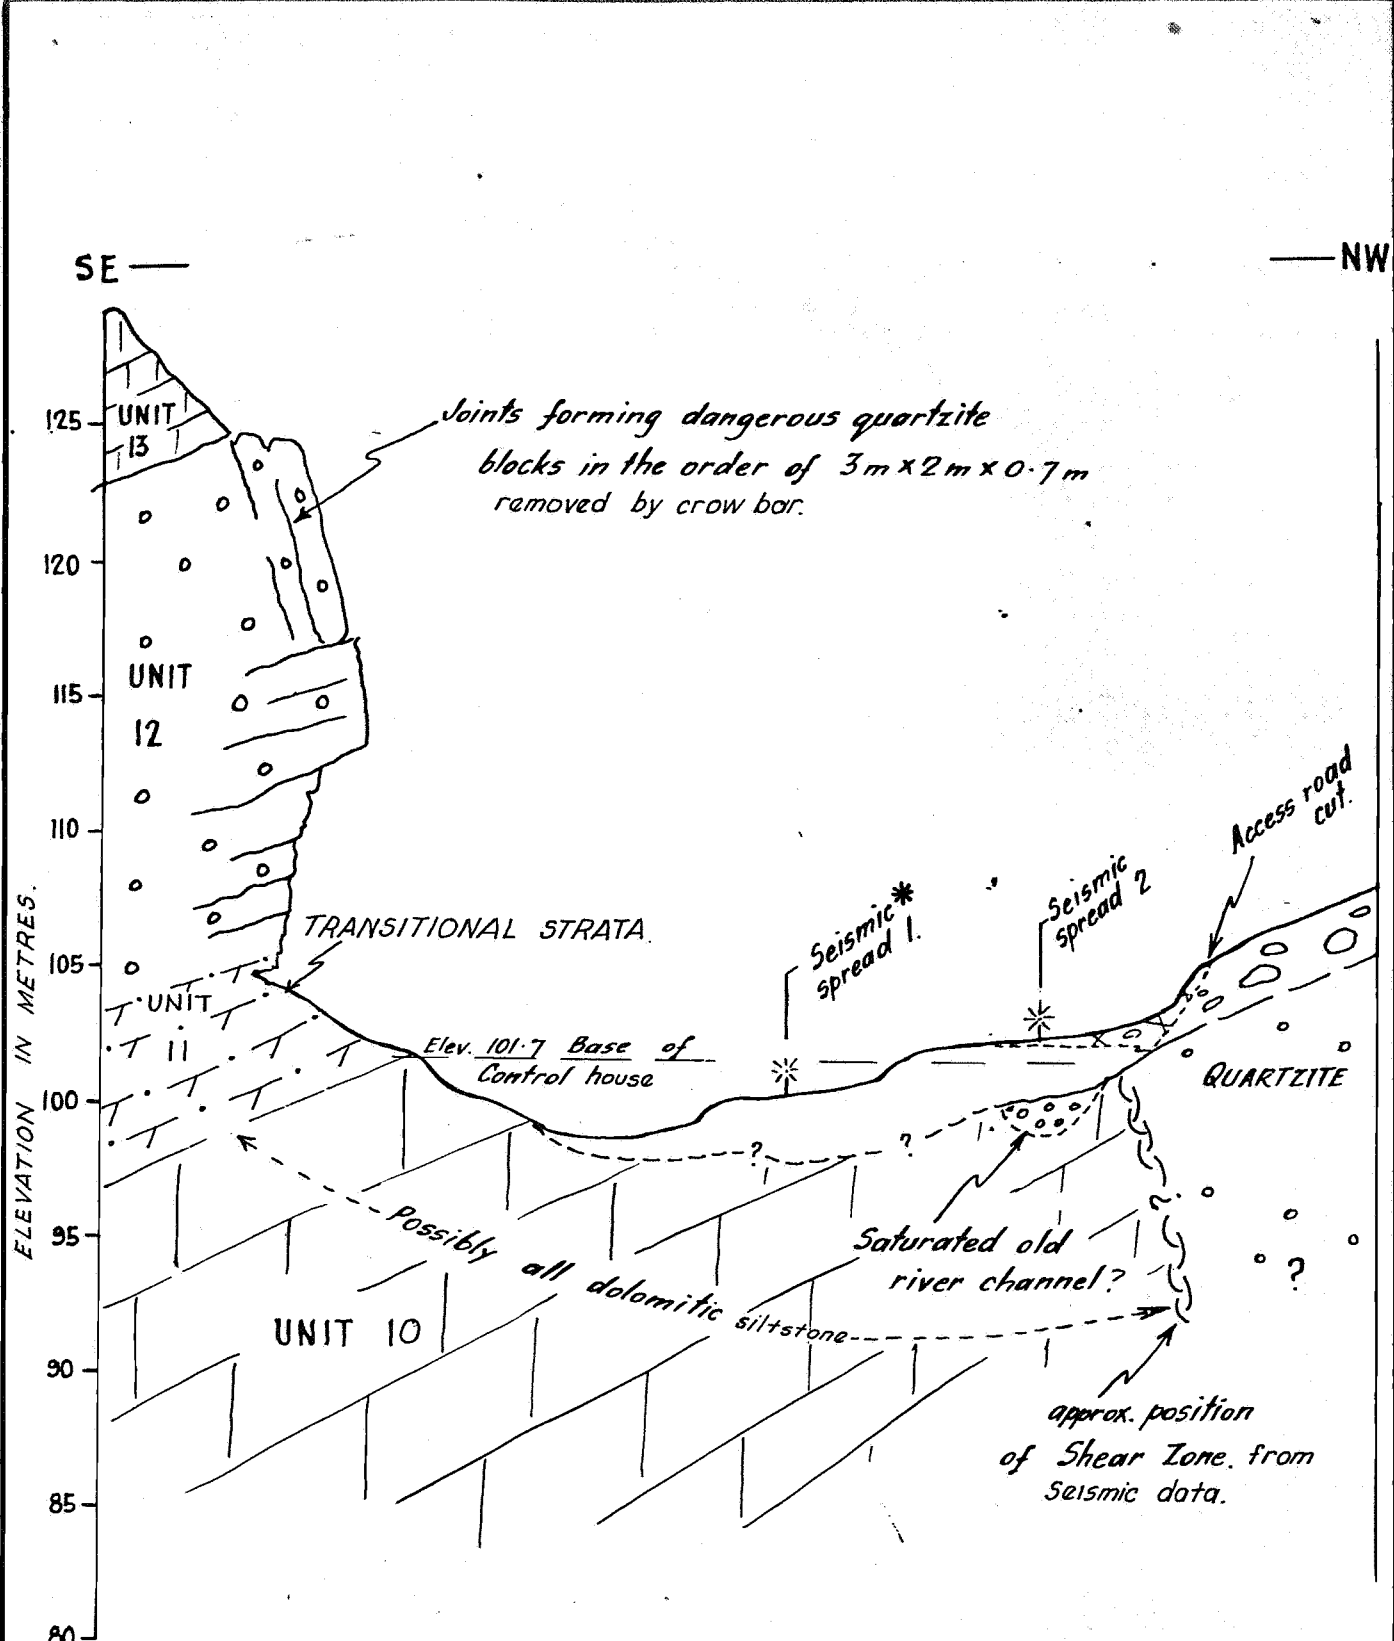
Fig. 25

A seismic refraction investigation (Figure 25) immediately downstream of the dam proved shallow bedrock (2.0 - 3.0 metres) beneath the Control House and Dissipating Chamber located at the downstream end of the Outlet Duct. Excavation confirmed an acceptable foundation not affected by the shear zone although the seismic work did show a change in bedrock nature. This was possibly attributable to shearing some 10.0 metres west of the Control House.

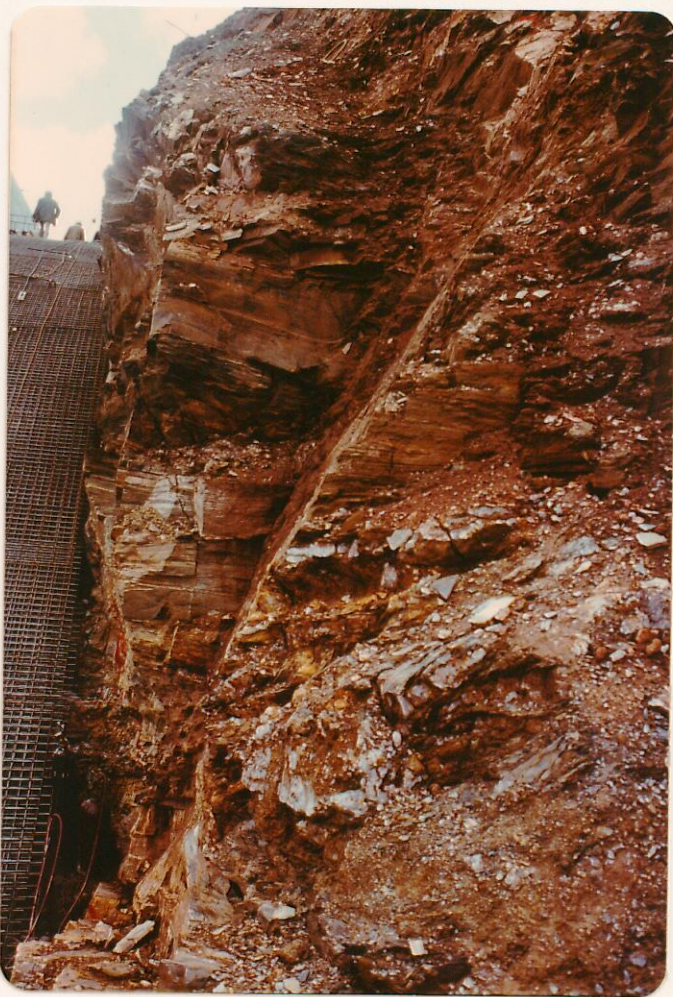
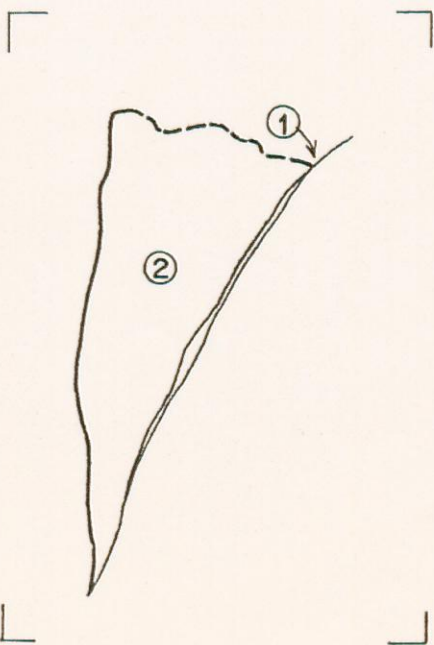
SLIDE NO. 12645 - July 1976
SPILLWAY SKI JUMP -
CHANNEL WALL

1. Clay infilled joint day-lighting into the spillway wall.
2. Unstable wedge was covered with cyclone mesh and pinned with dowels.

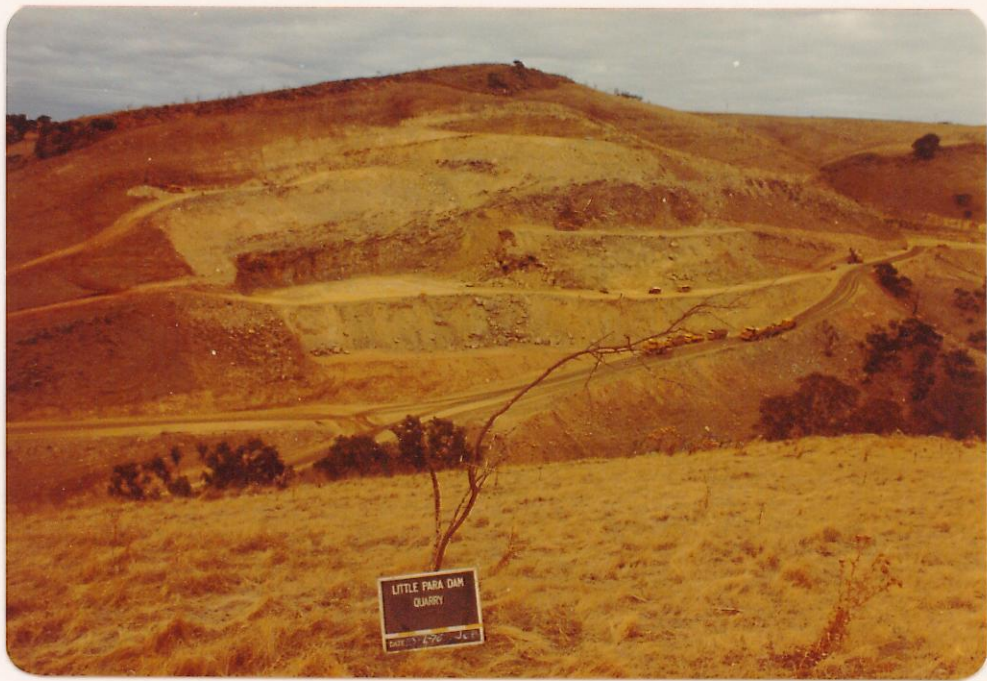
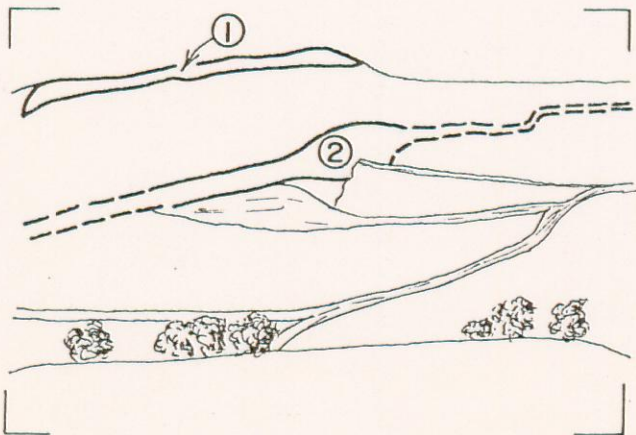
FIG. 29

The first survey assessed the short term stability during the period of excavation and the second survey the long term stability of batters completed (Appendix 3, Figure 55) to ensure the safety of the water treatment structures to be built on the two main berms at EL 110 and EL 120. (Figure 29).

NEGATIVE NO. 27513
April 1976
QUARRY AND WATER TREATMENT WORKS
1. Quartzite UNIT 12
2. Quartzite UNIT 9 thickened
by folding.

1. Removal of large unstable blocks in quartzite, (UNIT 9 & UNIT 12). For aesthetic reasons this was to be kept to a minimum where UNIT 12 formed a sky line.
2. Excavation of UNIT 9 along the central part of the quarry main face down to 2 - 3 m depending to what depth the folded strata which dips into the quarry is completely removed.

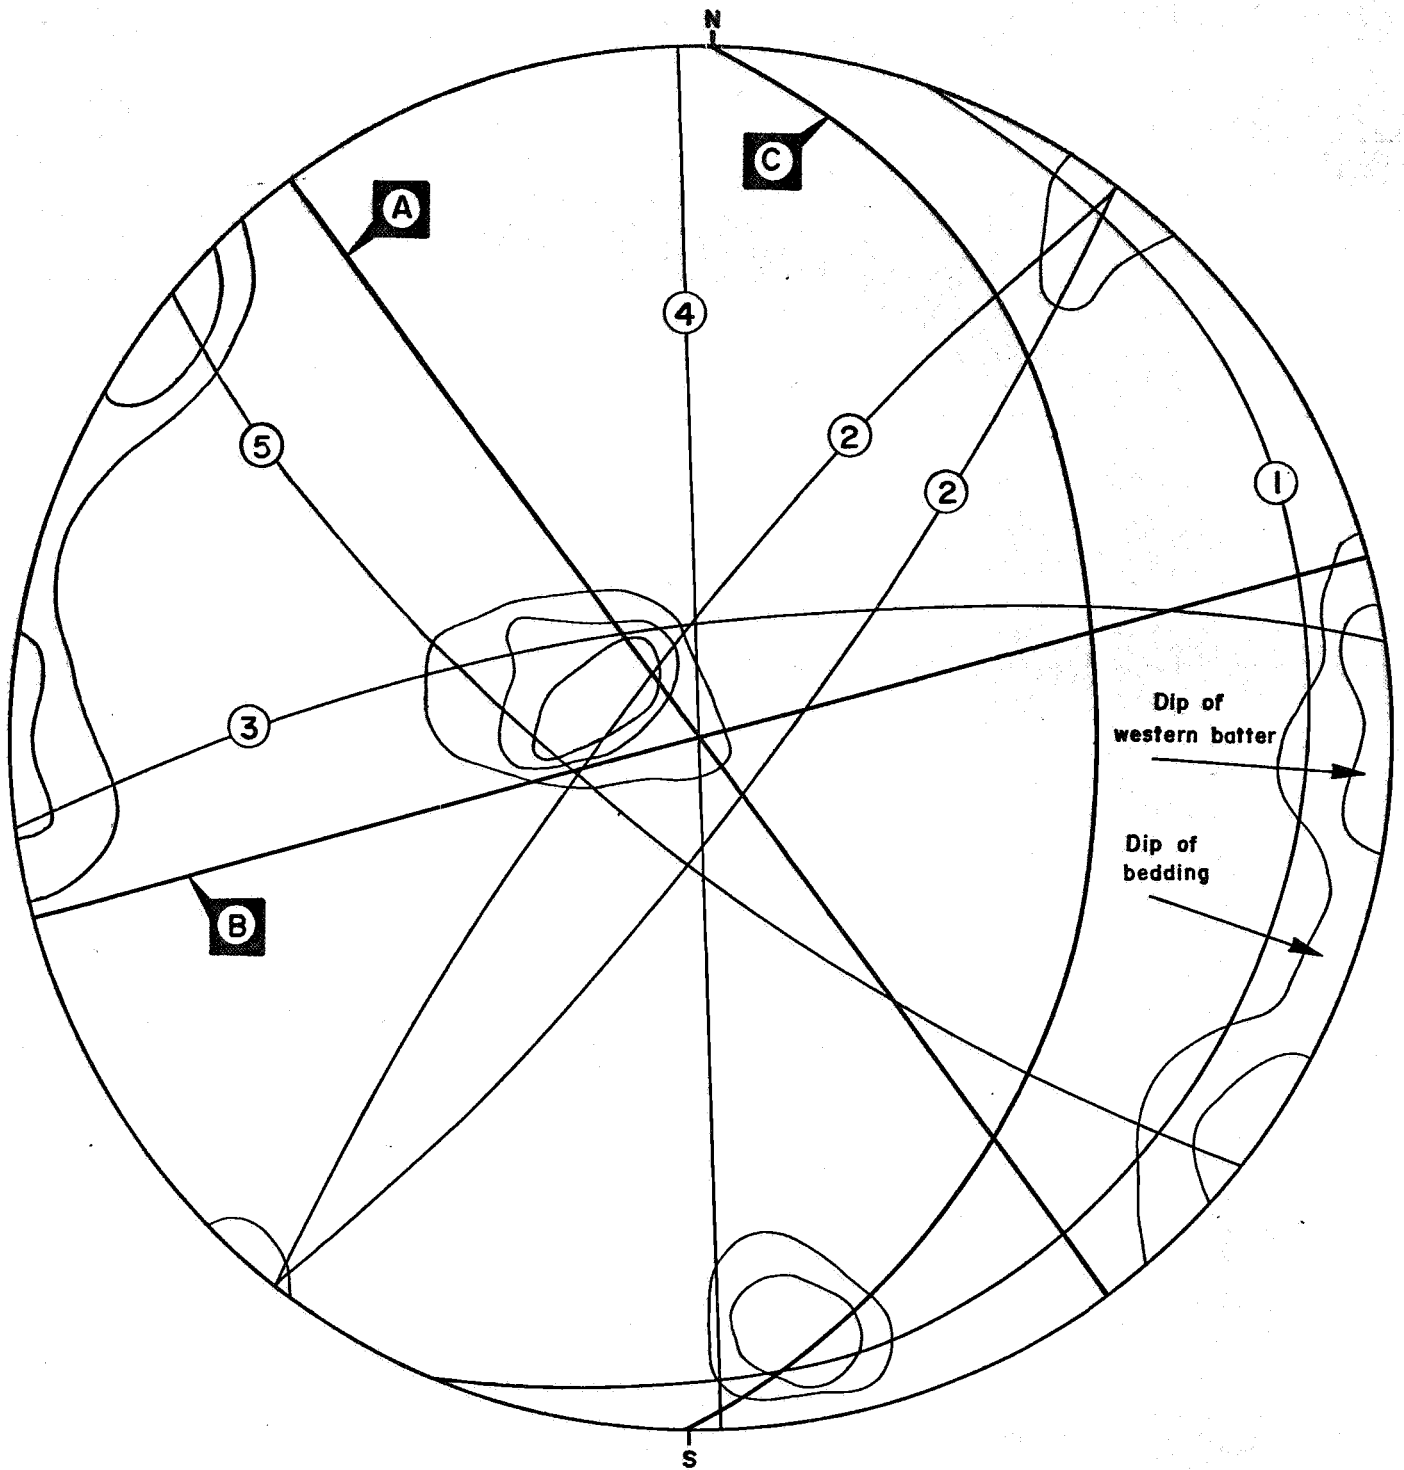
FIG. 57

Field data for the fracture analyses is shown as poles plotted on a stereogram (Figure 56). A summary of the field data for the eastern, central and western batters is shown in Figure 57 and the batters are referred to respectively as Regime I, II & III (Figure 58). Rock falls from the vertical batters of the central and eastern faces of the quarry can be expected with maximum block sizes of up to 1.0 m x 1.0 m x 0.50 m. Placement of a shallow ditch and cyclone fence at the foot of the batters has been advised, to prevent falling boulders from reaching the treatment works.

- ① Bedding plane.
- ② Near vertical joints in quartzite and dolomite.
- ③ Steep joints mainly found in quartzite and associated with shear zone.
- ④ Vertical joints mainly found in dolomite.
- ⑤ Near vertical joint mainly found in quartzite.

- A** EASTERN BATTERS VERTICAL
- B** CENTRAL BATTERS VERTICAL
- C** WESTERN BATTERS 40°-45°
