DEPARTMENT OF MINES AND ENERGY
SOUTH AUSTRALIA

REPORT OF INVESTIGATIONS

THE ENGINEERING GEOLOGY
OF THE LITTLE PARA
DAM SITE

October, 1979

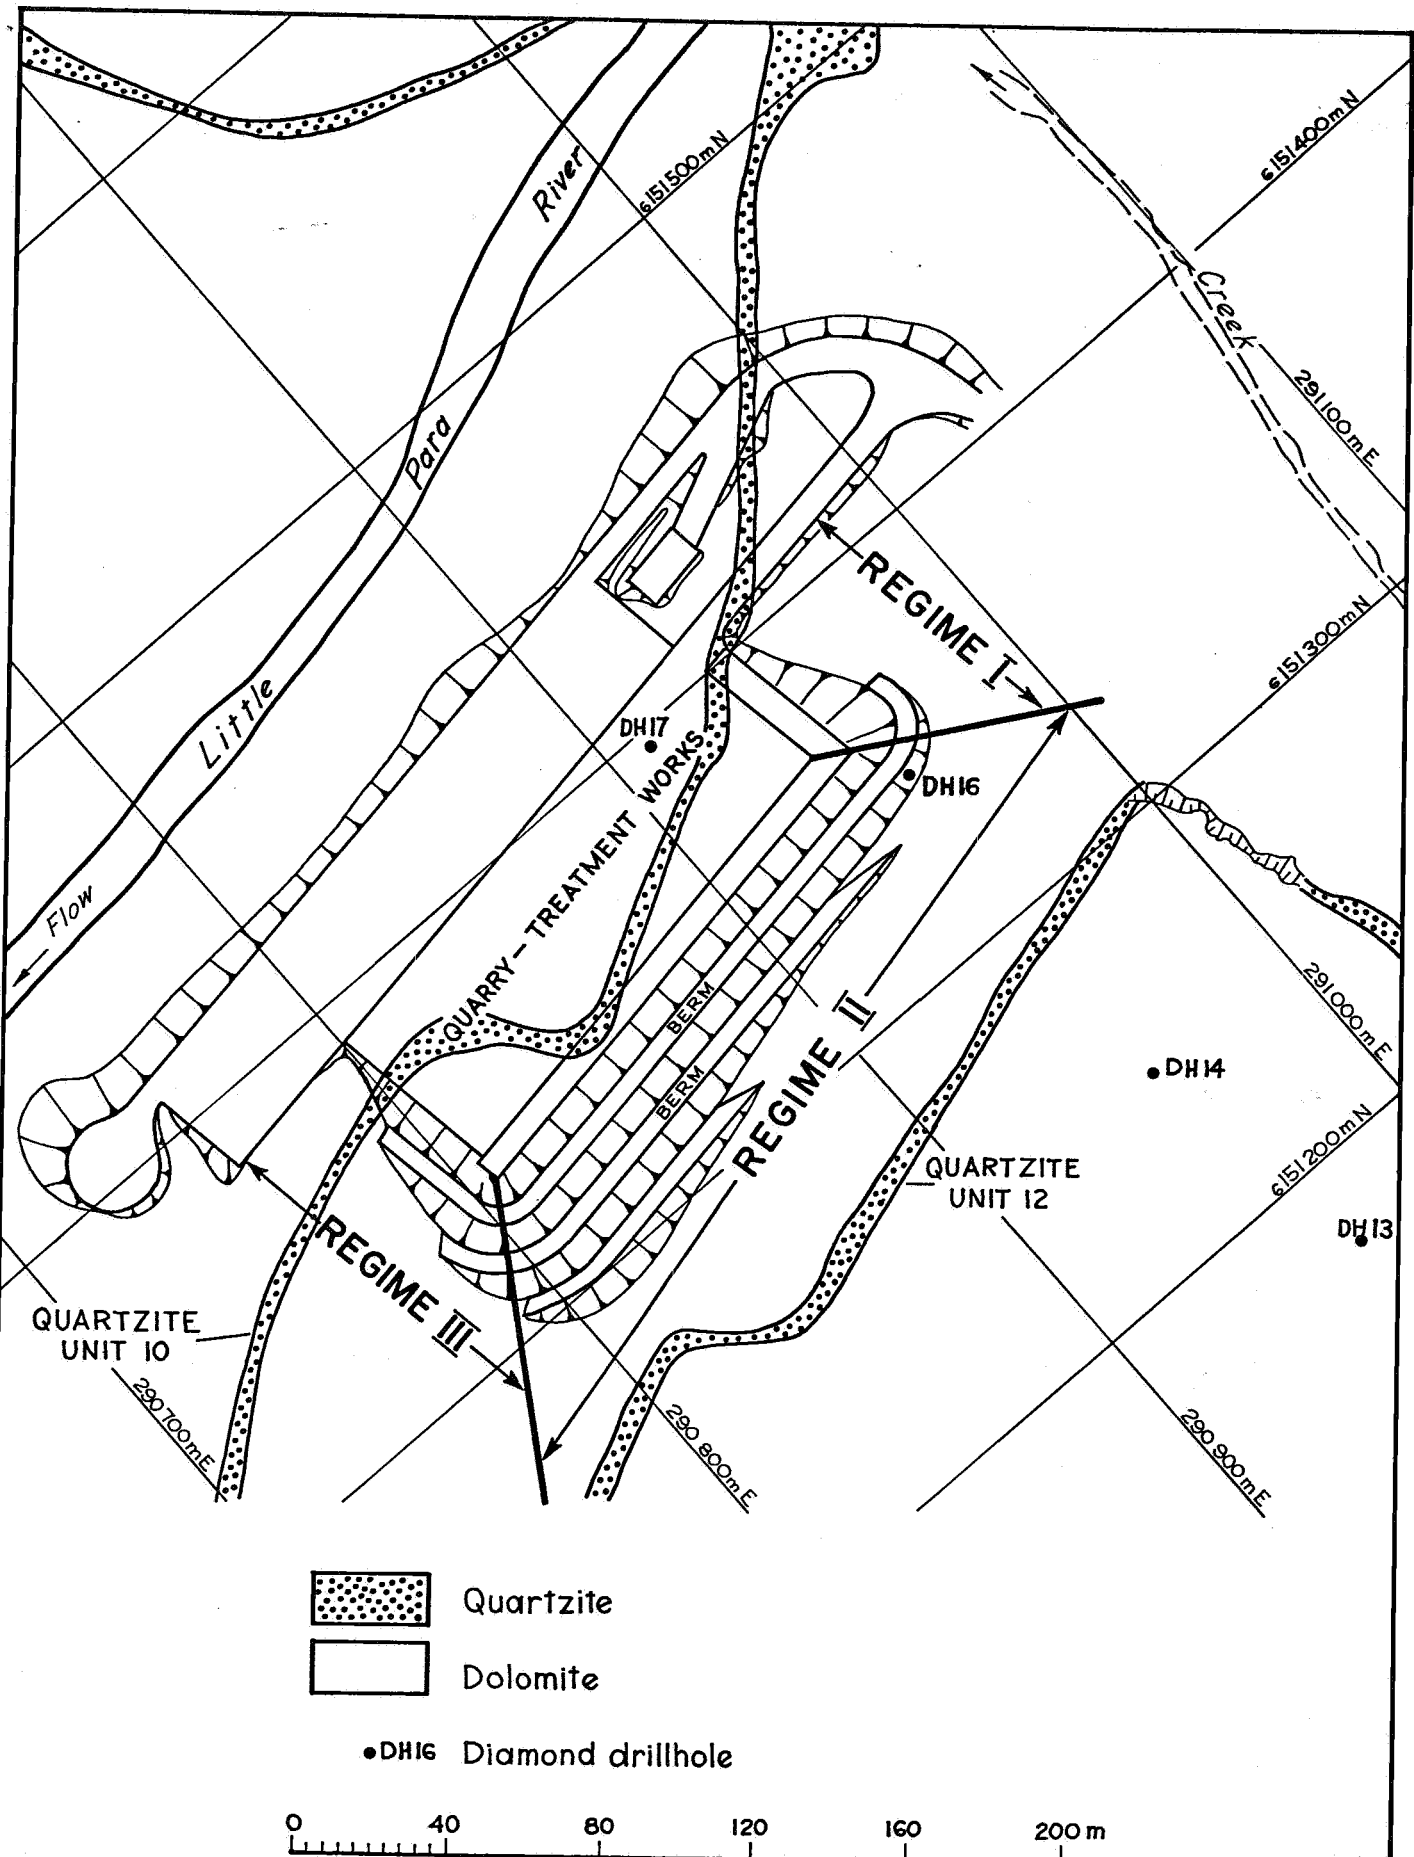
FIG. 58

Field data for the fracture analyses is shown as poles plotted on a stereogram (Figure 56). A summary of the field data for the eastern, central and western batters is shown in Figure 57 and the batters are referred to respectively as Regime I, II & III (Figure 58). Rock falls from the vertical batters of the central and eastern faces of the quarry can be expected with maximum block sizes of up to 1.0 m x 1.0 m x 0.50 m. Placement of a shallow ditch and cyclone fence at the foot of the batters has been advised, to prevent falling boulders from reaching the treatment works.

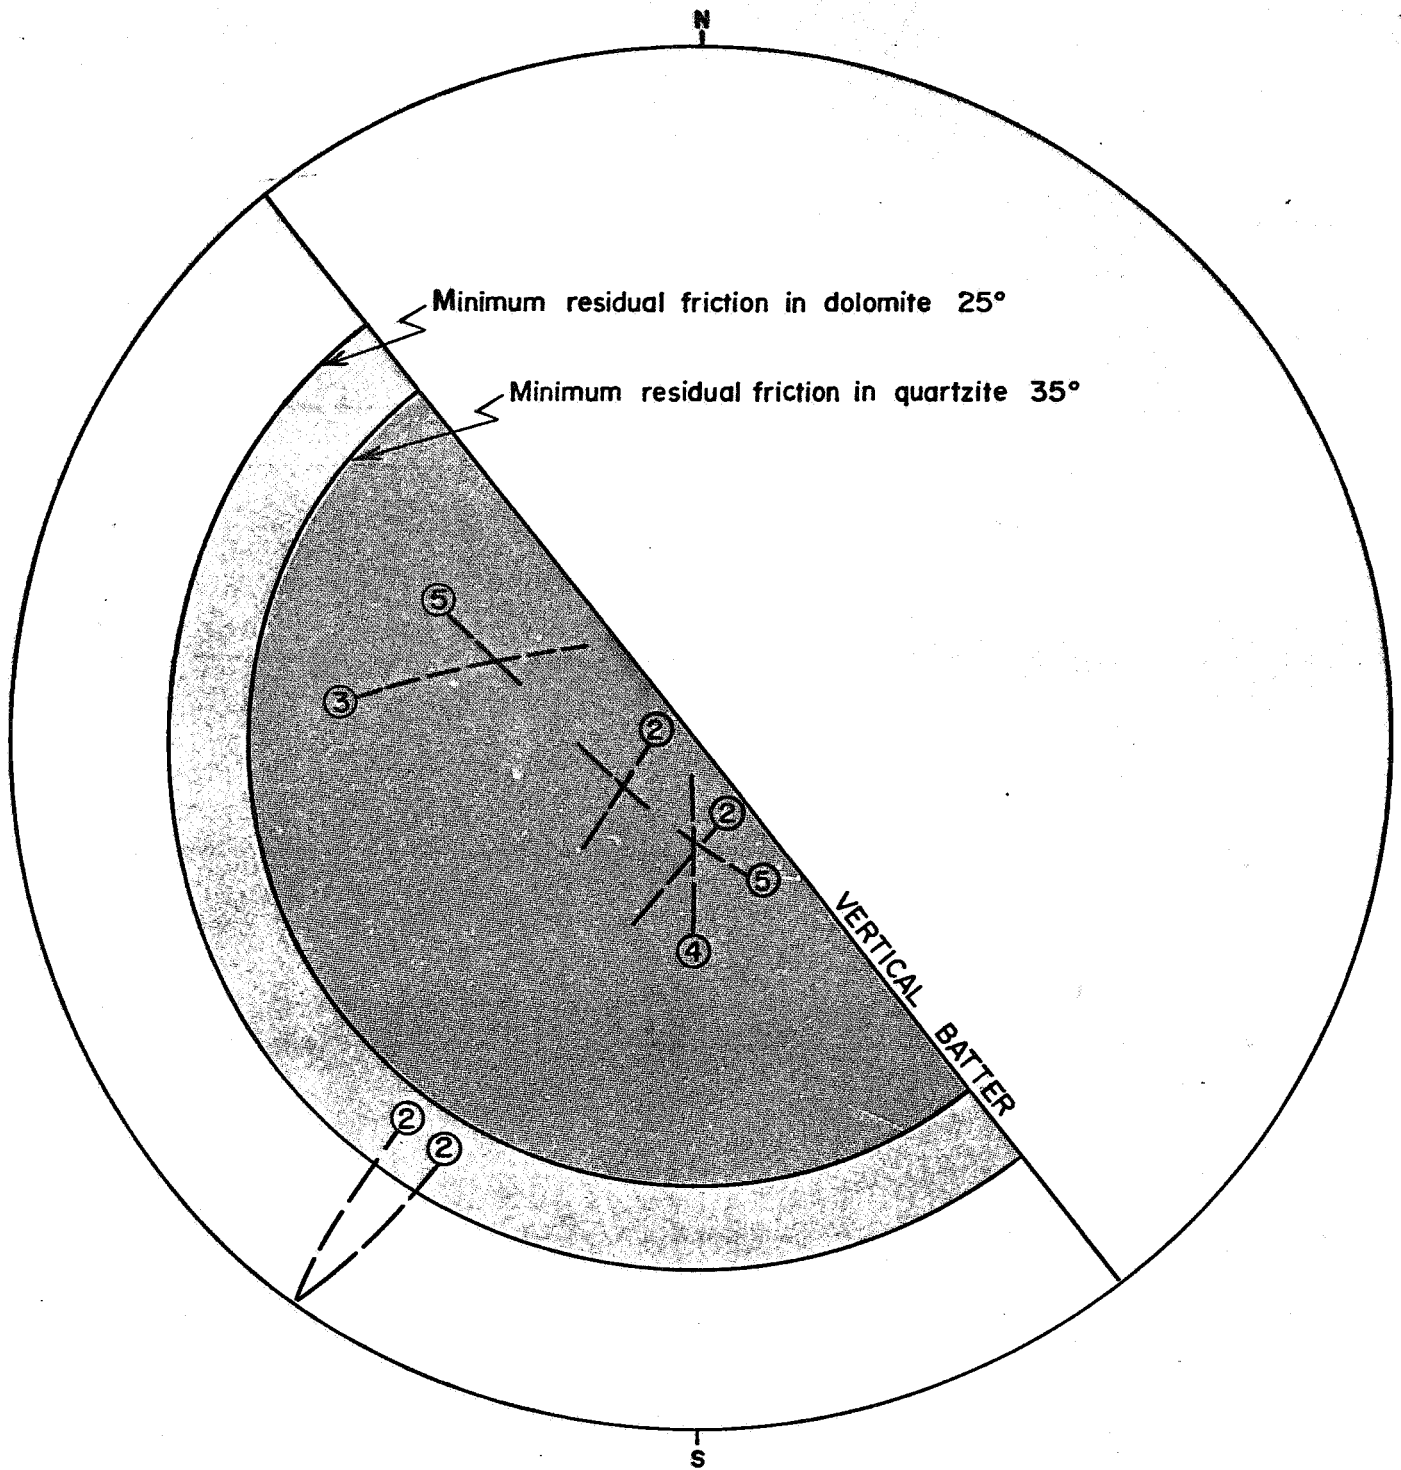
NO LARGE SCALE INSTABILITY

FAILURE MODE	FRACTURE INTERSECTIONS
Small wedge-blocks	5 and 3 ; 2 and 5 ; 5 and 4

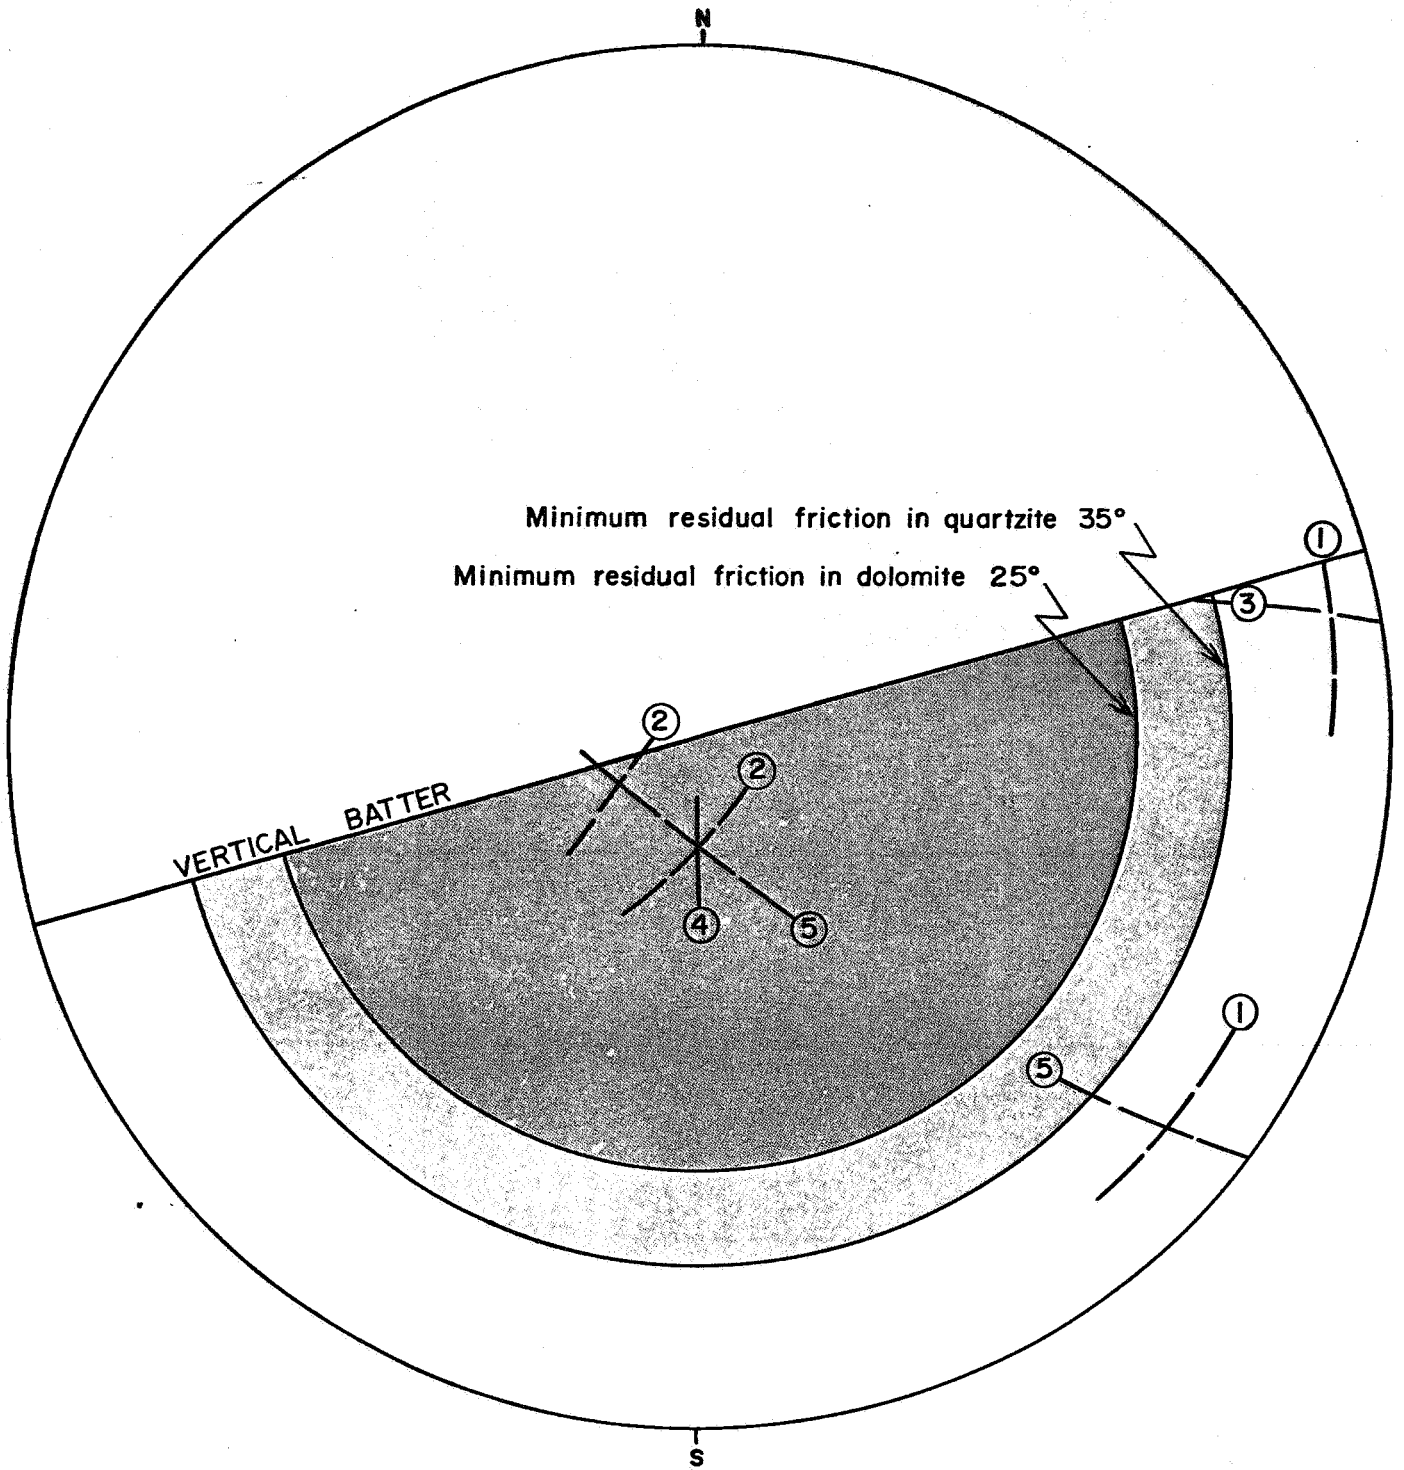
FIG. 60

FAILURE MODE	FRACTURE INTERSECTIONS
Wedge failure of small blocks	2 and 5 ; 4 and 5

Intersections falling within shaded areas forms potentially unstable wedges.

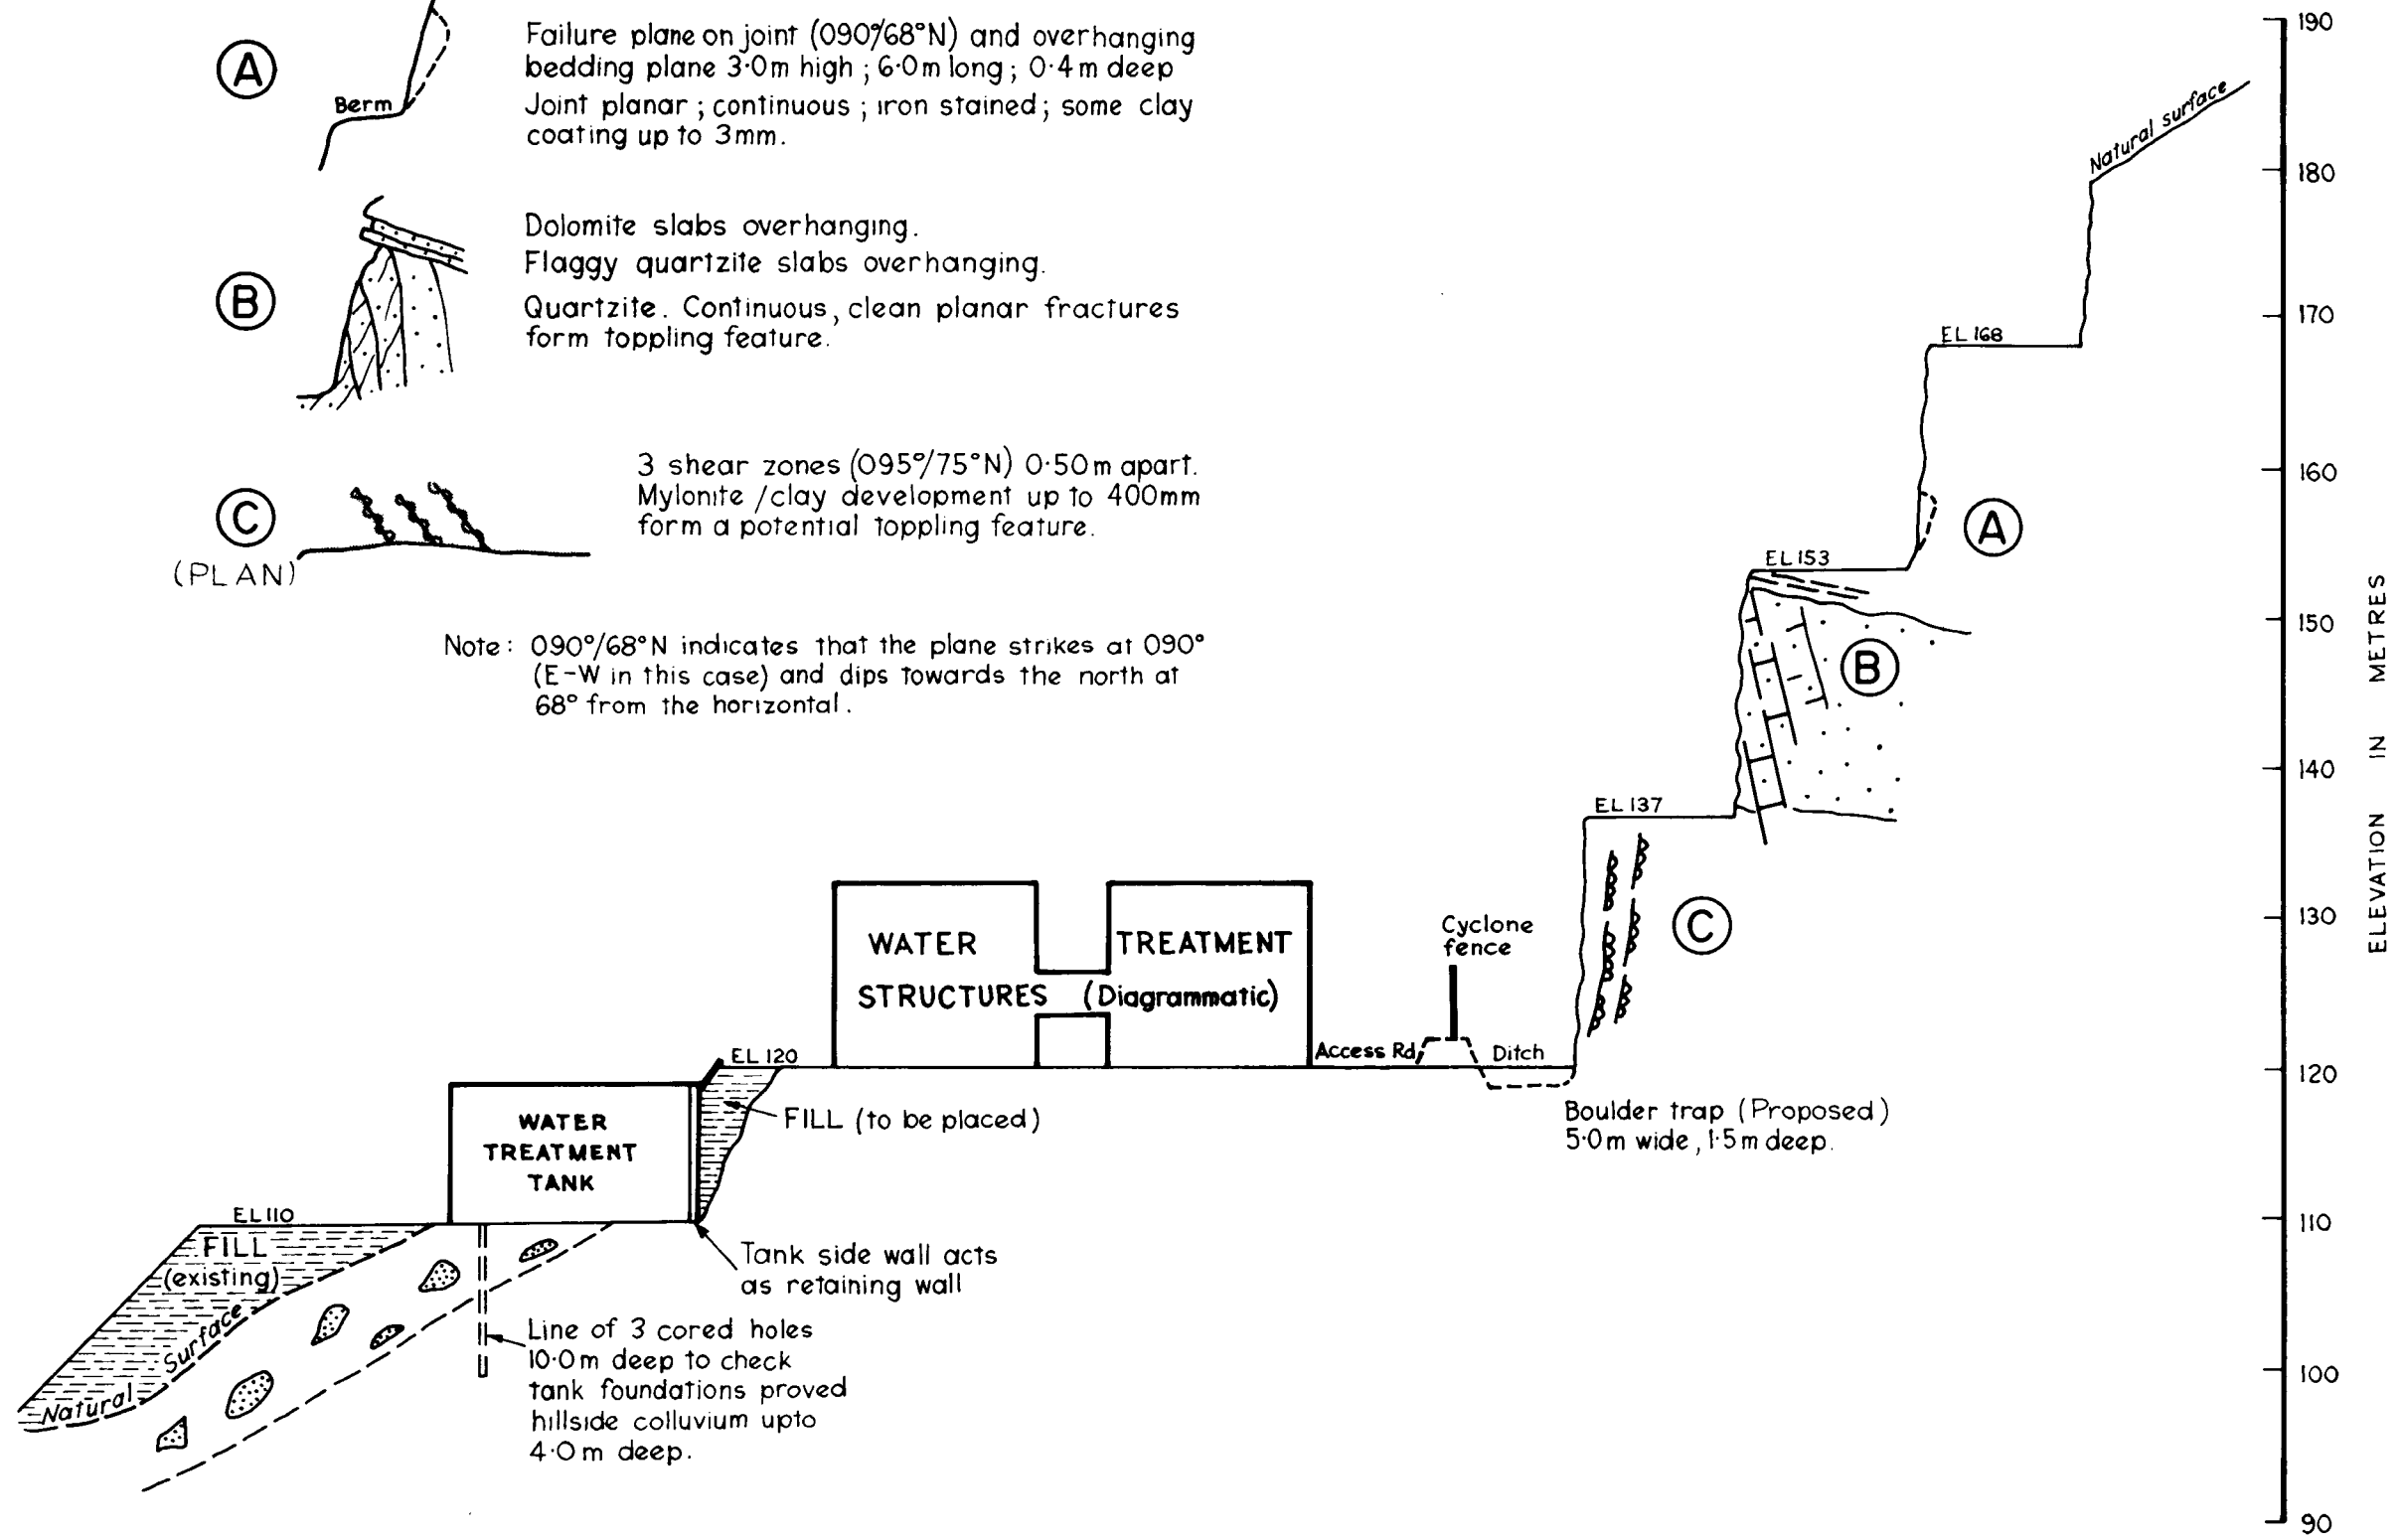
FIG. 62

Mylonite occurs in three 200 mm - 400 mm wide shear zones 0.50 m apart found in the centre of the quarry at EL. 110 - EL. 123 within the quartzite stratum traversing the quarry. (Quarry profile summary Figure 62). Discontinuous joints, parallel to these shears, are clay coated and where they intersect open bedding planes form the main toppling feature.

Failure plane on joint (090°/68°N) and overhanging bedding plane 3.0m high ; 6.0m long ; 0.4 m deep
 Joint planar ; continuous ; iron stained ; some clay coating up to 3mm.

Dolomite slabs overhanging.
 Flaggy quartzite slabs overhanging.
 Quartzite. Continuous, clean planar fractures form toppling feature.

3 shear zones (095°/75°N) 0.50m apart.
 Mylonite /clay development up to 400mm form a potential toppling feature.

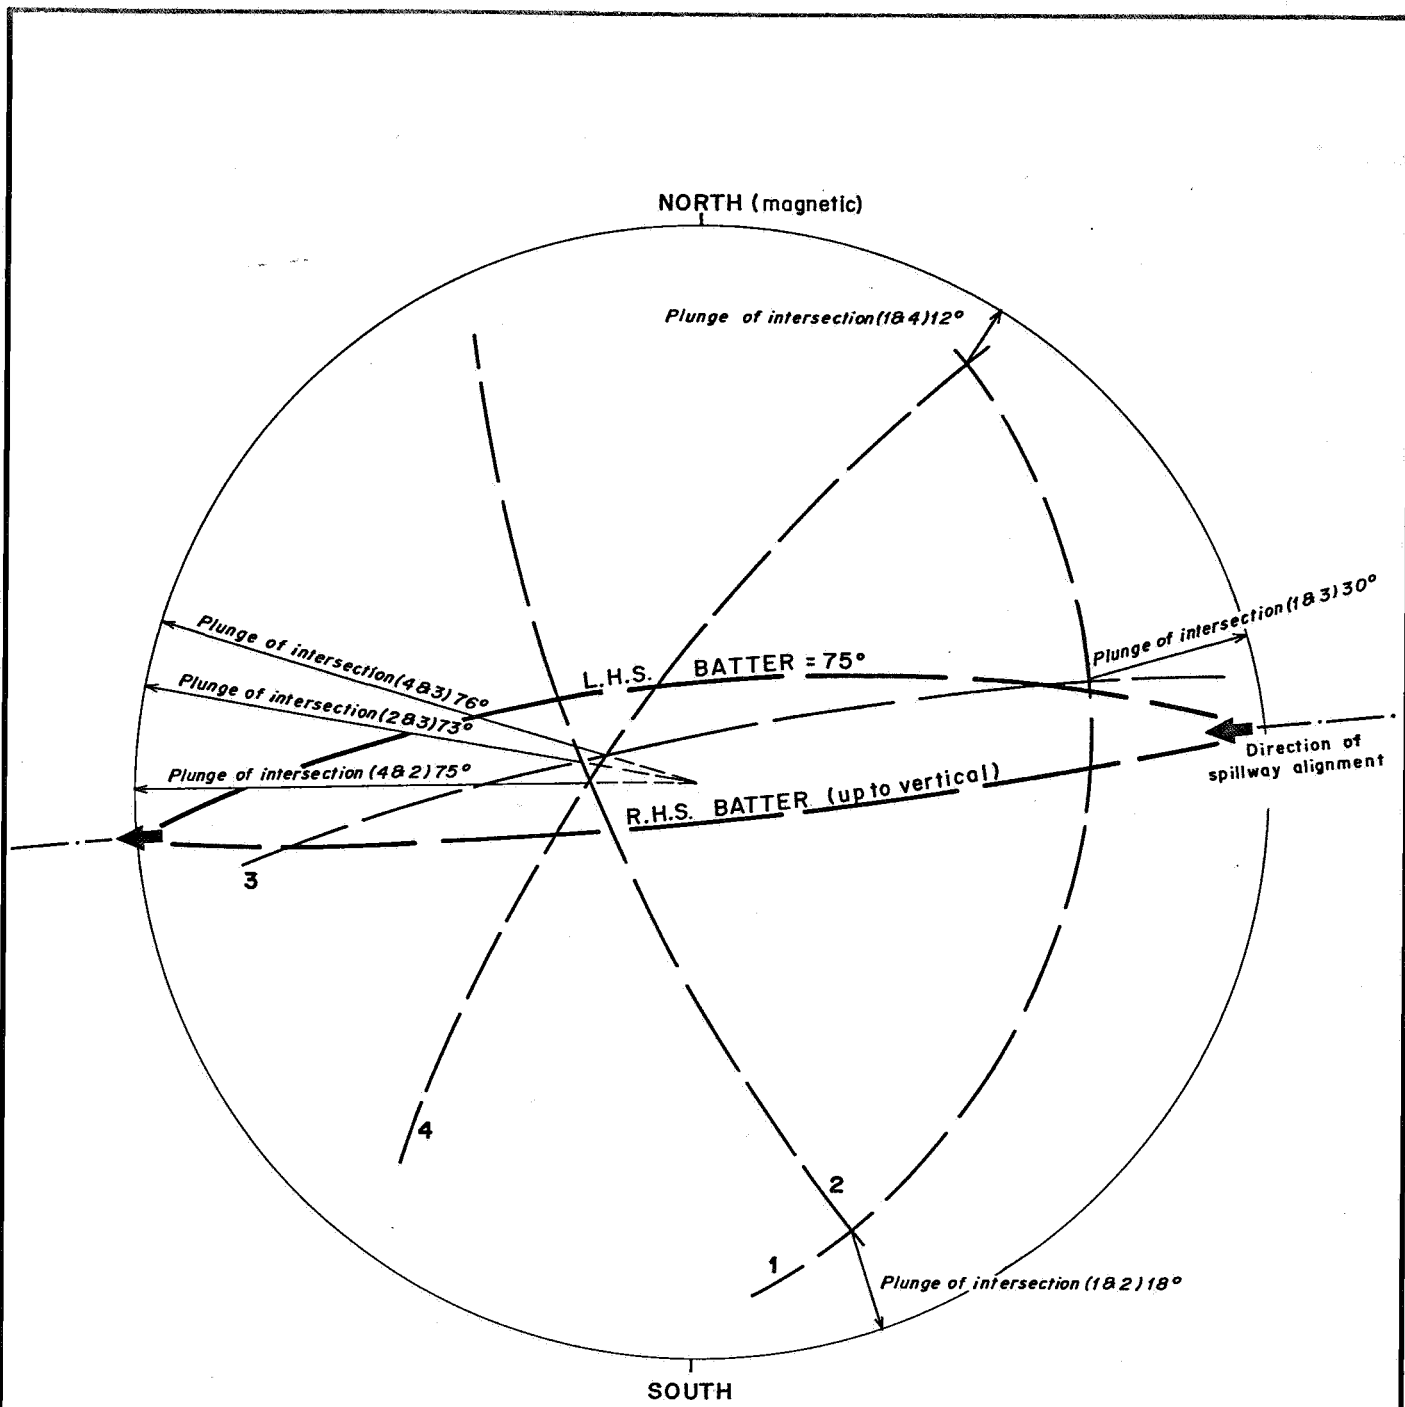
Fig. 63

Dip and strike measurements of fractures were taken on outcrops of the dolomitic siltstone and quartzite, and their poles plotted on a stereogram (Figure 63).

The bedding and cleavage in the dolomitic siltstone are sub-parallel to one another. Measurements taken along the spillway alignment show strikes and dips ranging from $005/29^{\circ}$ eastwards to $015/35^{\circ}$ eastwards, with rare exceptions dipping up to 48° eastwards. The mean is taken as $012/33^{\circ}\text{E}$ and is shown as Group 1 in the table below and in Figure 62.

FEATURE	STRIKE	DIP
1 Bedding	012°	33°E
2 Joint	156°	76°W
3 Joint	078°	83°N
4 Joint	215°	77°W
