REPT.BK.NO. 84/36
HAPPY VALLEY FILTRATION PLANT:
PROGRESS REPORT TO NOVEMBER
1983

GEOLOGICAL SURVEY

J.C. BEAL

MAY 1984

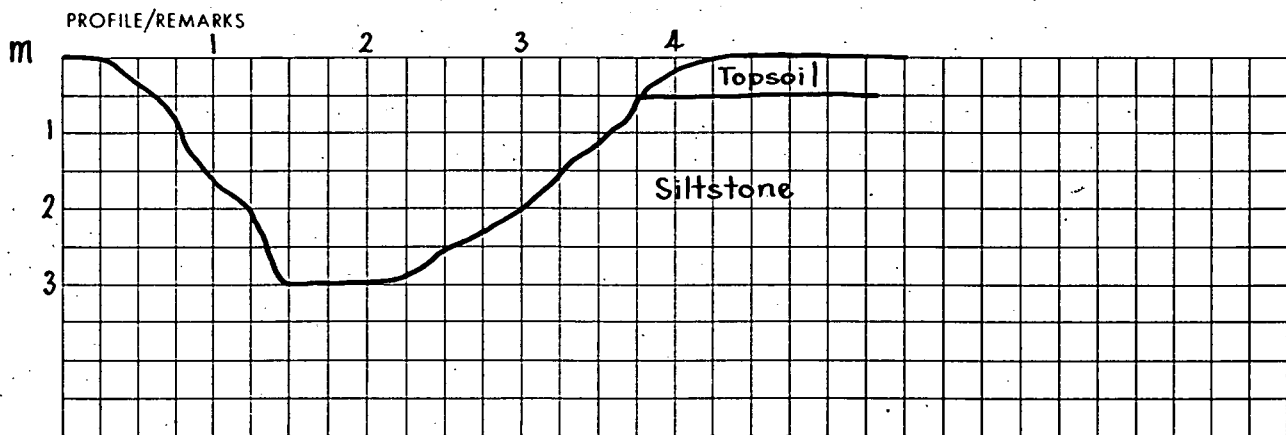
FORMATION SOIL HORIZON	PROFILE		UNIFIED SYMBOL	DESCRIPTION AND STRUCTURE (UNIFIED SOIL CLASSIFICATION)	WATER LEVEL	MOISTURE CONTENT	CONSISTENCY REL. DENSITY	TEST - *	SAMPLE - ■
	ELEV. m	DEPTH m							
A B			ML CL	Topsoil + 'B' Horizon					
		1		Siltstone Cream/pink - pale brown (HW) - (MW); W-MS		DRY			
		2							
		3

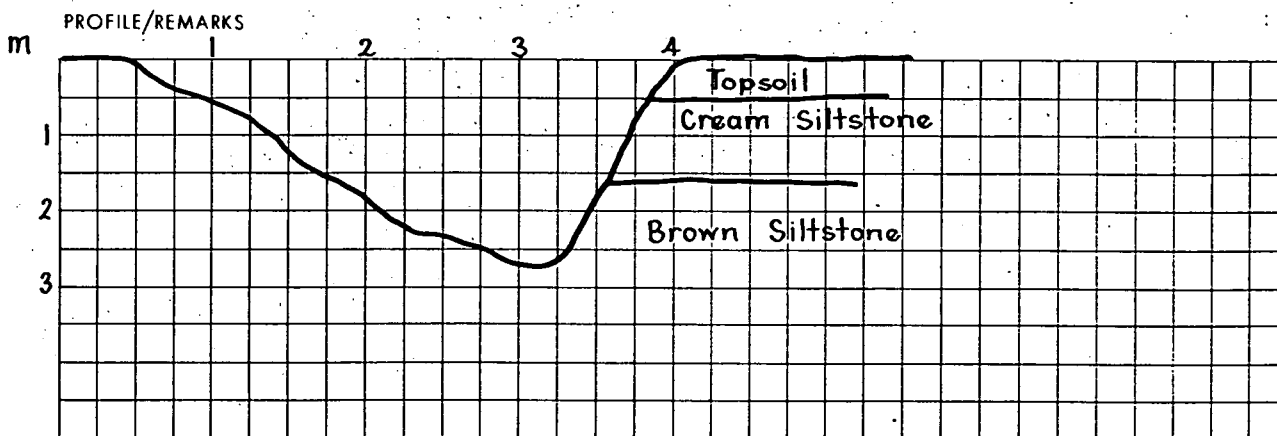
FORMATION SOIL HORIZON	PROFILE		UNIFIED SYMBOL	DESCRIPTION AND STRUCTURE (UNIFIED SOIL CLASSIFICATION)	WATER LEVEL	MOISTURE CONTENT	CONSISTENCY REL. DENSITY	TEST - *	SAMPLE - ■
	ELEV. m	DEPTH m							
A B			ML CL	Topsoil + 'B' Horizon					
		1		Siltstone Cream - pale brown (HW) - (MW); MS. Blocky, up to fist size	DRY				
		2		Brown

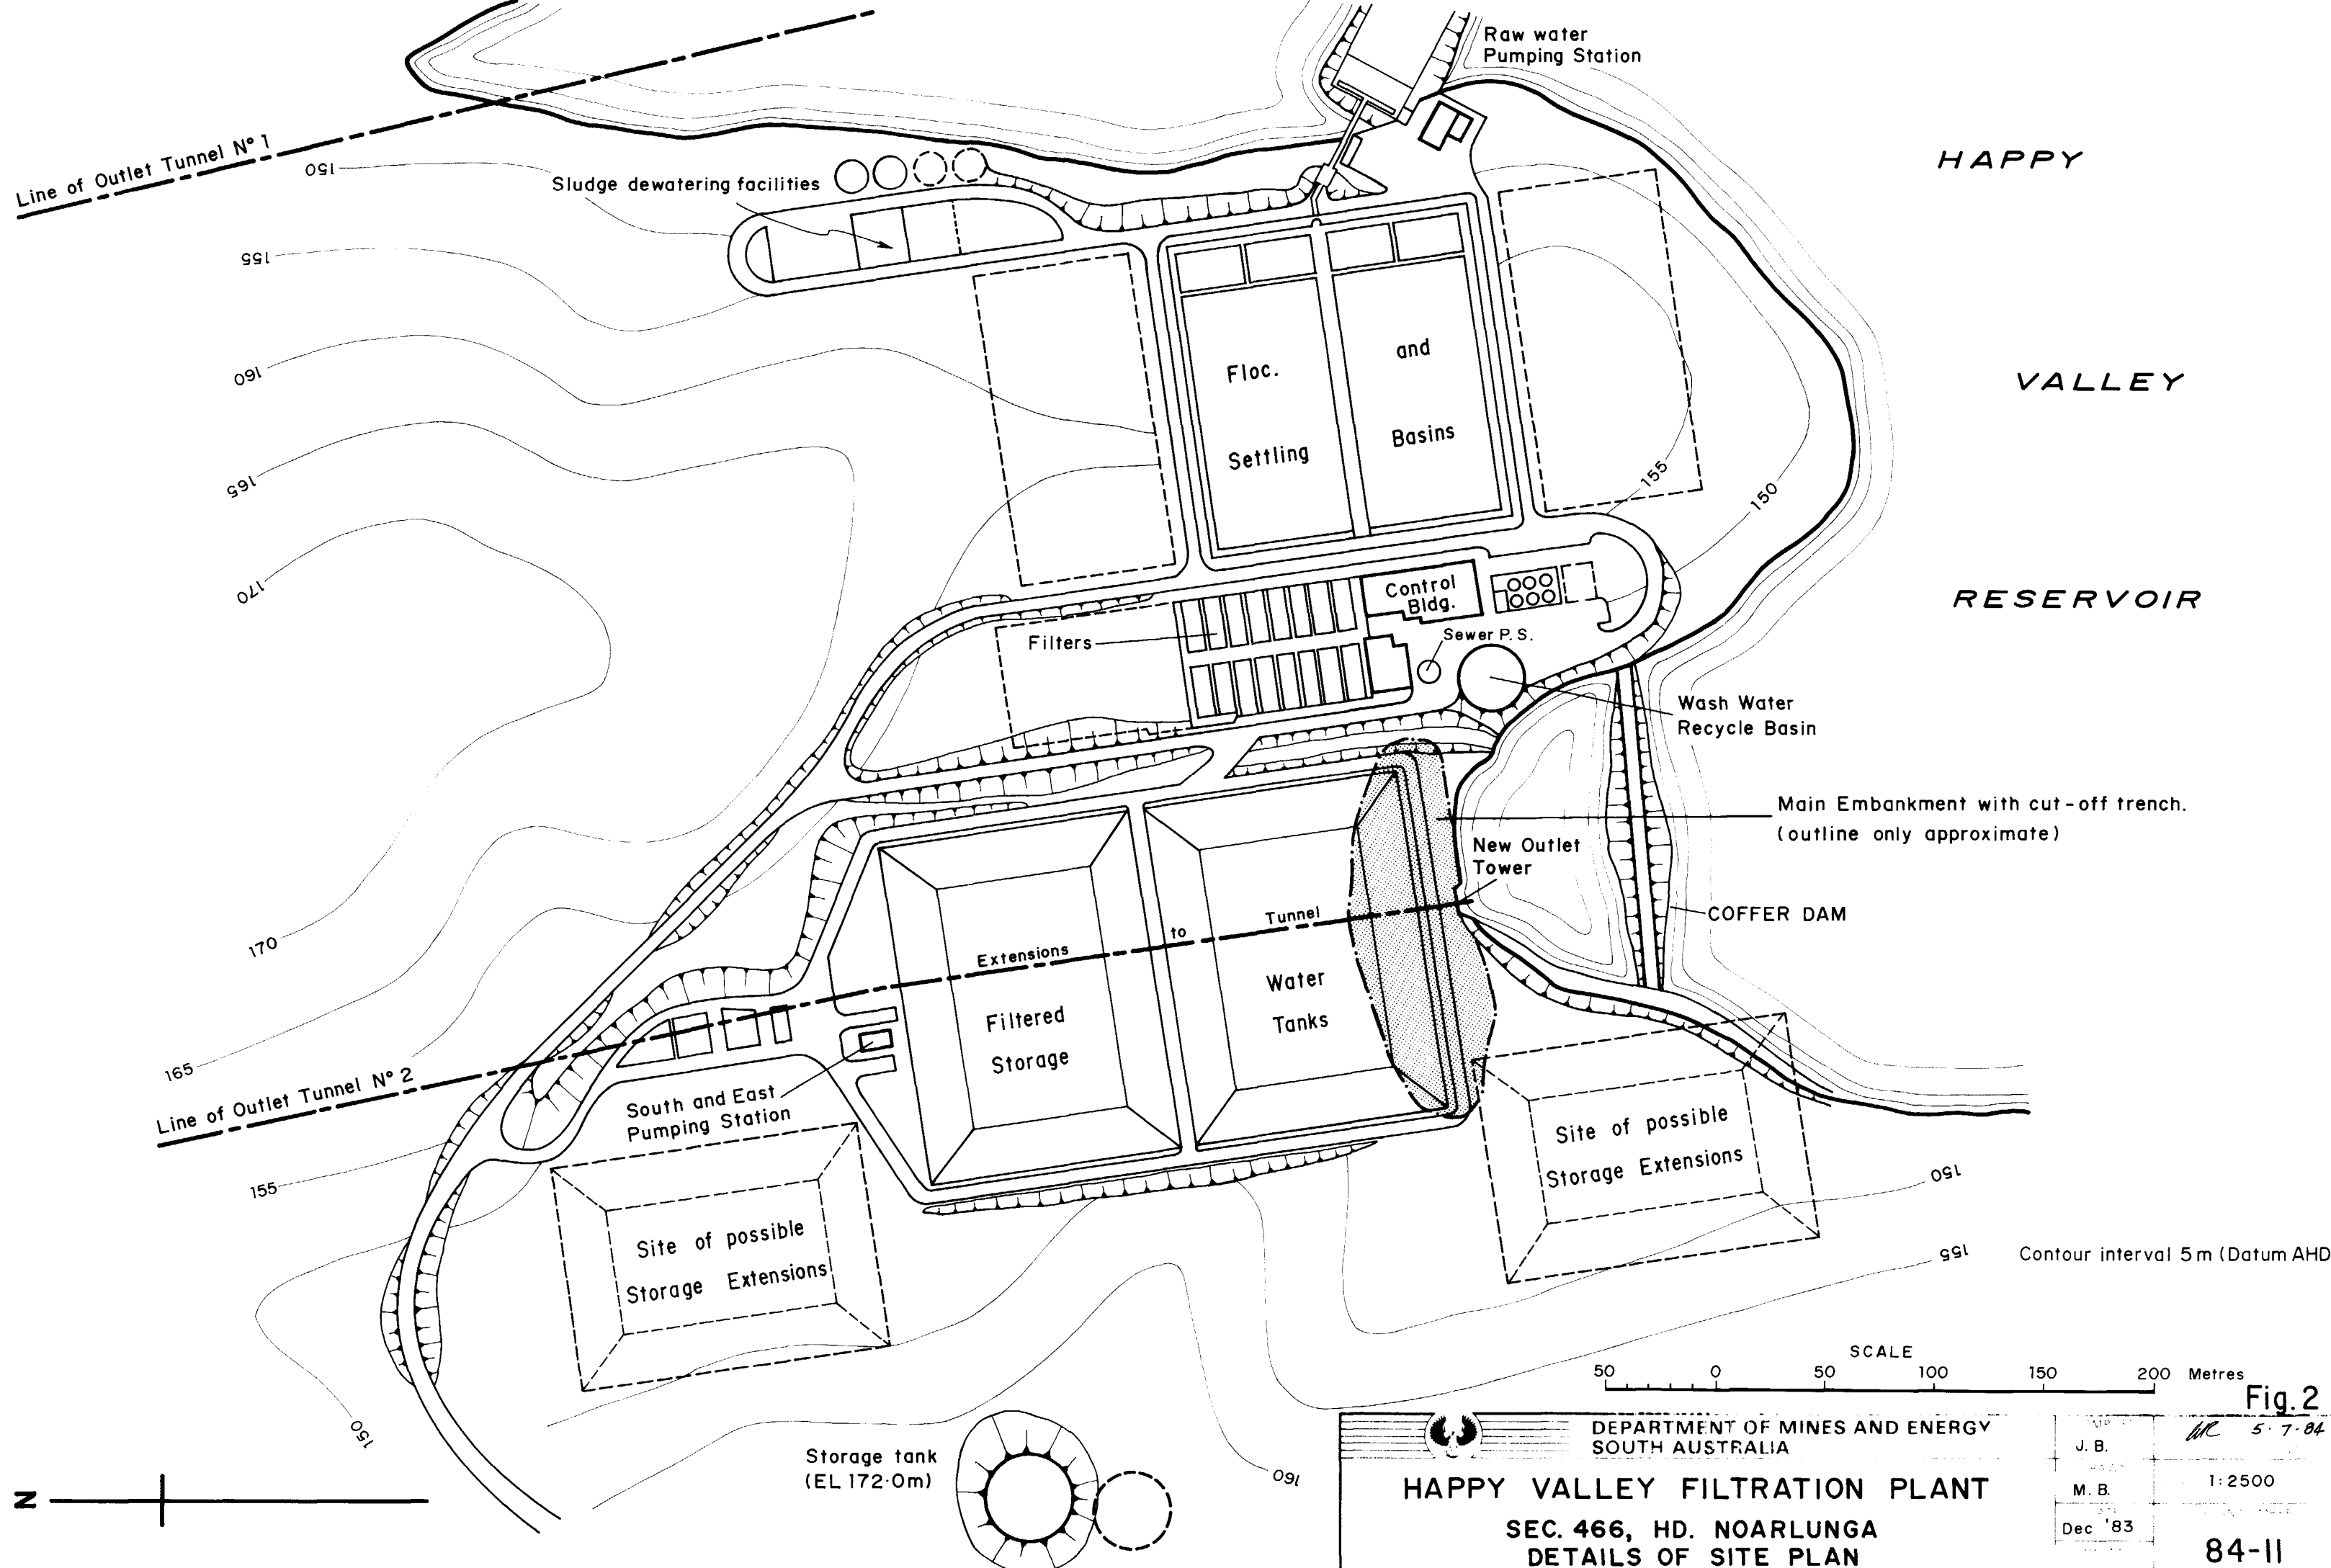
DEPARTMENT OF MINES AND ENERGY SOUTH AUSTRALIA		COMPILED J. B.	WR 5.7.84 C.D.O. DATE
	HAPPY VALLEY FILTRATION PLANT		DRAWN M. B.	SCALE
	DIAGRAMMATIC PLAN OF COFFER DAM		DATE Dec '83	PLAN NUMBER
			CHECKED	S17182

To enable construction of the filtration plant an coffer-dam was constructed across the arm of the reservoir leading to the new Happy Valley outlet tunnel. The coffer-dam consisted of driven sheet piling supported by placed coarse aggregate. After dewatering three or four springs (leakages) occurred from the north face of the embankment and two cable-tool holes (CHCD1; CHCD2) were drilled through the coffer-dam embankment (Figure 3 and plate 1) in an attempt to discover the cause.
