REPT.BK.NO. 85/51
STABILITY ASSESSMENT OF REHABILI-
TATION AREA, READYMIX-FARLEY
QUARTZITE QUARRY (RIVERVIEW
HIGHBURY).

J.C. BEAL

OCTOBER, 1985

STABILITY ASSESSMENT OF REHABILITATION AREA, READYMIX -
FARLEY QUARTZITE QUARRY (RIVERVIEW), HIGHBURY

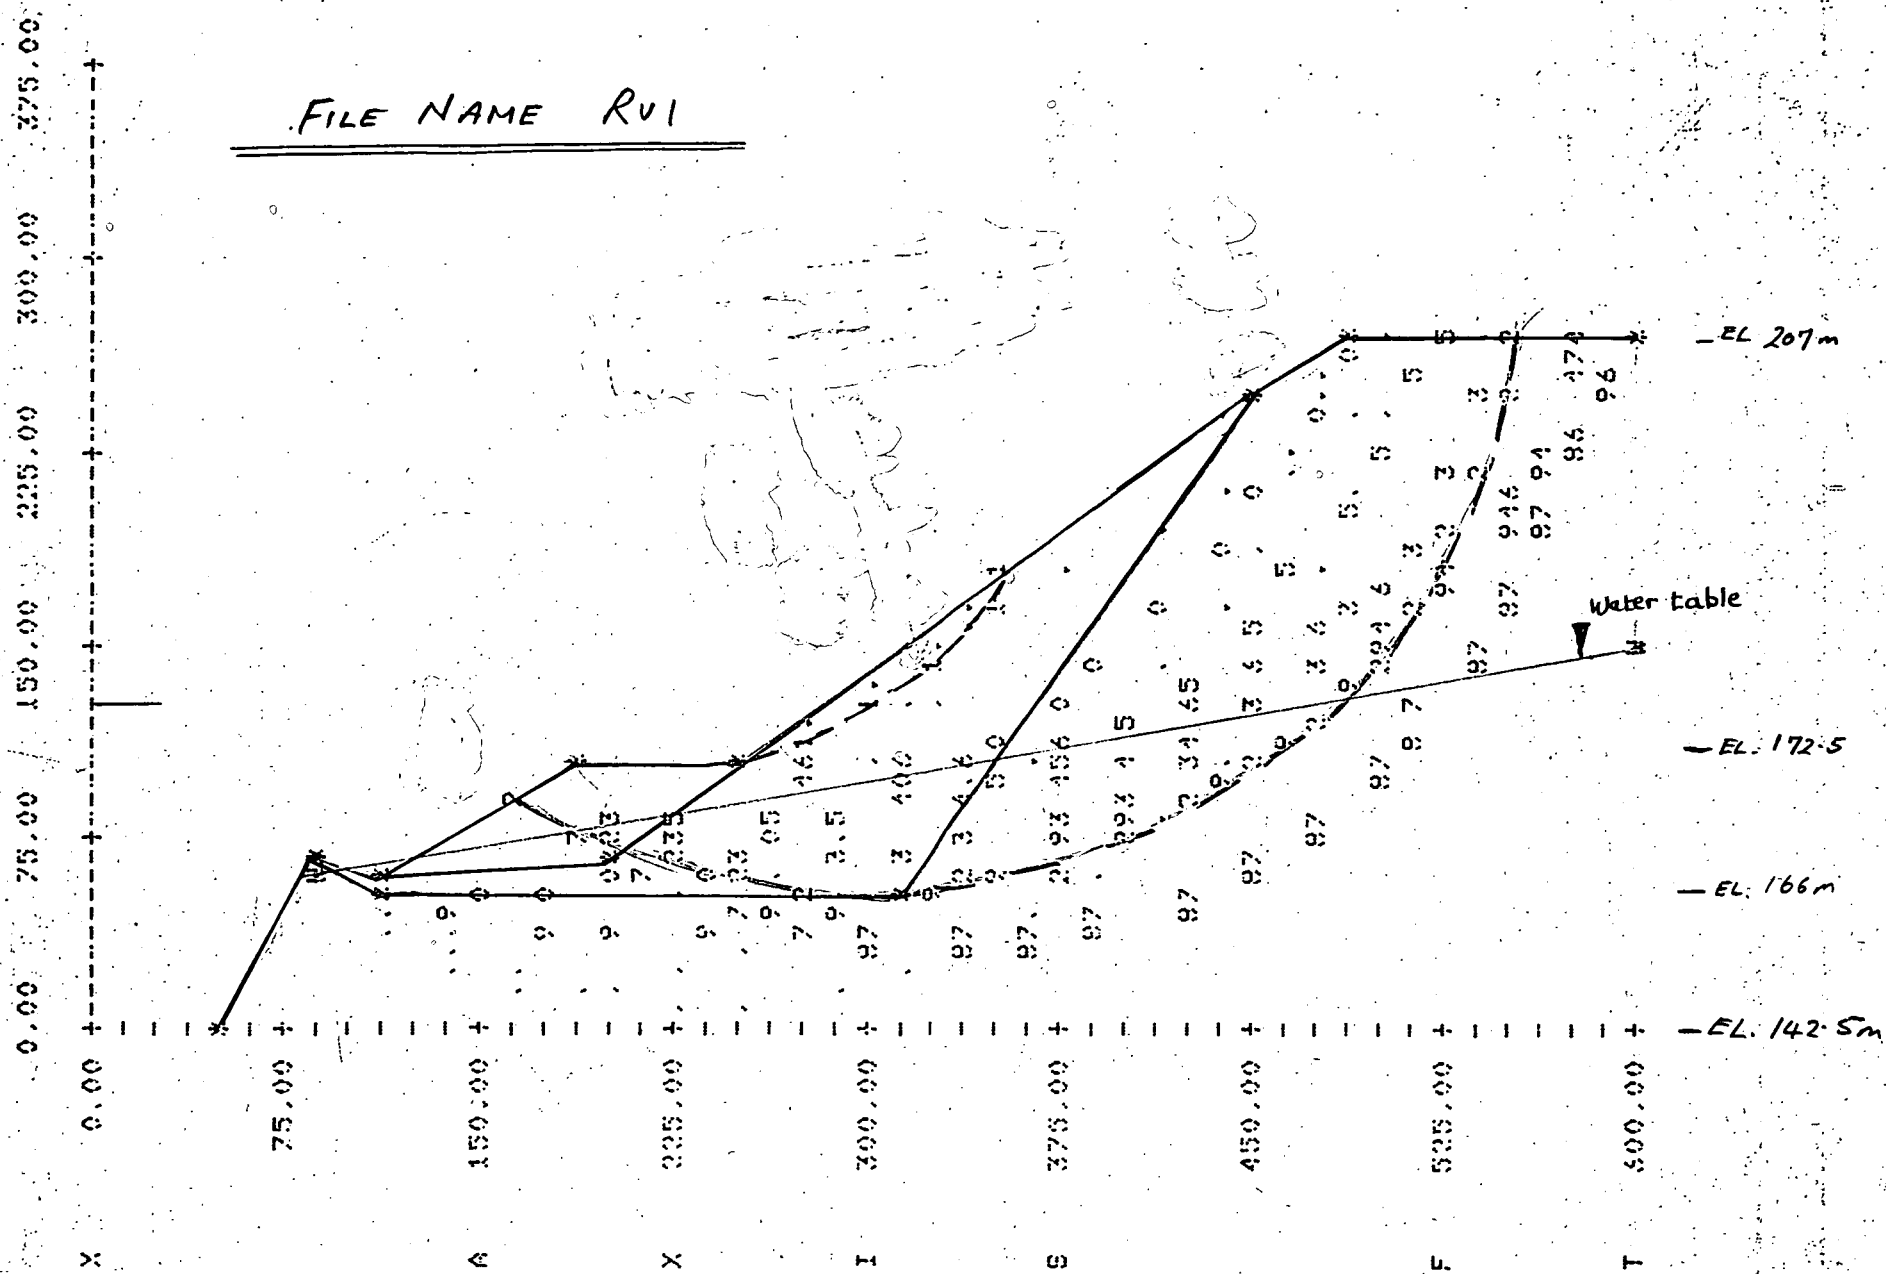
FILE NAME RV1

The programme repeatedly locates slip-failure surfaces and identifies the slip-circle associated with the minimum F.O.S. which in the cases examined range from 0.956 to 0.984, again underlining the unstable nature of the waste-fill. The slip circles in question are located above both water-table and toe-fill.

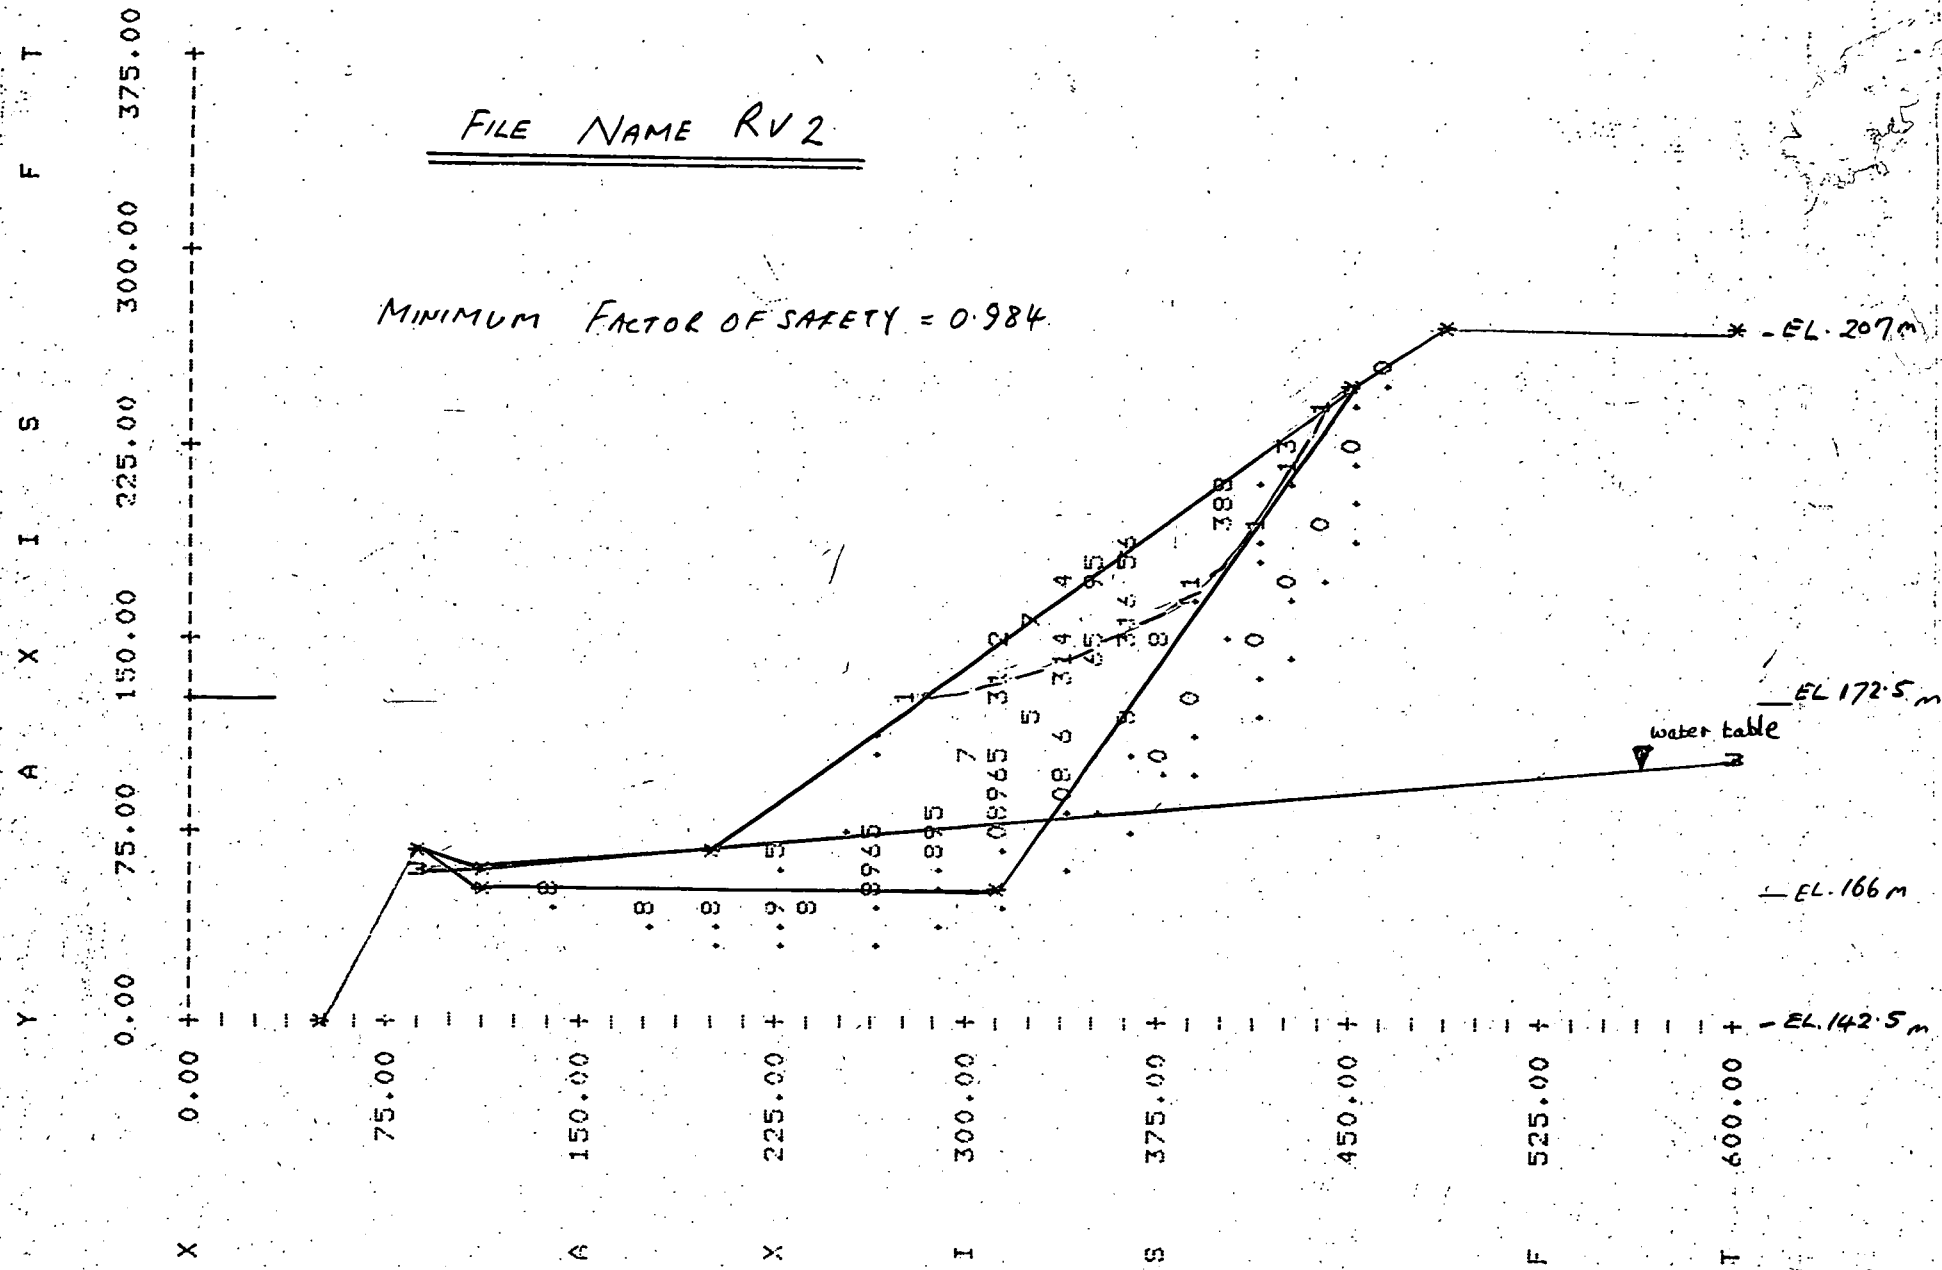
FILE NAME RV2

MINIMUM FACTOR OF SAFETY = 0.984

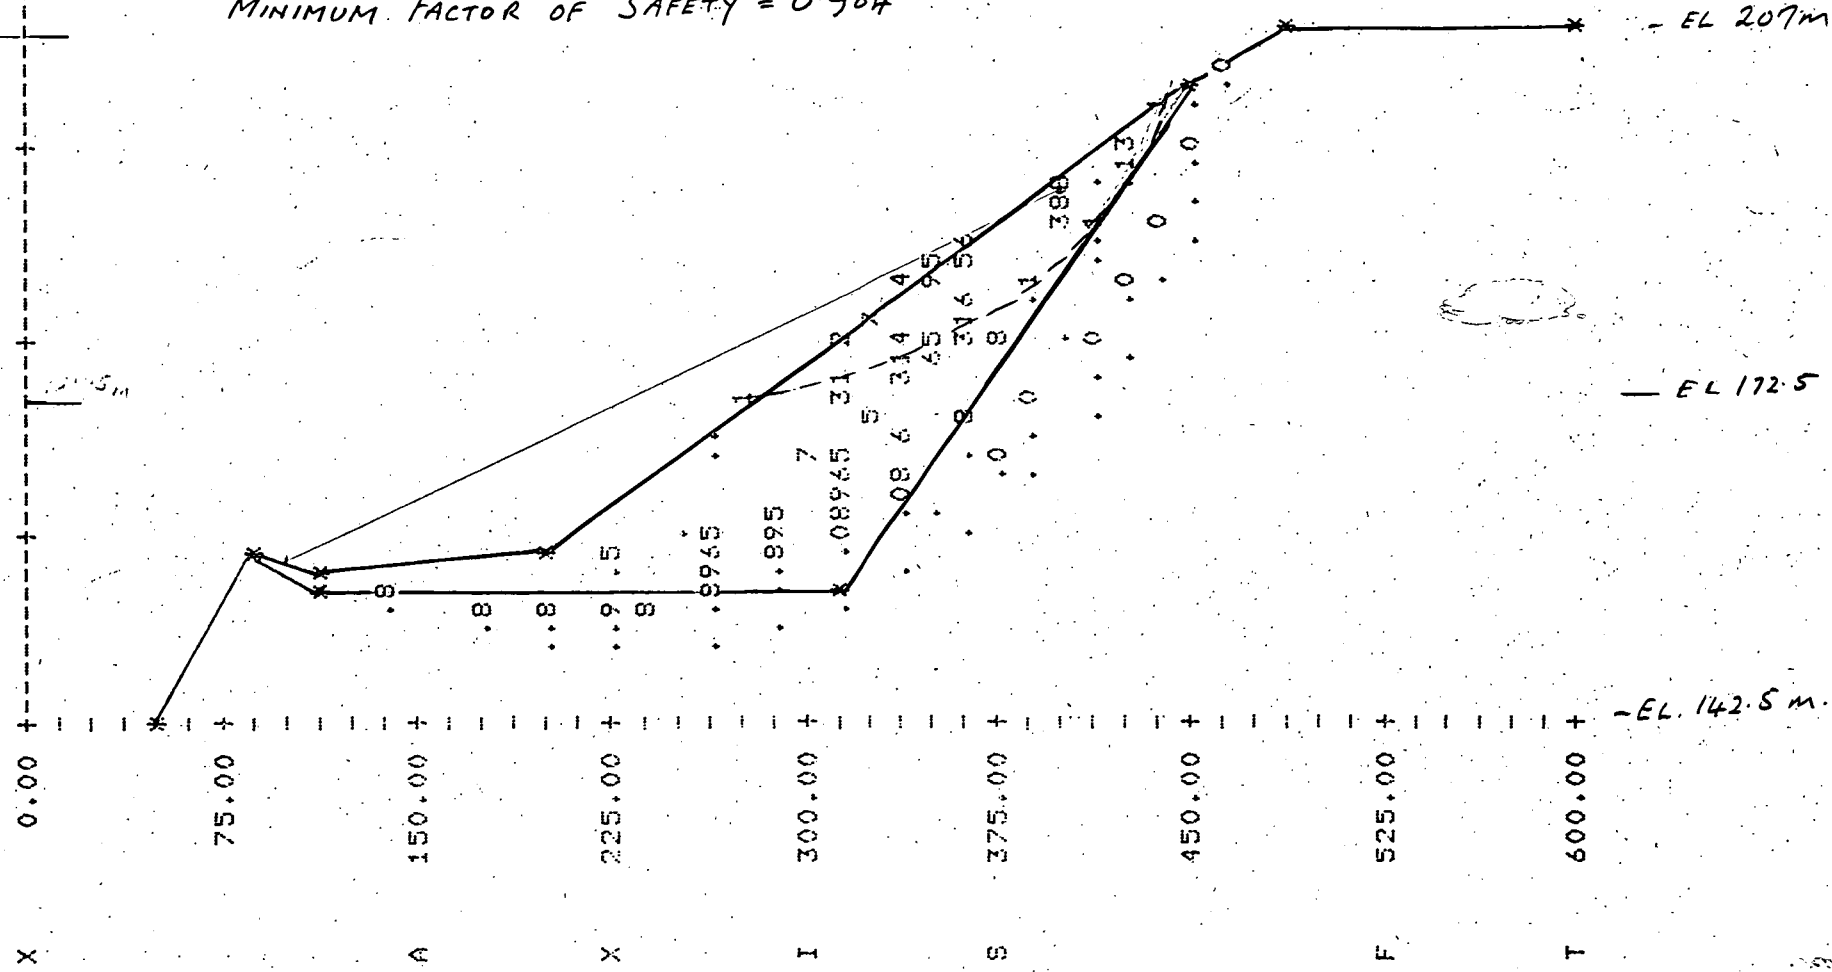
FILE NAME RV3...

MINIMUM FACTOR OF SAFETY = 0.984

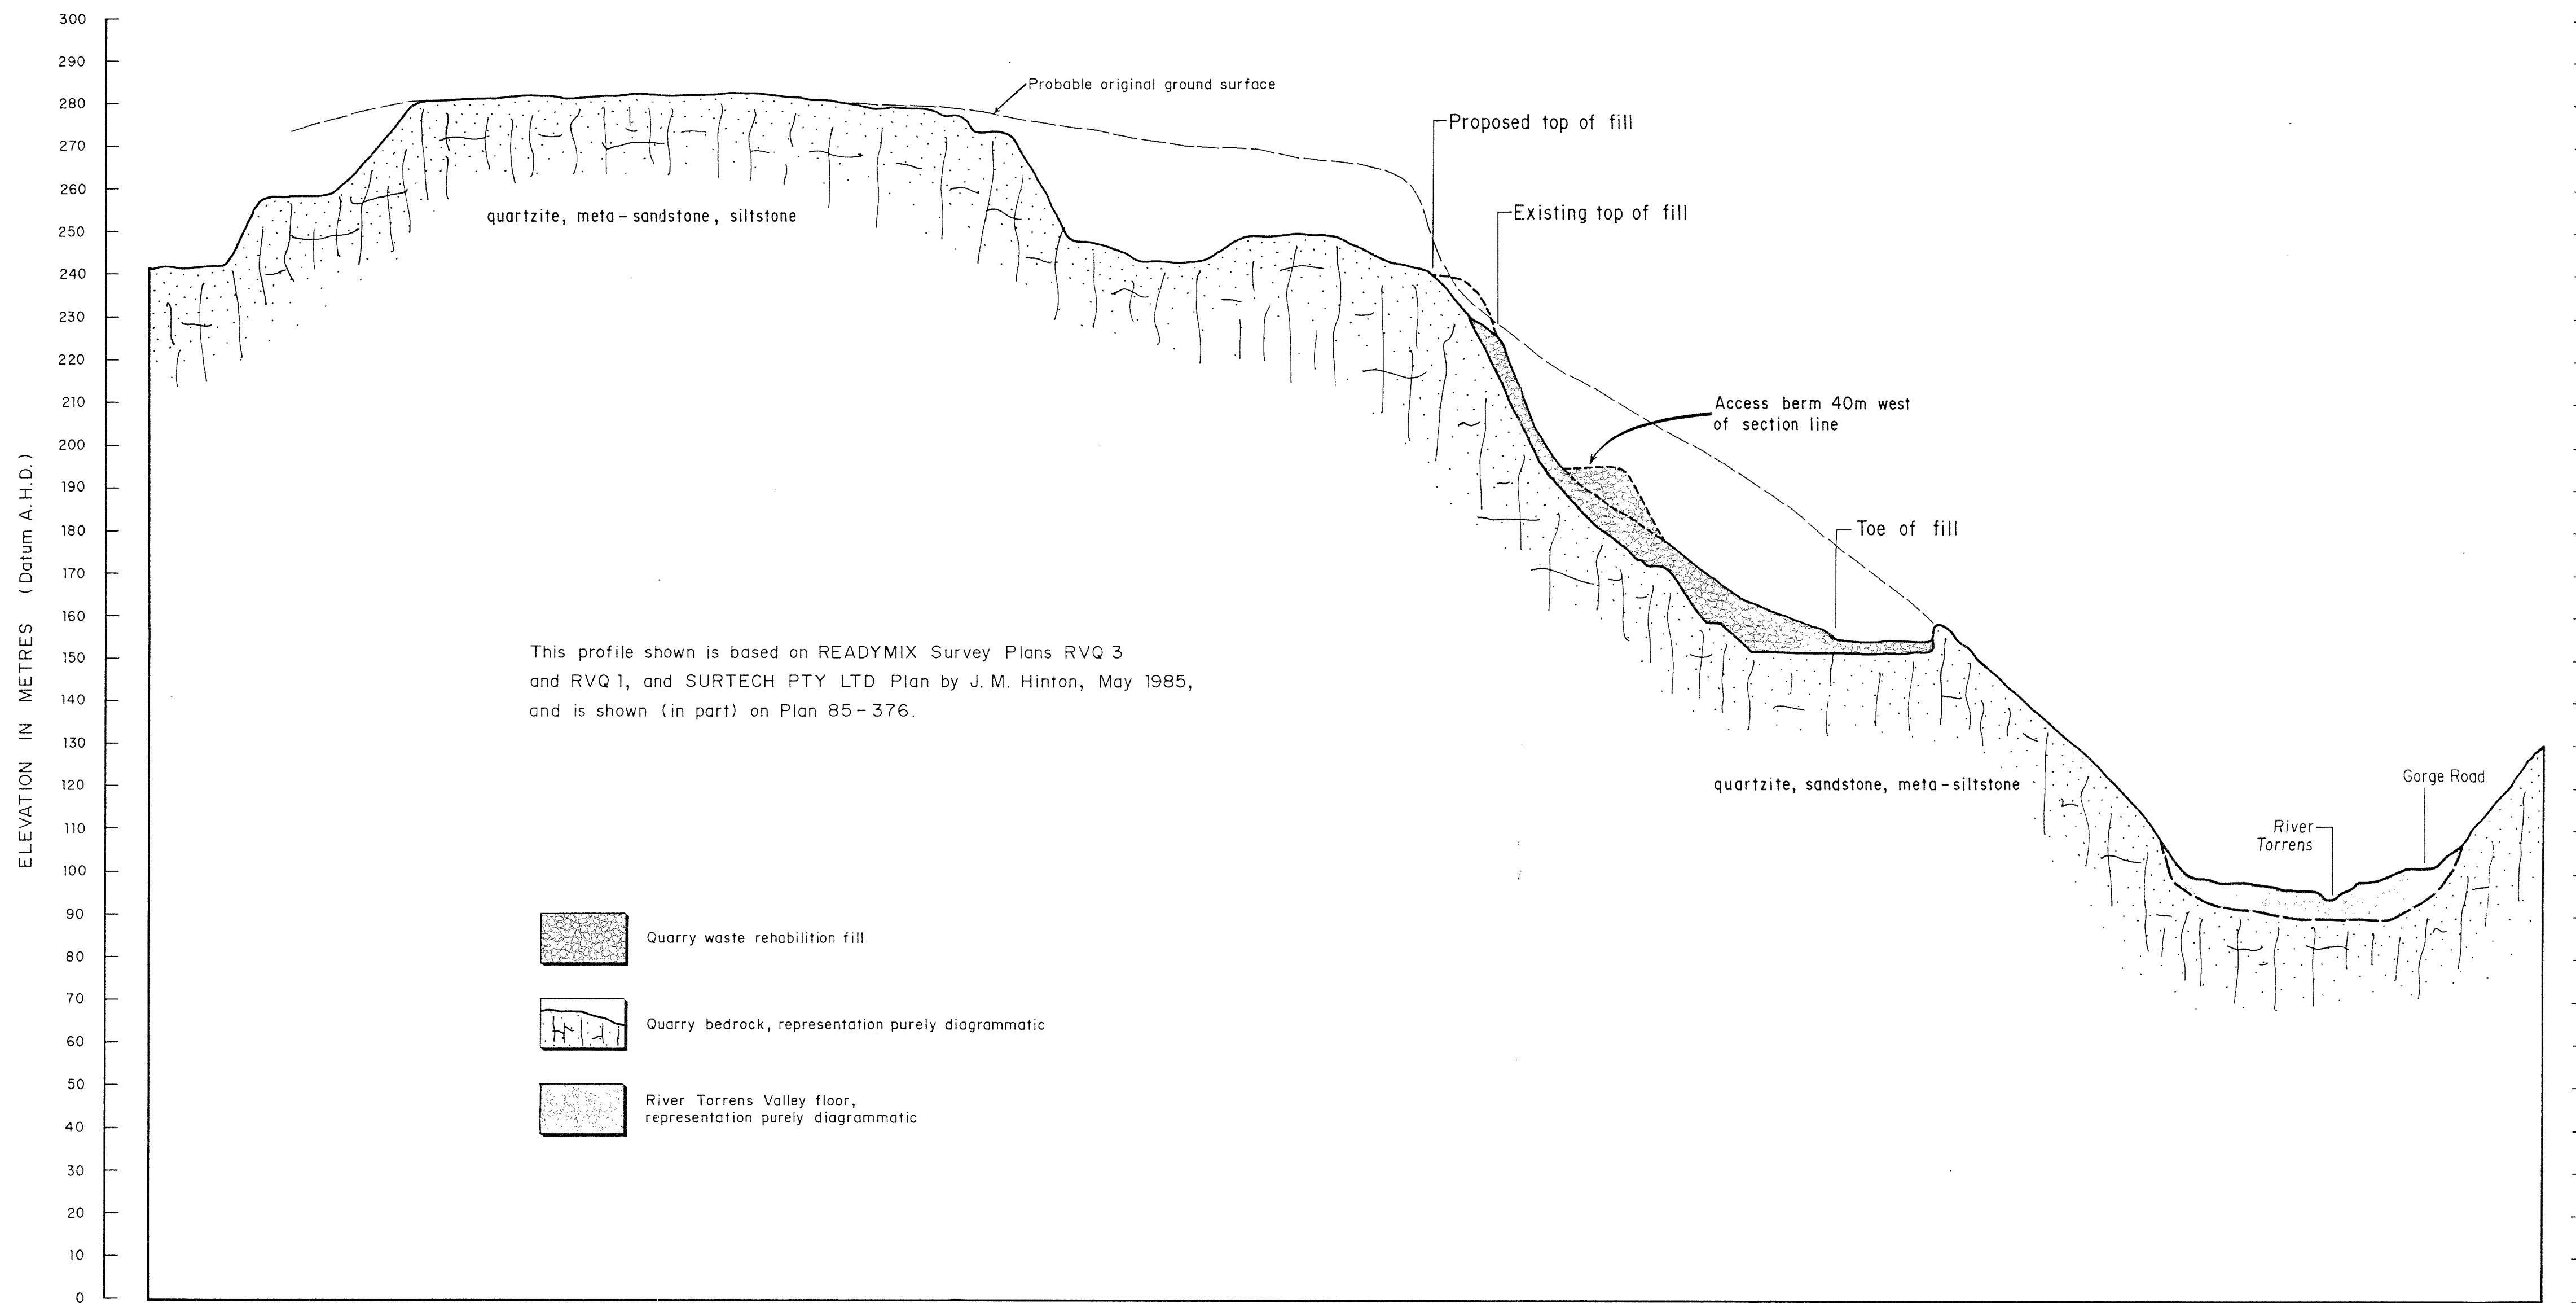
Fig. 3

The analyses show that the placement of a toe-fill at the base of the rehabilitated slope will increase the existing F.O.S. of approx 1.0 to a maximum F.O.S. of 1.4 for failures passing through the toe of the slope. For higher seated failures a F.O.S. of approximately 1.0 prevails for both the wet and dry condition.

Quarry waste not affected by failure surfaces

A toe-fill of free draining material having a slope angle no greater than 25° and a height to approximately EL 165 m could be placed along the foot of the rehabilitated slope but because this is not considered essential from a rehabilitation viewpoint use of rehabilitation funds cannot be recommended.
