Hydrogeological report on water well monitoring in Aboriginal lands — April to October 2000

A.R. (Sandy) Dodds and Lloyd D. Sampson

Report DWR 2001/005

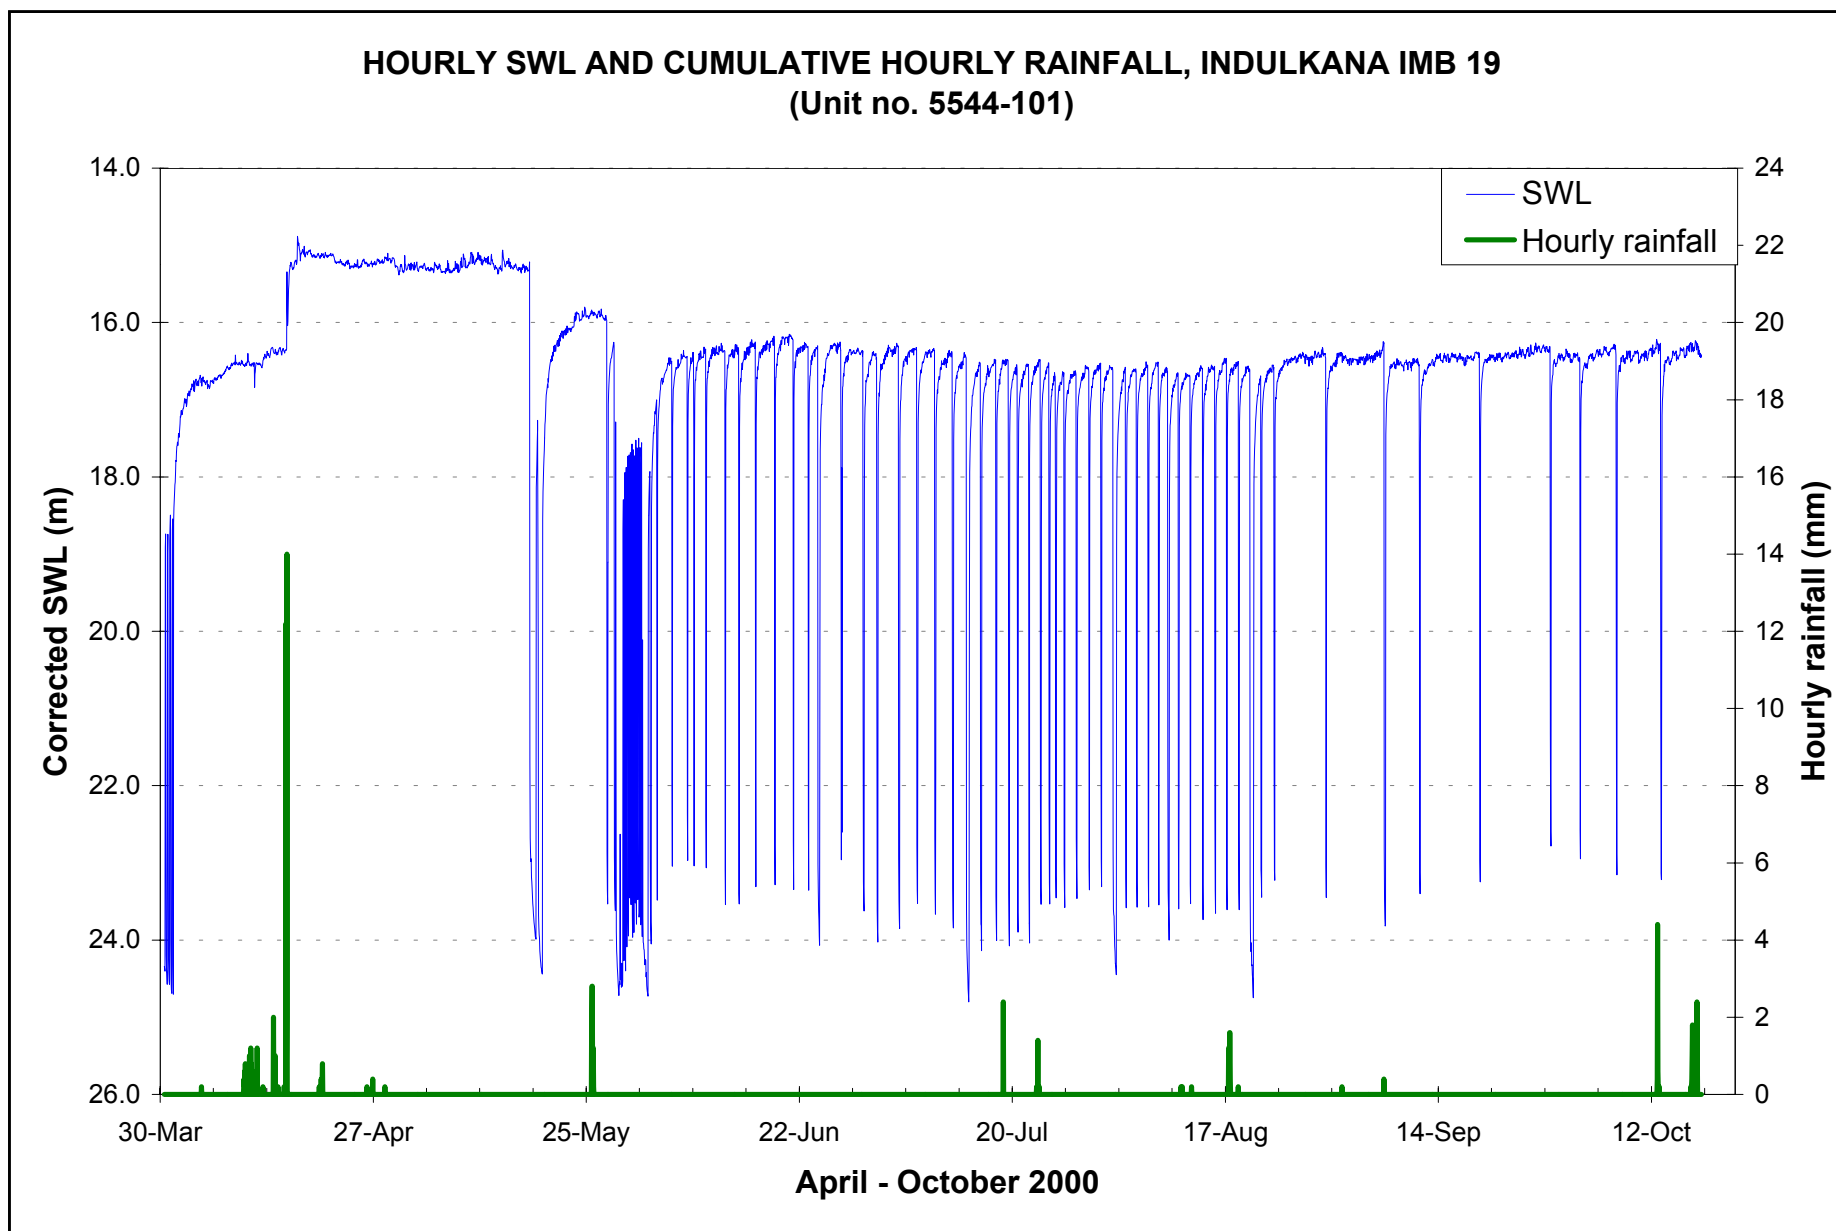
Figure 1.3

Water levels continued to rise in IMB 19 during this monitoring period, occurring primarily in two stages in late March and mid April 2000. The first event coincided with a cessation in pumping while the second coincided with a rainfall event of 14 mm (Fig. 1.3). Overall the water level rose about 2 m and is now within 1 m of the level the water reached at the time of drilling.

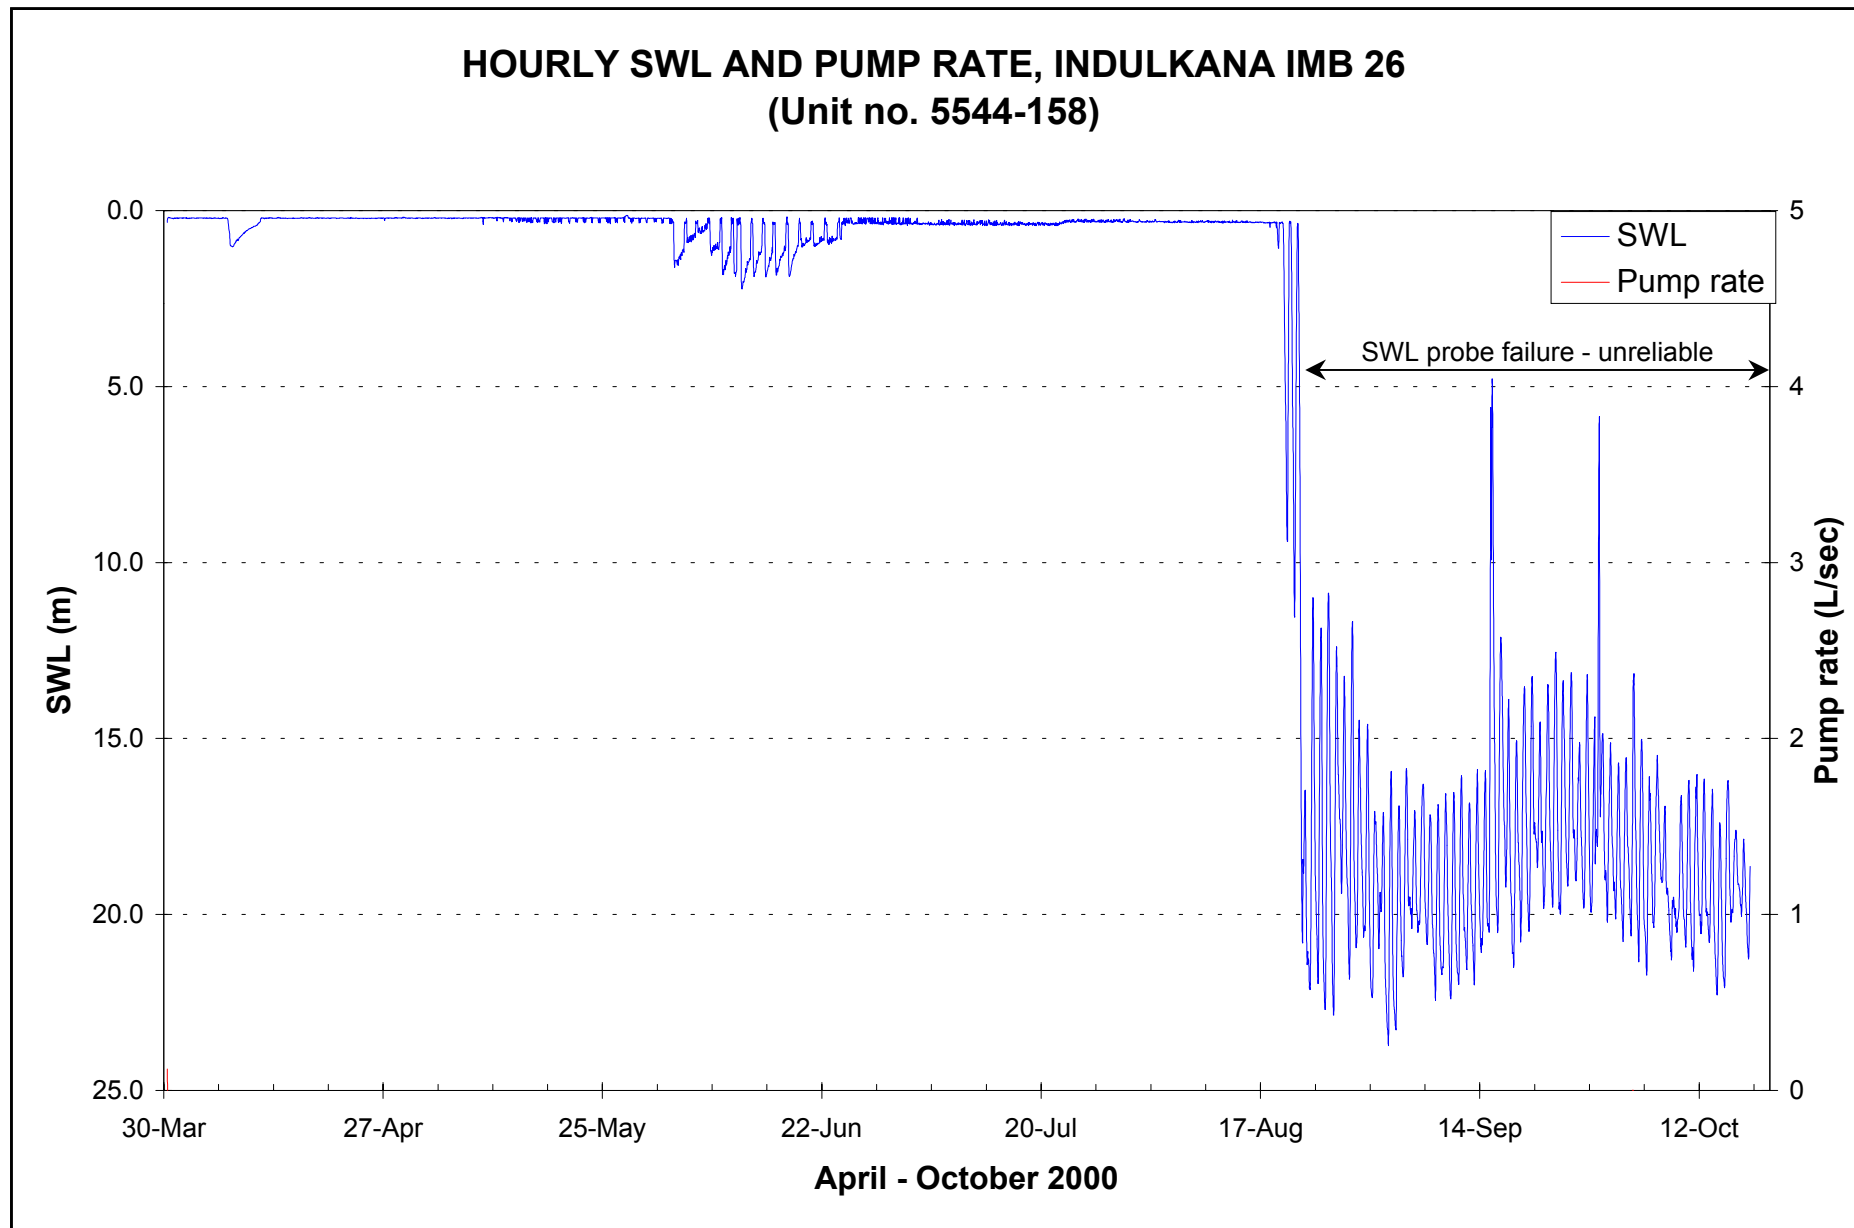
Figure 1.7

IMB 26 was not pumped during this monitoring period, with the SWL remaining close to surface. The SWL measuring unit failed in August 2000 (Fig. 1.7).

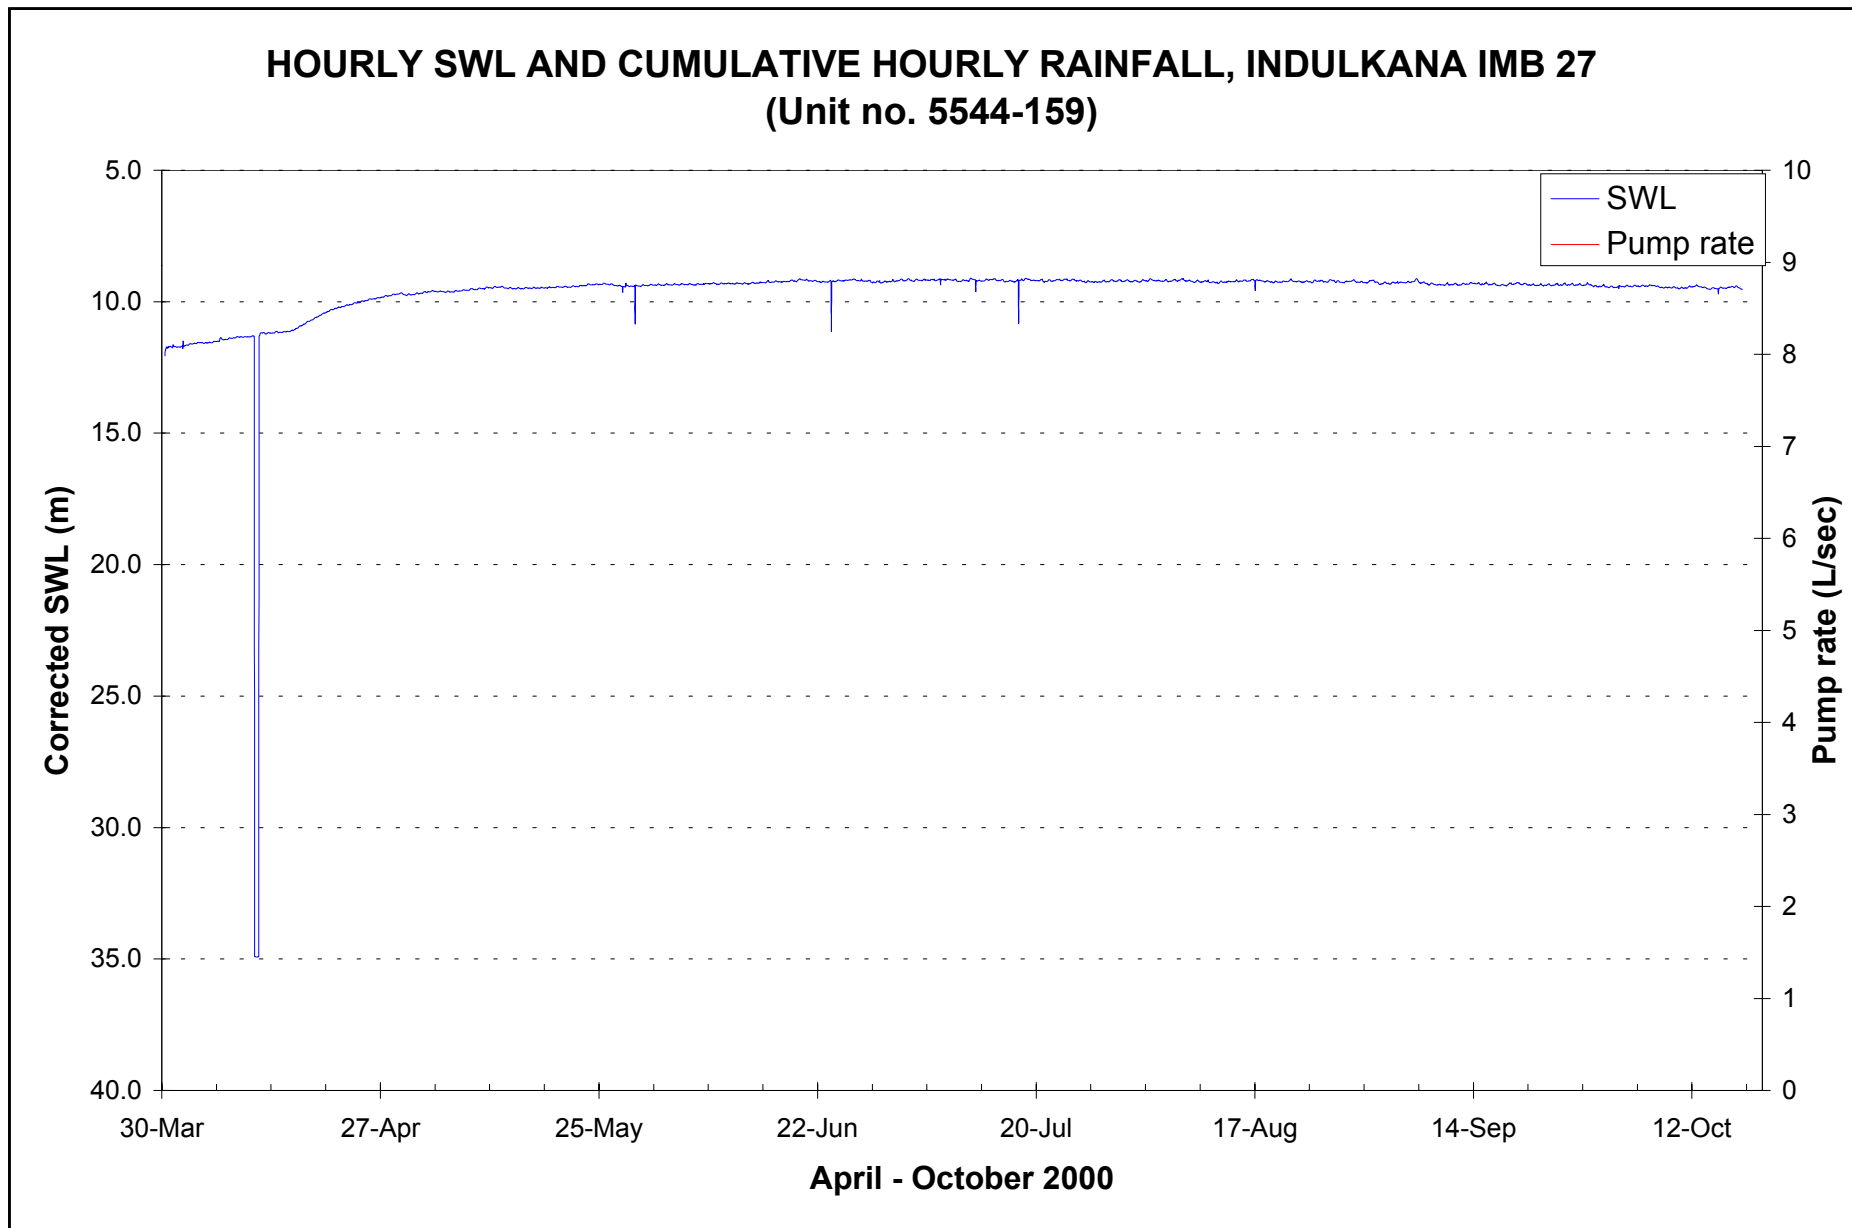
Figure 1.8

from recharge (Fig. 1.8). The logger failed to record SWL data, so the response time of the aquifer to the rainfall in February 2000 could not be ascertained.

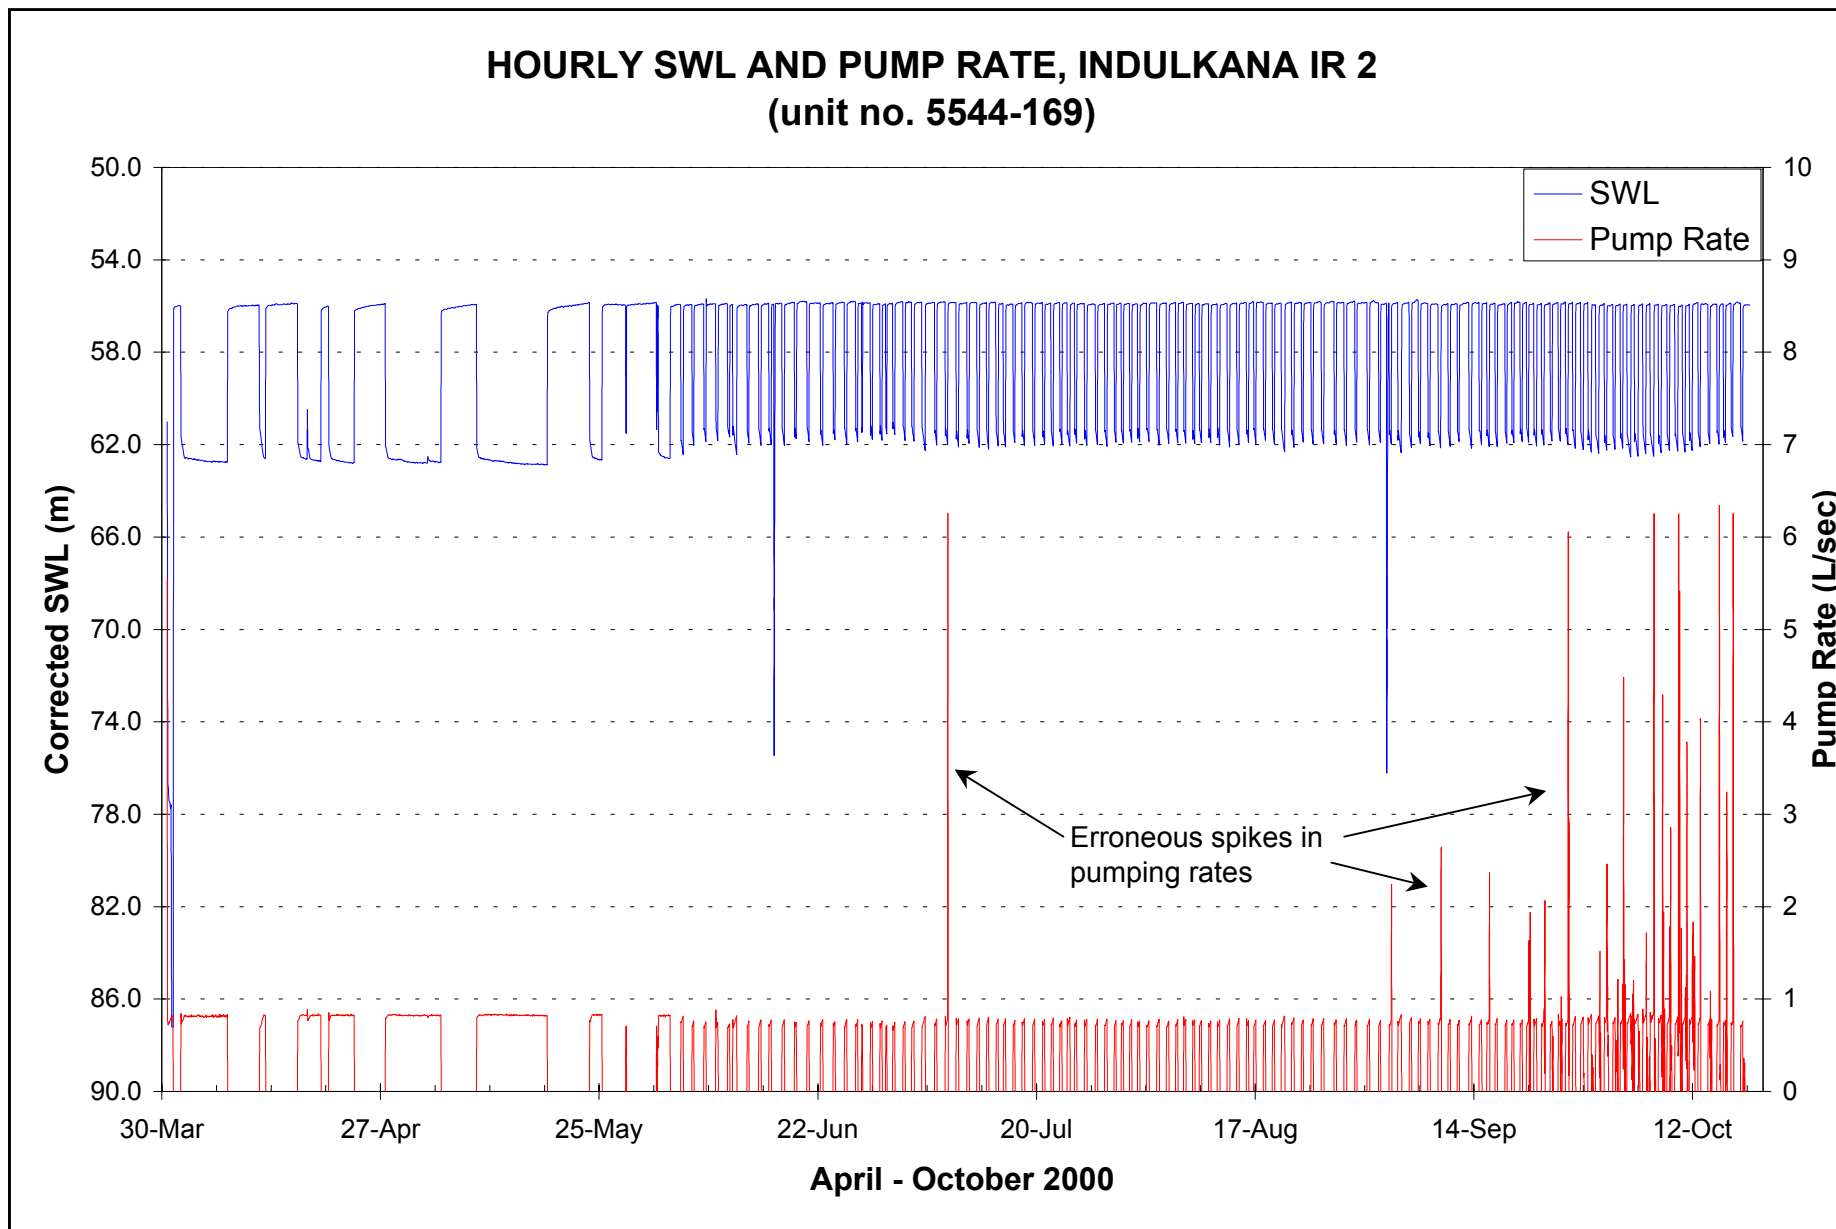
Figure 1.10

IR 2 produced a large proportion of Indulkana's water supply (5 ML). While the SWL has dropped from 55 m at the time of drilling to 56 m in October 2000, the water level remained constant during this monitoring period. A correction of -0.272 m was required to the logger SWL datum at the end of the period, which has been applied as a constant drift over the period. The well seems to be sustaining the current pumping rates without causing undue strain on the aquifer (Fig. 1.10).

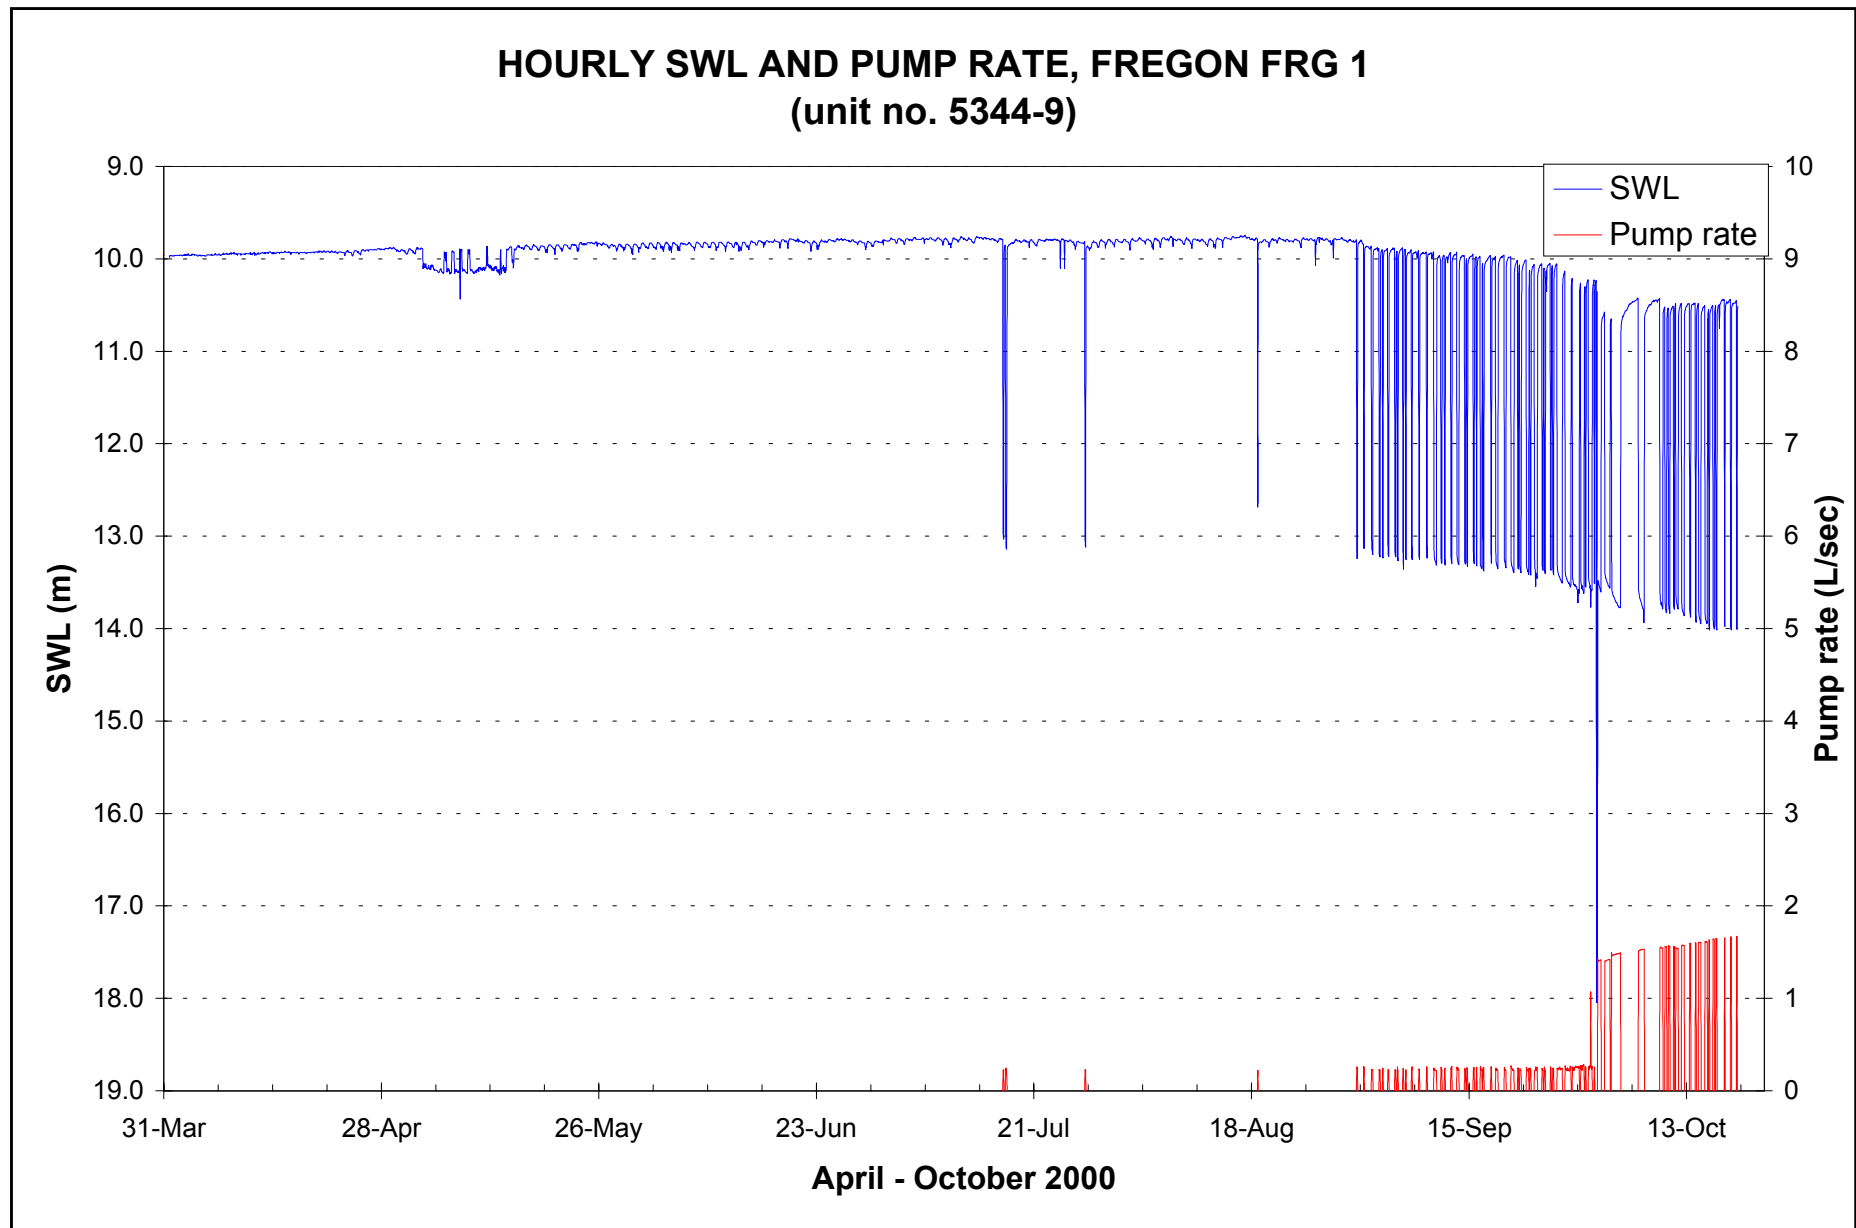
Figure 3.3

FRG 1 was used rarely until the end of this monitoring period, when it was pumped fairly heavily. The water level gradually rose by 0.2 m over the five-month rest period, but then dropped by 0.7 m when pumping commenced in September and October 2000 (Fig. 3.3). A manual SWL reading could not be taken at the time of download so possible corrections to the logger SWL datum are not known.

This well is slow to recover after pumping. Variations in the non-pumping water level are likely to be the result of the drawdown cone from pumping rather than any long-term drop in the water level of the aquifer. The pumping rate in September is inaccurate, and should be about 1.5 L/s rather than the 0.26 L/s shown (Fig. 3.3). There is little variation in water level over the five and a half years of monitoring, and no indication of recharge.

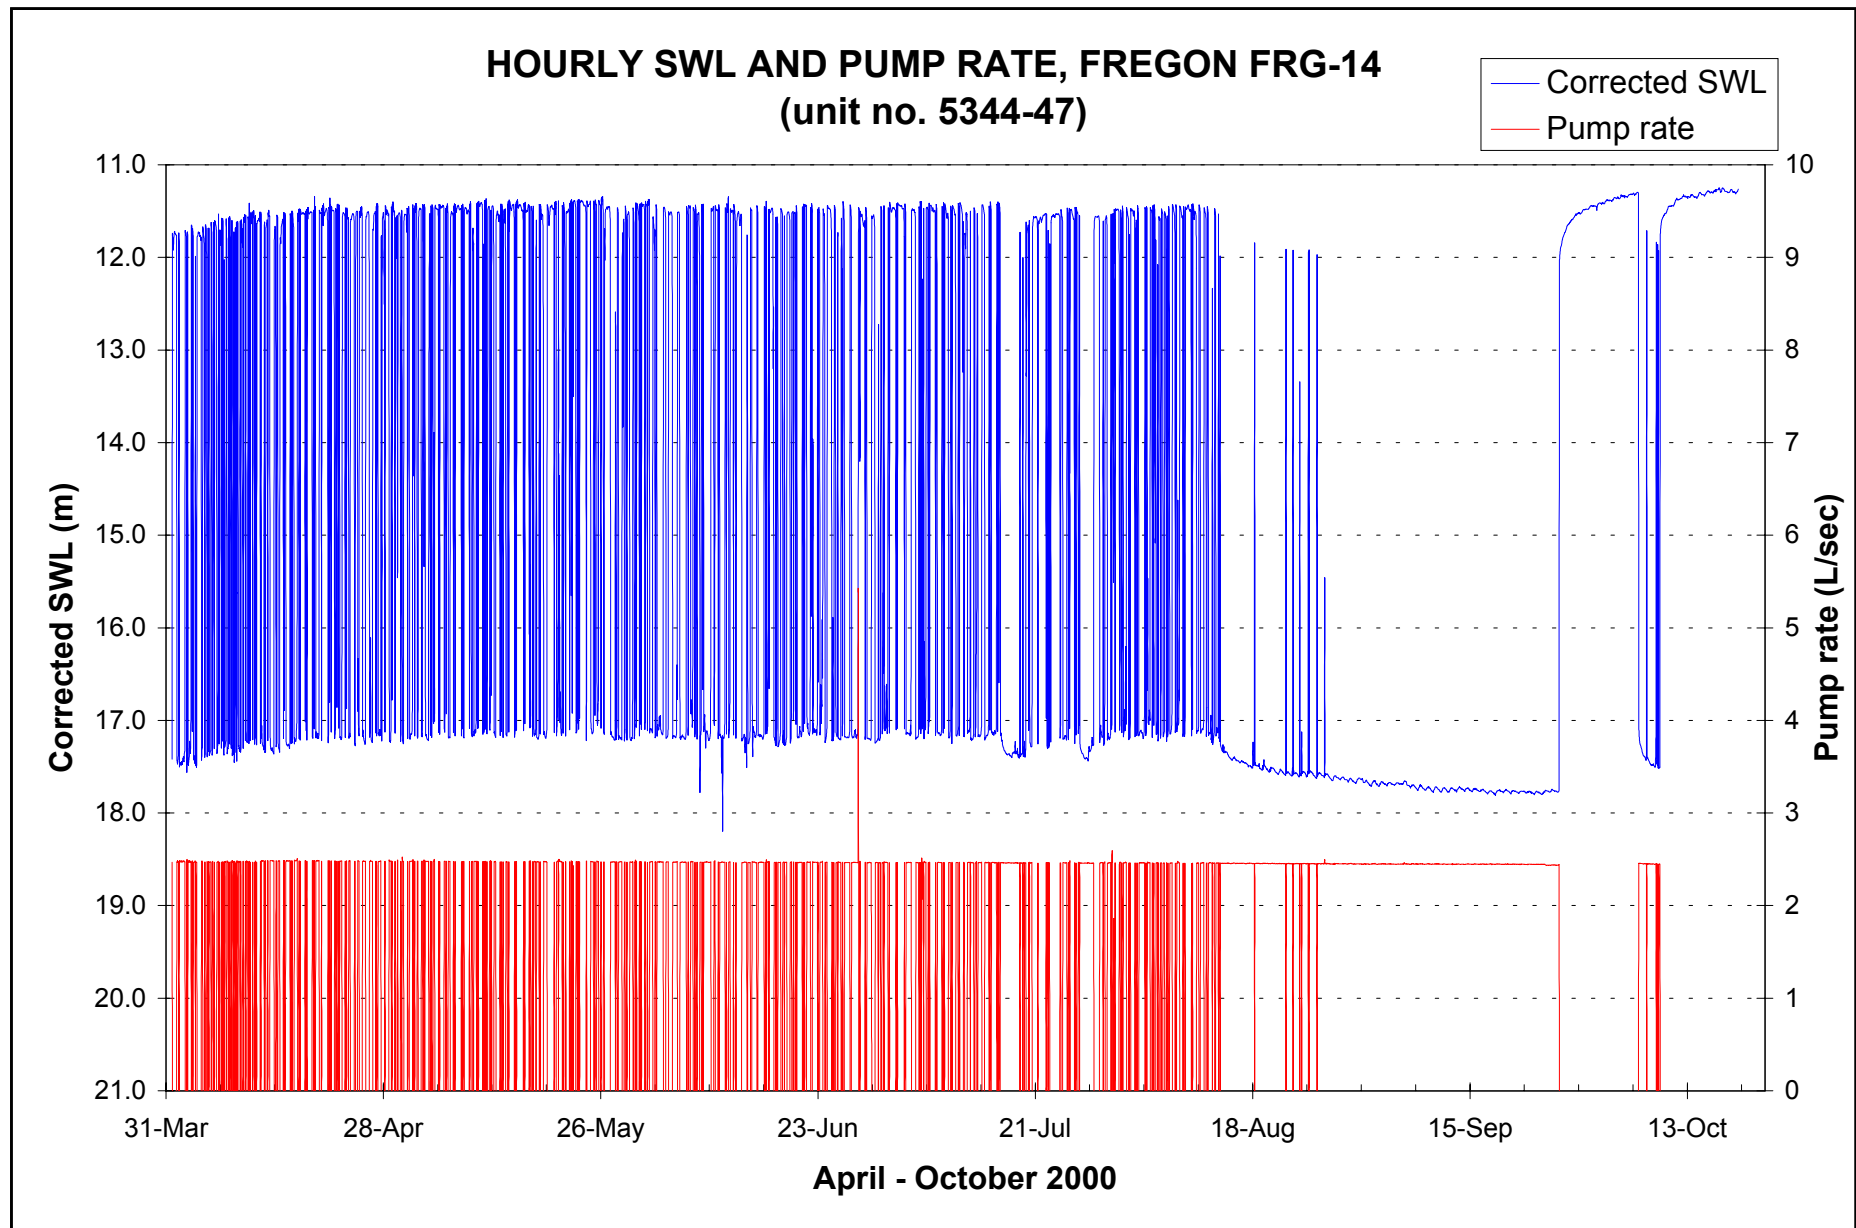
Figure 3.5

is becoming urgent that the SWL be ascertained and that a conduit system is installed to permit regular manual verification. Available data suggests that the water level is not varying much, and there is no evidence of recharge from the recent rainfall events (Figs 3.5–3.6).

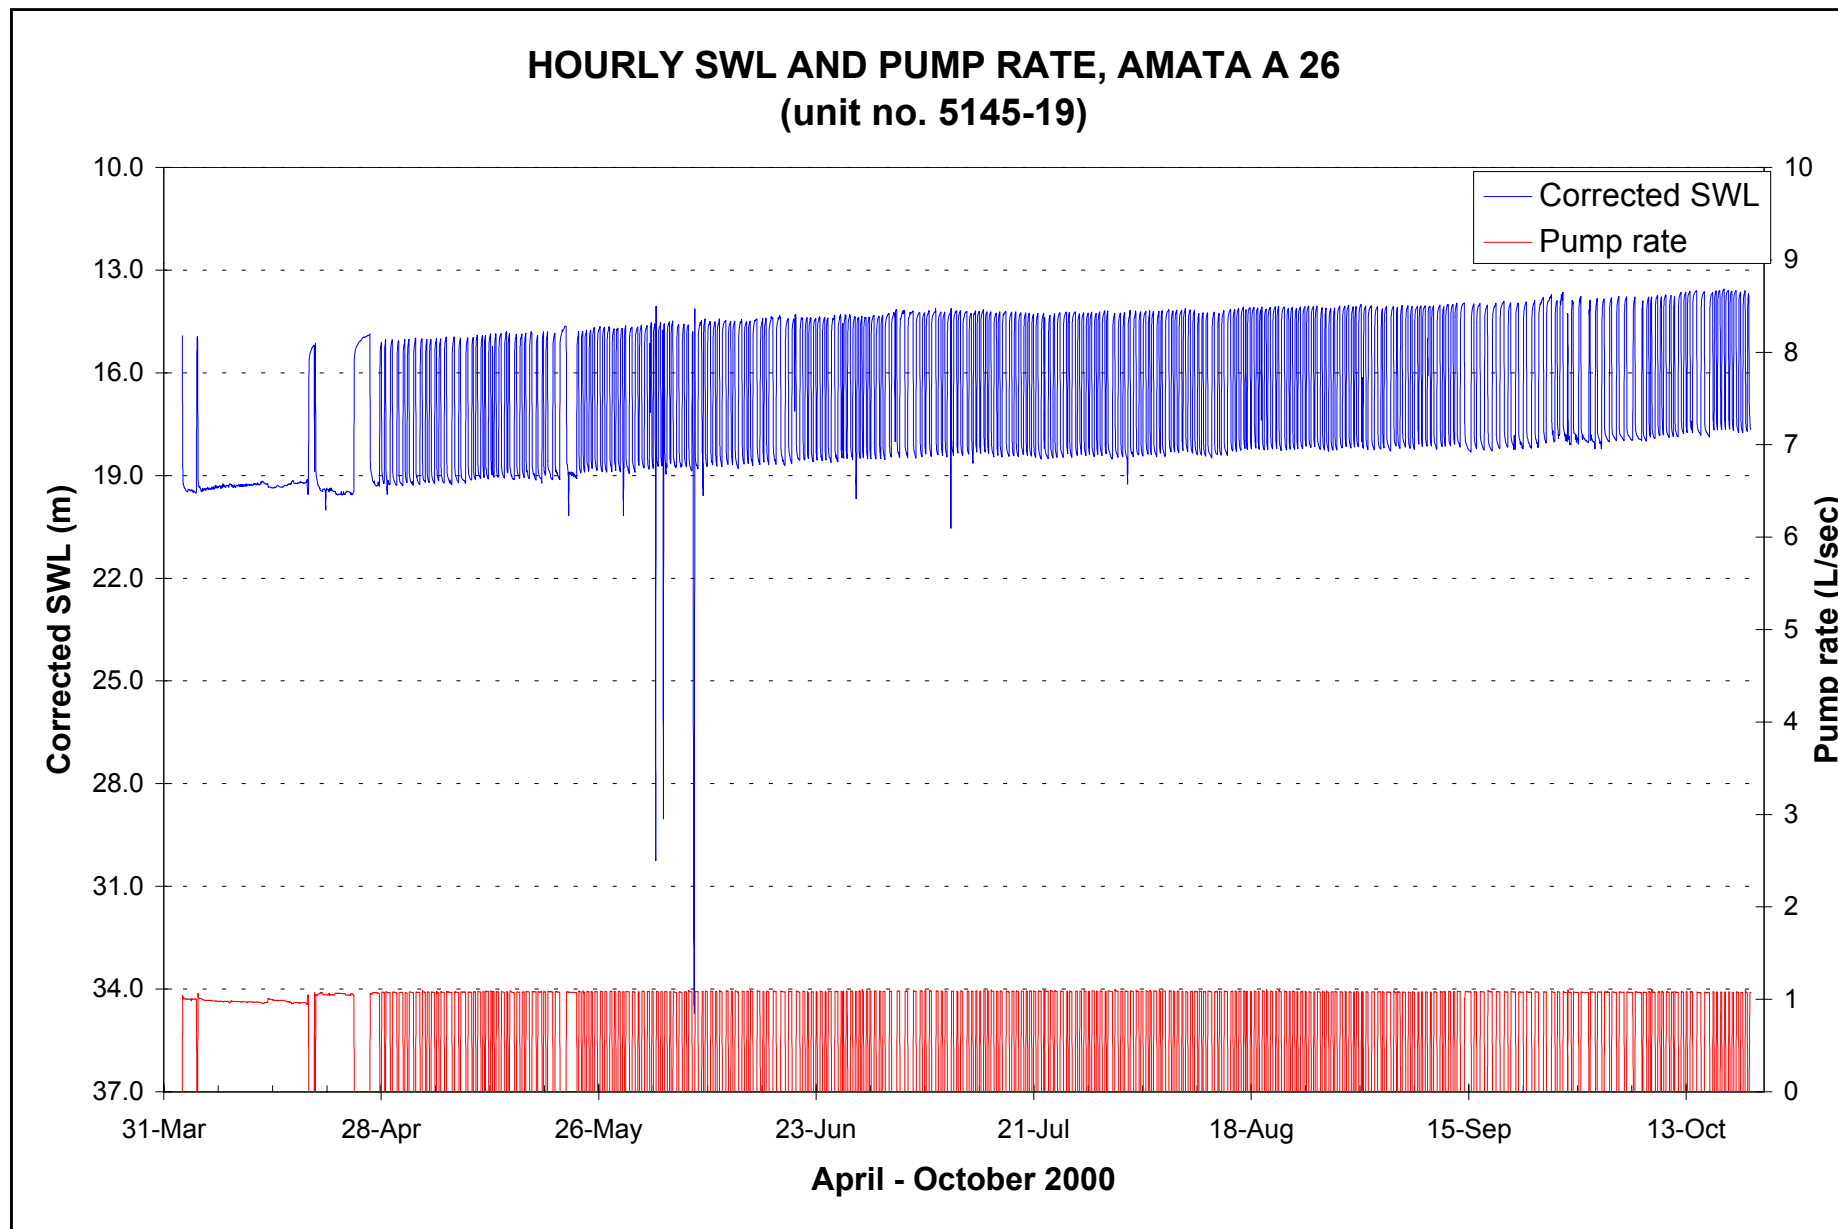
Figure 6.4

The SWL in A 26 continued to rise over this monitoring period, similar to A 17 and despite a 21% increase in water withdrawal (Fig. 6.4). Since the rains in February 2000, the total rise was 2.9 m from 16.5 m to 13.6 m, but the water level is still 3 m below the tentative level of 10.6 m measured when the well was drilled in 1966. A minimal correction was required to the water level datum in the logger.

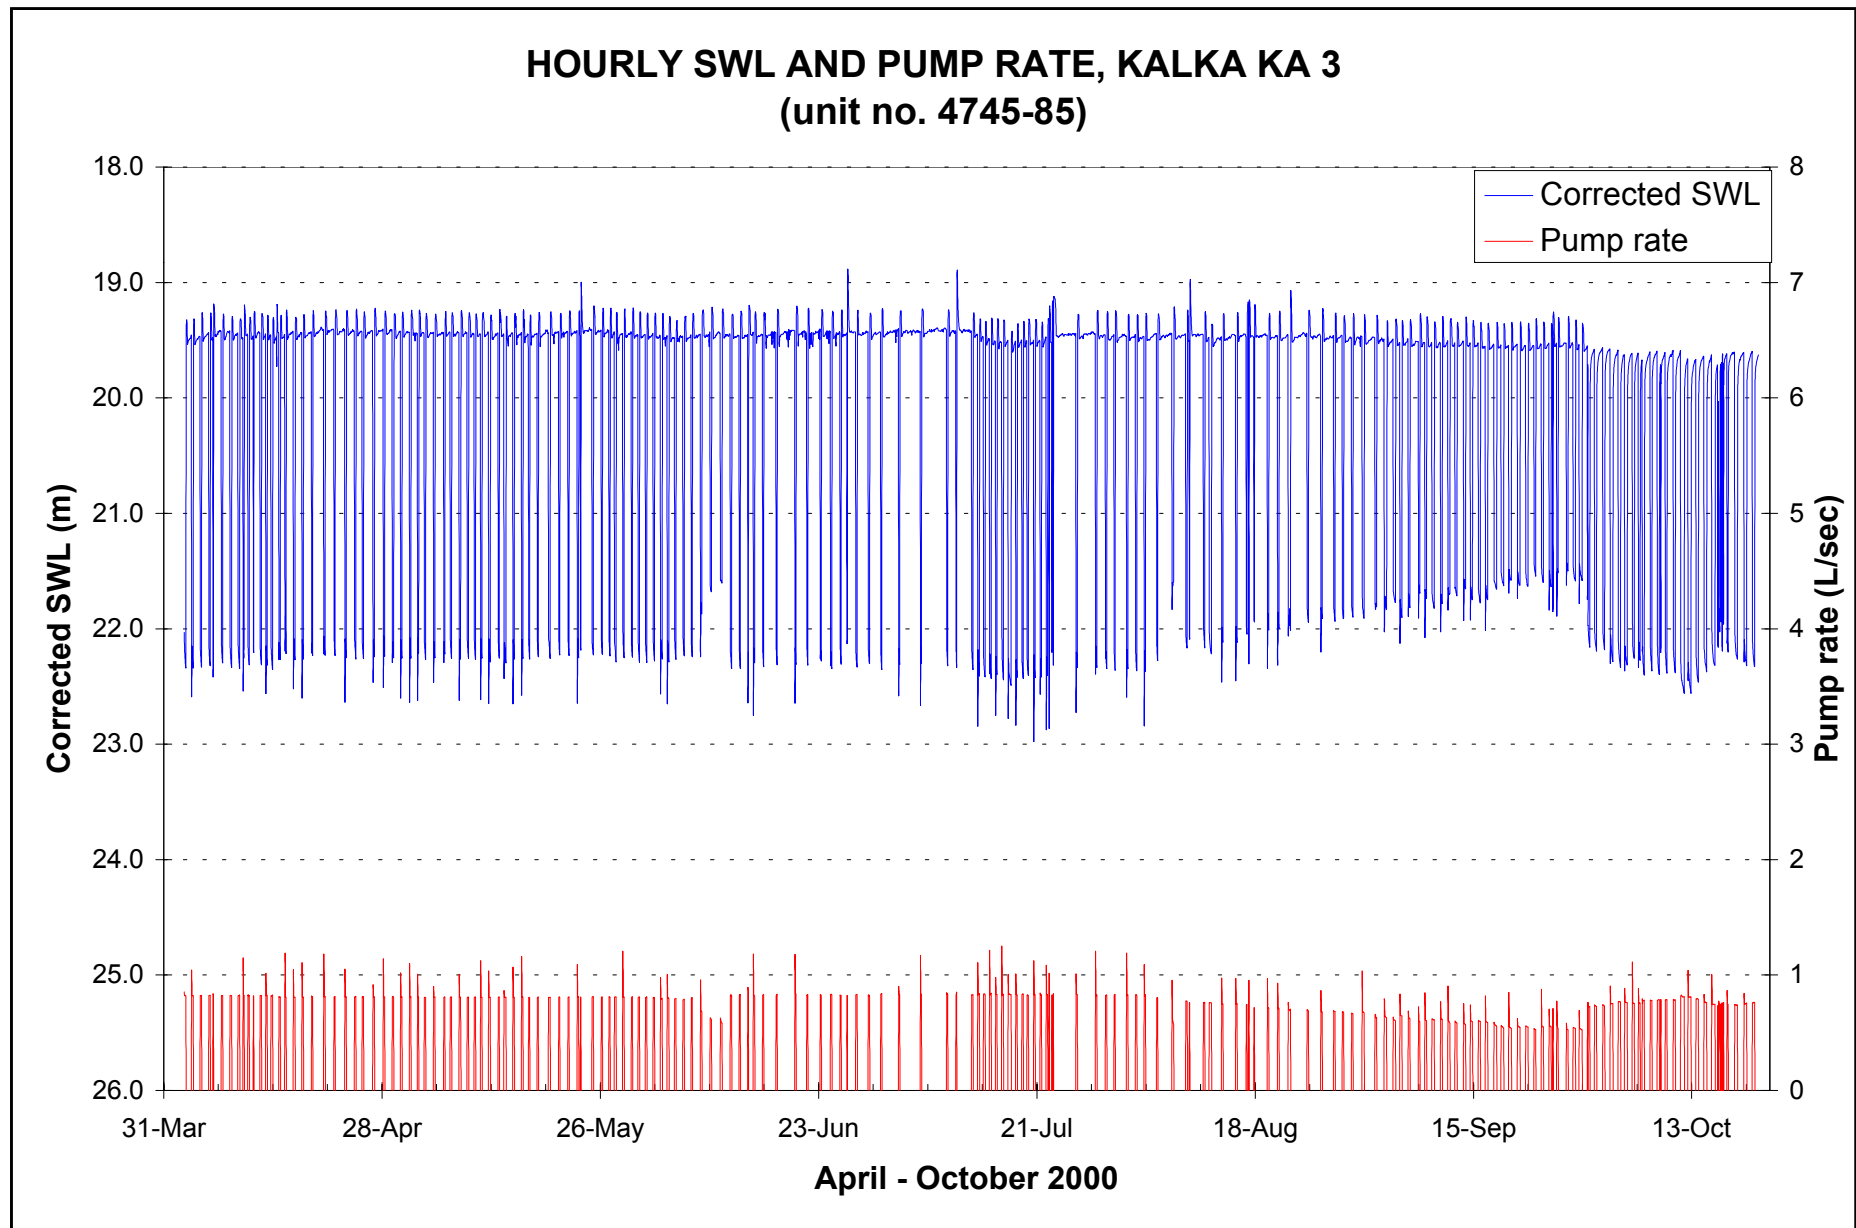
Figure 7.5

In KA 3 changing extraction rates resulted in the SWL measurements varying slightly, but the SWL shows no long-term change. For most of the monitoring period, there was an overshoot of just under 0.5 m when the pump switched off, but this ceased at the end of September 2000 (Fig. 7.5). During intensive pumping at the end of the period the water level fell 0.1 m. The SWL is now 0.4 m below the level recorded in 1998. Hourly rainfall for the period can be seen in Figure 7.6.

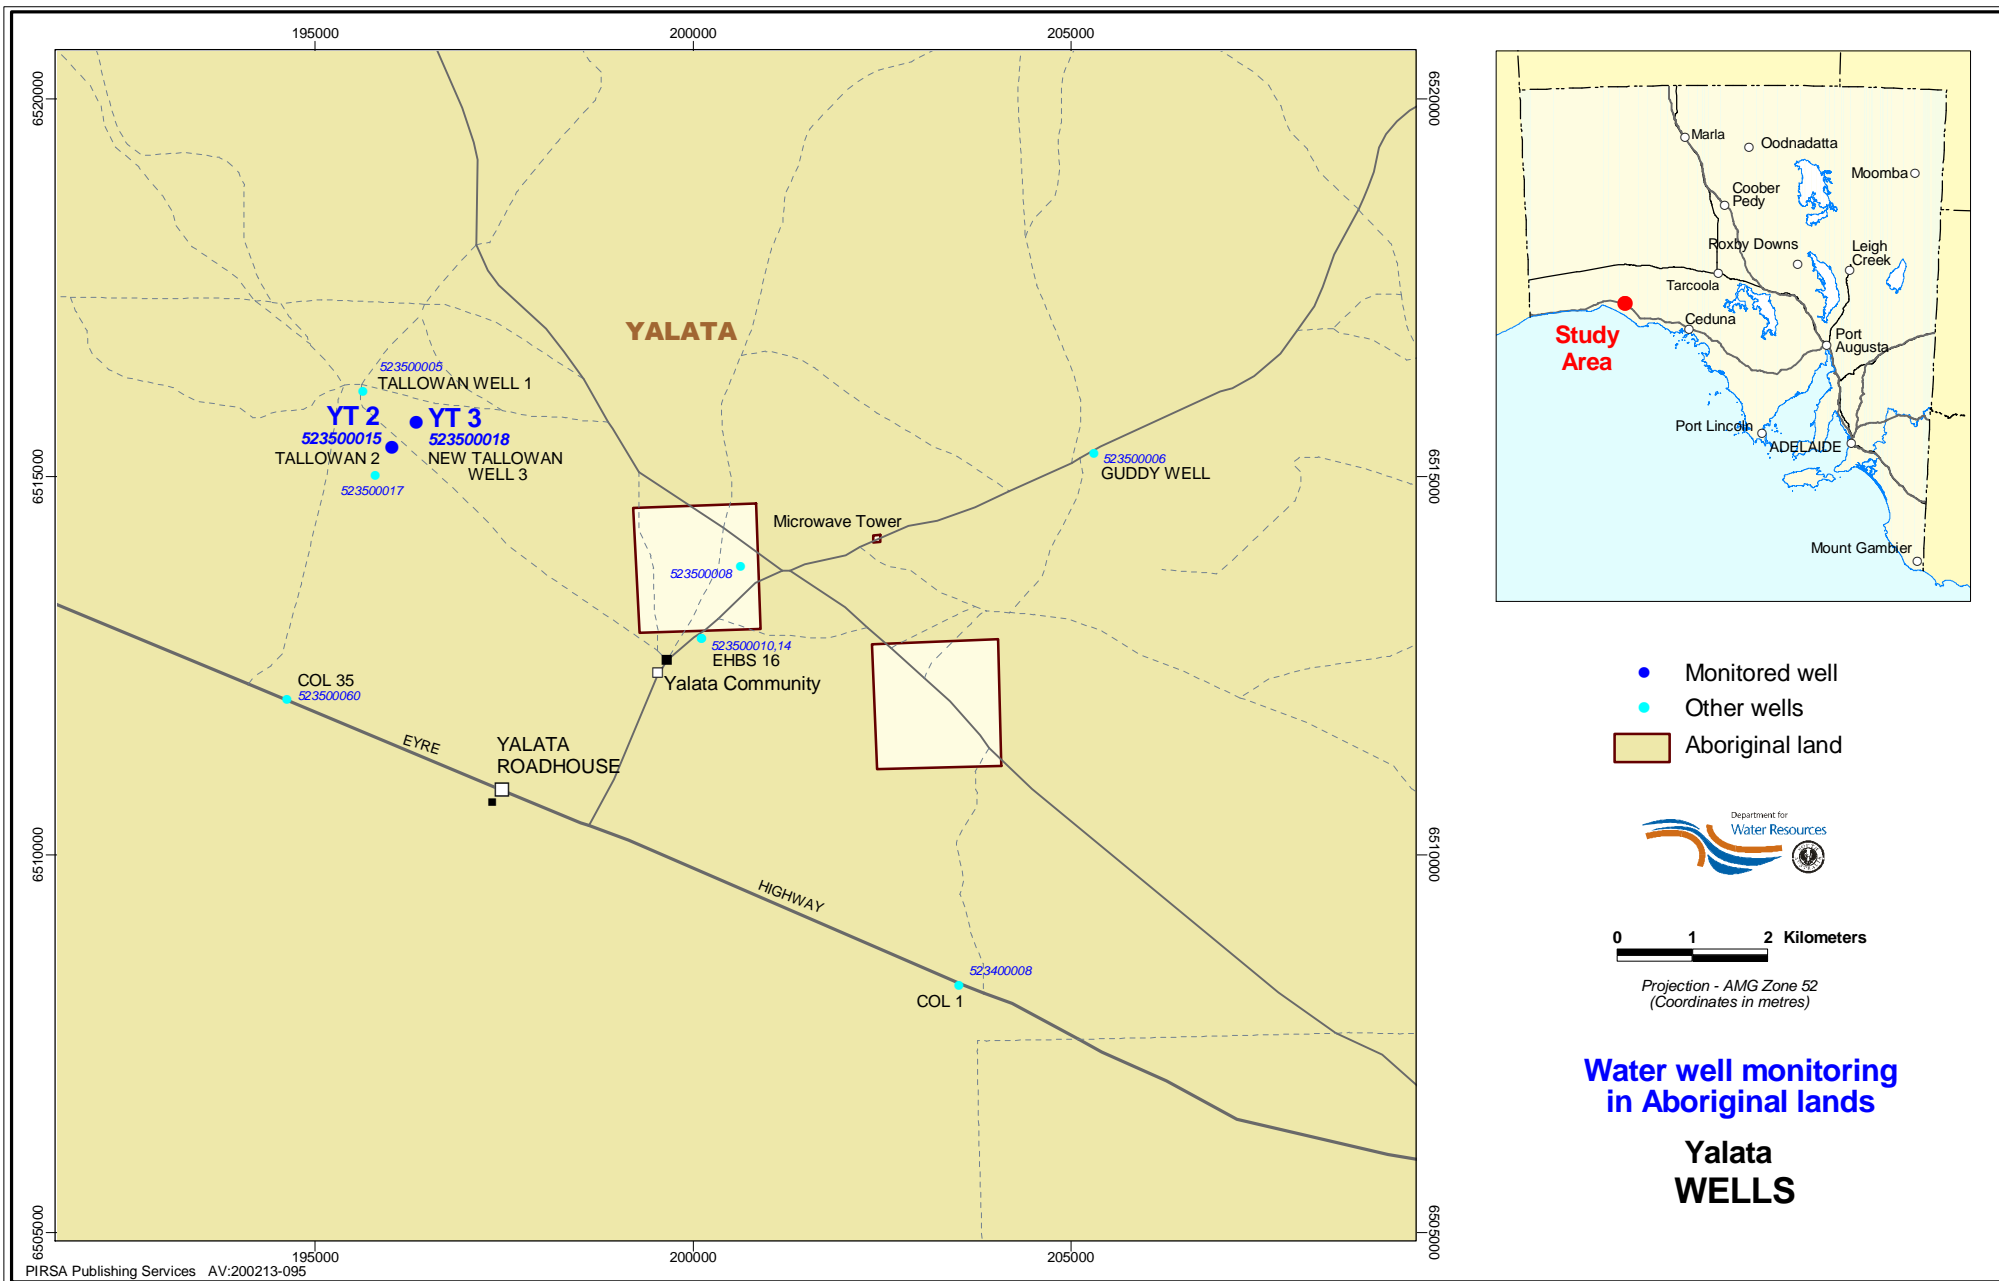
Figure 10.1

Water production data for the community at Indulkana is summarised in Table 10.1 for the latest four well monitoring periods, covering October 1998 to October 2000. Wells are located in Figure 10.1. Water extraction has been fairly consistent between 4000 and 5000 kL/m., with production for April 2000 peaking at 6200 kL.
