Hydrogeological report on water well monitoring in Aboriginal lands — April to October 2000

A.R. (Sandy) Dodds and Lloyd D. Sampson

Report DWR 2001/005

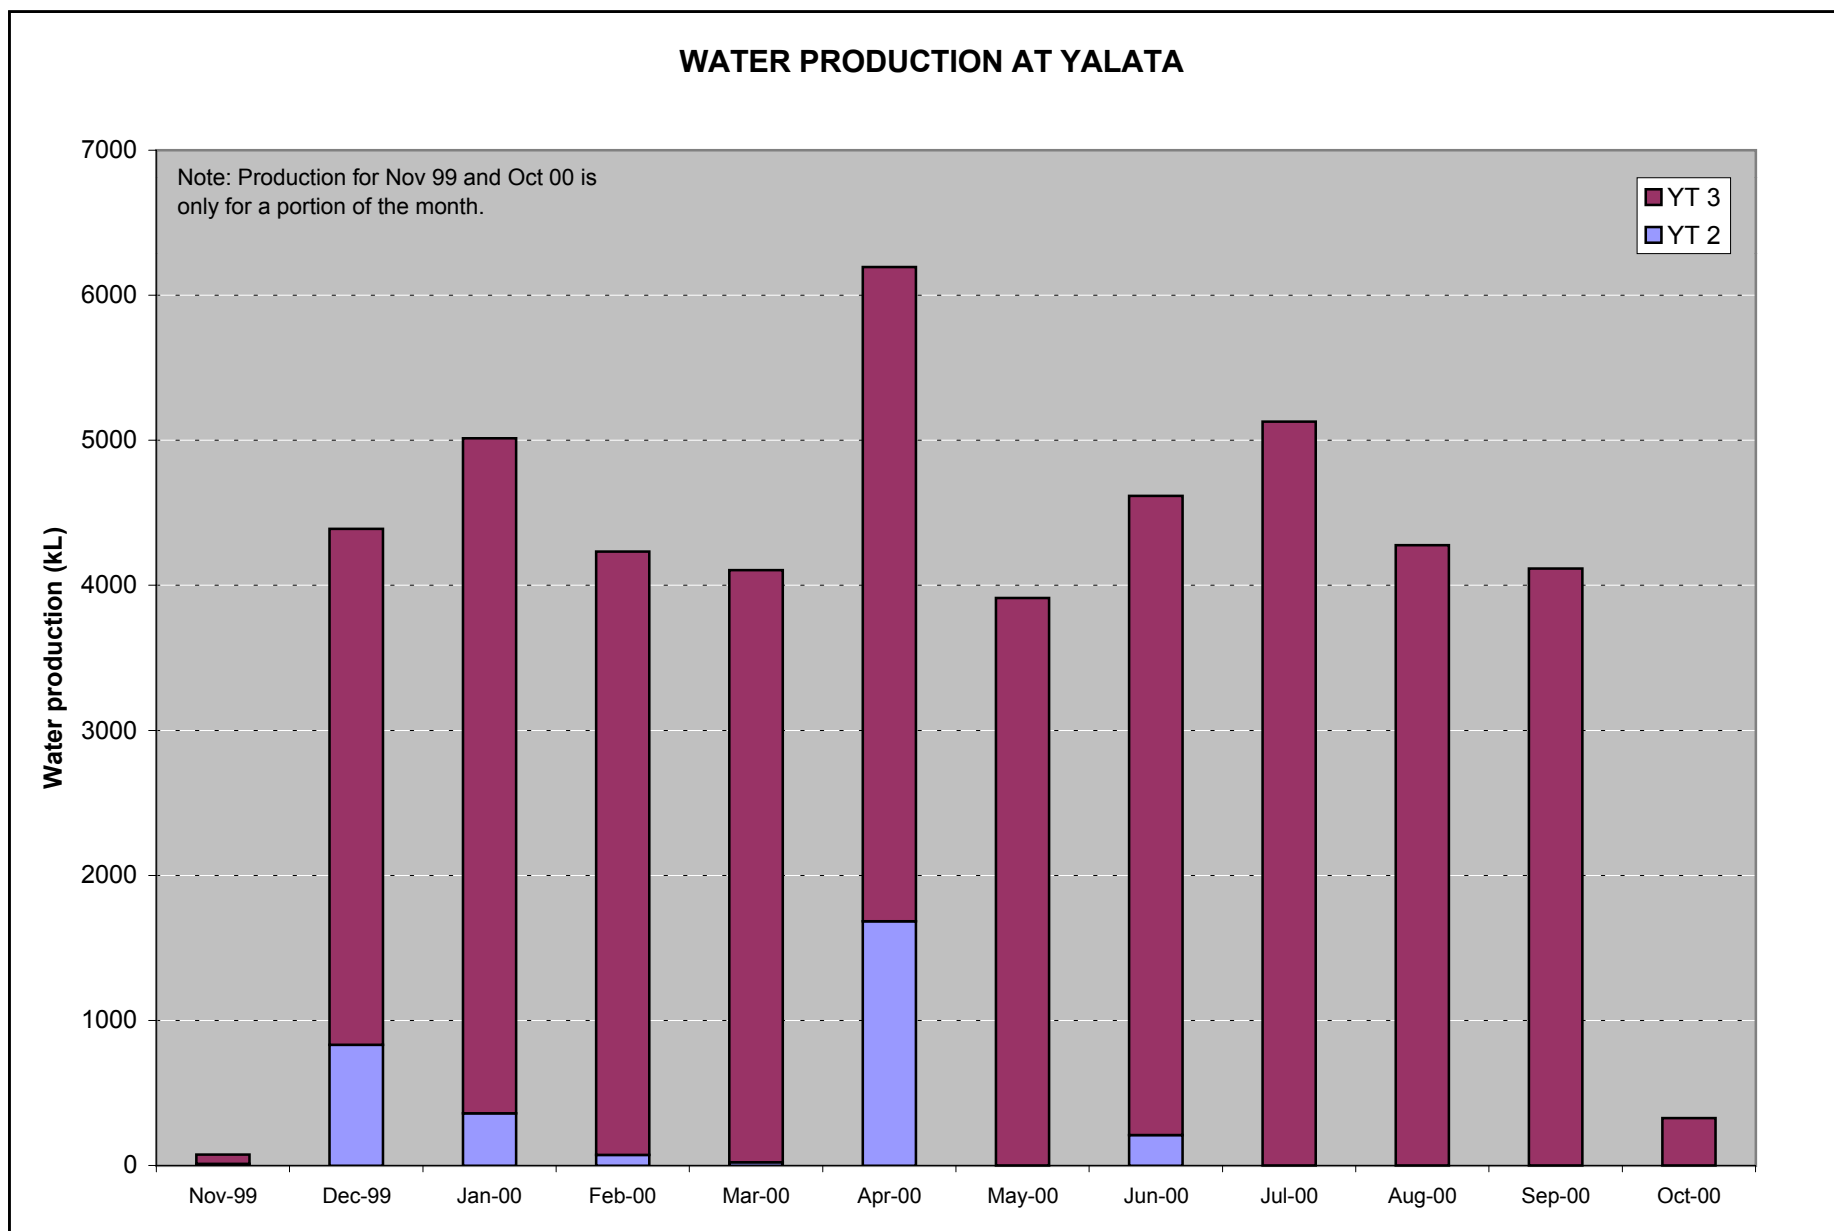
Figure 10.2

Approximately 95% of the community's water is produced from YT 3 (Fig. 10.2). Neither well shows any sign of stress.

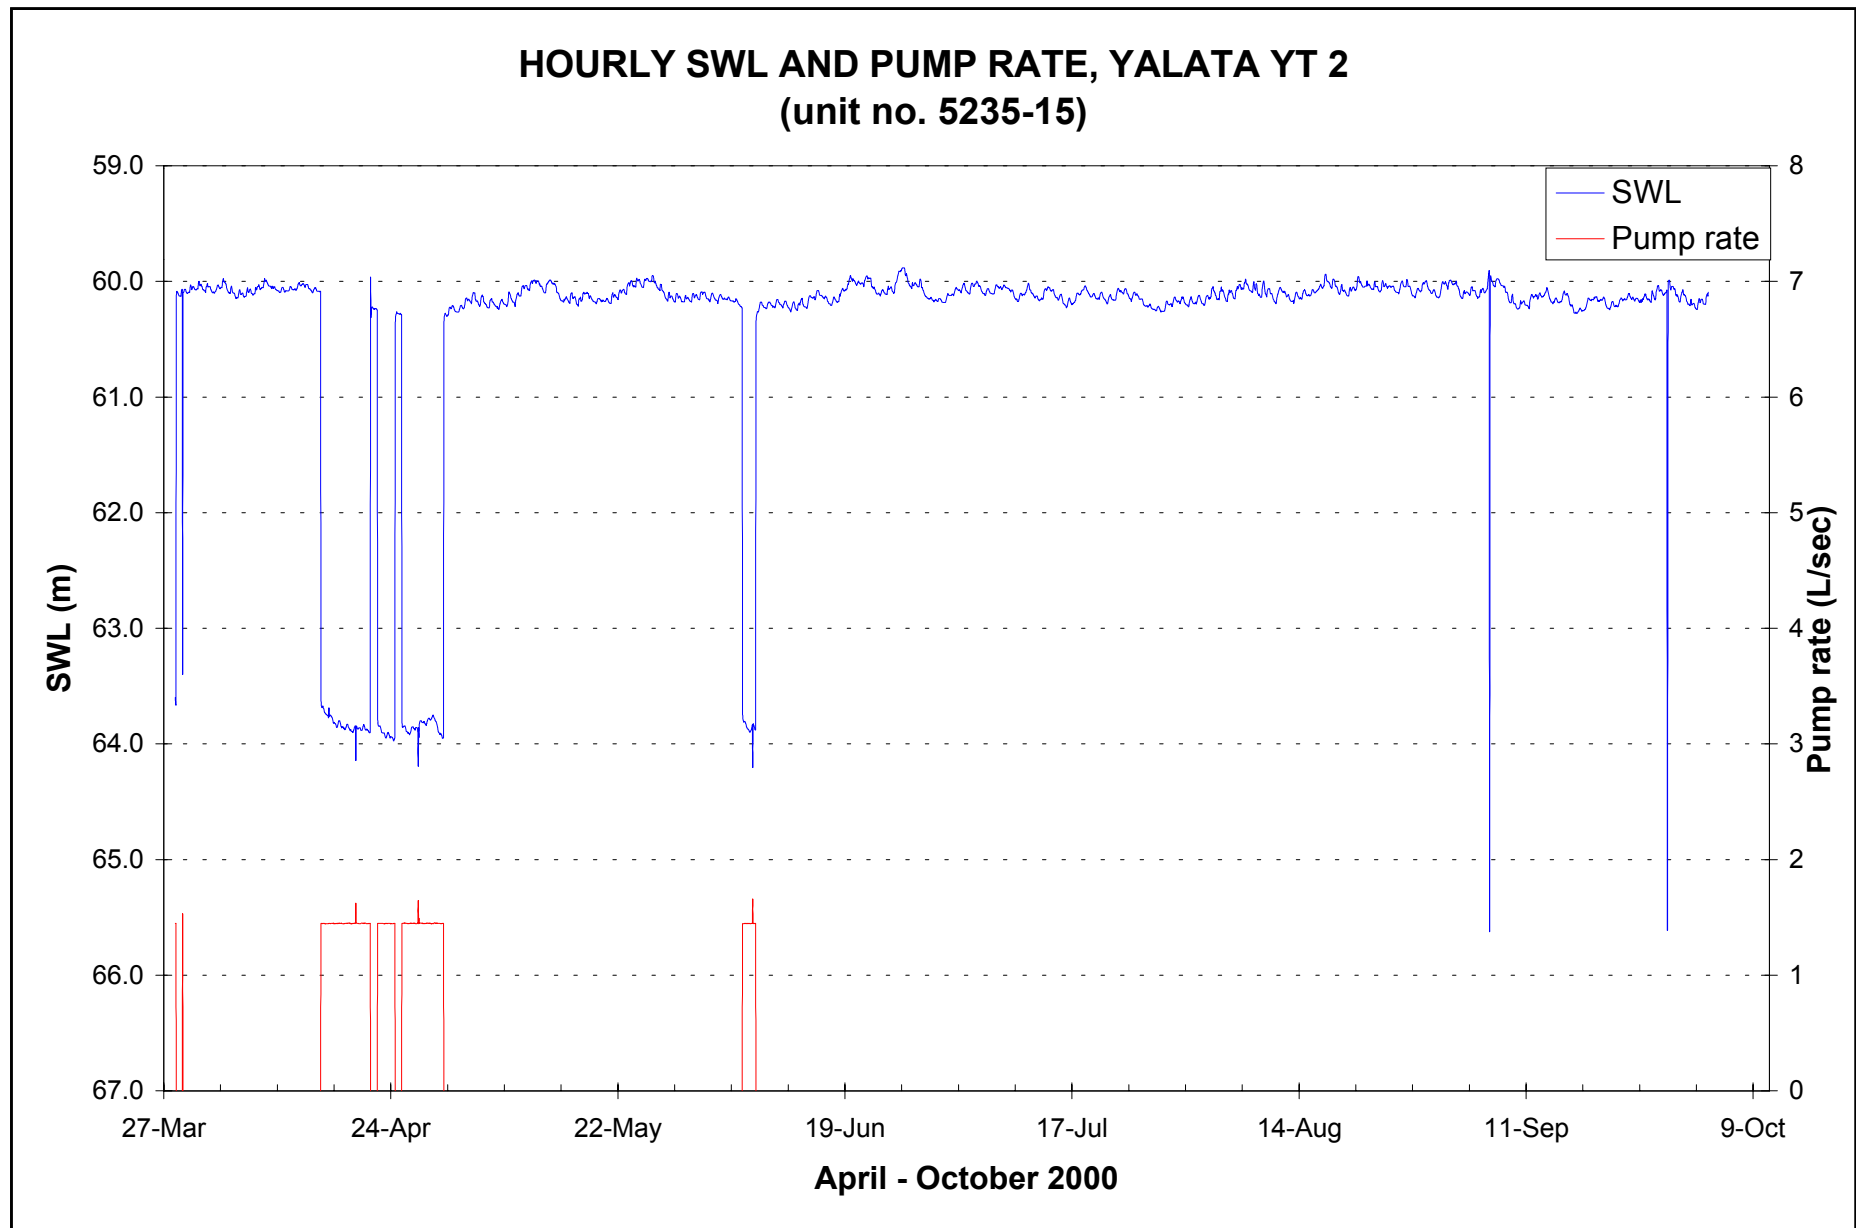
Figure 10.3

YT 2 was pumped occasionally (up to six days continuously) at about 1.5 L/s, with the non-pumping SWL remaining at about 60 m (Fig. 10.3). There are no indications of stress in the well at these pumping levels. This bore was not used after early June 2000.

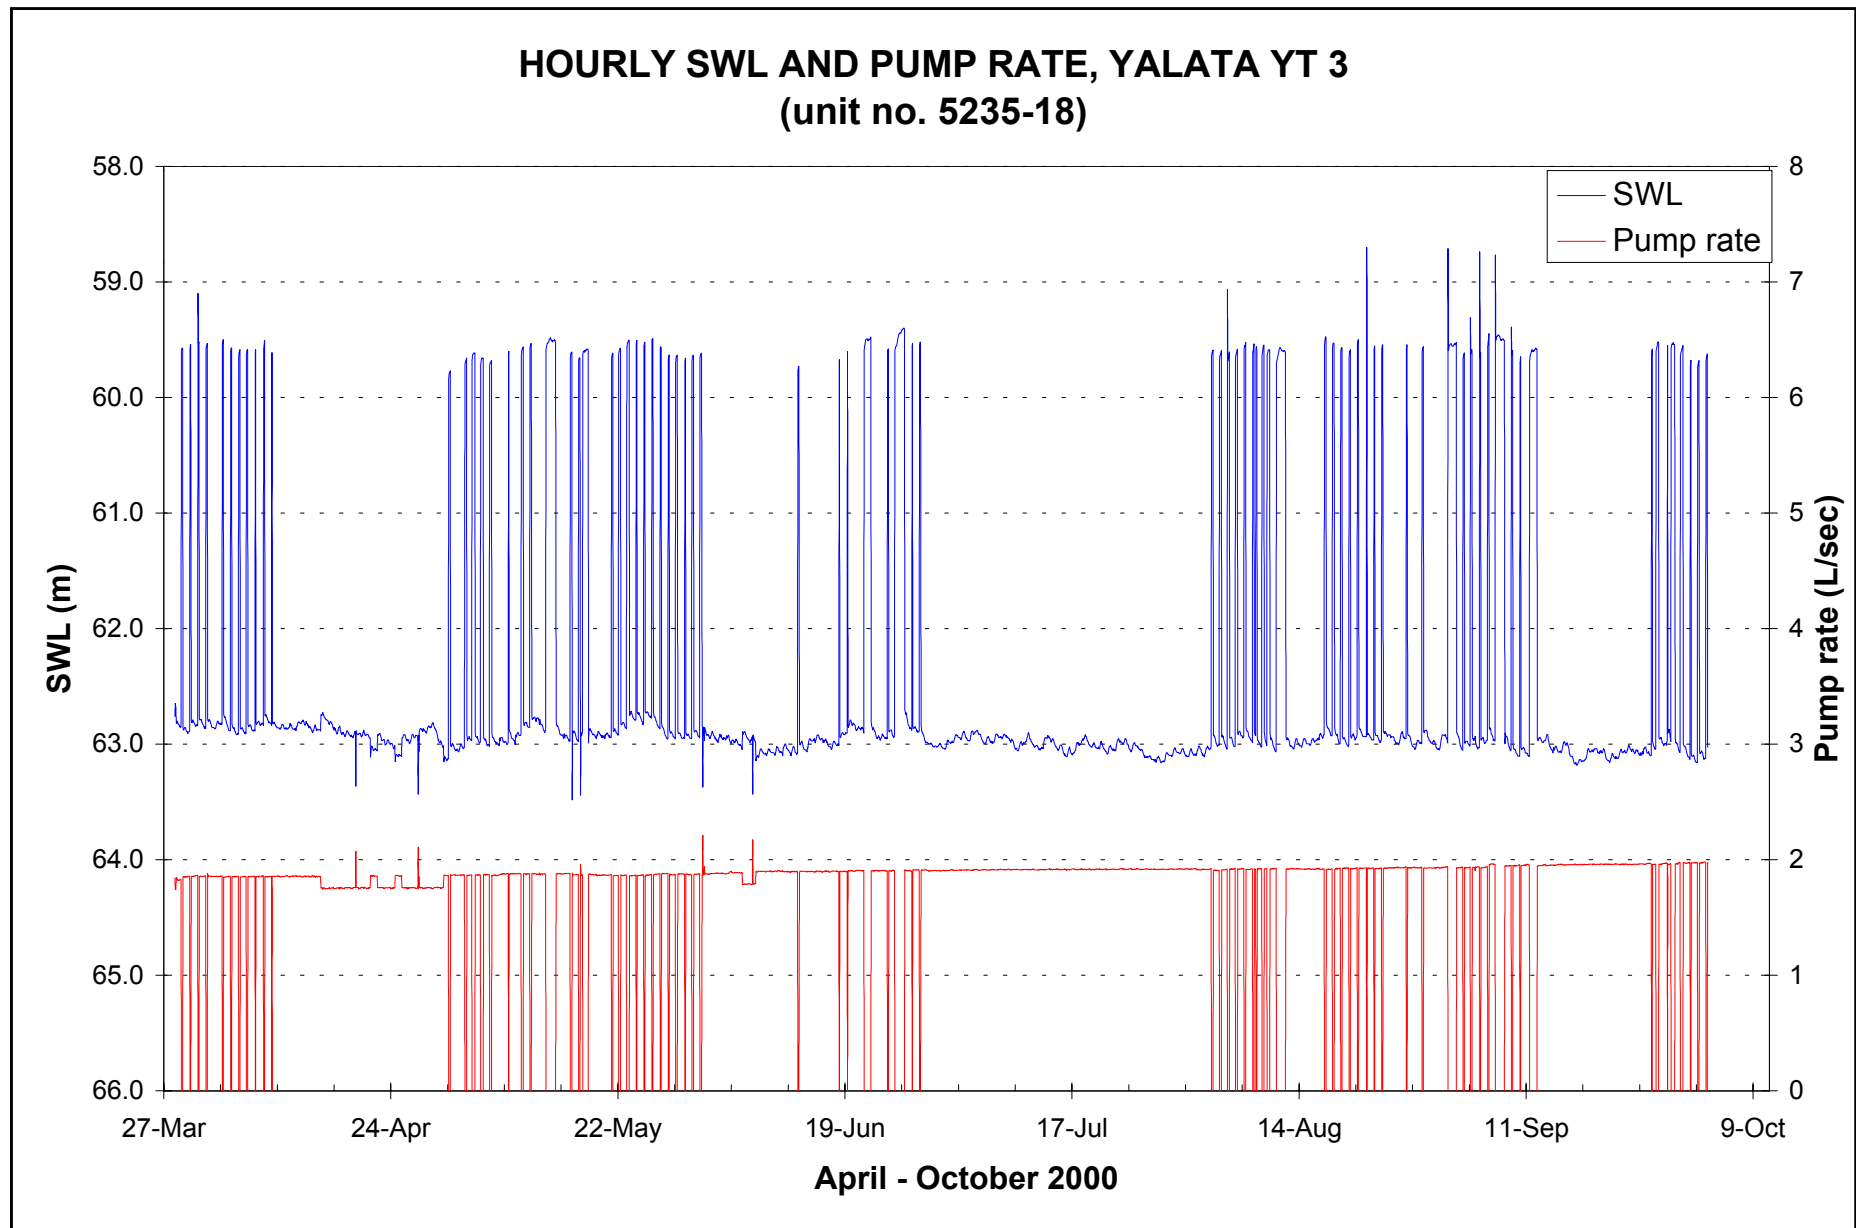
Figure 10.4

YT 3 has been pumped continuously over the period at a rate increasing from 1.8 to 2 L/s, resulting in an output of up to 169 kL/d. The decline in the pumping SWL, from 62.8 to 63.2 m, can be attributed to the increase in pumping rate (Fig. 10.4). However, there is no sign of stress to the aquifer. The non-pumping water level remained constant at approximately 59.6 m over the duration of the monitoring period.
