# **The City of Mitcham**

# **QUARRIES**

1999

#### MITCHAM QUARRIES EXECUTIVE SUMMARY.

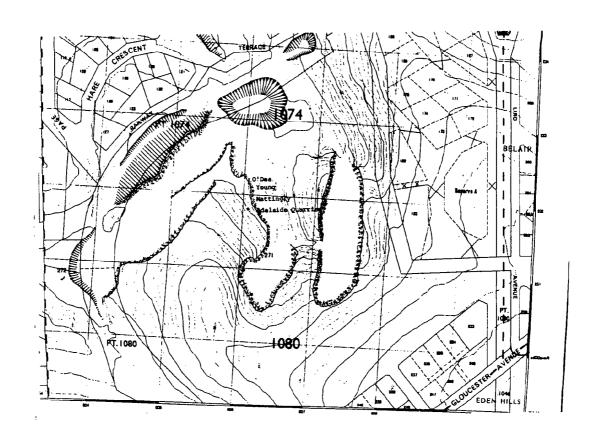
# O'DEA'S QUARRY

Comments
Emergency Access	Rating	Comments
(Recovery)		
Defined Road	1	30 metres away is a made road Mead Street
2. Vehicle access		
3. Defined walking trail

4. Trail steep, care required		
5. No trail		
Historic significance	Rating	
1. None		
2. Minimal value		
3. Significant	3	
4. Highly significant		
Geological significance	Rating
