Mine & Rehabilitation Annual Compliance Report

2013

Mine Name	Penrice Quarry & Mineral (PQM)			PEPR#	(2011/021)
Owner	Penrice Soda Products Pty Ltd			Tenements	
Operator	Penrice Quarry & Mineral (PQM)			PM 86	PM 120
Site Contact	Name	James Rowe		MPL 118	MPL 75
Email	james.rowe@penrice.com.au	Ph	08 8563 8822	ML 6233	RL109
Site Location Details: PQM is located approximately 2.5 kilometres north of the township of Angaston					
Report Details					
Reporting Period	1st January 2013 – 31st December 2013 inclusive		Date of Preparation		
Ownership Statement: This document represents a true and accurate account of the compliance status of the site at date of preparation.					
Name	James Rowe	Signature		Date

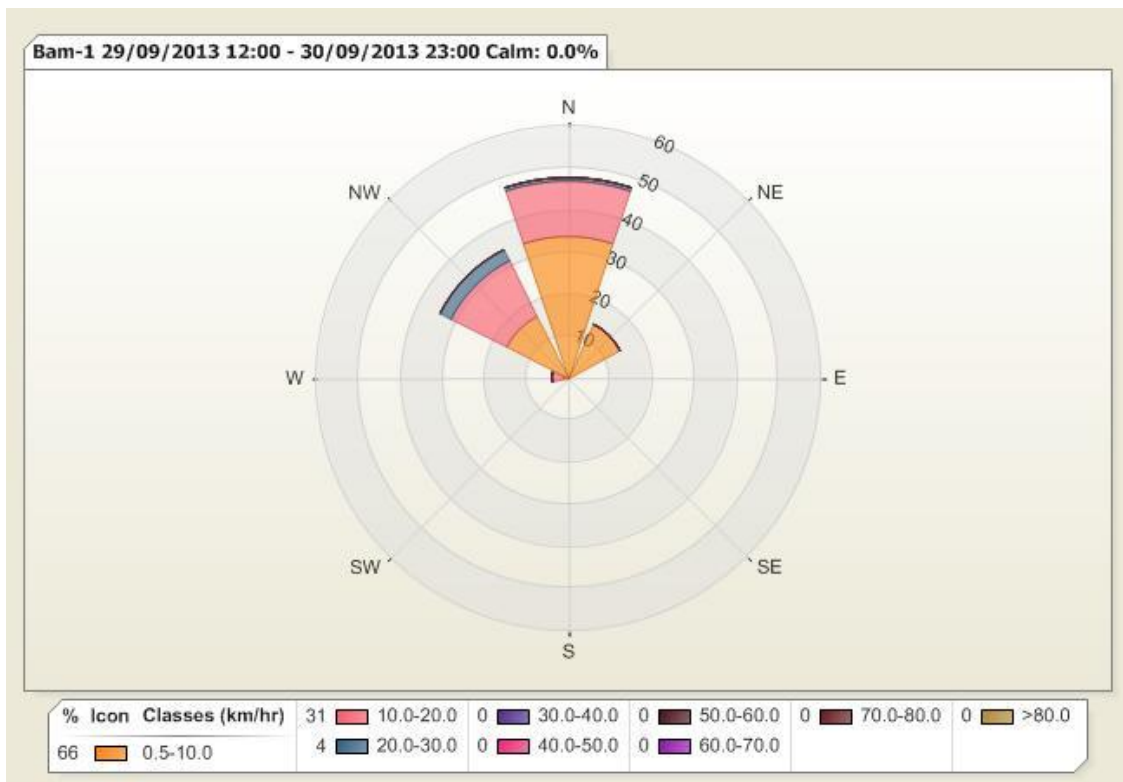
Figure 13 – Bam 1 Wind direction

On Monday the 30th September there were extreme weather warnings and conditions for the Barossa area with NW wind speeds up to 91 km/hr (Nuriootpa station 023373, BOM website). At 5am all three units had readings around 200 $\mu\text{g}/\text{m}^3$ see figure 12. The Dust Management Plan was implemented with all water trucks running and the Aggregate Plant remained off for the whole day. Wind direction during this period was predominantly NNW as shown in figure 13. With plant shut down and water trucks working continuously Penrice still contributed to the amount of dust going off site see figure 14. DMITRE and EPA were notified of the exceedence. A meeting was held between Penrice and DMITRE to discuss whether the PEPR conditions in criteria 1.2 can realistically be met when there are extreme weather events.
