ILUKA RESOURCES LIMITED

TECHNICAL REPORT

JACINTH-AMBROSIA PROJECT

Mining and Rehabilitation Compliance Report 2012

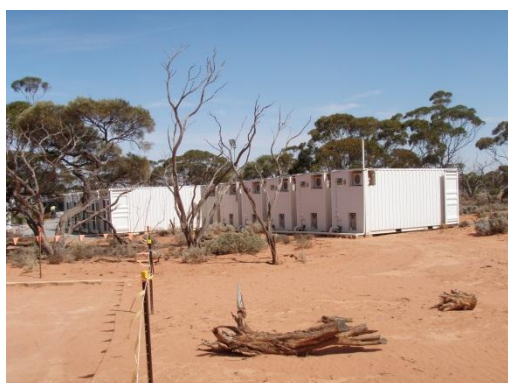
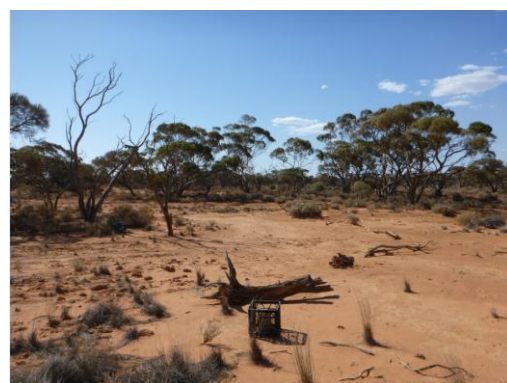
2012 Progress: No germination of natives or weeds, however all remaining plants seeded prolifically. No weed control required. LFA: 2011, 2012, next scheduled 2015, 2020. Photo-point: Figure 3.

Figure 3 – Canberra Camp photo-point, pre (left) and post (right) rehabilitation

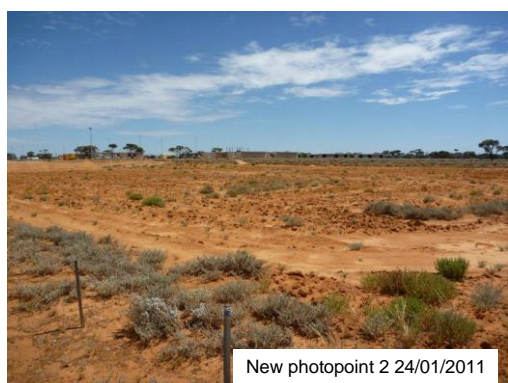
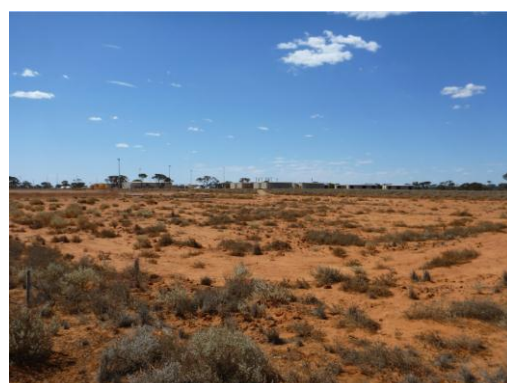
2012 Progress: No germination of natives or weeds. No weed control required. LFA: not scheduled on this small area. Photo-point: Figure 4.

Figure 4 – Lucas Camp photo-point, pre (left) and post (right) rehabilitation

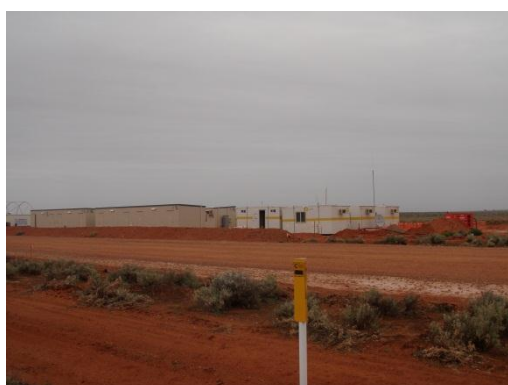
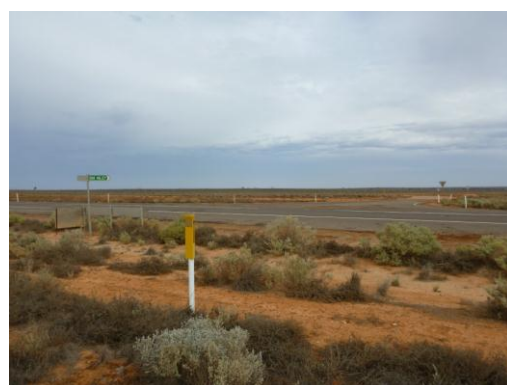
2012 Progress: No germination of natives or weeds. No weed control required. LFA: 2011, 2012, next scheduled 2015, 2020. Photo-point Figure 5.

Figure 5 – Tank Farm 1 photo-point, pre (left) and post (right) rehabilitation

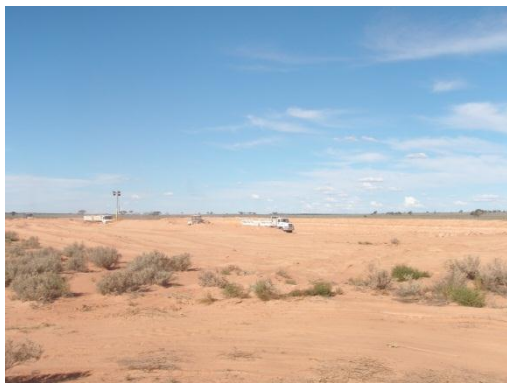
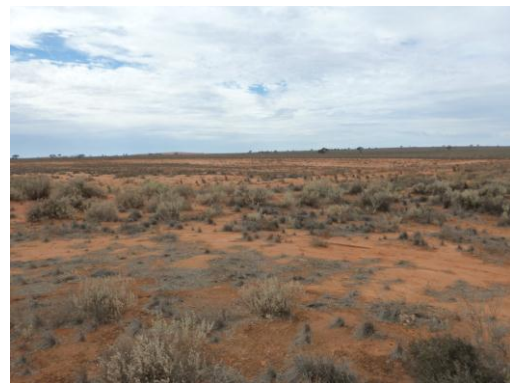
2012 Progress: No germination of natives or weeds. No weed control required. LFA not scheduled on this area. Photo-point Figure 6

Figure 6 – Calcrete Borrow Pit photo-point, pre (left) and post (right) rehabilitation

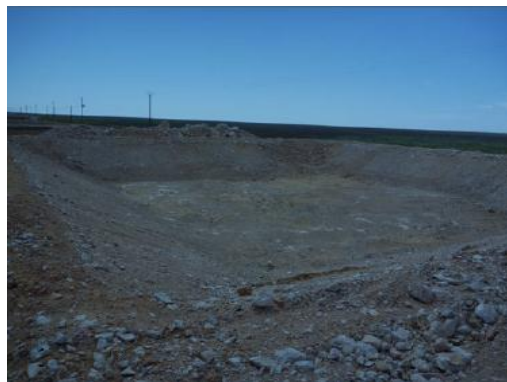
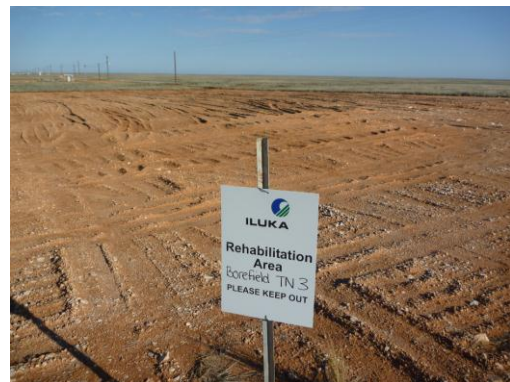
Figure 7 – Borefield Turkey's Nests photo-point, pre (left) and post (right) rehabilitation

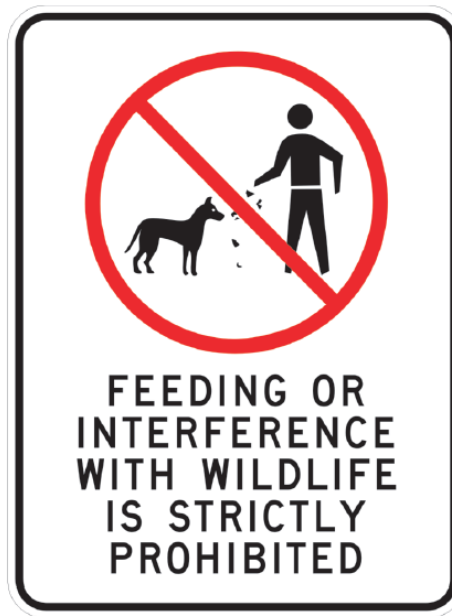
Figure 11 – Dingo ‘no feeding’ prohibition signs

- Rescue and release of dingos and birds from trapped in process water areas (several events);
- Dingo hit by mining haul truck and suffering extensive injuries – dingo euthanized in accordance with the JA Fauna Management Procedure and *Animal Welfare Act* by means of a quick blow to the head to immediately render the animal insensible to continued pain and distress. Notification sent to DEWNR.
- Iluka Contractor feeding dingo – non-compliance with *Parks & Wildlife Act*. Contractor dismissed from site; Site Notice distributed and signs installed concerning prohibitions on feeding dingos (Figure 11).

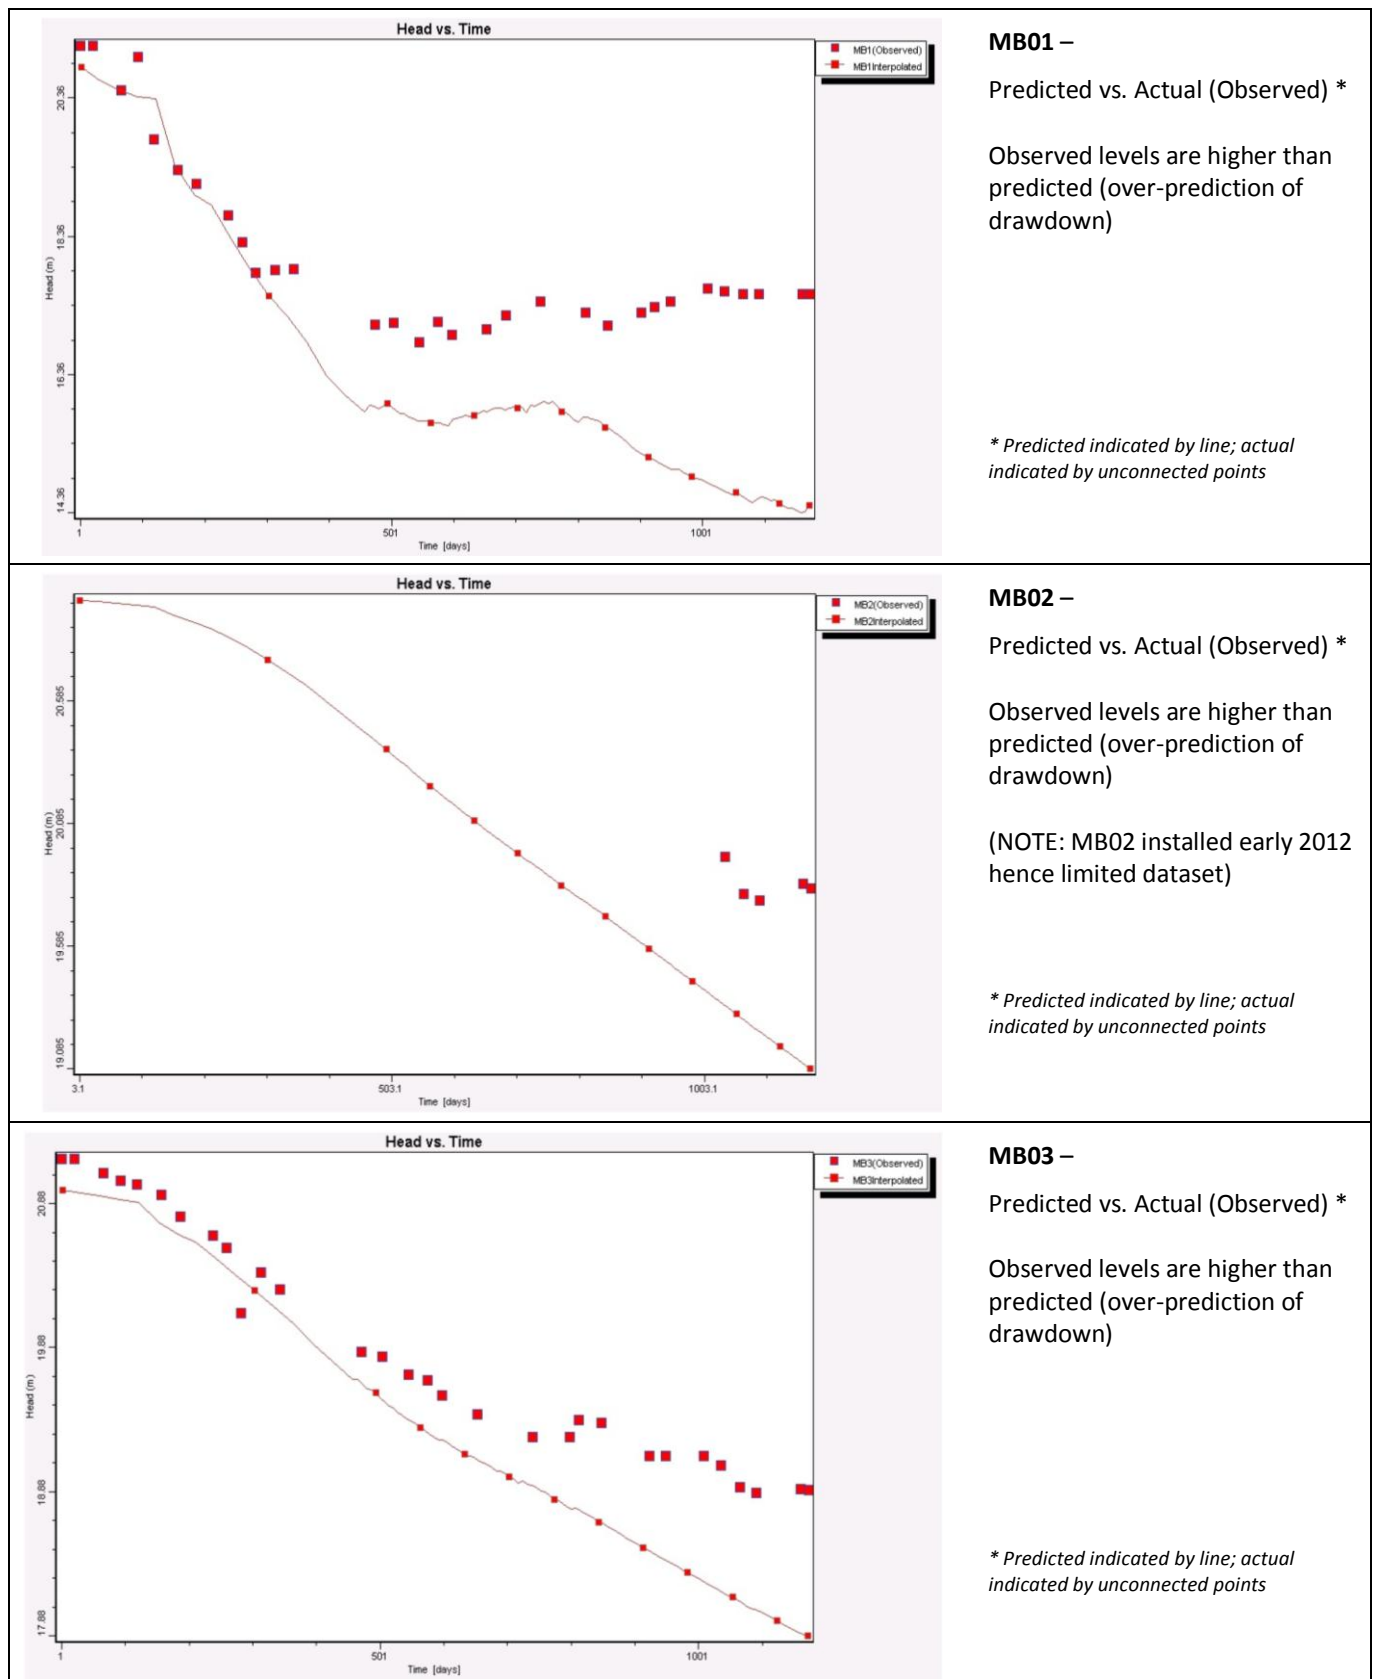
Figure 15 – Drawdown (actual vs. predicted) in monitoring wells north of borefield

- Predicted groundwater drawdown per the SKM model was over-predicted to the north of the borefield (Figure 15), and under-predicted to the south (Figure 16). This divergence suggests that groundwater flow is partially restricted to the south of the borefield and subsequently compensated by groundwater flows from the north;

Further review of the model will be undertaken to better represent aquifer orientation and number and to refine the model predictions.

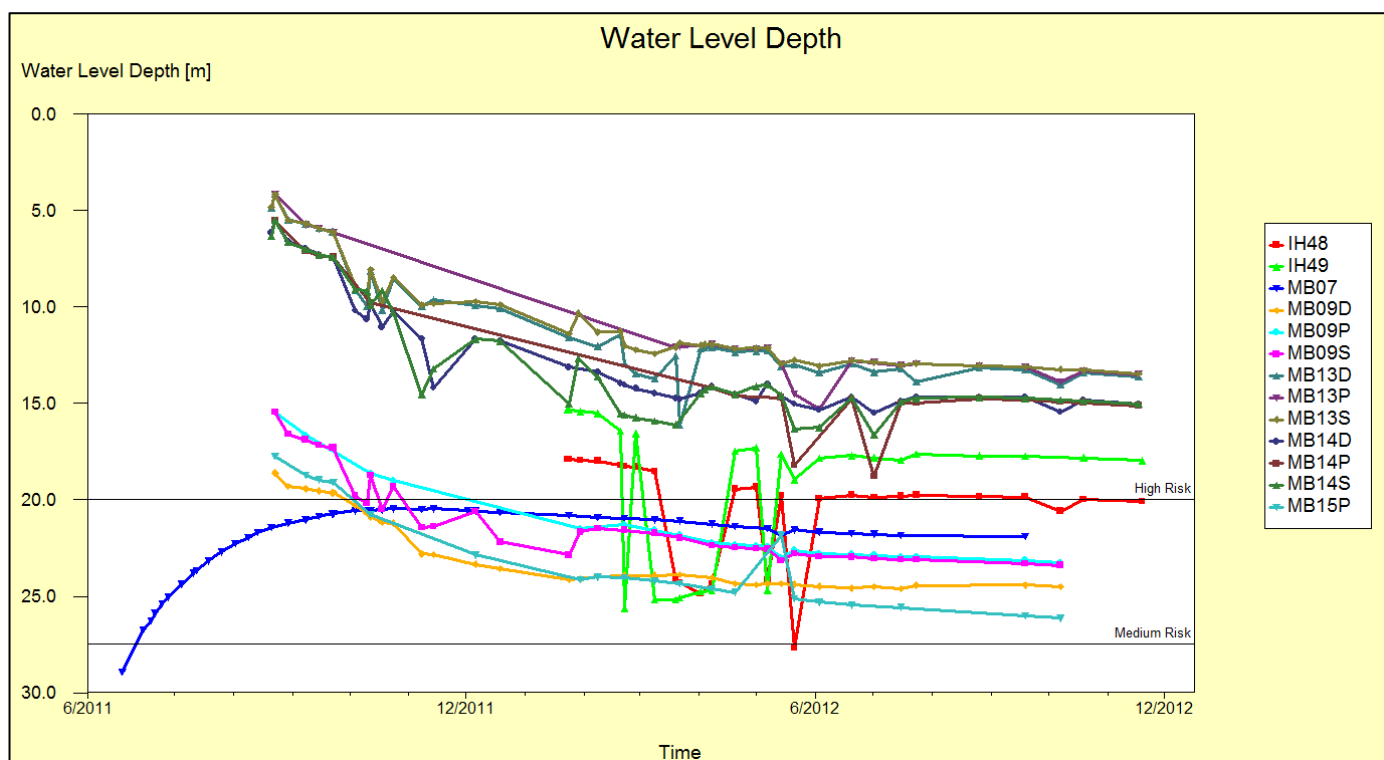
Figure 20 – Declining groundwater levels in Cell 1 bores, 01/01/11 – 31/12/12

Water levels in Cell 1 wells continued to decline in 2012 (Figure 20), slowing in the latter half of 2012 with reduced recovery rates observed in dewatering wells. Dewatering wells were switched off in June/July to accommodate the change in mining path to the north of the ore body. Hydrogeological assessment of Cell 1 groundwater levels, including viability for continued dewatering, is underway at time of reporting.

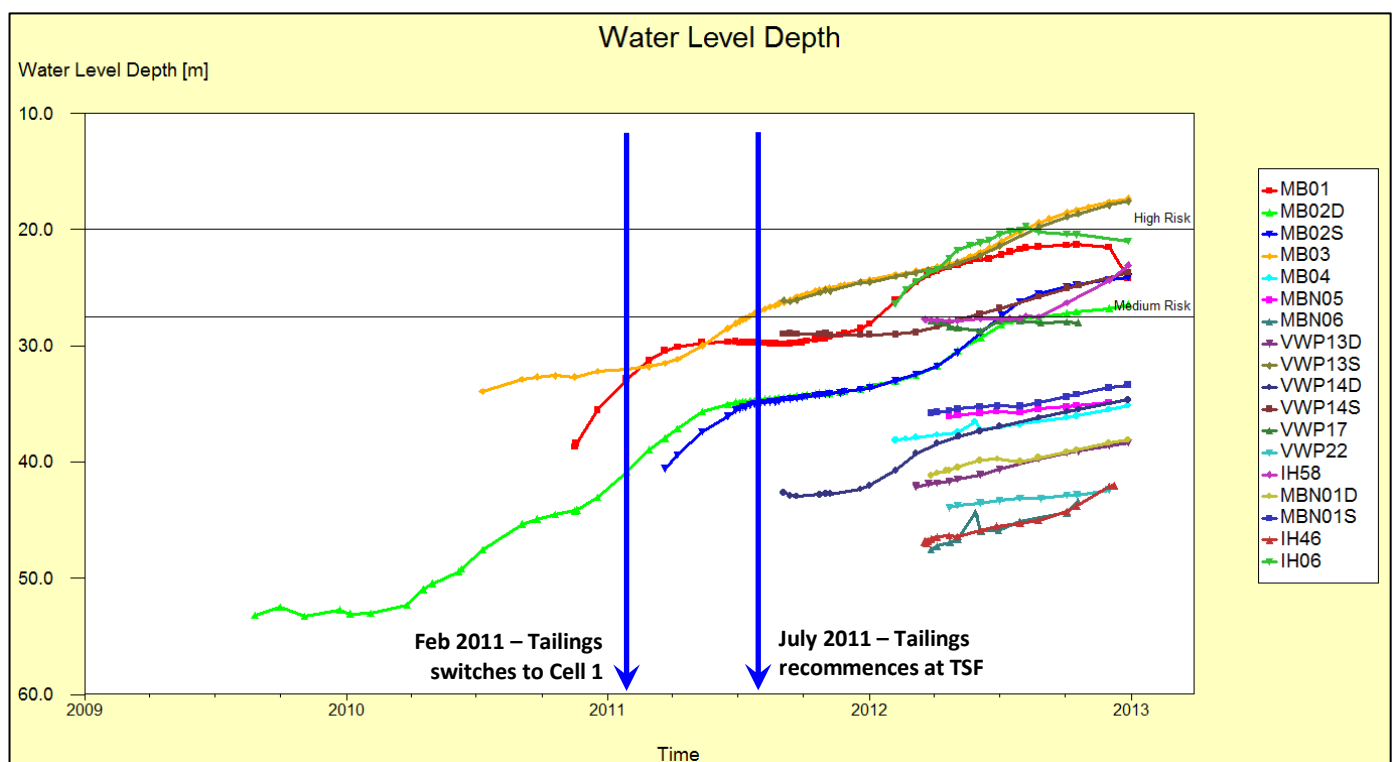
Figure 21 – Long-term trend in TSF monitoring wells and VWP's (01/01/09 – 31/12/12)

All monitoring wells adjacent to the off-path TSF showed continued groundwater rise in 2012 (Figure 21). As noted in the 2011 MARCR and *Groundwater Compliance Report and Management Plan*, this rise was anticipated in response to continued tailings activity and pending the installation of the TSF dewatering scheme. Key points:

- MB03 and VWP13D, located west/north-west of the TSF, showed increased rise into the “high-risk” zone in the latter half of 2012.
- Similar upward trend observed in MB02D and MB02S, east of the TSF;
- Wells and piezometers bordering the E/NE boundary of the TSF showing gradual rise. This is particularly evident in IH58 adjacent to the TSF eastern tailings cell and showing a response to tailings seepage.
- Decline in MB01 and IH06, wells located nearest the TSF interception scheme, in response to localised drawdown of the aquifer.

Further hydrogeological risk assessment of the groundwater rise east and west of the TSF, including options for the installation of additional interception wells, is currently underway at time of reporting.

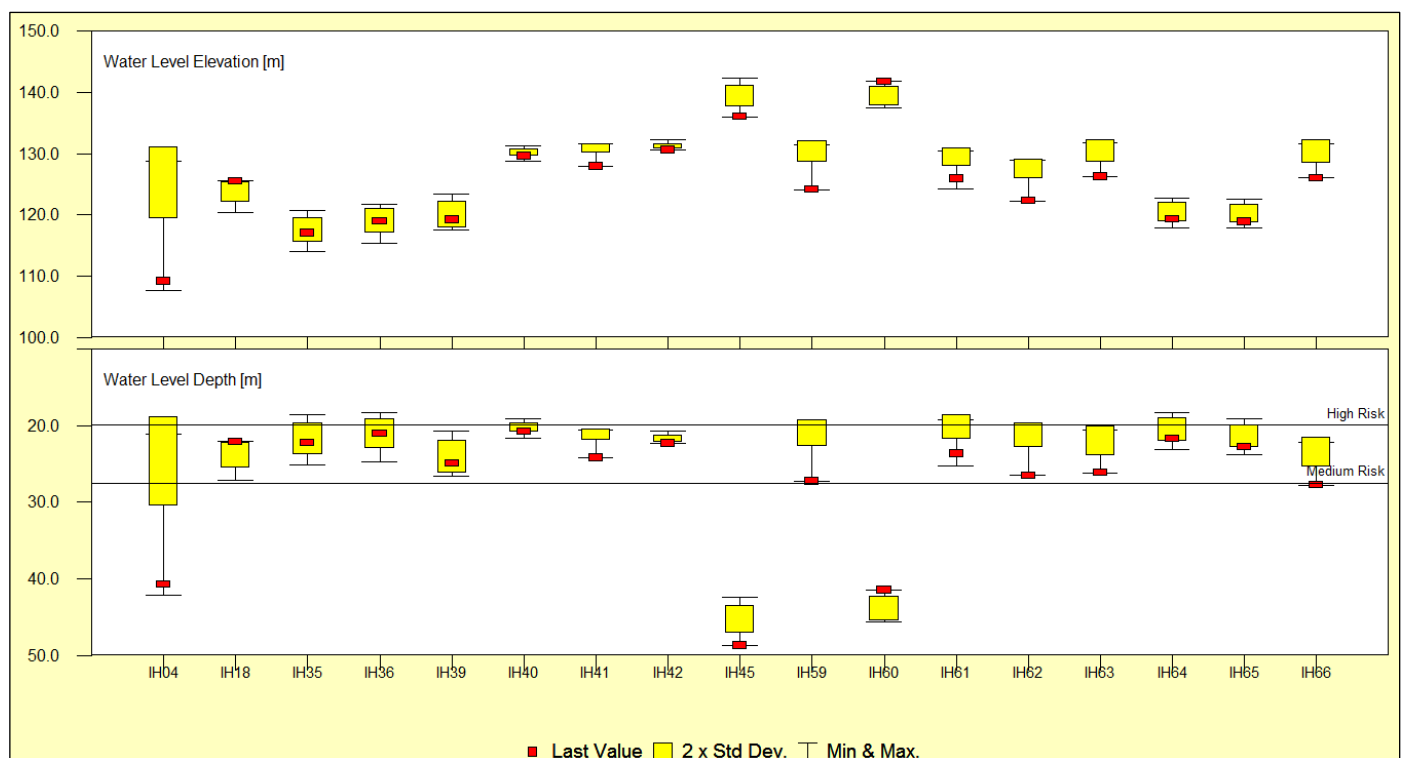
Figure 22 – Groundwater trend in TSF interception wells (01/02/12 – 31/12/12)

A box and whisker plot of water level elevation and depth for the interception wells is provided in (Figure 22). The plot shows the highest and lowest recorded levels for each well (i.e. 'min' and 'max') and the last observed reading (indicated by red marker, 'last value').

Levels in wells that had peaked above the 20m trigger level prior to installation of the interception system dropped following commencement of dewatering. It is important to note however that these levels are based on active pumping – levels rapidly return to pre-interception levels when pumps are offline.

Further analysis on drawdown performance will be provided in the 2013 MARCR when more data is available.

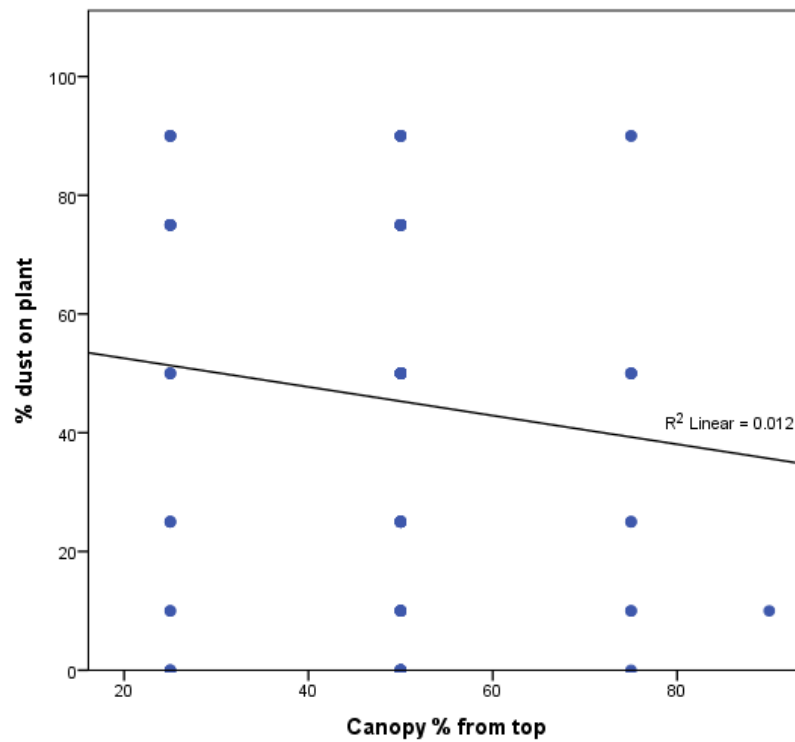
There were no differences between the top canopy density of shrubs coated in dust compared to no dust (Figure 12, Figure 18). Continuing this monitoring over a longer time frame will determine whether Pearl Bluebush top canopy density truly is unaffected by high dust loadings or whether it just takes several years for an effect to become apparent.

Figure 18: 2012 J-A Pearl Bluebush transects, % of dust on shrub vs % of top canopy.

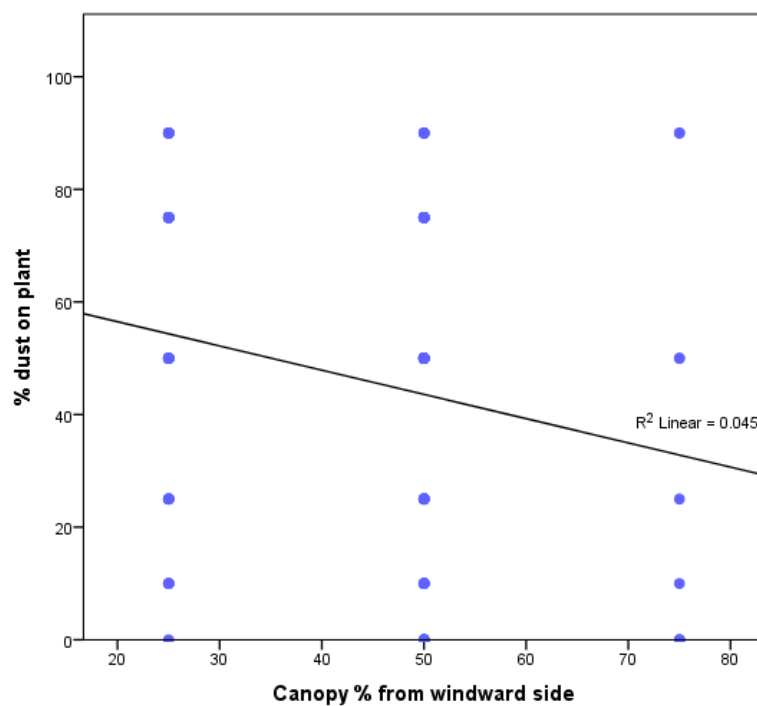
Similarly to the top canopy data, the side canopy data shows no relationship between percentage dust and percentage side canopy in 2012 (Figure 13, Figure 19).

Figure 19: 2012 J-A Pearl Bluebush transects, % of dust on shrub vs % of side canopy on dust source side of shrub.
