ILUKA RESOURCES LIMITED

JACINTH-AMBROSIA PROJECT

Mining and Rehabilitation Compliance Report 2014

31st March 2015

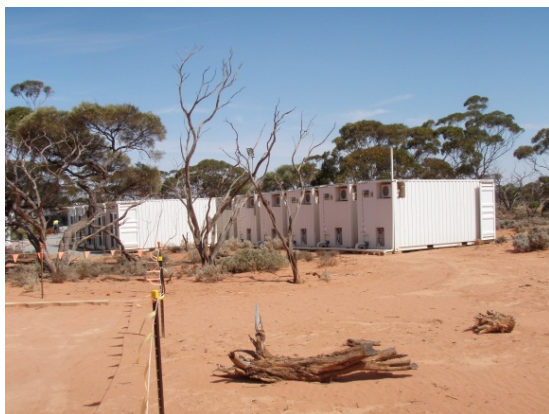
Plate 1 Canberra camp site 2009

Domain	Size (ha)	Progress in 2014	Planned for 2015
2 Airfield & Village			
2B, Canberra Camp	1.4	Germination of natives in some areas, however some small areas still compacted and had no growth. Some weed control required. Refer to Plate 1 and Plate 2	Old septic system and pipe still to be removed. Some compacted areas will need to be ripped. Weed control as necessary. LFA: 2011, 2012, next scheduled 2015.
2B, Contractor Camp	1.51	Germination of natives in some areas. No weed control was required in this area. Refer to Plate 3 and Plate 4.	Weed control as necessary.
3 Borefield and Access Road			
3C, Borefield Turkey's Nests	3.76	Very little germination has occurred in this area. No weed control was required in this area.	Weed control as necessary. Low level ripping and hand seeding planned for this area in 2015. LFA: Scheduled for 2014, 2015 and 2018.
3E, Tank Farm 1	3.02	Very little germination has occurred in this area. No weed control was required in this area. Refer to Plate 5 and Plate 6	Weed control as necessary. Low level ripping and hand seeding planned for this area in 2015. LFA: 2011, 2012, next scheduled 2015.

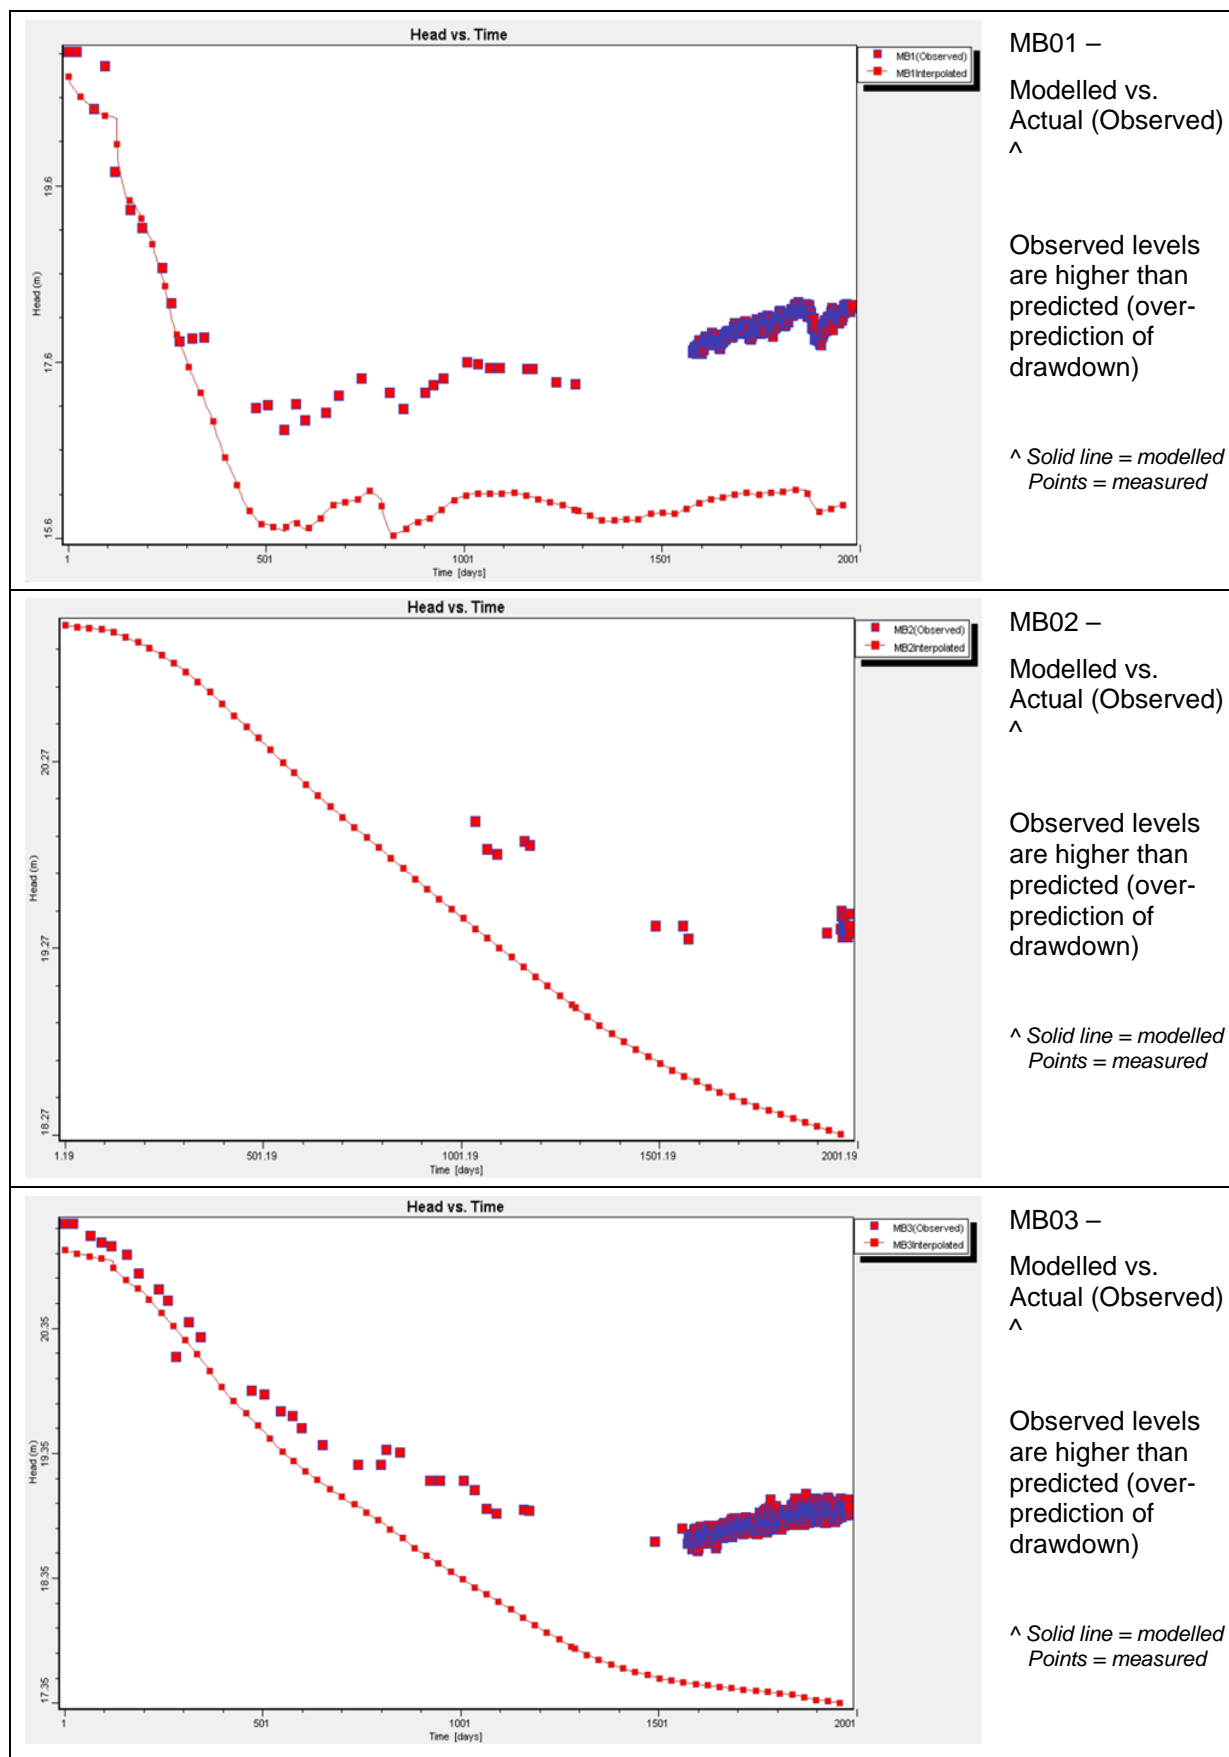
Figure 2 Drawdown (actual vs. predicted) in monitoring wells north of borefield

- The trends present between modelled and measured groundwater levels at the six monitoring wells indicated that the model over-estimates drawdown compared to measured groundwater levels. This overestimate indicates the model is providing a conservative prediction of palaeochannel groundwater response to pumping. The model is to be revised and re-calibrated in 2015.
- Measured groundwater levels at monitoring wells MB1, MB3, MB4, MB5 and MB6 demonstrated a general recovery in groundwater levels since 2014. This is a result of a decline in abstraction from the borefield driven by significant improvement in mine site water recoveries.

Monthly monitoring of groundwater levels at the borefield will continue.

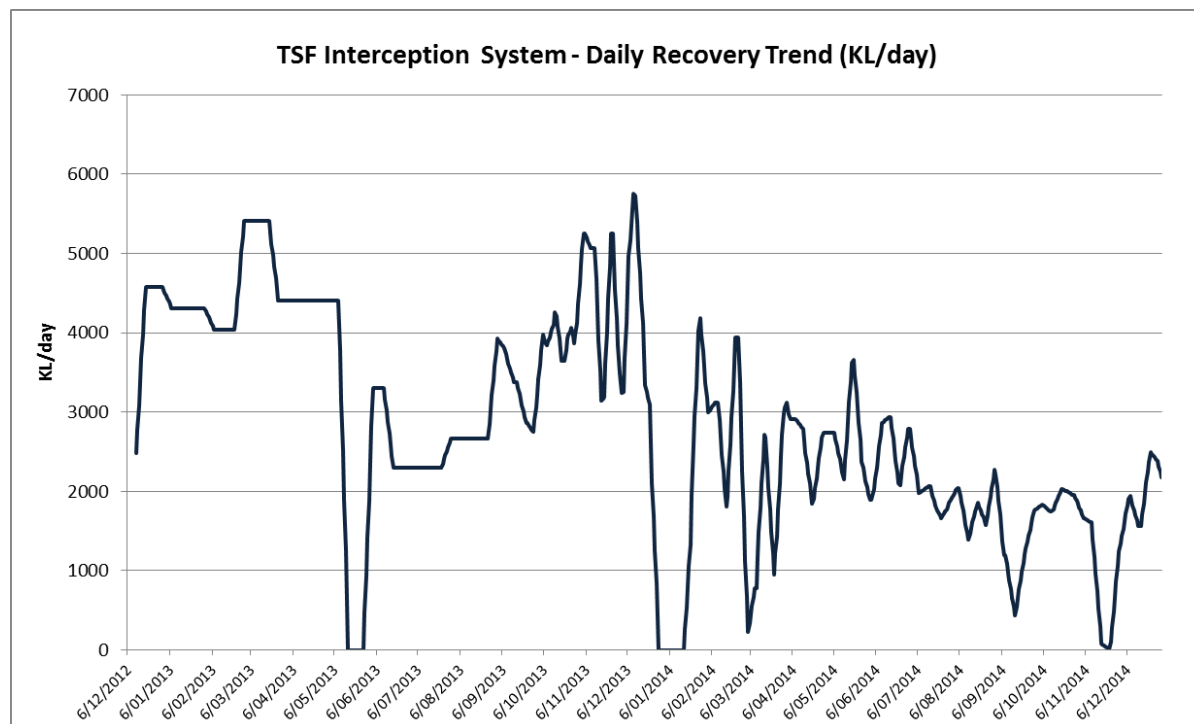
At time of reporting the system provides a yield of approximately 25 L/sec (approximately 2,100 KL/day) with reclaimed groundwater discharged to the Jacinth process water dam. Interception yield totals approximately 2.1 gegalitres to-date. As expected, recovery performance has declined gradually since commencement of dewatering in December 2012 (Figure 4) due to active interception and the cessation of tailings in May 2013.

Figure 4 TSF interception recovery (Dec 2012 - Feb 2014)

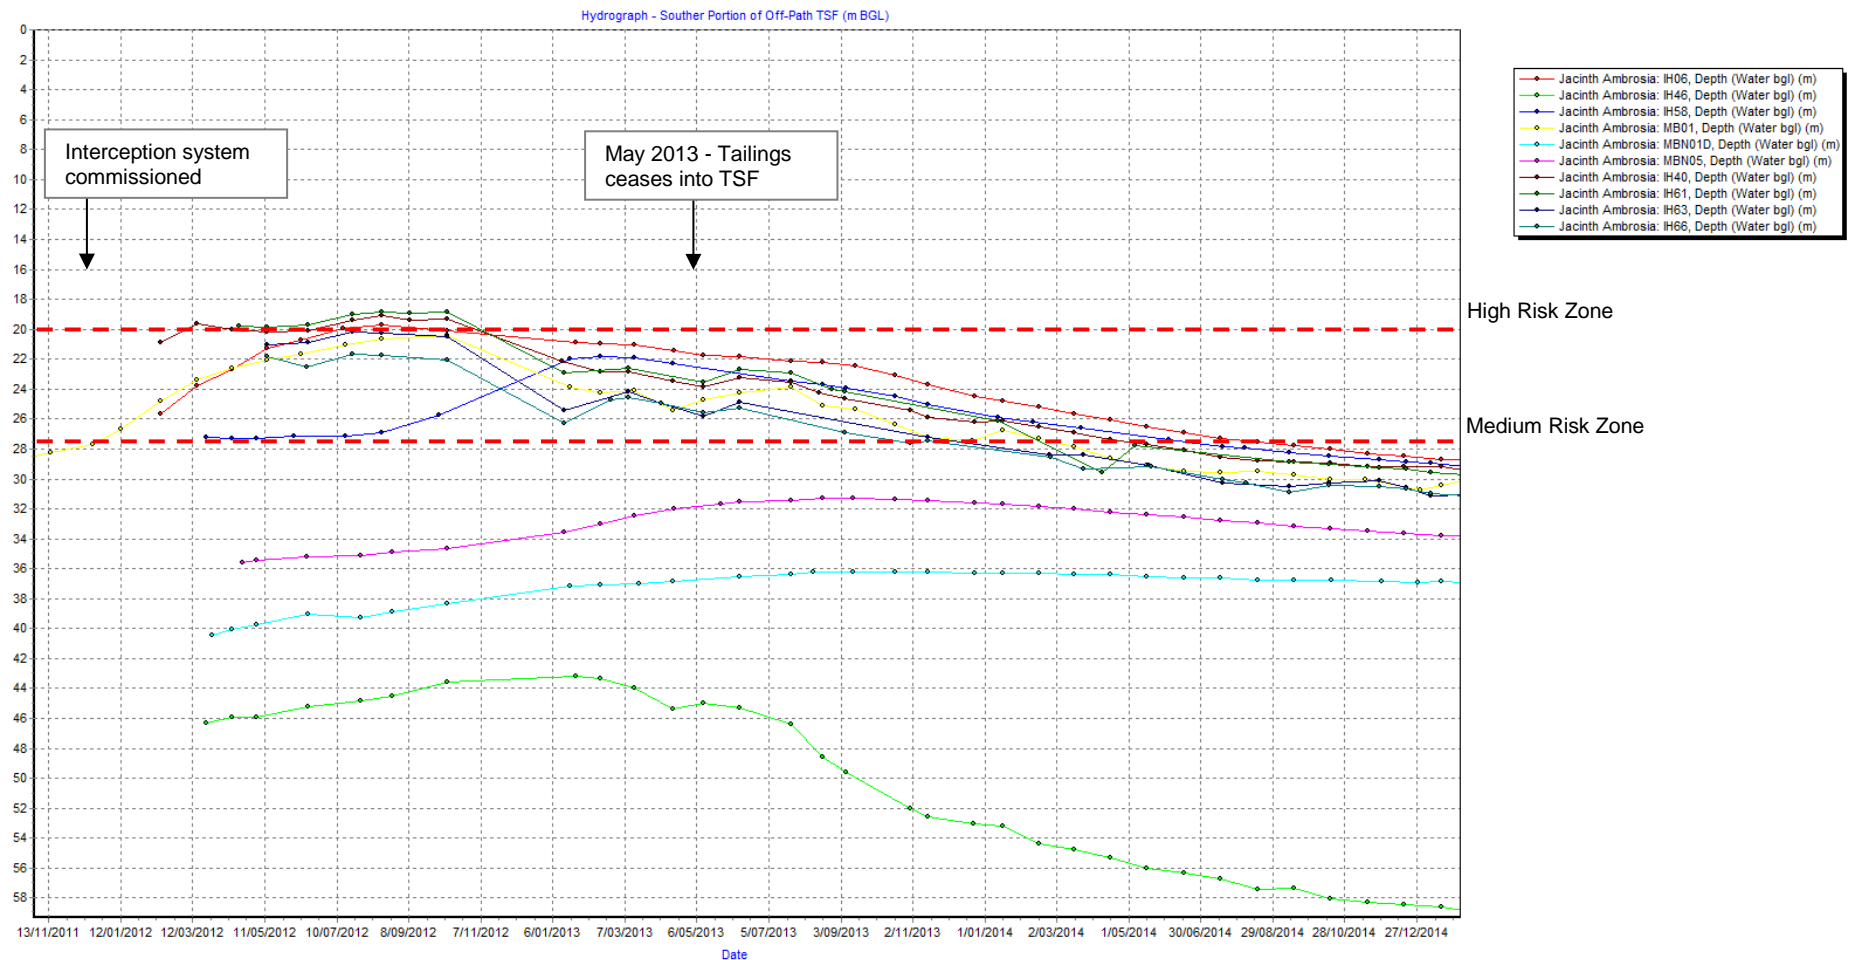
- All monitoring wells on the southern side of TSF below medium risk SSTL of 27.5 m BGL and are still declining (Figure 5).
- All monitoring wells adjacent to the northern side of the TSF are declining; however water levels are still exceeding either the high risk or medium risk SSTL of 20 and 27.5 m BGL respectively (Figure 6).
- Water levels of monitoring wells within the immediate footprint of the northern portion of the TSF range from 18 and 21 m BGL.
- Rising groundwater levels observed in down hydraulic gradient bores MBN11 and MBN08 (west to north-west of TSF) due to movement of the groundwater mound down the local hydraulic gradient toward Lake Ifould.

Figure 5 Long term trend in Southern TSF monitoring wells (1/11/11 - 1/2/15)

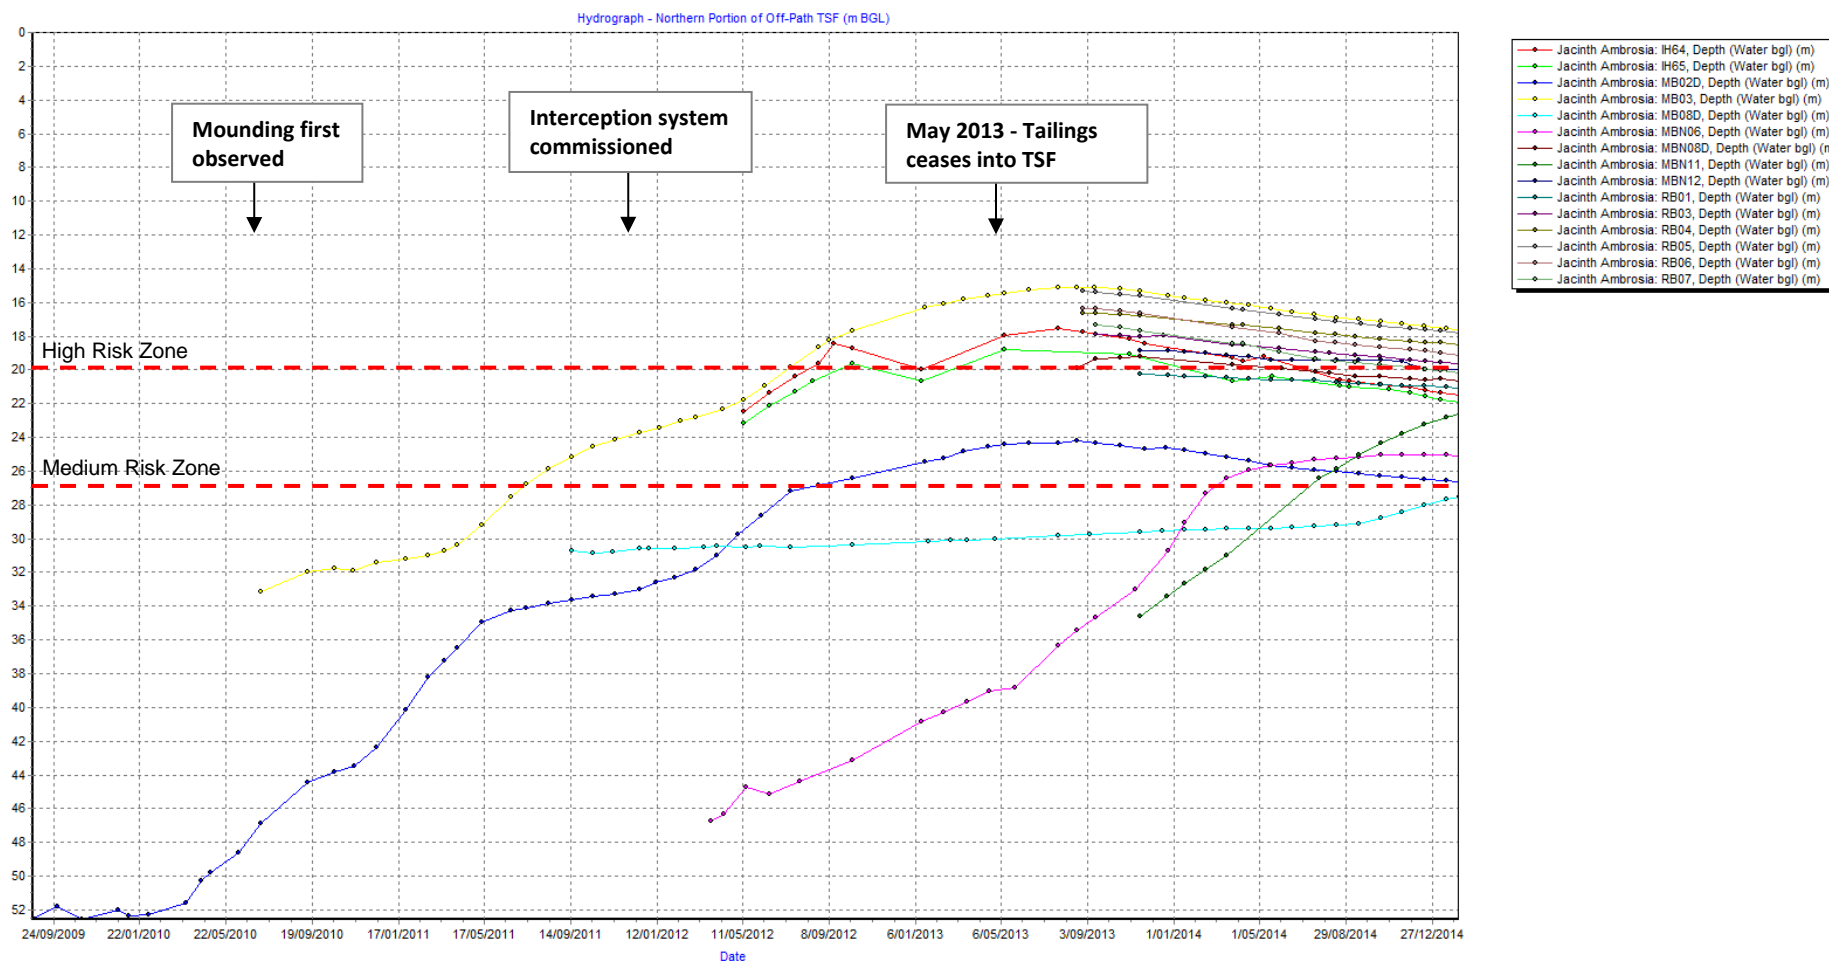
Figure 6 Long term trend in Northern TSF monitoring wells (1/9/09 - 1/2/15)

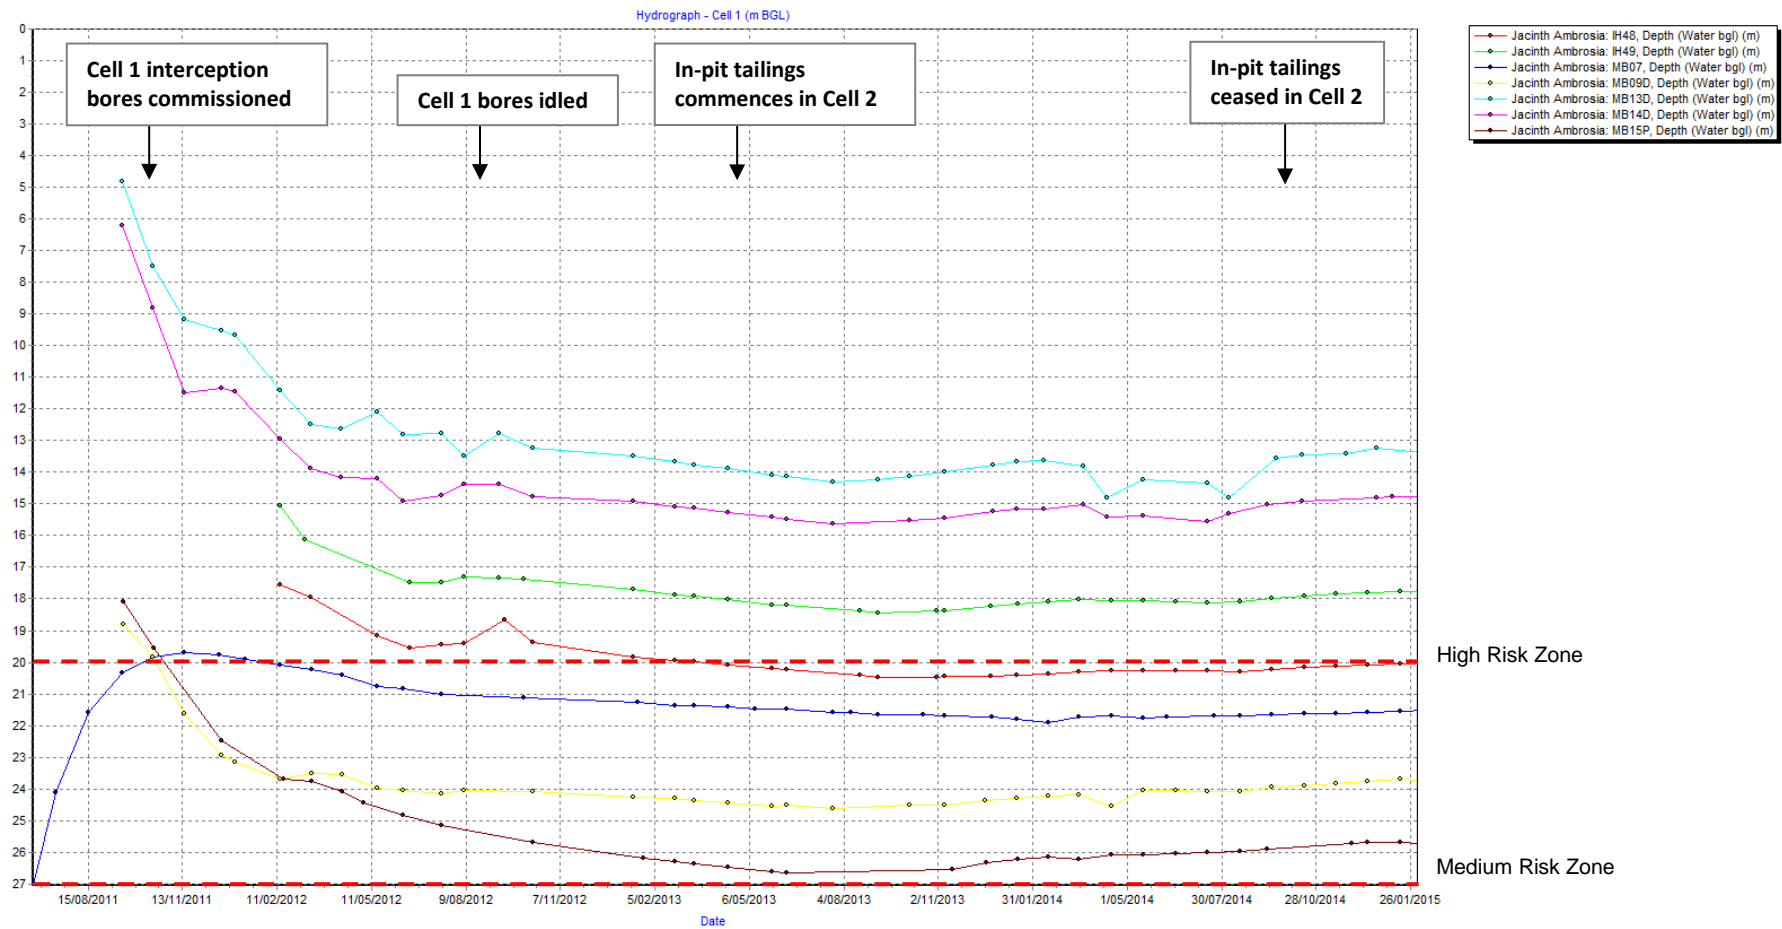
Water levels in Cell 1 wells continued to decline until September 2013, at which time recurring groundwater rise was observed. This rise was a lag-response to seepage from Cell 2 following the commencement of Cell 2 in-pit tailings in June 2013. However since December 2014 water levels in Cell 1 have generally stabilised (Figure 7).

Water balance data for Jacinth demonstrates water recovery efficiencies of approximately 70% (decant pond and sub-floor drainage recoveries) from Cell 2, with the remainder (approximately 30%) lost to infiltration and evaporation (Figure 7). Cell 1 hosts a hard granite basement and basement high running east-west along northern boundary of Cell 1 which serves to dam groundwater and impede the rate of natural infiltration. Thus, while groundwater levels under Cell 1 had shown gradual decline since interception ceased in August 2012, the rate has been extremely slow and a residual groundwater mound (above the 20 m 'high-risk' SSTL) has remained. Seepage from Cell 2 has acted as a recharge point for the residual mound and caused the recurring rise in groundwater levels.

However, tailing into Cell 2 ceased in October 2014 with the transition of active tailing to Cell 3A; at time of reporting it appears that this cessation of tailing into Cell 2 has reduced the seepage loss to and subsequently stabilised groundwater levels beneath Cell 1. Please note that further monitoring of Cell 1 is being undertaken to confirm this trend which will be discussed in the 2015 compliance report.

Figure 7 Long-term groundwater trend for Cell 1 bores 1/6/11 - 2/2/15

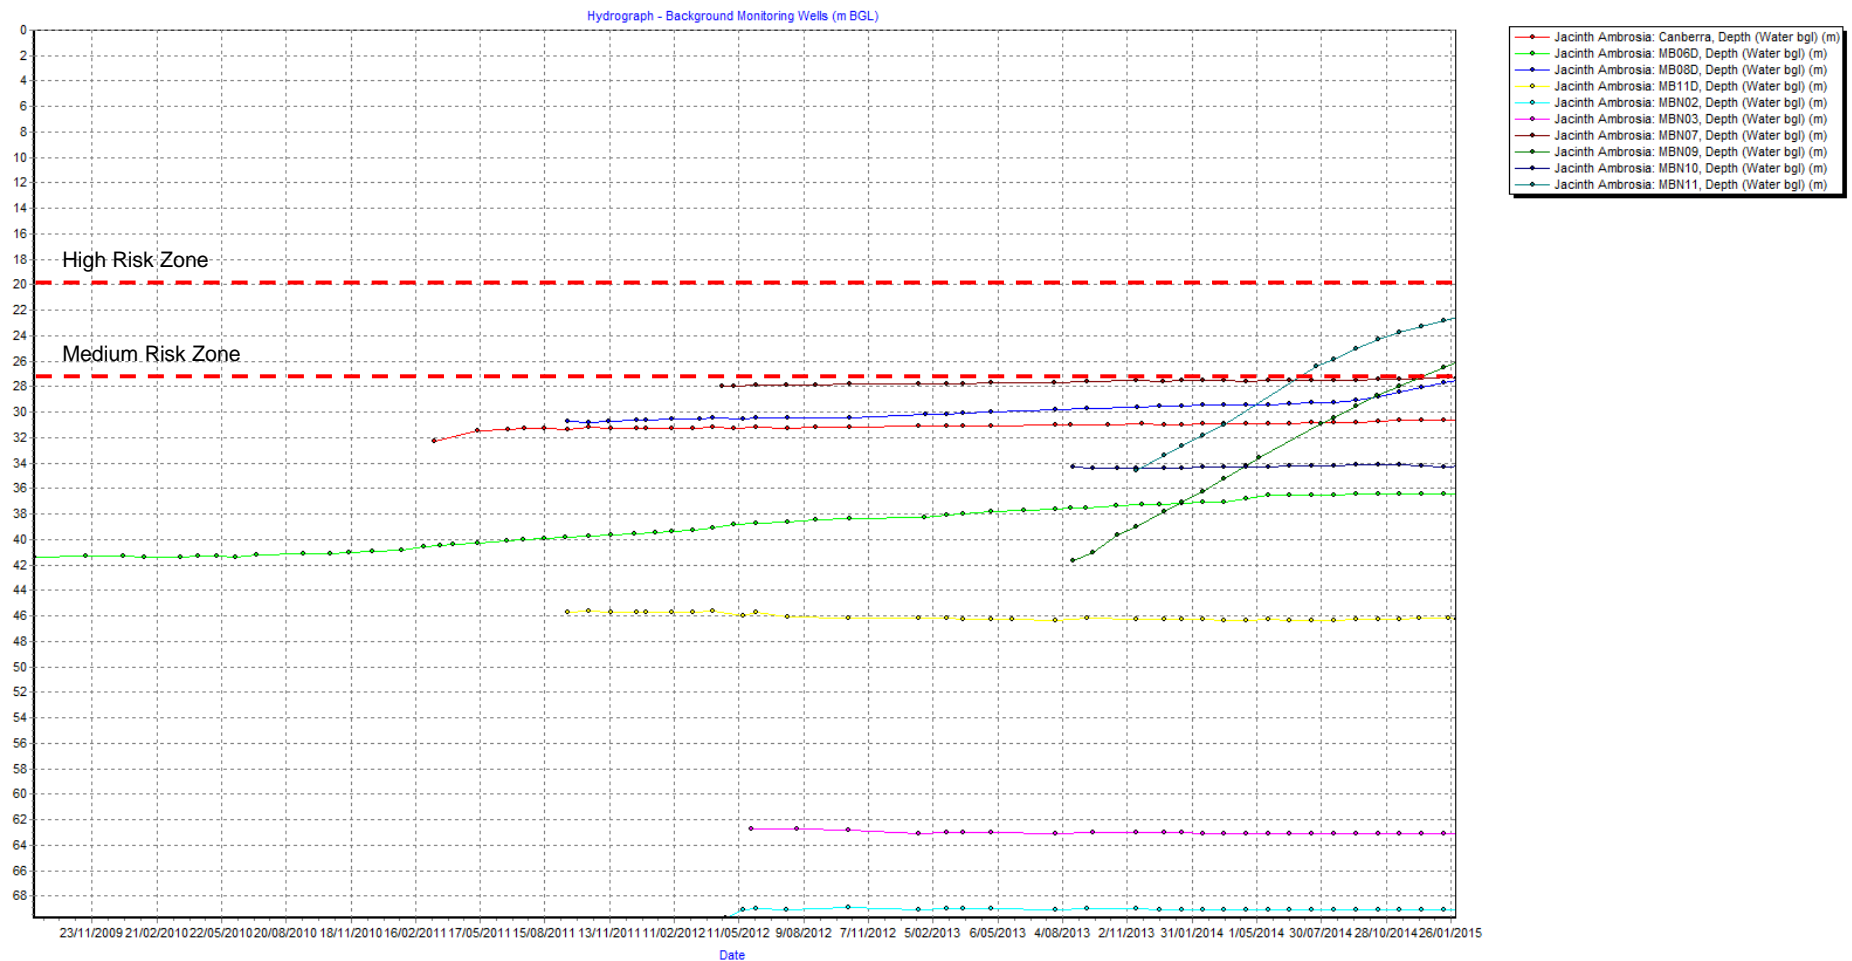
Consistent with previous reporting J-A background monitoring wells (Canberra, MBN02, MBN03 and MBN07) continue to remain relatively static (Figure 9).

Figure 9 Trend in outlying mine site monitoring wells (1/6/2009 - 1/2/2015)

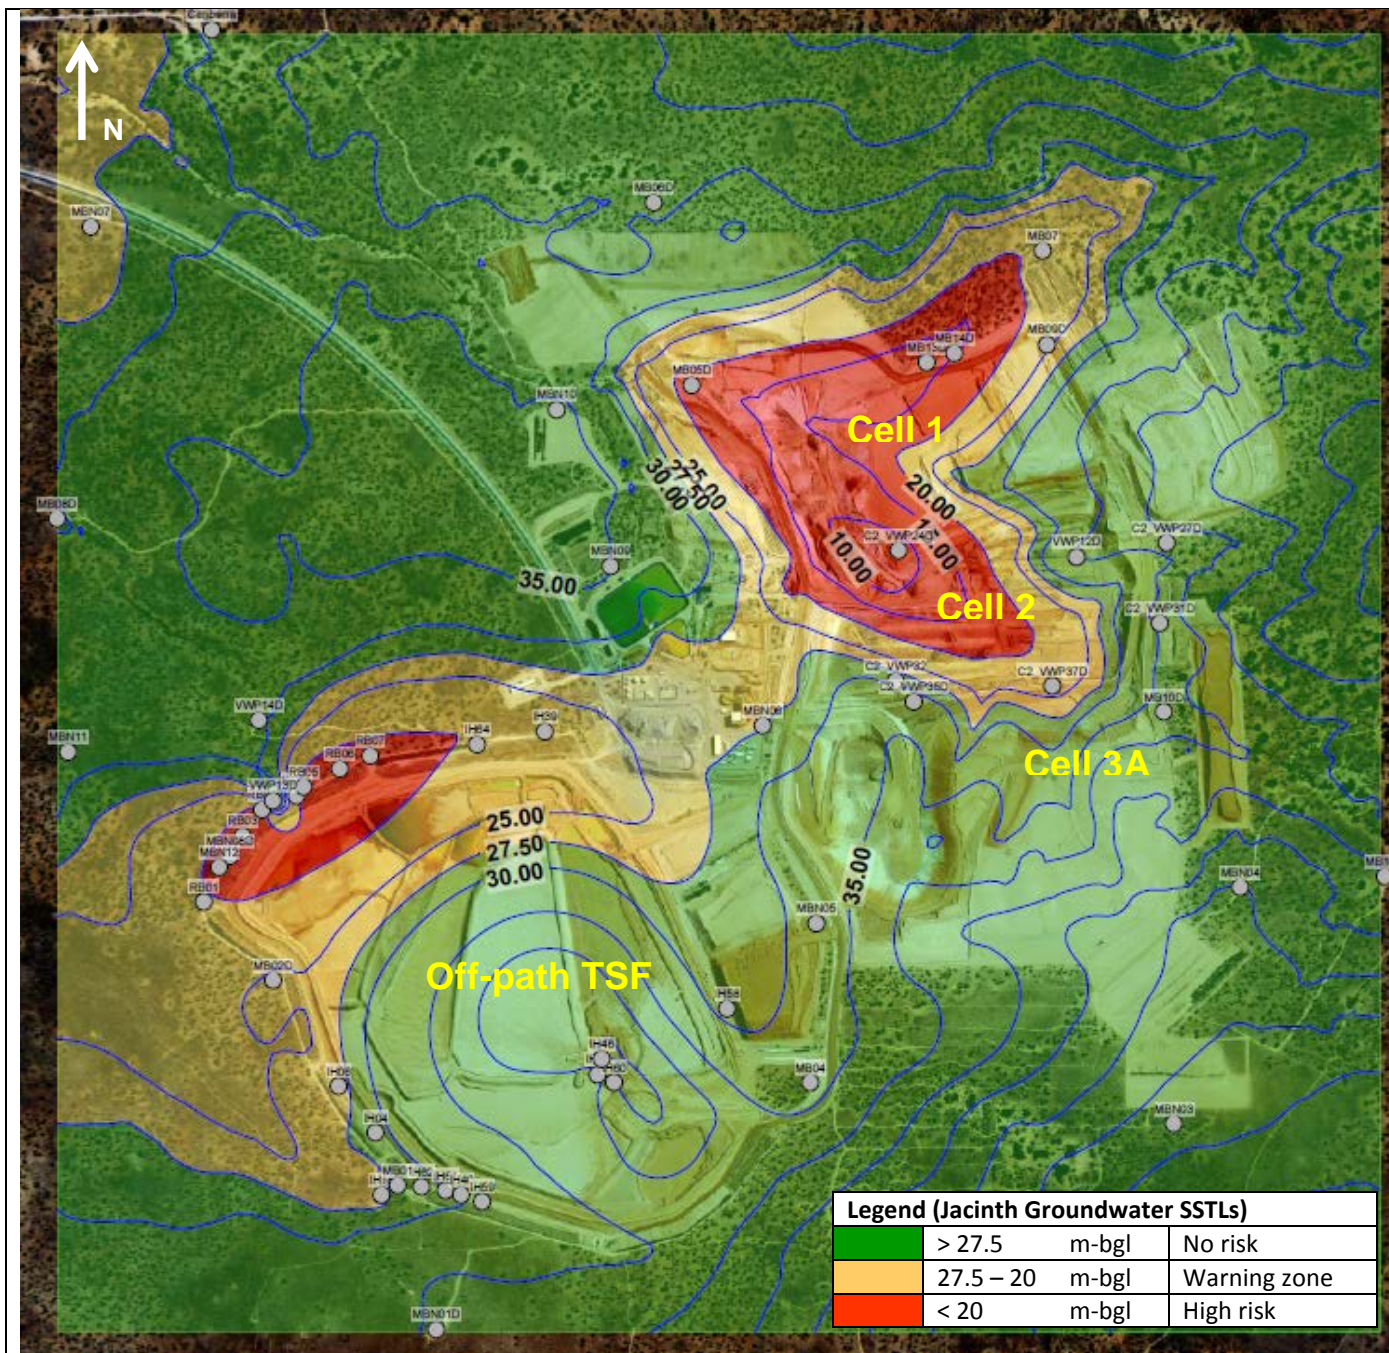
Groundwater contour, January 2014

- Groundwater levels on southern portion of TSF are below the "no risk" levels.
- Groundwater levels on the north western portion of the TSF still exceed the "high risk" SSTL.

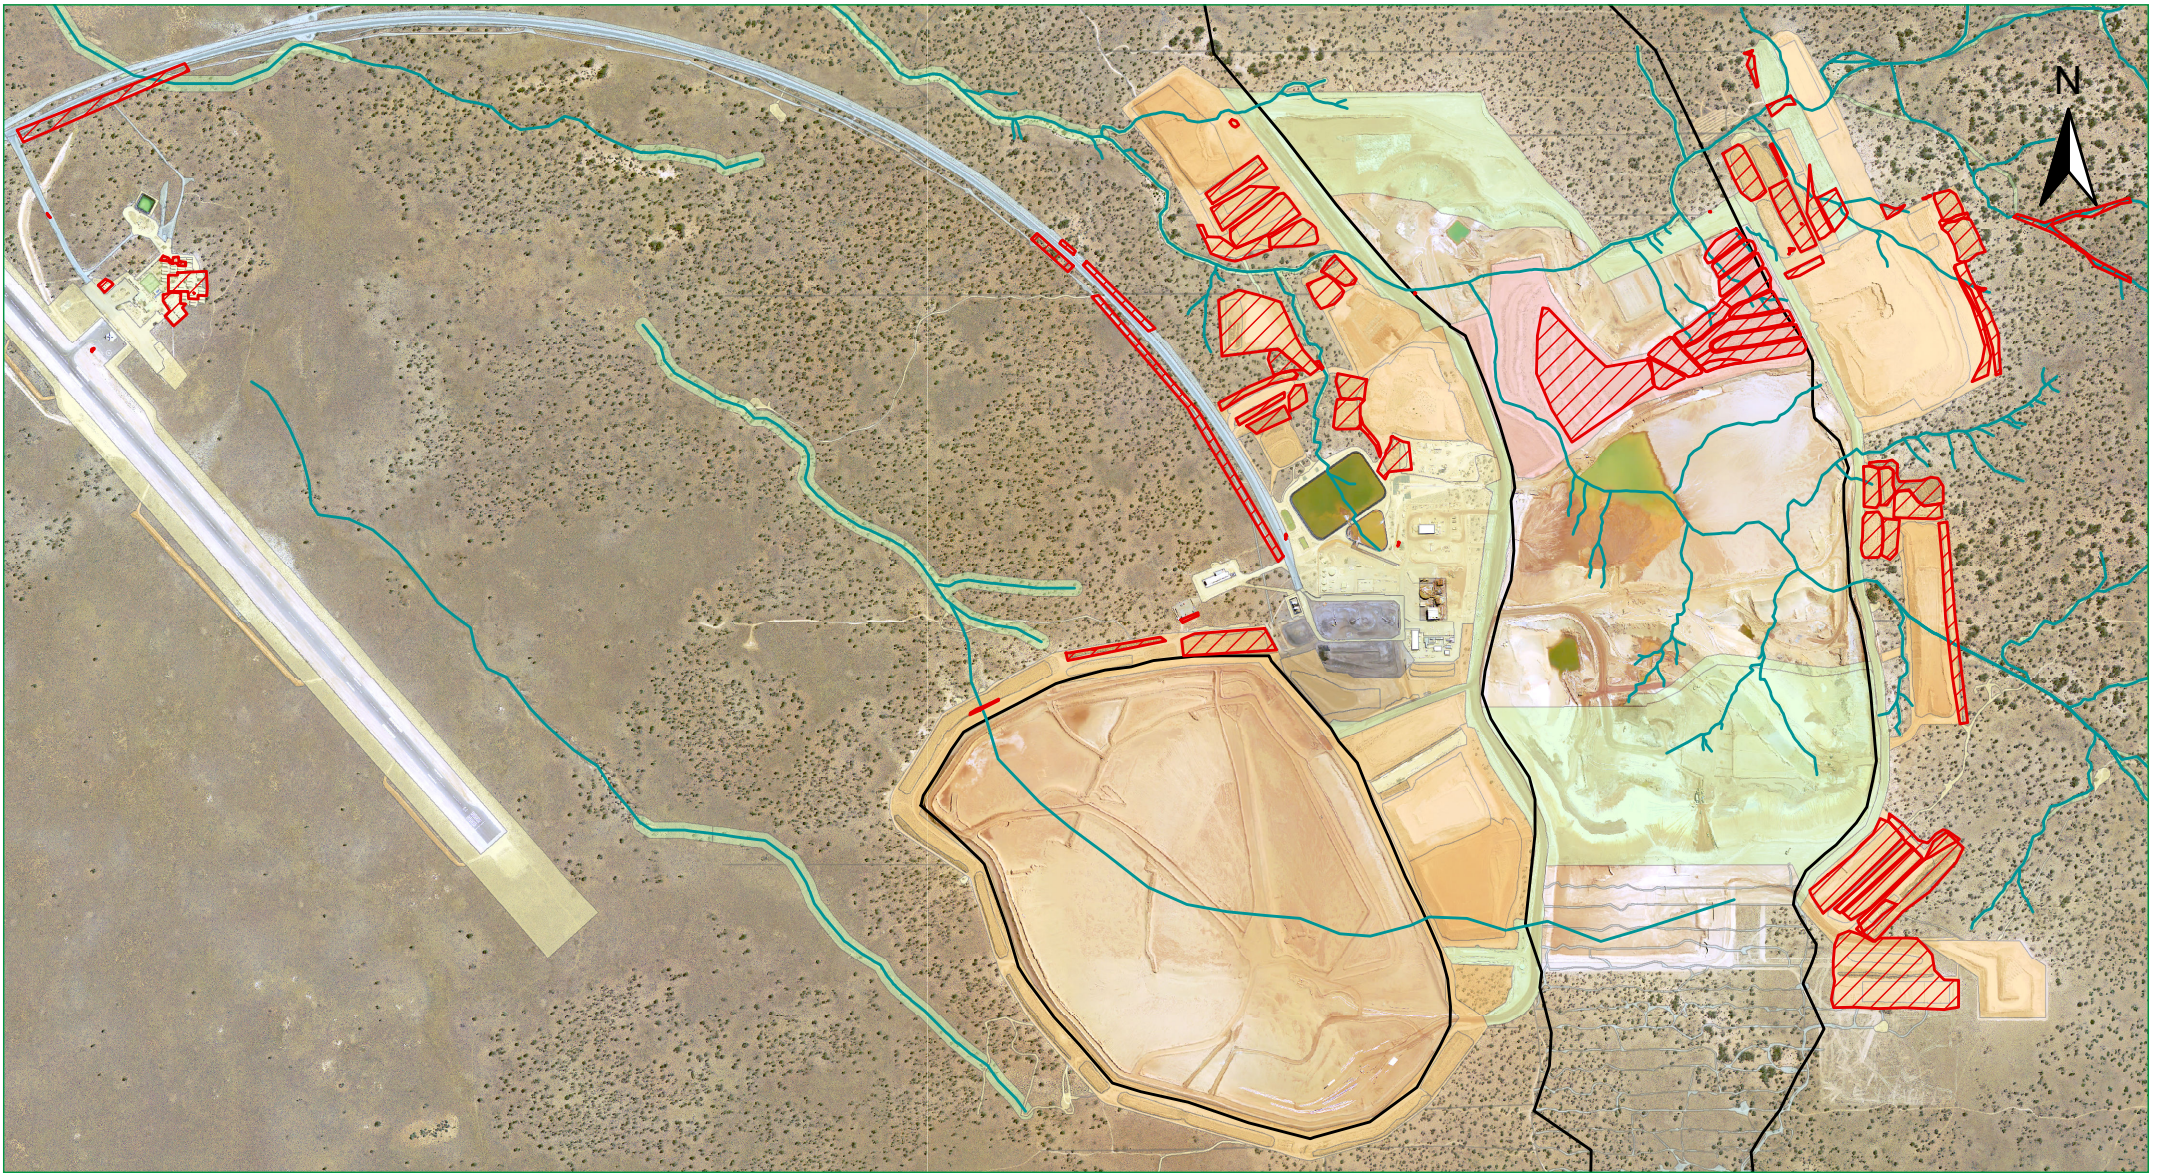
FIGURE: 1

- Location: the landscape types most prone to weed invasion are identified as the highest priority areas, this includes rehabilitation areas, soil stockpiles and areas with frequent offsite vehicle movement (Appendix B Figure 1). All weed species will be managed in these high priority areas, regardless of weed species priority.
- Weed Species: noxious weeds and weeds listed under the NRM Act are given the highest management priority this includes buffel grass, horehound, and ruby dock. These weeds will be managed across all landscape types. They will also be managed on low priority landscape types if they occur in an area that has the potential to influence mining operations, e.g. transport corridor.

Following rain events the ephemeral creeks were also inspected including creeks upstream of the mine area, which upon inspection were infested with weeds and are likely to be a source of weeds entering the mine footprint (Appendix B Figure 1). These areas will continue to be monitored as part of the weed management program.
