DEPARTMENT OF MINES
SOUTH AUSTRALIA

REPORT ON DRAINAGE PROSPECTS

PT. SEC. 521. HD. NOARLUNGA

- Town Planner - re Olson, Mattiazzo, & Agostinetto -

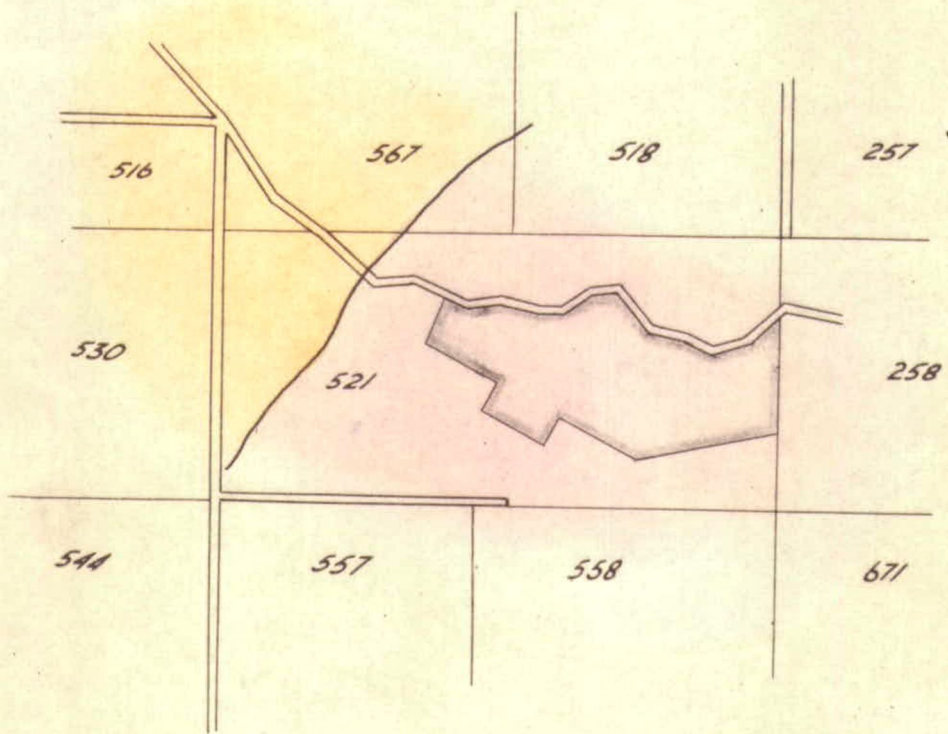
N

TERTIARY

Clays and sands

In the proposed subdivision, the single lines of allotments, such as those north of Seaview drive, and west and south of Romney Road will probably be all right because they will not be receiving effluent from blocks upslope, from which they are separated by a road which will act as an interceptor.

Subsurface drainage is poor. Trouble may occur in two areas, being Allotments 30-38 and 54-59, and it is suggested that Allotments 33, 35, 54, 55 and probably 56 should be deleted. Conditions in the other parts of these areas may not be bad enough to warrant such a recommendation.
