FLINDERS MEDICAL CENTRE - BEDFORD PARK GEOLOGICAL INVESTIGATIONS REPORT NO. 2 DESIGN STAGE

Client: Public Buildings Department

B.J. MORRIS

Rept.Bk.No. 72/27

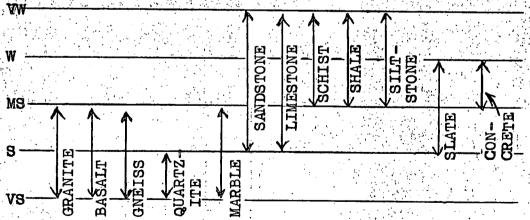
# RANGE OF STRENGTHS OF SOME COMMON ROCK SUBSTANCES IN THE FRESH STATE\*

\*Samples of fresh rock tested to Australian Standard, For rocks showing planar anisotropy the long axis of the sample is normal to fabric planes.
